PAERATA SOUTH
CONTAMINATION STUDY

PRELIMINARY SITE
INVESTIGATION

Project No.	31948	Approved for Issue	
Version No.	1	Name	Ray Hodgland
Status	FINAL	Signature

Authors	T Bellingham	Date	25 August 2010
Reviewer	Sean Finnigan

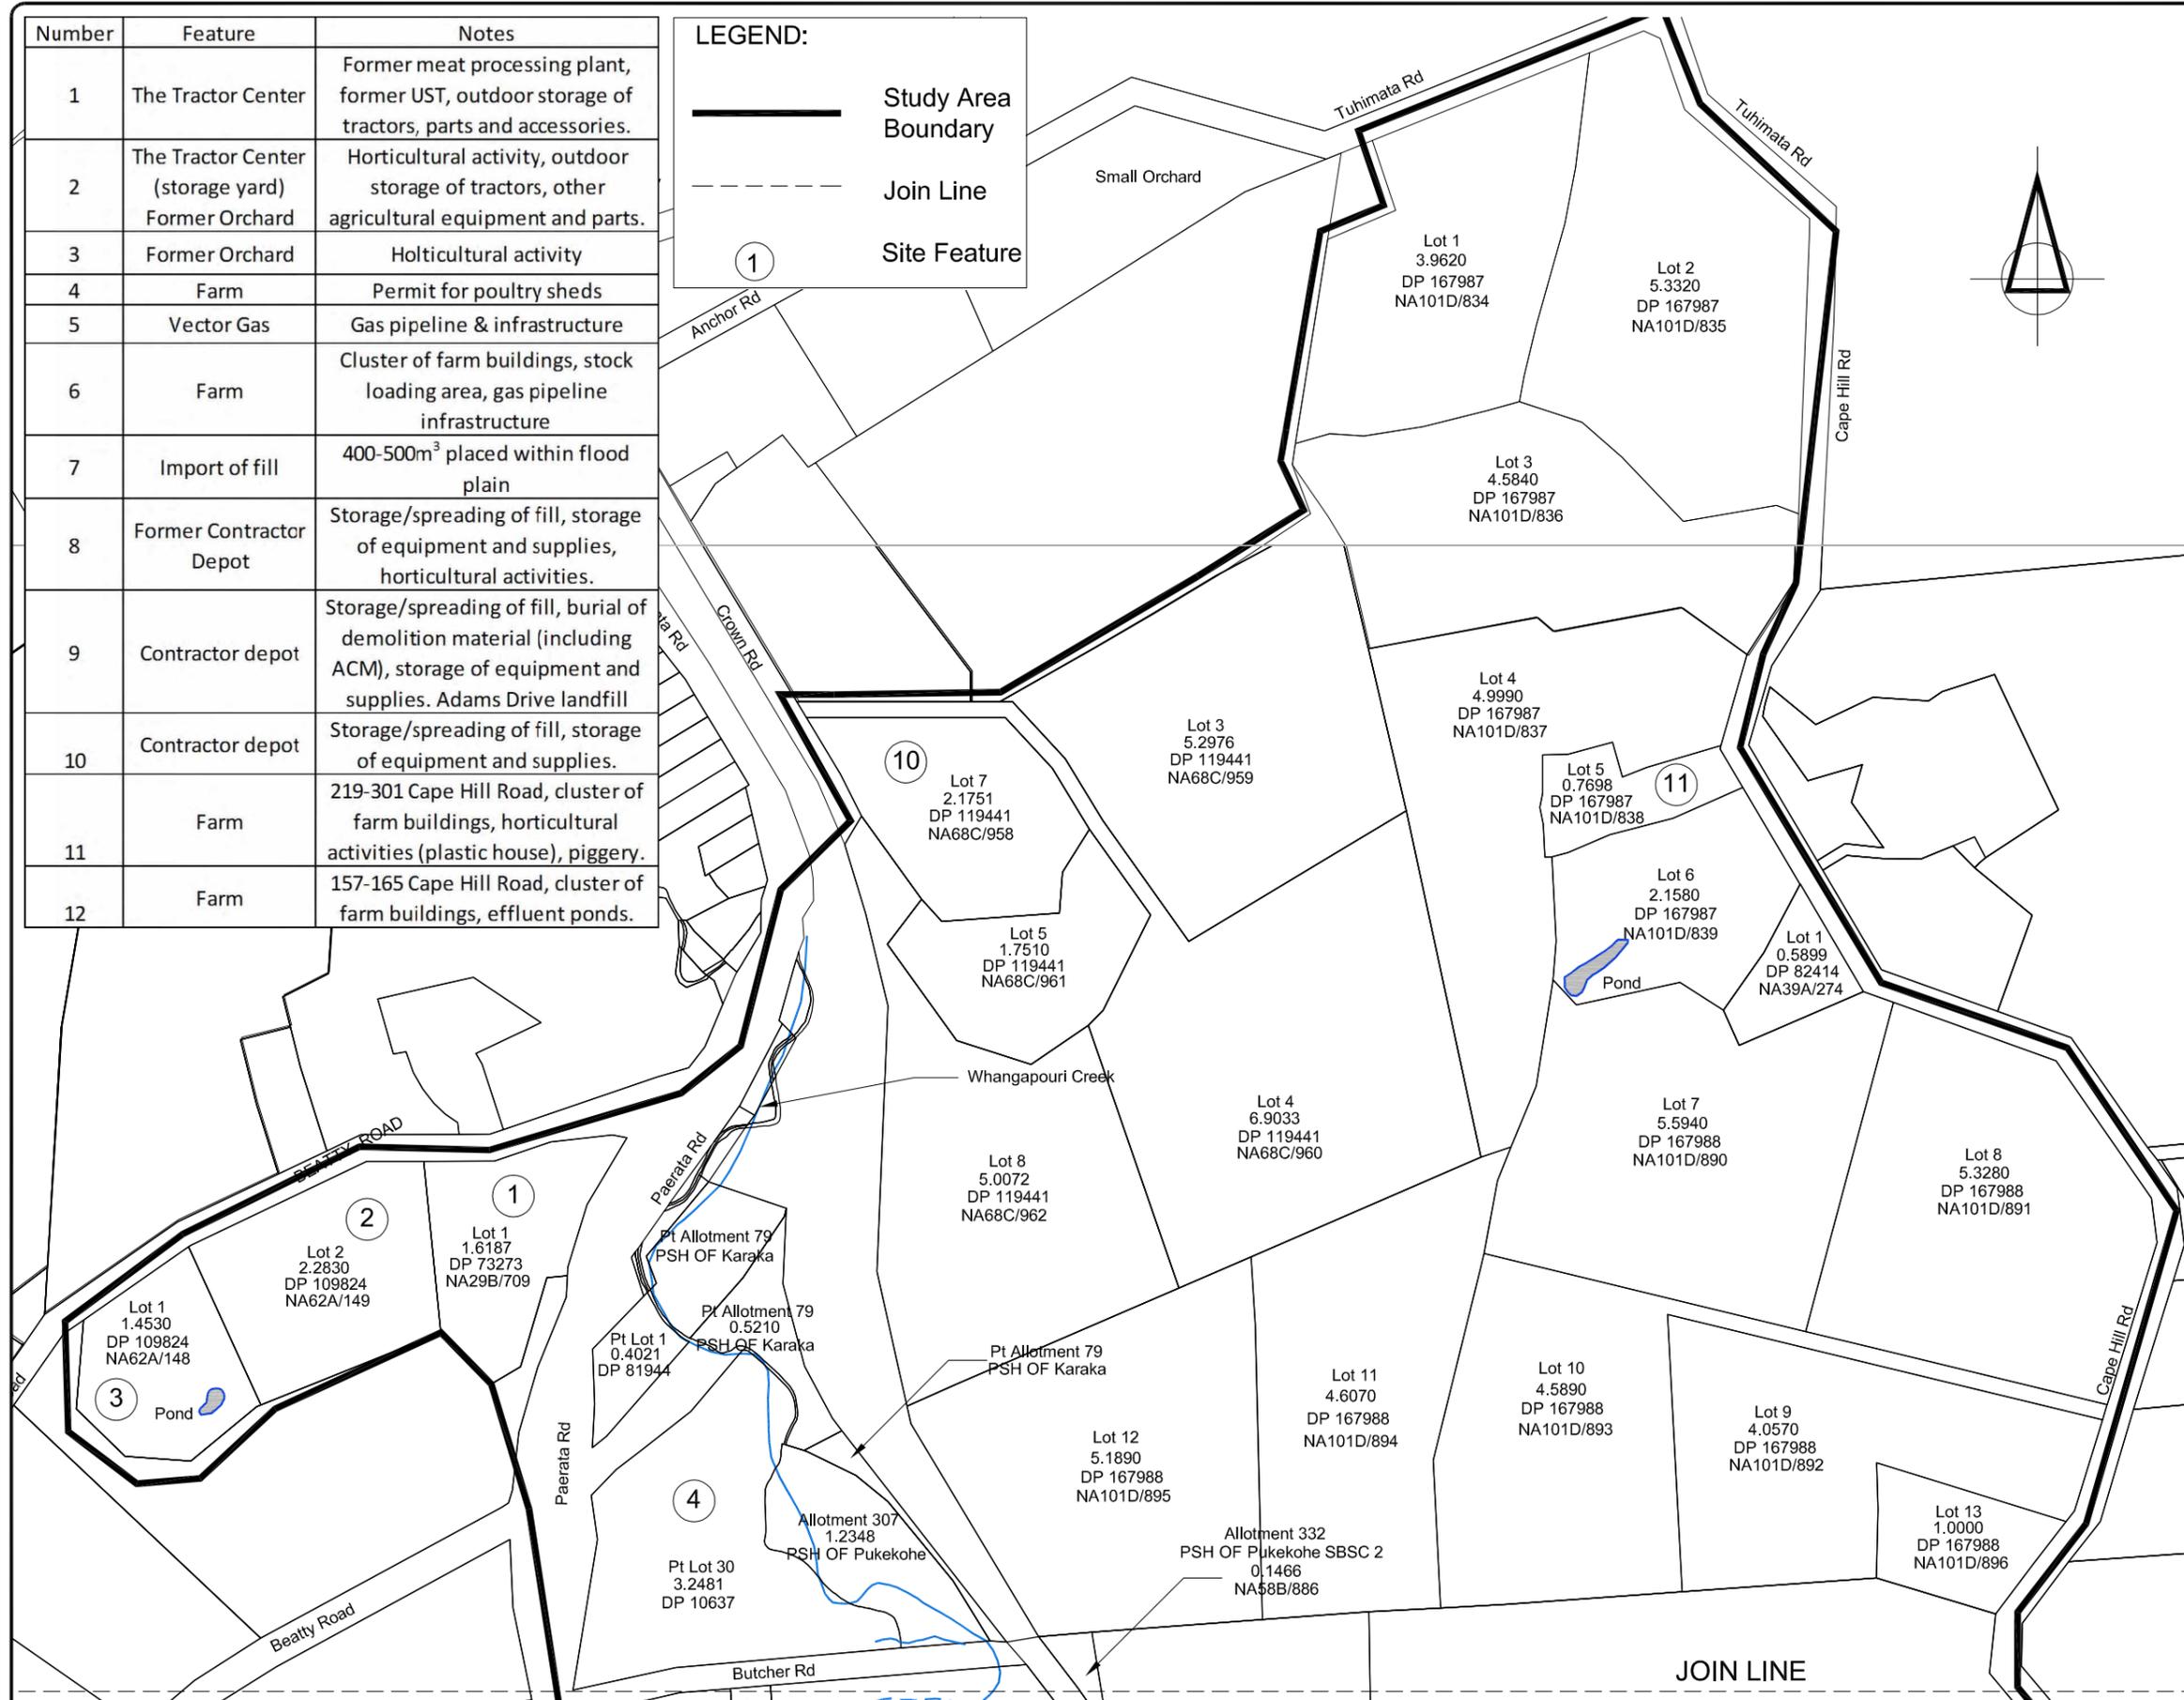
The results of the desktop study and the limited site walkover survey are summarised in this section and illustrated in drawings 31948/1, 2 and 3. Associated site walkover photos are presented in Appendix B of this report. Throughout the site walkover survey, a visual assessment was used to classify any foreign materials as particular contaminants, without any formal identification. Hence, reference to a specific contaminant in the survey results should essentially be read as “suspected contaminant”, unless otherwise stated.

Appellation and certificate of title details are shown on drawings 31948/1-3. There are two main landowners within the study area at present. The entire southeast area (~48ha) is owned by Daniel G. Brownlee Ltd and the northeast part of the site (~52ha) is owned by the McCall family. Other significant landowners include Tuakau Trustee Ltd, TTC Properties, Hongbo Wang, Henry Heng Chiang, Kirk, Flowerday and FDC. Historic certificates of title indicate that the area has mainly been used for agriculture, with farmers being the main landowners in the past.

Drawings 31948/1-3 give appellation details for locating the main sites of concern referenced above. The drawings also contain a table summarising the activities with potential to cause land contamination.

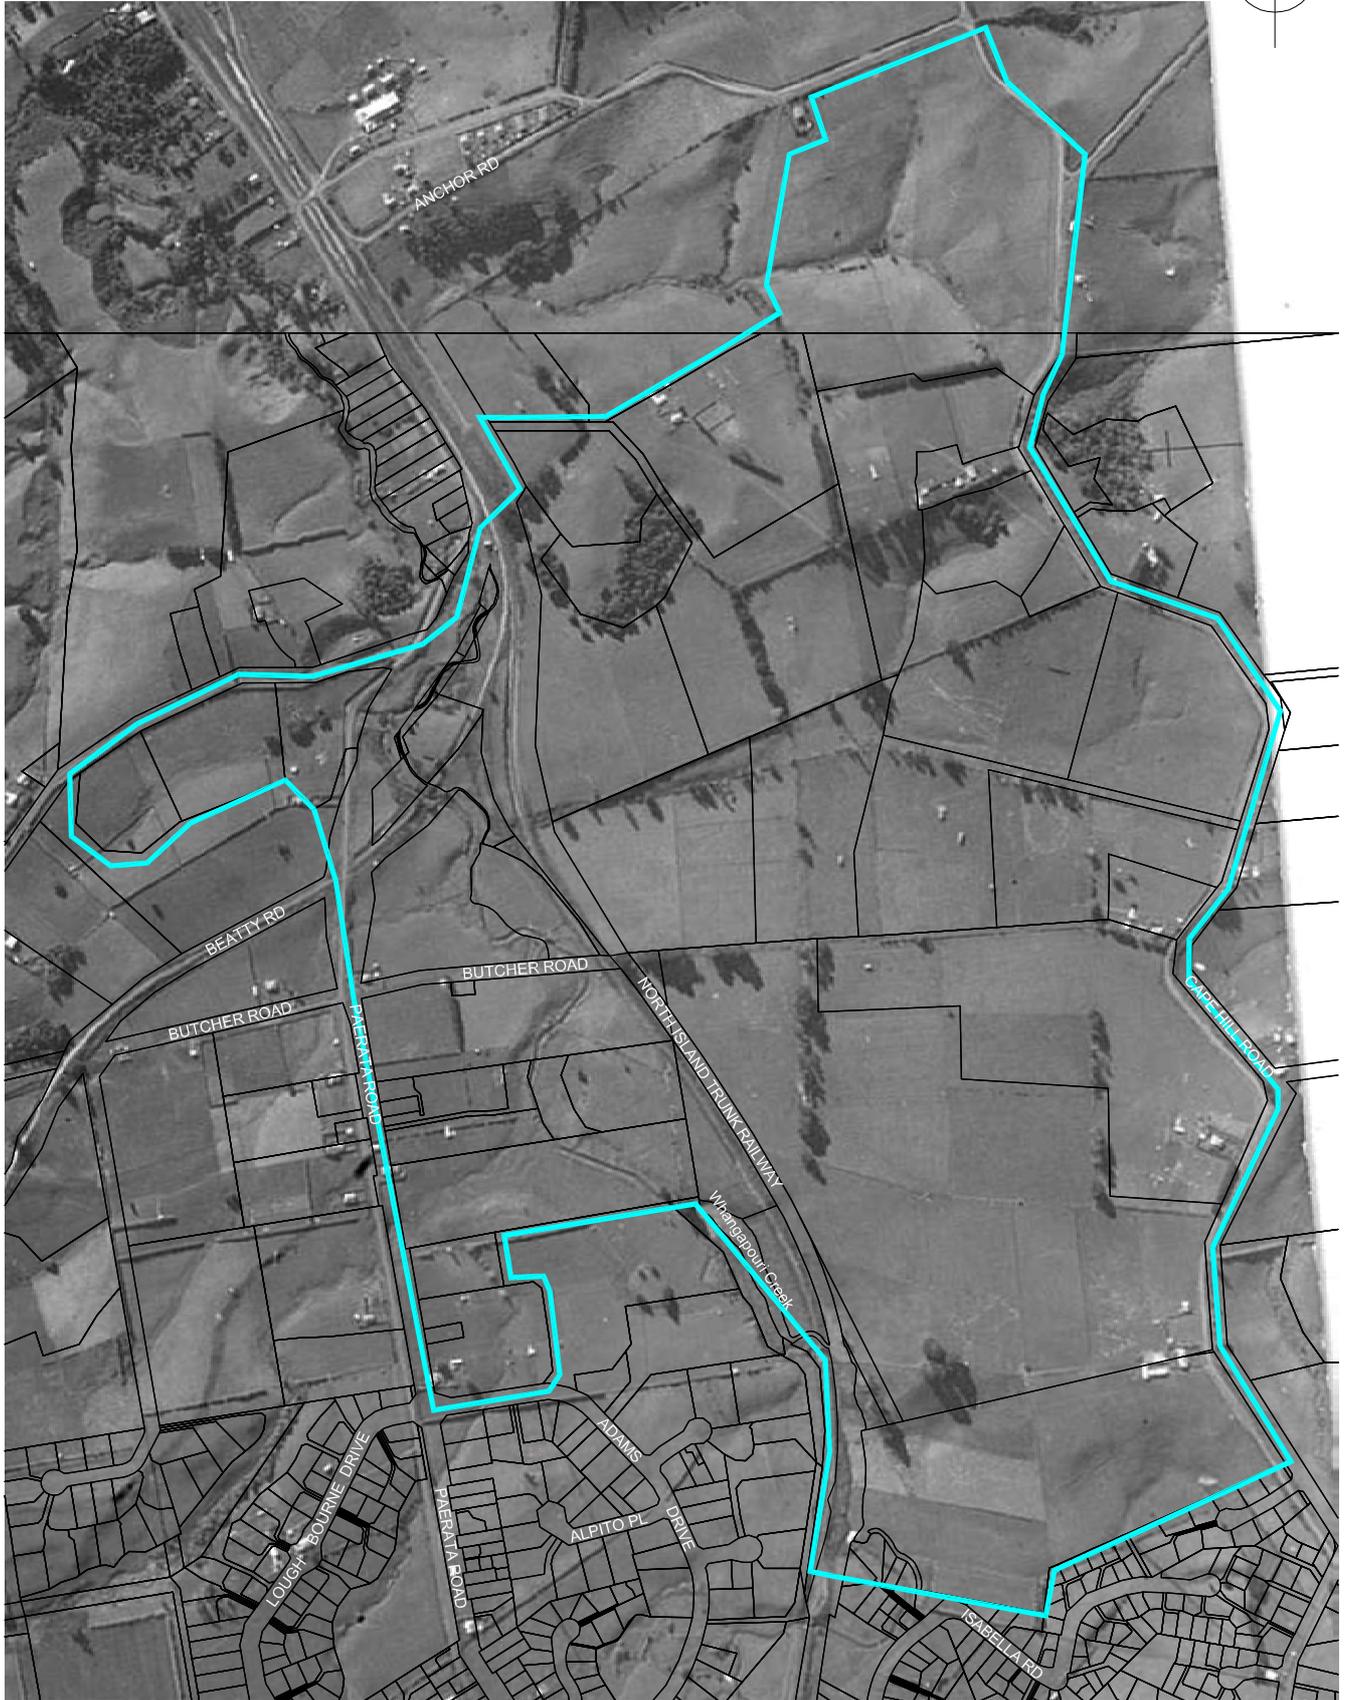
1942 Aerial (Drawing 31948/4)

This aerial photograph shows the entire study area to be in agricultural use. There are farmhouses sprinkled along each of the main roads, and a small cluster of buildings visible at the dairy factory site to the north. The stream through the study area can clearly be seen, and the entire area between the railway line south to Pukekohe and Cape Hill Road comprises farm paddocks. Neither Butcher Road (off Paerata Road), nor the Adams Drive area to the south, exist at this time.

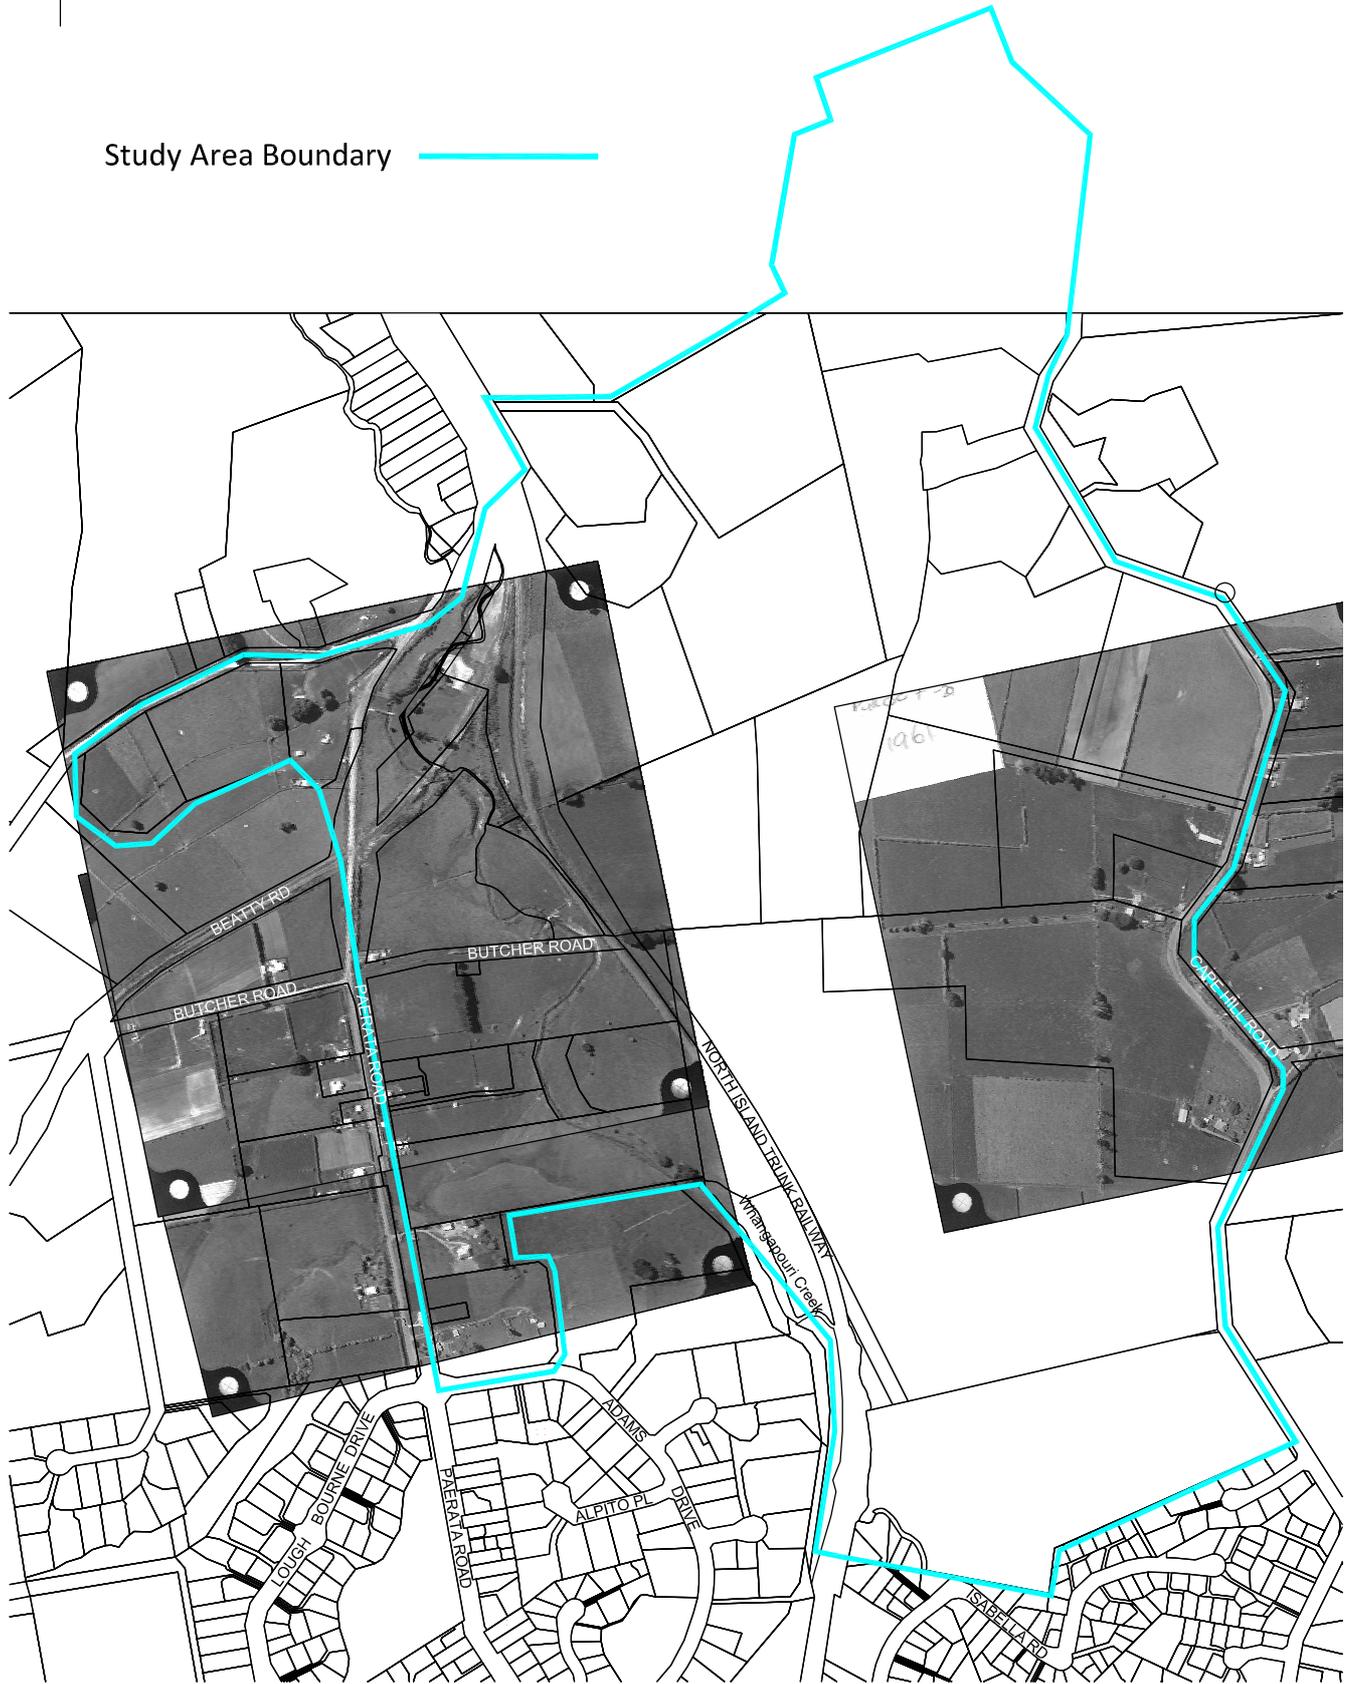
1961 Aerial (Drawing 31948/5)

There are three separate aerials of the area available from 1961, detailing only the section of Paerata Road south of the railway junction and a southern length of Cape Hill Road. Each photograph shows various farm houses to be present, and the main use of land being typically rural. Several small stream crossings appear to be visible over the stream where it crosses Lot 1 DP65101, Pt Lot 30 DP10637 and Allotment 307 Parish of Pukekohe. Some recent earthworks can be seen in the area near Heights Road, and where the railway lines branch. Butcher Road has not yet been formed.
