Western Springs Pine Tree Removal

LUC60321424 C16

Approved Resource Consent
Document

Land Management Plan

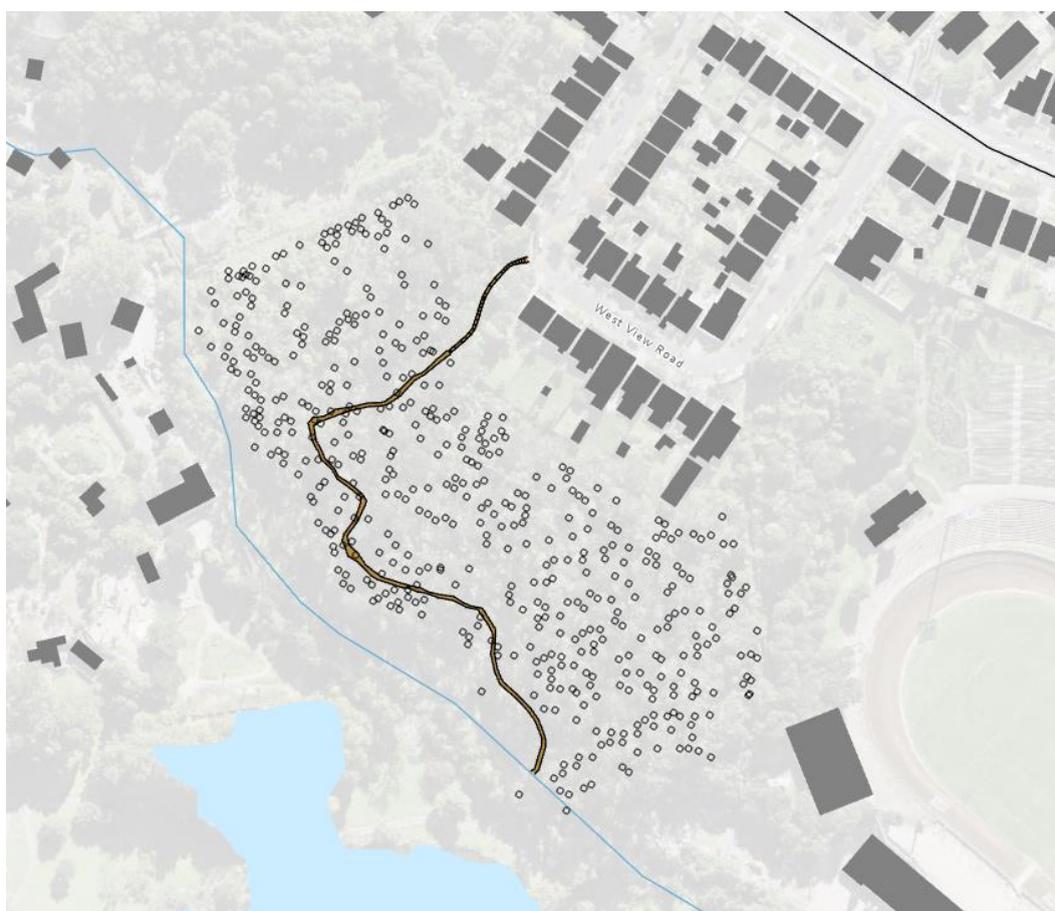
Figure 1: Western Springs pines and surrounding structures.

Existing buildings and structures within proximity to the pine trees includes various structures and enclosures associated with Auckland Zoo located to the west as well as Western Springs Stadium to the east and private properties to the north. Other features within the area includes bridges and stairs along the walking track, stormwater and wastewater infrastructure including underground services, open stormwater channel/streams, manholes and aboveground pipe bridging.

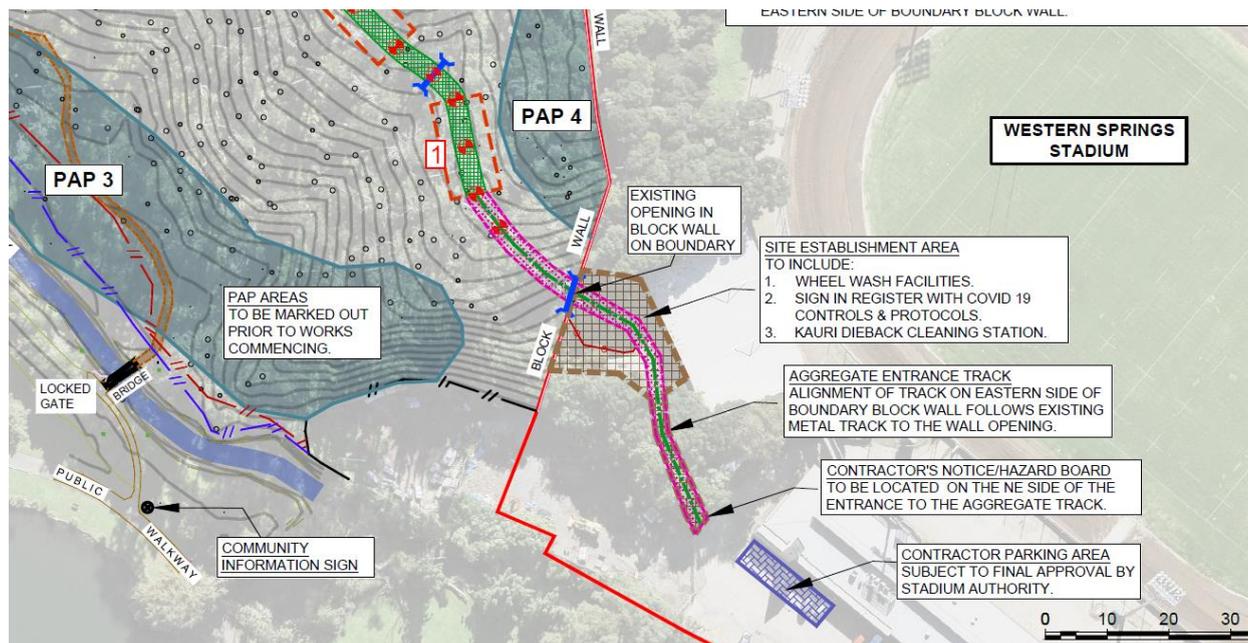
Figure 2: Site establishment area within Western Springs Stadium grounds

The site establishment phase will occur over two weeks involving installation of silt fencing, protective security fencing. Site setup with signage, wash stations and site amenities will be located consistent with the Overall site Plan. Silt and security fencing will be transported into site from two entrances, one via the Motions Creek bridge via Western Springs Park and the other will be through the site access from

Western Springs Stadium grounds. Site sign in register, hazard board, COVID-19 and Kauri dieback wash stations will be established at the site entrance.

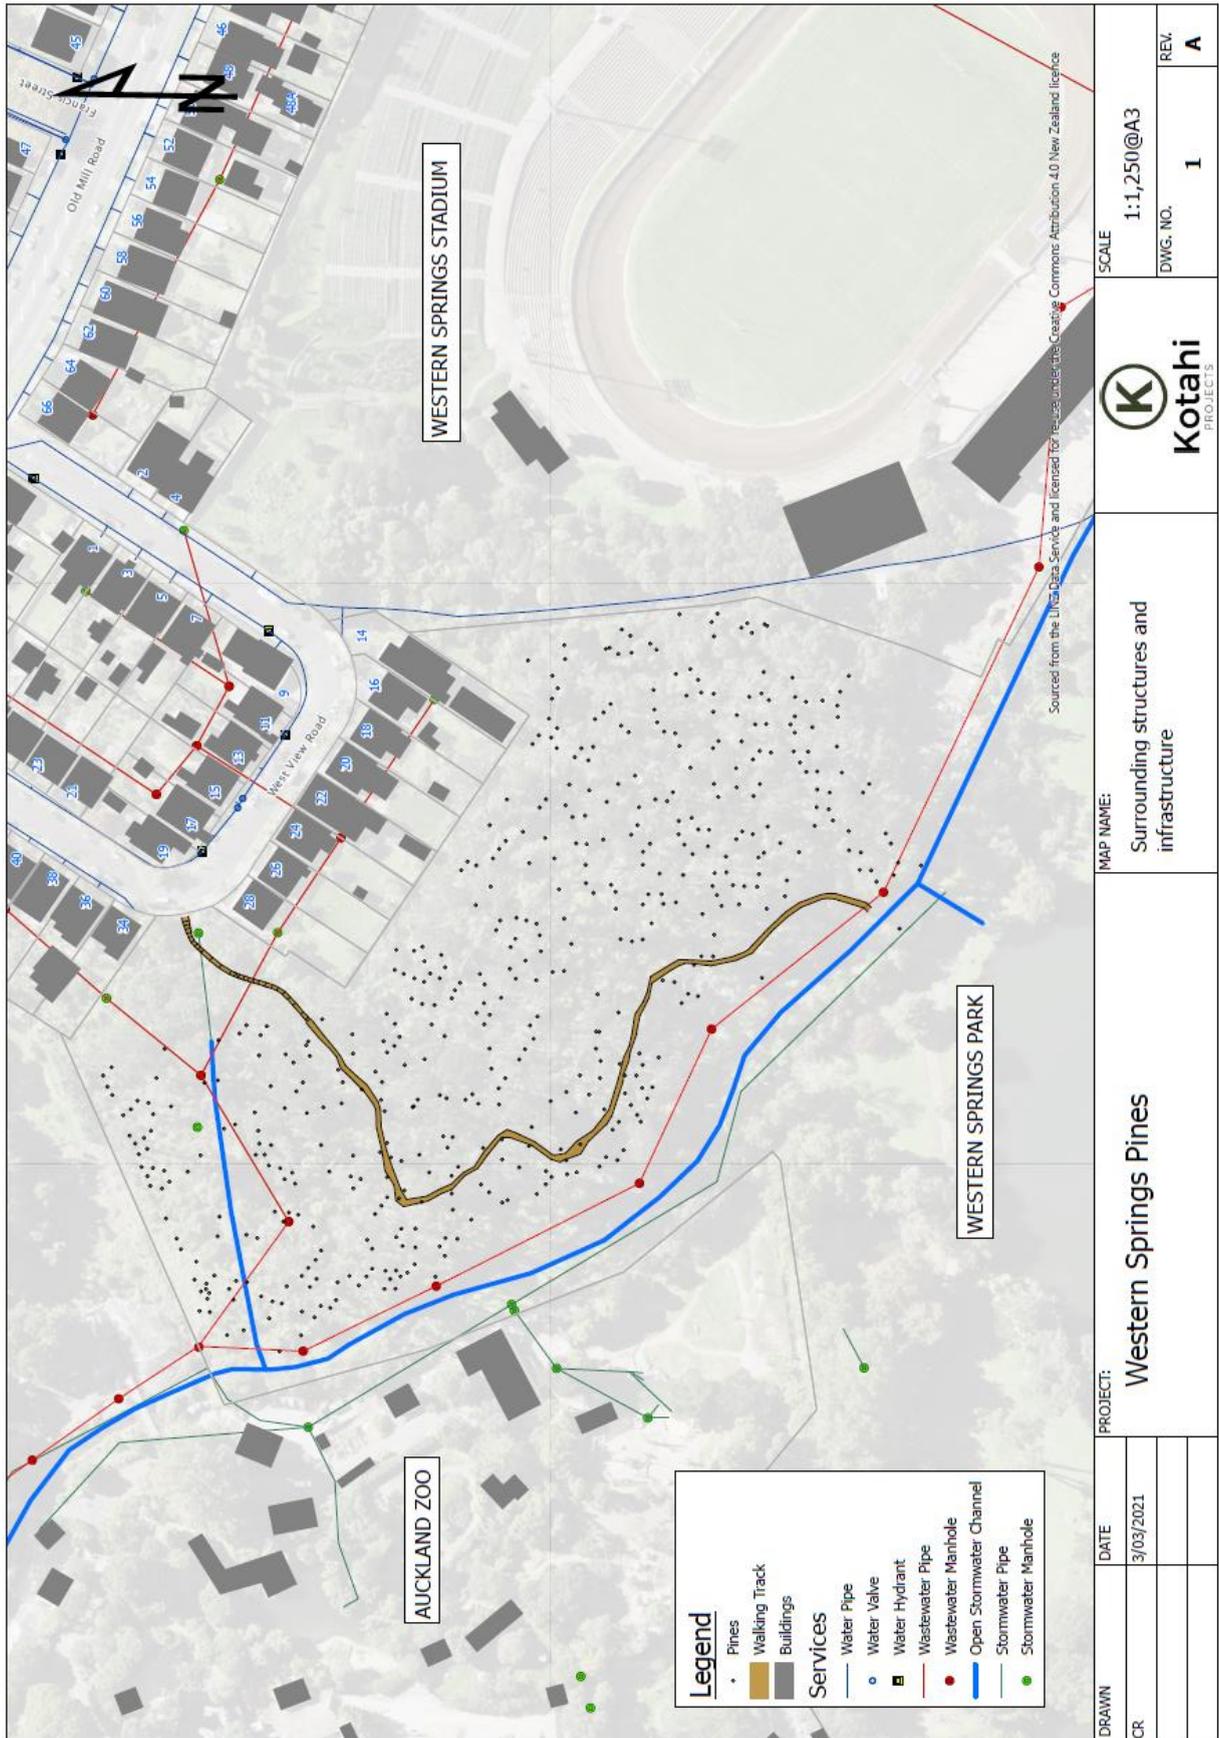
Structures and services
