SCOTT POINT SUSTAINABLE SPORTS PARK

Sustainability Annual Report

October 2021 – October 2022

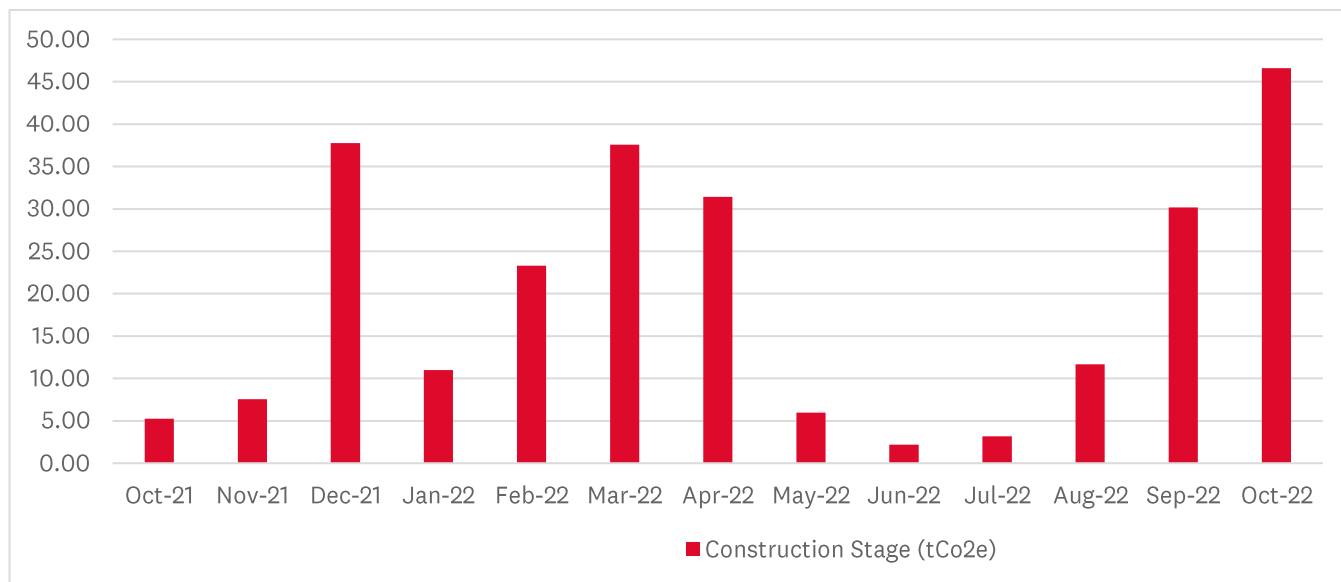
Figure 1 Construction Use Greenhouse Gas Emissions (tCo2e). Note: Excludes vegetation clearance as per Q1 2022.

Over the last year, construction activities produced 202.04 tCo2^e greenhouse gas emissions from 75,107 L of diesel (Figure 2), largely due to: demolition and clearance, earthmoving activities; installation of services and stormwater; and the installation of the carpark and pathways onsite (Error! Reference source not found.2, Figure 2, Figure 3). The lost carbon sink onsite from the removal of vegetation results in a foregone sink of 971.10 tCo2^e greenhouse gas emissions in October and November 2021.

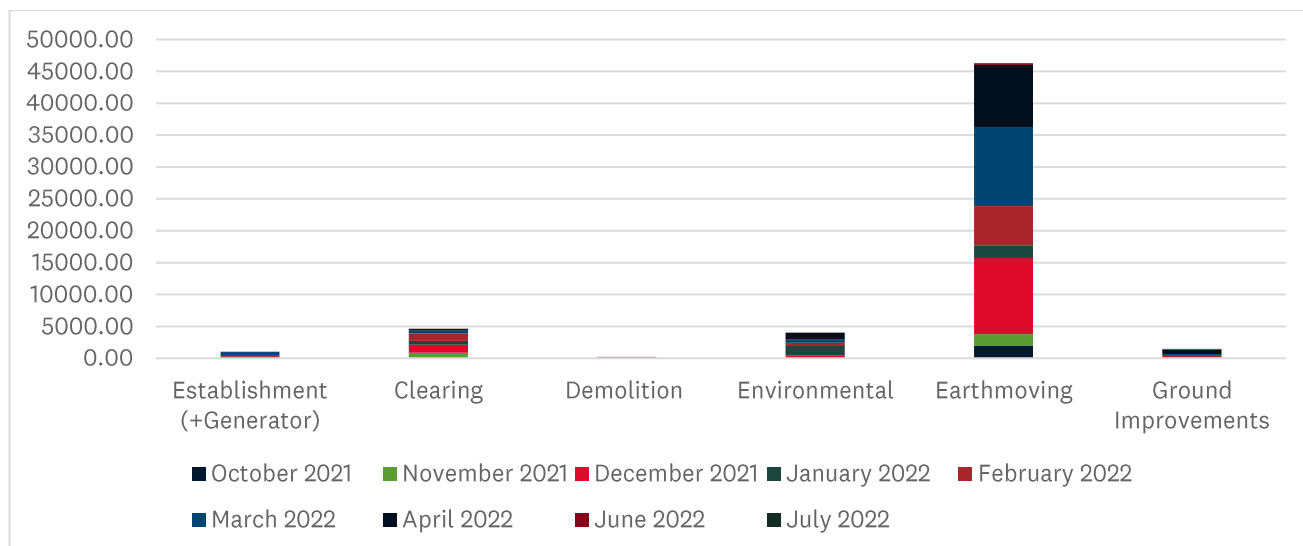
Figure 2 Energy Use (L) within Early Works Phase by category

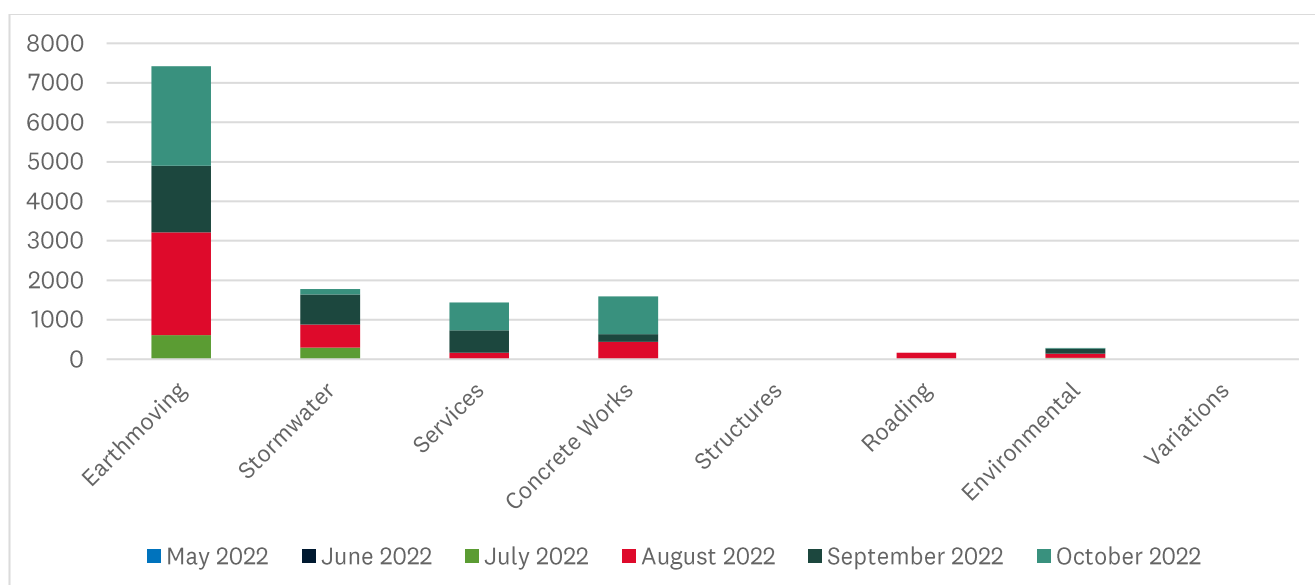
Figure 3 Energy Use (L) within Construction Phase 1A by category

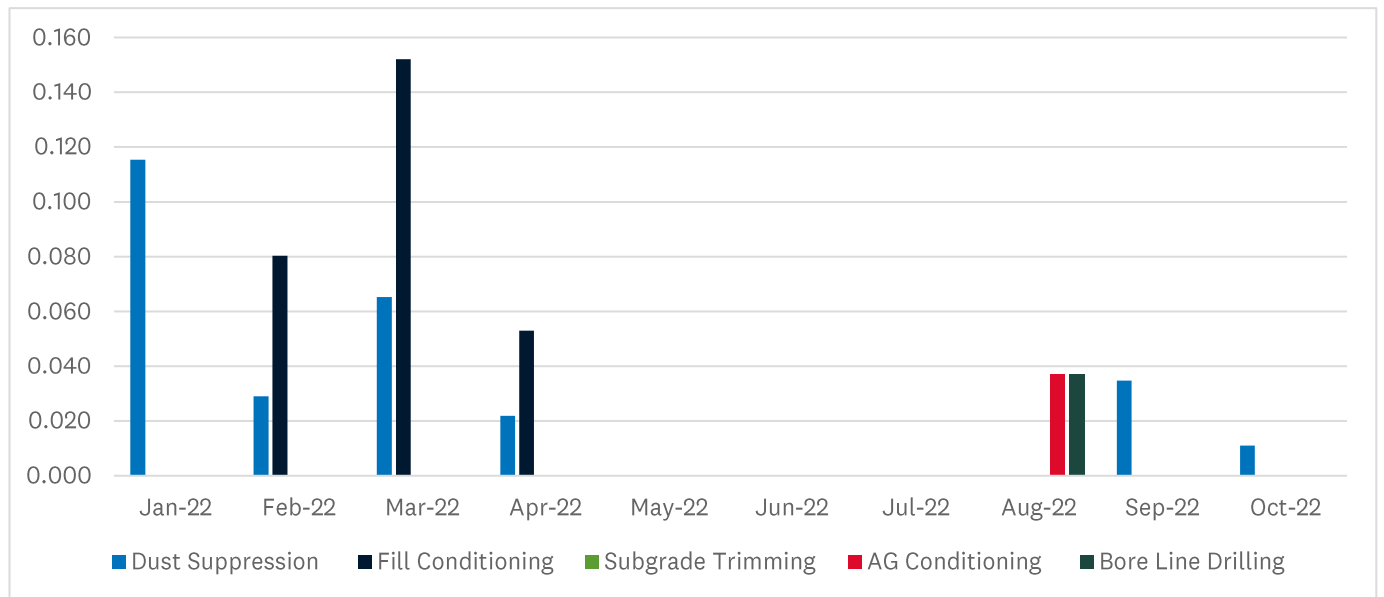
Figure 5 Water Use - Construction Stage (ML)

To date 0.96ML of water has been used onsite for dust suppression, fill conditioning, subgrade trimming to date, AG Conditioning and Bore Line Drilling (Figure 5), with 2.1ML provided for every month of earthworks within the Actual Case for a 12-month earthworks season. All water used onsite to date has been from a non-potable source - 100% from the onsite bore.

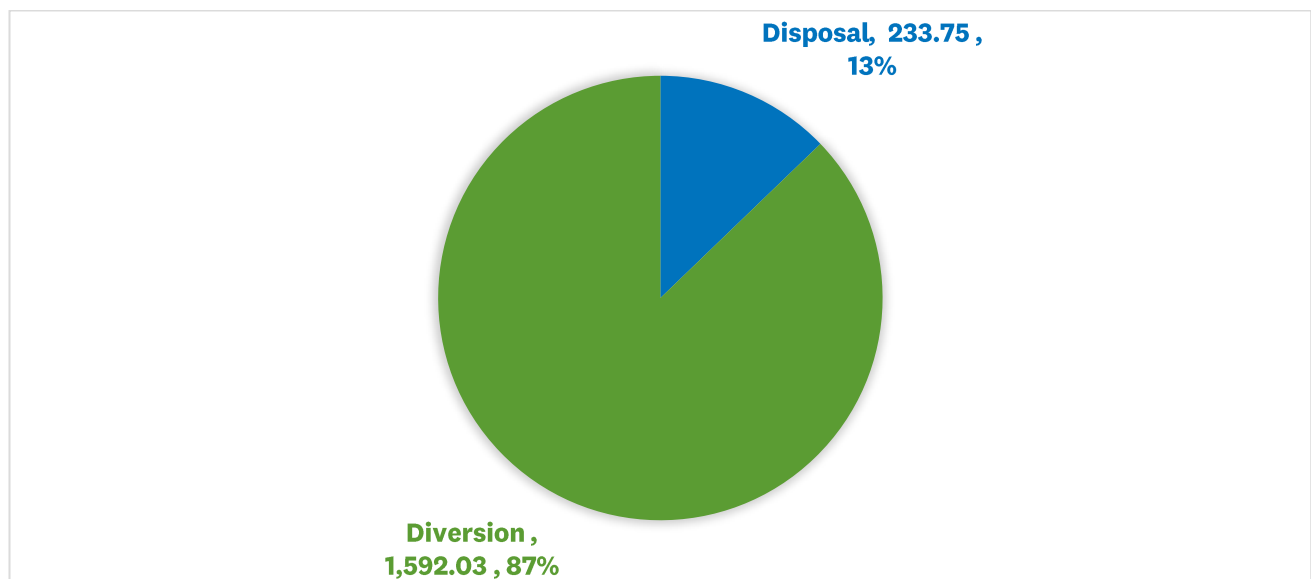
Figure 6 Construction and Demolition Waste Diversion to date (tonnes & percentages)

Construction and demolition waste diversion is at 87% currently, dropping 3% off the targeted 90% (Figure 6). This is slowly crawling back toward 90%. Investigation is underway into the upcoming waste creation streams anticipated for Phase 1a in order to ensure waste diversion options are investigated and implemented ahead of time.
