Rawene Road Update

Friday 29th June 2018

Land slip remediation activities on site

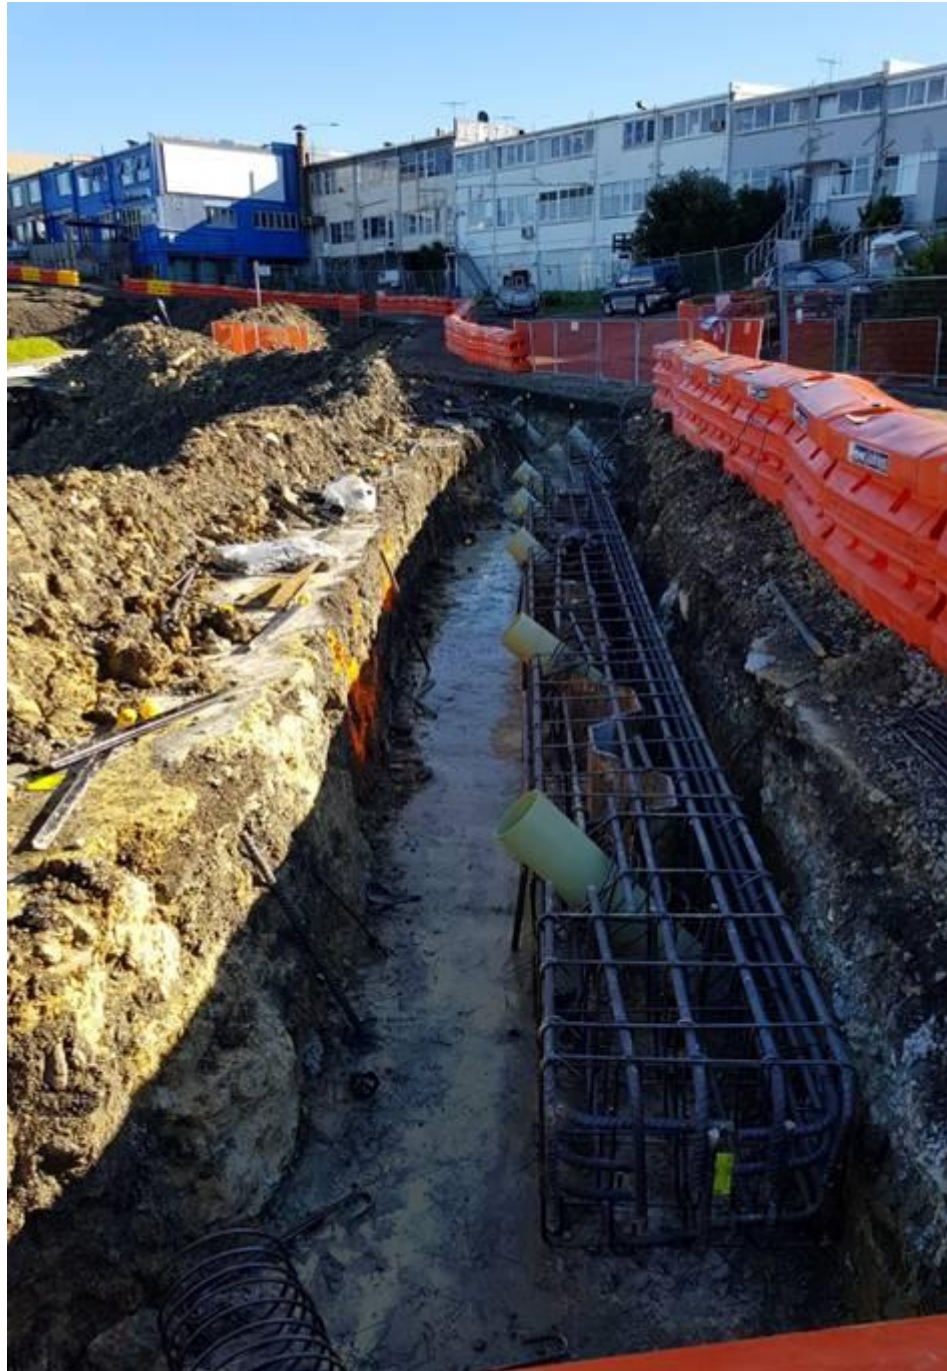
The first photo, taken from the western side of the site, shows the cut sheet piles and capping beam trench. The piles are now all a uniform height, about

0.5 metres from the bottom of the trench level. They are being enclosed in steel, for strengthening. This work will continue along the entire length of the piles towards the eastern end of the site, effectively all the way along the plastic barriers to just beyond the top left corner of this picture. This is expected to take another week or so. The concrete capping beam will be poured over the entire trench, encasing the steel-enclosed sheet piles, and connecting all of the piles together as one structure.

- Concrete will be cast over the trench and sheet piles – it is expected that this will be in a week or so and can be done in one day.
- A fence (or hoarding) will be installed along the top of the beam, as well as water filled crash barriers to prevent cars from driving over the top of the beam. A kerb and channel will also be installed to direct water towards catchpits.
- Installation of the retaining wall for the access ramp.
- Installation of column drains to help remove water from the slope.

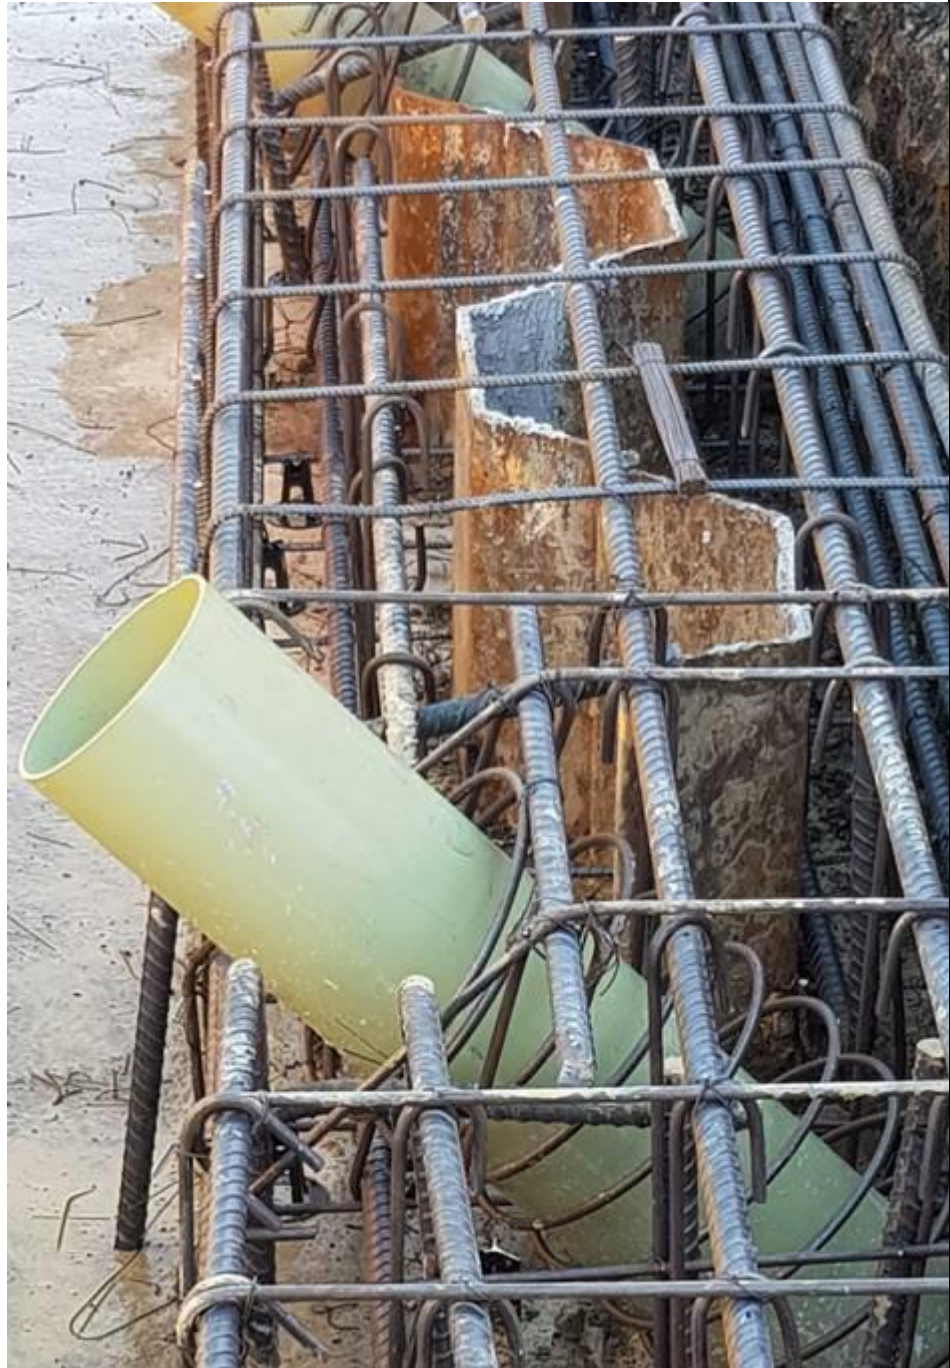
The second photo is a close up of the steel enclosed sheet piles. A number of ducts or holes are being constructed along the capping beam to allow for the installation of ground anchors if required as part of the stabilisation works. These are the pipes that can be seen along the length of the works. At this stage, it is still undecided about whether the ground anchors

are going to be required, but provision is being made for them as provided for in the stabilisation design.

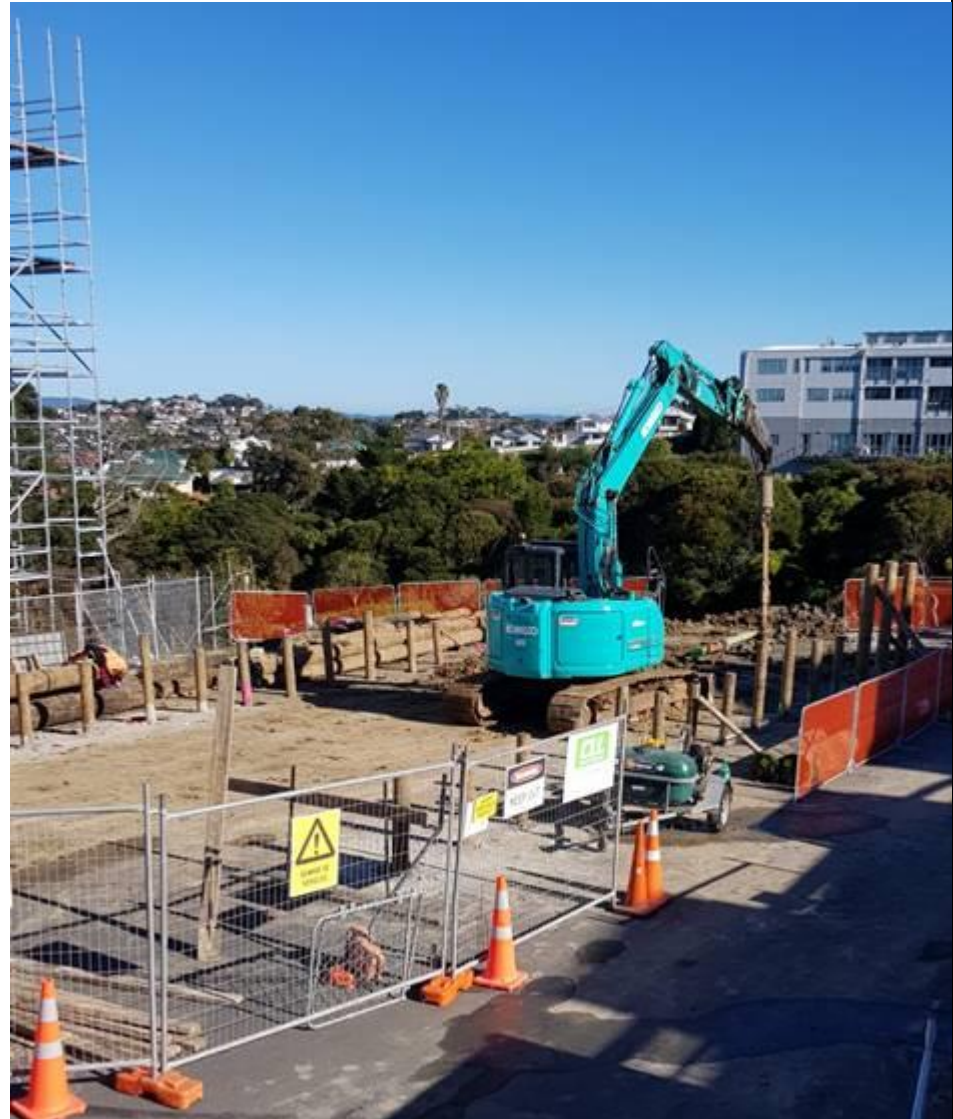
The final photo, taken from the public carpark, shows the construction of the new vehicle access (path) that will lead to the area of new parking below the sheet pile stabilisation work. A timber-pole retaining wall is currently being constructed on either side of the new accessway. Once the retaining is complete, the digger will begin to remove material from the path to create the vehicle access down towards the new carpark site.
