Harania Flood Resilience Works - Tennessee Bridge

Ecological Impact Assessment

Prepared for
Auckland Council

Prepared by
Tonkin & Taylor Ltd

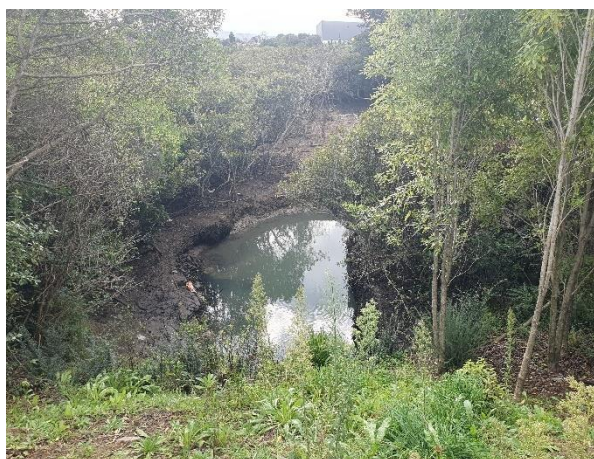
Photograph 4.1: Coastal mangrove habitat north/downstream of the Tennessee embankment.

The CMA is defined by Auckland Council as the area downstream (north) of the Tennessee embankment. During low tide, a low flow channel meanders through the mangroves providing connection between the subtidal area and the upstream permanently flowing freshwater environment (Photograph 4.1). An embankment housing the Eastern Interceptor Sewer pipe forms a partial barrier between the lower tidal reaches from the upper freshwater reaches; twin culverts of approximately 1200 mm \varnothing maintain flow connectivity through the embankment. Similar mangrove habitat exists upstream and downstream of the embankment (described further in Section 4.2.3.1).

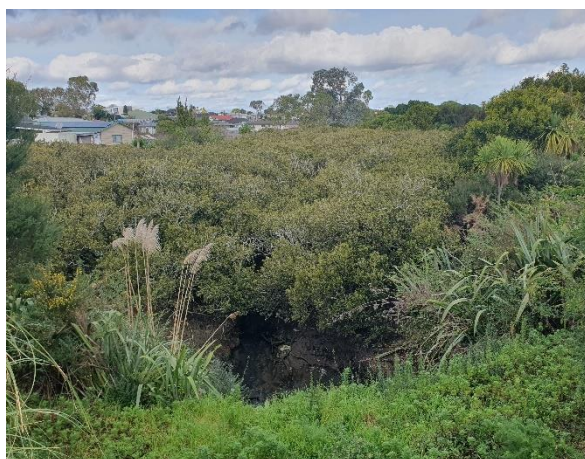
Photograph 4.2: Coastal mangrove habitat south/upstream of the Tennessee embankment.

The extent of the Tennessee branch to the south/upstream is considered to be a 'river or stream' under the RMA, despite the predominantly estuarine/coastal characteristics (Photograph 4.2). While deemed a 'river', its freshwater elements are limited to those present during low tide within a shallow subtidal channel. The twin culverts that connect the upper and lower reaches of the Tennessee branch are not currently acting as a significant barrier to fish passage.

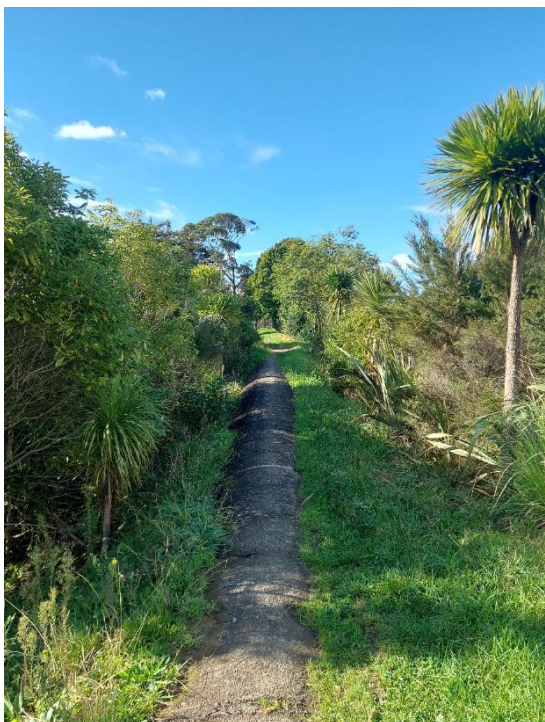
Photograph 4.3: Native vegetation either side of the Eastern Interceptor pipeline.

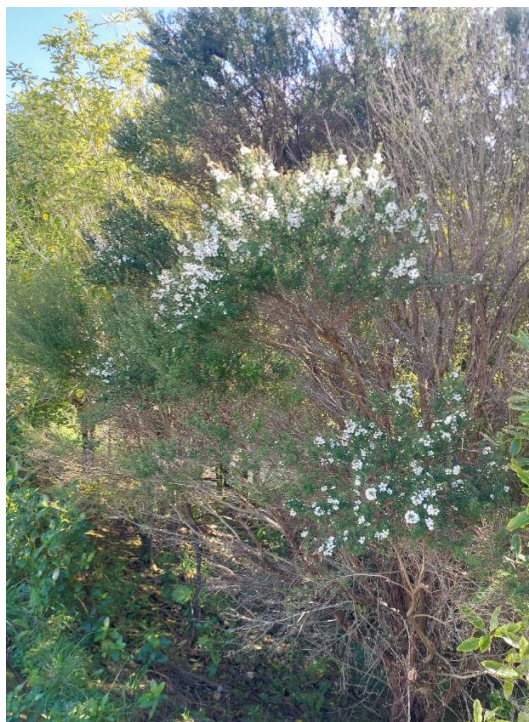
Photograph 4.4: Mānuka shrub forming part of the native vegetation along the Eastern Interceptor pipeline.

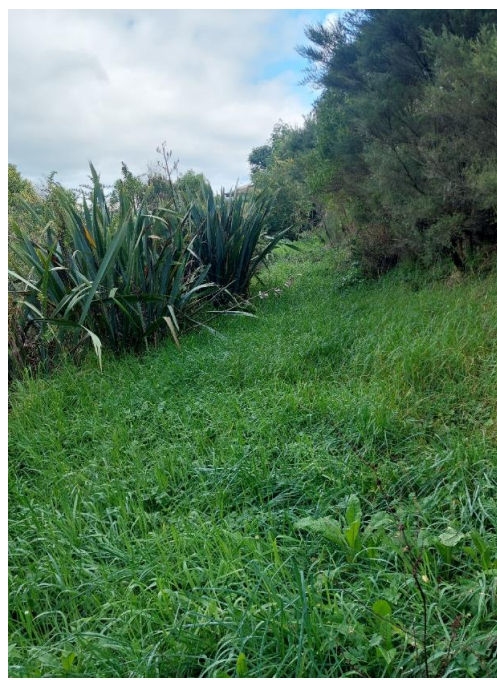
Photograph 4.6: Rank grassland south of the Eastern Interceptor pipeline.

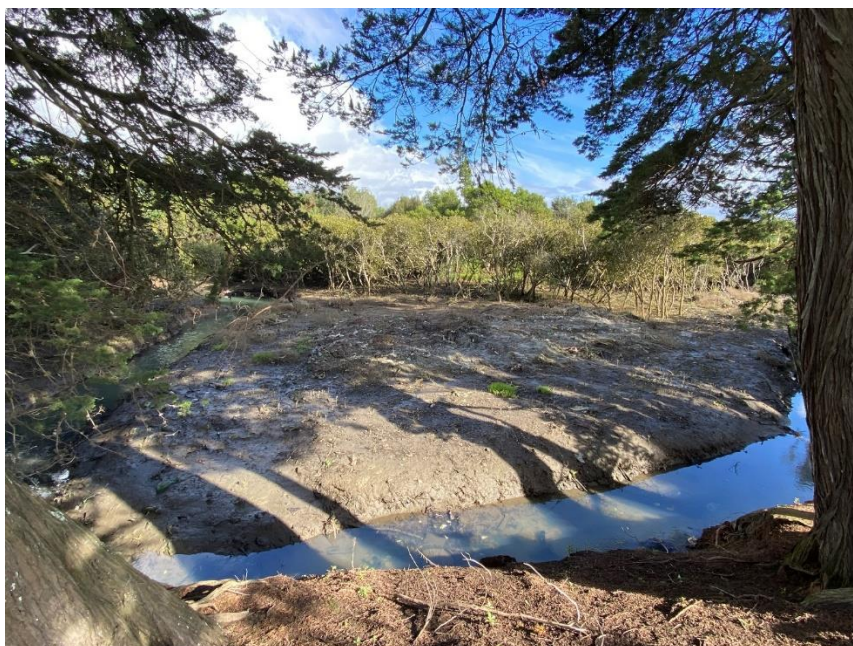
Photograph 4.7: Area of cleared mangroves, north/downstream of the Tennessee embankment.

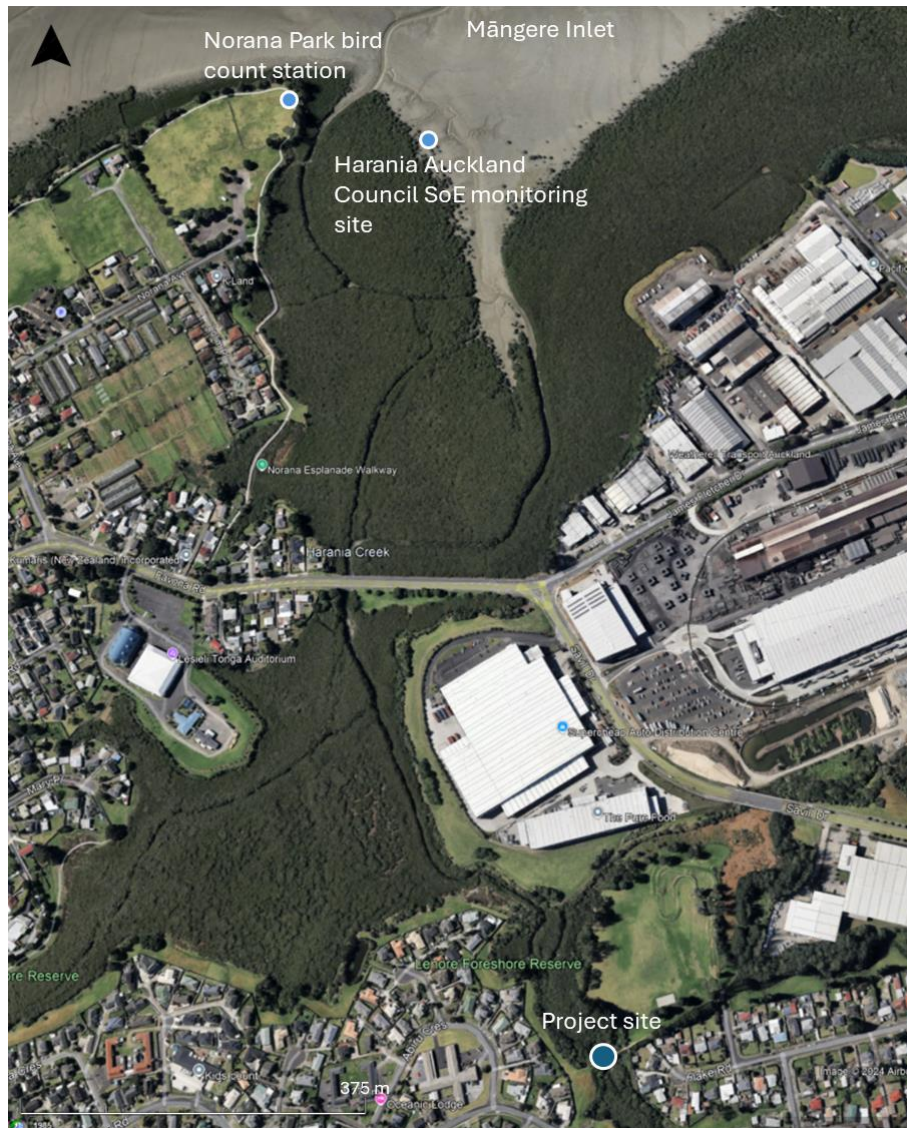
Figure 4.1: The project footprint (Tennessee embankment) in relation to the Māngere Estuary, Auckland Council State of the Environment (SOE) monitoring site and previous bird survey undertaken within the area (De Luca et al, 2016).
