Community newsletter

Muriwai Beach cyclone recovery

Pages 2-9 | In this edition geotech and natural hazards specialist **Ross Roberts** describes the geotechnical situation in Muriwai and introduces some of the concepts being considered to inform the next steps.

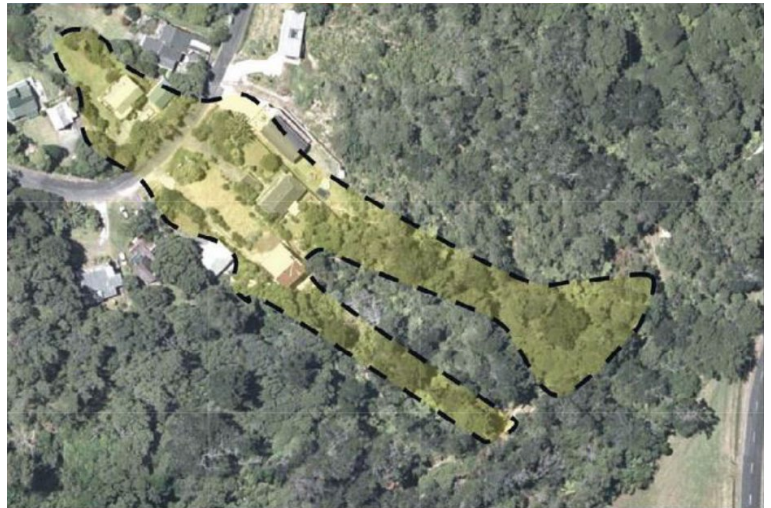
Figure 2: Figure 2: Map of the 1965 landslide extent overlain on the 2006 aerial photograph (from Bruce Haywards paper "The tragic 1965 Muriwai Landslide" published in *Geocene* 28: 2-5 (https://gsnz.org.nz/assets/Uploads/branches/Geocene-28_Feb-2022.pdf))

In August 1965, following heavy rainfall, landslides occurred on consecutive days at the south-east end of Domain Crescent, completely destroying two houses and killing two people. The landslide extent is denoted in yellow in the figure below. The debris avalanche flowed right across the road and deposited sediment up to 1.5 m thick over parts of 34 and 36 Domain Crescent. The destroyed batches were on the uphill side of the road. One was demolished while the second was swept off its foundations and carried across the road.

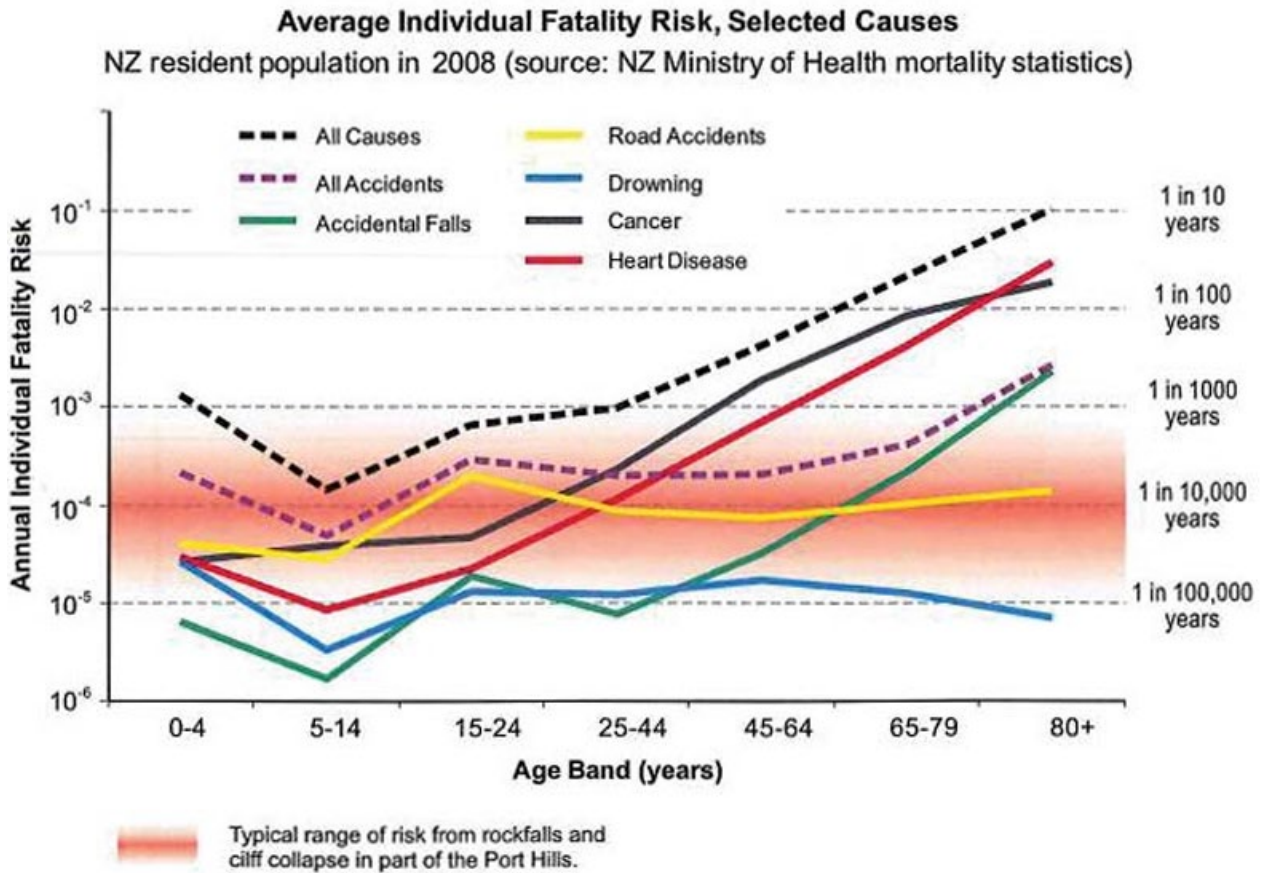
Figure 6: Average individual fatality risk New Zealand residents are exposed to from a range of hazards and other causes, with the risk of cliff collapse in the Port Hills after the Canterbury Earthquake Sequence highlighted in orange as an example of a similar

Although the phrase "safe as houses" implies that buildings are very safe, nothing is perfect. Our building code sets a standard for new buildings of 1 in 1,000,000 (the bottom line on the graph in Figure 6). In New Zealand this is generally considered "safe".
