# Healthy Waters – Te Ararata Flood Resilience Works – Walmsley Road Bridge Replacement

Landscape and Natural Character Effects Assessment  
Prepared for Healthy Waters  
5 November 2024

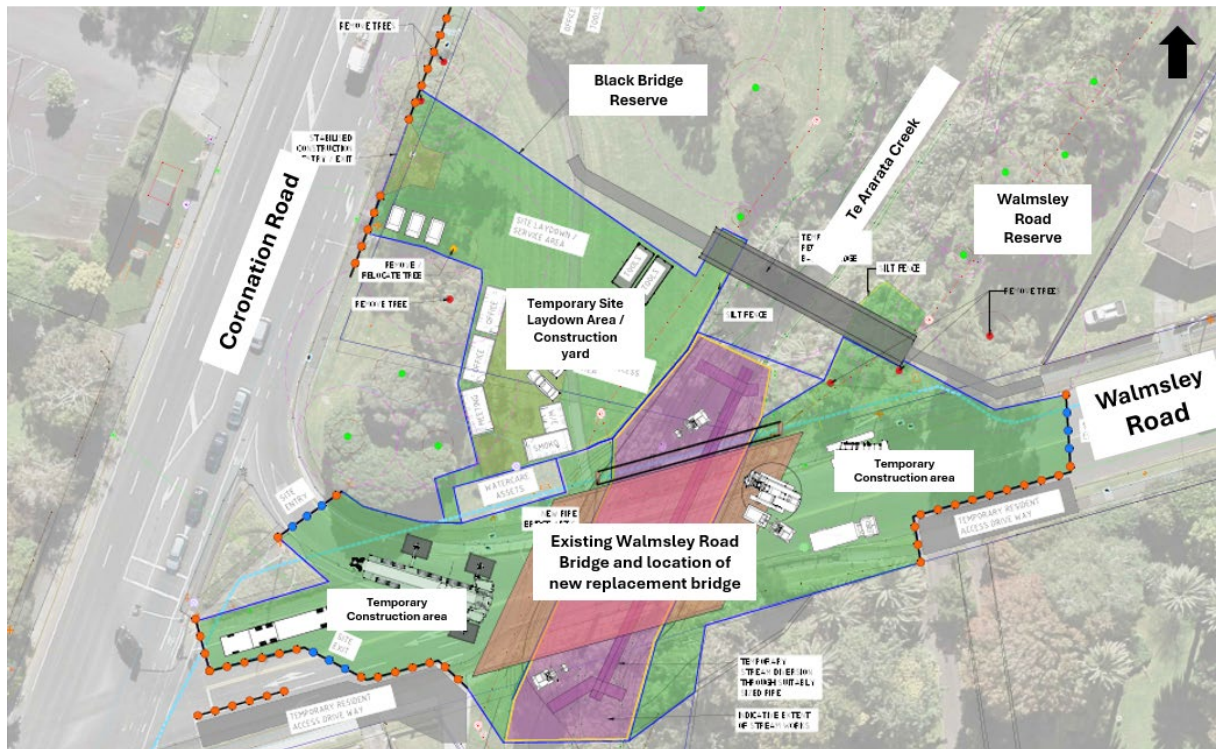
Figure 1: Proposed location and works extent for the Project Site

It is noted other activities such as temporary construction yards/laydown areas and construction equipment (i.e., cranes) will also be located within the Project Site. These are not however within the scope of this assessment as they can be undertaken as Permitted activities under the relevant chapters of the AUP OiP including under Chapter E26 Infrastructure and E40 Temporary Activities. The full list of relevant Permitted activities are further identified in the AEE.

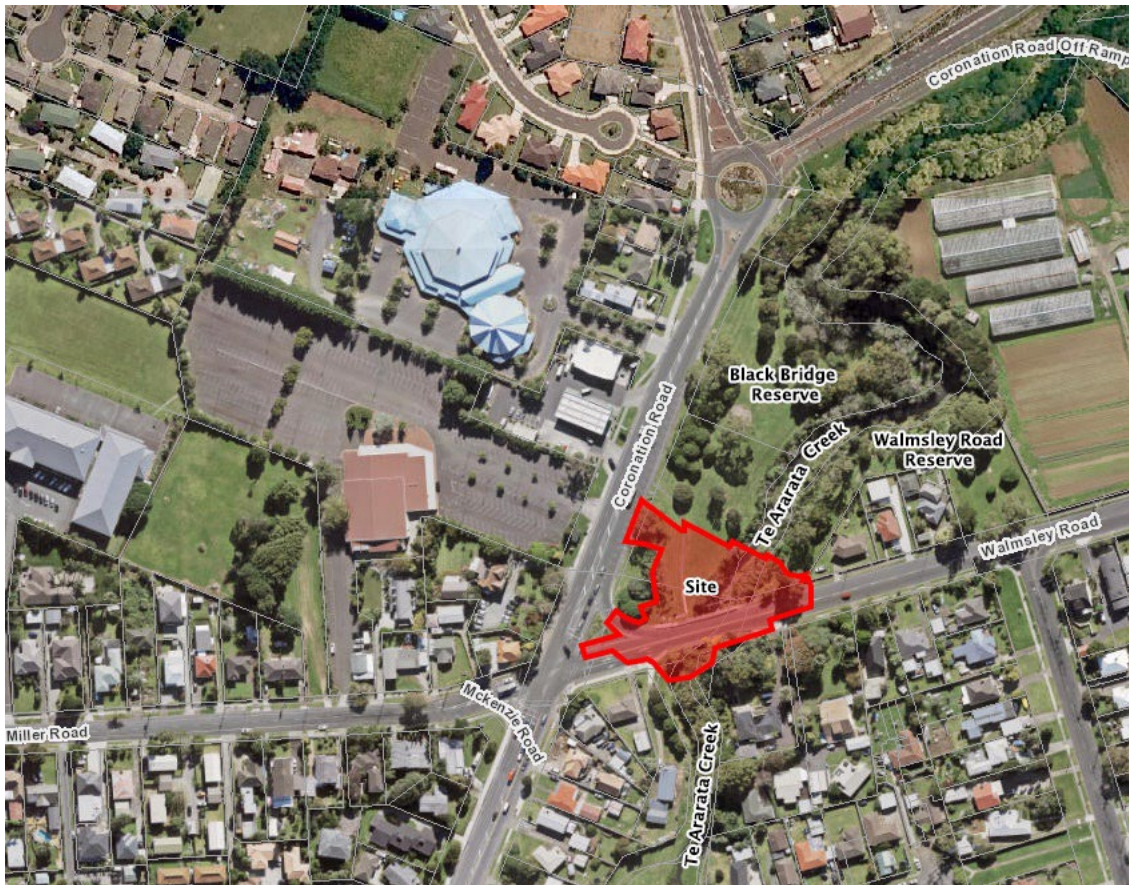
Figure 2: Indicative Site boundary (in red) and the wider landscape context.

The Site is located across Black Bridge Reserve (west of the Te Ararata Creek), Walmsley Road Reserve (east of the Te Ararata Creek), Walmsley Road and Te Ararata Creek (refer to Figure 2 below). Coronation Road is a busy arterial road connecting to the Southwestern Motorway (SH20) and Walmsley Road is a key arterial road between Mangere and Ōtāhuhu (refer to Figure 3 below).

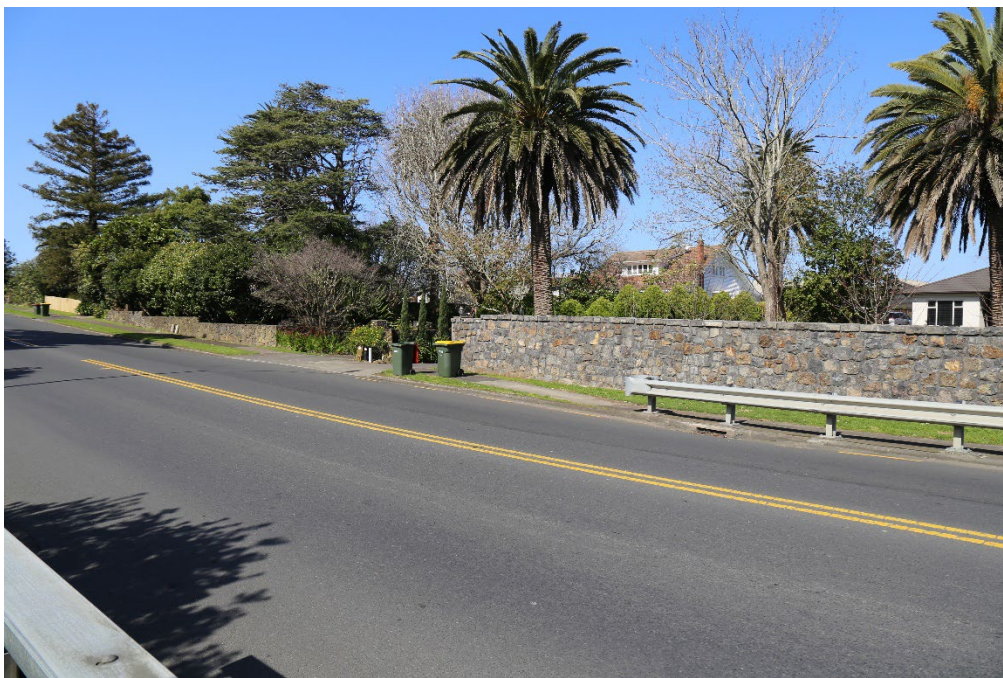
Photograph 1: Front yards of residential properties to the south of Walmsley Road.

Residential development to the south of Walmsley Road is reasonably dense, although not as dense as allowed for in the zone. Dwellings are generally set back from the road and generally have front yards which support established vegetation with amenity planting providing separation from the road. However, residential audiences to the west of the Te Ararata Creek have open boundaries to the road.

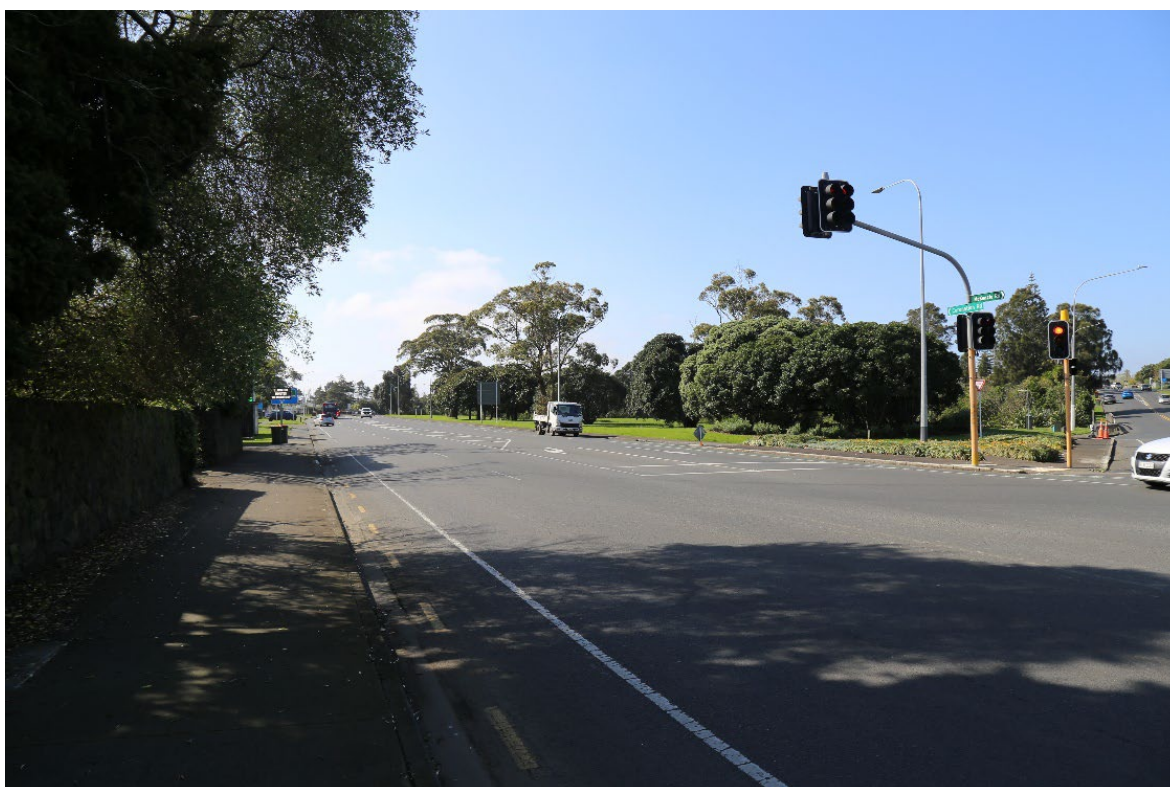
*Photograph 2: View north along Cambridge Road from the corner of Miller Road.*

The four lanes of arterial road provides a considerable separation between the Black Bridge Reserve to the east and the developed land to the west (refer to Photograph 2 below). No street trees located along Coronation Road or Walmsley Road, all substantial vegetation is located within privately owned residences, businesses and Black Bridge Reserve.

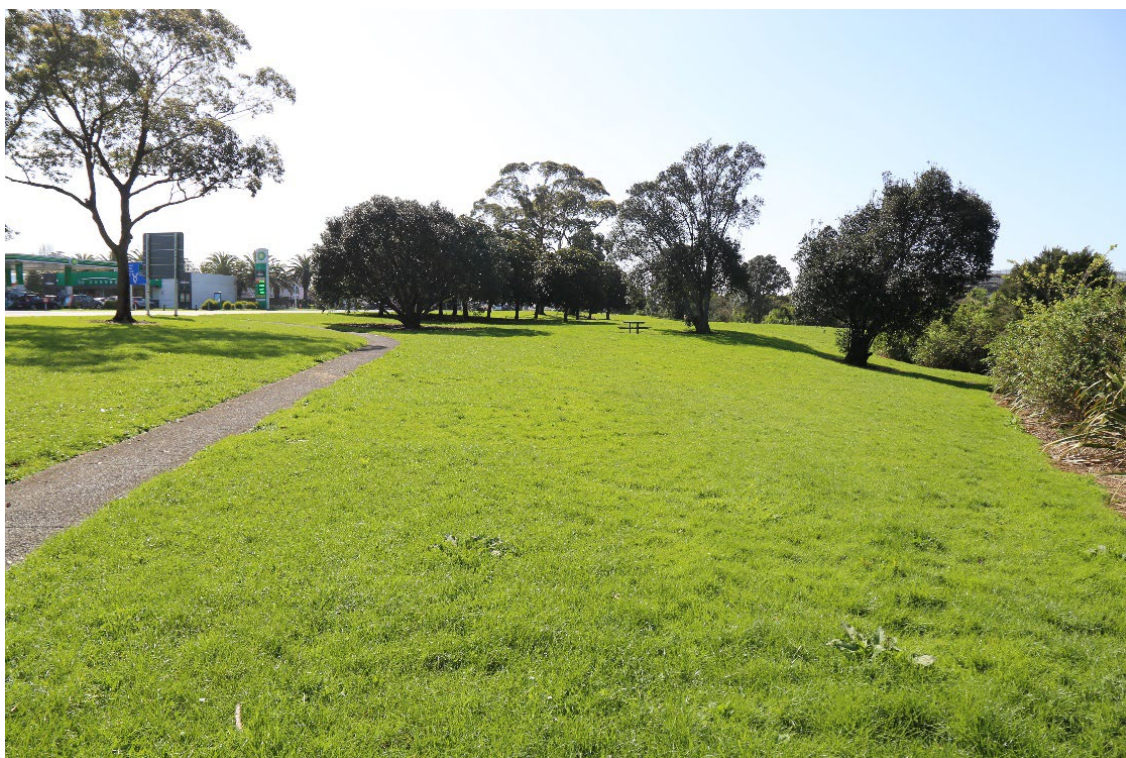
*Photograph 3: View north through Black Bridge Reserve from the southern boundary of the reserve.*

Within Black Bridge Reserve predominantly comprises mown grass interspersed by exotic and indigenous tree species (refer to Photograph 3 below).

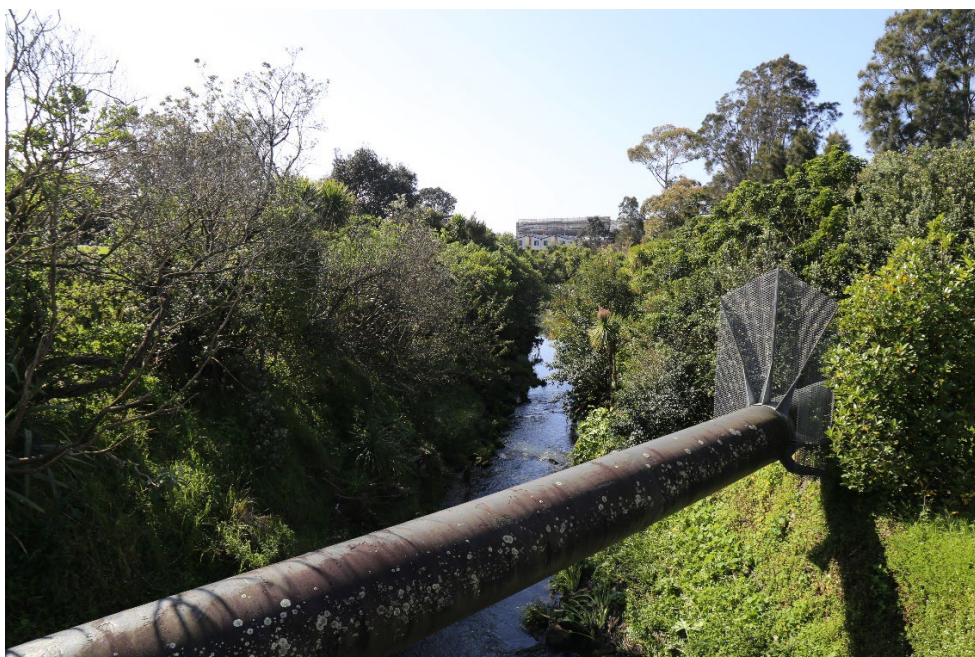
*Photograph 4: View north along the Te Ararata Creek viewed from the Walmsley Road bridge Culvert, the Watercare watermain pipe bridge can be seen in the foreground.*

The Walmsley Reserve is located between the Te Ararata Creek and the residential properties at 15, 17, 17A and 19 Walmsley Road. The riparian edge of the Te Ararata Creek comprises the same species as within the Black Bridge Reserve, however amenity tree planting comprises mature evergreen exotic species including , English elm, she oak, bunya pine and eucalyptus.

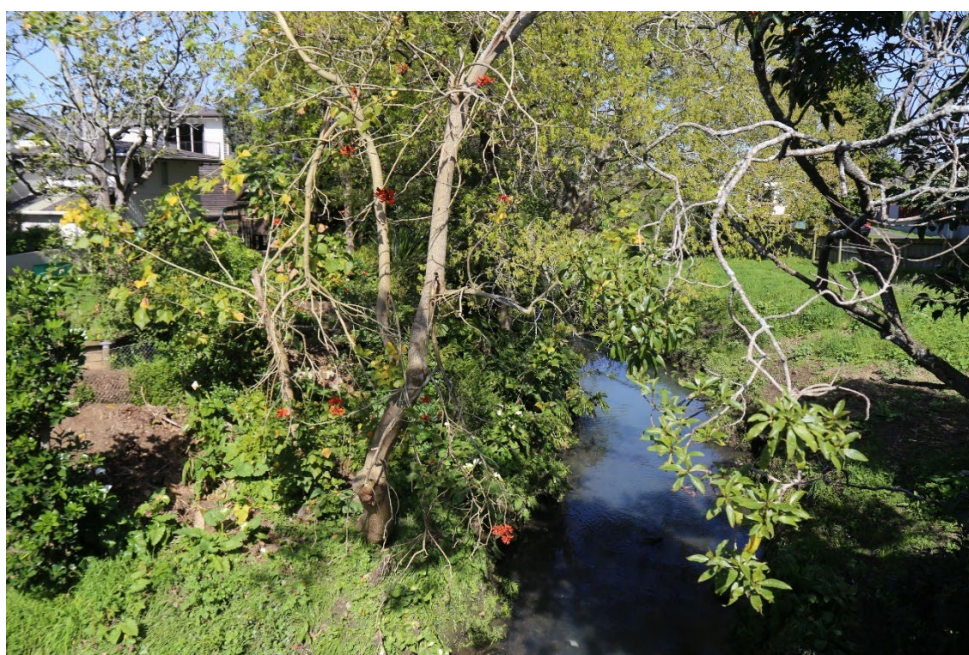
*Photograph 5: View south along the Te Ararata Creek viewed from the Walmsley Road bridge Culvert into the Te Ararata Creek Reserve.*

To the south of the Walmsley Road bridge the Te Ararata Creek Reserve linear open space extends 0.9km to the Moyle Park open space (refer to Photograph 5 below). This linear open space supports a pedestrian pathway to the west of the Te Ararata Creek which links Moyle Park to Hinau Road. Vegetation within the Te Ararata Creek Reserve comprises ngaio and karaka species which are typical of species within urban stream corridors. The Te Ararata Creek Reserve also contains non-native species including phoenix palm, English oak and privet. Residential properties back on to the eastern and western side of the Te Ararata Creek Reserve, which creates a sense of enclosure and separation from the wider landscape.

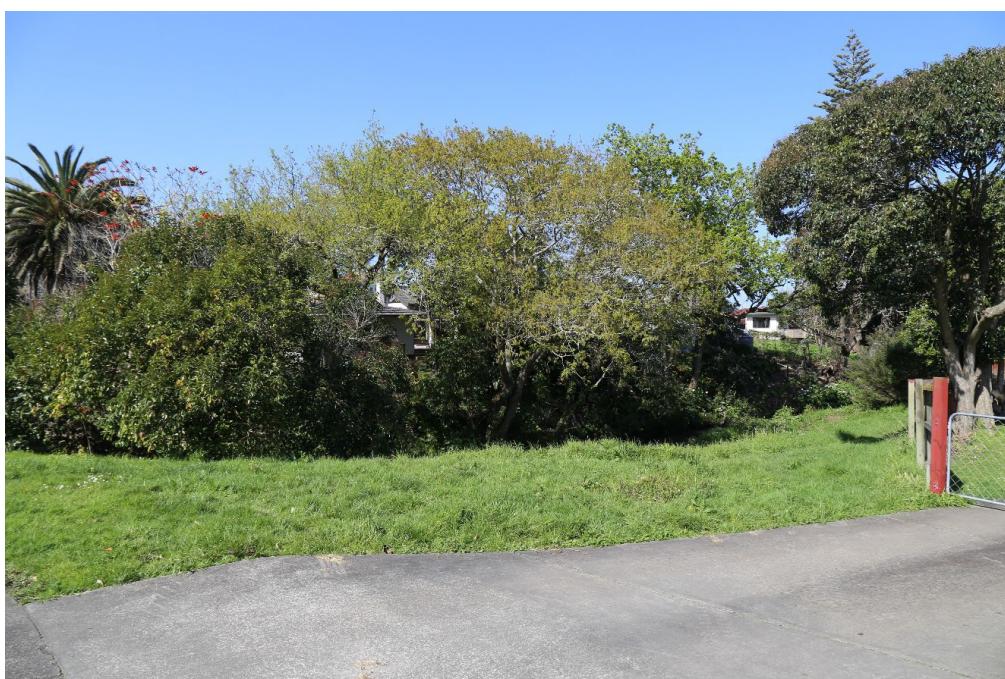
Photograph 6: Exotic trees located to the south of Walmsley Road bridge on the eastern bank of Te Ararata Creek

To the north of Walmsley Road bridge the stream is bordered by riparian vegetation and large trees with their canopies are set back from the stream. To the south of the Walmsley Road bridge the stream is shadowed by the canopies of exotic trees including English oak, phoenix palm and coral tree species, predominantly on the eastern bank of the stream (refer to Photograph 6 below).

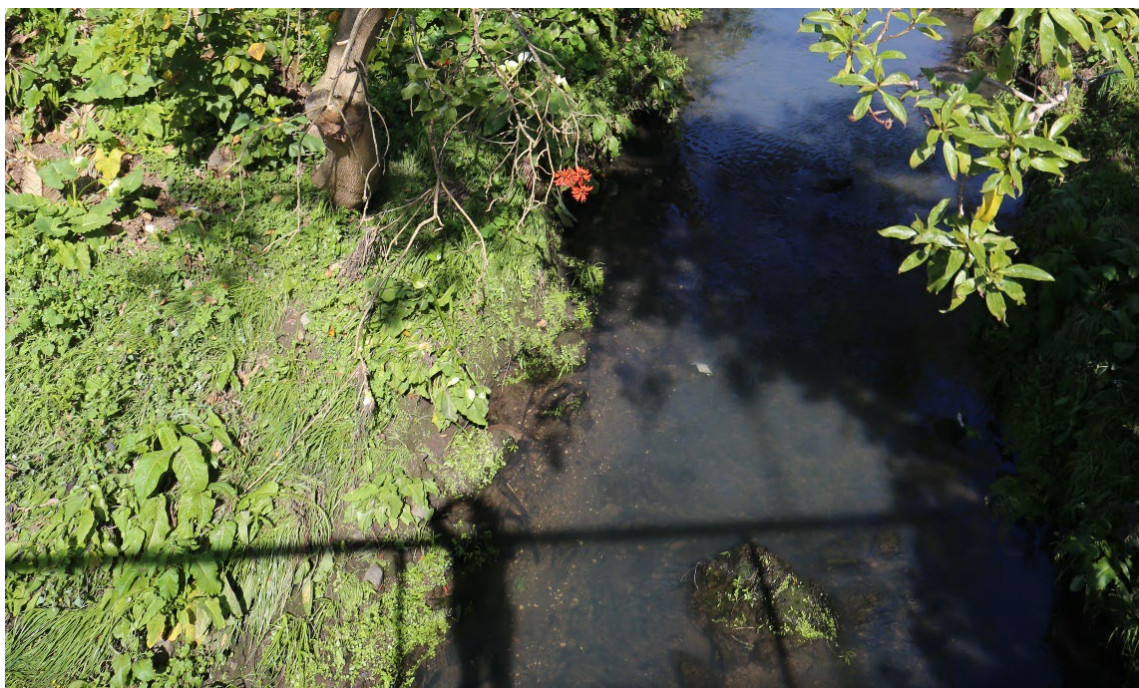
Photograph 7: The Te Ararata Creek viewed from southern edge of the Walmsley Road bridge

The flow of the stream was observed to have to be moderately slow flowing with some visible suspended sediment. It is noted that debris including tree limbs and litter have been observed within the stream particularly after heavy rainfall (refer to Photograph 7 below). A range of aquatic fauna have been identified within the Te Ararata Creek, a full list of species is provided in the Ecological Management Plan provided by Tonkin + Taylor. The notable “threatened” and “at risk” species identified are Redfin bully (*Gobiomorphus huttoni*), Inanga (*Galaxias maculatus*), Longfin eel/tuna (*nguilla dieffenbachia*) and Smelt/pōrohe (*Retropinna retropinna*) and Giant kokopu (*Galaxias argenteus*).

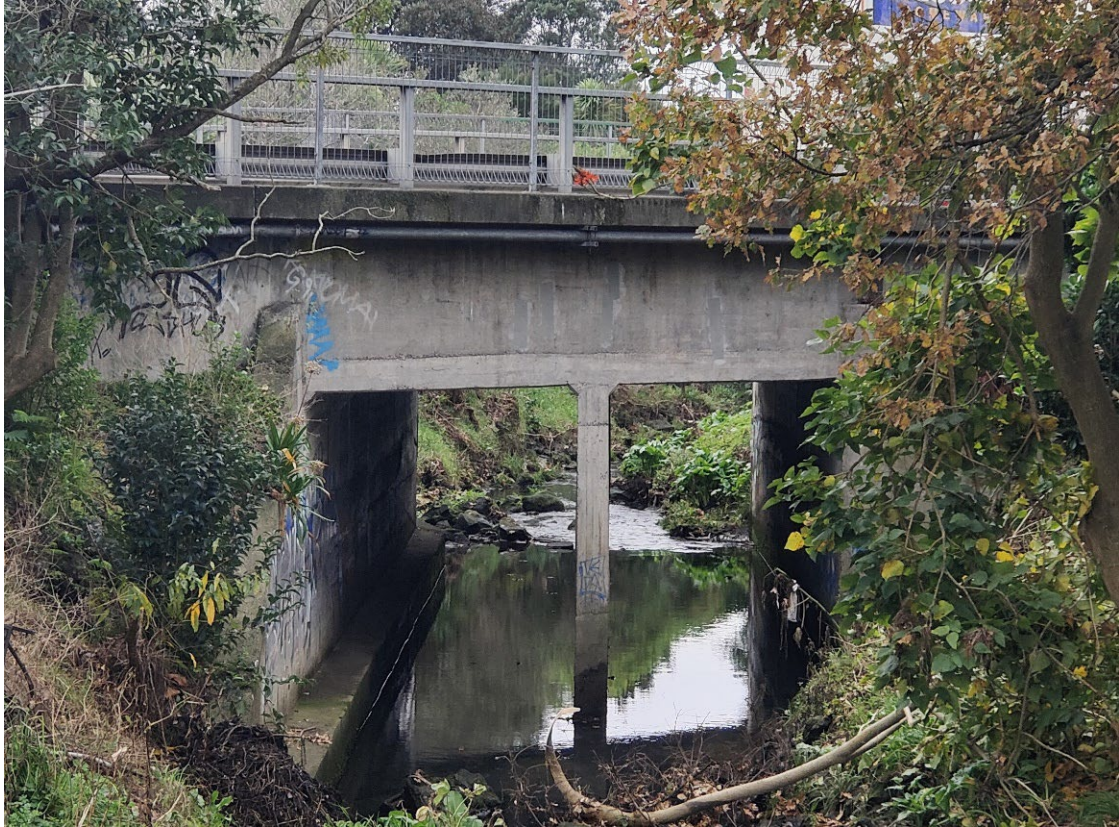
*Photograph 8: The Walmsley Road bridge culvert viewed from the south.*

During operation, the existing culvert will be removed and the active stream bed will be restored. It is anticipated that this will improve the flow of the stream and reduce interruption during and after storm events. The margins of the stream will be altered by rock armour retaining wall works and abutments for the Watercare watermain pipe bridge, however these will be set back from the active stream bed. With the above in mind, it is anticipated that the operational effects on the natural character attributes of the stream will result in neutral or positive effects. The proposed replacement bridge will materially appear the same as the existing bridge, once the proposed RPP planting has established (approximately after 3 years). It is anticipated in the experiential values of the Te Ararata Creek will be broadly the same, however the changes to the stream banks including retaining resulting in a change to the natural appearance of the stream resulting in **Very Low** adverse effects.

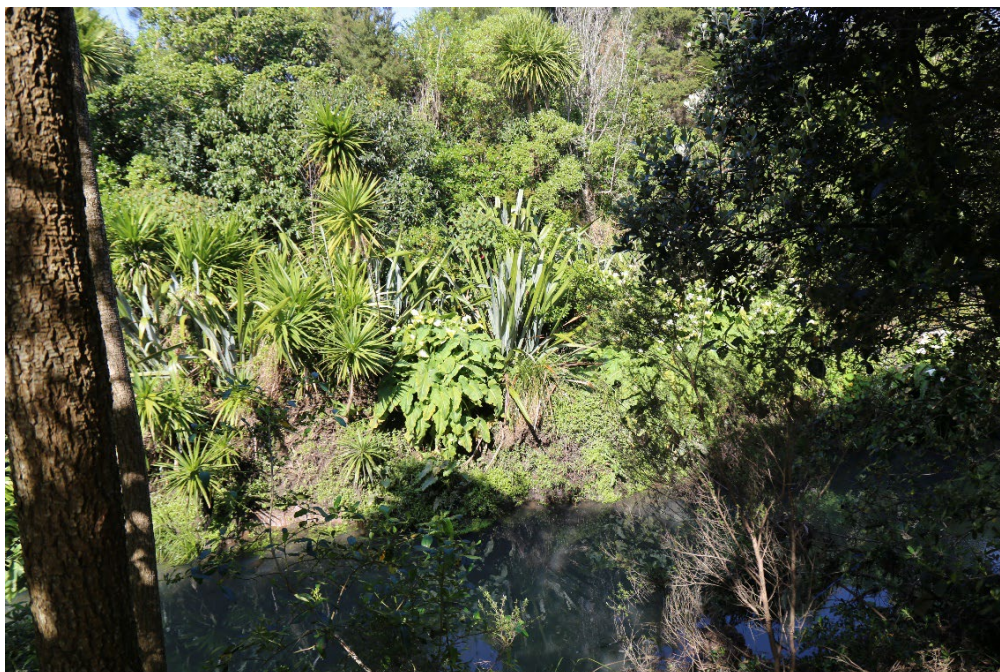
*Photograph 9: Riparian planting along the eastern bank of the Te Ararata Creek*

The implementation of the Project will require the alteration of the landform, removal of existing trees, temporary alteration of the watercourse, and the construction of a replacement watercourse crossing. This will result in permanent and temporary changes to the Site. The most valued physical aspects of the Site are the mature trees within the Black Bridge Reserve, the Te Ararata Creek and associated indigenous riparian vegetation along the watercourse (refer to Photograph 9 below).

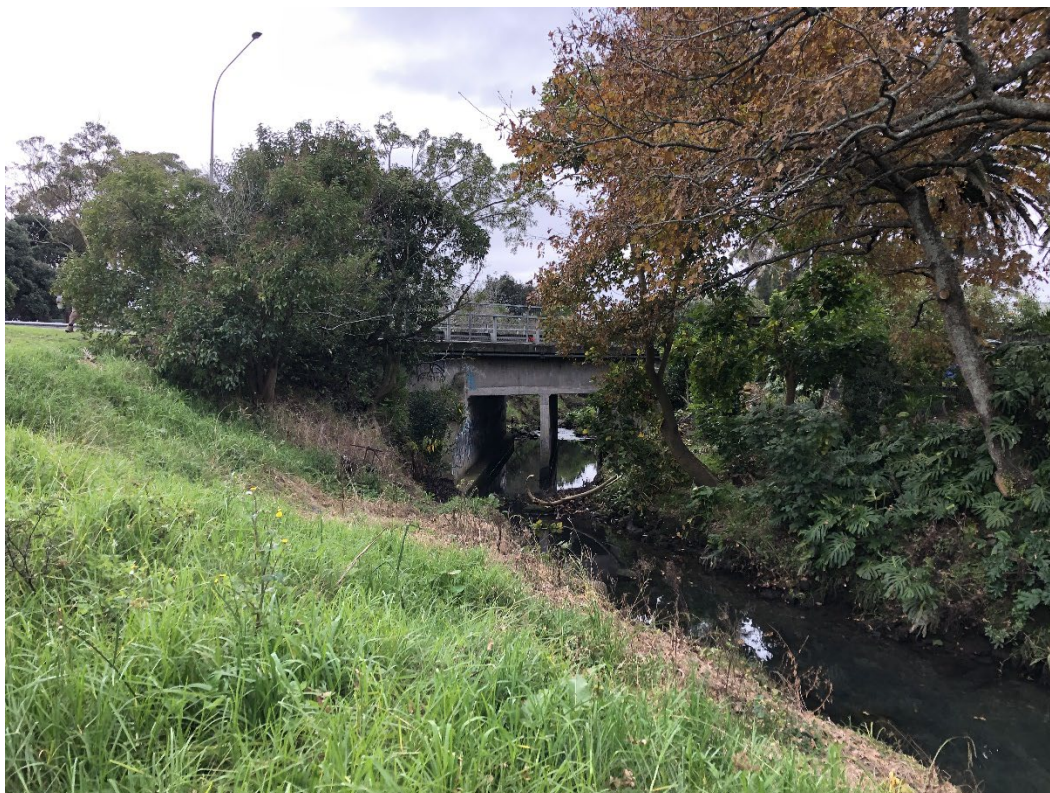
*Photograph 10: Riparian planting along the Te Ararata Creek viewed from the Te Ararata Creek Reserve to south of the Walmsley Road bridge.*

It is anticipated that riparian vegetation in proximity to the existing Walmsley Road bridge will be removed to facilitate the construction of the Project (refer to Photograph 10 below). Works within the stream to regrade the banks, install rock armour retaining walls and replace the abutments of the Watercare watermain pipe bridge will alter the structure and form of the banks of the creek within proximity to the Walmsley Road Bridge. The wider area of the banks will be regraded and planted to have a natural appearance.

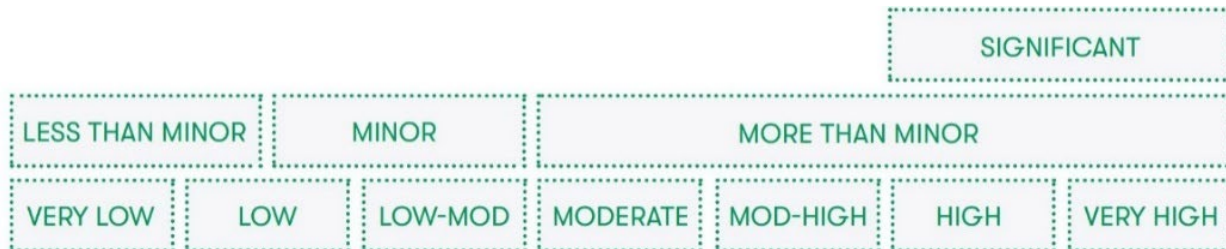
This assessment has adopted the following scale applied to relevant RMA circumstances<sup>9</sup> (refer to diagram below), acknowledging low and very low adverse effects generally equate to 'less than minor' and high / very high effects generally equate to significant<sup>10</sup>.
