HEARING REPORT – VOLUME TWO NOTICE OF REQUIREMENT DESIGNATION 6302 NORTH ISLAND MAIN TRUNK RAILWAY LINE KIWIRAIL

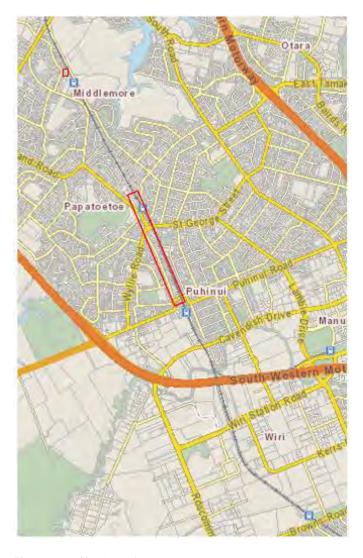
Figure 2.1: Site Location

The PSI covers properties located adjacent to the rail corridor between Rosella Road, Mangere East in the north and Bridge Street, Papatoetoe to the south, over a distance of approx. 3.6 km, as shown on Figure 2.1. The properties are listed and described in Table 2.1, broken down for ease of discussion into four parts (Part One, Part Two, Part Three, and Part Four). They largely comprise residential properties, in additional to some reserve land, on or close to the western side of the railway corridor. Information on the areas of land within each property potentially affected by the improvements is also presented, including land required for construction access, rail infrastructure and retaining walls.. Further information is provided in Appendix A.

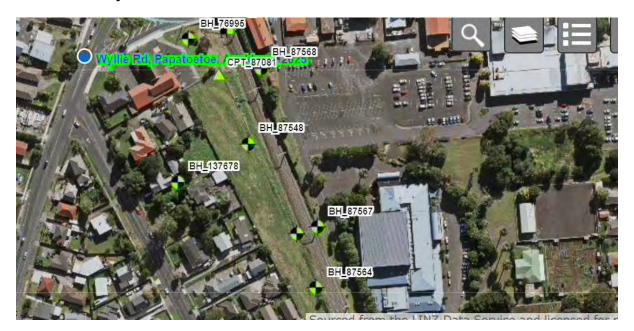
Part 3 12/14 Wyllie Road

Client: ONTRACK **DH101** Project: Auckland Electrification Project 139 Carlton Gore Road PO Box 9762 Location: St George St Church, Papatoetoe Newmarket Auckland, New Zealand Tel: +64 9 520 6019 Project Reference: 203299 ww.aurecongroup.com Sheet 1 of 8 CO-ORDINATES [ME2000] DRILLING INFORMATION Date Started: 25/06/2010 Date Completed: 30/06/2010 Drilling Method: Truck Mounted Drill Rig Diameter Core: HQ (60mm) Flush: Water Easting: 407703.86 Northing: Ground Level: 788855.54 Inclination: 23.59m Orientation: Contractor: [Auckland 1946 msl] Boart Longyear Weathering/USCS Details Standard Water Level (m) **Drilling Method** Fracture Index Penetration Sample Type (%) Graphic Log Code %) (%) Geological Tests Description of Materials Depth (m) Additional Information Installation ROD ([SPT] (E) (Defect Description) Layer Peak/ R.L. Residual 'Su' or Blows 0m: Clayey SILT with minor fine sand, dark brown. Soft, wet, high plasticity. Frequent rootlets. [TOPSOIL]. 0m: FILL 23.5 ₹ Representative samples taken from hand auger Ē SS 0.1m: Silty GRAVEL, dark brown. Loose, wet. Angular, 10-30mm in size. Frequent rootlets. cuttings. D.35m: AUCKLAND VOLCANIC FIELD mottled orange brown and light grey. Firm to stiff, wet, high plasticity, Frequent rootlets. (TUFF). 23.0 MH 50 MI 22.5 67 3/1,1,1,1 4 1.5m: ...50mm band of medium SAND, orange 22.0 brown. Medium dense, wet, non plastic. 1.55m: Fine sandy SILT, medium brown. Firm to stiff, wet, low plasticity. SPI 89 21.5 ¥ 2.2m: ...increase in sand content, some fine Auckland Volcanic gravels (<0.5mm). 2.25m: Sandy clayey SILT, banded orange brown and light grey, Firm to stiff; wet, low plasticity. 5 86 21.0 2.6m: Very clayey SILT, orange brown. Firm to stiff, wet, high plasticity.

2.7m: ...light brownish grey with discrete orange brown streaks and brown organic streaks. 3 0/0.1,1.2 4 20.6 SPI 100 3.3m: ...light to medium grey. 20.0 Ξ 4 19.5 1/0,0,0,0 4.5m: Very clayey SILT, medium grey with dark brown organic staining. Very soft, wet, high 4.5m PALEOSOL 2010 2:10:29 p.m 19.0 SPT A.7m: Very clayey SILT, light to medium grey with dark brown organic staining. Very soft, wet, high plasticity.minor medium to coarse white pumiceous sand. [TAURANGA GROUP]. 100 4.7m: TAURANGA GROUP Remarks: 1. Hand Auger to 1,2mbgl for service check. Logged: HH Casing to 24.0mbgl. HH Input: No groundwater measured on the day of drilling. Checked: PKC 4. Hole backfilled with gravel and bentonite. Verified:

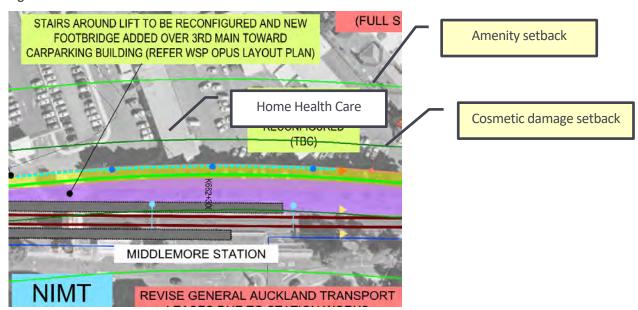
Figure 5: Vibration contours for Home Health Care

The healthcare facility (Home Health Care which is a part of Middlemore Hospital) at 38 Orakau Road is in very close to the Third Main. Works may be as close as 6m from the closest building. At this setback distance, vibration levels are predicted to be very high (>10 mm/s), and alternative construction methods may need to be implemented. Potential mitigation and management measures are discussed in Section 5.6.

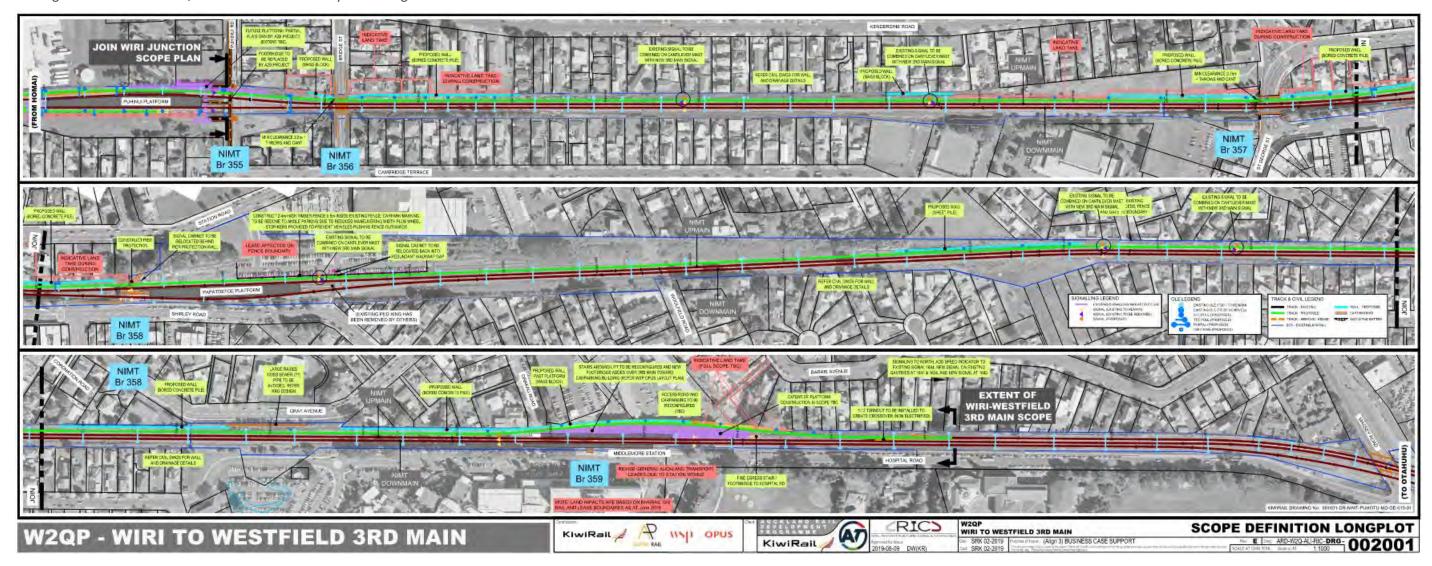
APPENDIX B PROPOSED THIRD LINE

The alignment is shown below, and the wider community and zoning is shown over leaf

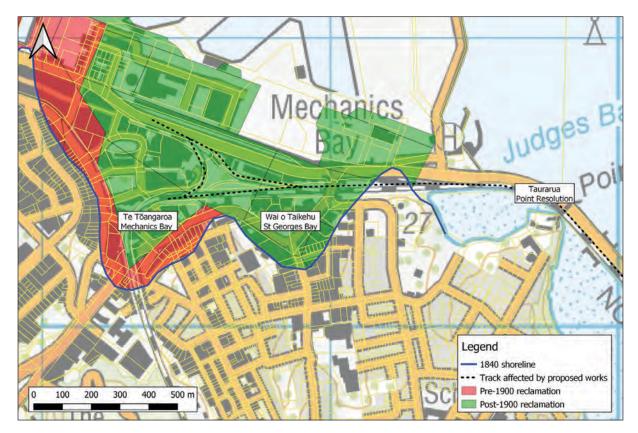
Figure 2. Map of the Quay Park area showing the 1840 coastline and reclamations near the proposed works area.

Kelly's map of Māori place names in Tāmaki Makaurau also illustrates the pre-1840 coastline as marked in Figure 2 (Kelly 1940). Te Tōangaroa / Mechanics Bay was west of the proposed works area. The Māori name can be translated to 'the dragging of a waka across a long distance.' This refers to the fact that the tide in this bay went out very far, so if a waka was landed at low tide it had to be dragged a long way to the beach. When European settlement began in Auckland, this bay was the location of the dwellings of the first workmen employed by the government, as well as sawmills and boatyards, giving it the name Mechanics Bay (Campbell n.d.). East of this was Wai o Taikehu / St George's Bay. Taikehu was an ancestor of Ngāi Tai who arrived on the *Tainui*, and the Māori place name can be translated as 'the waters of Taikehu.' The easternmost point along this coastline is at Judges Bay and Taurarua / Point Resolution, where Judge Martin and Attorney General Swainson built houses in 1841. Taurarua has been translated as 'two ropes,' potentially referring to these two men who were supposed to be administrators of British justice (Campbell n.d.)
