APPLICATION MATERIAL
VOLUME TWO
PRIVATE PLAN CHANGE 40
CLAYDEN ROAD, WARKWORTH

PRIVATE PLAN CHANGE 40, CLAYDEN ROAD, WARKWORTH

ATTACHMENT H
STORMWATER MANAGEMENT PLAN MAVEN

STORMWATER MANAGEMENT PLAN

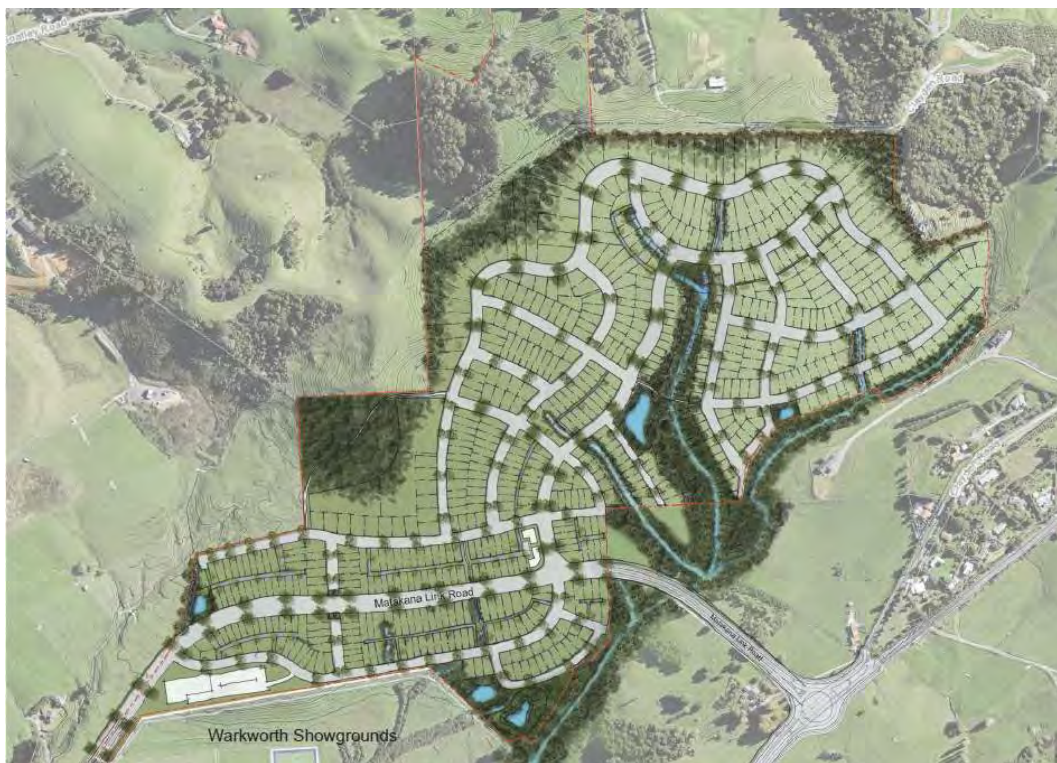
Figure 15: Warkworth Clayden Road Development – Master Plan

This development will retain covenanted areas of existing bush and several existing streams. The overall scheme of the development is illustrated in Figure 12, below.

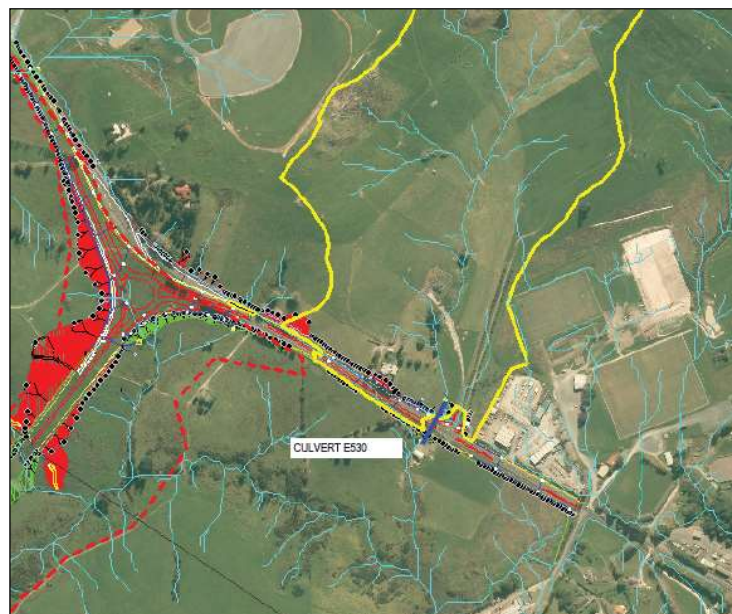
Figure 17a: SH1 E530 Culvert Location

- 2) The NZTA/SH1 Culvert (Known as Culvert E530, as part of the NX2 Puhoi to Warkworth Motorway project currently underway).

Culvert E530 is being replaced as part of the NX2 Puhoi to Warkowrth Motorway project. Although reports made public as part of the project (51// SH1 widening stormwater memo V6 28-26-2018) completed by Tonkin and Taylor determine that the hydraulic properties of the replacement culvert are to more of less meet the existing

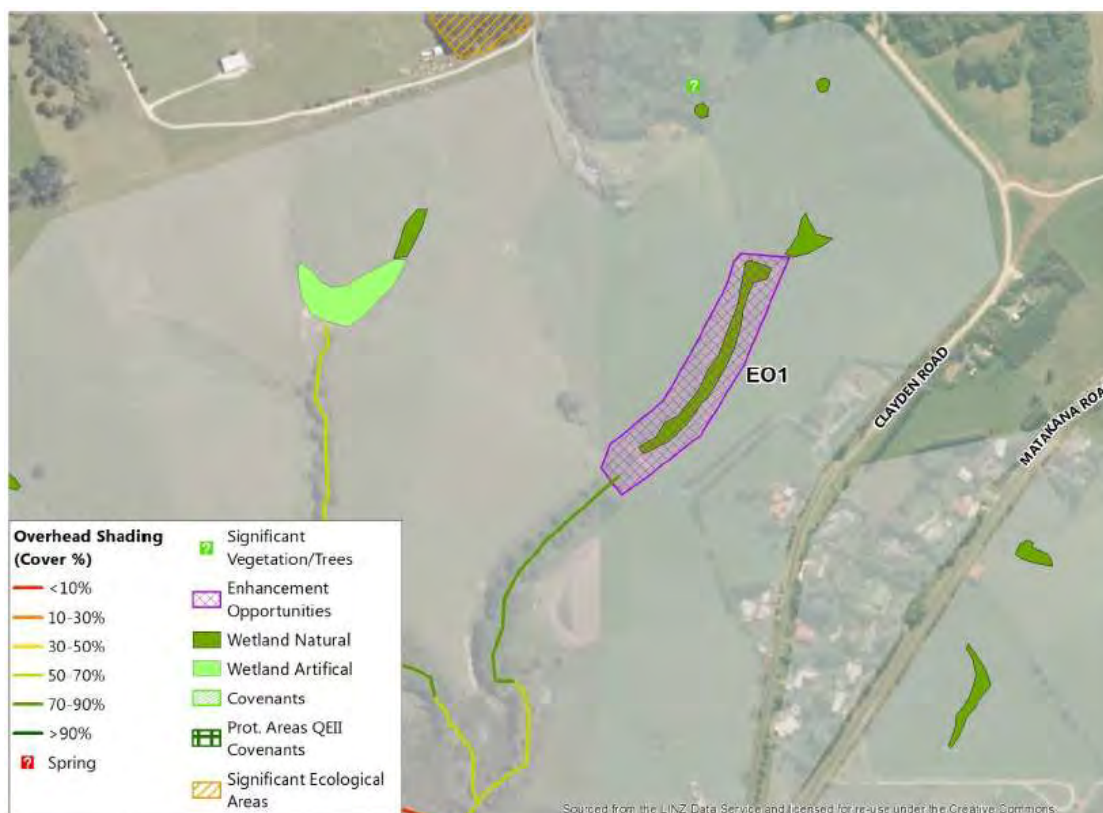
Figure 17c: Warkworth FUZ WAR – Enhancement Opportunity 1 Area

The area posed can be found identified below (Figure 17b).

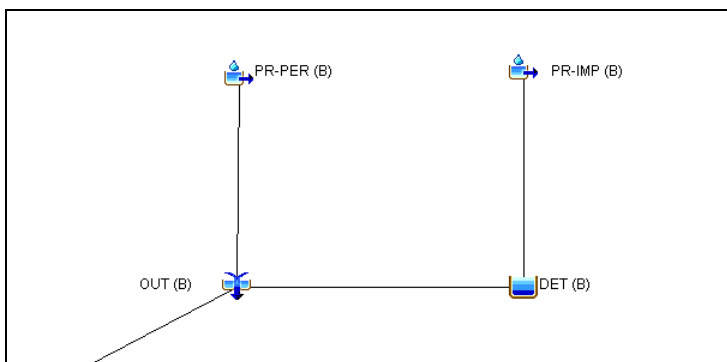
Future impervious coverage within each lot will require detention of peak flows above pre-developments levels. Each catchments future impervious area has been modelled separately to model attenuation of these sub-catchments, an example of this is catchment B can be found below:

The modelling completed is theoretical in nature only, to include the attenuation benefits of onsite mitigation on the downstream ponds and wetlands and greater catchment.

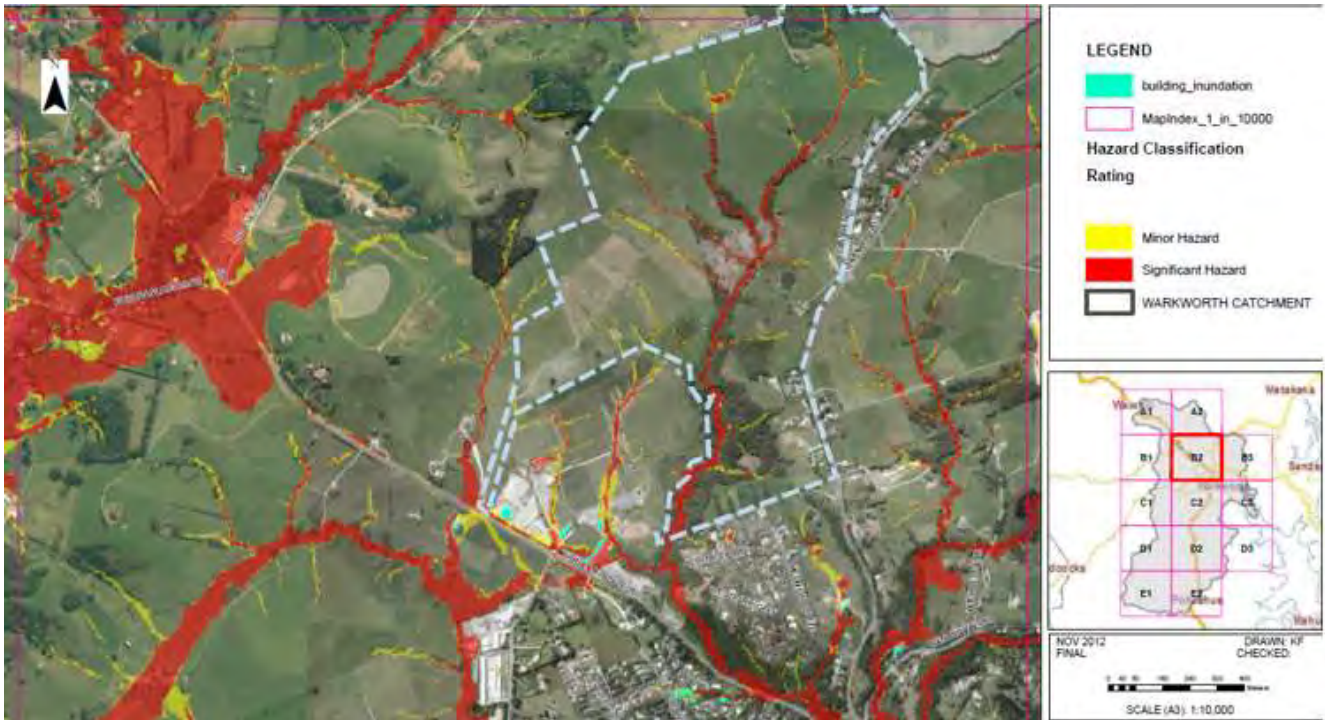
Figure 12: Warkworth North East Rapid Flood Hazard Assessment Map (Source: Auckland Council)

Auckland Council Rapid Flood Hazard assessment maps (Figure 12) concur with the conclusion that there is no major flooding outside of the well-defined watercourses of the subject site (outlined in yellow within Figure 12) or directly downstream of the site.
