Ref No: J01662 (Rev A)

**RE: INTERIM ADVICE - Preliminary Geotechnical Appraisal Report and Groundwater Standpipe Installations at the Muriwai Downs Farm.**

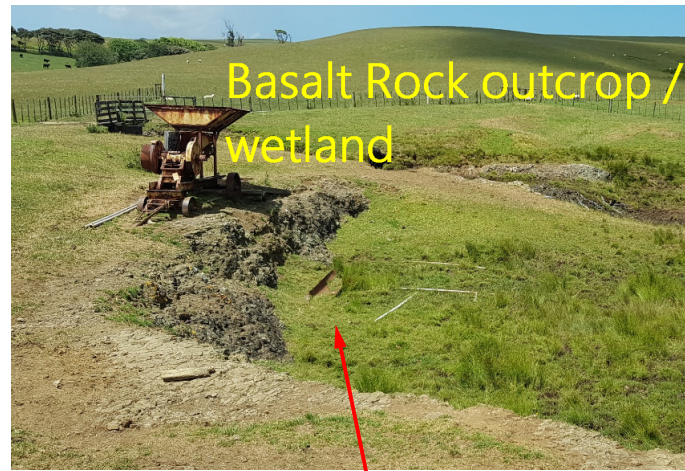
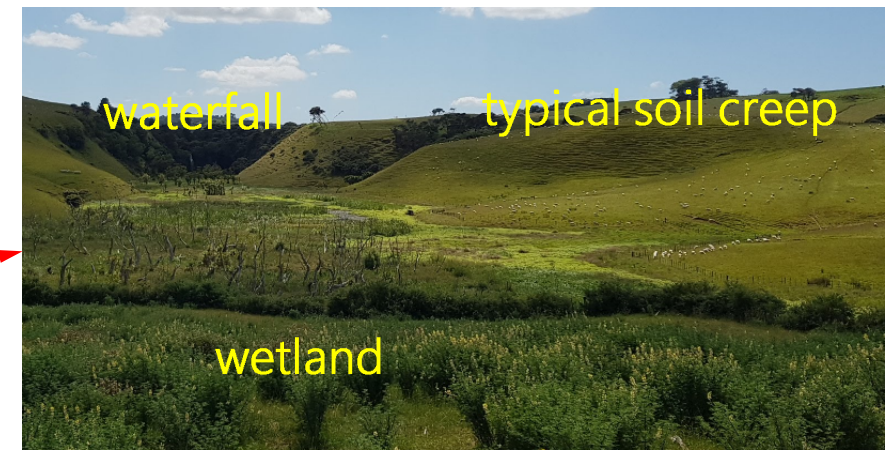
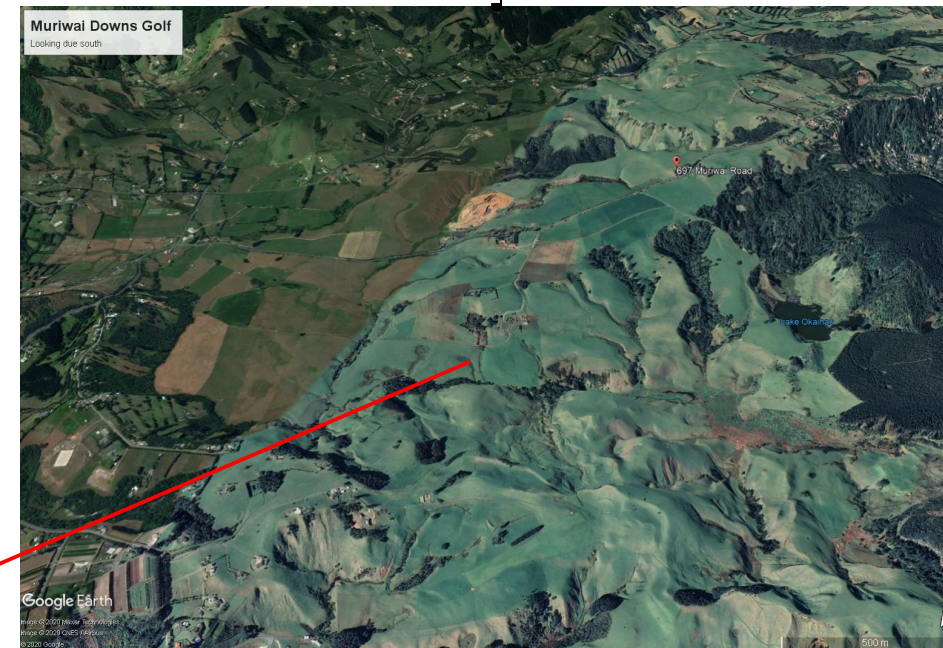
revision	description				drawn	SI	 	client: THE BEARS HOME PROJECT MANAGEMENT LTD	
					drawn	SGL		project: MURIWAI DOWNS FARM	
					approved	NTS		title: PRELIMINARY GEOMORPHIC FEATURES PLAN	
					date	A3		project no: J01662	figure no: 6
					scale

Figure 6 (attached) presents oblique views across the Site sourced from Google Earth (displaying 3x vertical exaggeration), with photographs superimposed to illustrate certain typical geomorphic features from our site walkover (on 14/12/20). Detailed geomorphic mapping is recommended focussing on the golf course layout once the concept(s) is firmed up. From a preliminary sense the main geomorphic observations are summarised as follows:

- Soil Creep: shallow seated slope instability (also known as sheep tracks), commonly occurring on areas where slope gradients exceed 1(v) in 4(h). More prevalent over the western half of the site where the terrain is more severe than the central and eastern portions.
- Basalt Rock outcrops: isolated to a small area in the central region of the site (red shaded area on Figure 5 geology map).

- Sandstone Rock outcrops: isolated to the waterfall features within in the main dividing gully defining the central region of the northern boundary of the Site (orange shaded area on Figure 5 geology map). Unlikely to be developed over so is probably of little consequence.
- Low lying ground / wetland: generally located in the base of various incised watercourse / gully features, typically flanked by areas displaying soil creep (e.g. over the western half of the site where the gullies are more incised than the central / eastern portions). Low lying ground in the eastern part of the site may be prone to flooding (subject to confirmation by a specialist).
- Gently Rolling to Flat Terrain: The majority of the central and eastern portions of the Site and offers easy contours to develop over, but this terrain is less common over the western half of the site where the landform is more severe.

There is a relatively small area in the centre of the Site shown to contain Basalt Rock (refer Figure 5). This was observed to be outcropping during the site walkover (refer Figure 6) and appears to have the relict workings of a minor quarrying operation. Near surface rock presents constraints to bulk earthworks (e.g. cuts) using conventional prime movers (e.g. motor scrapers, bull dozers, excavators, etc) and may require blasting to remove, if this is a requirement. Deep pond excavations may also encounter rock (e.g. 'Pond J', in light of the borehole findings presented in Section 3 below) , and will be subject to specific design to help assess any design conflicts in this regard.

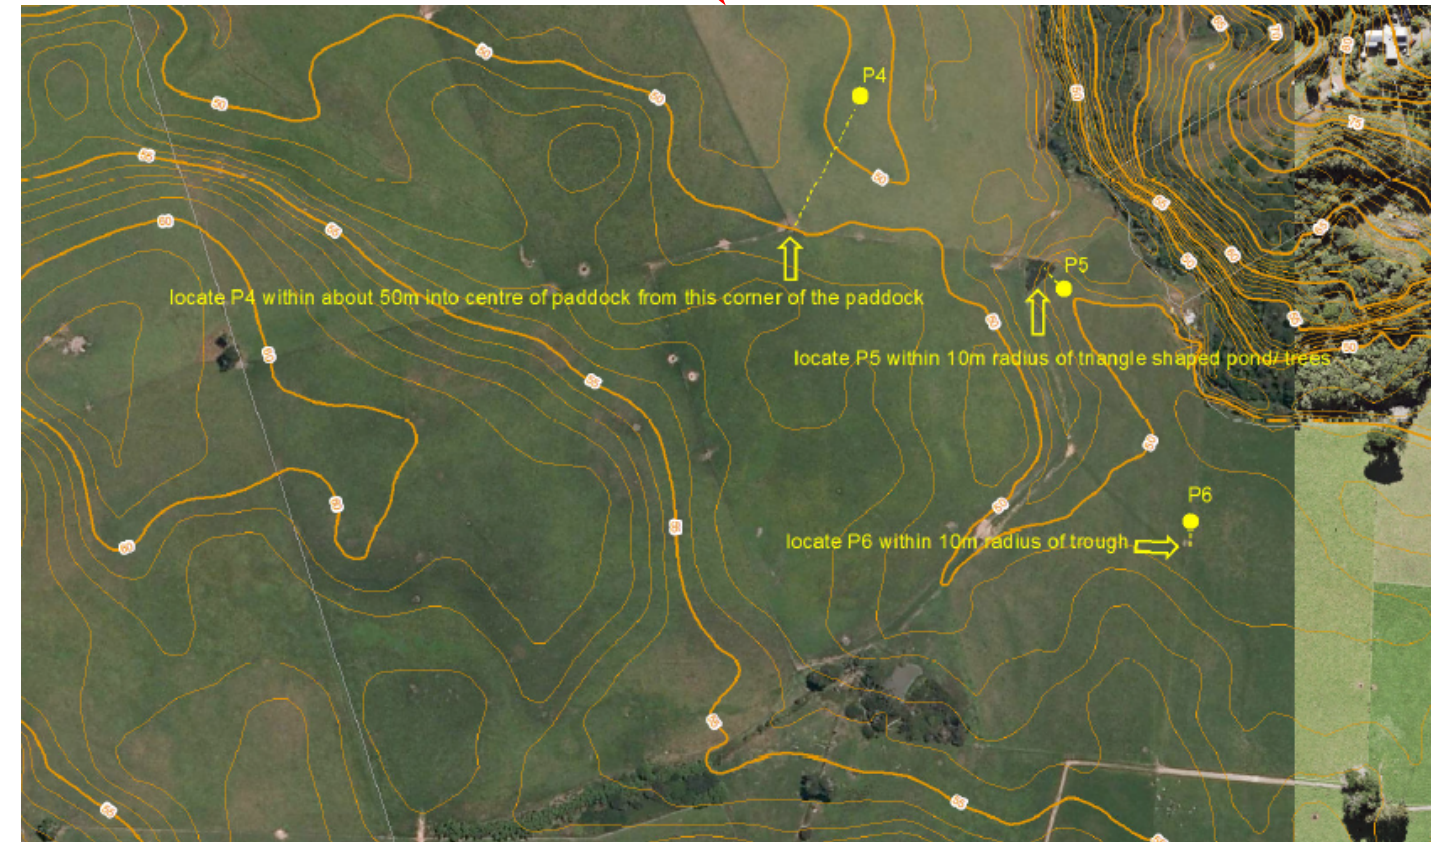
revision	description				drawn	SI	 	client: THE BEARS HOME PROJECT MANAGEMENT LTD	
					drawn	SGL		project: MURIWAI DOWNS FARM	
					date	26/01/21		title: STANDPIPE BOREHOLE LOCATION PLAN	
					scale	NTS		project no: J01662	figure no: 8
					original size	A3

In the vicinity of Pond J, six (6) PVC standpipes were installed (on 12/01/21) to depths of up to 5 mbgl in the locations shown on Figure 8 (attached). The standpipes were sleeved with geotextile filter sock and bentonite seal to facilitate long term monitoring (e.g. between summer and winter) should that be desired. One groundwater monitoring round was undertaken on 20/01/21. To the best of our knowledge the standpipes have been protected since our monitoring round by post and wire fences to minimise interference / destruction from farm livestock.

Full boreholes records containing descriptions of the materials encountered are also attached together with measured groundwater levels, which ranged from approximately 0.9 to 3.9m mbgl. The logged materials indicated a softer (more compressible) soil profile in the vicinity of P6. The other boreholes typically display firm to stiff soils. No peat or highly organic soils were identified. P1 and P5 encountered refusal conditions prior to reaching target depth and this may infer the top of the Nihotupu Formation (sandstone and siltstone) unit, at depths of 1.3 and 2.5m respectively. Deep ponds may encounter these inferred deposits, and this issue is subject to ground proving investigations.
