**GEOTECHNICAL
INVESTIGATION REPORT
MURIWAI DOWNS RESERVOIR
MURIWAI VALLEY**

GEOTECHNICAL INVESTIGATION REPORT MURIWAI DOWNS RESERVOIR, MURIWAI VALLEY

Report reference: 210339-A

Date: 18 November 2021

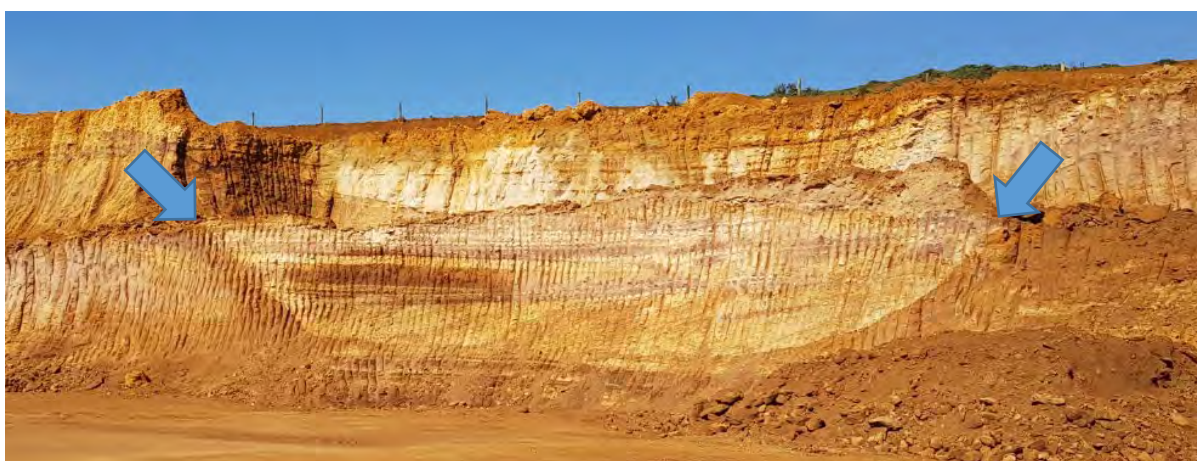
Photo 1: Natural filling of depression with later dune deposits in Awhitu Group exposed at the Muriwai Sandstone Quarry. Boundaries of the depression are arrowed. Within the depression fill is cross bedding and an unconformity.

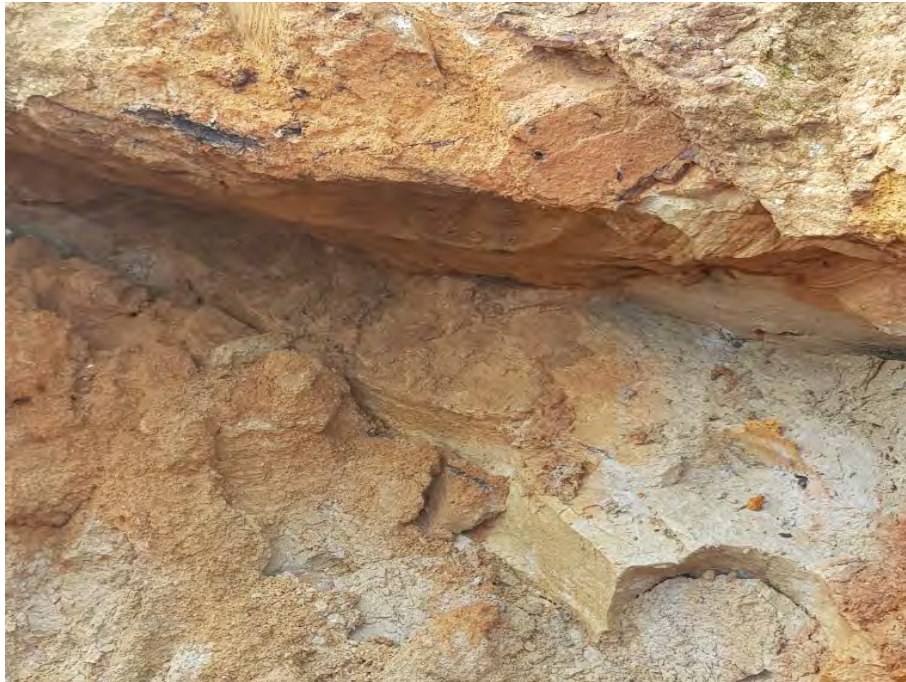
Photo 2: Weakly cemented sand material overlying clayey silt exposed in the quarry. The clayey silt has been subject to preferential erosion compared to the sand above most likely due to frittering on stress relief joints. This fine-grained material, including some organics, filled a small depression under the weakly cemented sand. This preferential erosion of layers is also seen near the subject site.

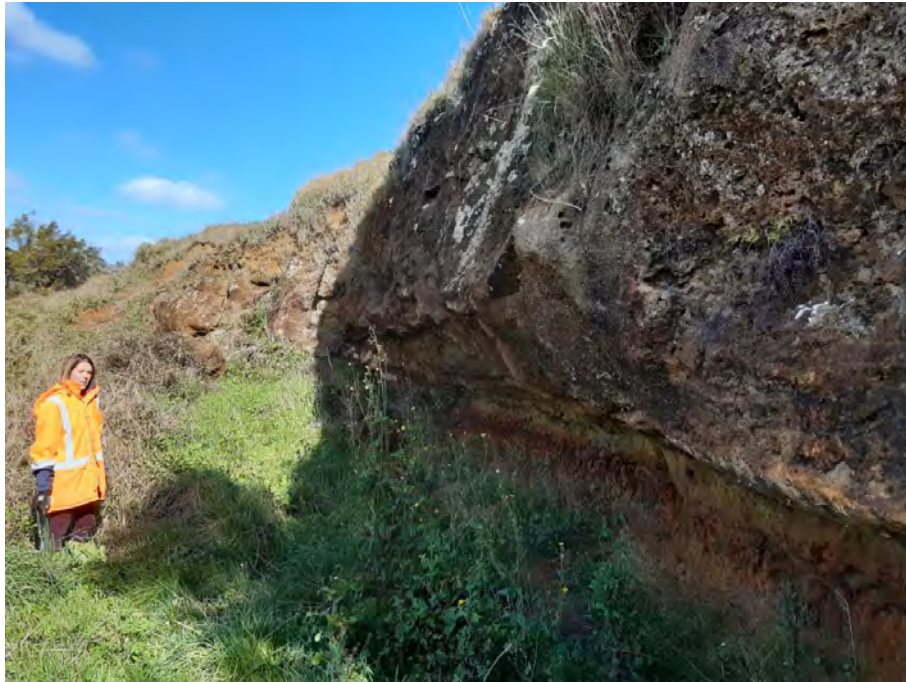
Photo 3: Weakly cemented sand horizon underlain by interlayered silts and sands. The weakly cemented sand is relatively resistant to erosion whereas the weaker interlayered beds beneath have been preferentially weathered. Although the strength of the weakly cemented sand horizon does vary across the site, this stratification is believed to underlie much of the ridge the proposed works are to be undertaken.

- Erosion associated with incision of these streams has exposed an apparent more resistant and stronger cemented sand horizon around the perimeter of the ridge upon which the reservoir is proposed (Photo 3). This layer, which appears to be dipping gently to the west, often presents on-site as outcrops and steeper slopes. It also appears to be associated with water springs. The cementation of this horizon does appear to vary across the site. Near the eastern corner of the proposed reservoir the strength of this layer appears to be significantly less than other locations as evidenced by lack of steeper slope definition and greater gully headward erosion (Figure 2). This is also supported by subsurface investigation at the location.

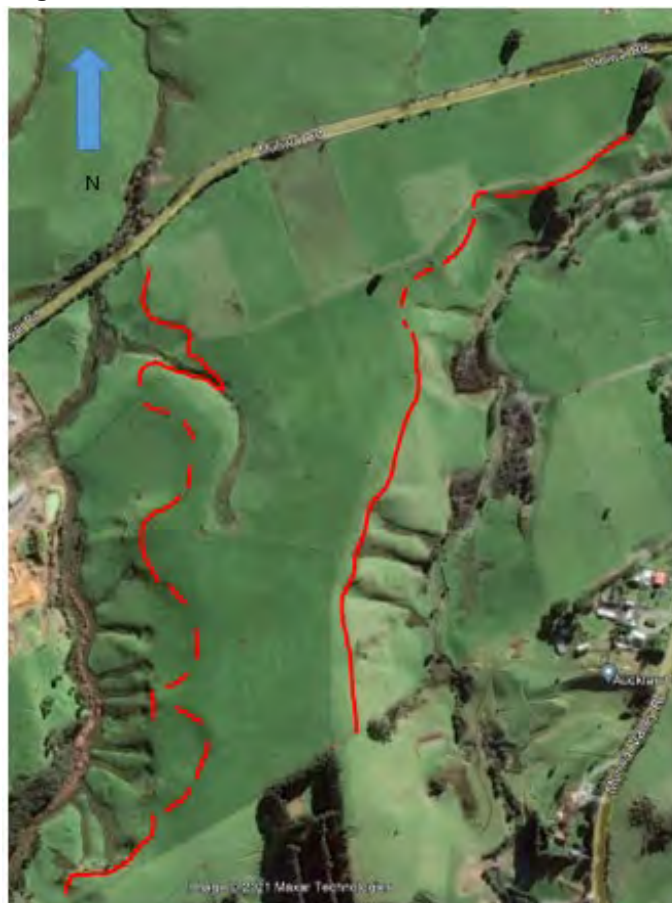
Figure 3: Image from Google Earth (date July 2015). Solid red lines illustrate inferred extent of weakly cemented resistant sand layer as exposed at the surface. Dashed lines signify where the sand layer is possibly less cemented and subject to headward gully erosion. Evident is the water springs which appear to align with the cemented sand horizon.

- The springs are noted to be associated with gully headward erosion near the proposed development, likely as a result of saturation of the soil deposits and possible degradation of cementation (Figure 3). The springs appear to emerge beneath the weakly cemented sand layer and with preferential erosion undermining the cemented sand layer.

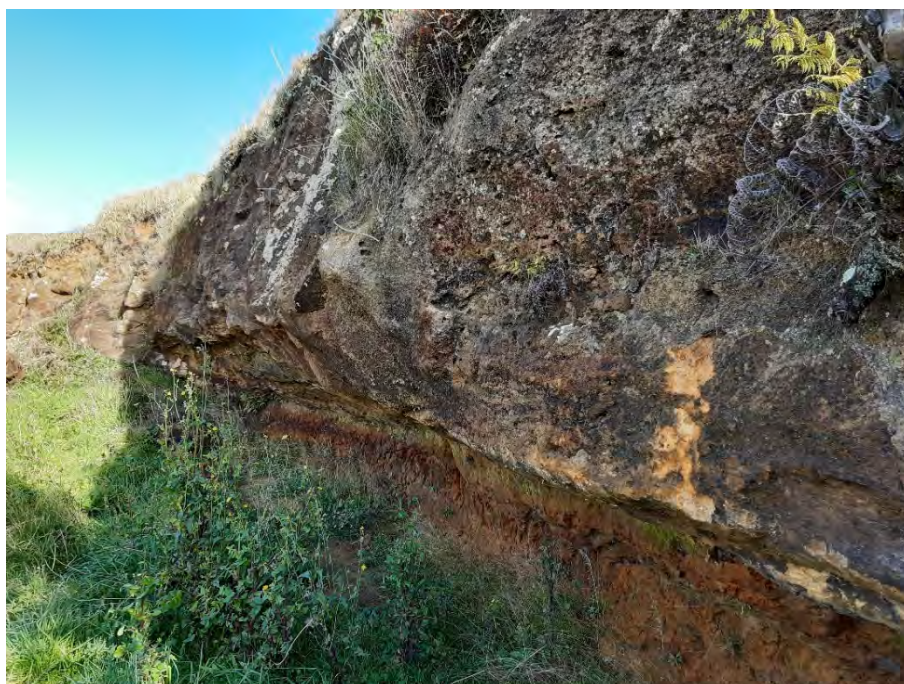
Photo 4: Outcrop of weathered Awhitu Group dune sands exhibiting weak cementation in the upper portion and assessed not susceptible to liquefaction.

There is evidence of cementation of sand grains and “hardpan” features in weathered outcrops around the site, which have a strength consistent with “extremely weak rock” in terms of the NZGS field description guidelines (Photo 4).

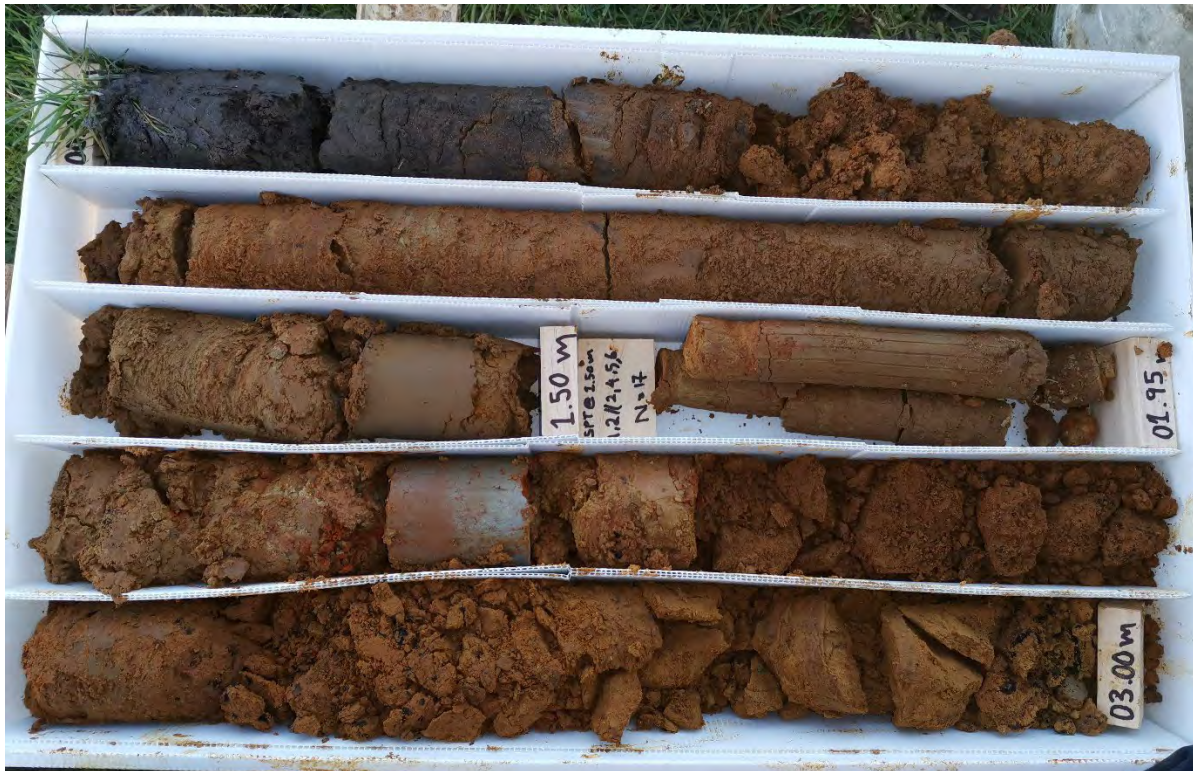
Photo 1: MH2 from surface to 3m bgl

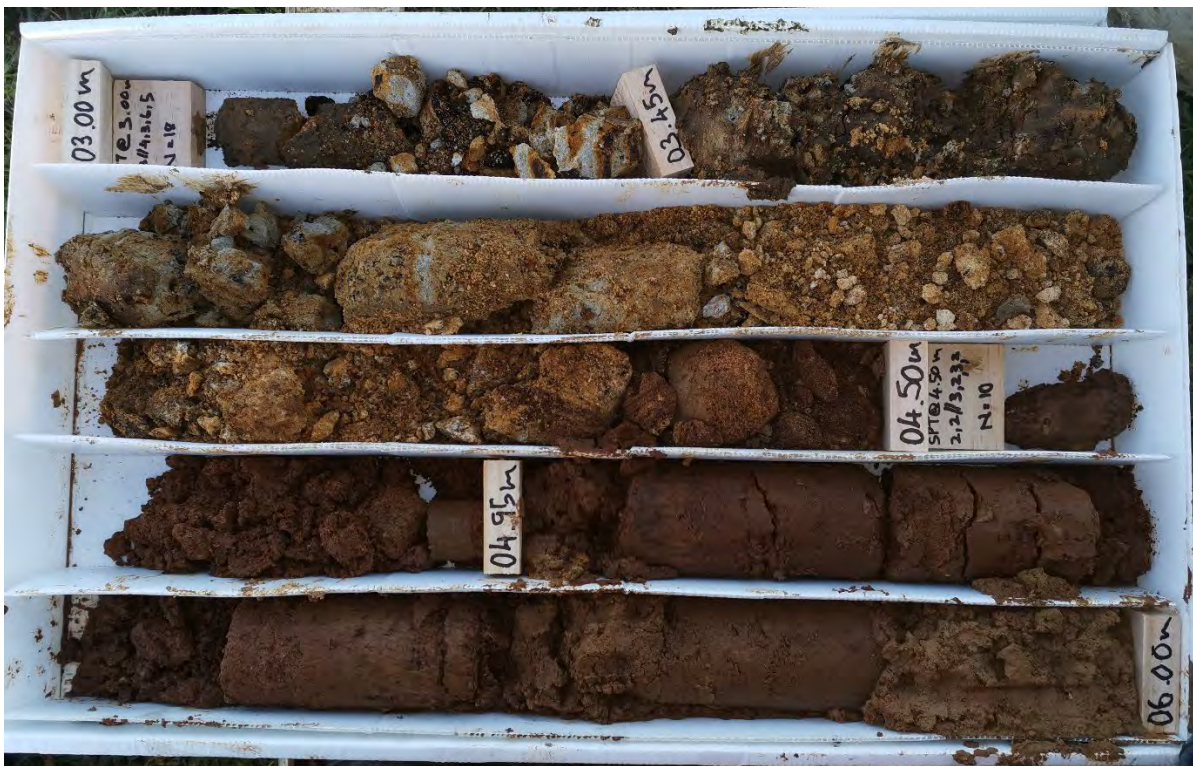
Photo 2: MH2 from 3m to 6m bgl

Sample recovery was generally good with greater than 75% recovery in all boreholes except for MH02, which experienced 100% core loss between 5.5m to 6.0m. This is attributed to the presence of saturated, loose to medium dense sand that appears to have liquefied by the drilling process.

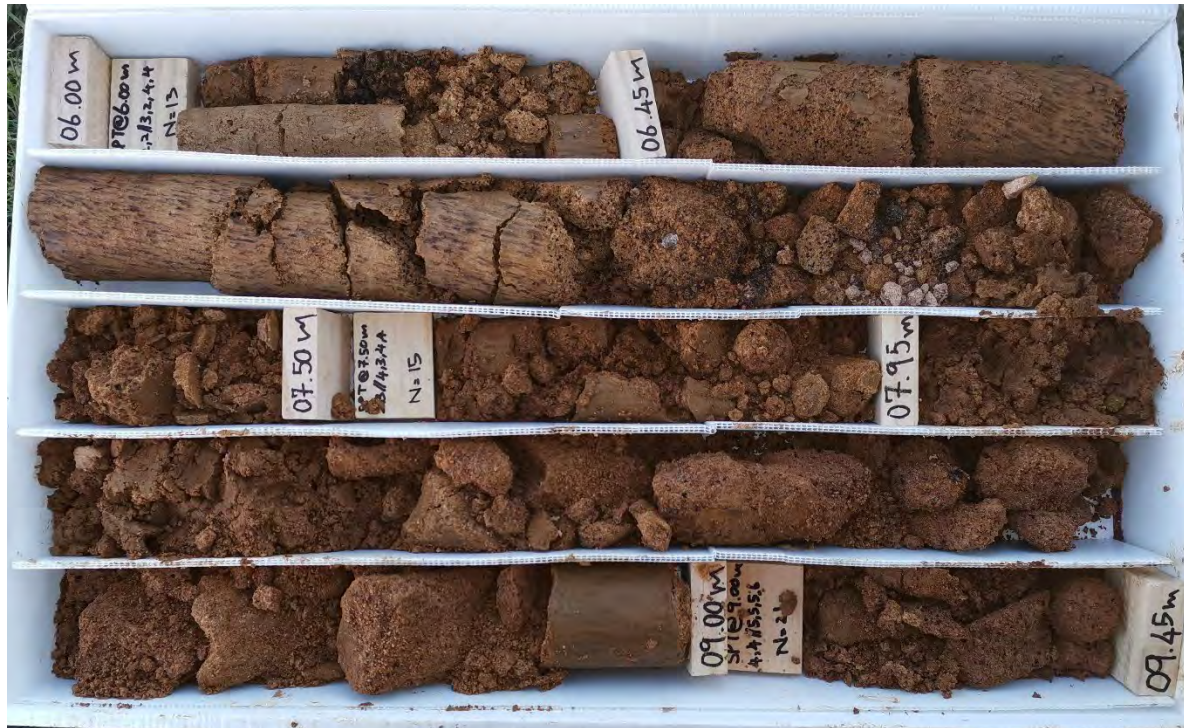
Photo 3: MH2 from 6m to 9.45m bgl

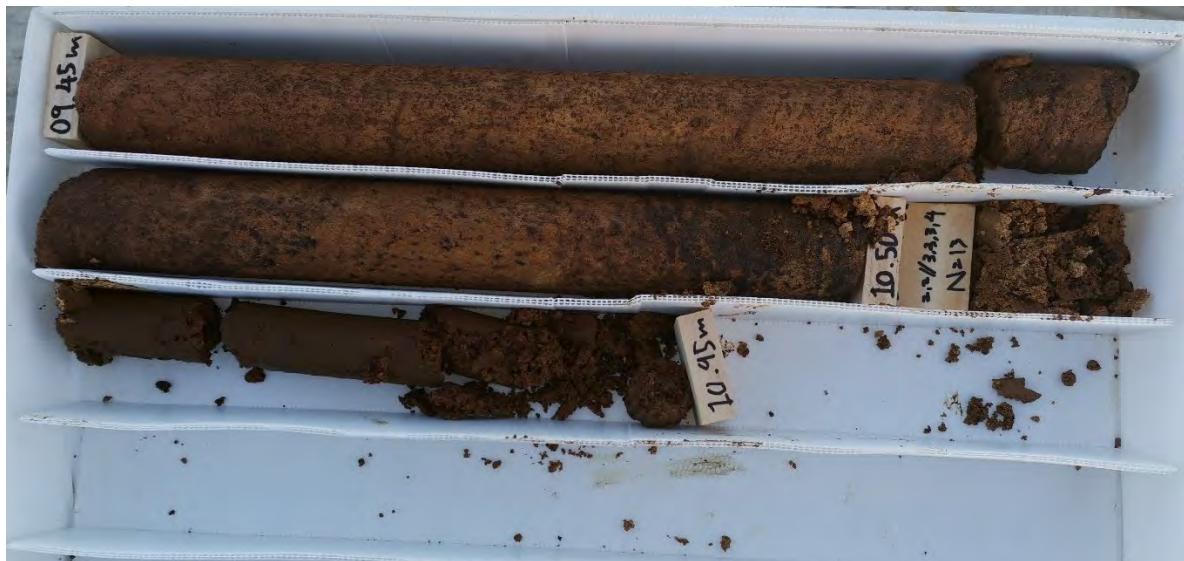
Photo 4: MH2 from 9.45m to 10.95m bgl

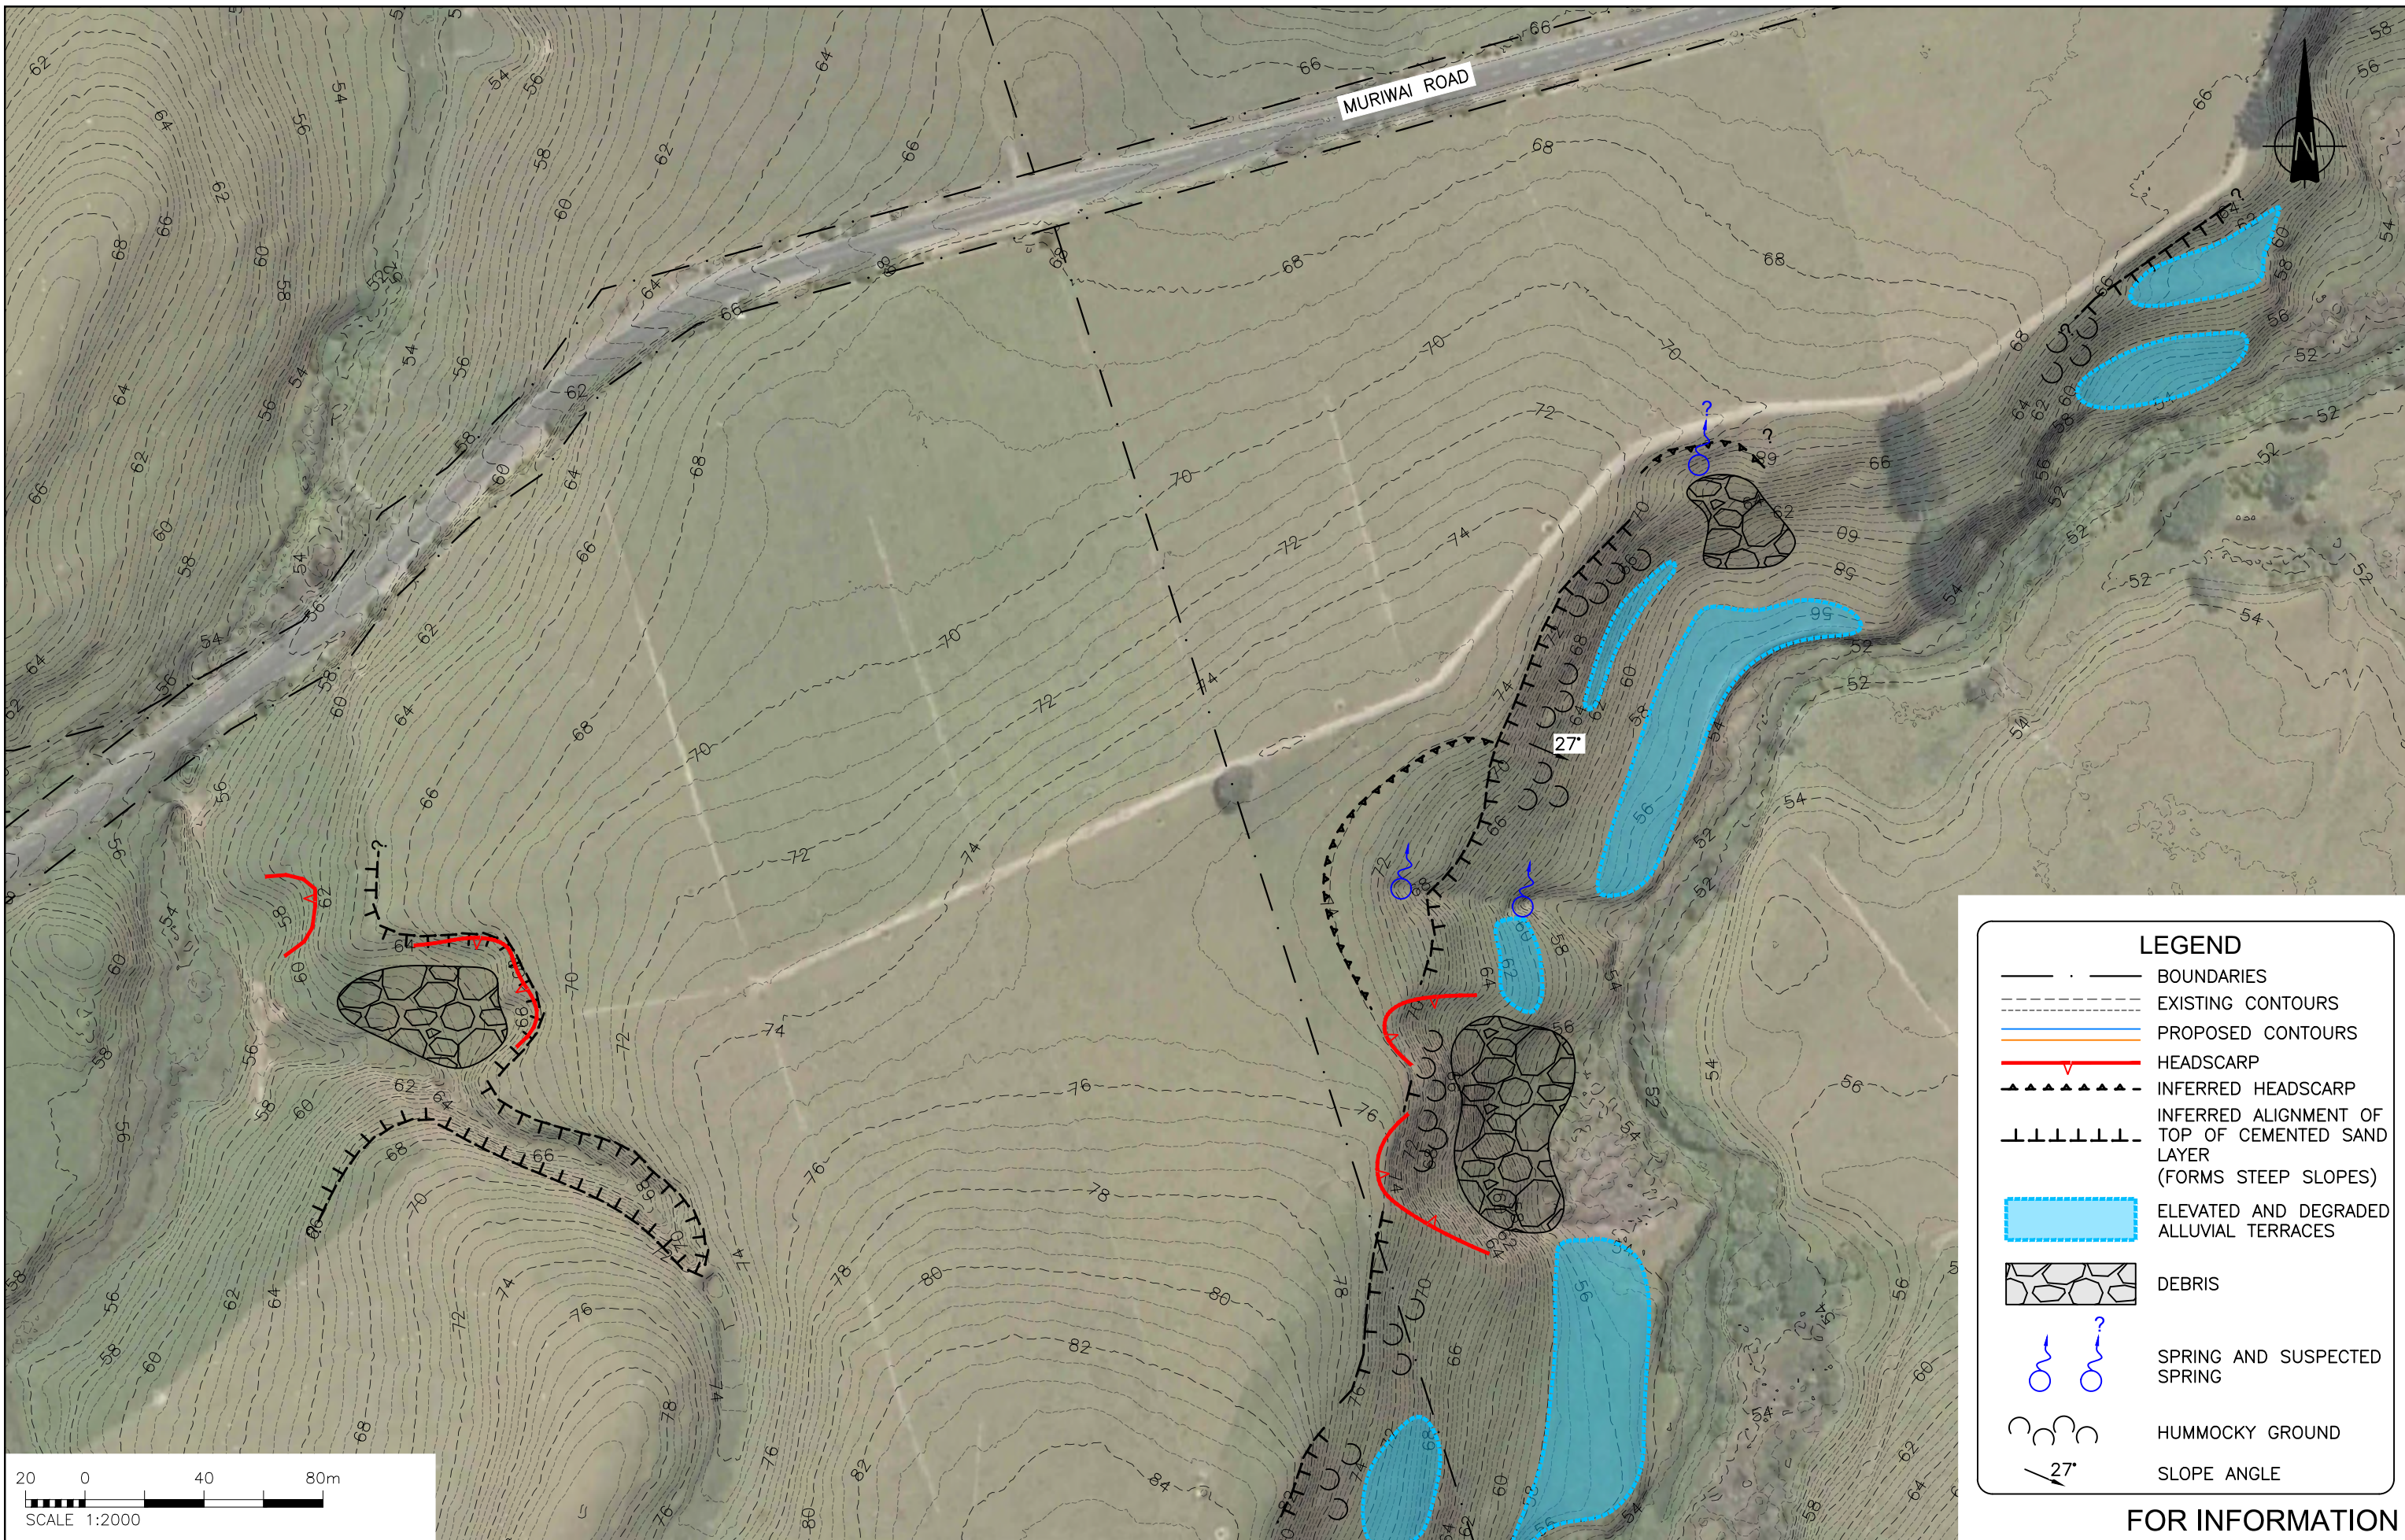
ACENZ	CADFILE	210339-1.dwg
	SCALE (A3)	1:2000
ISO COMPLIANT GCS	ORIG. SHEET SIZE	A3
	DRAWING No.	210339-1
	REV.	1

CLIENT	THE BEARS HOME PROJECT MANAGEMENT LTD
ADDRESS	710 MURIWAI ROAD, MURIWAI VALLEY, AUCKLAND
PROJECT	MURIWAI DOWNS GOLF COURSE
SHEET TITLE	GEOTECHNICAL INVESTIGATION - SITE PLAN
