Eastern Busway

EB2 and EB3 Residential

Archaeological Effects Assessment

Document Number: EB234-1-PL-RP-Z2-000023

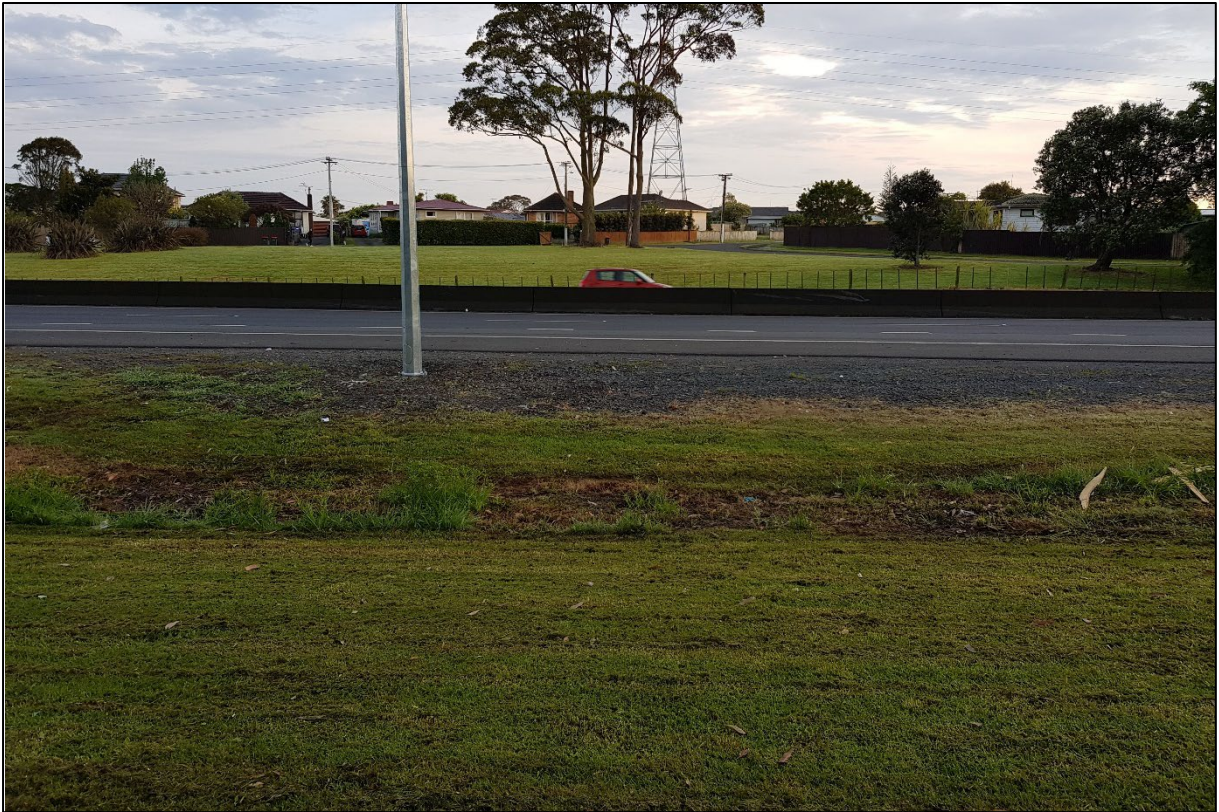
MCC_P98066C, MCC_108673, and 89-18 were accessed from the Pakuranga Highway. The area where the proposed discharge points are to be located has been heavily modified through reclamation and road building (Figure 3). The inlet directly south of them was checked, but no visible archaeological material identified (Figure 5).

Figure 5. View from stormwater discharge point 89-18 towards Dale Crescent. This area is all reclamation which may contain sub surface archaeological deposits associated with the original coastline.

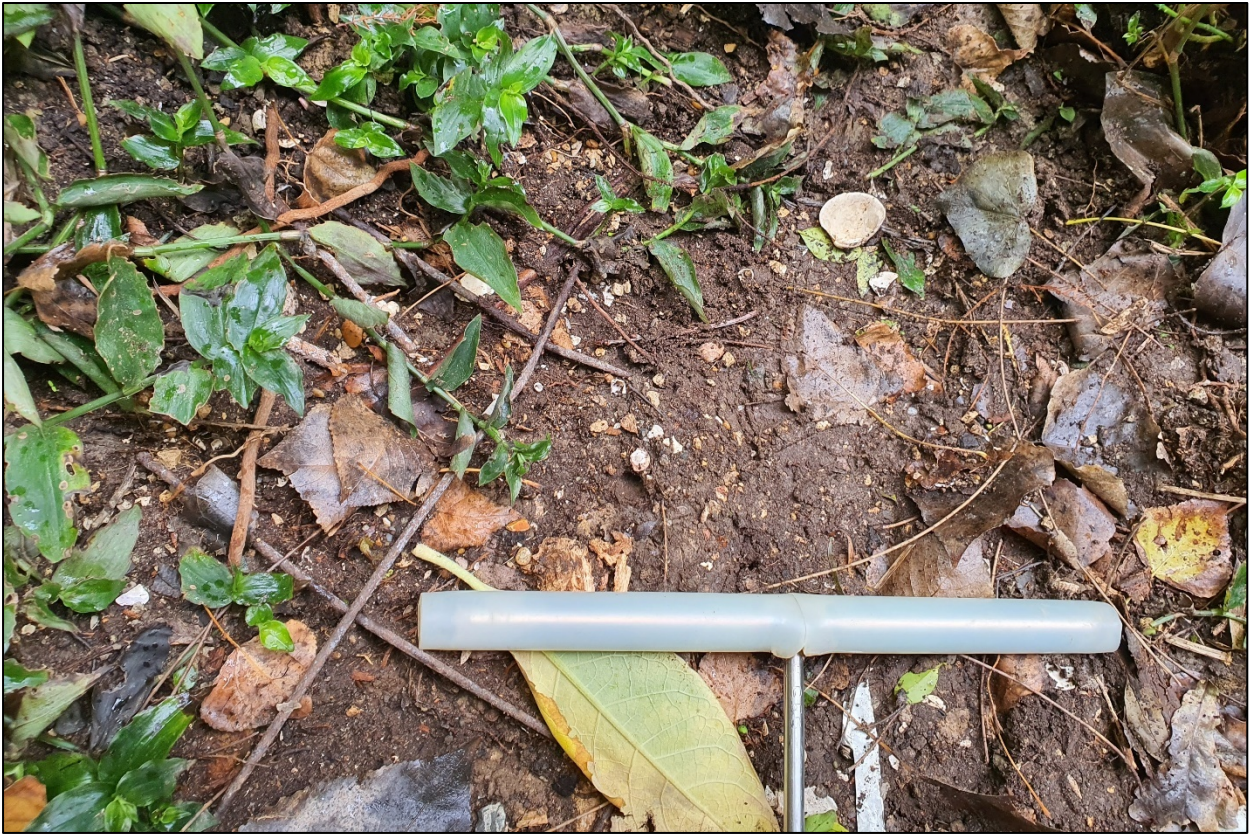
Redeposited midden was within an area where vegetation had been cleared, possibly by council contractors. This midden was visible for 1.0 x 0.5 m and consisted of whole and fragmented tuangi cockle and gastropods (Figure 6). This was within the same slumping material as the rest of the bank, which indicates it probably originated in the backyard of 63A Ti Rakau Drive. This redeposited midden has been recorded in the NZAA SRS as R11/3403 (Figure 7).

Figure 6. Close-up of fragmented midden R11/3403 visible within council reserve. Probe handle = 0.45 m.

Condition	The portion of this site that was identified is redeposited, but it is possible that in situ material still exists.
Rarity	Midden/Oven sites are a common site type, both regionally and nationally.
Context	The Tāmaki River was an important waterway, and there is evidence of the creek being used for navigation and access in both pre-European and historic periods. Any in situ material associated with this site would have contextual value linked to Māori settlement and movement patterns.
Information	There is the potential for scientific information to be recovered by archaeological means if in situ archaeological material associated with this site is uncovered during works.
Amenity	No amenity values are known. Any potential archaeological information could be presented to the public using interpretive materials.

Due to the risk of encountering evidence related to pre-European Māori and historic land use, we recommend applying for an authority from HNZPT under Section 44 of the HNZPT Act (2014) to cover the areas of EB2 and EB3R to ensure that if anything is encountered it can be dealt with in a timely fashion. An AMP will be prepared for the project as part of the application process to clearly outline induction requirements for contractors (and sub-contractors) and procedures for archaeological monitoring, inspection, and investigation.

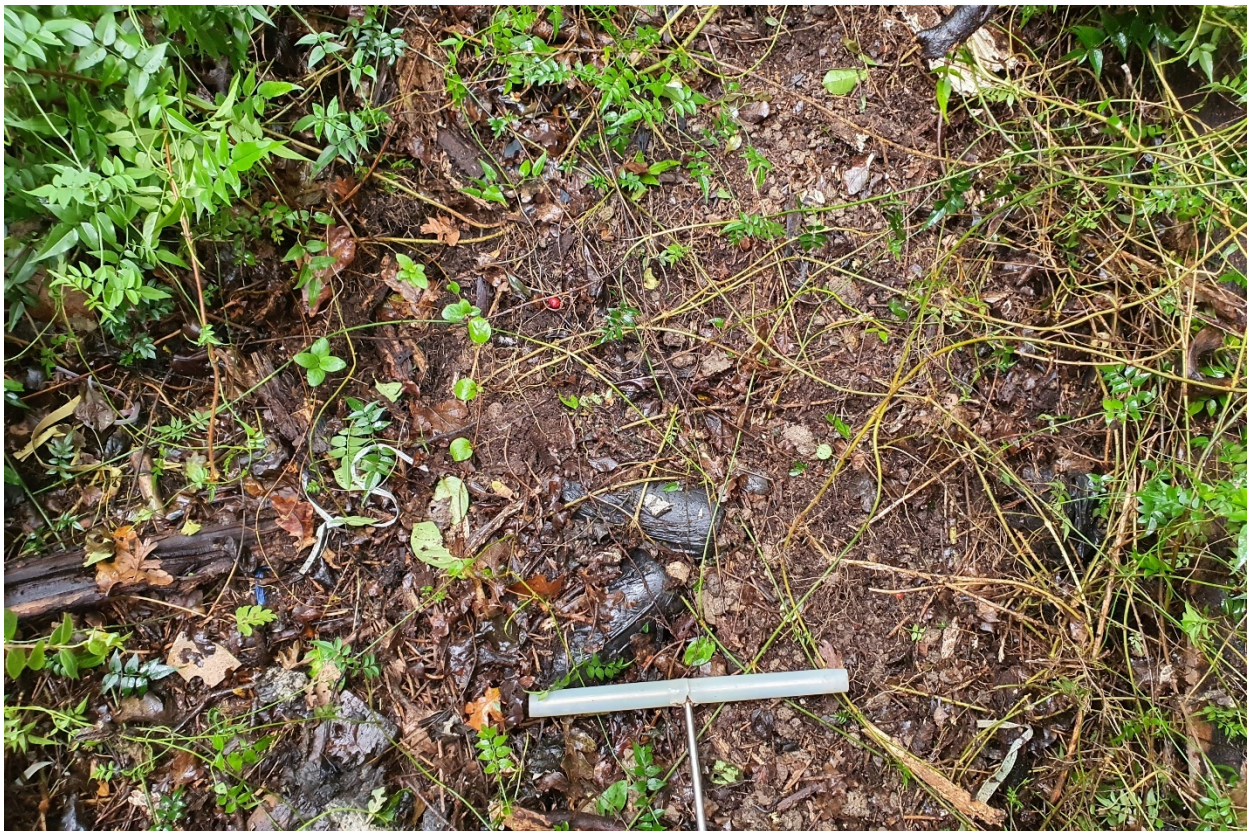
MCC_108707 was accessed through the backyard of 97 Ti Rakau Drive. This portion of the inlet had been infilled or dammed in the past and consisted of redeposited soil and rubbish. Probing proved inconclusive, but it appeared that the slump material is at least 500 mm deep and possibly more than 1 m. No archaeological material was noted within this discharge point.

Figure 8. Ground surface near outflow MCC_108707. Probe handle =0.45m.

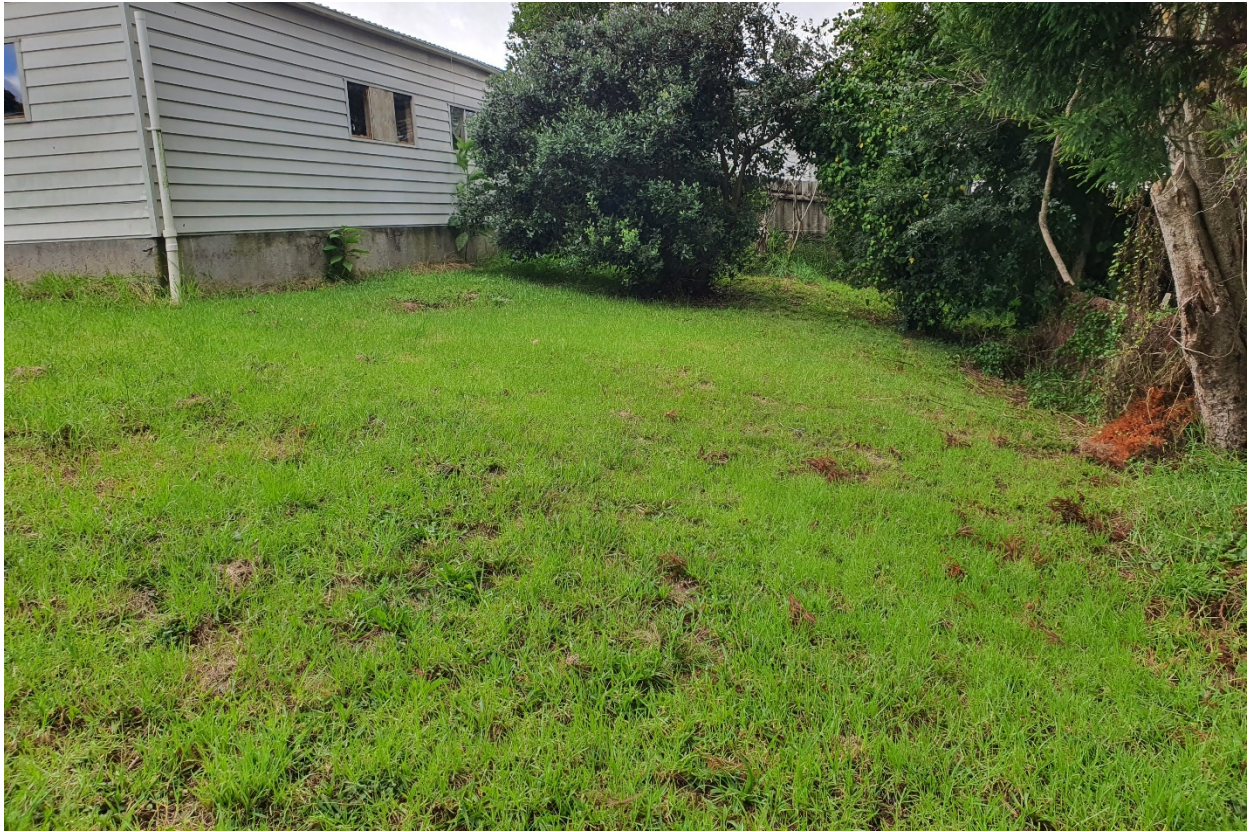
MCC_108718 was accessed through 151 Ti Rakau Drive. The proposed outflow is within the inlet but will require trenching through the bank. The bank itself is steep and no archaeological material was noted. The backyard of 151 Ti Rakau Drive was intermittently probed but this proved inconclusive. The backyard appears to have poor drainage so would not have been ideal for permanent settlement but may have been suitable for seasonal use (Figure 9 and Figure 10). No archaeological material was noted within the vicinity of this discharge point.

Figure 9. Backyard of 151 Ti Rakau Drive where stormwater discharge will be trenched through.

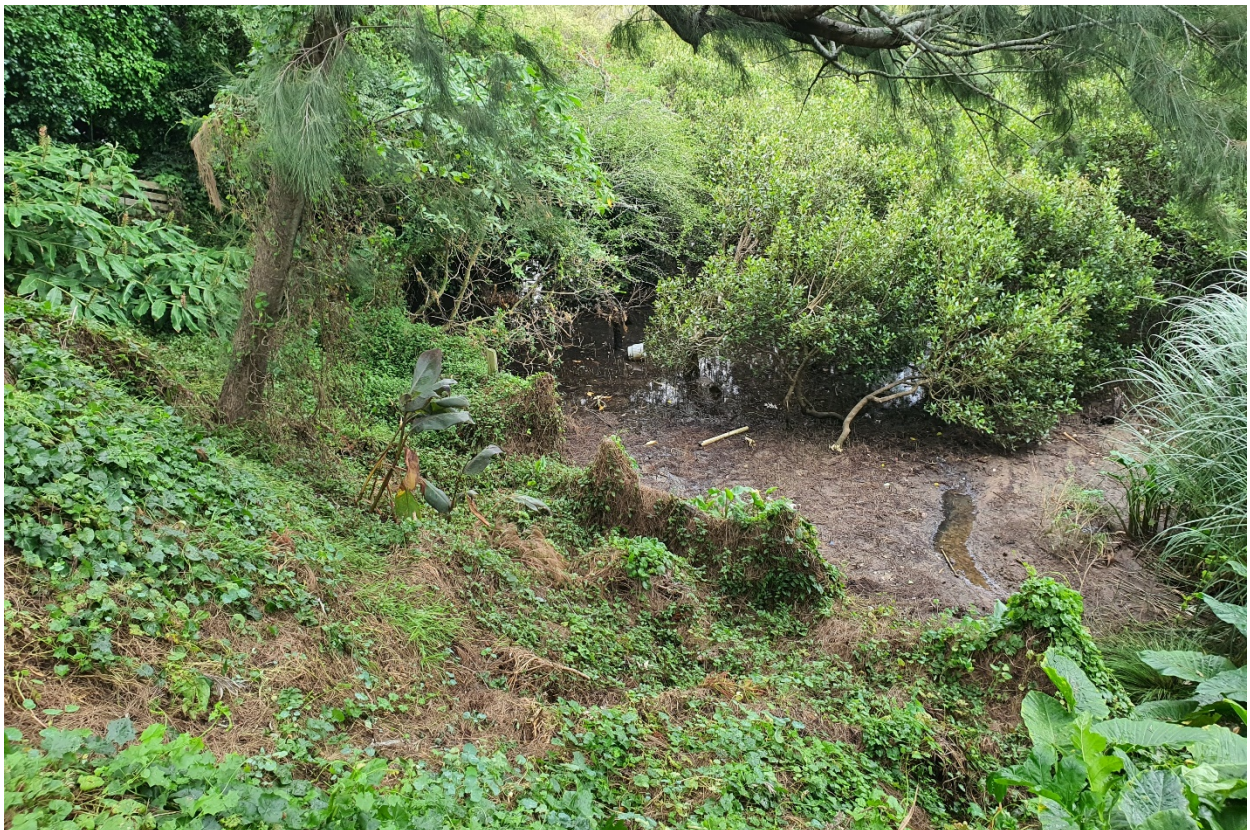
Figure 10. Mangrove portion of inlet where stormwater discharge MCC_108718 will be located.

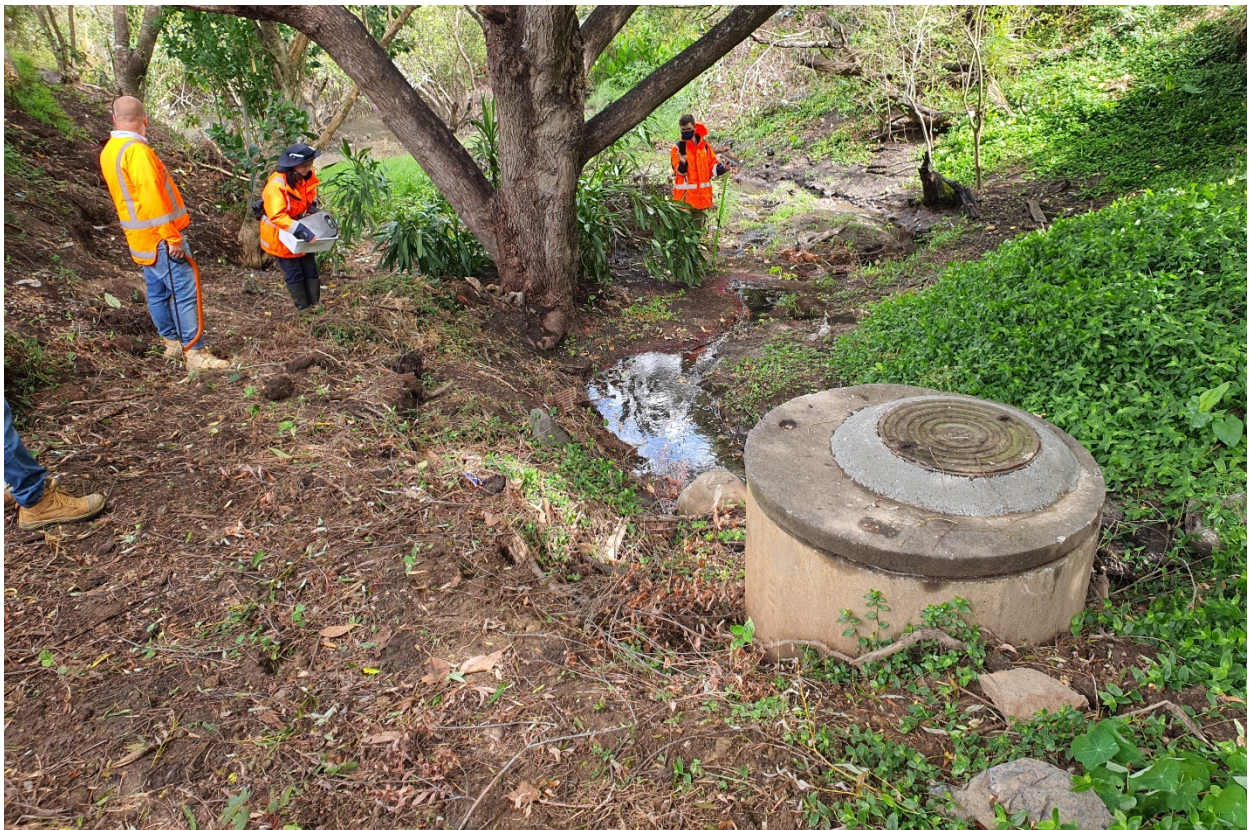
MCC_108738 was accessed between 171 and 173 Ti Rakau Drive. The area is mainly in grass, with some smaller plants and a large willow where the outflow is proposed (Figure 11). During the 2018 survey this area was overgrown, but subsequent stormwater works has exposed the area. An access track has been cut into the esplanade reserve, presumably associated with the stormwater upgrades. This cut is up to 1m deep and exposed redeposited soil and rubbish (Figure 12). The natural ground surface does not appear to have been exposed during these works. The depth of reclaim/filling in this area is not able to be established, but it is assumed that it is associated with levelling of the neighbouring properties for the creation of house platforms. No evidence of archaeological material was identified in the vicinity of this discharge point.

Figure 11. Recently cleared area around MCC_108738 for stormwater upgrades.

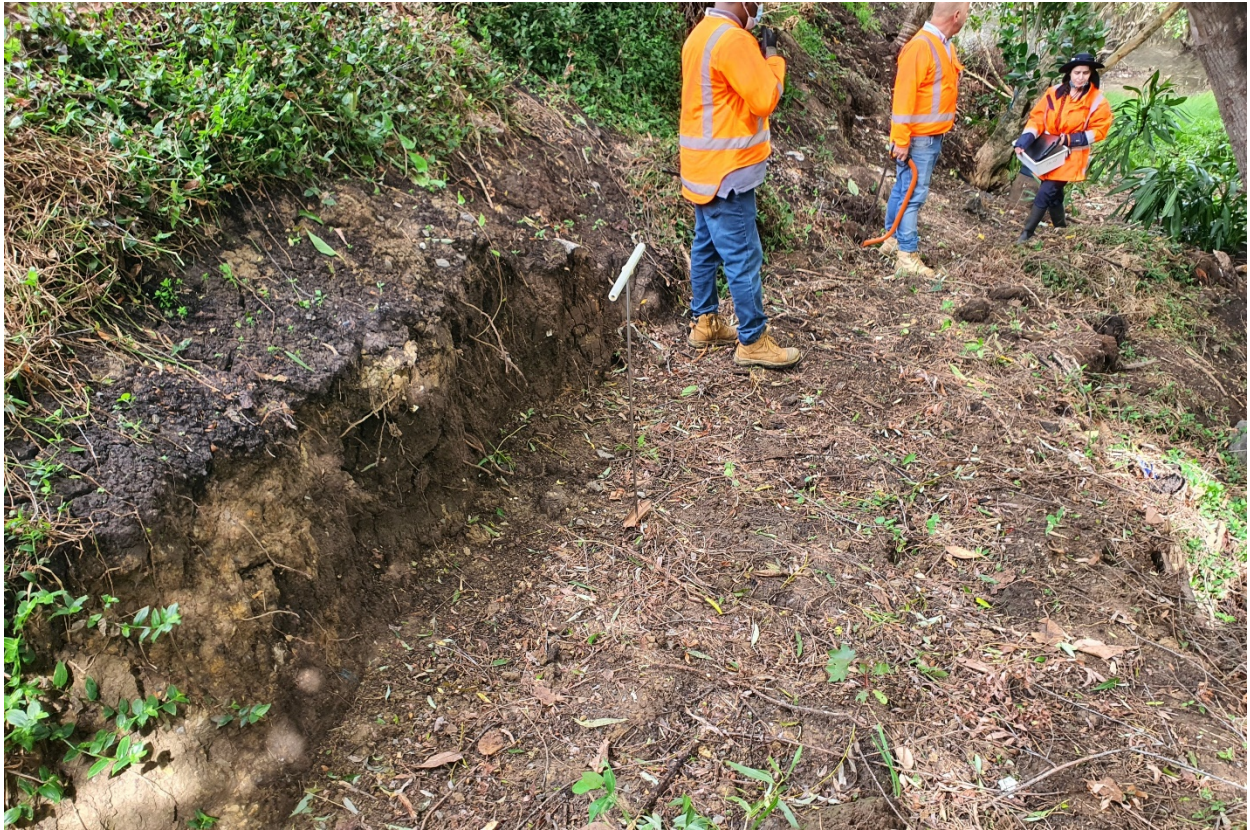
Figure 12. cut made for digger access showing up to 1 m of fill.

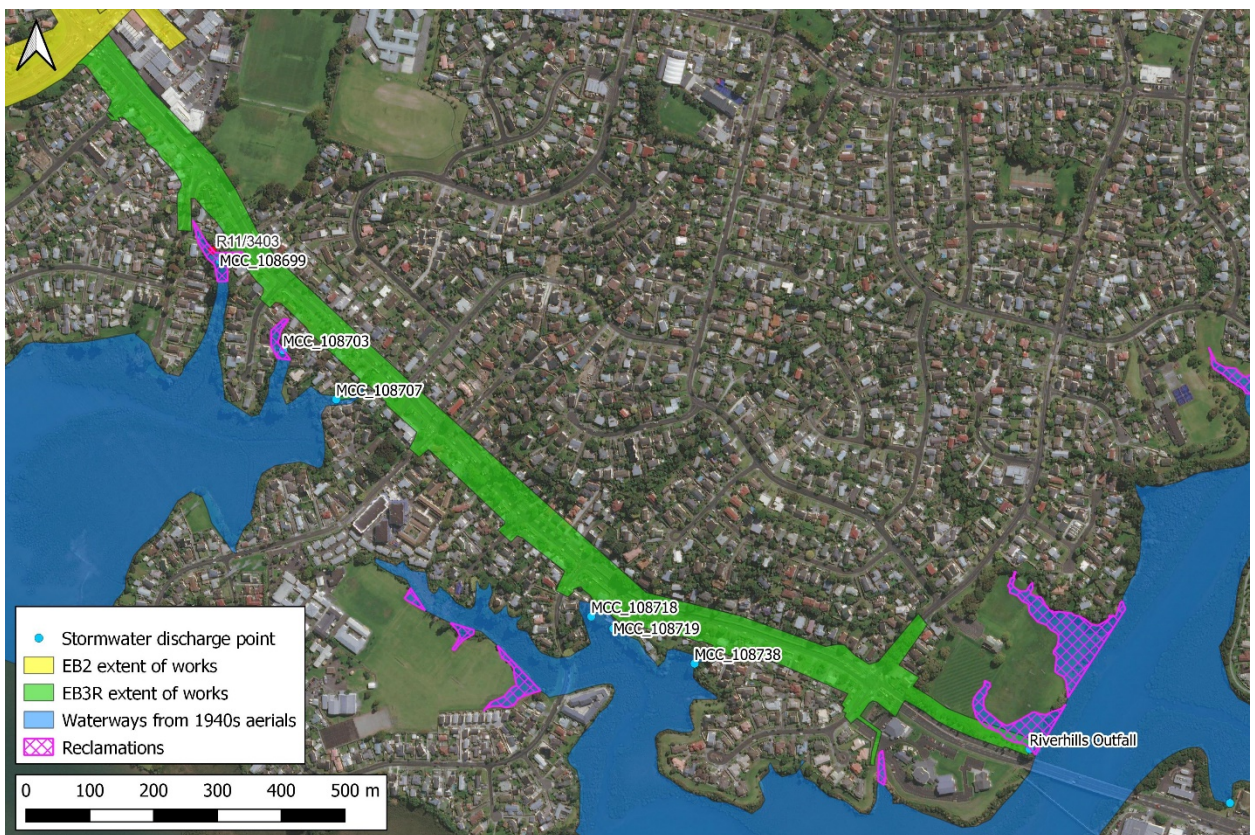
MCC_108746 is within the reclaimed and built-up portion of Riverhills Park. It is directly next to the original stream bank (Figure 14), so it is possible that sub-surface archaeological deposits may be exposed during works. No evidence of archaeological material was identified in the vicinity of this discharge point.

Figure 14. EB3R showing areas where silting or reclamation has obscured inlets and proposed stormwater discharge points.
