Eastern Busway

EB2 and EB3 Residential

Marine Ecology and Coastal Avifauna Effects Assessment

Document Number: EB234-1-PL-RP-Z2-000027

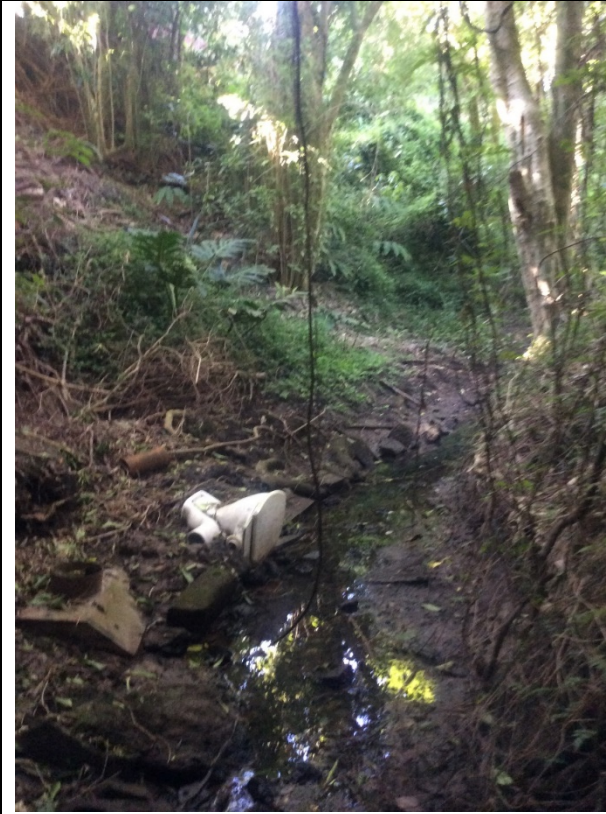
Photograph 1: Adjacent to Outfall 1A (Stream present - see Terrestrial and Freshwater Ecology Assessment).

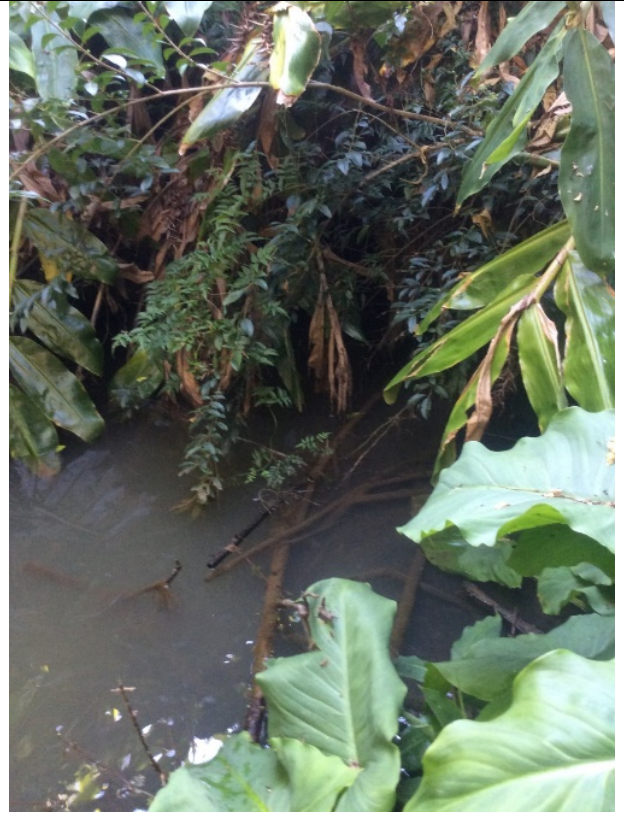
Photograph 2: Adjacent to Outfall 1B (Stream present - see Terrestrial and Freshwater Ecology Assessment).

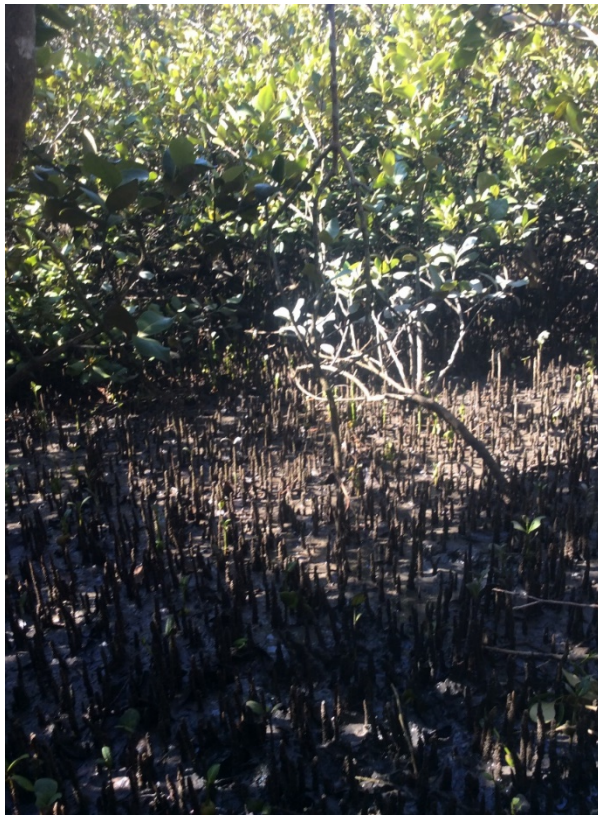
Photograph 9: Adjacent to proposed revised location outside of Transpower cables adjacent to outfall 8/11.

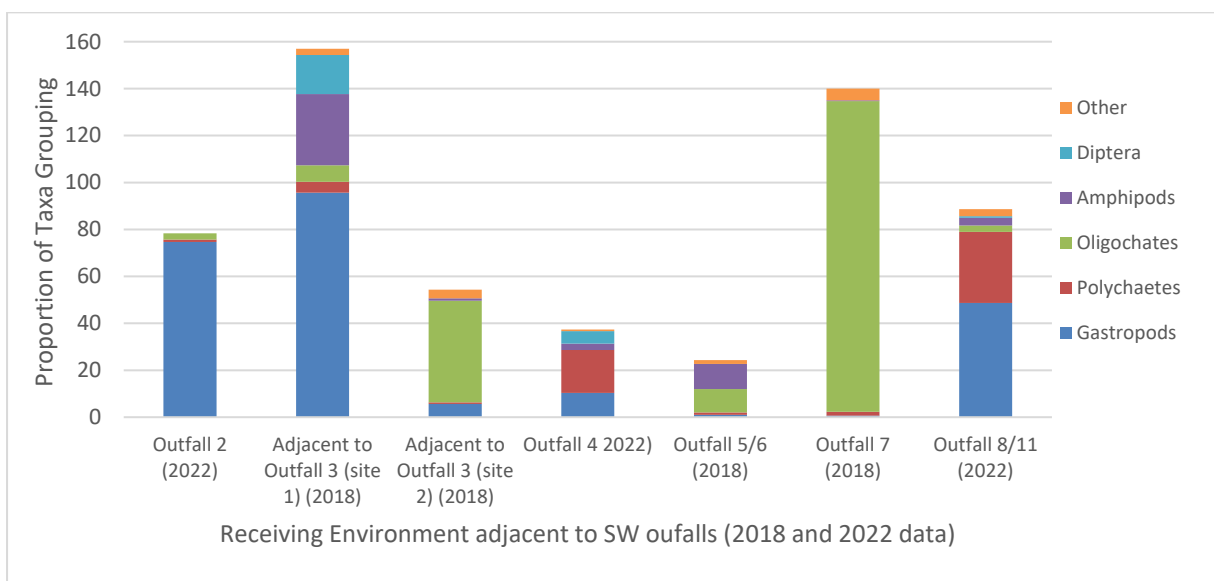
The benthic invertebrate assemblages at all sites were largely dominated by oligochaete worms, estuarine gastropods (*Potamopyrgus estuarinus* and *Amphibola crenata*) and amphipods (Figure 4). These are typical species present in mangrove stands. Abundance of benthic invertebrates ranged between an average of approximately 20 individuals at stormwater outfall 5/6 to approximately 150 at stormwater outfall 3 (site 1) (Figure 4).

Figure 4: Proportions of main taxa groups by abundance at each selected stormwater outfall site.

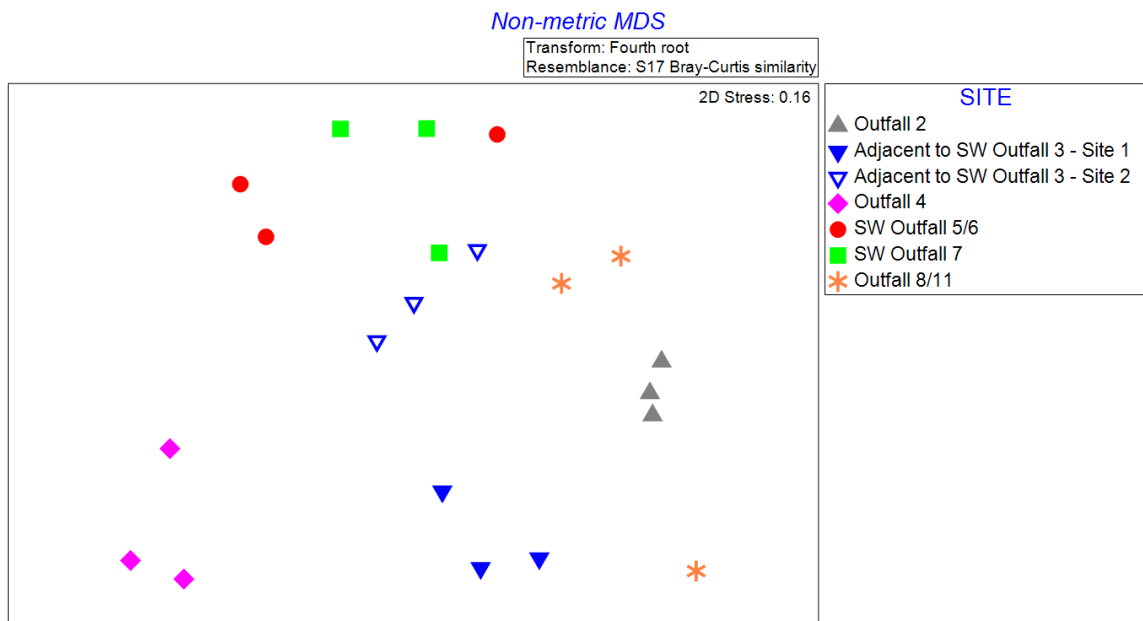
The difference in benthic invertebrate assemblages at selected stormwater outfall sites is shown in the Multi-Dimensional Scaling (MDS) Plot⁹ below, with most sites clustered separately, particularly outfall 2, 4 and outfall 3 (site 1) (Figure 5). Outfall 7 had similarities to outfall 5/6 and outfall 3 (site 2) (Figure 5).

Figure 5: Multi-dimensional Scaling Plot of benthic invertebrate infaunal assemblages at proposed stormwater outfall sites.

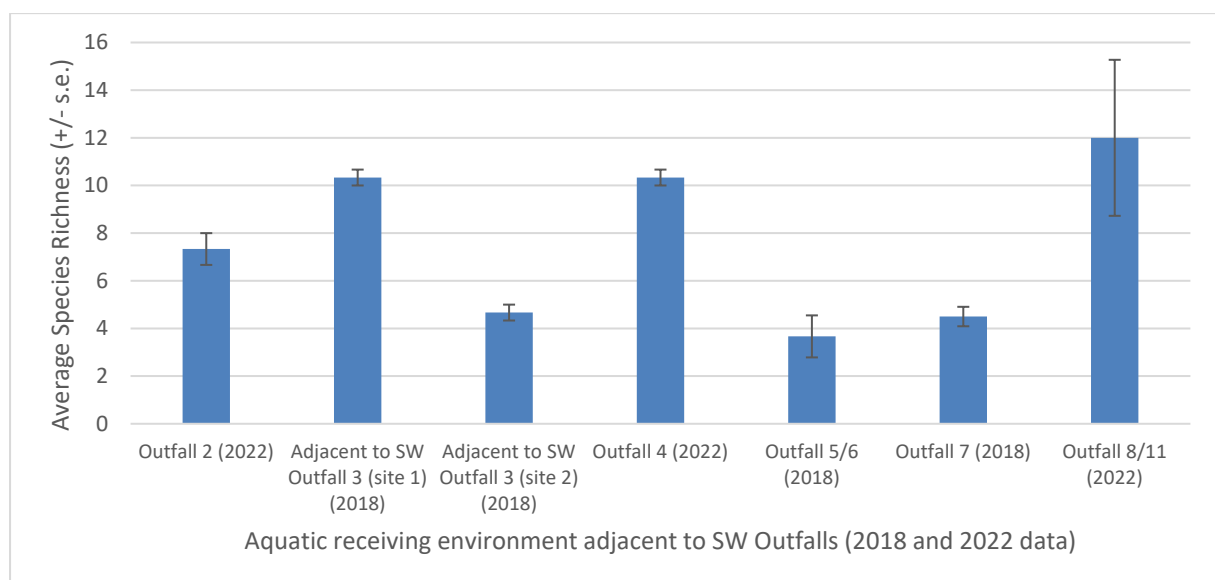
Species richness was highest at outfall 8/11 (location of redesign of stormwater outfall to avoid underground Transpower cables) with approximately 12 species detected. Outfall 3 (site 2), outfall 5/6 and outfall 7 had the lowest number of species of around 4 taxa per site (Figure 6).

Figure 6: Average species richness of benthic invertebrates by site (2018) adjacent to SW outfalls.

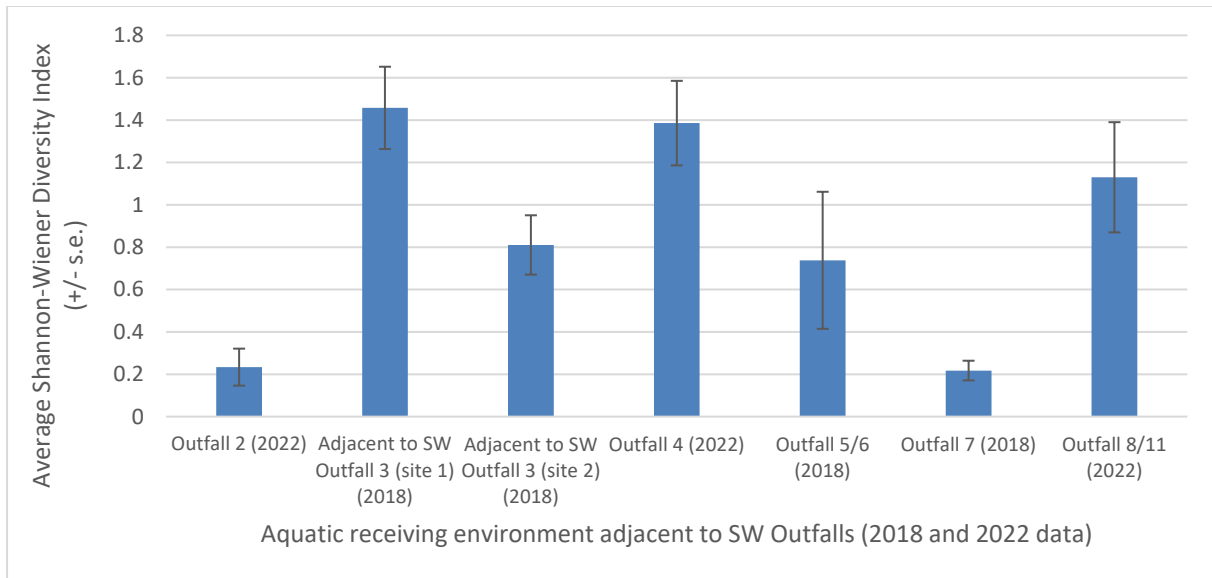
Average Shannon-Wiener diversity varied from low (0.2 at stormwater outfall 2 and 7) to moderate diversity (just below 1.5) at stormwater outfall 3 (site 1) and outfall 4 (Figure 7).

Figure 7: Average Shannon-Wiener Diversity Index by Site (2018) adjacent to SW outfalls.

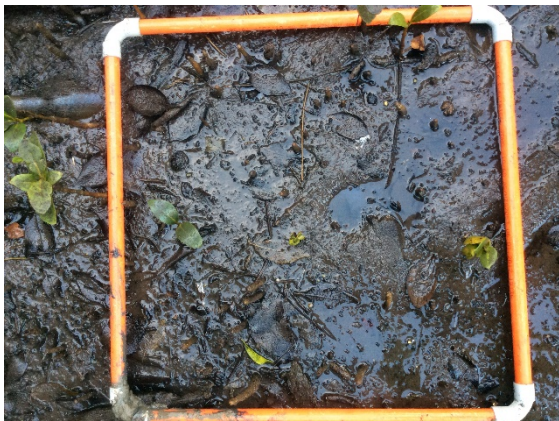
Sunlight exposed sites exhibited extensive mangrove seedling and pneumatophores and some gastropods (*Potamopyrgus estuarinus*) (Photograph 11 to Photograph 17). Although, not captured in the quadrat photographs collected, *Amphibola crenata* (mud snail) were present at some sites along with mangrove stands.

Photograph 11: Stormwater Outfall 2 - Mangrove pneumatophores, seedlings and leaf litter.

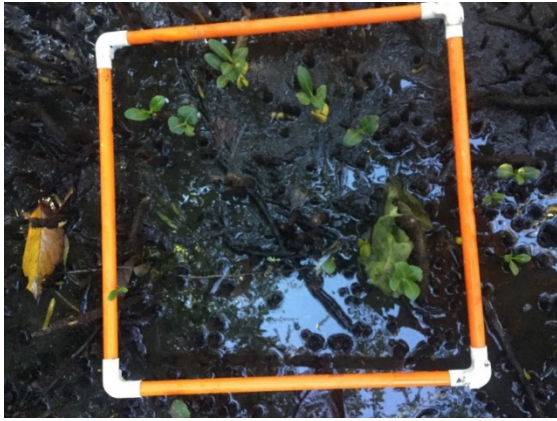
Photograph 13: Stormwater Outfall 3 (site 2) - Mangrove pneumatophores and seedlings, and *Potamopyrgus estuarinus*.

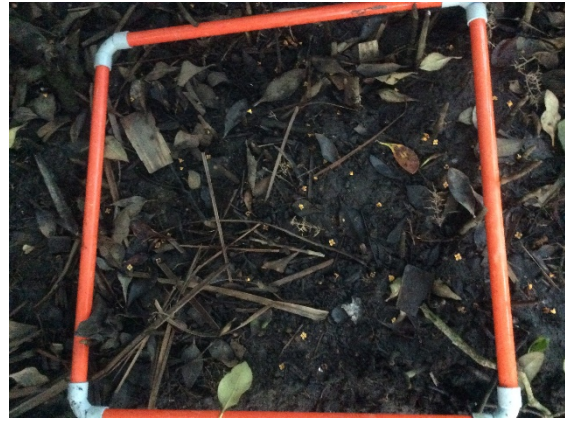
Photograph 14: Stormwater Outfall 4) - Mangrove leaf litter.

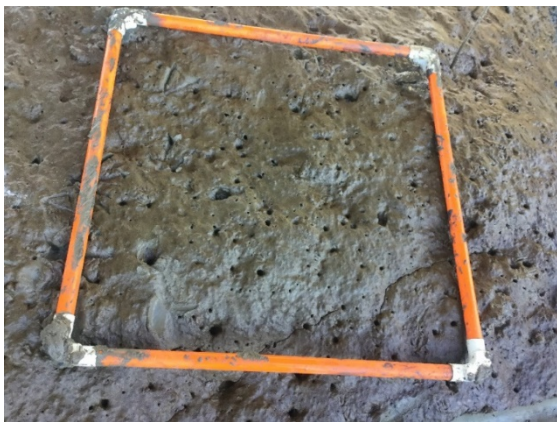
Photograph 15: Stormwater Outfall 5/6- Mud crab burrows, no mangrove pneumatophores.

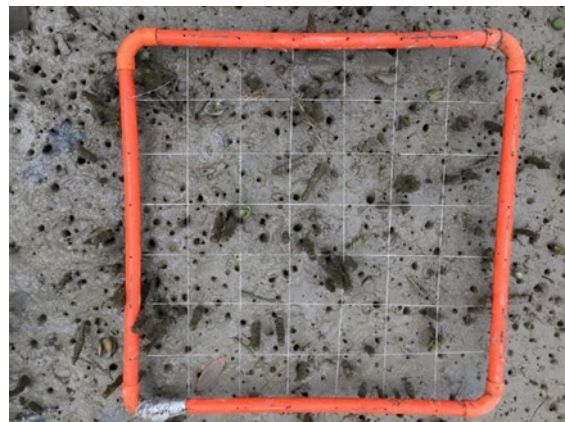
Photograph 16: Stormwater Outfall 7- Mud crab burrows, and mangrove pneumatophores

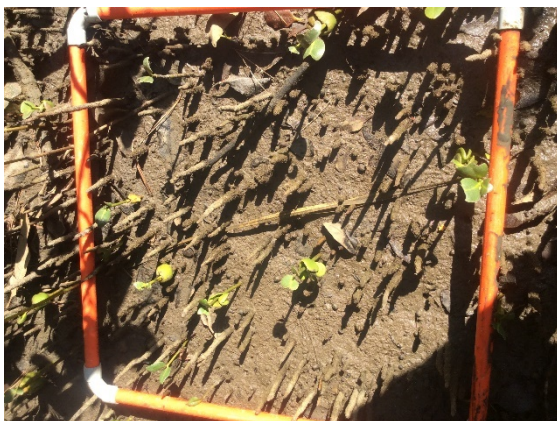
Photograph 17: Stormwater Outfall 8/11- Mangrove pneumatophores and seedlings.

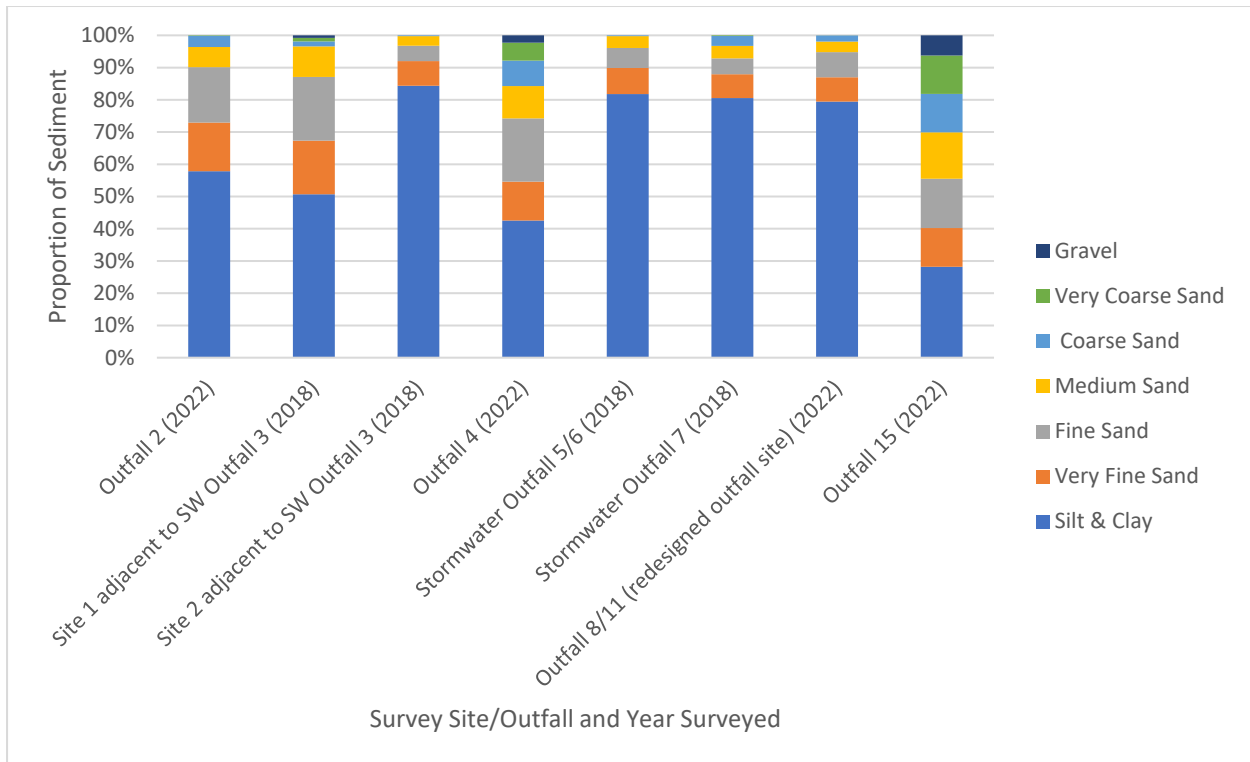
Surface sediment at all sites was dominated by silt and clay and had shallow depth of oxygenated sediment. Silt and clay at all sites comprised greater than 50%, except for outfall 4 and 15. Stormwater outfall 3 (Site 2) had the highest proportion of silt and clay at approximately 85%. Outfalls 5/6, 7 and 8/11 had approximately 80% silt and clay (Figure 8). A high proportion of silt and clay is typical of upper estuarine depositional environments, such as many of the outfall sites surveyed (Figure 8).

Figure 8: Proportion of grain size distribution in surface sediment.
