Auckland Regional Landfill

Geotechnical Factual Report

Prepared for
Waste Management NZ Ltd

Prepared by
Tonkin & Taylor Ltd

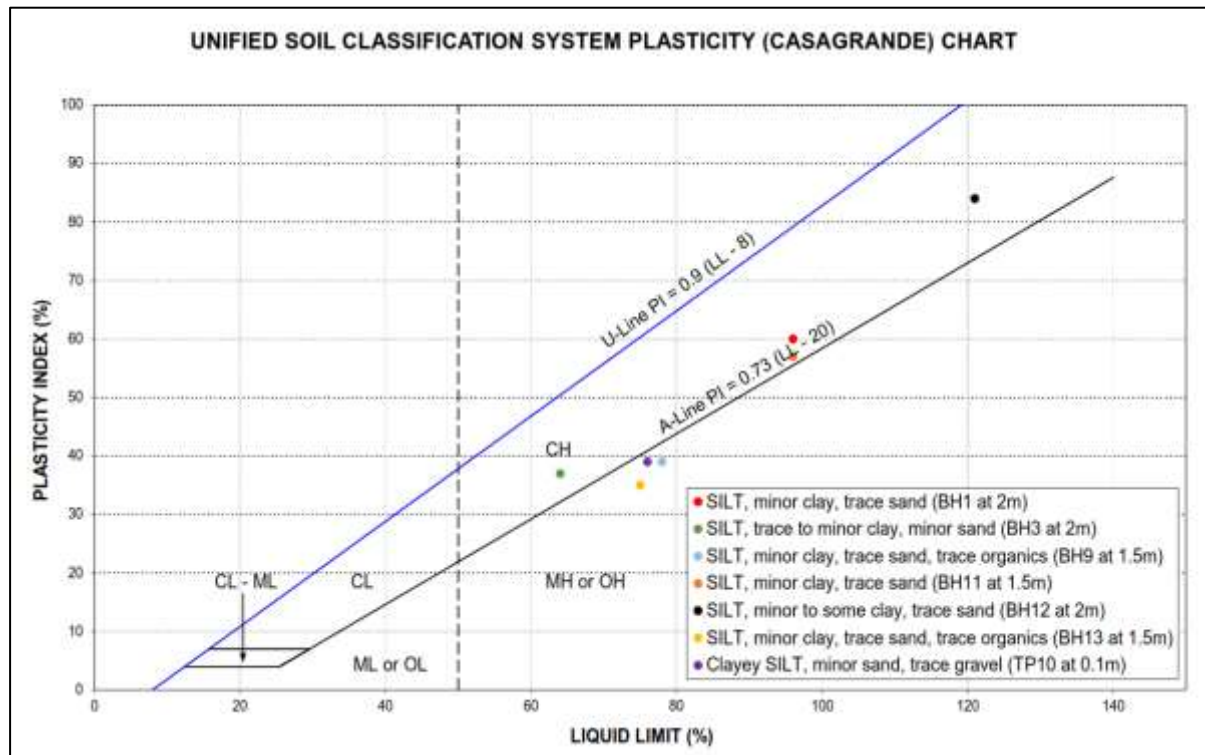
Figure 4.1: Unified Soil Classification System (USCS) plasticity chart

Atterberg limit testing was undertaken on six samples collected from the machine boreholes and one sample from test pit TP10. The results of the Atterberg limit testing are attached in Appendix C. A summary of the results is presented in Table 4.9 below. The results are also plotted on a USCS plasticity chart and presented in Figure 4.1 below.

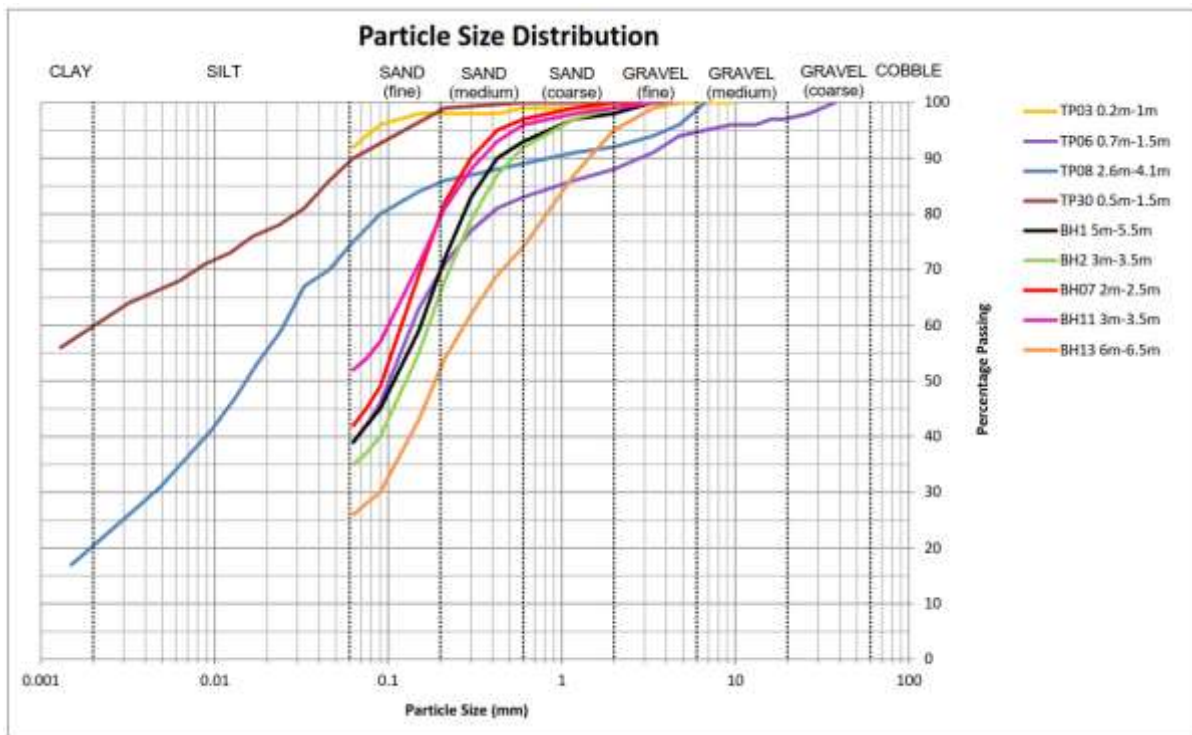
Figure 4.2: Particle size distribution analyses summary of results

The grading curves for sampled soils were determined using the wet sieve method (NZS 4402: 1986 Test 2.8.1) and hydrometer (NZS 4402: 1986 Test 2.8.4). A total of nine tests were conducted on samples retrieved from machine boreholes and test pits across the landholding. A summary of the results is presented in Figure 4.2 below. The test results are attached in Appendix C.
