**34 & 36 Sandspit Road, Warkworth:
Ecological Assessment of Effects
April 2022**

Document title:	34 & 36 Sandspit Road, Warkworth: Ecological Assessment of Effects
Prepared for:	The Kilns Ltd
Version:	002
Date:	11 April 2022
Document name:	34 & 36 Sandspit Road Ecology AEE.docx

Reference: Bioresearches (2022). 34 & 36 Sandspit Road, Warkworth: Ecological Assessment of Effects. Report for The Kilns Ltd.

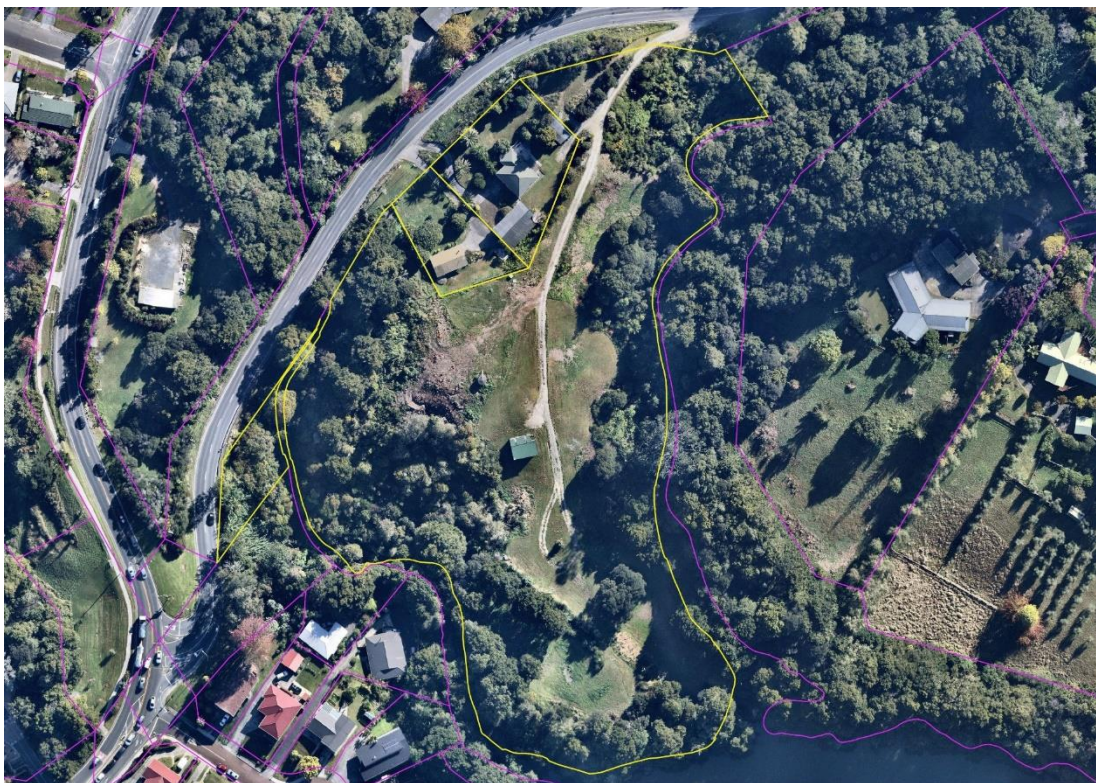
Figure 1. *The Site (yellow polygon) at 34 and 36 Sandspit Road, Warkworth.*

The Kilns Ltd is in the process of developing a residential subdivision at 34 and 36 Sandspit Road, Warkworth (the Site, Figure 1). As part of the development earthworks will be undertaken to facilitate development of residential lots, roads, underground infrastructure and a walkway/pathway. necessitating the removal of vegetation within an identified Significant Ecological Area (SEA). The area is currently zoned Future Urban and a private plan change request is being processed by Council seeking Residential – Mixed Housing Urban zone be applied to the land. Vegetation outside of the SEA can be removed as a permitted activity, while removal of vegetation within the SEA is a restricted discretionary activity. In addition, subdivision of the site will yield an esplanade reserve around the east, west and southern boundaries. The reserve will generally be located 20m from the watercourses with the exception of a small area in the south east where the width will be reduced to approximately 10m.

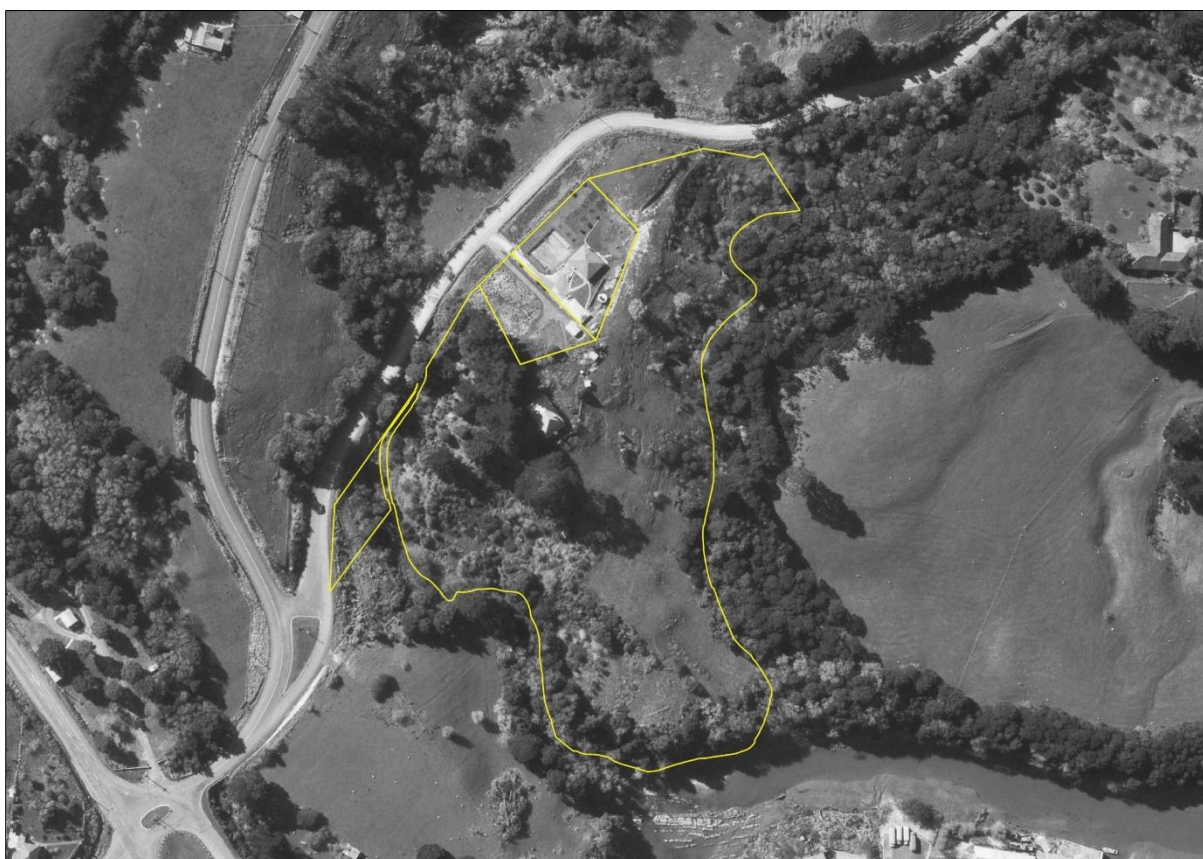
Figure 2. Aerial image of the Site (yellow polygon) in 1962 (historical image sourced from Retrolens).

Historically, the Site would have likely comprised of the ecosystem type; pūriri, taraire forest (WF7-2; Singers *et al.*, 2017). The characteristic native flora would have typically comprised of a mixed broadleaved forest commonly dominated by pūriri, karaka, kohekohe and, locally, taraire. This ecosystem type would have supported a diverse range of invertebrates, amphibians, reptiles, birds and bats. However, the majority of the site has been cleared for at least sixty years and has remained largely unchanged since 1963 (Figure 2). It is understood that, from 1859 until 1880s, the site was used as a lime quarry, with three kilns, a rail line and a quarry area present in the southern portions of the site.

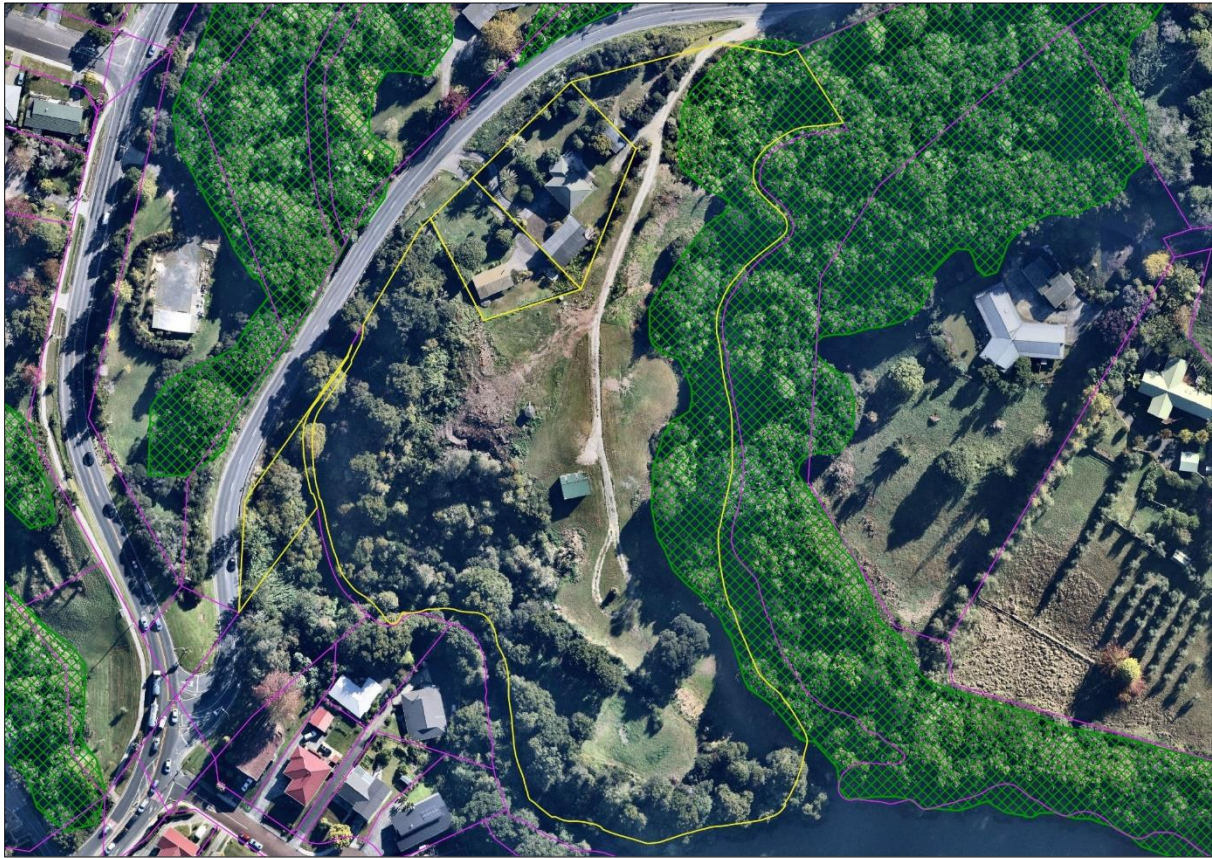
Figure 3. Aerial image of the Site (yellow polygon) with the SEA overlay (green hatch).

The vegetation along the eastern boundary of the Site (0.5 ha), adjoining an unnamed tributary of the Mahurangi River, is subject to a Significant Ecological Area overlay (SEA_T_6684, Figure 3). SEA_T_6684 covers a total area of approximately 8.5 ha and the wider area was assessed as an SEA by

Auckland Council based on all five factors/criteria; 'Representativeness', 'Threat Status and Rarity', 'Diversity', 'Stepping-Stones, Migration Pathways and Buffers' and 'Uniqueness or Distinctiveness'.

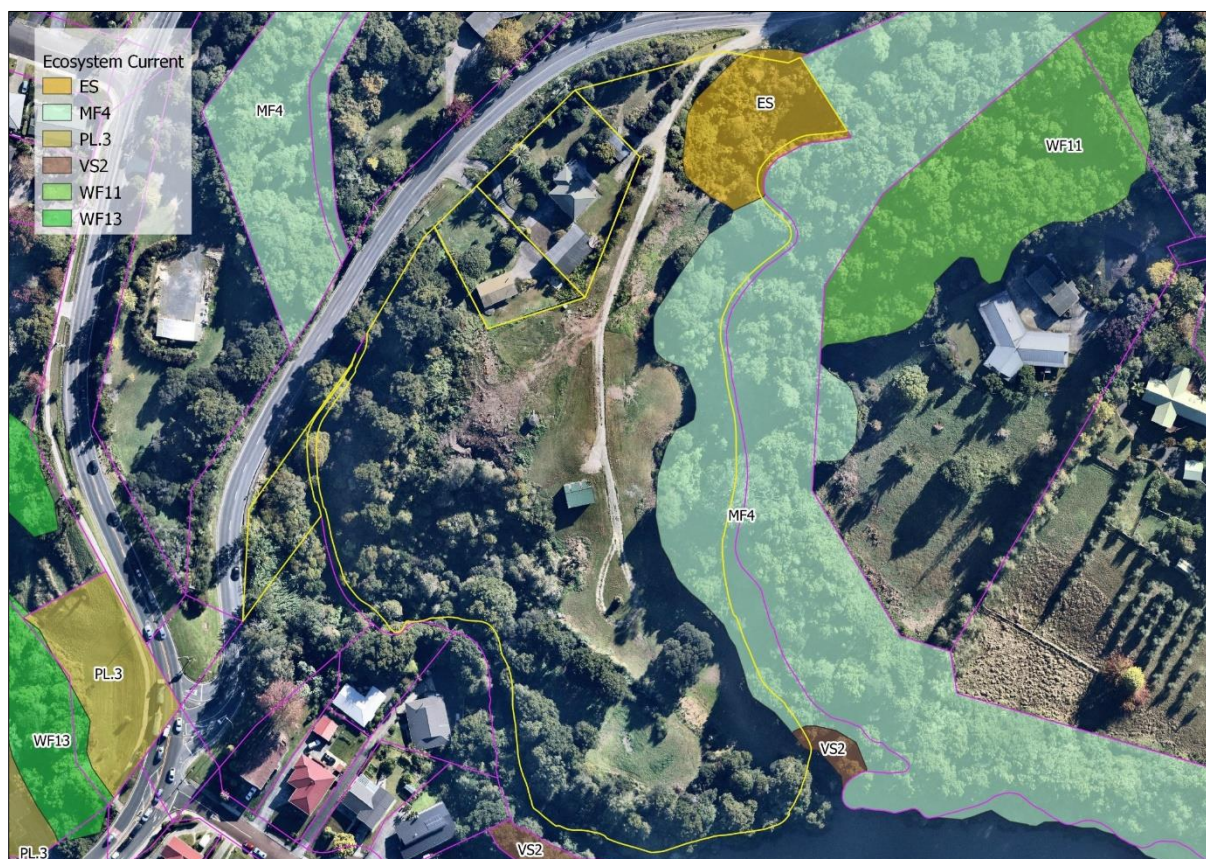
Figure 4. Aerial image of the Site (yellow polygon) with the Auckland Council Geomaps 'Current Ecosystems Extents Overlay'.

Currently, the Auckland Council Geomaps classifies the vegetation within the Site and subject to the SEA overlay as either Exotic Scrub (ES, 0.17 ha), Kahikatea Forest (MF4, 0.32 ha) and Kānuka scrub/forest (VS2, 23 m²) (Figure 5). The remaining area of the Site, including the existing vegetation adjacent to the Mahurangi River and Viponds Creek, does not have a current ecosystem classification as per the Auckland Council Geomaps.

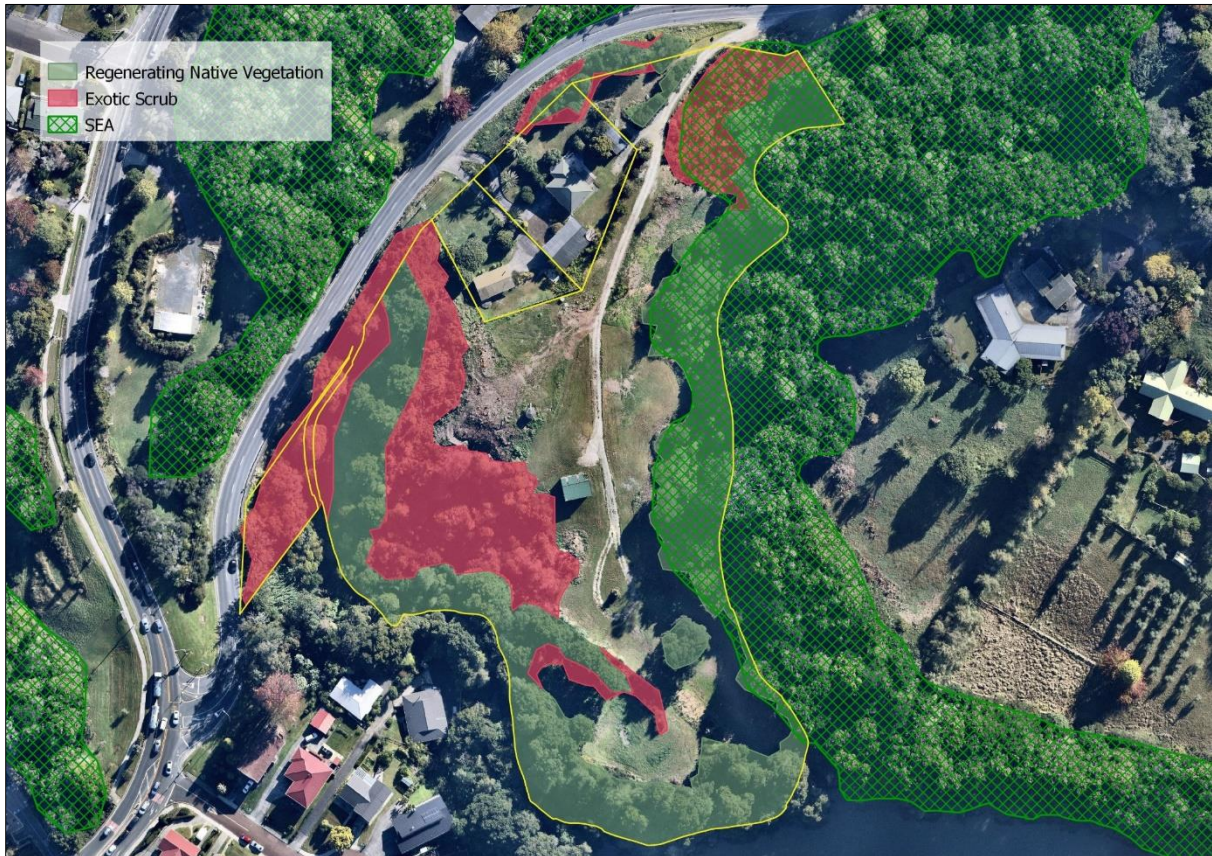
Figure 5. Aerial image of the Site (yellow polygon) with the ground truth vegetation types and extents.

Based on a site visit and aerials, Bioresearches classified and mapped the vegetation cover. Three main vegetation types were identified; regenerating native vegetation, exotic scrub and lawn and amenity/garden planting (Figure 5).

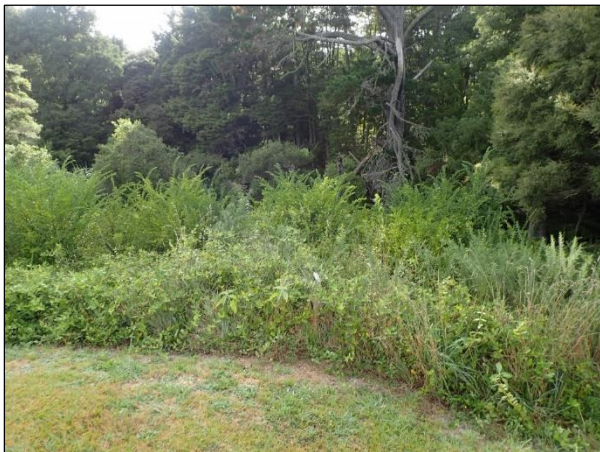
Photo 5. Exotic species along the eastern boundary which extends into the native vegetation.

In regards to the exotic scrub, while this vegetation is connected to the native vegetation, due to its low stature it is not acting as an effective buffer against edge effects. In fact, contrarily, this vegetation provides a significant source of pest plant species to the adjacent native vegetation and wider SEAs. As such, overall the exotic scrub was considered to have a very low amount of ecological connectivity and functioning and is expected to contribute to the further degradation of the native vegetated areas, if left unchecked.

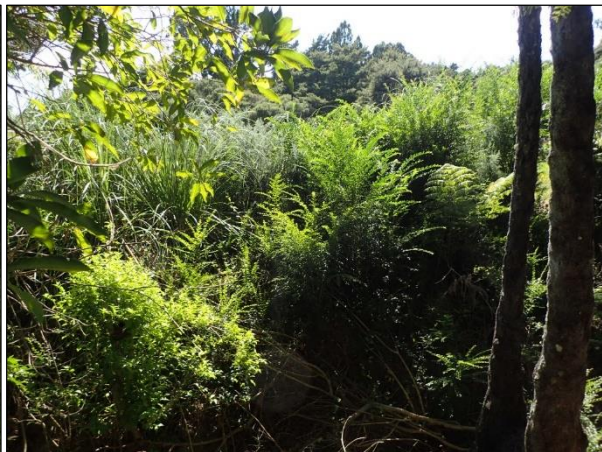
Photo 6. Exotic species within native vegetation along the southern boundary.

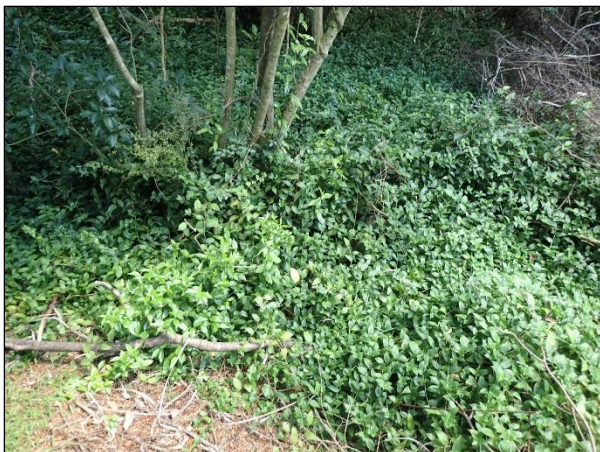
Photo 7. Exotic species within native vegetation along the western boundary.

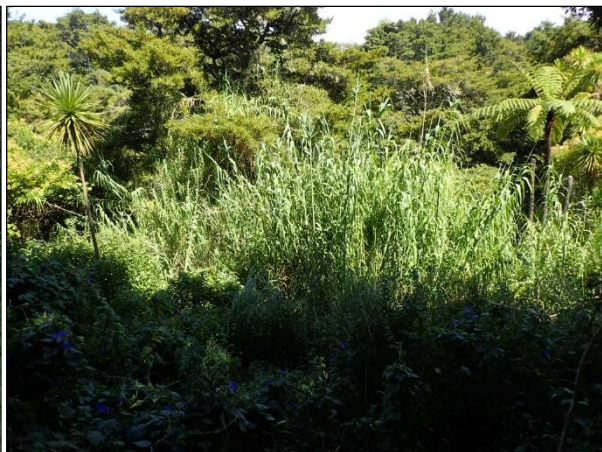
Photo 8. Exotic species within native vegetation along the north-western boundary.

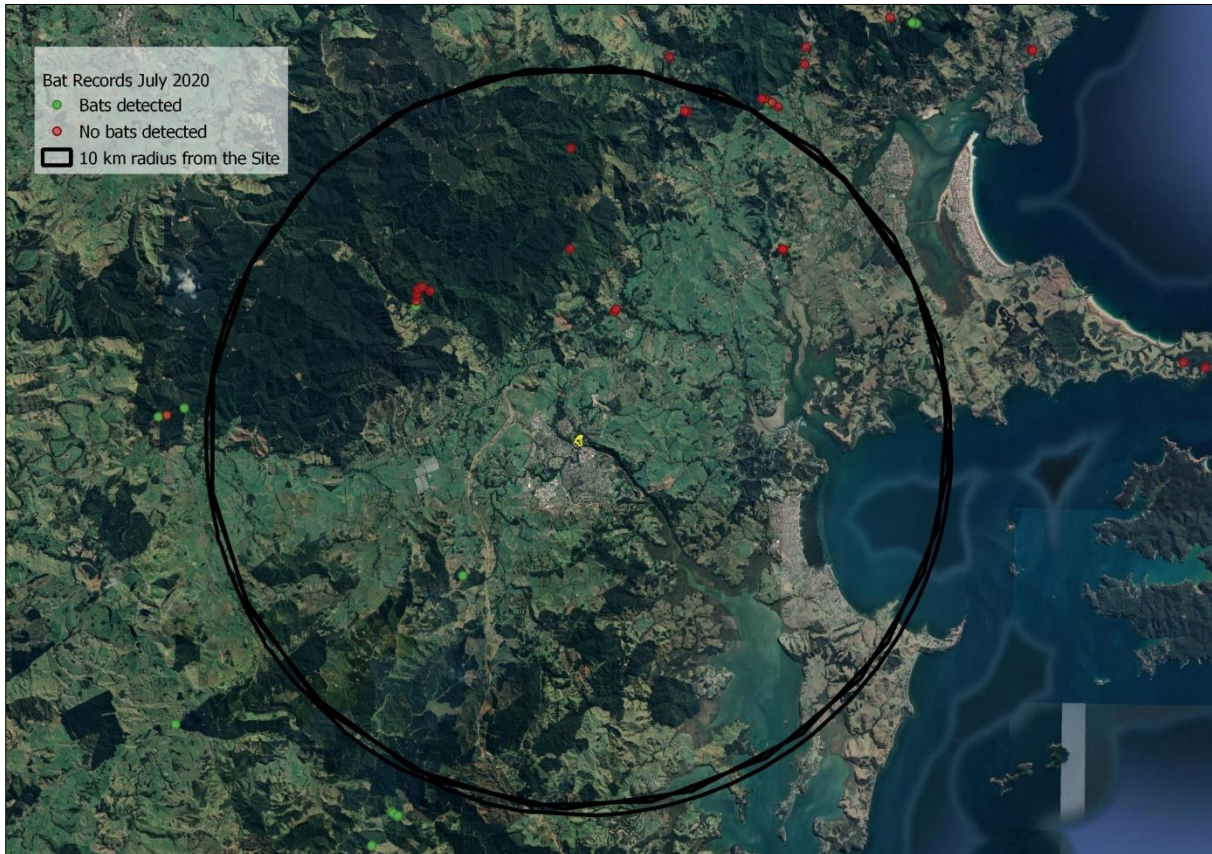
Figure 7. Aerial image of the Site (yellow polygon) with the location of bat detection records (green dots).

No formal surveys were undertaken for LTBs. However, LTBs are known to occur at several sites across the Auckland Region with scattered records through the Rodney District, including records to the west (4.7 km) and north (5.6 km) (Figure 7). As such, the Site is well within the flight range of known LTB habitat.

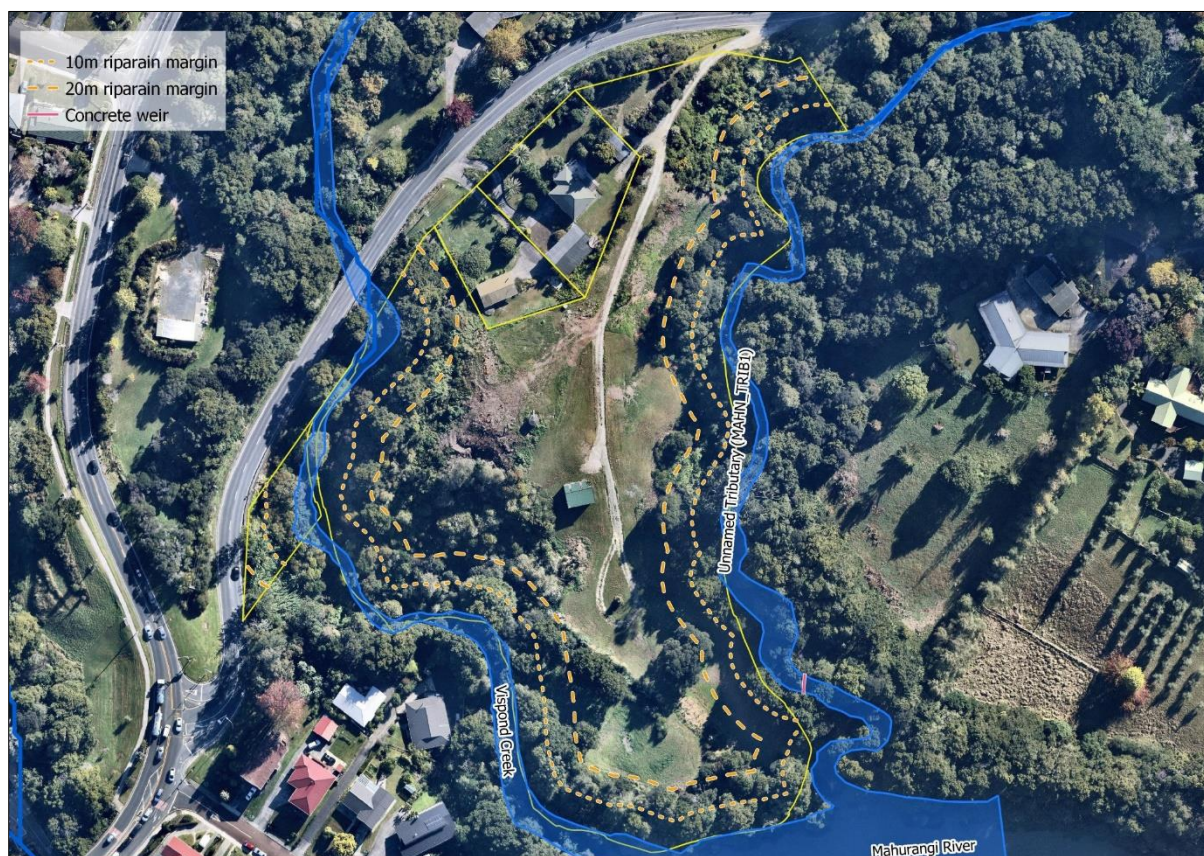
Figure 8. Aerial image of the Site (yellow polygon) with the identified freshwater habitat of the Site.

The Site is bounded on the west, east and south by two streams and a river, with an unnamed tributary to the east, the Viponds Creek to the west, and the tidally influenced Mahurangi River to the south (Figure 8).

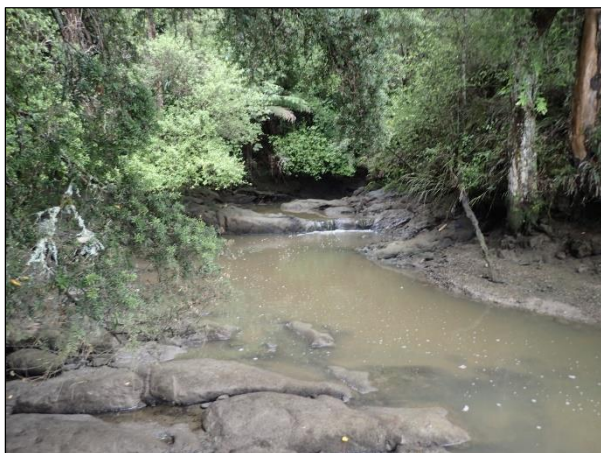
Photo 13. Unnamed tributary looking upstream from mouth.

Stream banks were steep on both sides, restricting floodplain connectivity. The riparian margin on the true right bank (within the Site) generally extended between 10 and 20 m. On the true left bank, the riparian margin extended further than 20 m. Riparian vegetation consisted of a closed canopy, which provided high amounts of shading, organic input, and bank stability.

Viponds Creek was considered to have a high ecological value, predominately due to the extent of the riparian margins as well as the abundance and diversity of habitat features present.

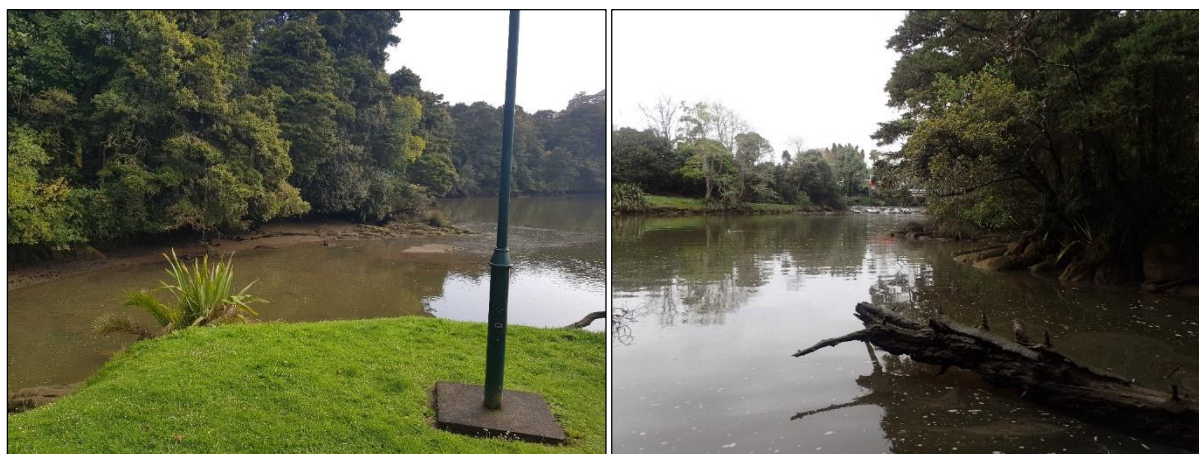
Photo 15. Mahurangi River, looking downstream from main weir. **Photo 16. Mahurangi River, looking upstream From Viponds Creek.**

Approximately 500 m downstream of the Site, a section of the Mahurangi River is subject to Natural Stream Management Area overlay; defined as “stream reaches with high natural character and high

ecological values” with “an unmodified river or stream bed with existing indigenous riparian vegetation on both sides” (AUP OP, D4.1).

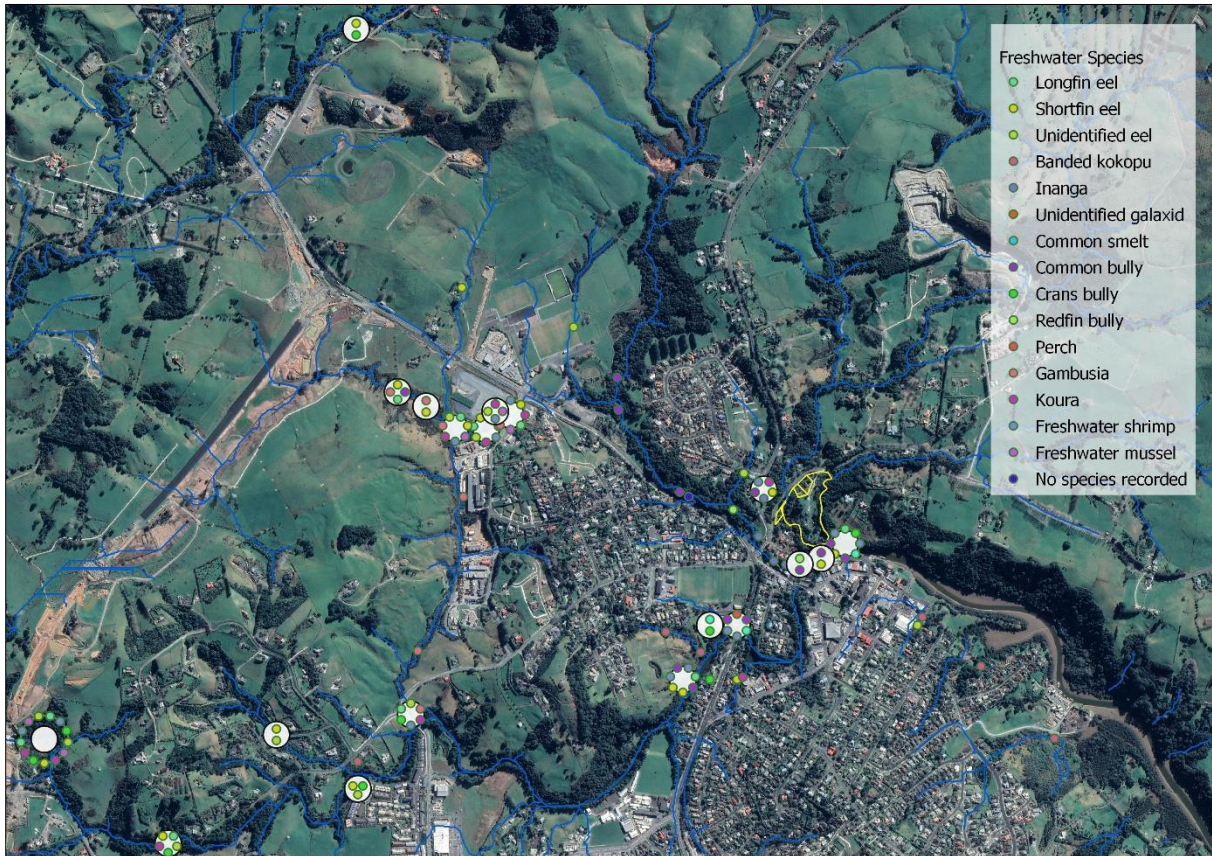
Figure 9. Aerial image of the Site (yellow polygon) with local NZFFDB records.

No records have been submitted for the unnamed tributary. The concrete weir within the stream is likely acting as a significant fish migration barrier, as such, fauna diversity is likely limited to eels (*Anguilla spp.*), banded kōkopu (*Galaxias fasciatus*), resident bullies (*Gobiomorphus spp.*) commonly found in the wider catchment, kōura (*Paranephrops planifrons*) and freshwater shrimp (*Paratya curvirostris*).

Viponds Creek has records for shortfin eel (*A. australis*), common bully (*G. cotidianus*), kōura, freshwater shrimp and īnanga. However, it is highly likely that other species are present including; longfin eel (*A. dieffenbachii*), banded kōkopu, Cran’s bully (*G. basalis*) and redfin bully (*G. huttoni*).

Within the immediate reach of the Mahurangi River, the NZFFDB has records for longfin and shortfin eels, freshwater shrimp, Cran’s bully, common bully, redfin bully and giant bully (*G. gobioides*). However, the river is likely to have a higher diversity particularly in the upper catchments and also acts as the main migration pathway for all migratory species.

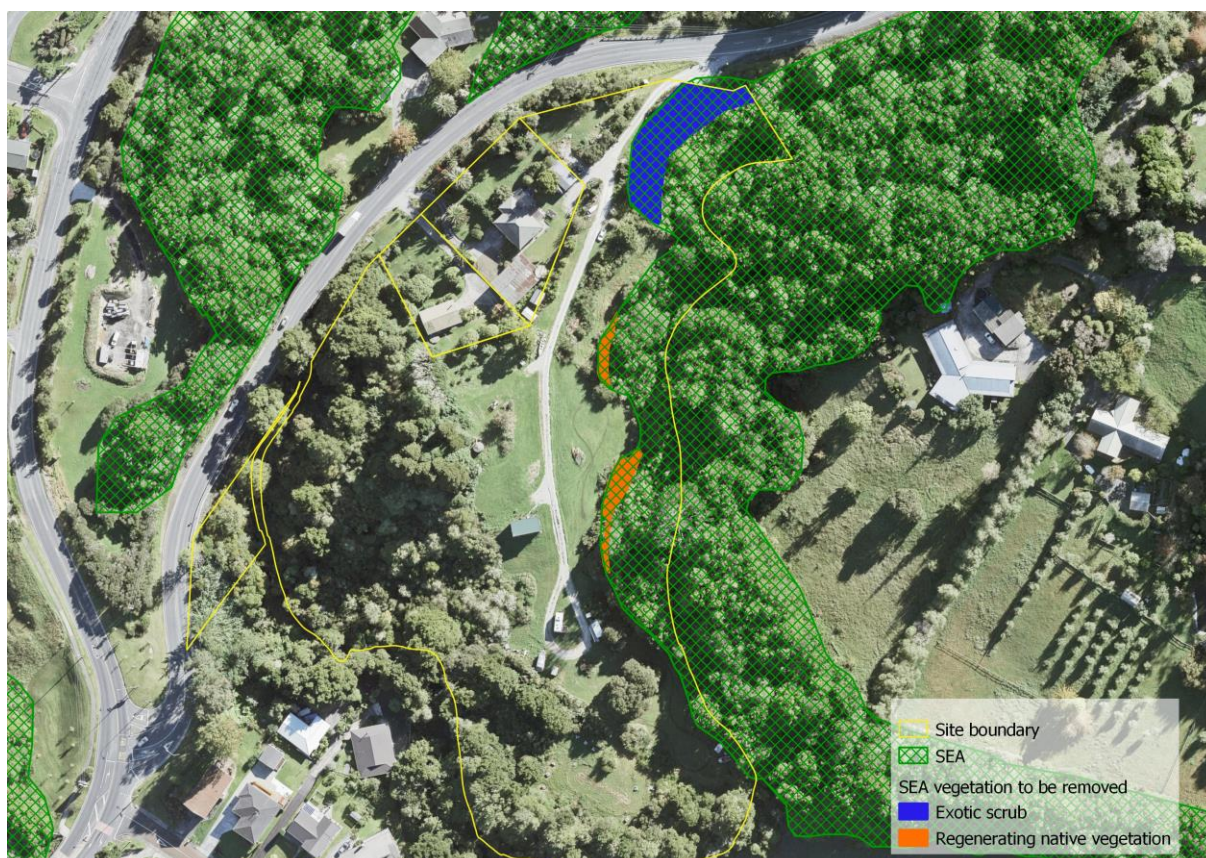
Figure 10: Vegetation within the SEA to be remove

The removal of 970m² of SEA vegetation is not expected to result in a loss of connectivity, as the remainder of the SEA will stay intact, and contiguous along its length. The areas to be removed are all dominated by exotic weedy species on the edge of the SEA and will not result in fragmentation. There will be edge effects resulting from the removal, however these will be localised to areas immediately adjacent to the removed areas. It is recommended weed management is ongoing throughout the site which will mitigate the effects of weed invasion into the new edges. There will be some changes in composition of these areas as light availability will be difference from what is currently experienced. Overall, however, these changes are not expected to adversely affect the functioning of the SEA either within the site itself, or as a whole. Removal of weeds is expected to result in positive ecological outcomes through the removal of the weeds themselves, as well as removal of a seed source for invasion into the remainder of the SEA.

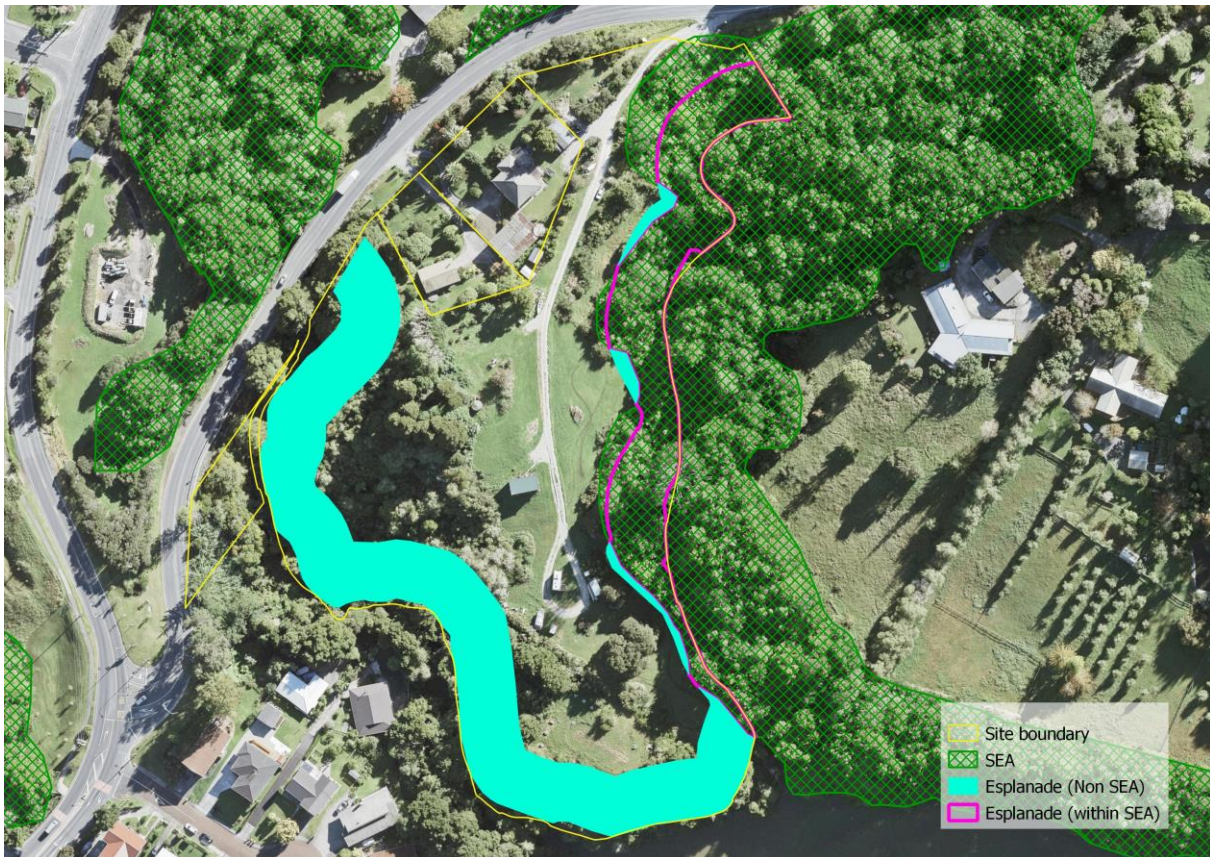
Figure 11: Proposed esplanade

The remainder of the site will have an esplanade reserve with a width of 20m established around the three watercourses. The reserve will be planted, with the exception of the area around the kilns (boundaries to be determined by a heritage expert), and any areas where public access/pathways will be established.
