COMBES/DALDY LIME WORKS
34 & 36 SANDSPIT ROAD, WARKWORTH, AUCKLAND
HISTORIC HERITAGE IMPACT ASSESSMENT
SUBDIVISION AND LANDUSE APPLICATION
PREPARED FOR THE KILNS LIMITED
APRIL 2022

**COMBES/DALDY LIME WORKS
36 SANDSPIT ROAD, WARKWORTH, AUCKLAND
HISTORIC HERITAGE IMPACT
SUBDIVISION APPLICATION
PREPARED FOR THE KILNS LIMITED
MARCH 2022**

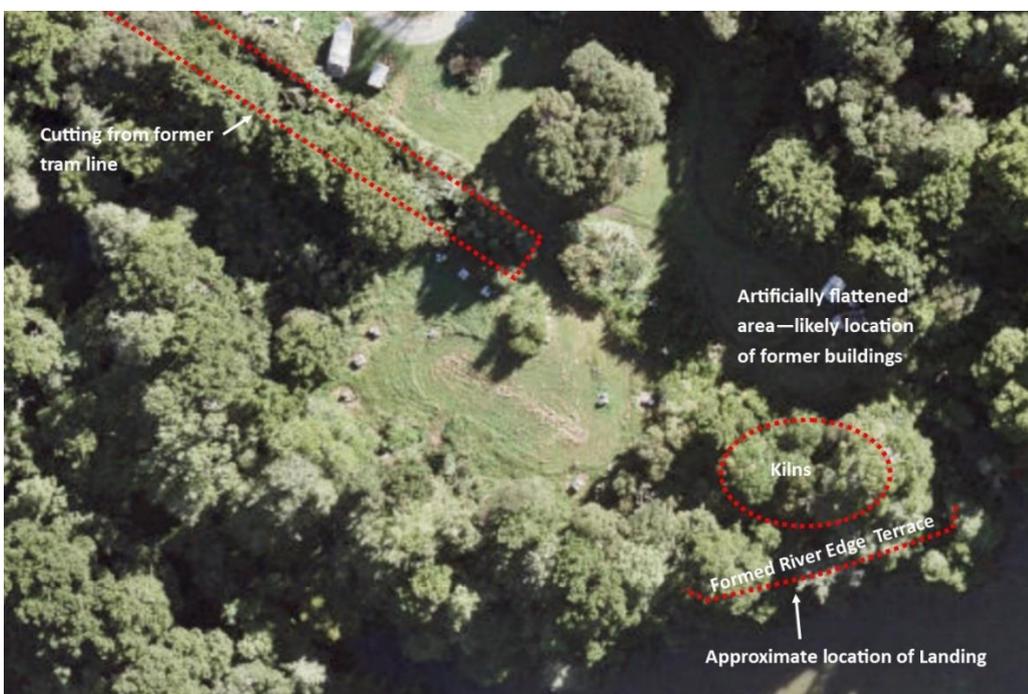
Figure 24. Plan of the site from the— Proposed Walkway and Cycleway project (Judge 2019 – note that a more recent geotechnical report has assessed this terrace as a natural formation⁶)

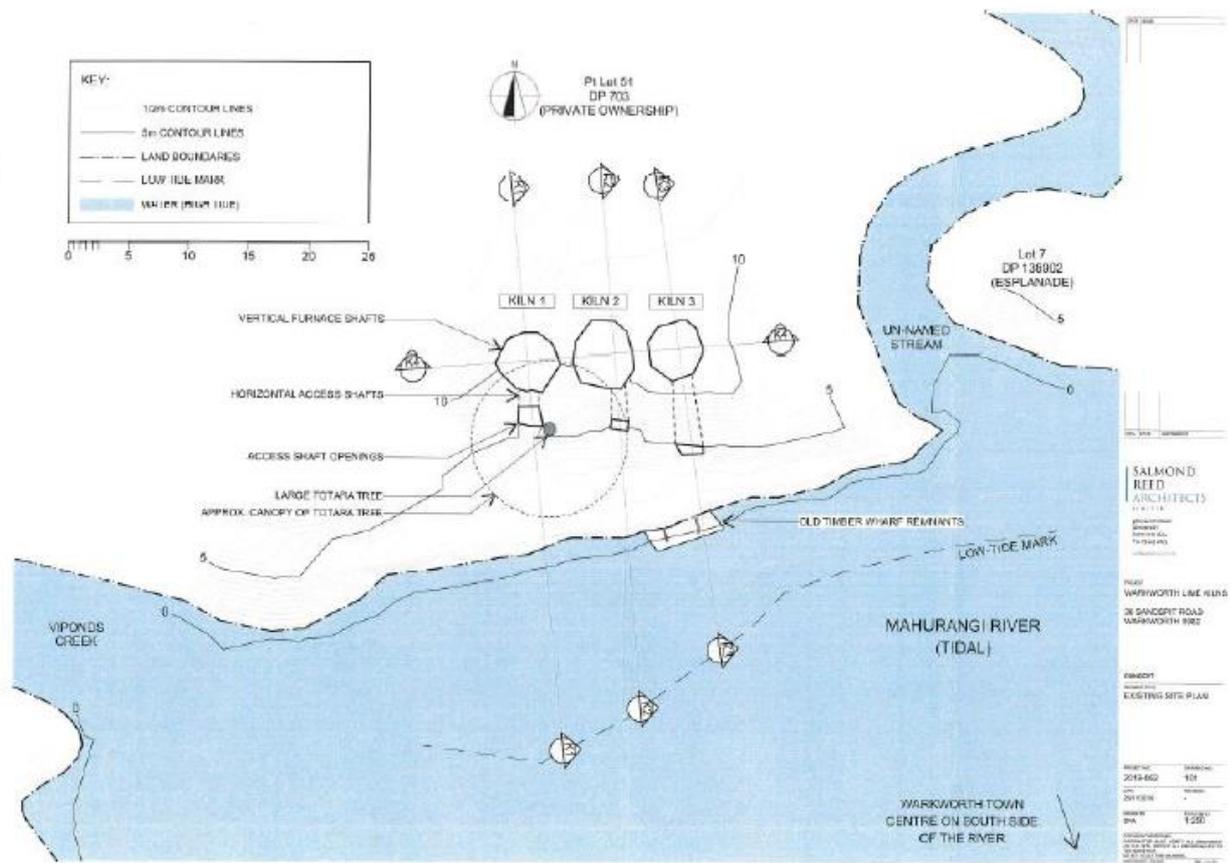
Figure 25. Existing site plan of the kilns (Salmond Reed 2020)

The coastal section of the site was inspected by Charlotte Judge as part of a field survey undertaken in 2019 for a proposed walkway/ cycleway connection between Warkworth and Snells Beach (Figure 24). At the same time a Condition Survey was undertaken for the lime kilns was undertaken by Salmond Reed Architects, which included recommendations on public access and interpretation for the walkway/ cycleway project (Salmond Reed Architects 2020). This included some mapping and photographs of the kilns (Figure 25; Figure 26).

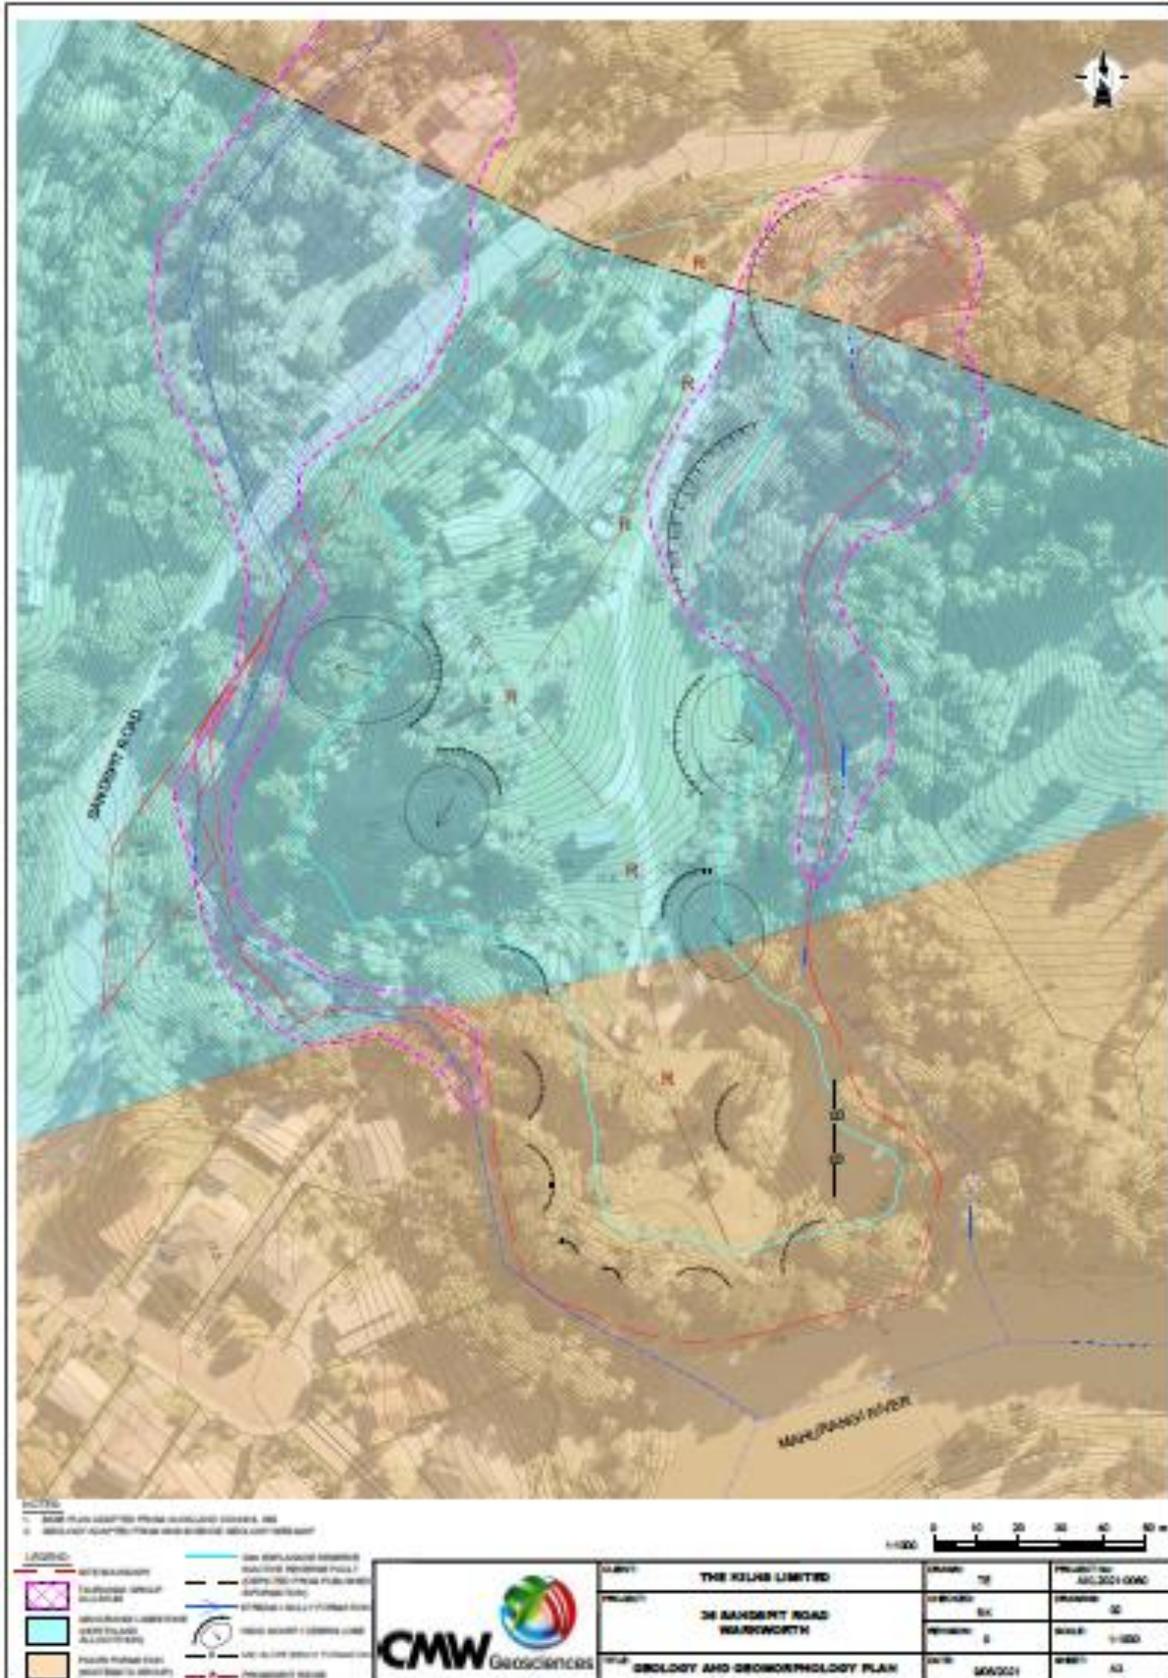
Figure 27. Geosciences Geotechnical investigation report 8 September 2021 – Appendix A, plan showing assessed extent of Mahurangi Limestone formation (blue) and natural scarps/ debris lobes across the site (blue shading)

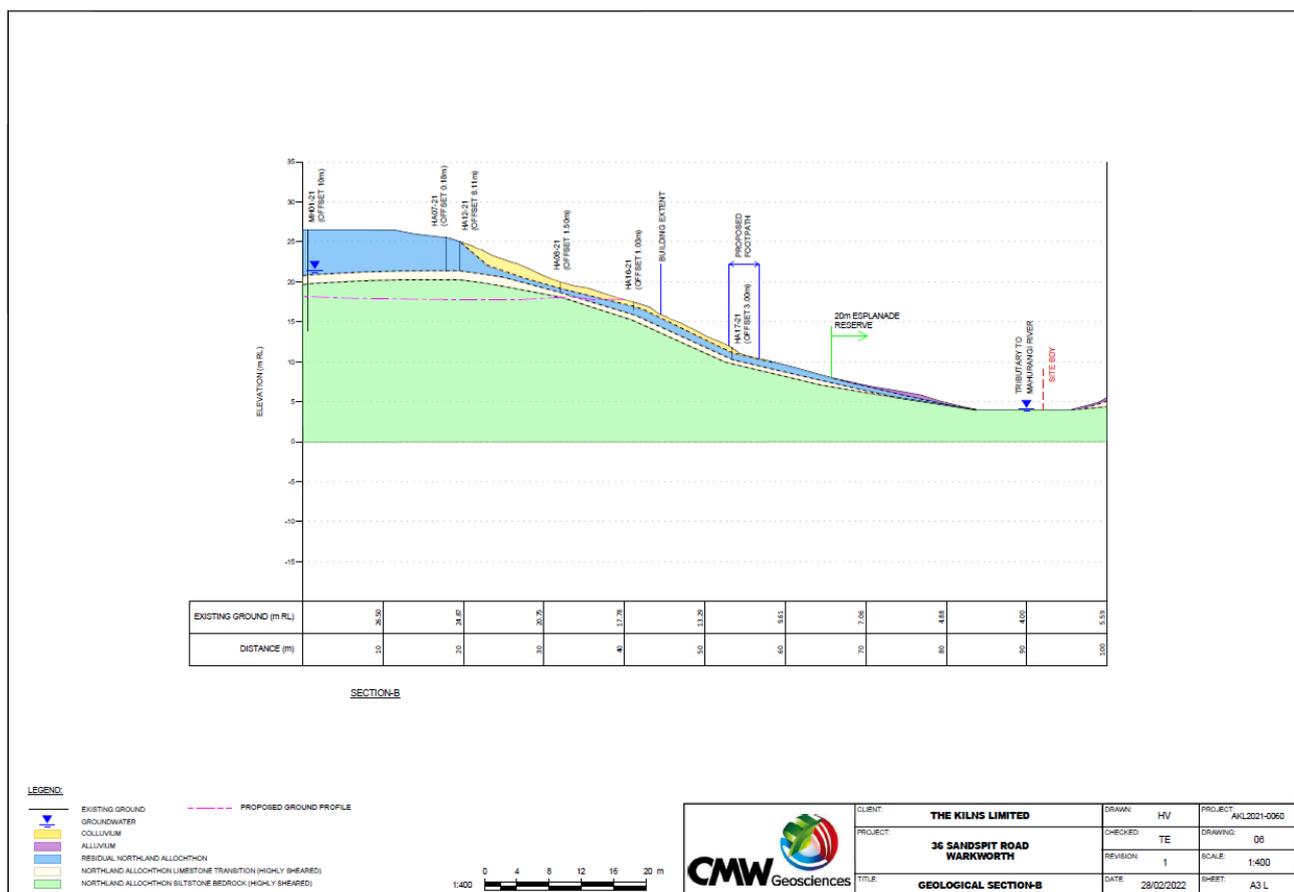
Figure 28. Geosciences March 2022. Cross-section B illustrating colluvium deposits (yellow) and residual soils (blue) above Weathered limestone (cream)

During the site visit it was observed that there is a remnant river terrace or path to the stream edge (evident on topographical maps) at the base of the slope (Figure 36). The slope itself is covered in what appears to be generally loose colluvium caused by rain and downslope creep, as is typical on hillslopes. This interpretation is supported by the cross-section provided by GeoSciences (September 2021: Appendix A), shown in Figure 28.

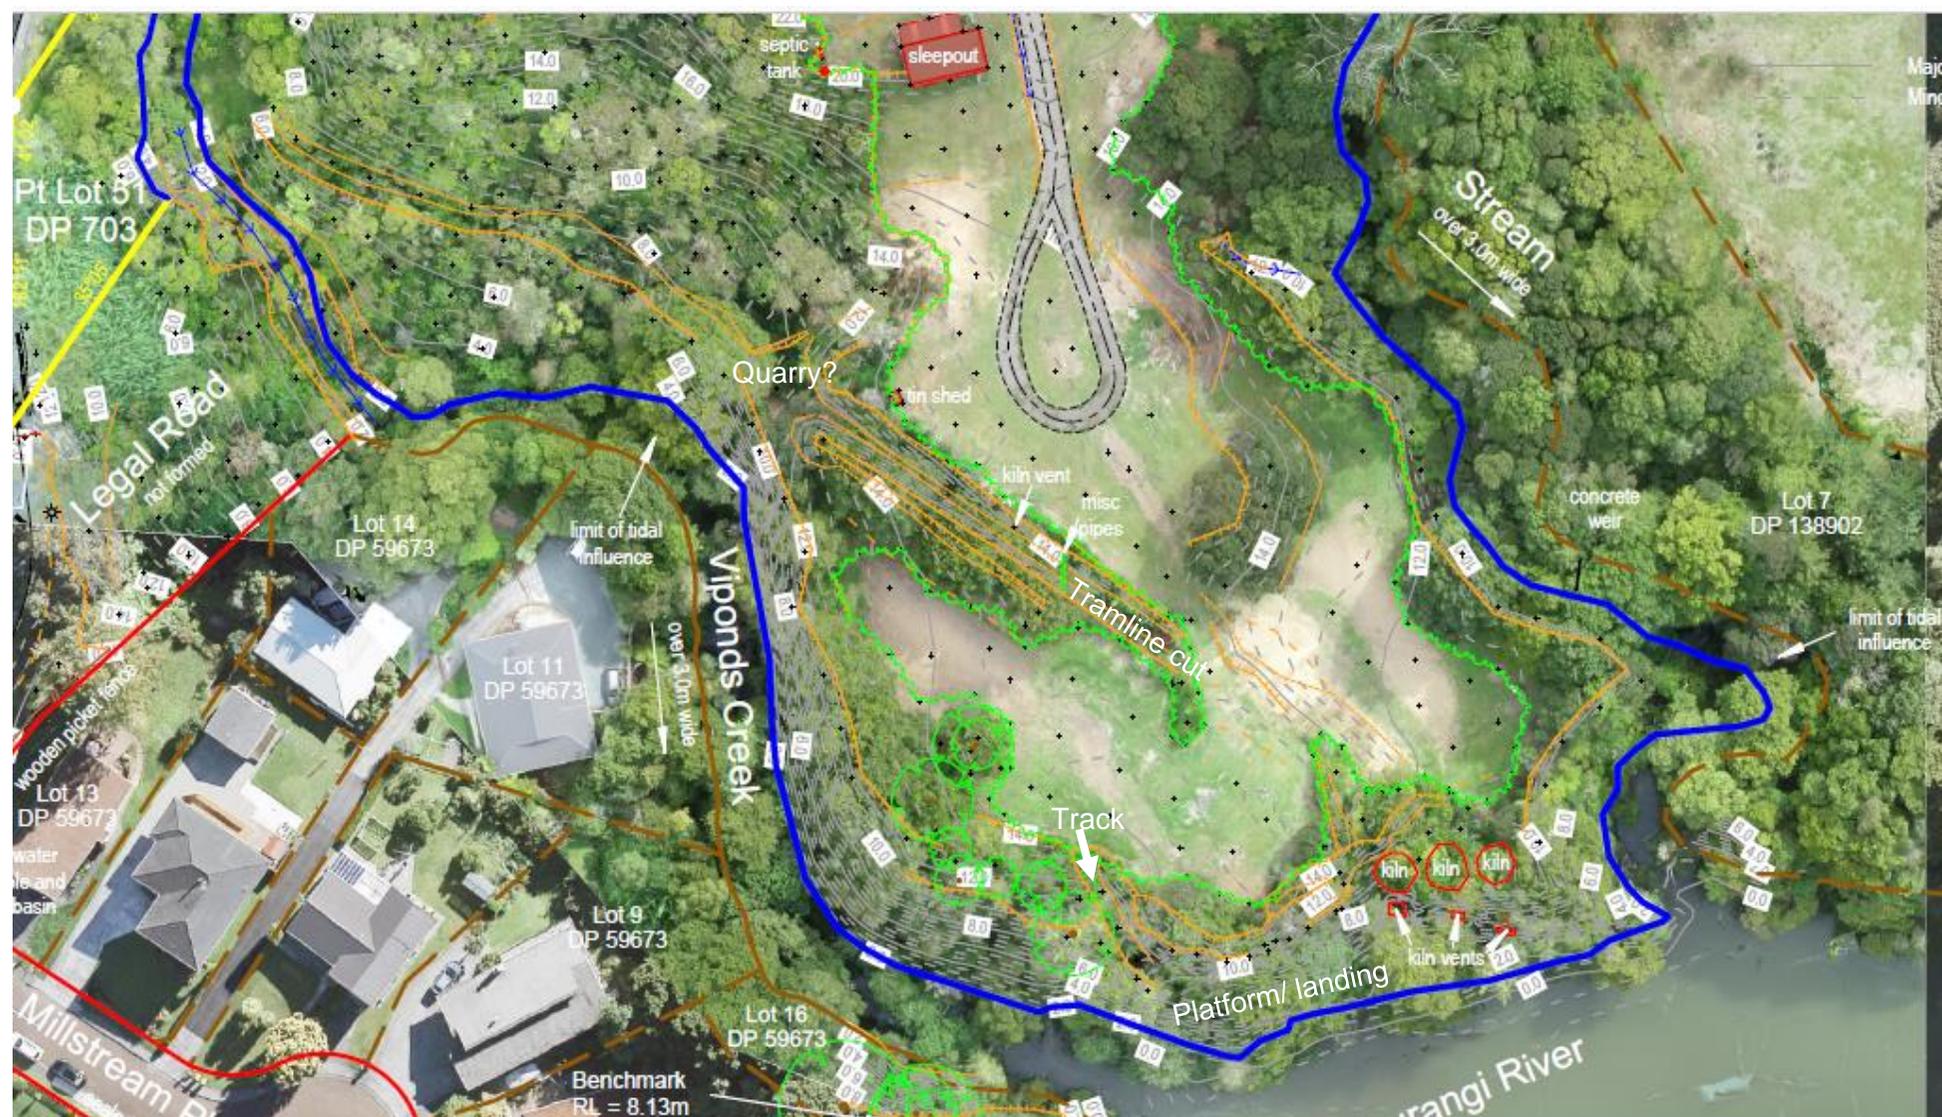
Figure 29. Site plan (southern) with topographic survey overlaid on drone imagery. Archaeological features identified during the survey undertaken 6th April 2021 are shown. Most of these are thought to relate to the Combes/ Daldy lime works site (NZAA R09/2240/ AUP 569). (Base map Buckton Consulting Survey 06/05/2021)

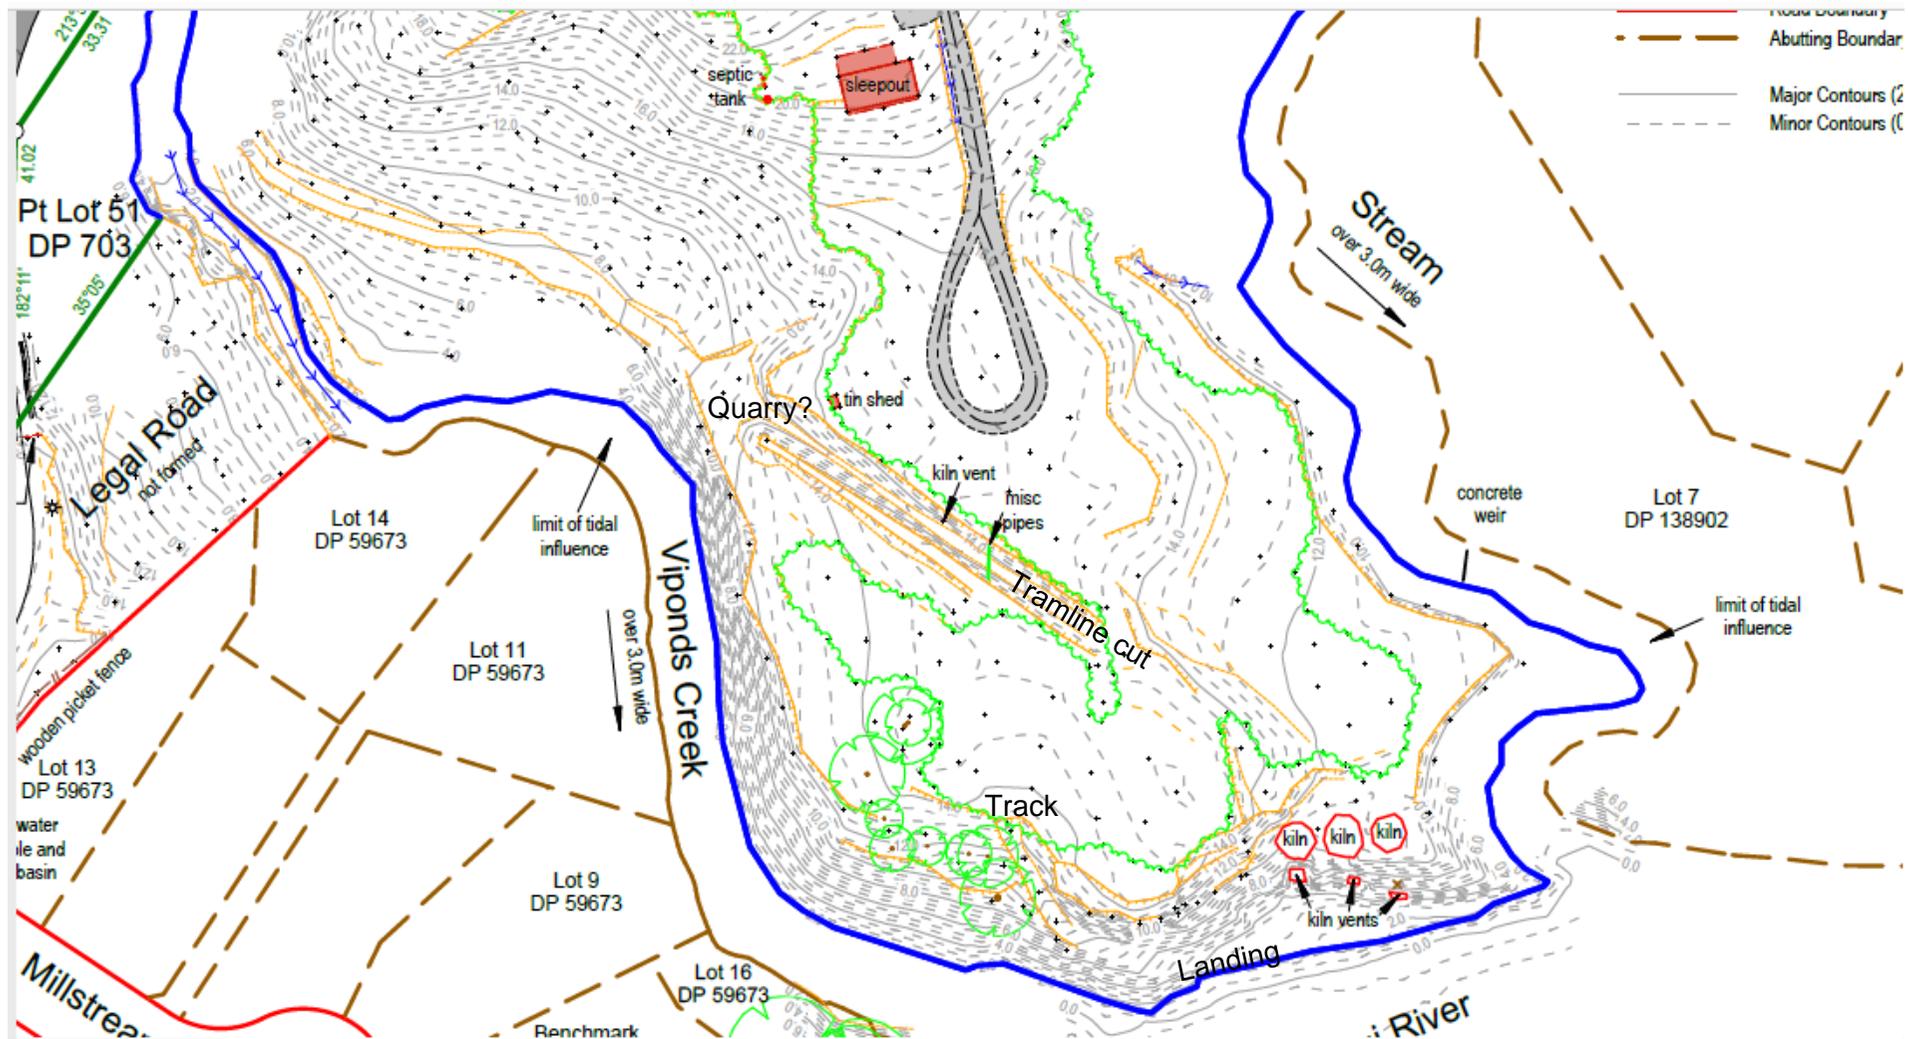
Figure 30. Site plan (southern) showing the topography and archaeological features identified during the survey undertaken 6th April 2021. The tramline cut, 3 kilns and features identified on the river landing relate to the Combes/ Daldy lime works site (NZAA R09/2240/ AUP 569). (Base map Buckton Consulting Survey 06/05/2021)

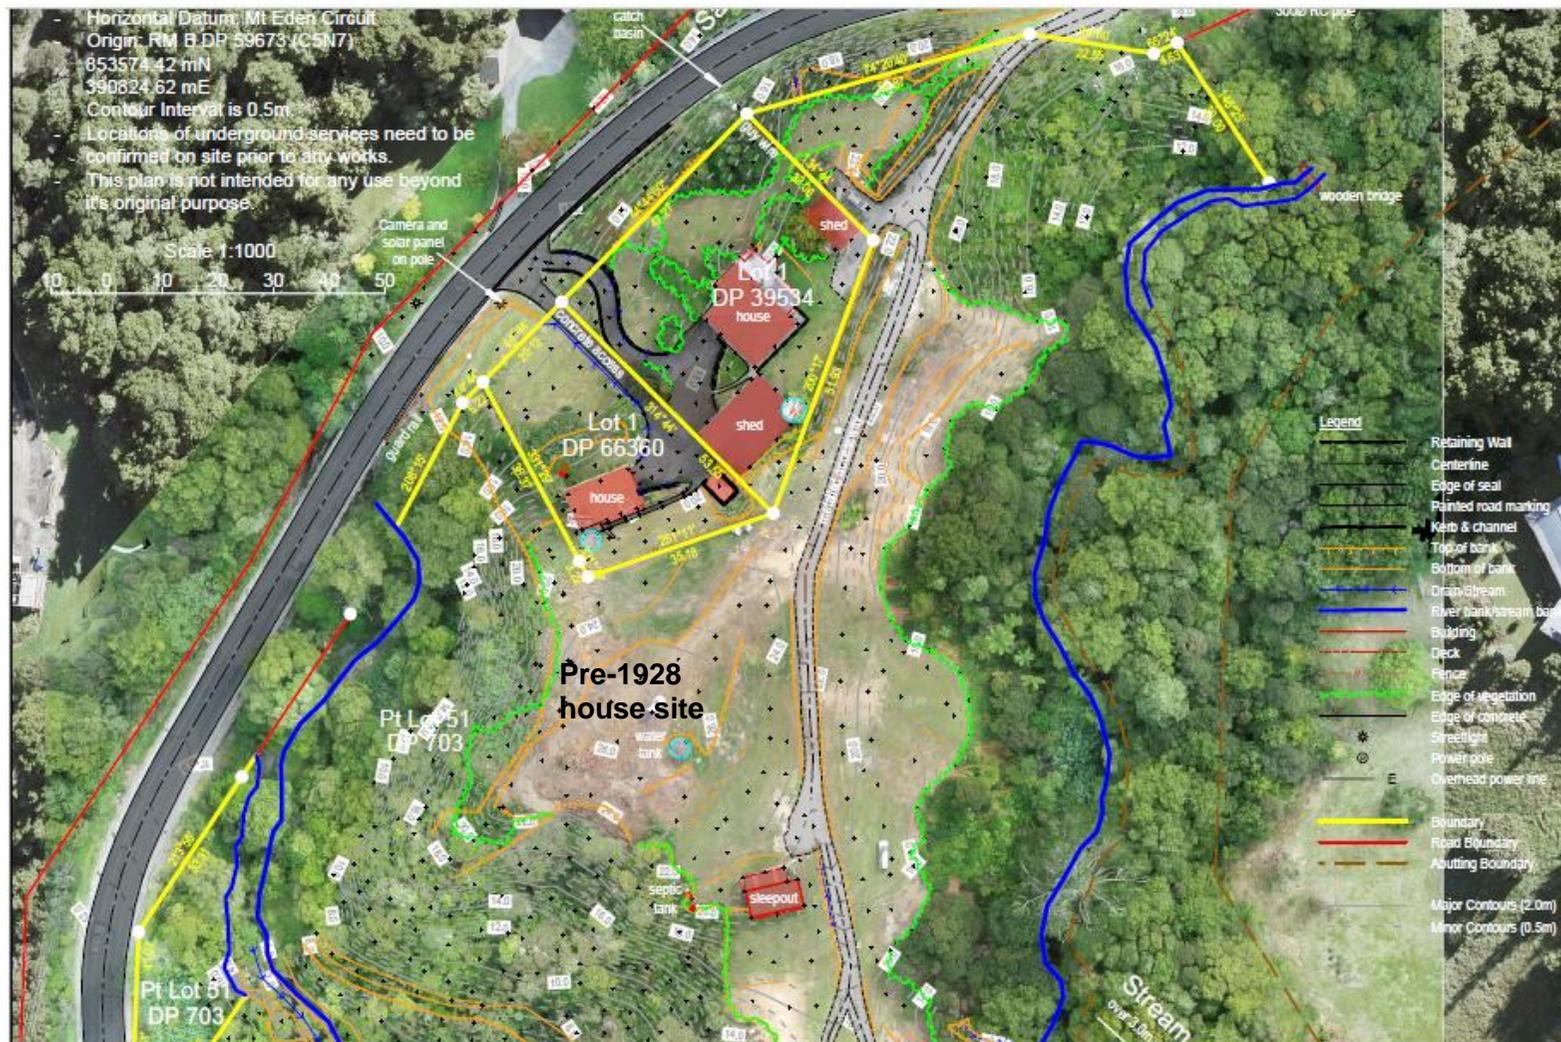
Figure 31. Site plan (northern) with topographic survey overlaid on drone imagery. No archaeological features were identified in this area during the survey undertaken 6th April 2021. It is not thought that the Combes/ Daldy lime works site (NZAA R09/2240/ AUP 569) extended this far north, which is why this area is outside the Historic Heritage Overlay. The former pre-1928 house site is shown (Base map Buckton Consulting Survey 06/05/2021)

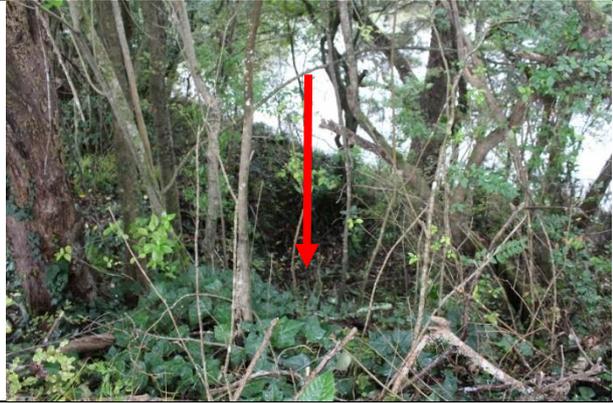
View looking down onto the head of kiln 1, from possible terminus of the tramway, Looking S	View of the head of kiln 2, from possible terminus of the tramway, looking SE

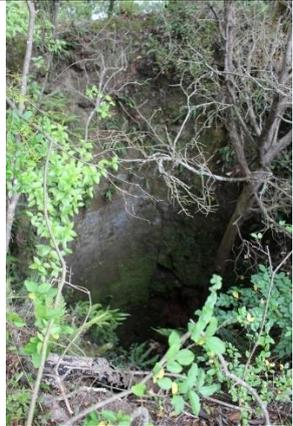
Kiln 3 head, looking SW	Kiln 1 head, looking SW

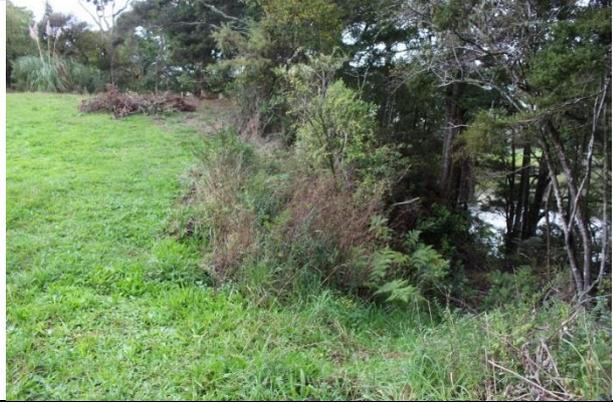
Walkway down to the river landing and kiln vents, looking SW	The river terrace/ landing, with kiln vents (white markers) in river bank, looking E

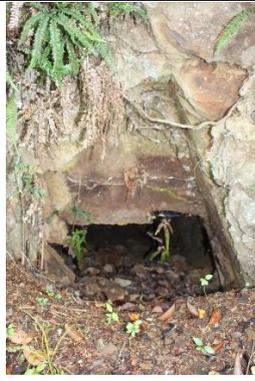
Kiln 2 vent, looking N	Kiln 3 vent, looking NE

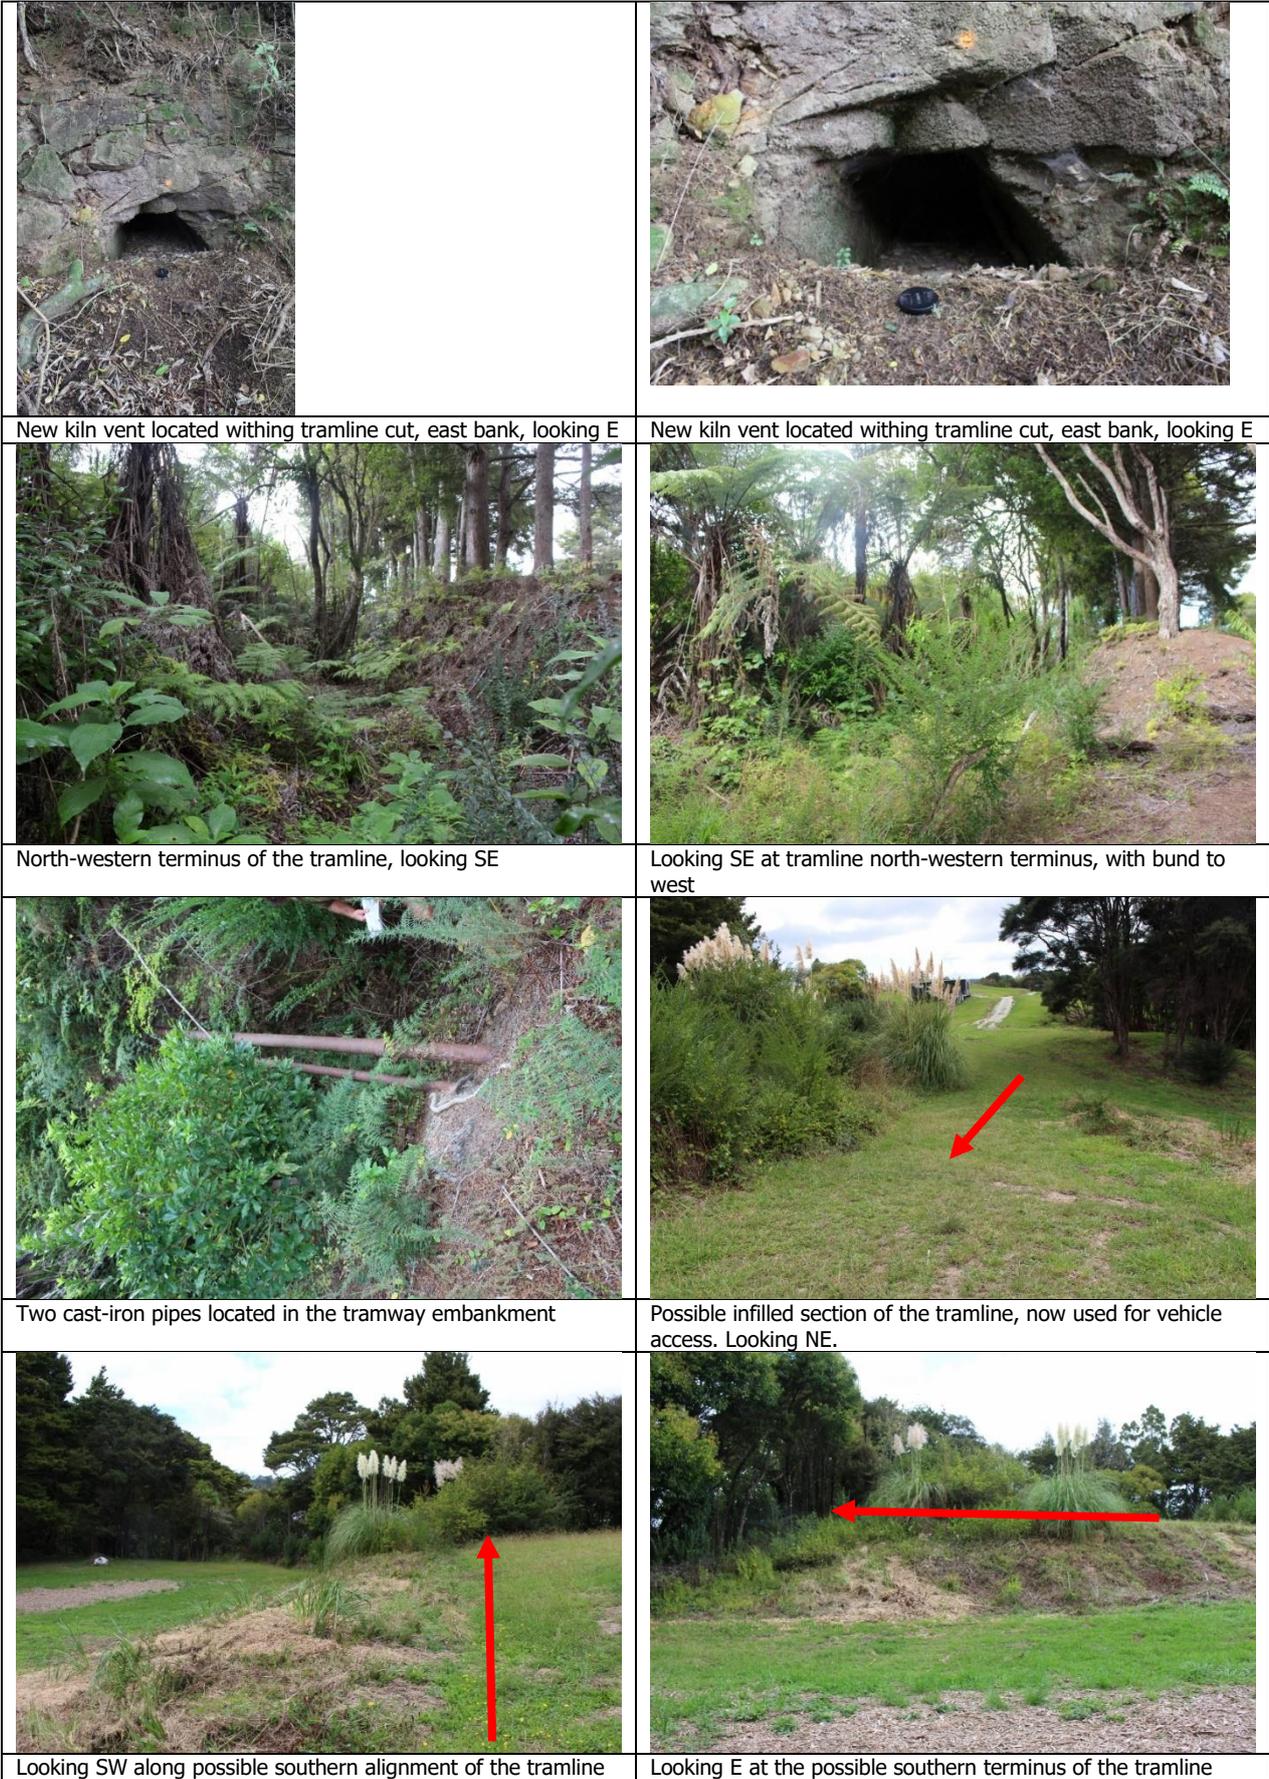
Figure 34. Tramline cut (Brown 06/04/2021)

One small kiln vent/draw hole was located within the eastern side of the cutting for the tramway, which is partly filled with debris (Figure 34). The visible opening of the vent is c. 40cm high and 50cm wide, approximately 2m deep. No kiln head was located, suggesting it may not have been

Two cast-iron pipes (largest 4 inches diameter) were found within the cutting for the tramway, approximately 50cm deep (Figure 34). These possibly run NE/SW through the southern part of the site, but the exact alignment is yet to be confirmed. They are most likely water pipes and could be late 19th/ early 20th century in origin. Their date and association with the lime works is yet to be established, and this may be revealed if they can be traced back to the source (see section 5.9 below).

New kiln vent located withing tramline cut, east bank, looking E

Looking E at the possible southern terminus of the tramline

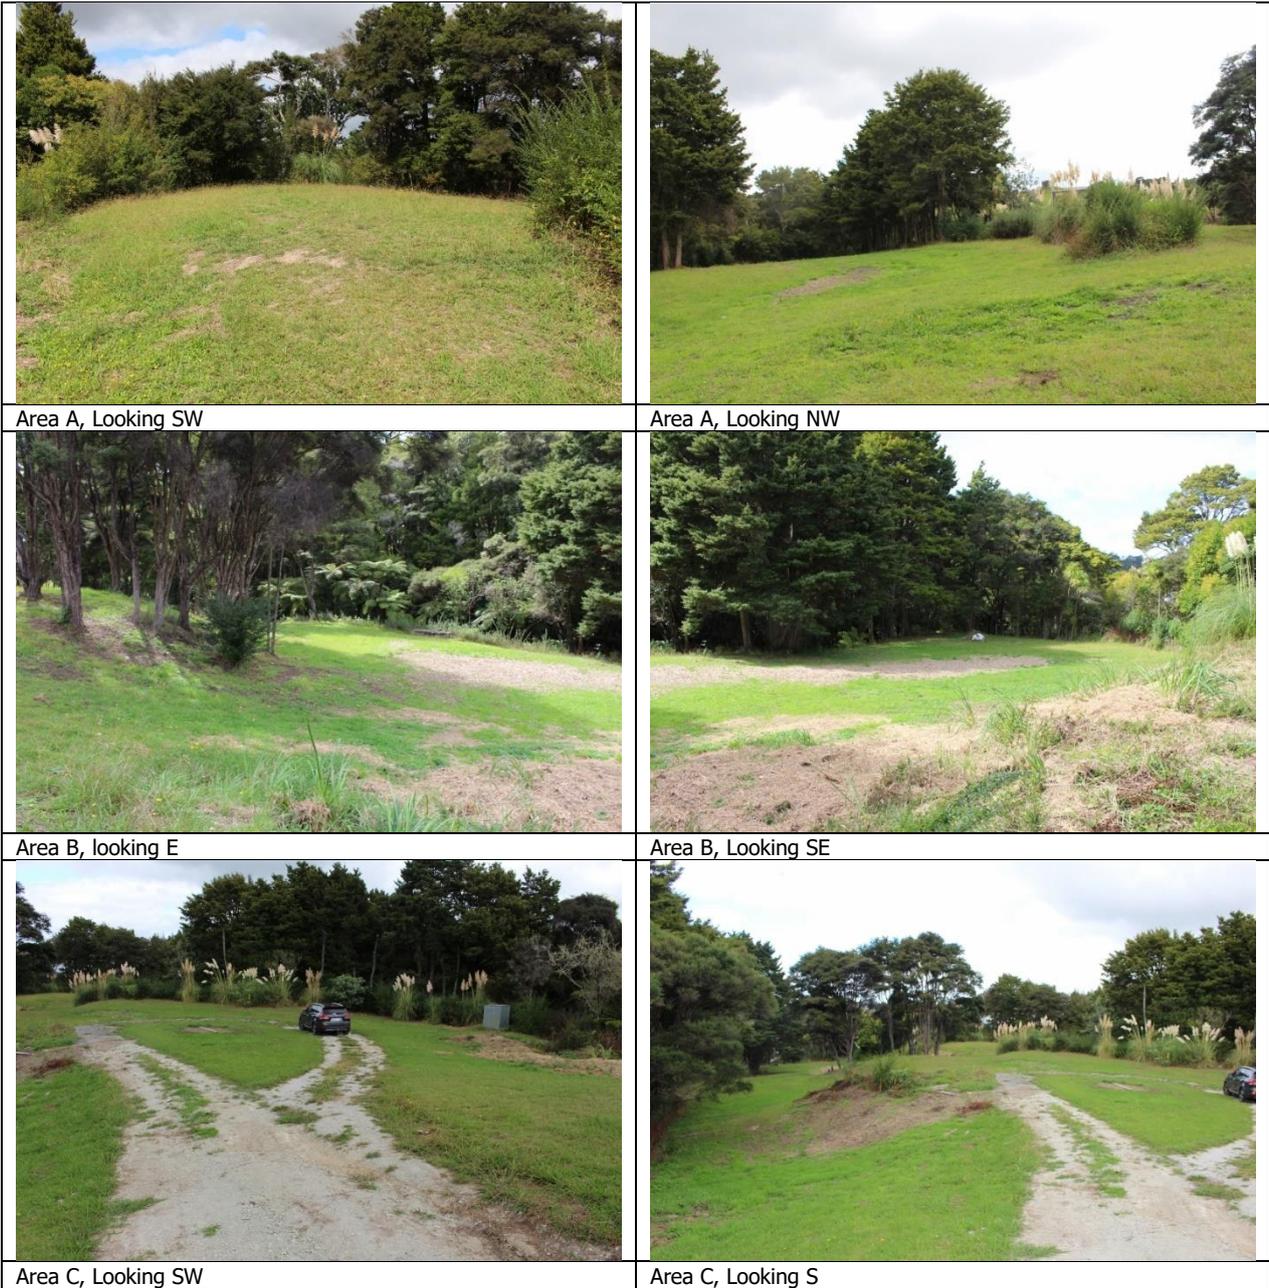
Figure 35. Flat areas (Brown 06/04/2021)

In the southern end of the property there are three flat/ terraced areas, separated from each other by a natural break in slope (Figure 35). For the purposes of this assessment these have been labelled areas A, B and C, in Figure 37.

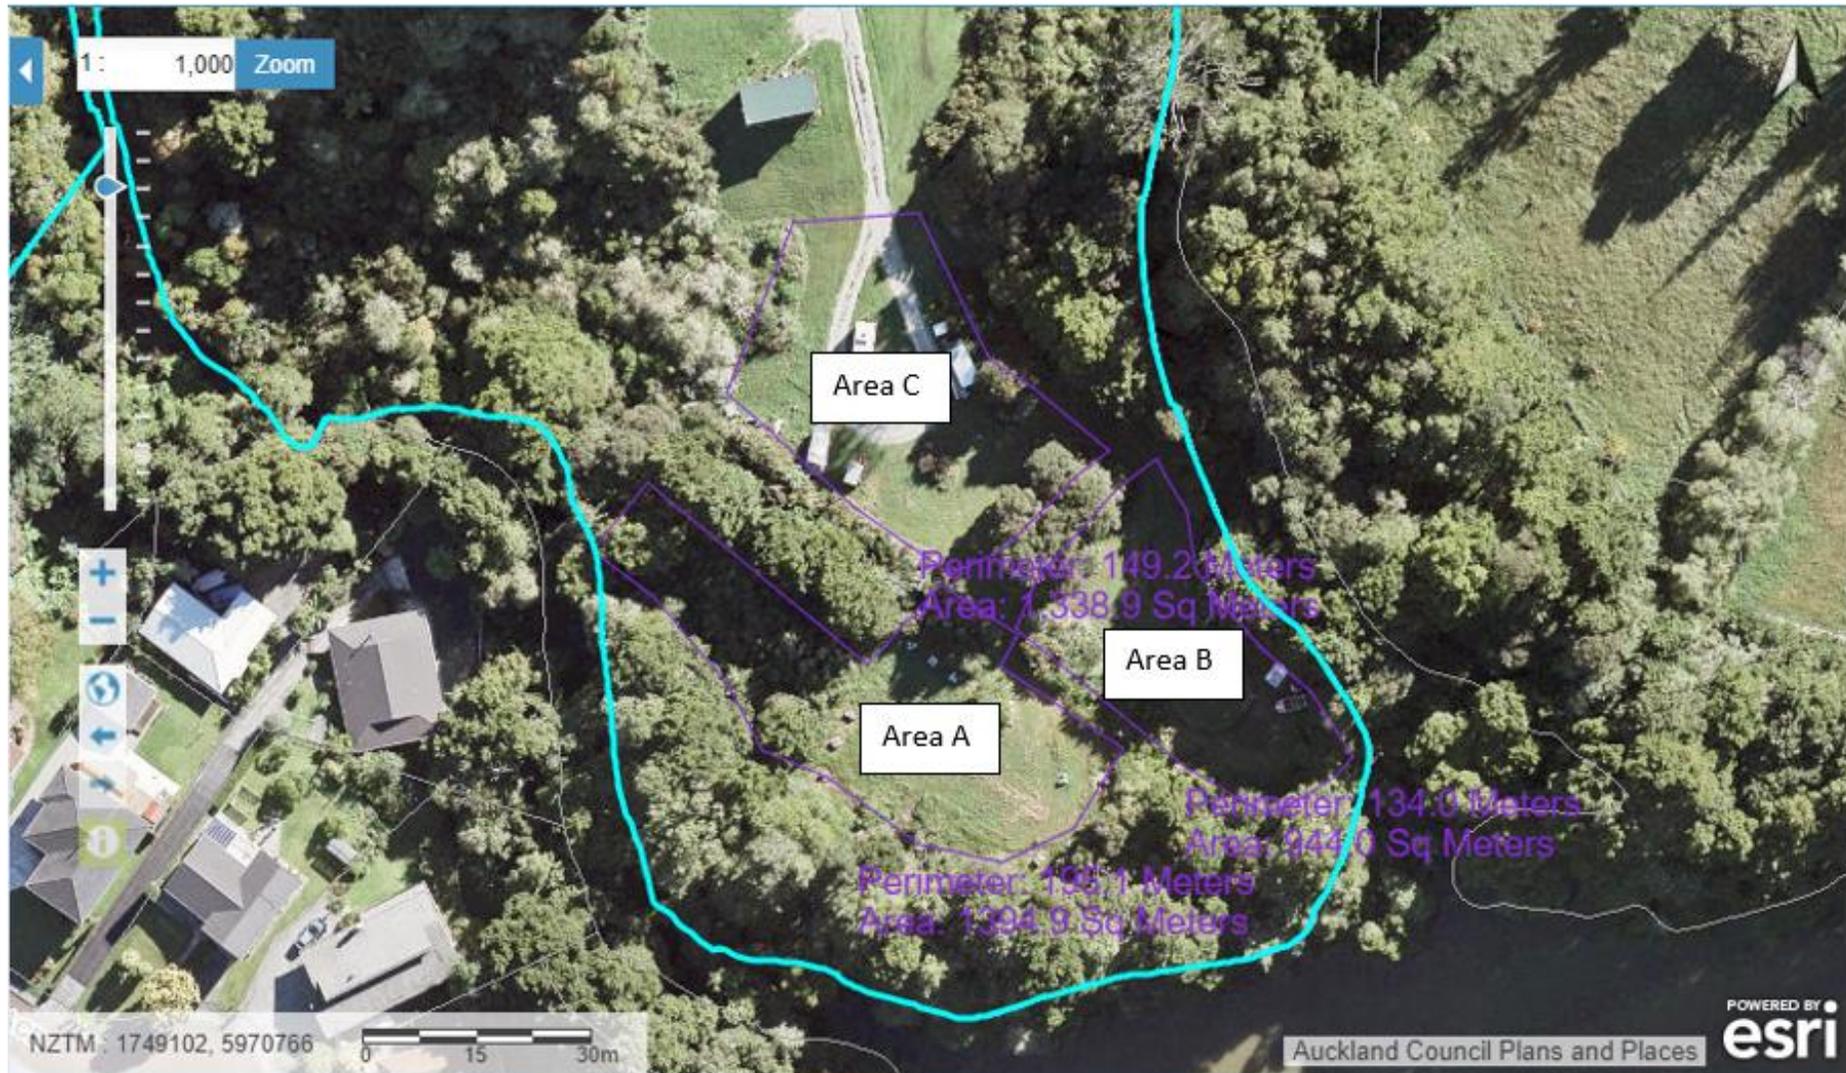
Figure 37. Areas A, B & C identified during the May 2021 field survey as having archaeological potential, but which required further investigation (Base map Auckland Council Geomaps)

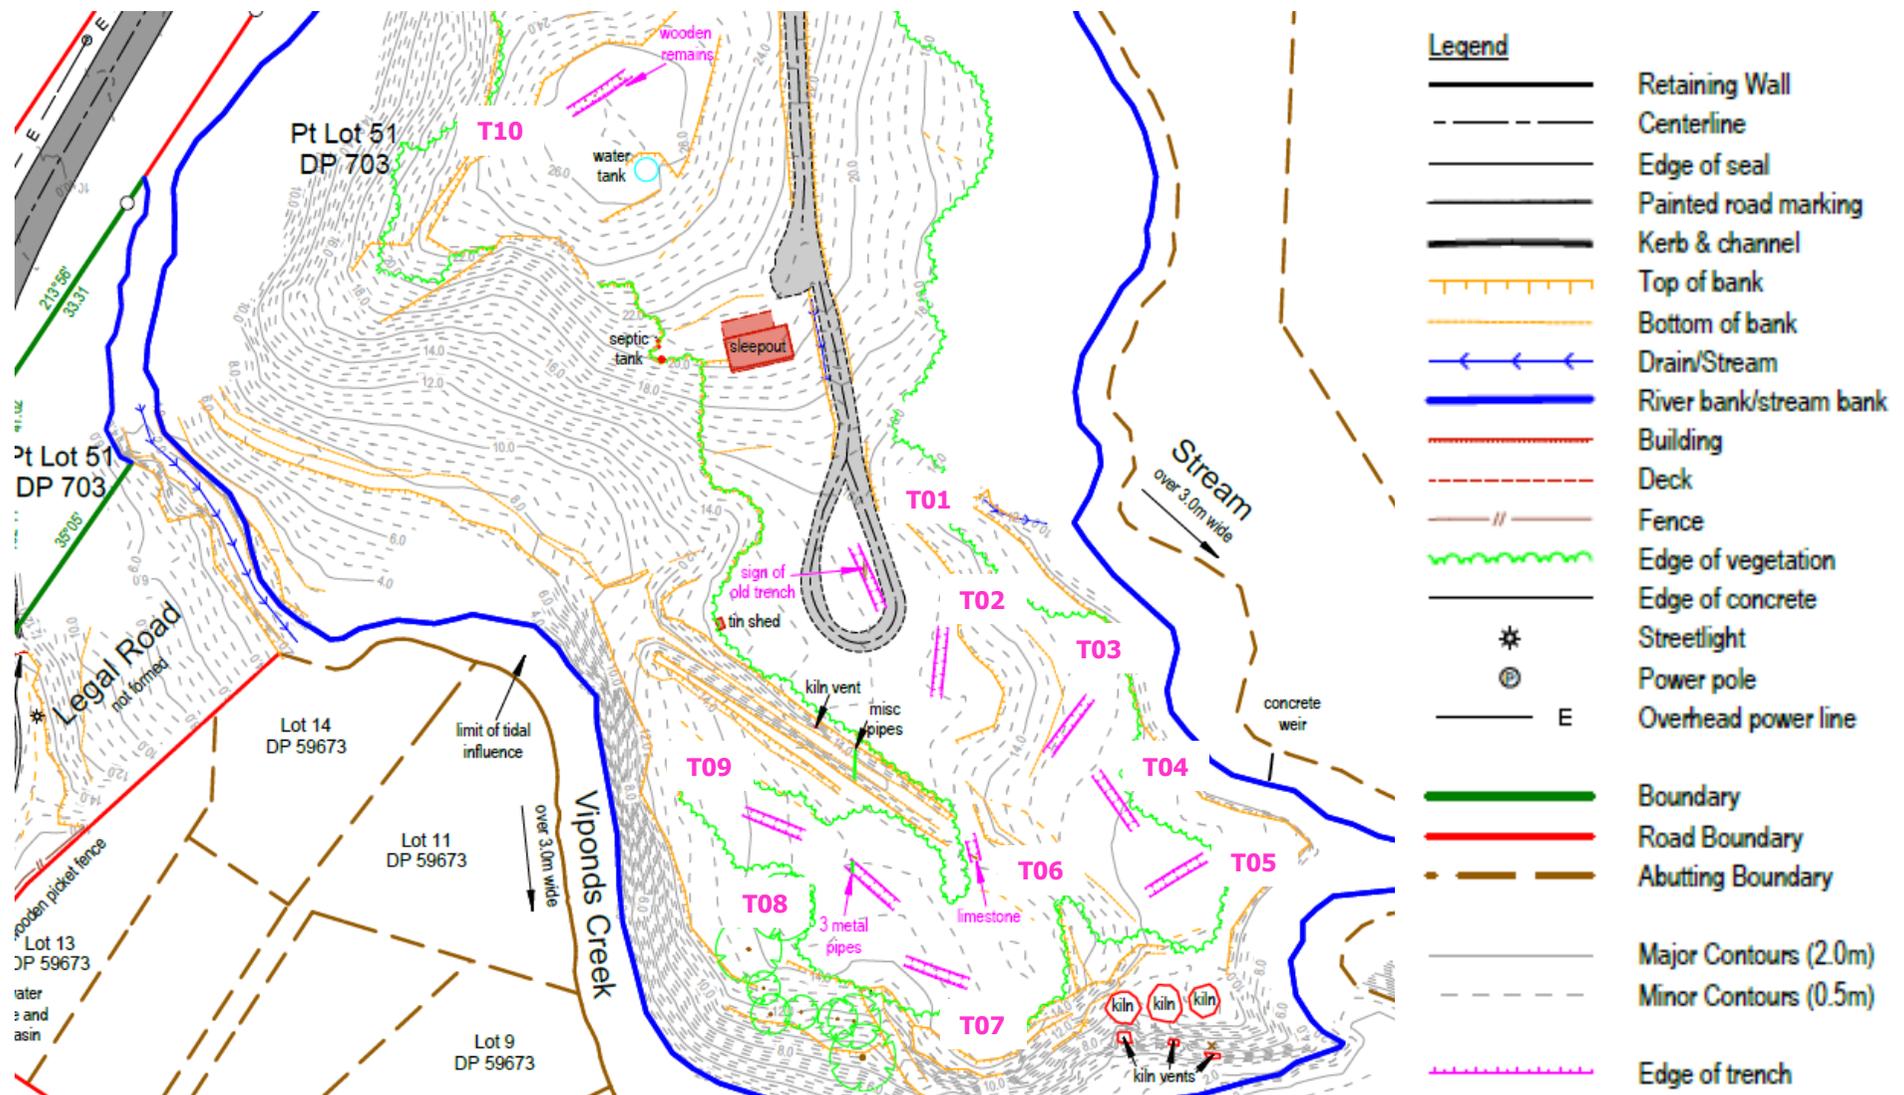
Figure 39. Exploratory Investigation trench locations excavated in January 2022 (plan by Buckton Consulting Surveyors Limited)

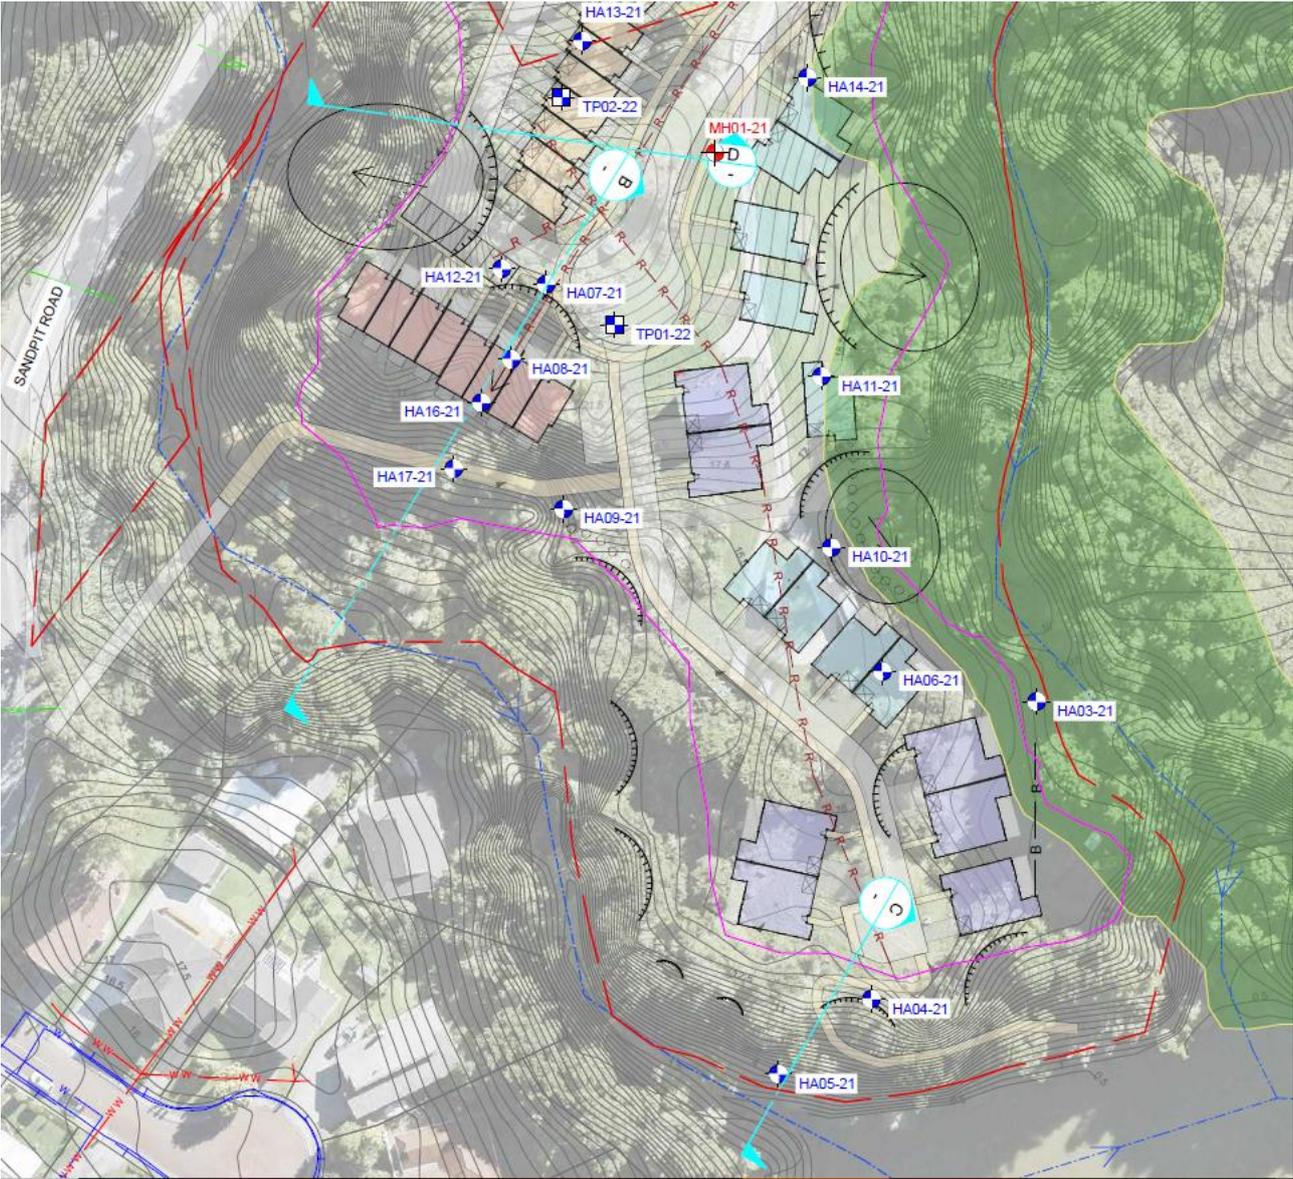
Figure 41. Geotechnical investigations 'as completed' with scheme plan overlaid (detail from CMW Geosciences Ltd March 2022)
