COMBES/DALDY LIME WORKS
34 & 36 SANDSPIT ROAD, WARKWORTH, AUCKLAND
HISTORIC HERITAGE IMPACT ASSESSMENT
SUBDIVISION AND LANDUSE APPLICATION
PREPARED FOR THE KILNS LIMITED
APRIL 2022

**COMBES/DALDY LIME WORKS
36 SANDSPIT ROAD, WARKWORTH, AUCKLAND
HISTORIC HERITAGE IMPACT
SUBDIVISION APPLICATION
PREPARED FOR THE KILNS LIMITED
MARCH 2022**

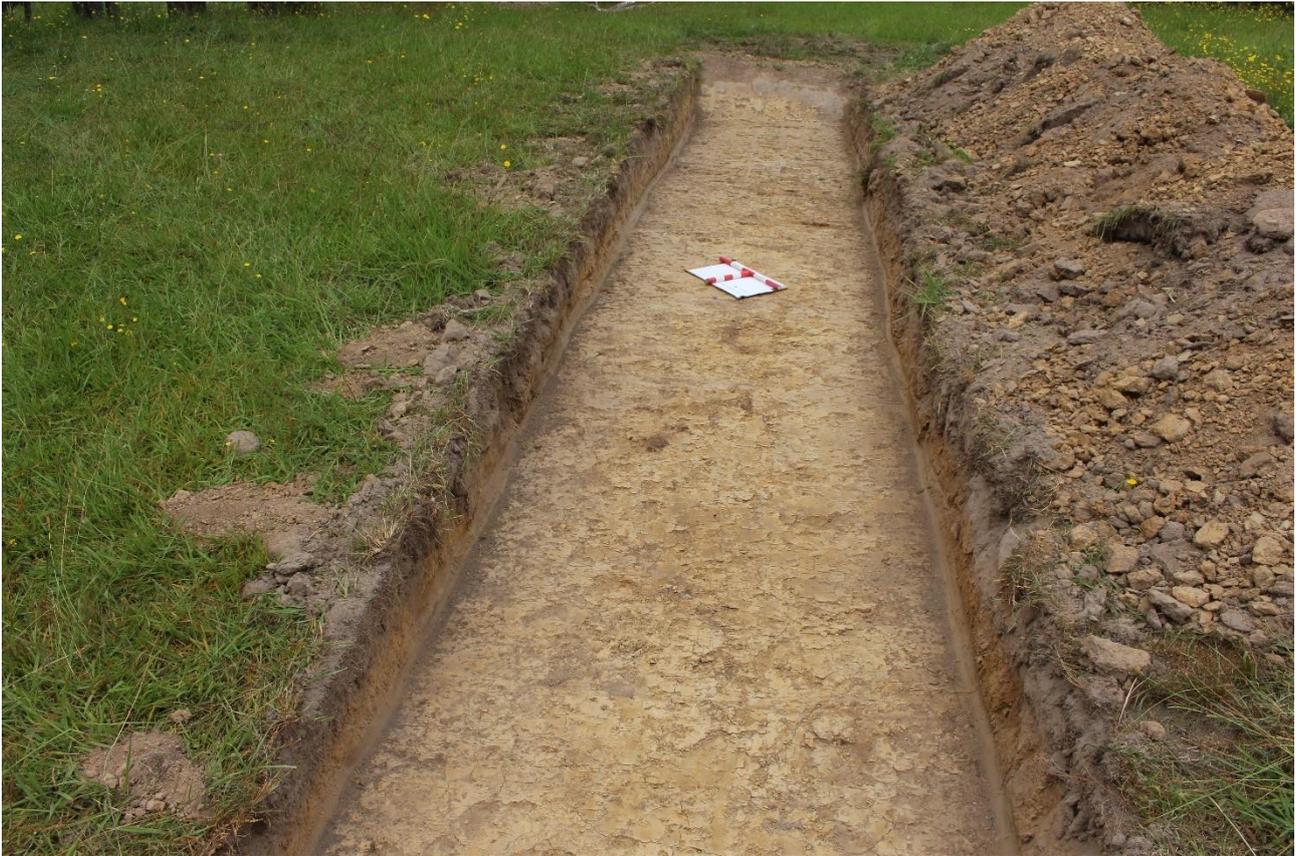
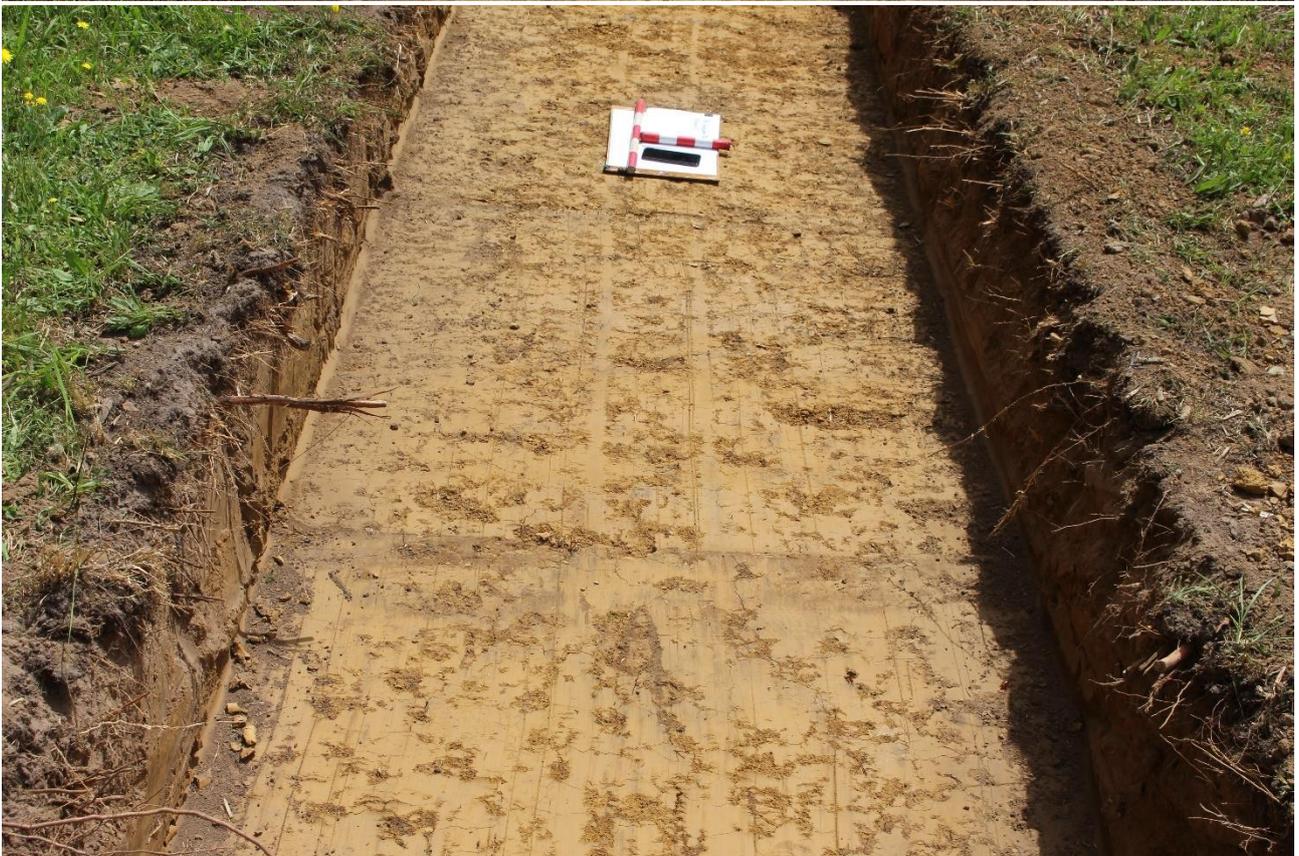
Figure 42. Exploratory Trenches 02 (Top), 03 (bottom) showing natural ground with no archaeological features

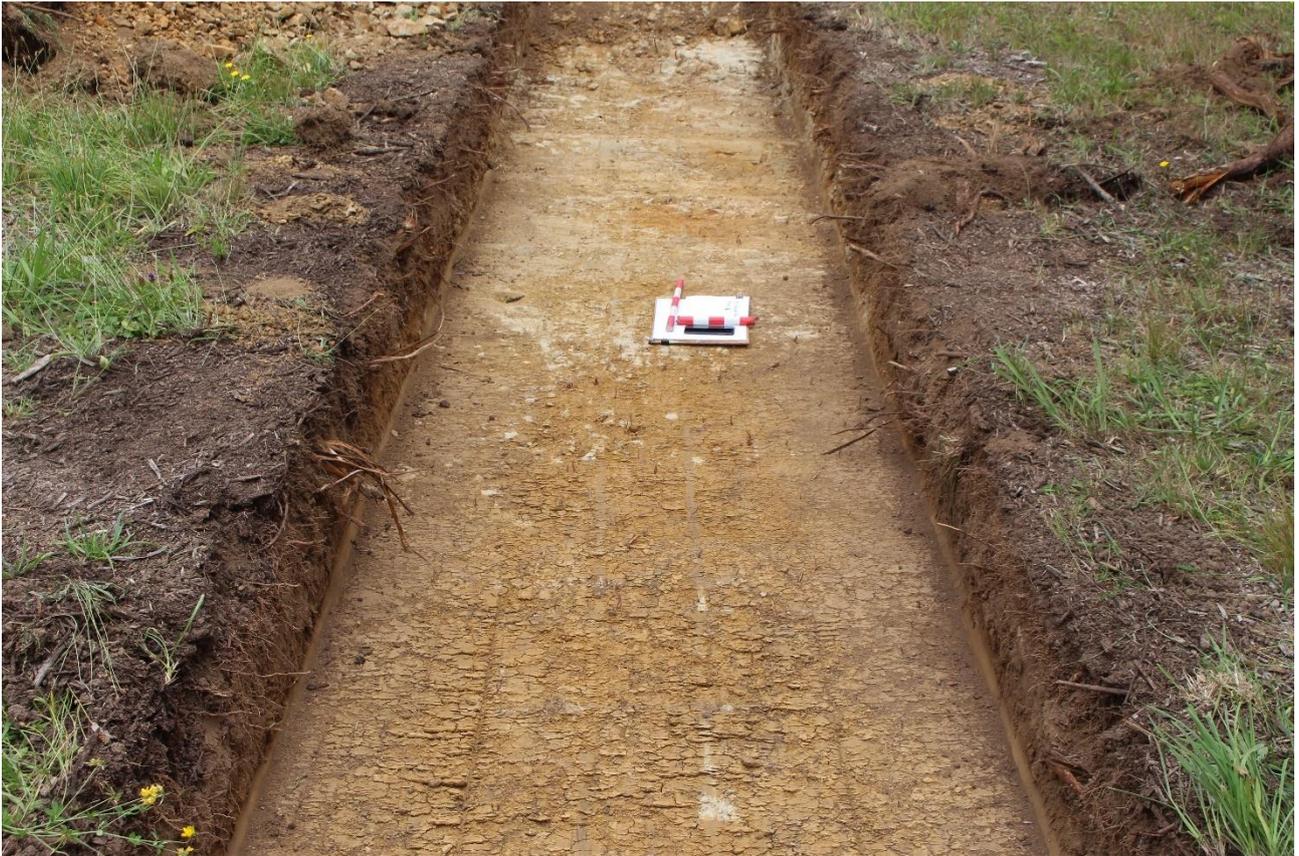
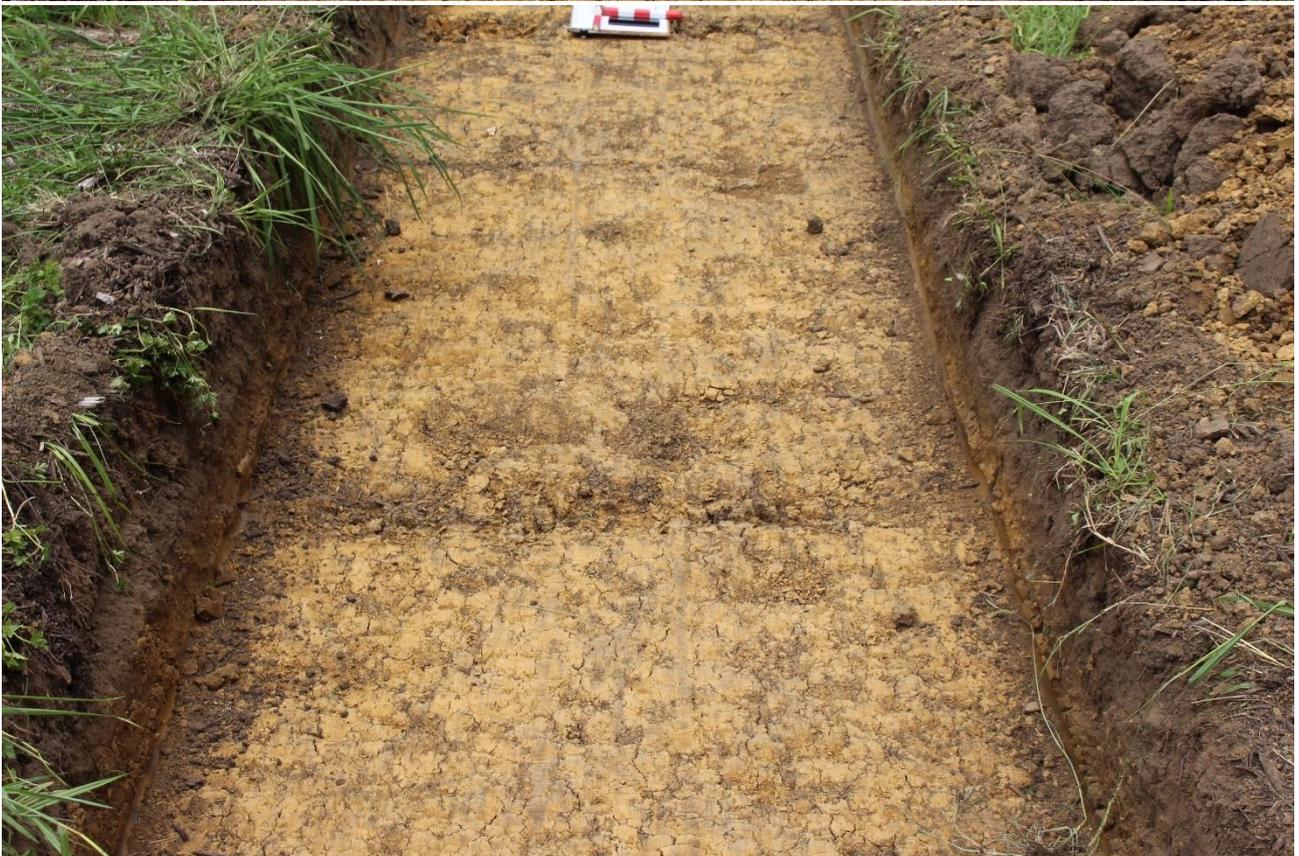
Figure 43. Exploratory Trenches 04 (top), 05 (bottom) showing natural ground with no archaeological features

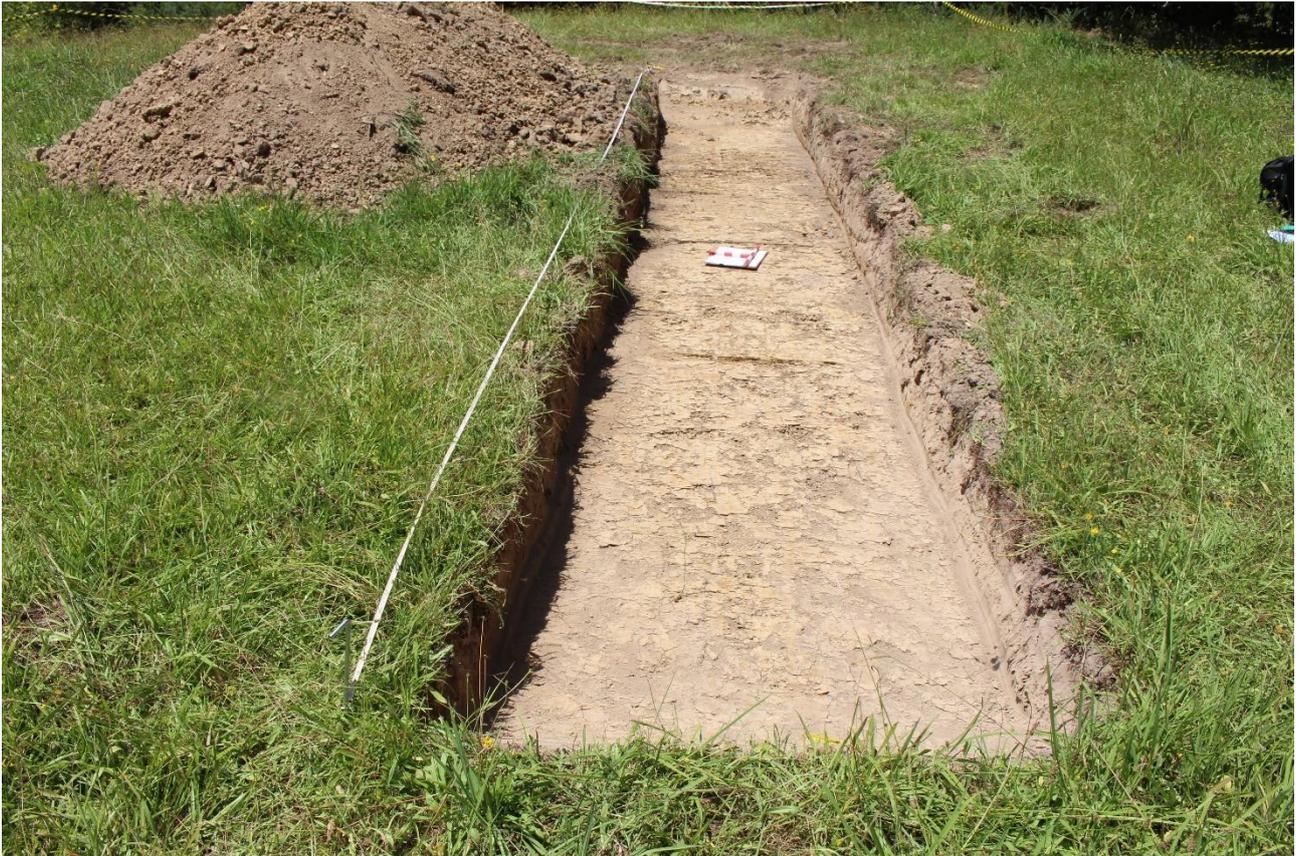
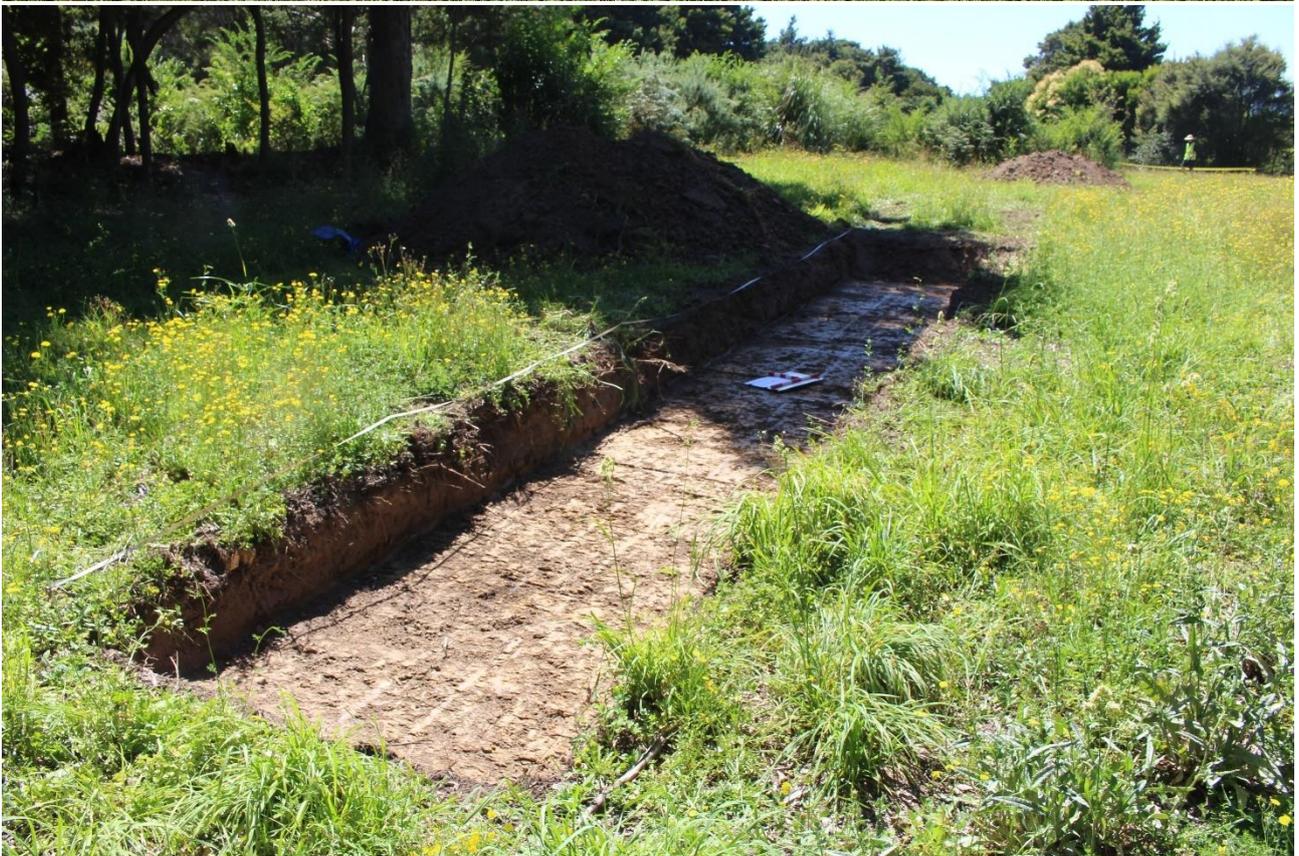
Figure 44. Exploratory Trenches 07 (top), 09 (bottom) showing natural ground with no archaeological features

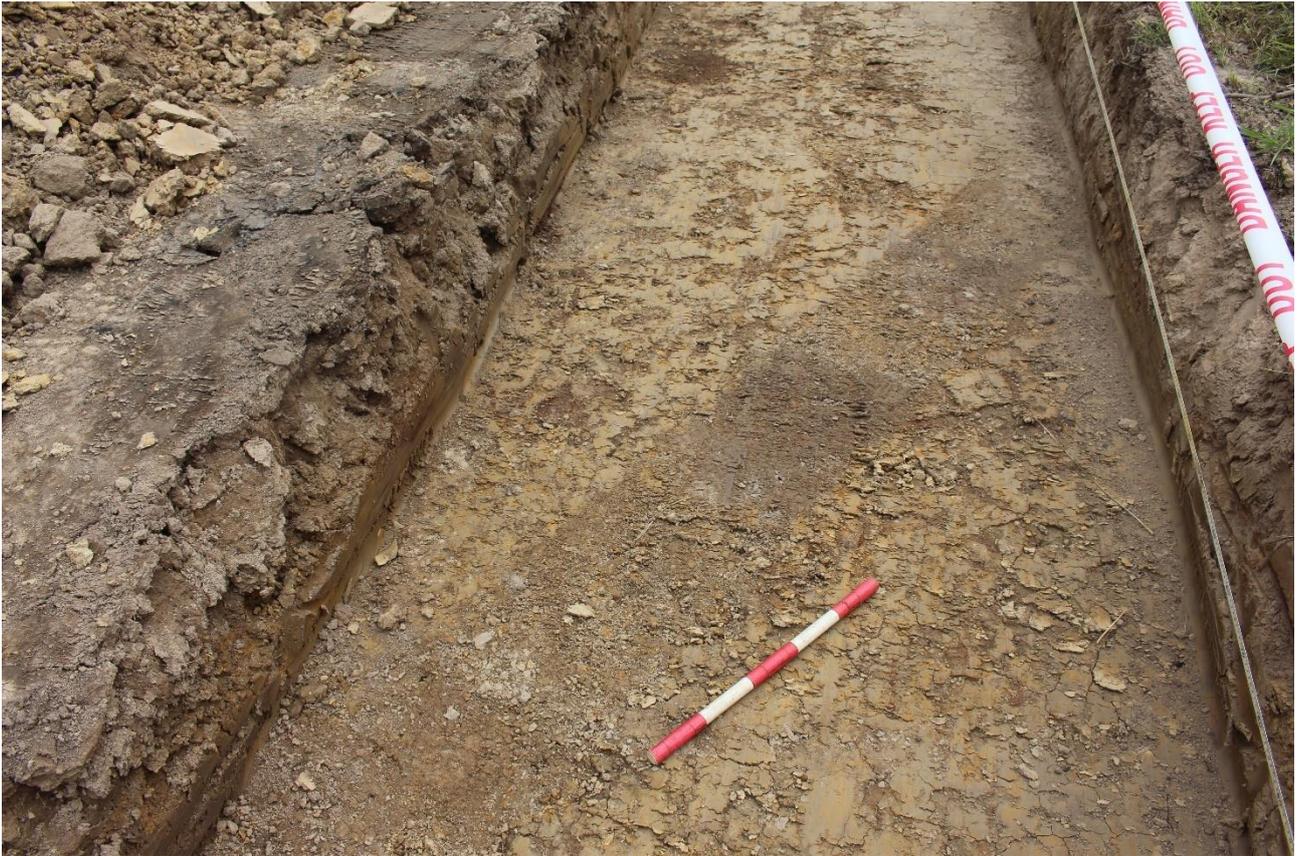
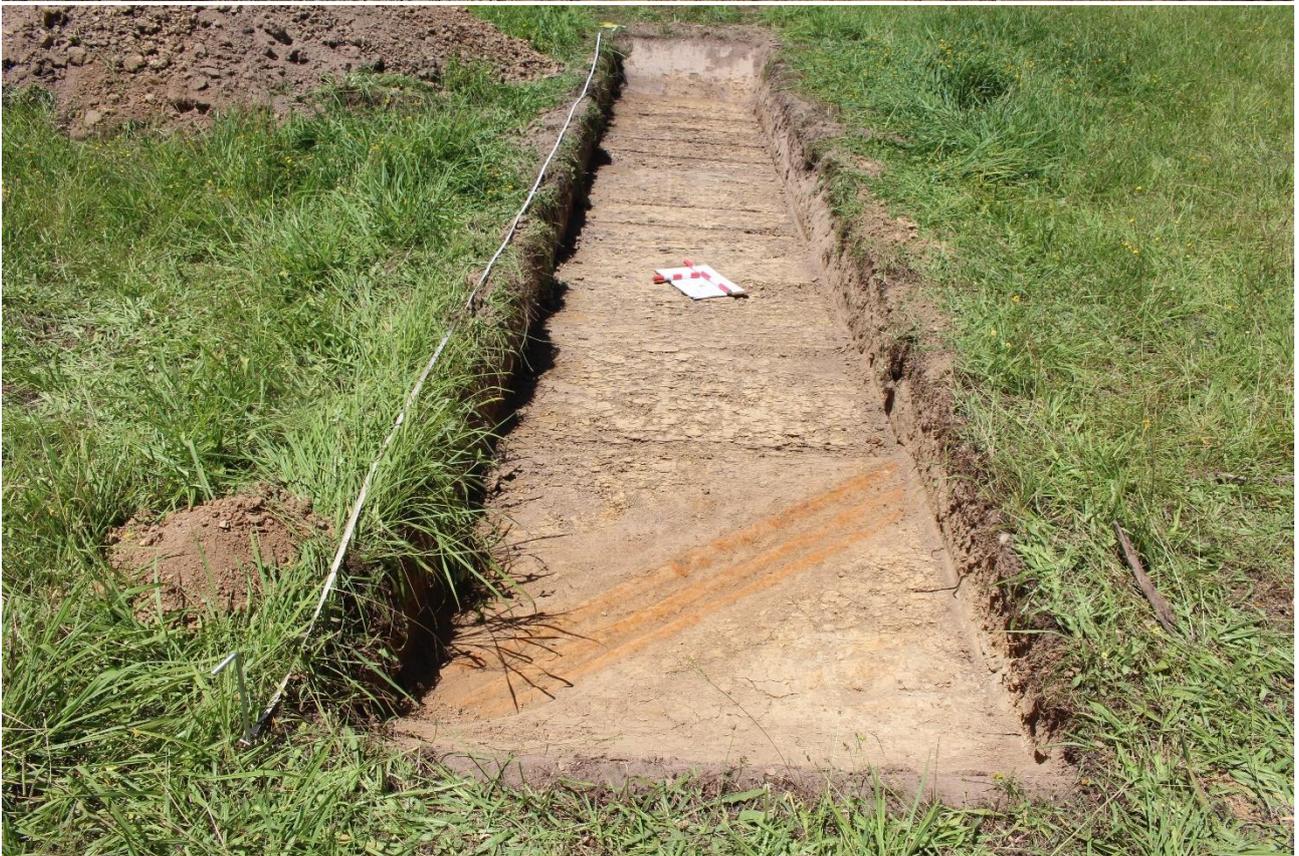
Figure 45. Exploratory Trenches 01 (top) and 08 (bottom) showing line of water pipes.

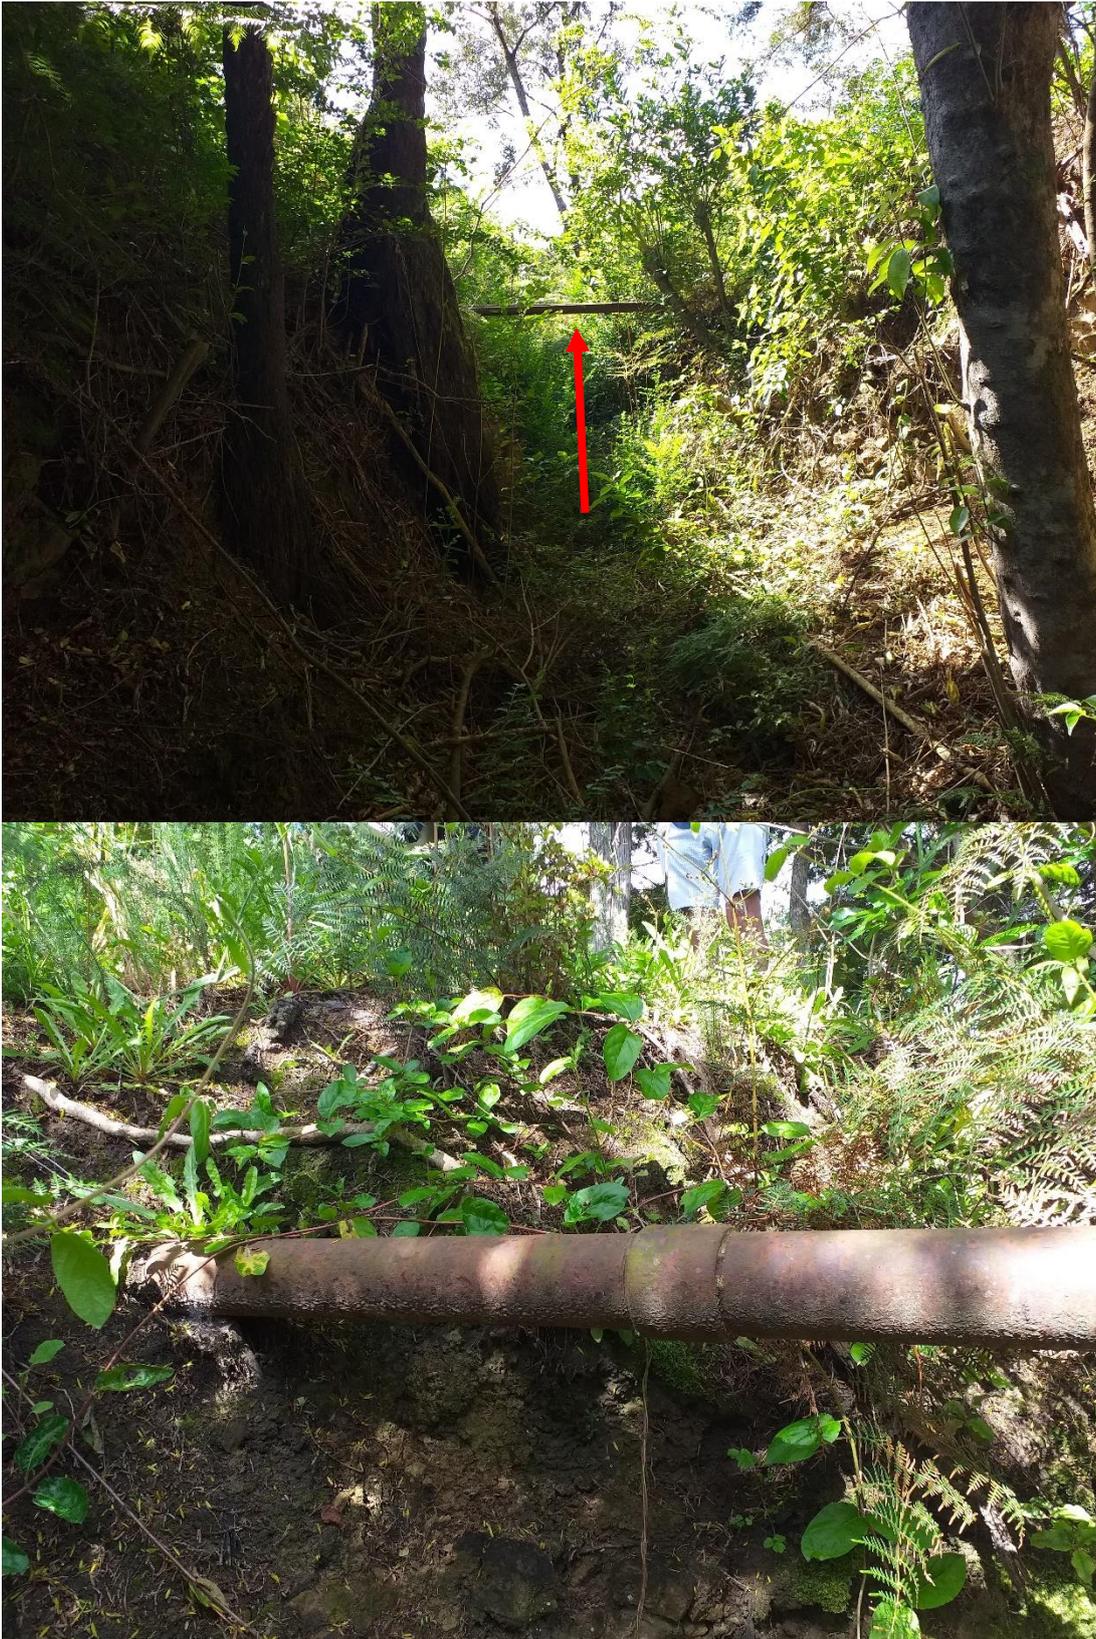
Figure 46. The waterpipes crossing the tramway cutting, just below modern overburden and stratigraphically later than the tramway cutting itself.

Two cast-iron pipes (largest 4 inches diameter) were found within the cutting for the tramway, approximately 50cm deep (Figure 34). These possibly run NE/SW through the southern part of the site, but the exact alignment is yet to be confirmed. They are most likely water pipes and could be late 19th/ early 20th century in origin. Their date and association with the lime works is yet to be established, and this may be revealed if they can be traced back to the source (see section 5.9 below).

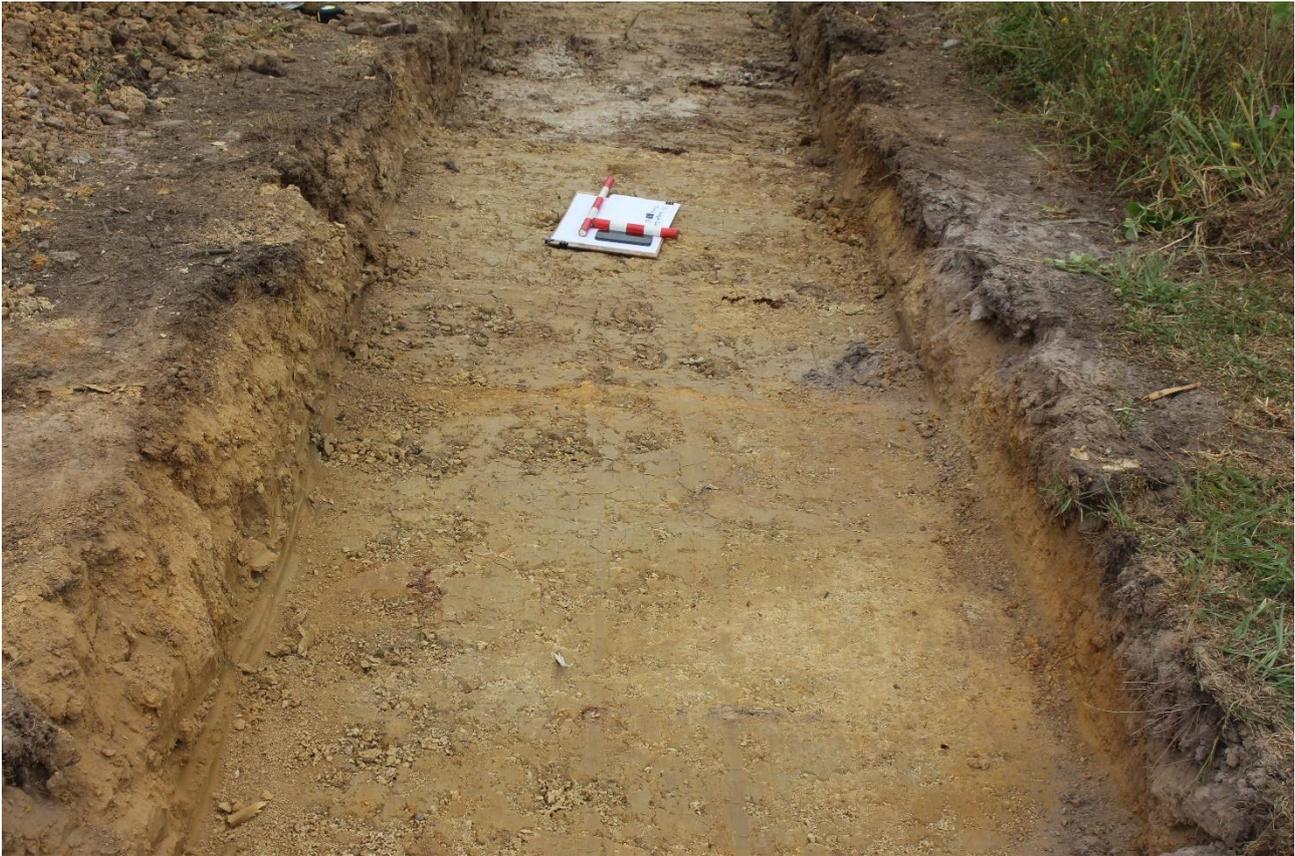
Figure 47. Exploratory Trench 10 – Probable Early 20th century house site (top), detail of pile in situ (bottom left), chimney base (bottom middle), unstratified surface finds (bottom right)

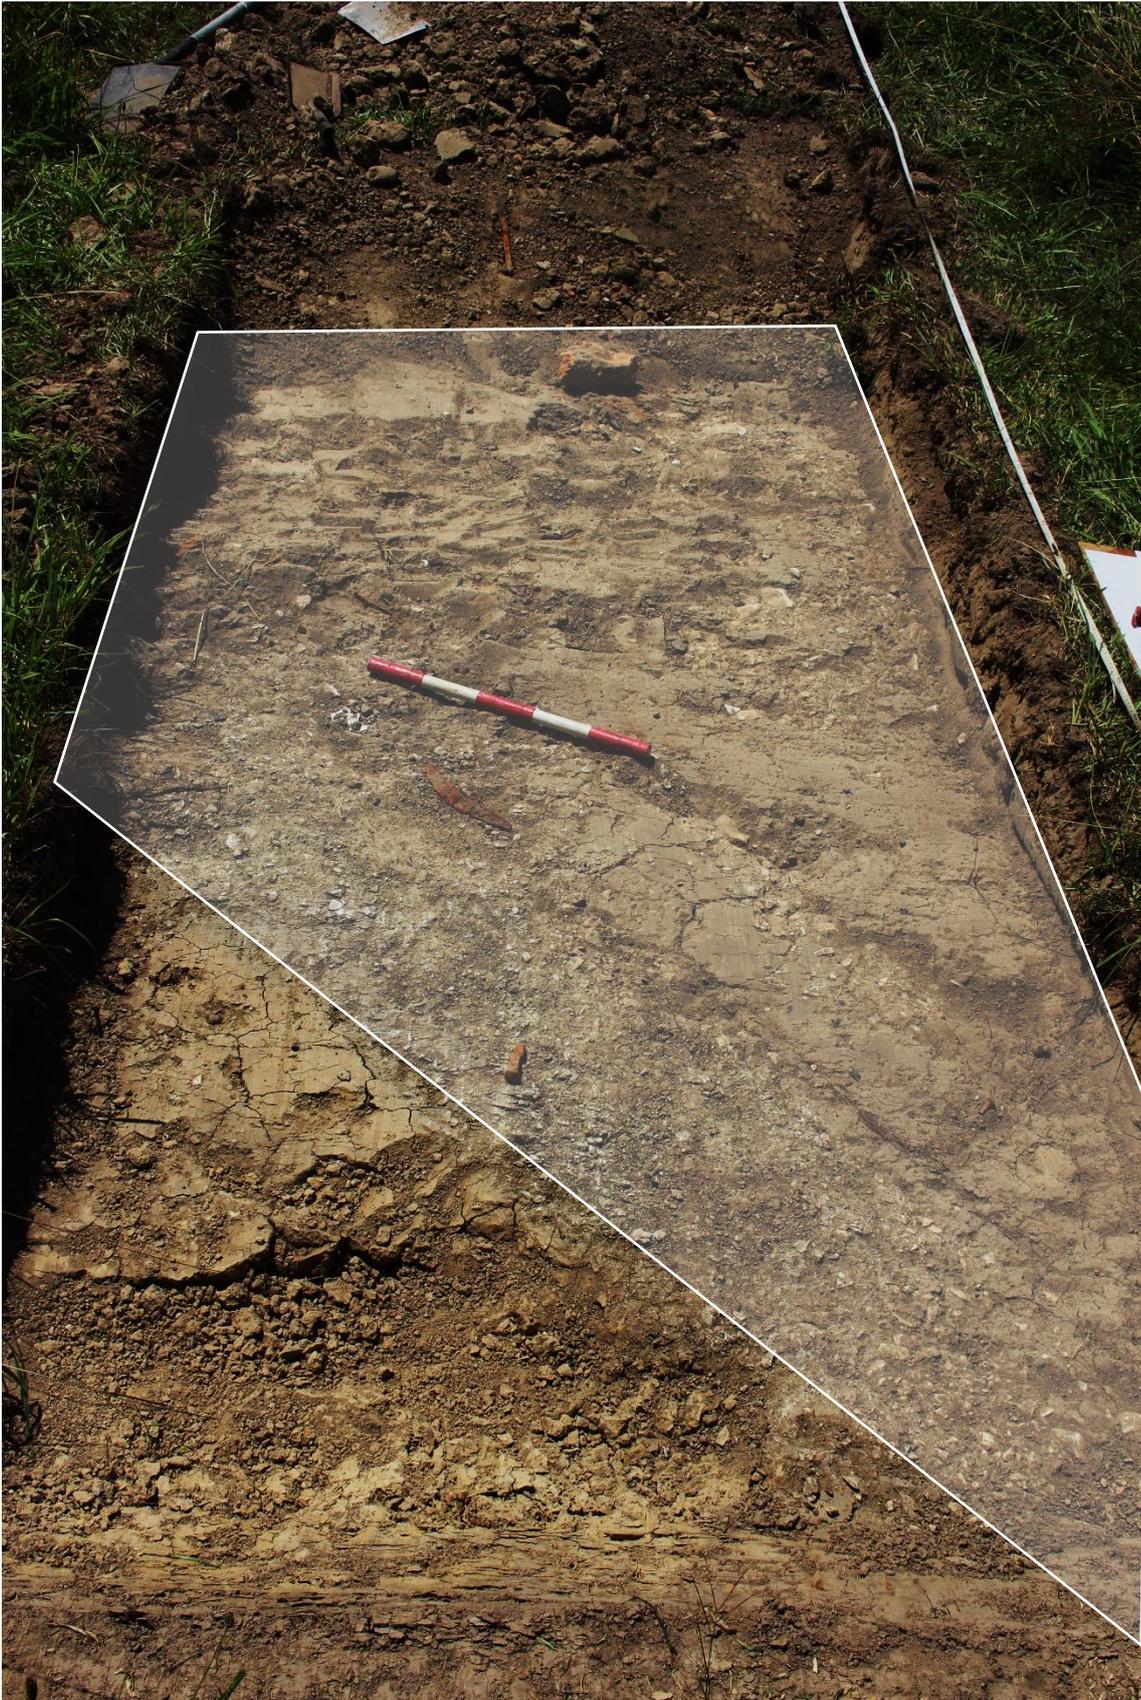
Figure 48. Exploratory Trench 06 looking NW- Continuation of tramline showing *in situ* archaeological surface (highlighted)

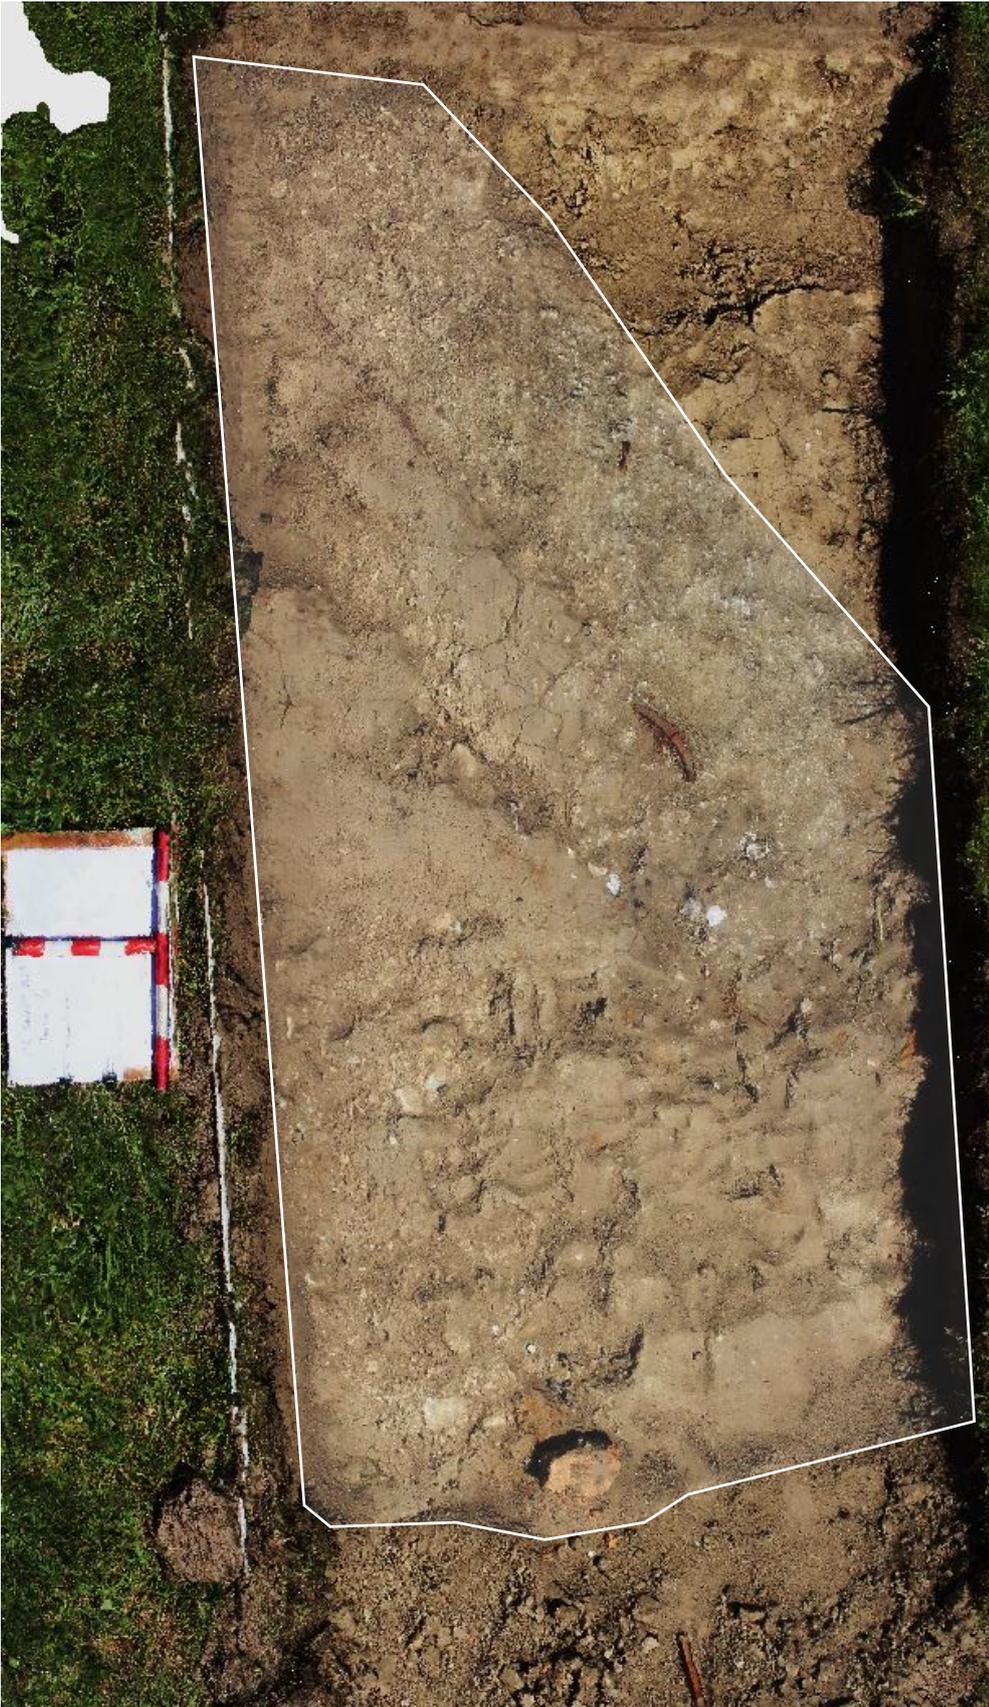
Figure 49. 3-dimensional digital plan of Trench 6, with Tramline highlighted (Plan.Heritage Limited)

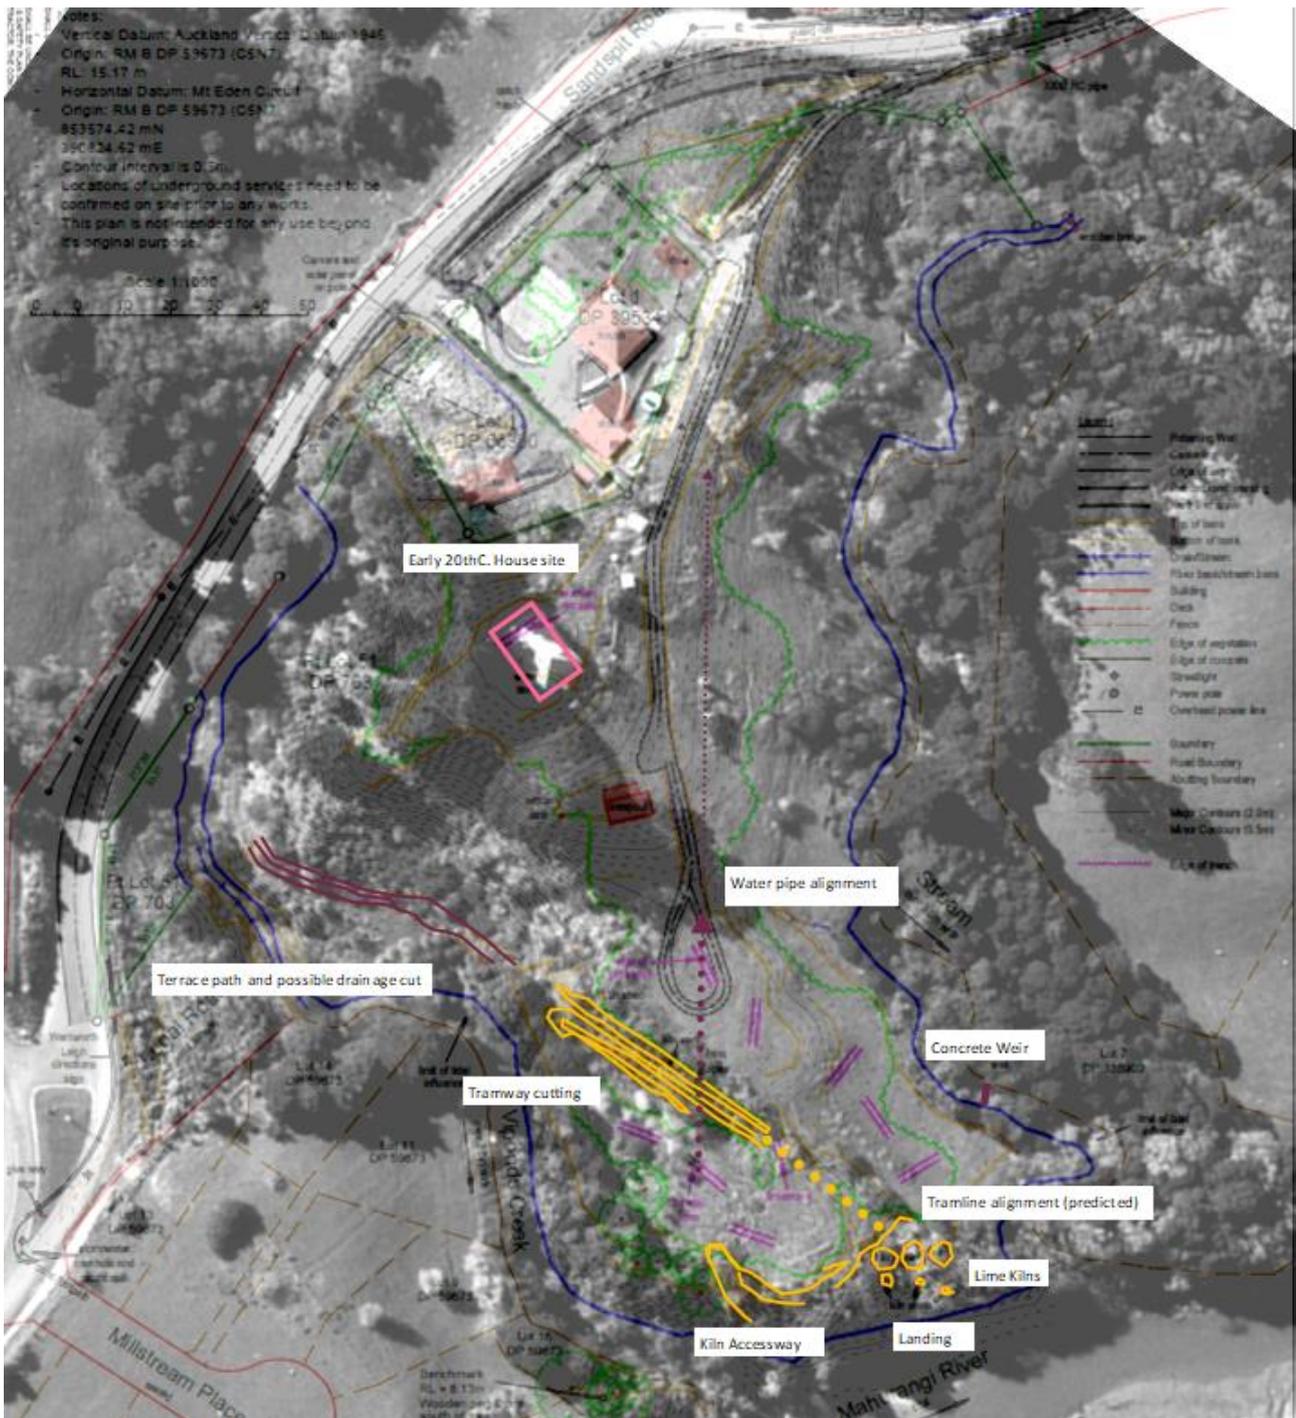
Figure 50, comparison of recorded site features, topographical and geophysical survey results, and 1962 aerial photography. Archaeological features confidently associated with the Lime works are highlighted in yellow. Other features of interest are shown in dark purple, and the early 20th century house site as a pink rectangle.

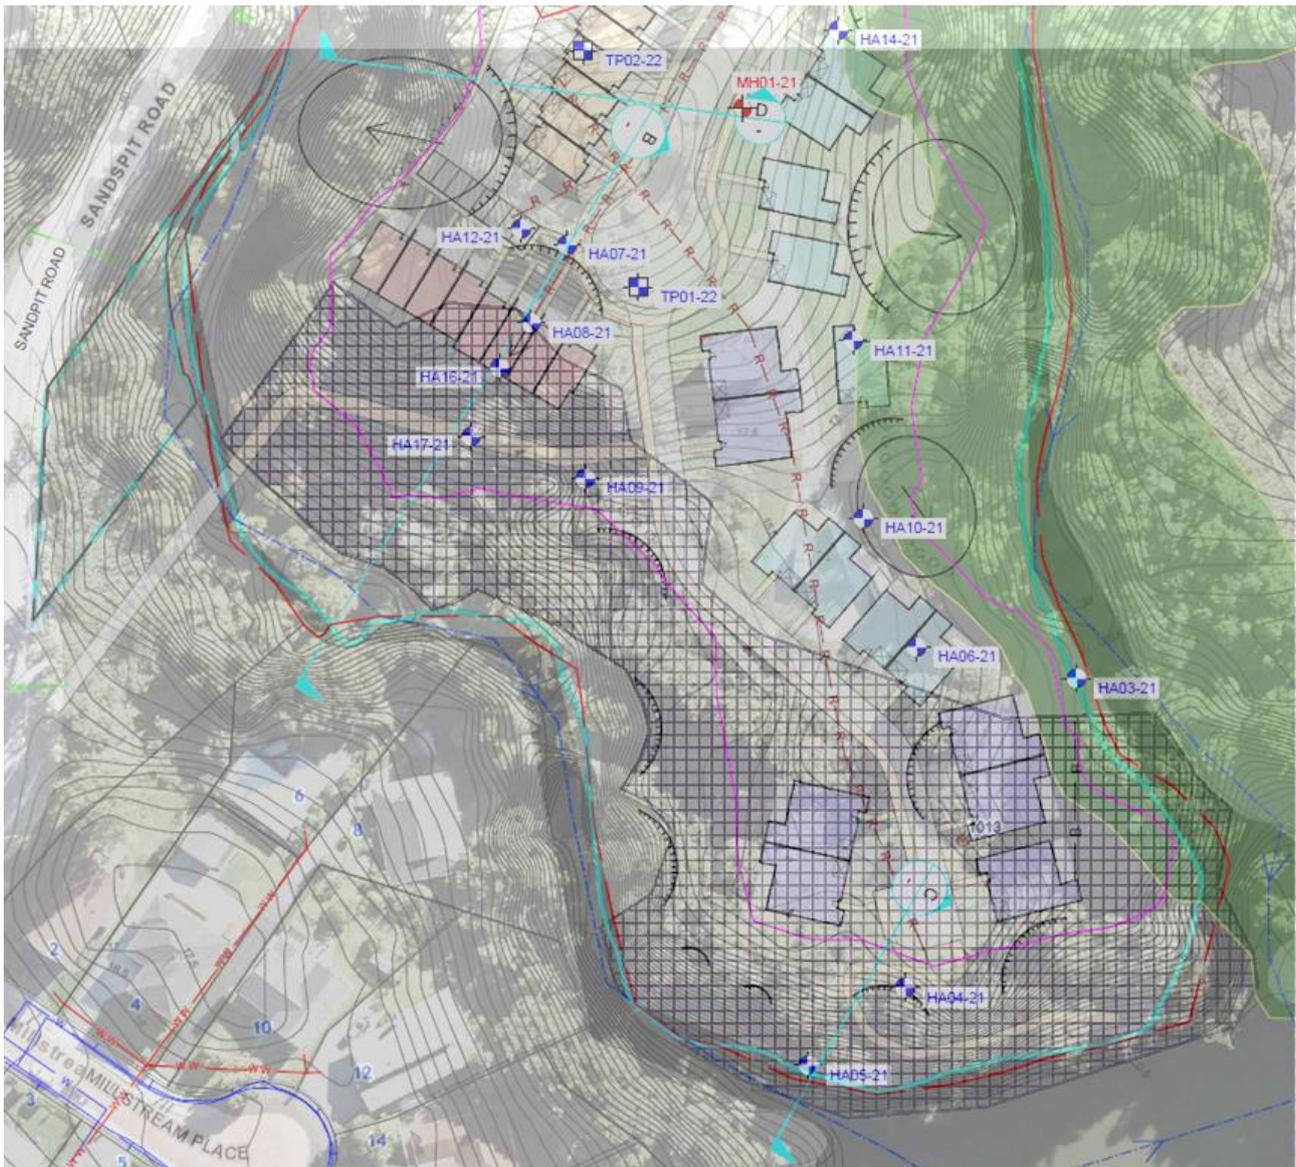
Figure 51. Georeferenced Geotechnical hand auger locations HA16-21 and HA17-21 and line of Geotechnical cross-section B, approximately overlain to the Combes Daldy Lime Works Site Extent of Place (Purple hachures) from base maps by Auckland Council Geomaps and CMW Geosciences

the west. By contrast, hand augers taken in the extent of place (HA16-21) and HA17-21) found deposits of colluvium up to 1m, but were terminated at this depth and did not reach limestone deposits (Figure 51).

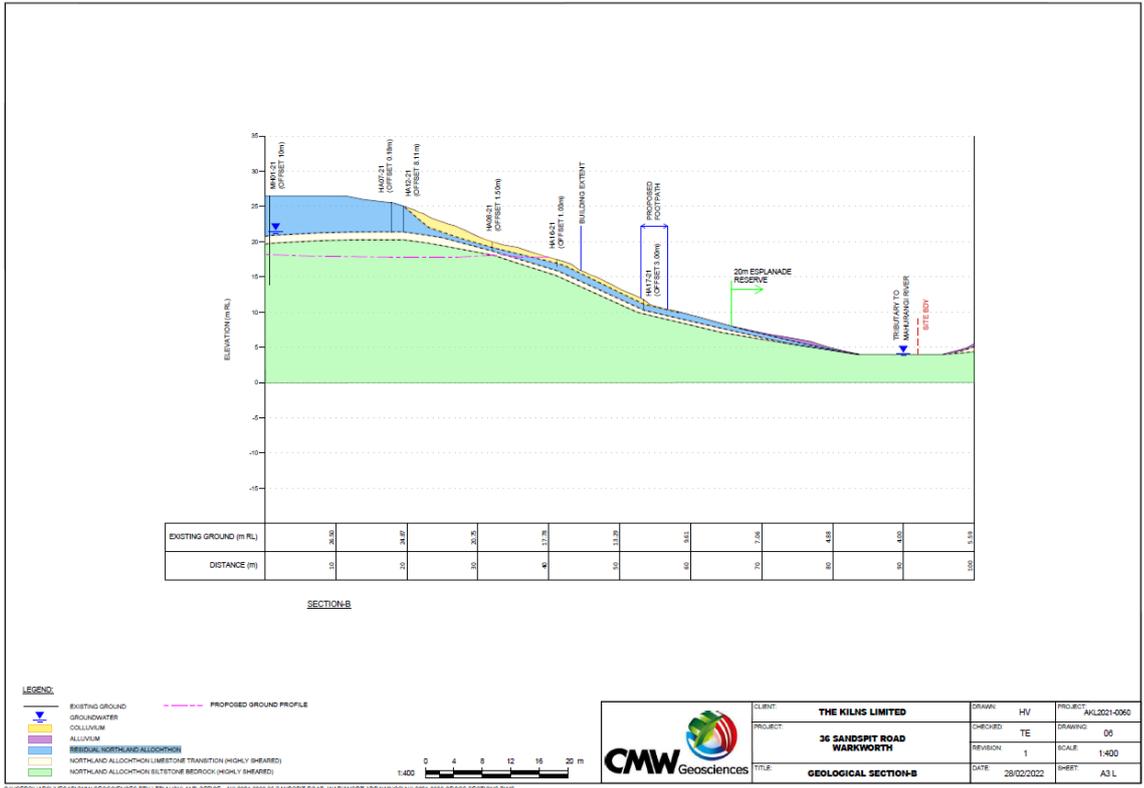
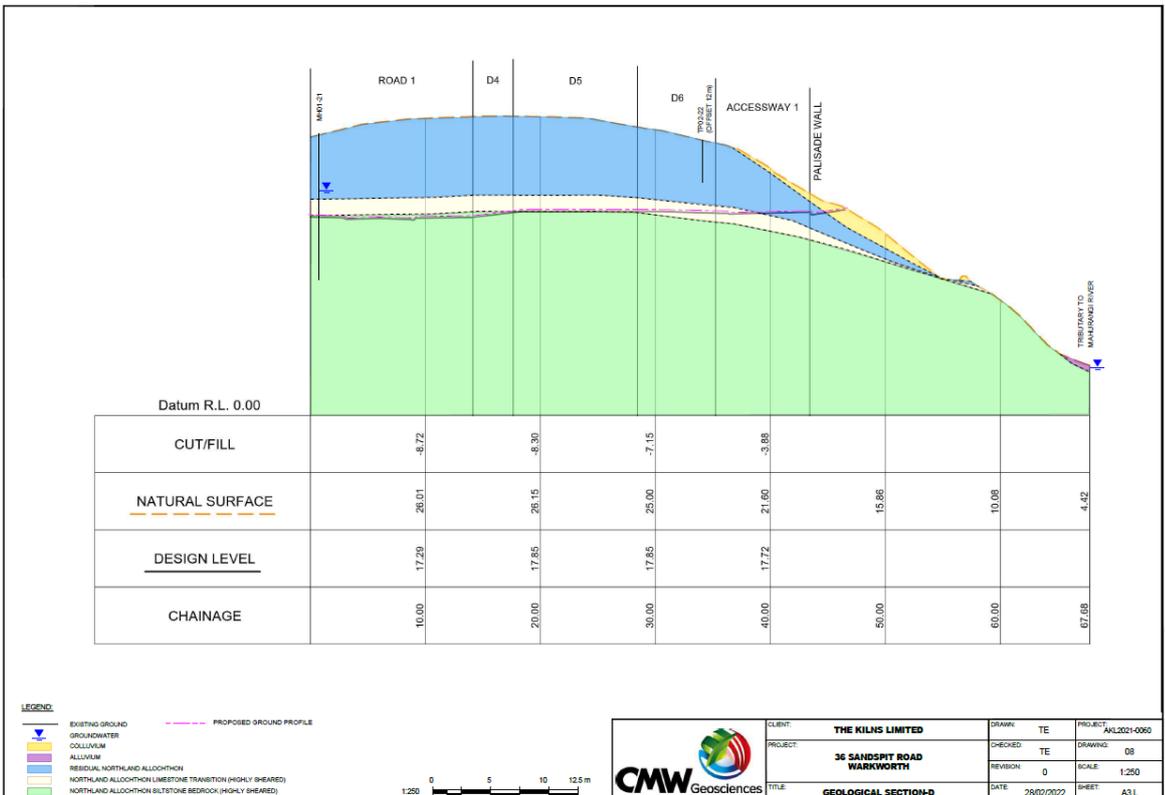
Figure 52. comparison of geotechnical sections B and D (CMW Geosciences March 2022)

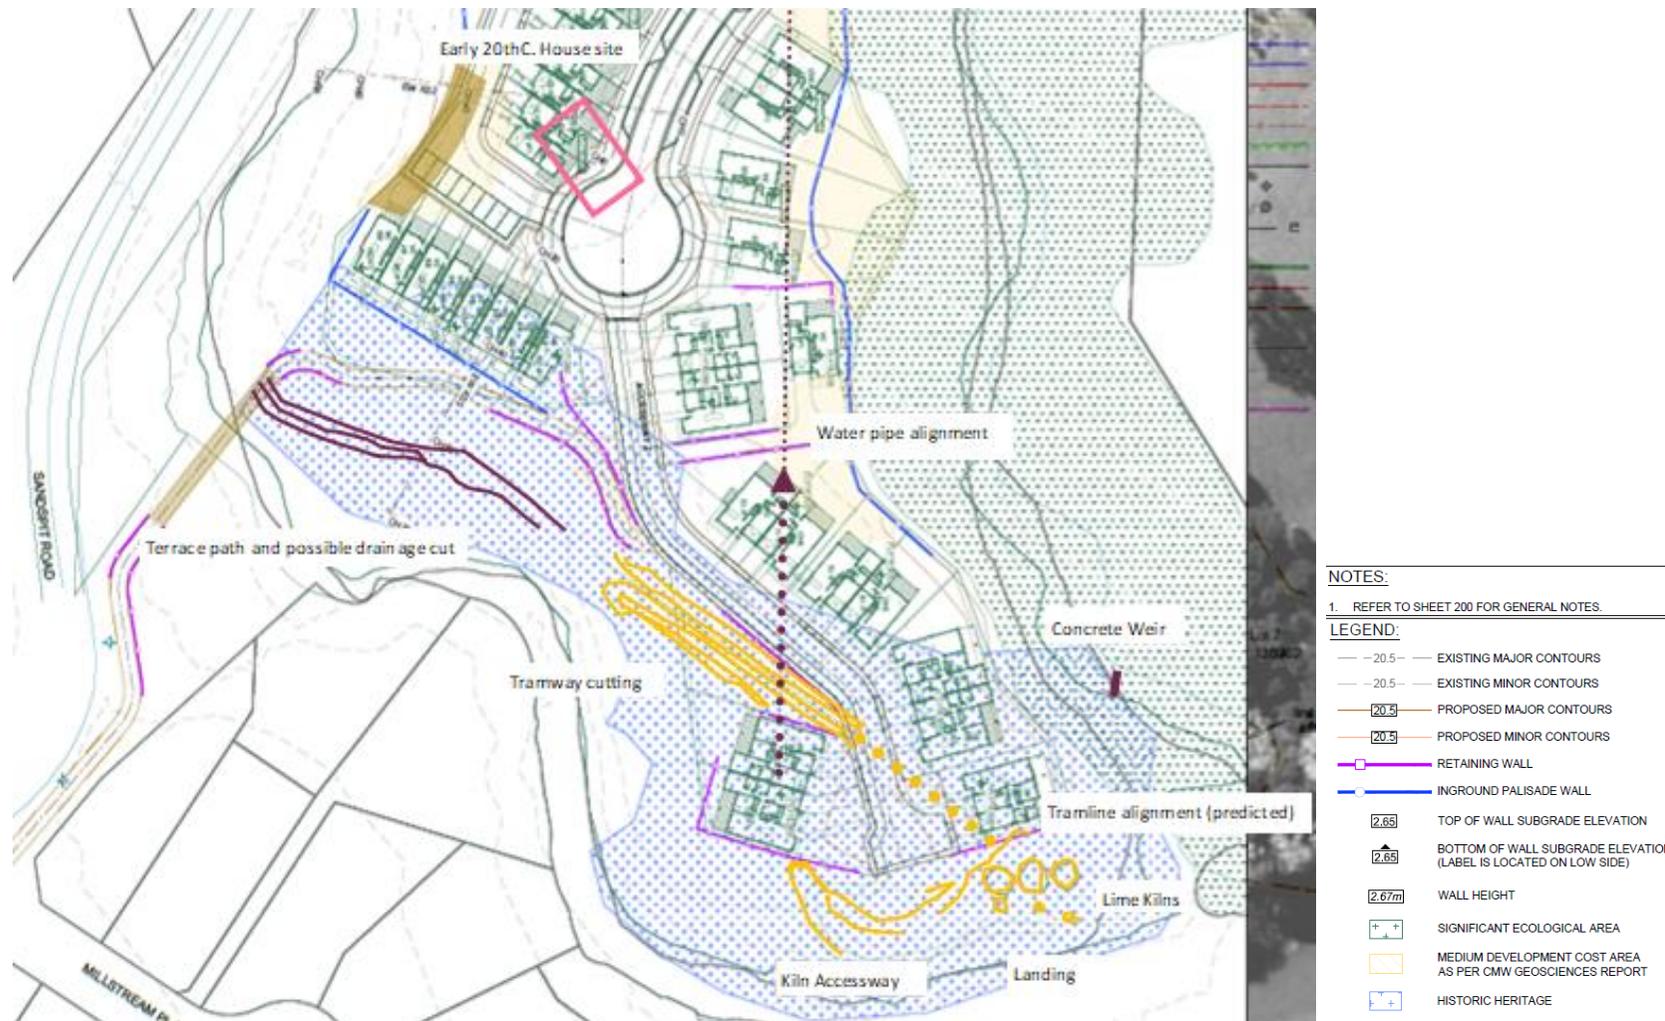
Figure 59. Subdivision plan overlain with confirmed archaeological recorded features (solid yellow lines), Early C20th century house site (pink rectangle) line of water pipe (Dashed purple arrow) undated track and weir features (solid purple lines) and Historic Heritage Extent of Place (blue hachures) (base plan prepared by Airey Consultants limited)
