COMBES/DALDY LIME WORKS
34 & 36 SANDSPIT ROAD, WARKWORTH, AUCKLAND
HISTORIC HERITAGE IMPACT ASSESSMENT
SUBDIVISION AND LANDUSE APPLICATION
PREPARED FOR THE KILNS LIMITED
APRIL 2022

**COMBES/DALDY LIME WORKS
36 SANDSPIT ROAD, WARKWORTH, AUCKLAND
HISTORIC HERITAGE IMPACT
SUBDIVISION APPLICATION
PREPARED FOR THE KILNS LIMITED
MARCH 2022**

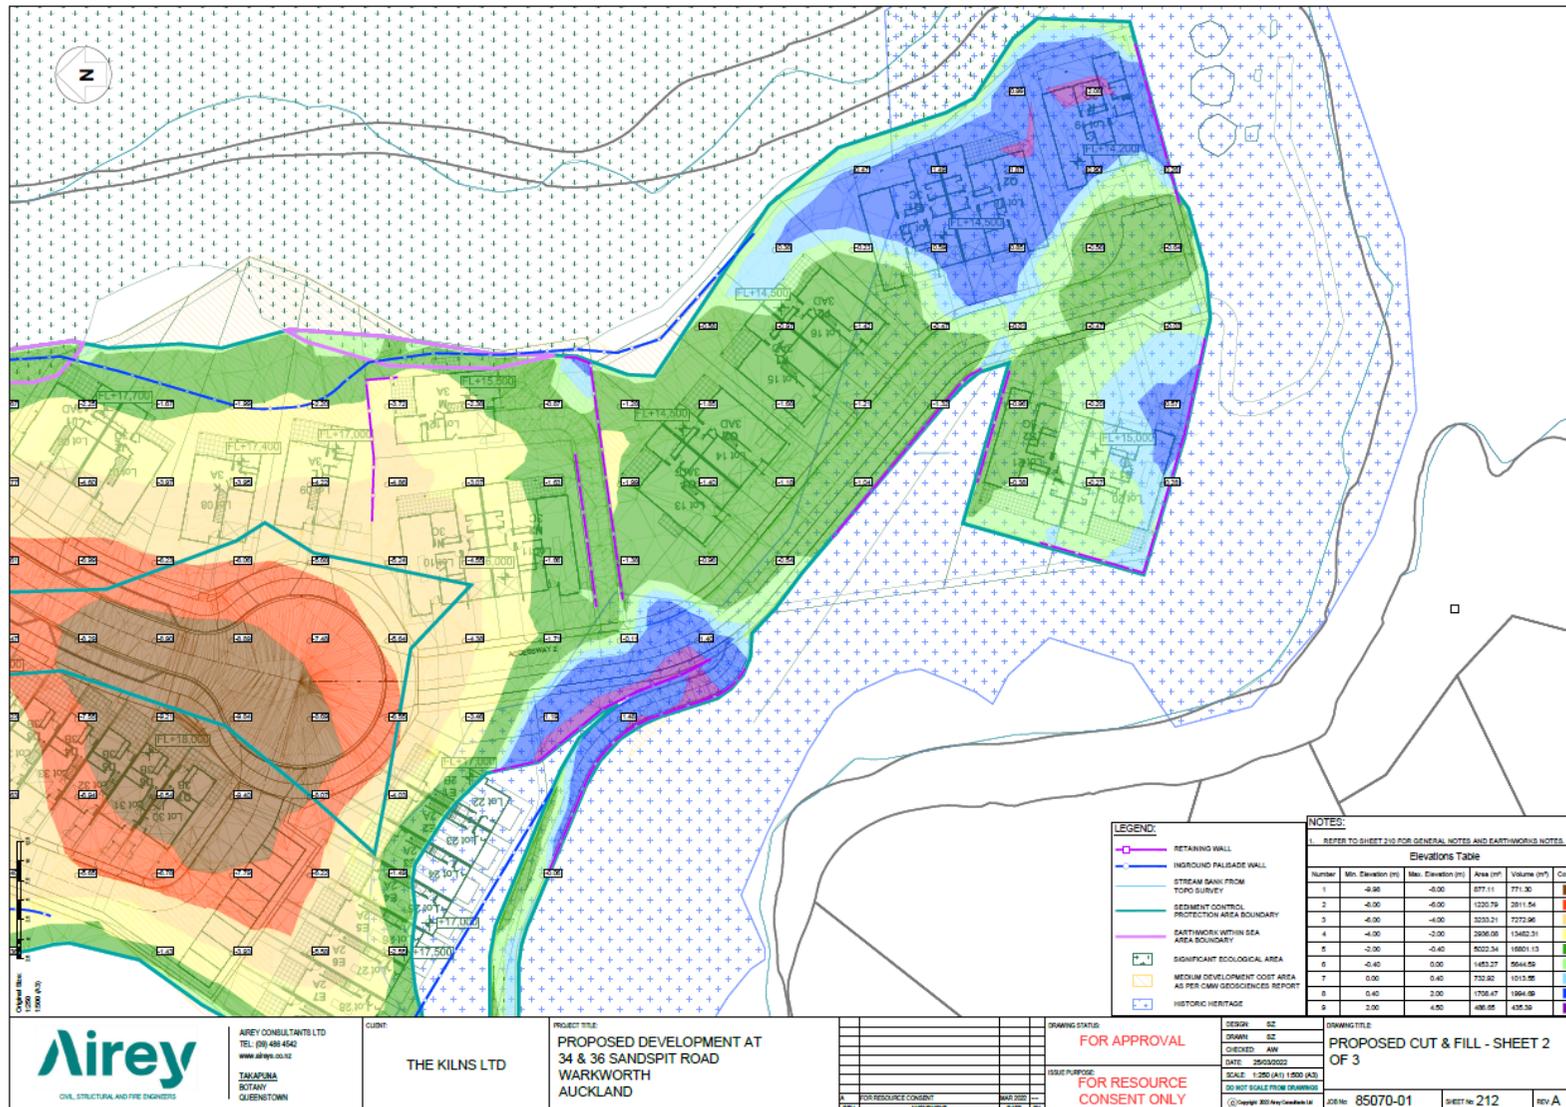
Figure 61. Historic Heritage Overlay Extent earthworks detail – east (base map by Airey & Buckton Consulting Surveyors Ltd March2022)

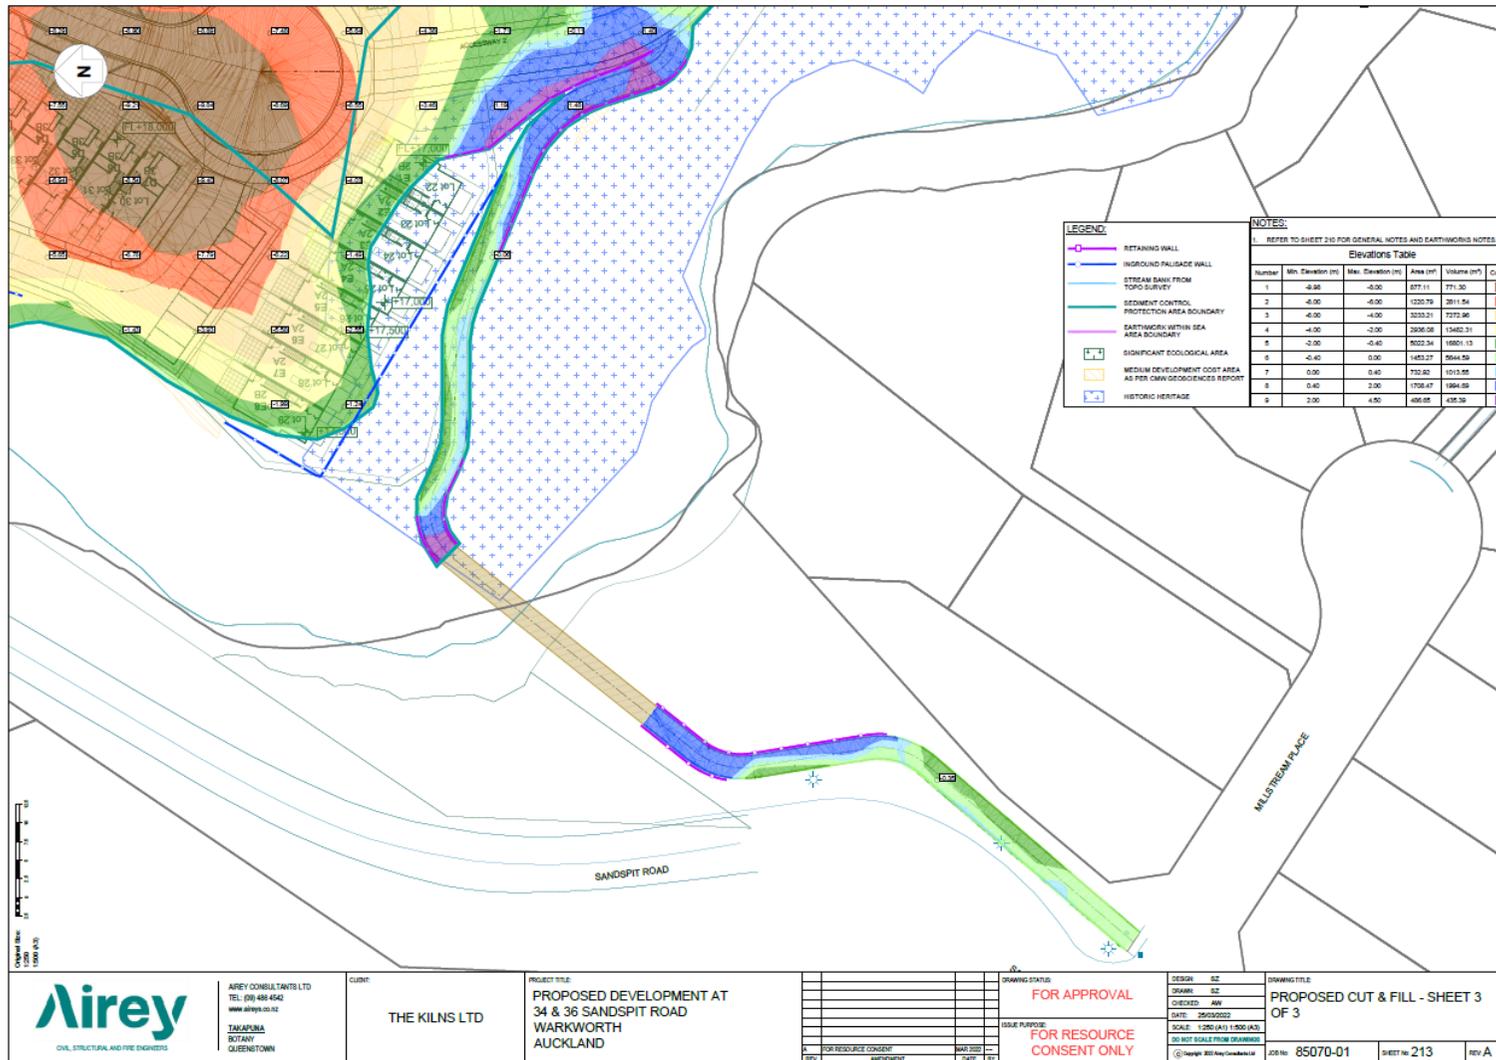
Figure 62. Historic Heritage Overlay Extent of Place earthworks detail - west (Airey and Buckton Consulting Surveyors Ltd March 2022)

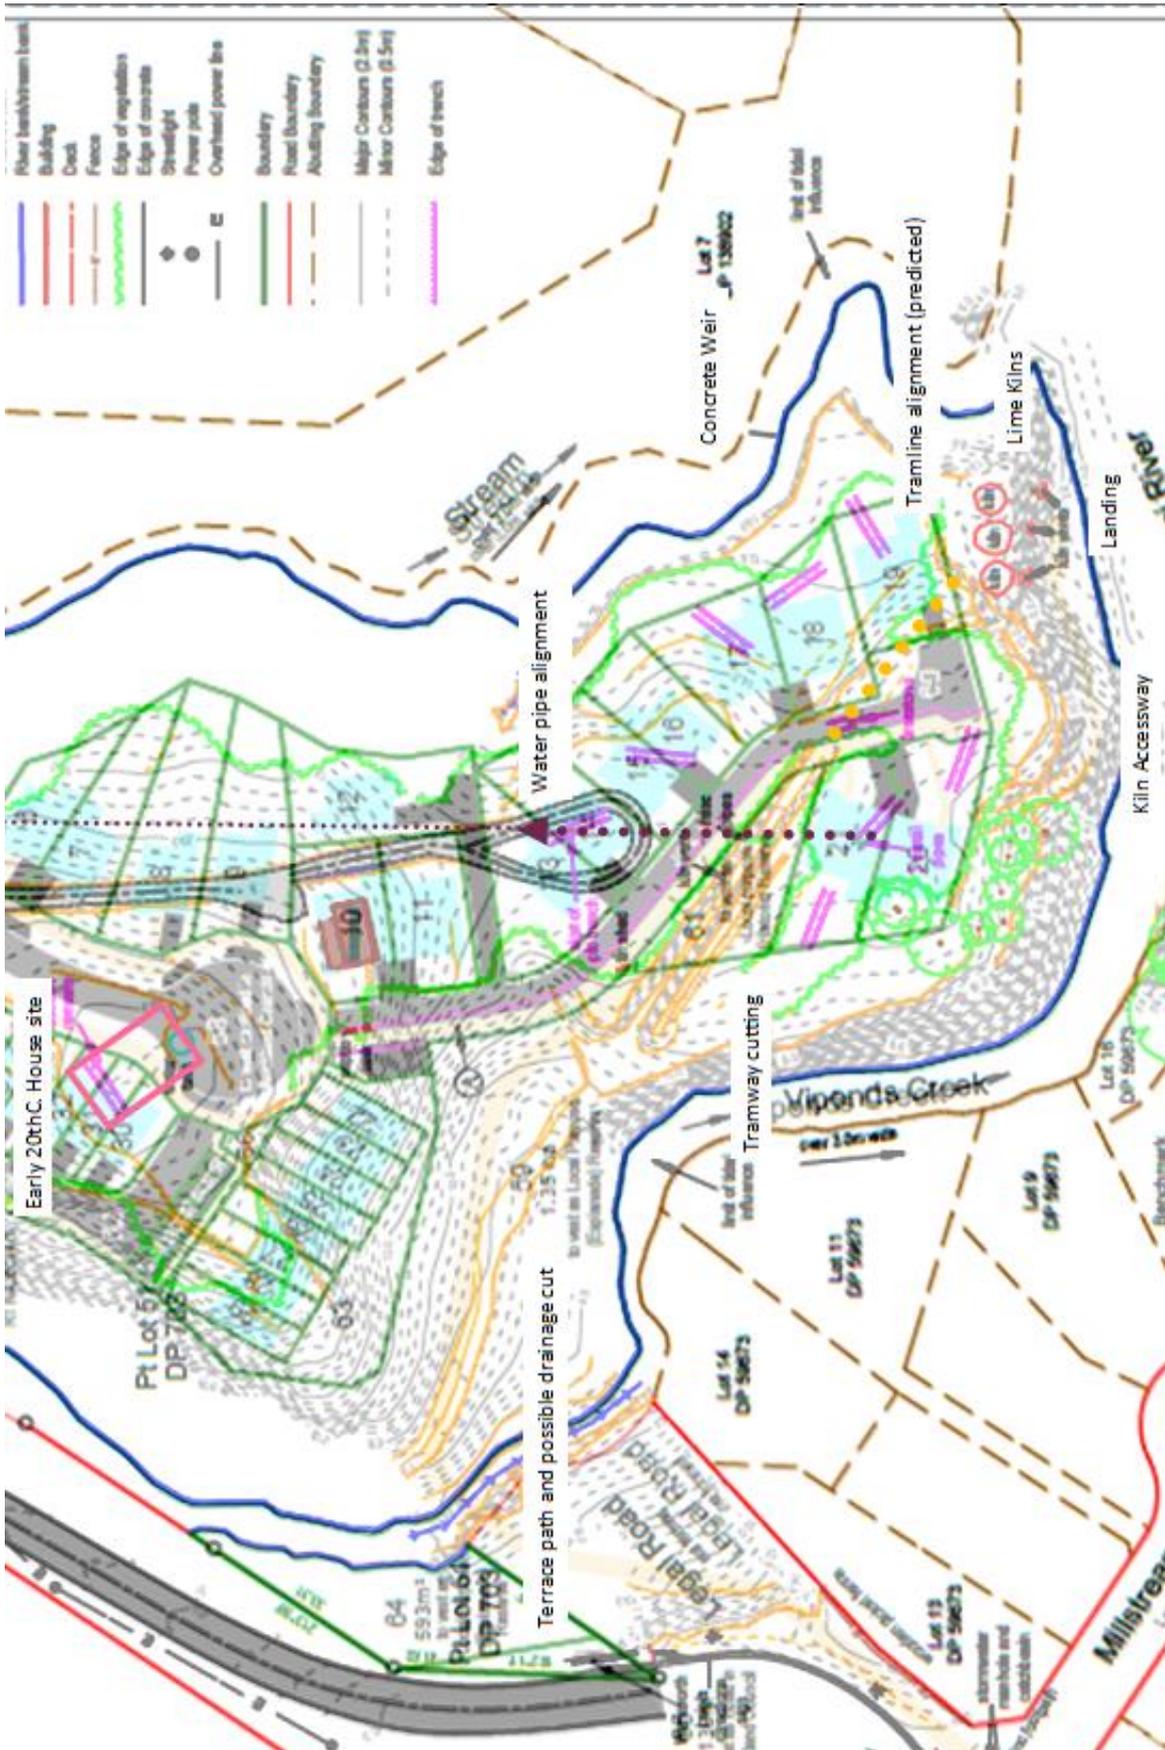
Figure 64. Overlay of topographic survey with proposed reserves (base maps by Buckton surveyors Ltd)

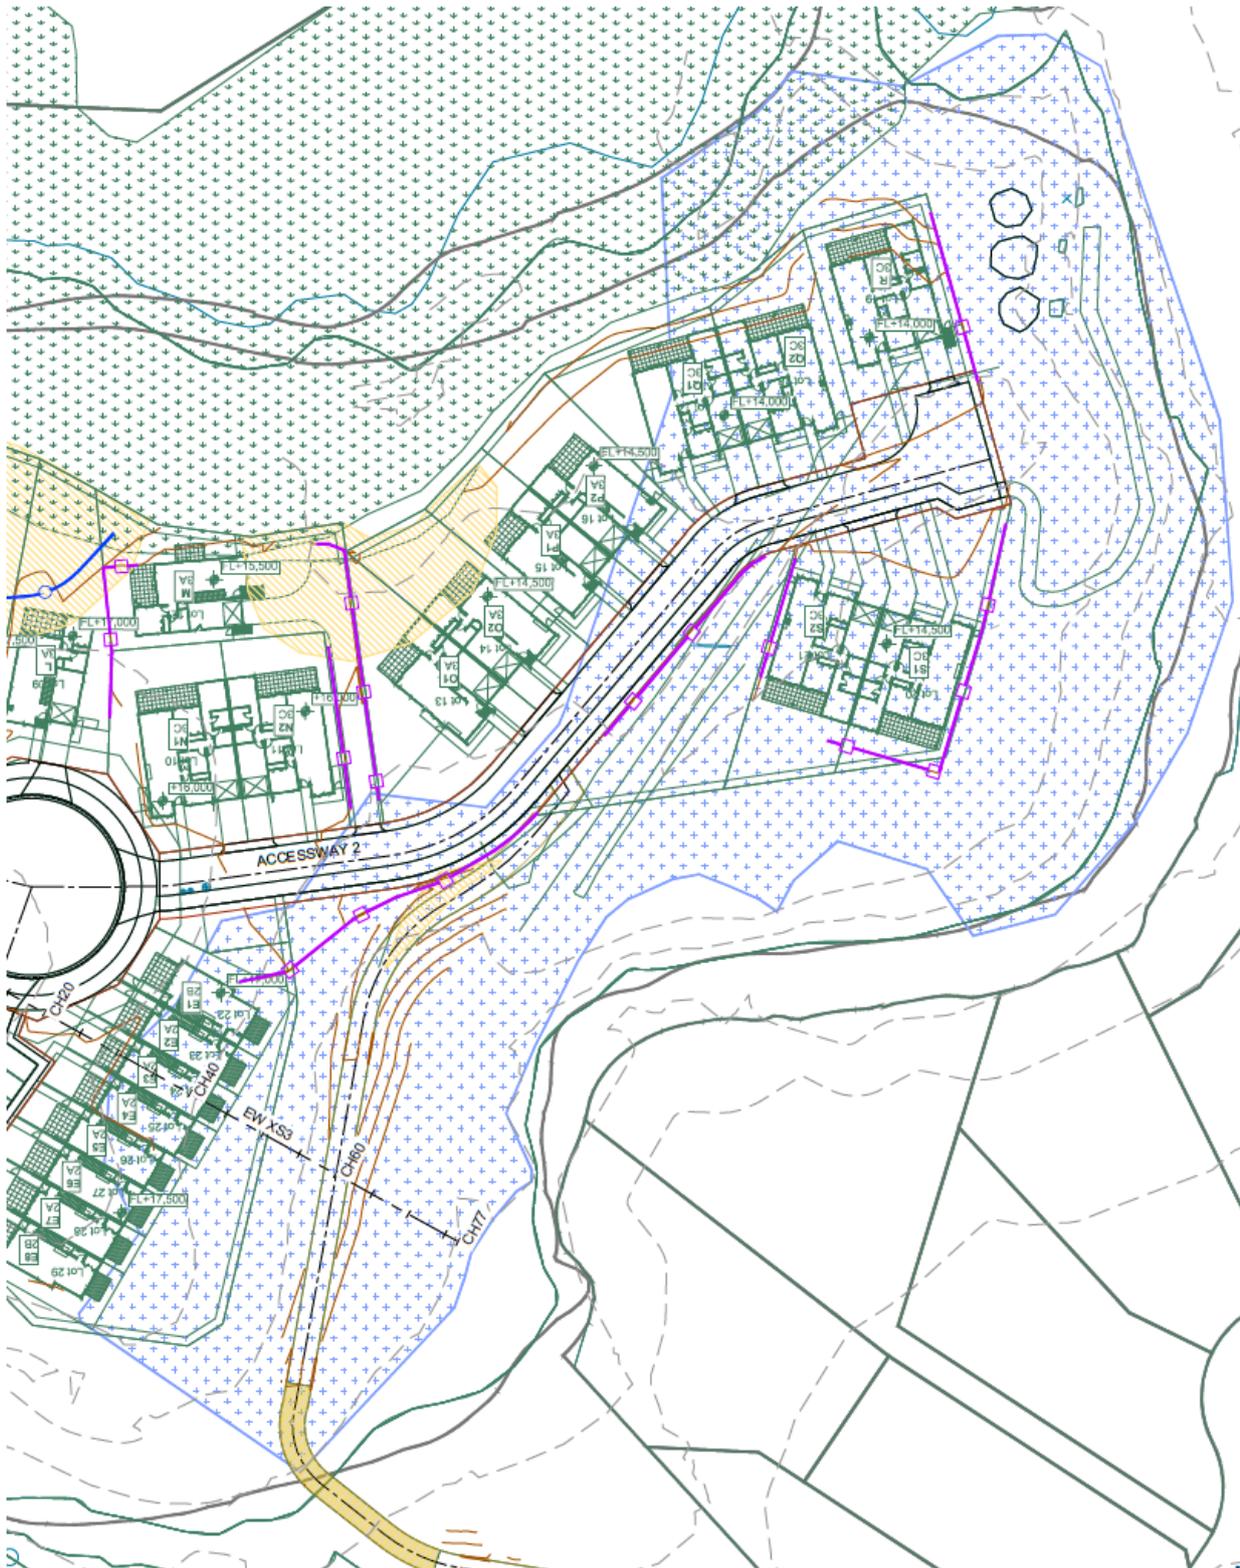
Figure 65. Part plan showing the proposed bridge and footpath access to the subject property (yellow) and retaining walls (purple) (Airey Consultants Drawing 85070-01-200-Rev A; March 2022)
