DETAILED SITE INVESTIGATION (DSI)

34-36 SANDSPIT ROAD, WARKWORTH

REFERENCE NUMBER: REP-1568A/DSI/FEB22

PREPARED FOR: THE KILNS LTD C/- THE PLANNING COLLECTIVE LTD

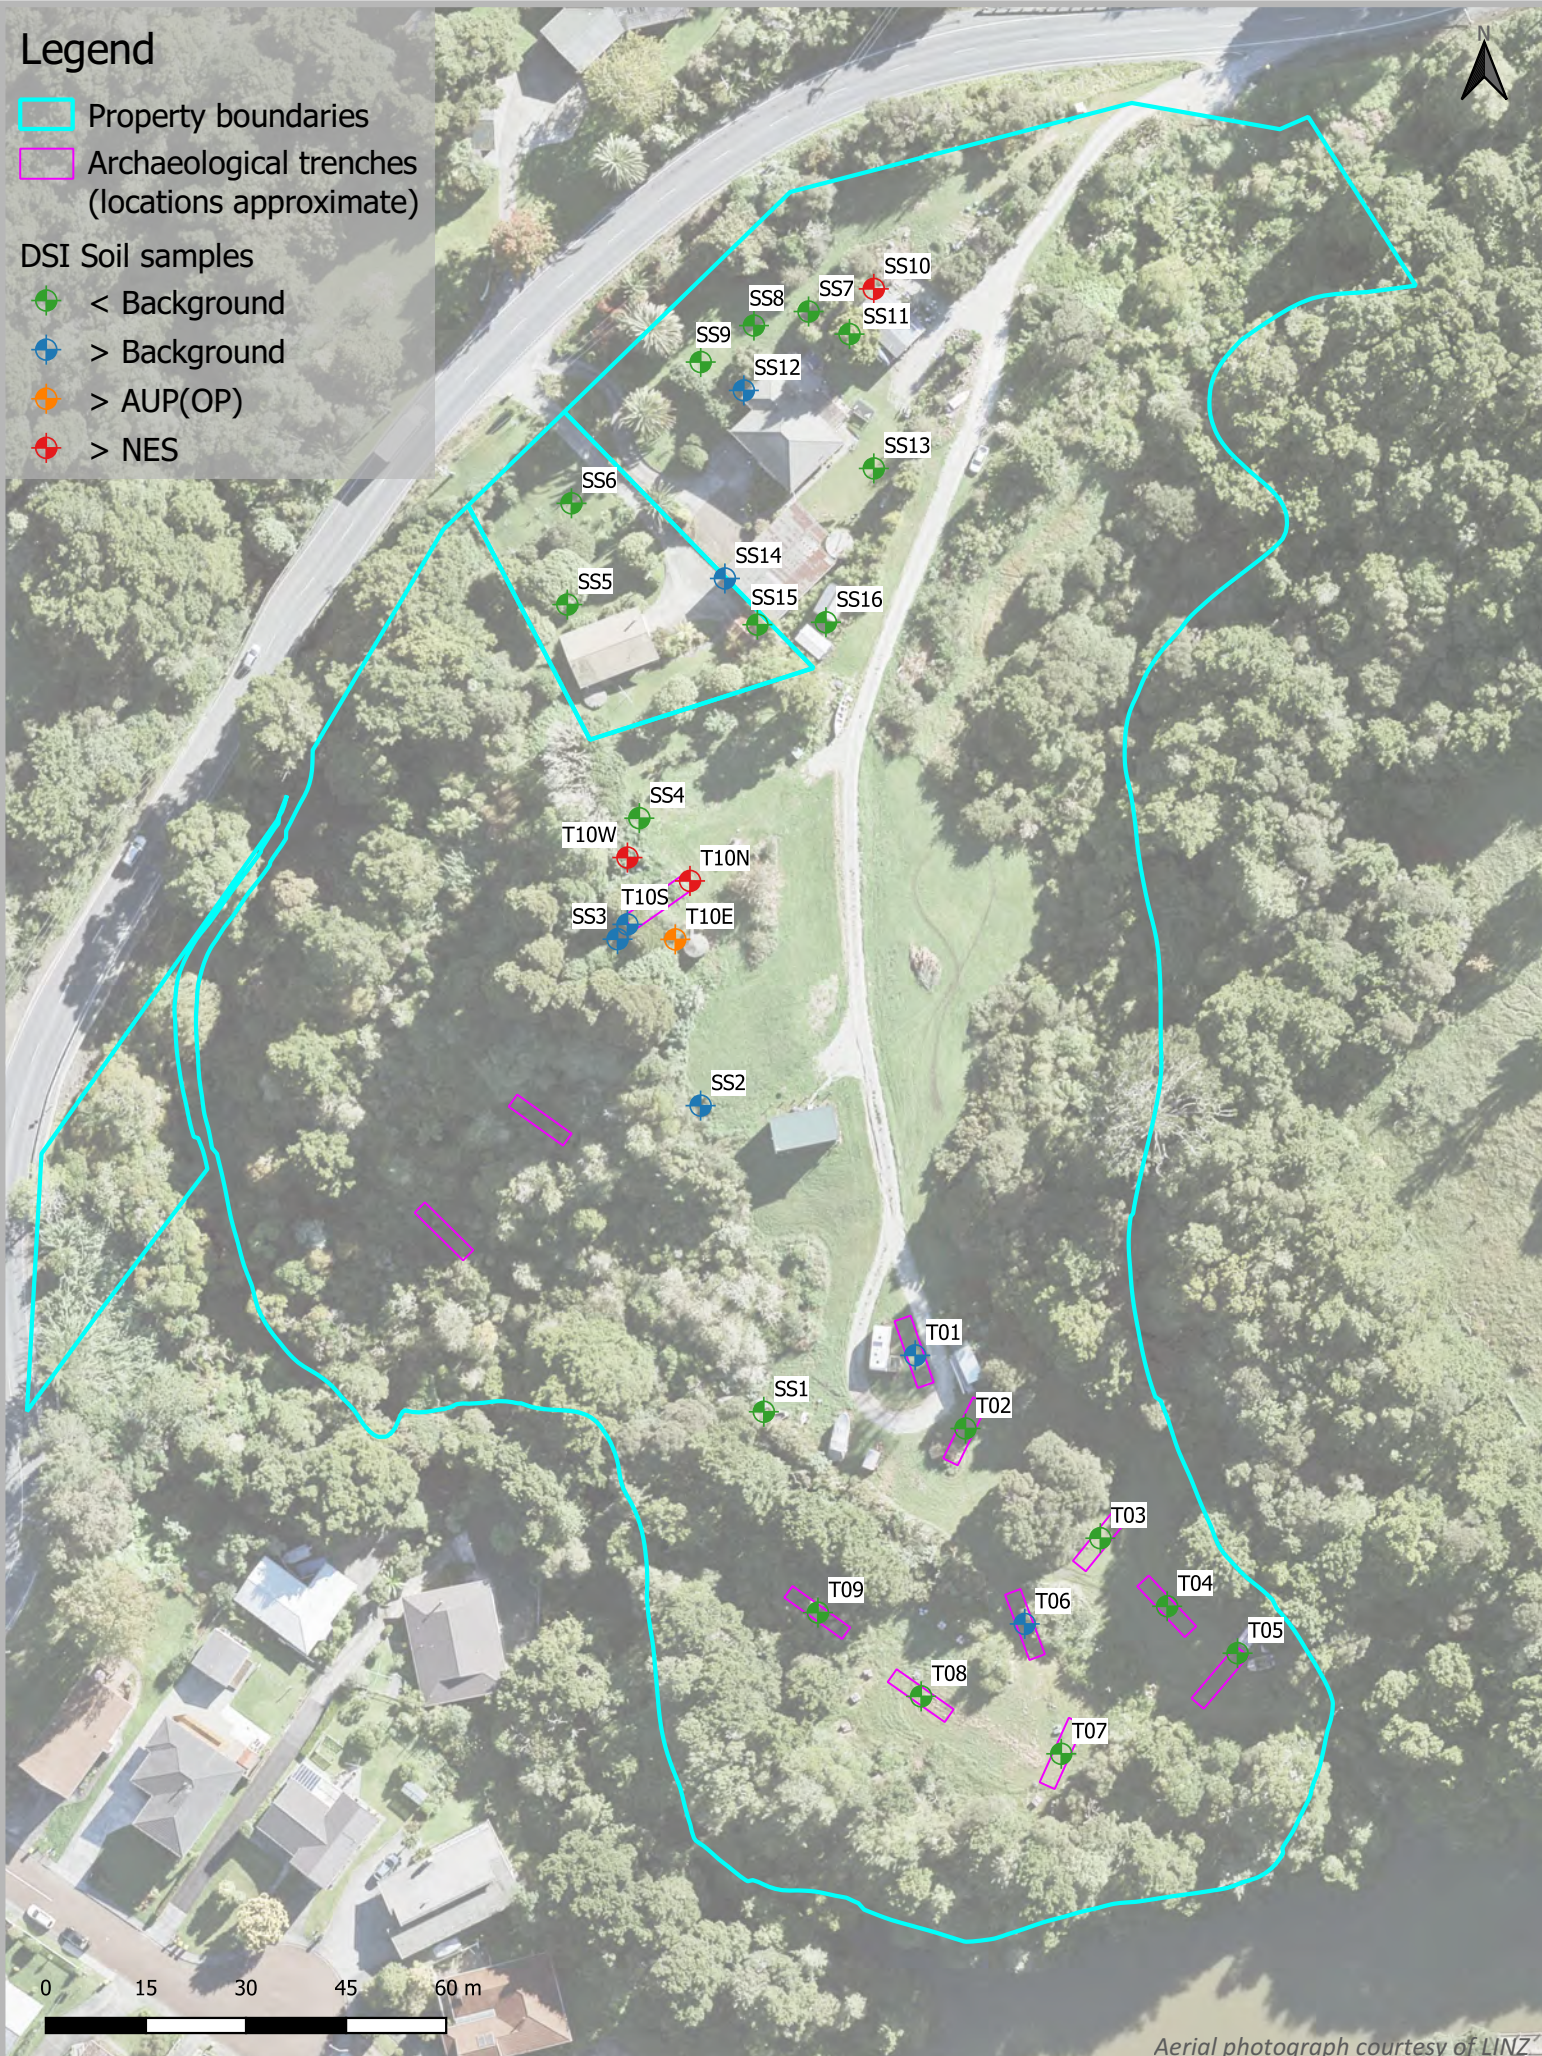
Figure 4 - Soil Sample Locations
34 & 36 Sandspit Road, Warkworth, Auckland

- Property boundaries
 - Archaeological trenches (locations approximate)
- DSI Soil samples
- + < Background
 - + > Background
 - + > AUP(OP)
 - + > NES

An additional six soil samples returned concentrations of contaminants of concern above the expected naturally occurring background concentration ranges for non-volcanic soils in the Auckland Region, including lead around the dwelling (*SS12*) and storeroom (*SS14*) on 36 Sandspit Road, lead near the south-western face of the historic dwelling on the knoll (*SS3* and *T10S*), arsenic at the discharge point of the septic tank at the minor dwelling (*SS2*), and arsenic at the large burn area at the end of the farm track (*T01*).

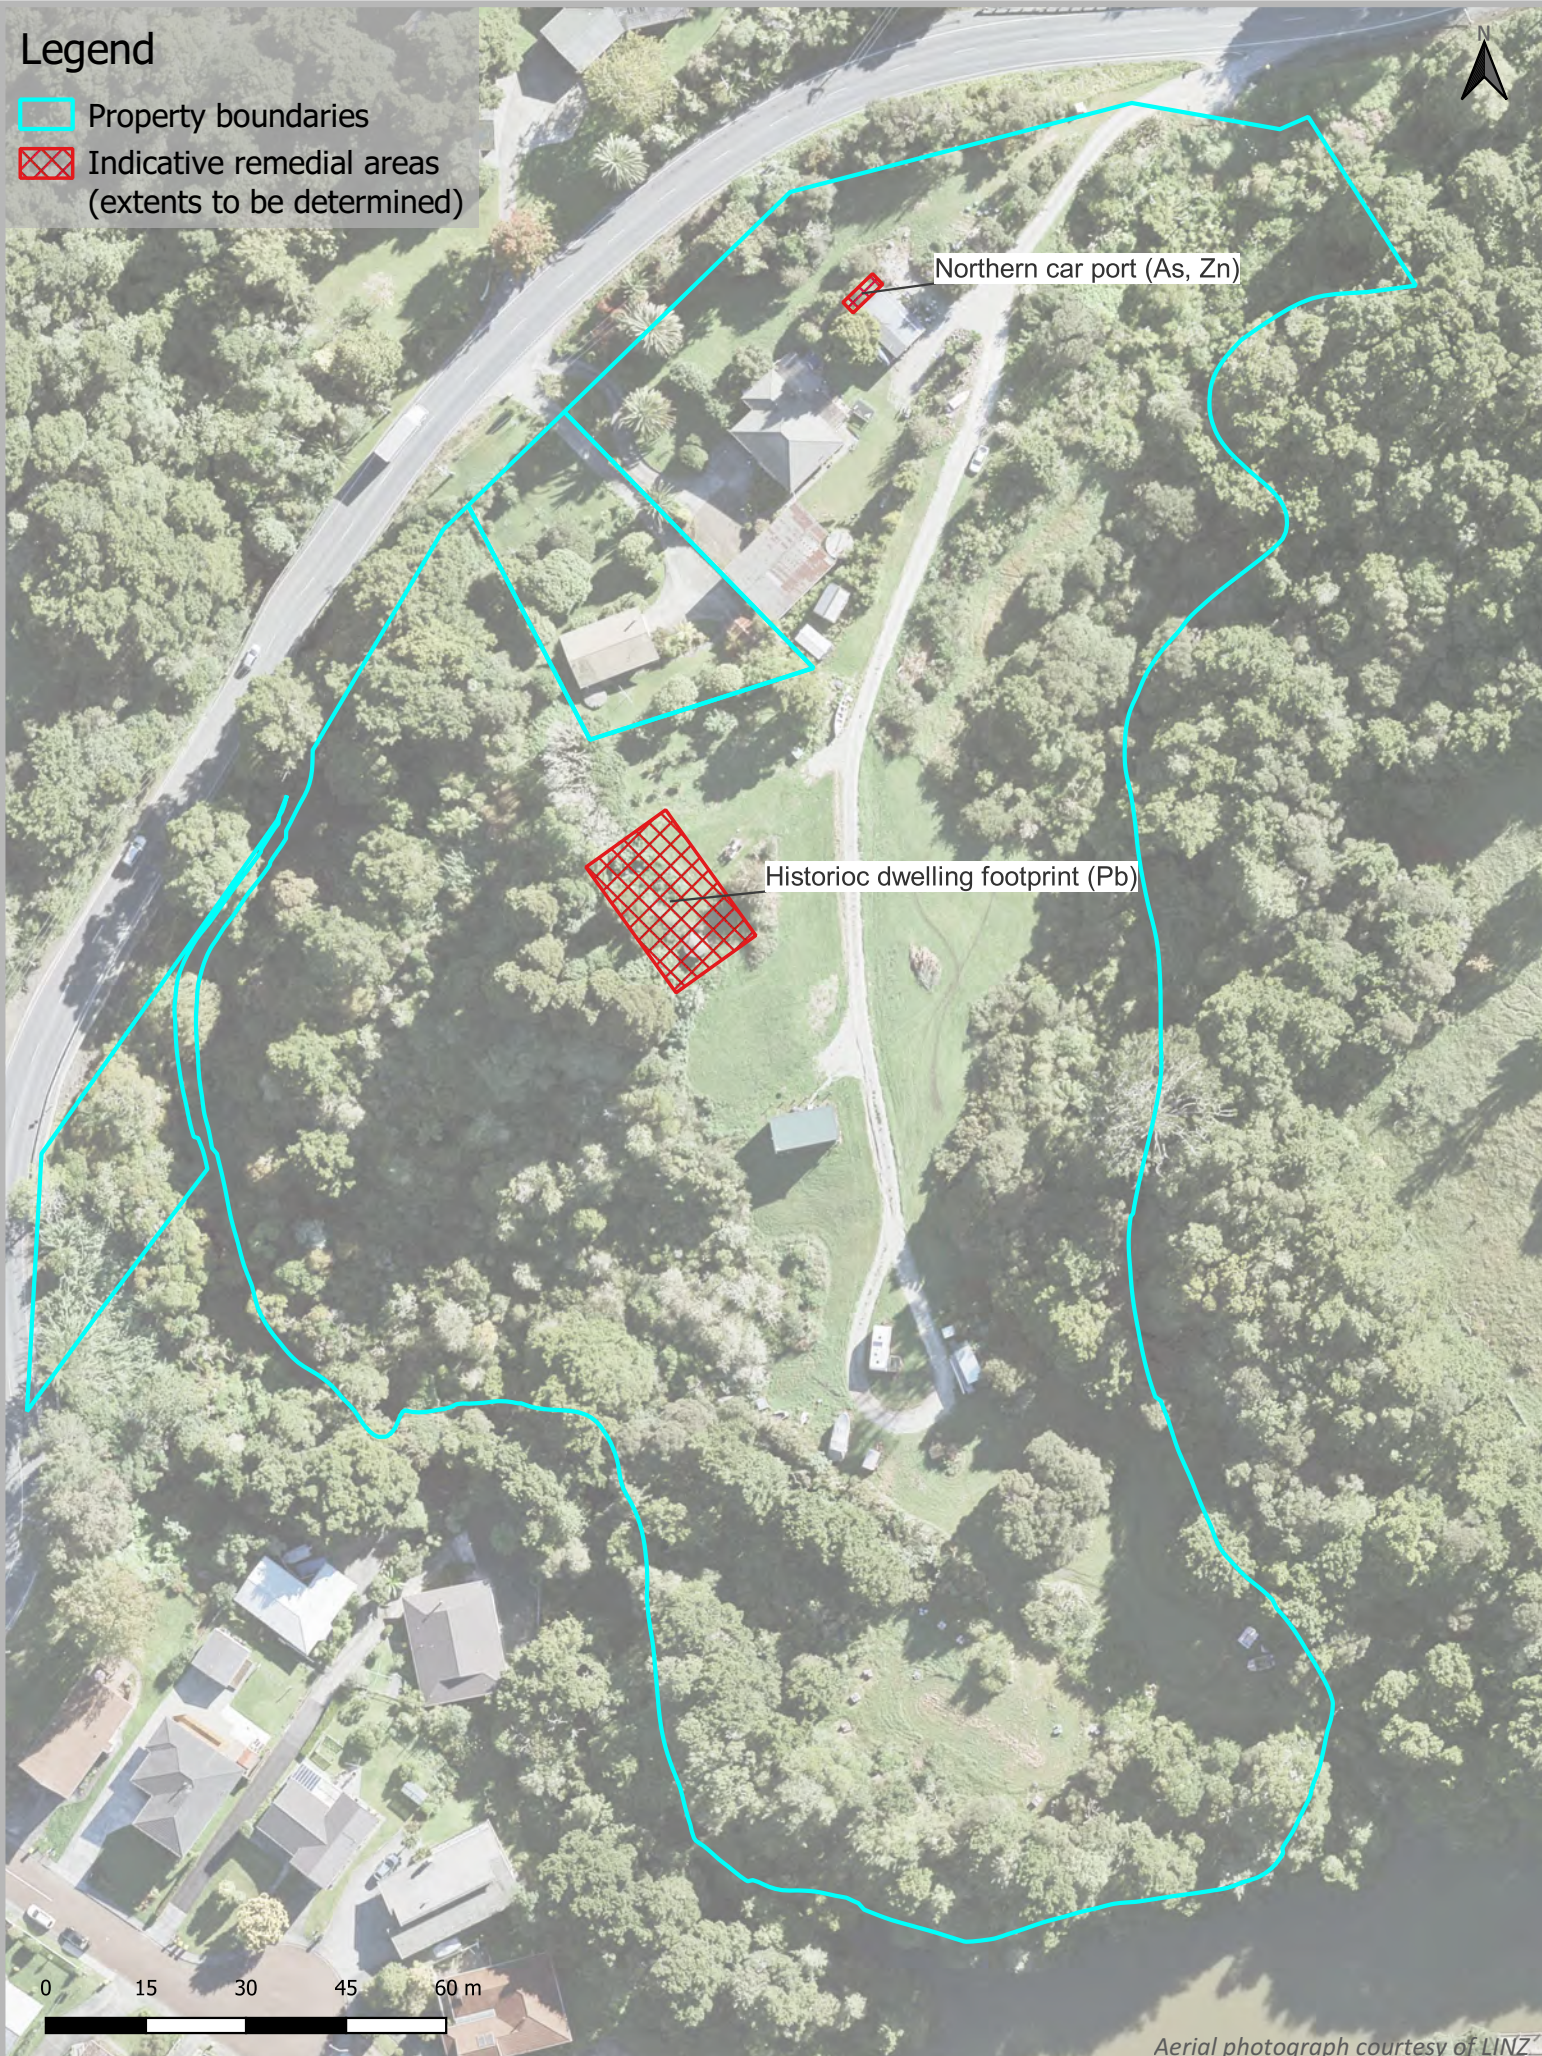
Indicative remedial areas (extents to be determined)

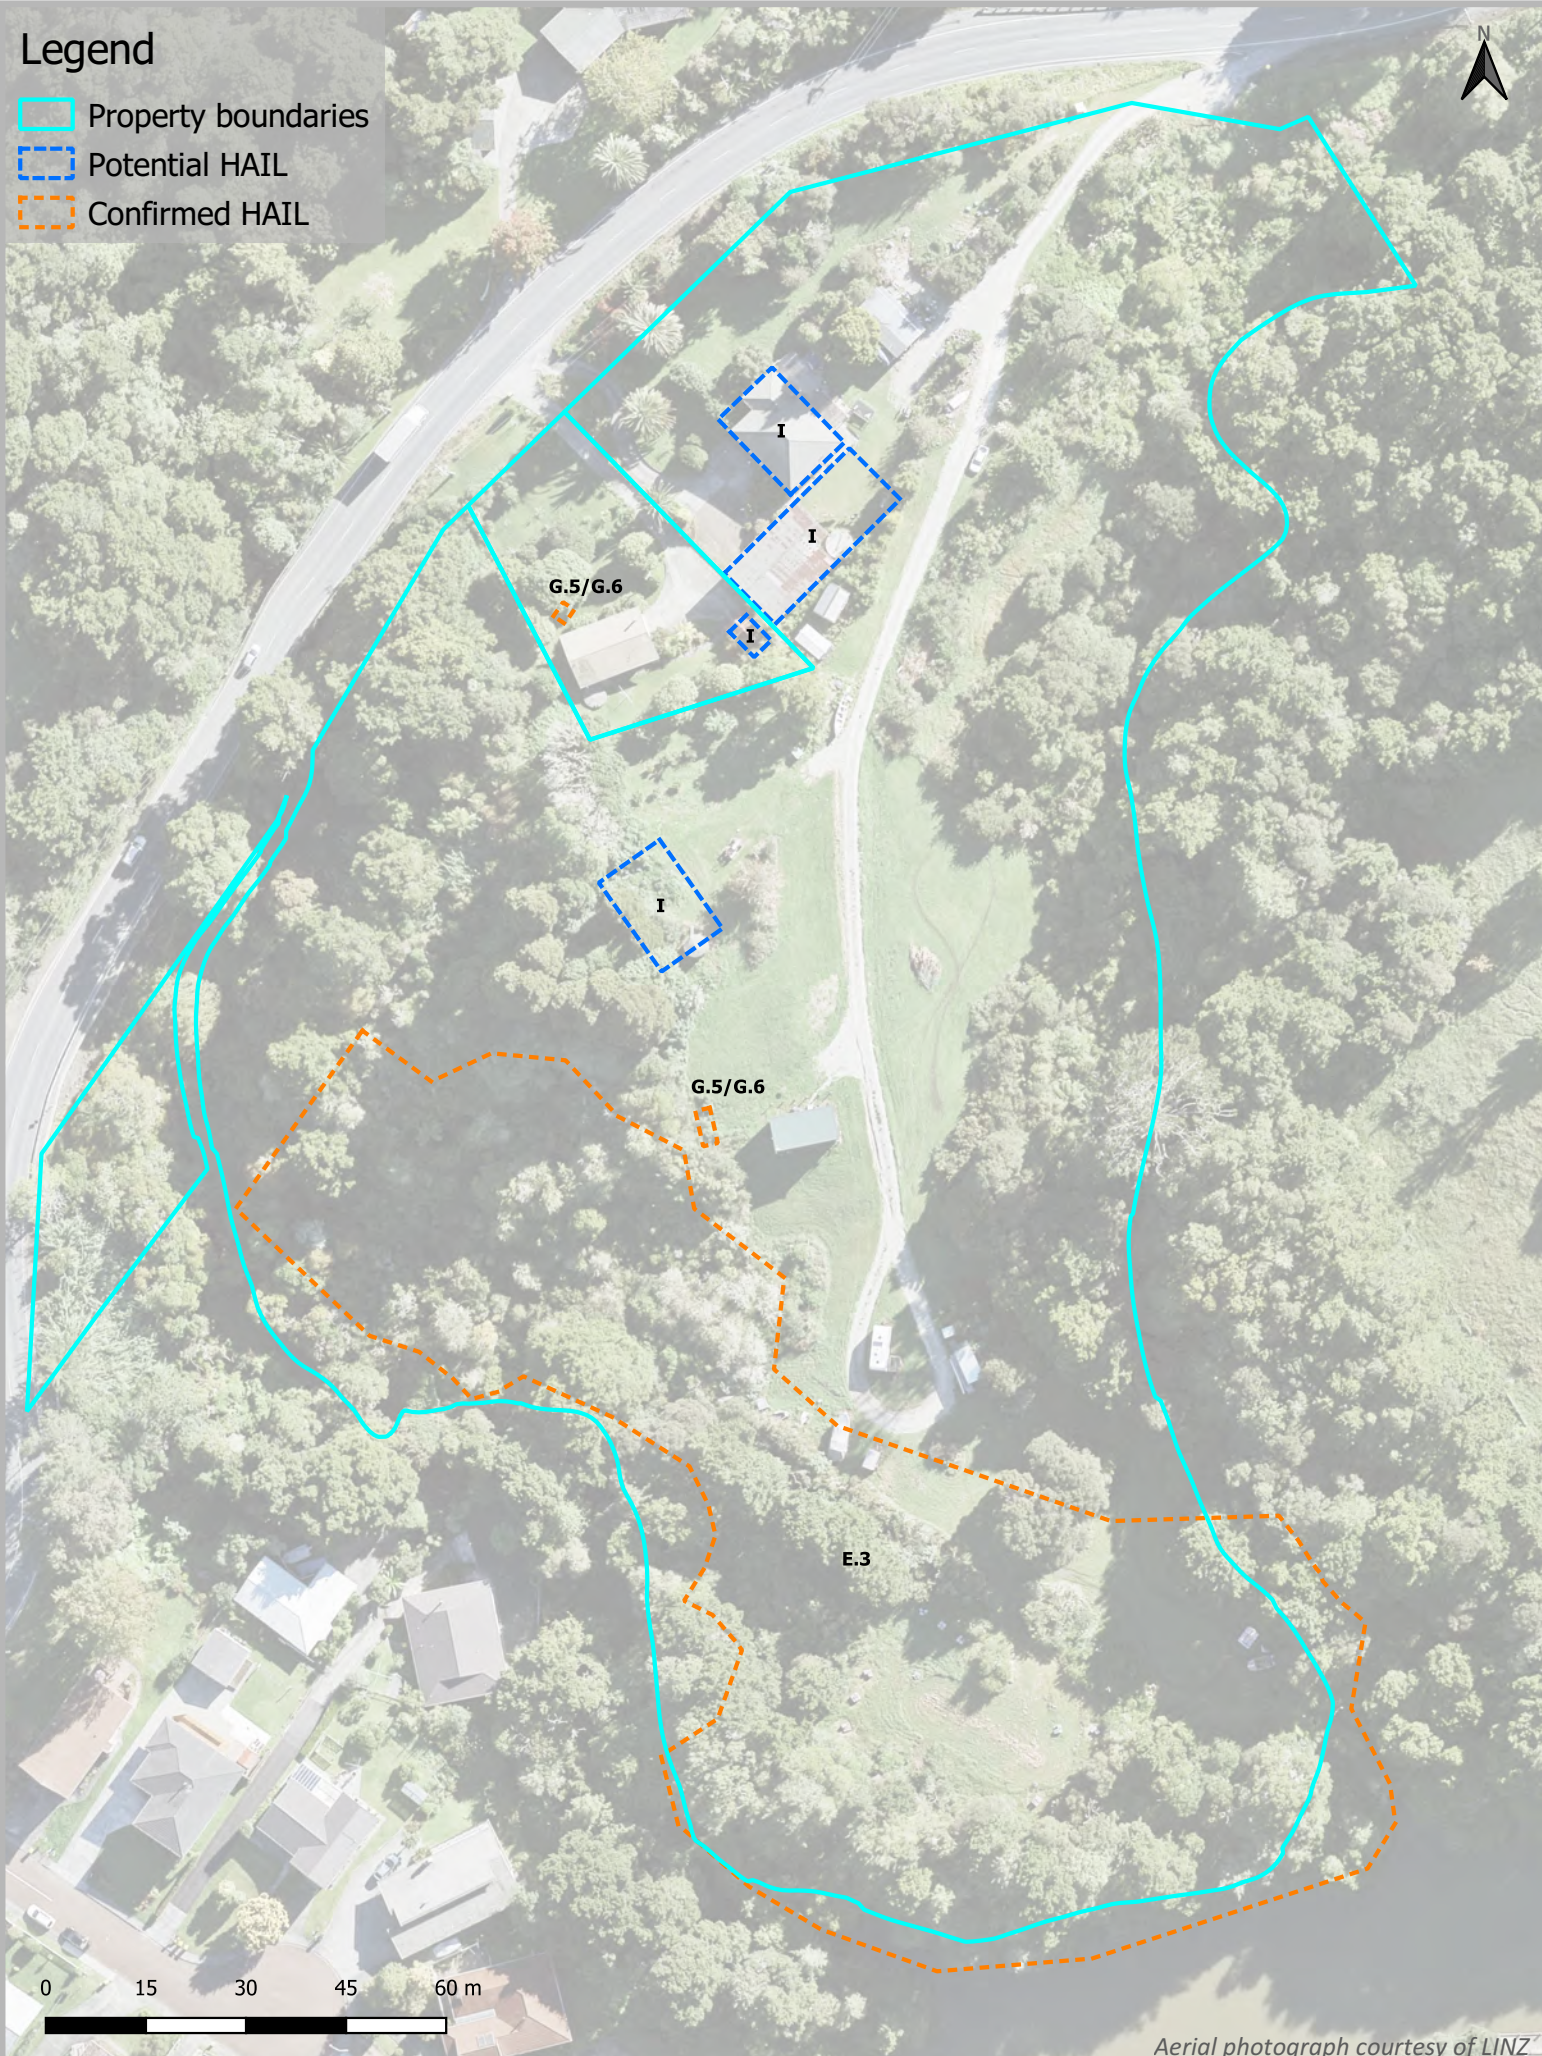
- Property boundaries
- Potential HAIL
- Confirmed HAIL

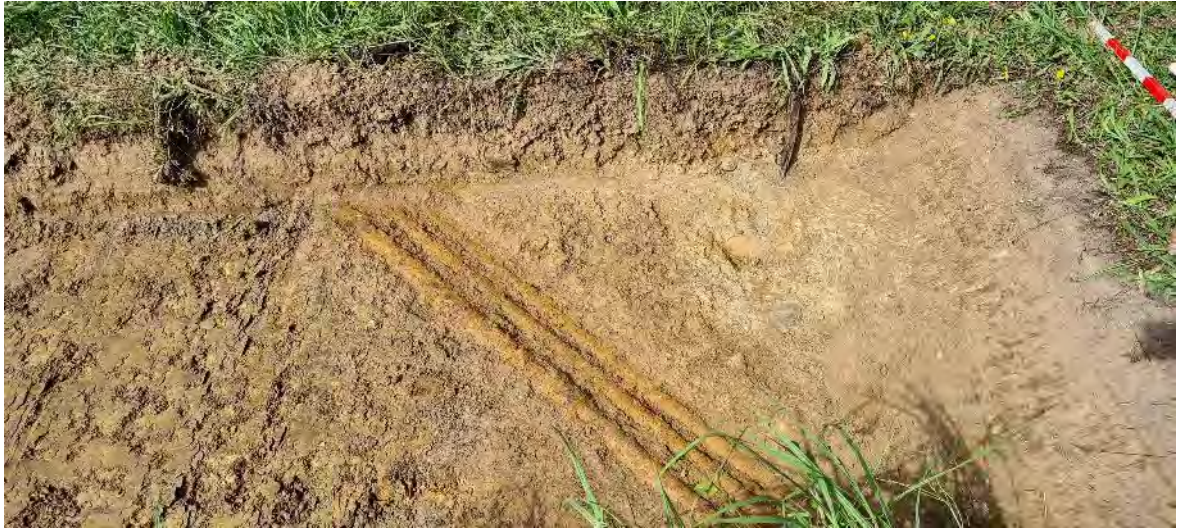
- *T01* and *T08* contained historic buried iron pipes, likely for water transfer, backfilled with natural soil;
- *T06* contained archaeological demolition waste from the historic tram line linking the historic lime quarry in the west to the kilns in the south-east. Material observed included fragments of limestone, iron, and mussel shell; and
- *T10* contained evidence of the former dwelling located at the crest of the knoll, including fragments of glass, brick, and ceramics in a very thin (50 mm) layer of topsoil, and historic timber piles embedded in natural subgrade soil (silt with trace clay) within the dwelling footprint.

PLATE 1: Historic iron water pipes in T08

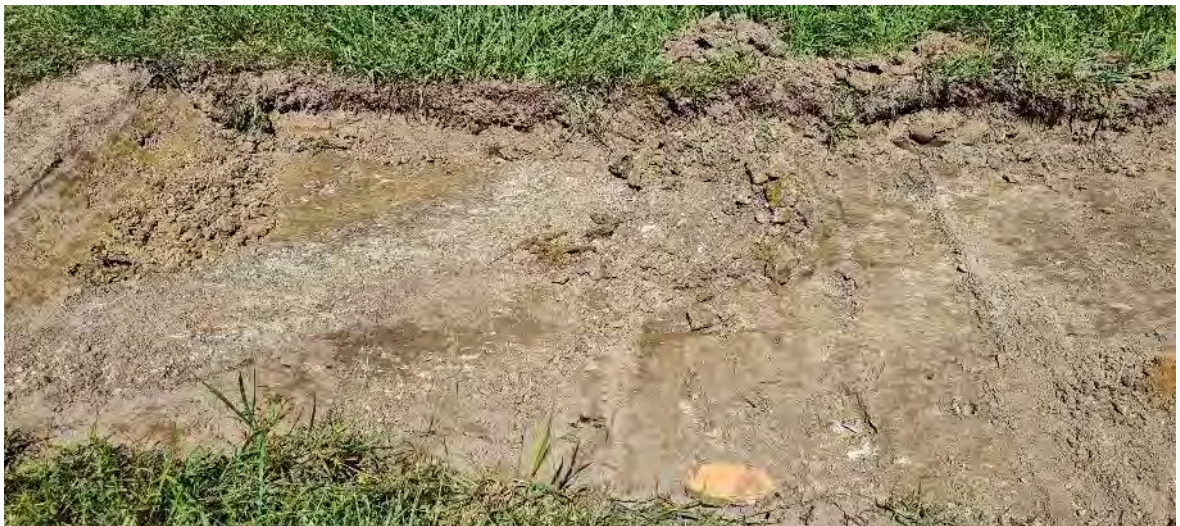
Both carcinogenic (BaP equivalence) and non-carcinogenic (pyrene) polycyclic aromatic hydrocarbons (PAHs) were detected at only one location, in the archaeological trench (*T06*) where remnants of the historic tram line were identified. It is noted that the detected concentrations are virtually indistinguishable from the laboratory limit of reporting and do not pose a risk to either human or environmental health as they are within the applicable NES and AUP(OP) criteria; however, they're detection is regarded as being above the expected naturally occurring background concentrations for non-volcanic soils in the Auckland Region as they are anthropogenic in origin.

PLATE 2: Historic tram line demolition waste in T06

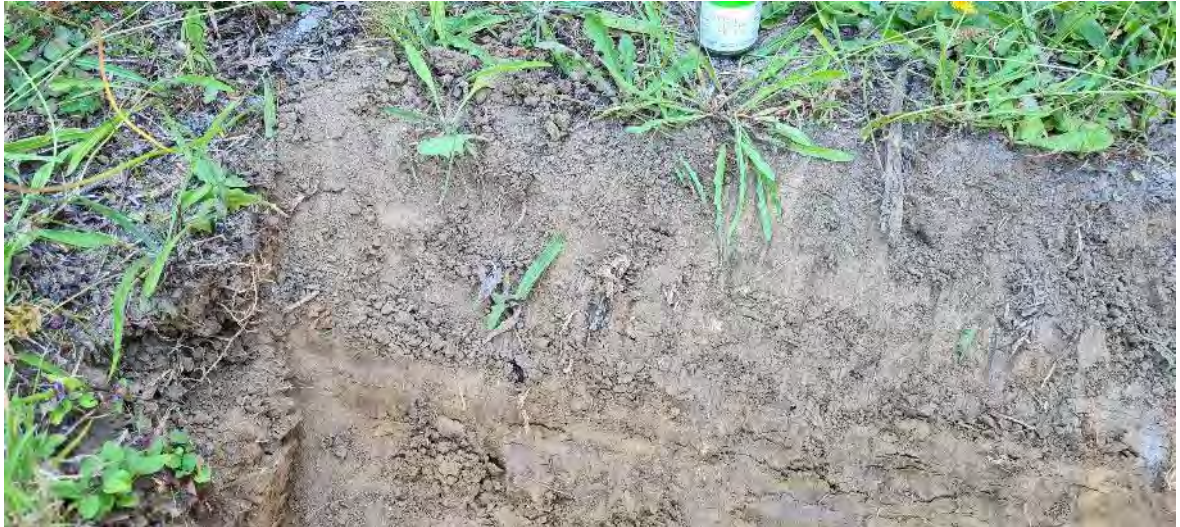
Localised surface disturbance as a result of relatively recent burning of organic waste (green waste, treated / construction timber, and suspected timber furniture) was also noted at *T01* and to a lesser extent at the eastern end of *T05*. While the burn footprint at *T05* was small (approximately 2 m²) and appeared disused, the burn footprint at *T01* encompassed approximately 60 m² and appeared more actively used, with a large pile of unburnt green waste present at the time of the inspection. Both locations contained a layer of ash on the surface of the topsoil but did not display any mixing with the underlying natural subgrade soils. No visual evidence of potentially hazardous materials, such as asbestos containing material (ACM) was noted at either location. Given the size and content of the burn footprint at *T05*, it is likely that it was used for occasional recreational fires and not for wholesale burning of waste materials.

Inspection of the two identified burn areas, located at archaeological test pits *TP01* and *TP05* indicates that the burning activities are restricted to very distinct locations, with no evidence of ash or partially burnt material mixing further than 50 mm into the underlying topsoil. While rainfall may have resulted in percolation / leaching of the more mobile contaminants from ash into the topsoil horizon, migration is likely to be minimal as the burning activities appear relatively recent and once within the soil matrix, persistent contaminants such as heavy metals tend to adhere strongly to soil particles. Concentrations of potential contaminants are therefore expected to be highest within the top 100 mm soil horizon within the visible extent of each burn area.

PLATE 3: Topsoil horizon with no mixing of surface burnt organic matter in T05

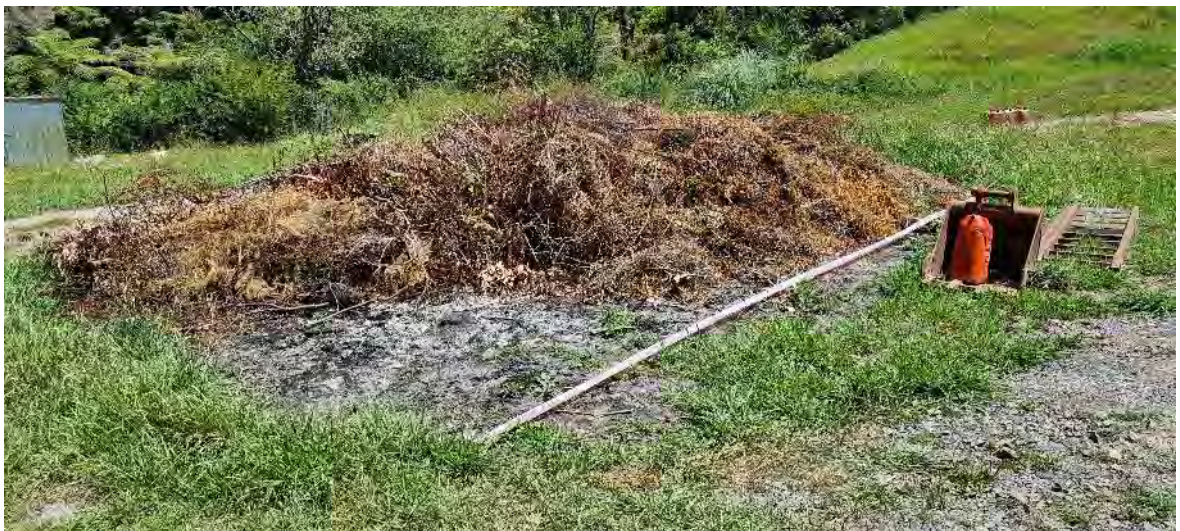
The burning of organic waste such as green waste and timber (treated and / or untreated construction timber etc.) can result in the accidental release of potential contaminants to a degree that poses a risk to human or environmental health. Combustion of construction timber can release heavy metals, such as arsenic, chromium, and copper used in CCA treatment or lead from timber painted with lead-based paints, while incomplete combustion of organic materials, including green waste, can release polycyclic aromatic hydrocarbons (PAHs). Accidental or unintentional inclusion of asbestos containing materials (ACM) when burning construction timber can also result in the accidental release of asbestos fibres. The primary contaminants of concern associated with the two burn areas are therefore heavy metals, PAHs, and asbestos fibres in soil.

PLATE 4: Green waste and timber for burning at T01 (demarcated by tape)

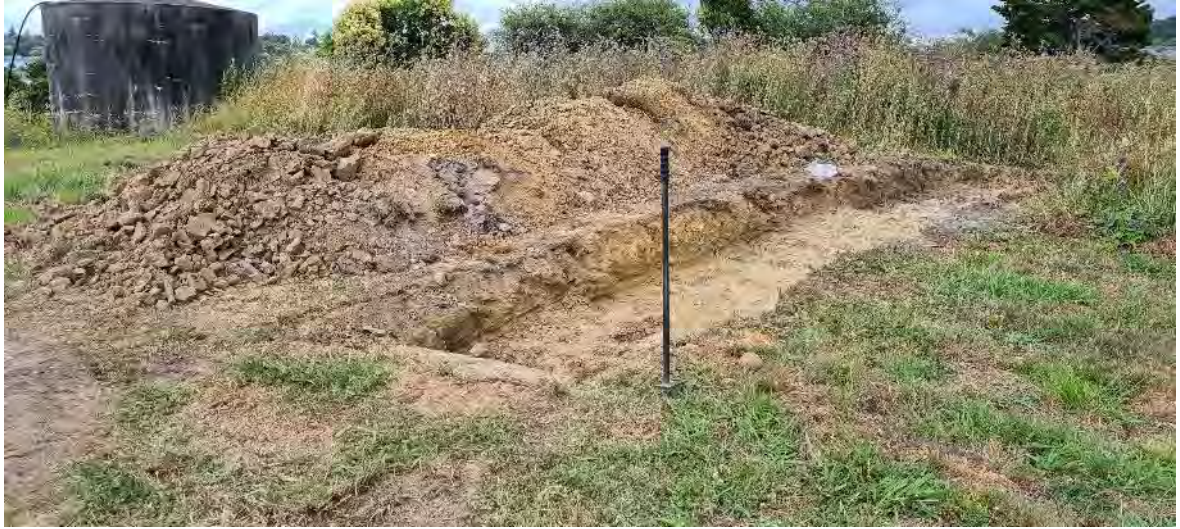
PLATE 5: T10 in footprint of historic dwelling at crest of knoll

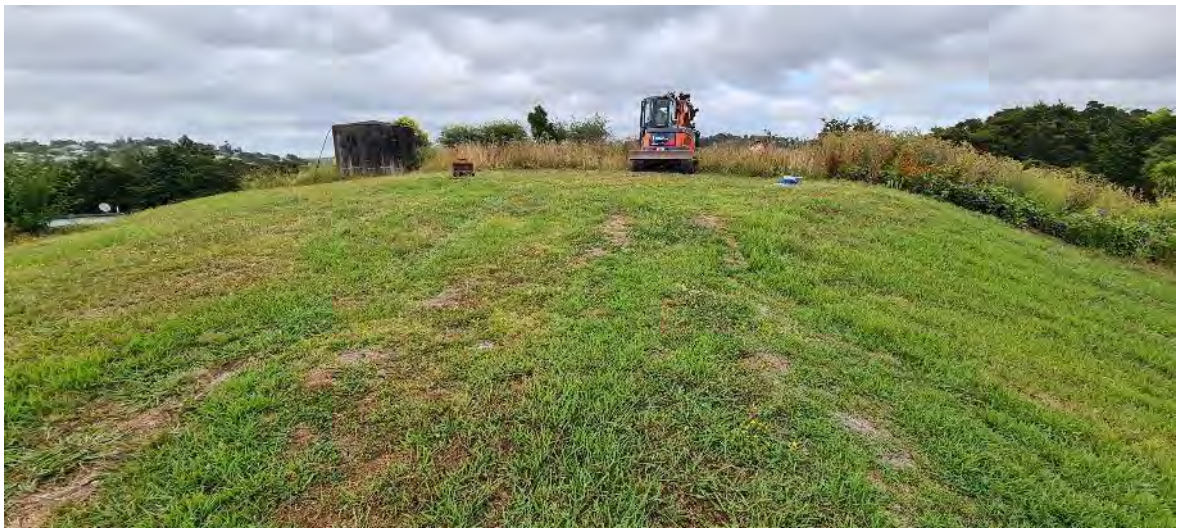
PLATE 6: Excavator at T10 on knoll containing historic dwelling footprint

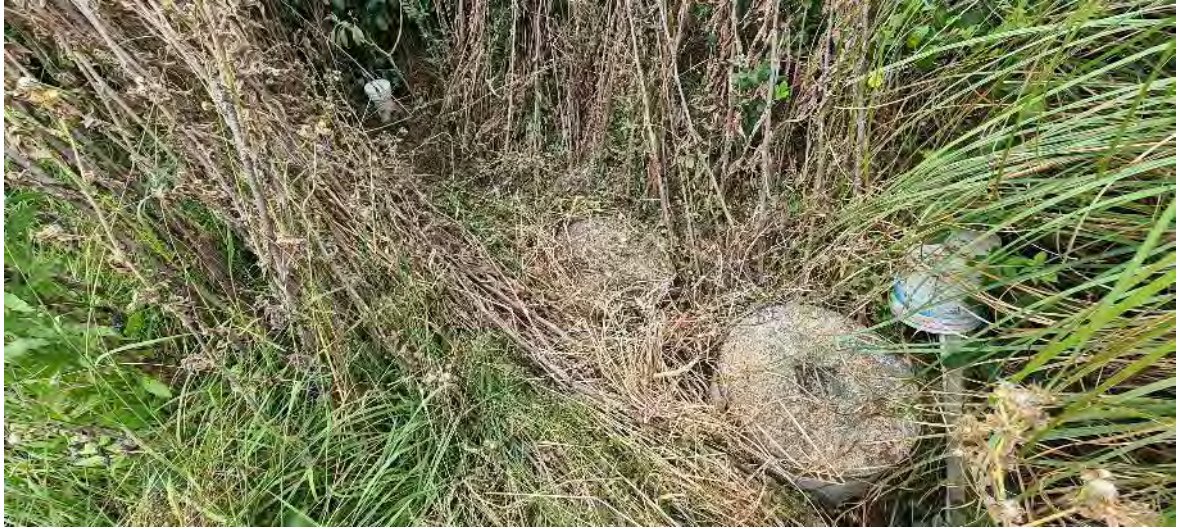
PLATE 7: Septic tanks west of minor dwelling (SS2)

GSL recommend a stand-down period of three months, during which the septic system should not be used, prior to its decommissioning and removal from site to ensure that the biological constituents in the residual effluent have been neutralised. The primary contaminants of concern associated with the disturbance of the septic system and effluent discharge field are therefore persistent heavy metals likely to be present when the system is disturbed. Due to the low mobility of heavy metals in soil, concentrations are expected to be highest in the topsoil horizon surrounding the dropper lines and attenuate rapidly with depth and lateral distance, with any potential lateral migration expected to move down-gradient.

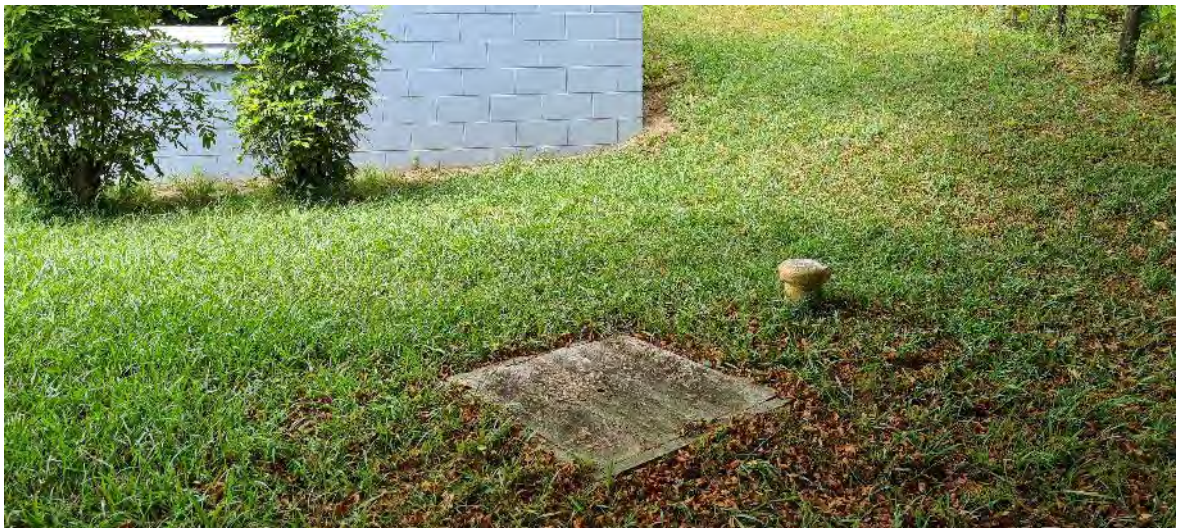
PLATE 8: Septic tank at 34 Sandspit Road

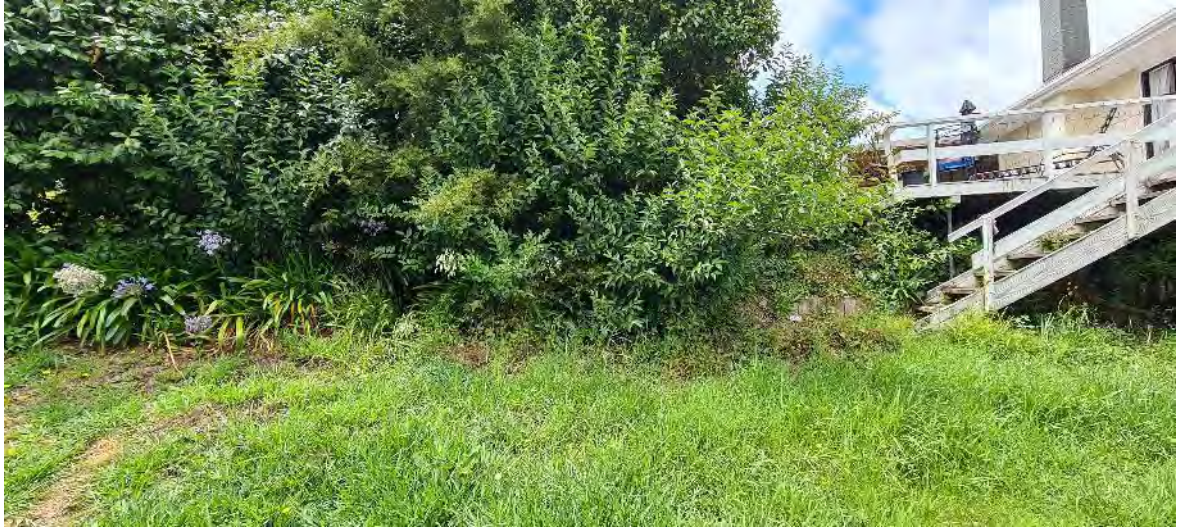
PLATE 9: Septic tank at 36 Sandspit Road within thick vegetation

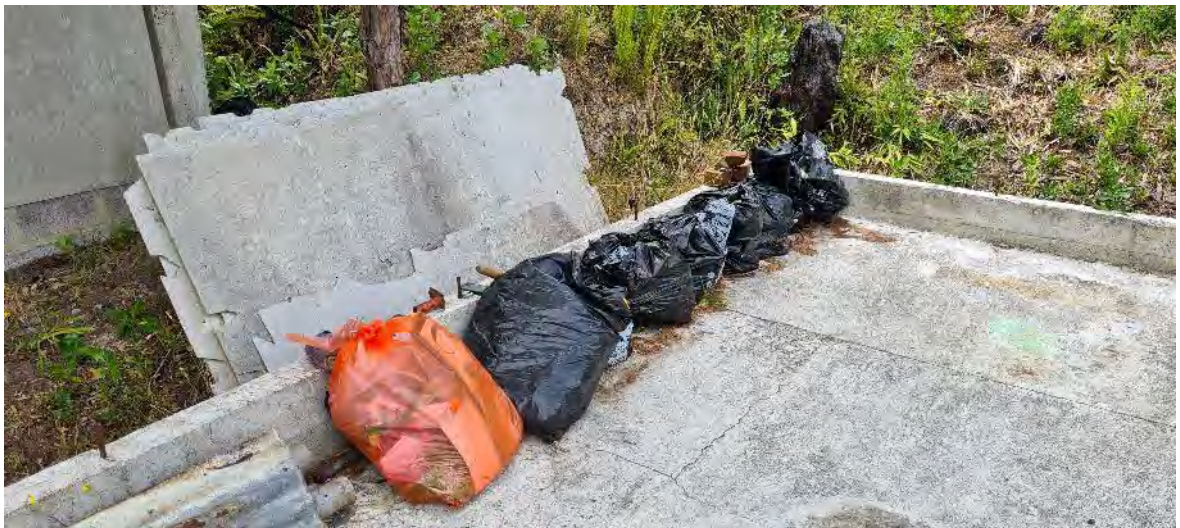
Suspected ACM on the main dwelling on 36 Sandspit Road were also in good condition and well painted; however, suspected ACM cladding on the associated storeroom was generally unpainted and displayed damage and deterioration at the southern end of the building. Additionally, several large sheets of suspected ACM appeared to have been removed from the building and replaced with a modern compressed cement product, with the suspected ACM sheets stacked on the soil surface adjacent to a concrete slab in the north-eastern corner of 34 Sandspit Road. The concrete slab, previously the location of a single garage for 34 Sandspit Road, also contained several large, heavy duty refuse bags containing broken fragments of suspected ACM sheets.

The majority of the identified suspected ACM was on both the large storeroom and the residential dwelling on 36 Sandspit Road, as well as the residential dwelling on 34 Sandspit Road. Overall, the material was in good condition with only minor damage noted in a few locations; however, several large panels had been removed from the southern end of the storeroom on 36 Sandspit Road. These panels, and several large plastic bags fragments assumed to be from the panels' removal from the storeroom, were still present on site, with the panels stacked upright on a soil surface while the bags of fragments were stored on a concrete slab.

PLATE 10: Suspected ACM panels and bags containing suspected ACM fragments at southern end of storeroom

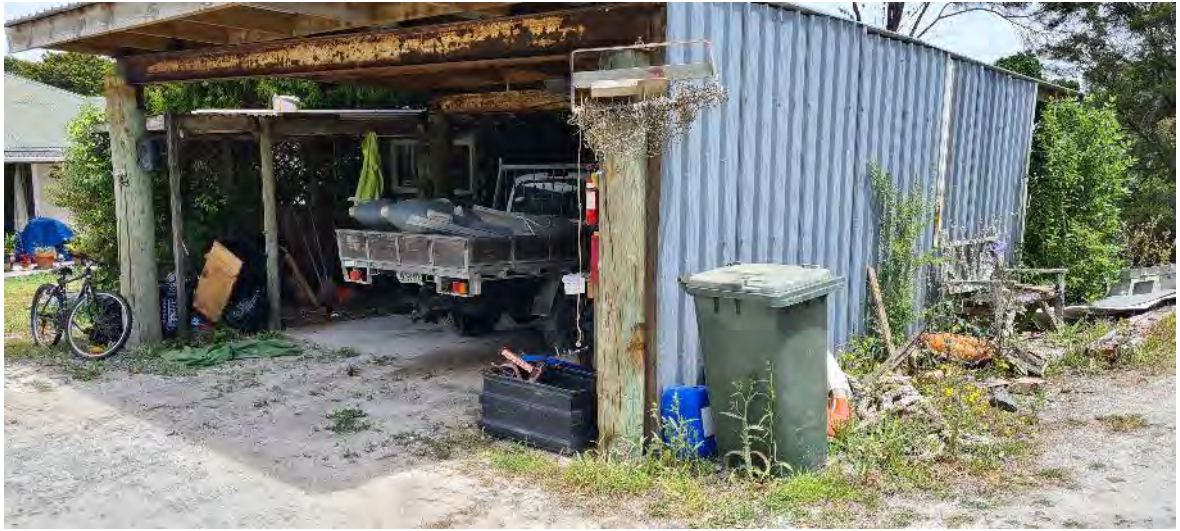
While the area was initially identified as a potential source of contamination due to small-scale domestic vehicle maintenance (e.g. of the ride-on lawnmower), the concentrations of arsenic, copper, and chromium suggest that the source of the arsenic contamination may be the timber poles forming the structure of the car port, if the poles had been treated with chromated copper arsenate (CCA) and not been allowed to dry completely following treatment. As the poles displayed a green staining, typical of CCA treatment, it is considered likely.

An elevated concentration of zinc present in the same sample containing elevated arsenic is most likely attributed to degradation of a rusting piece of galvanised steel forming the north-western wall of the car port. As with arsenic, the elevated concentrations are expected to attenuate rapidly

PLATE 11: Northern car port (facing west)

Given the concentrations of lead and zinc identified at the historic dwelling footprint and northern car port respectively, soil from those areas will require disposal at a licensed Class A landfill facility able to accept material of that nature. Additional delineation soil sampling is recommended to determine the full extents of the lead contamination around the historic dwelling footprint and arsenic and zinc contamination around the northern car port, and therefore minimise the volume of soil requiring disposal at a landfill facility. It is noted that while the zinc concentration is within the expected natural background range for volcanic soils in the Auckland Region, it is likely anthropogenic in origin and therefore should not be accepted at managed fill facilities consented to accept volcanically derived soils containing elevated zinc concentrations.

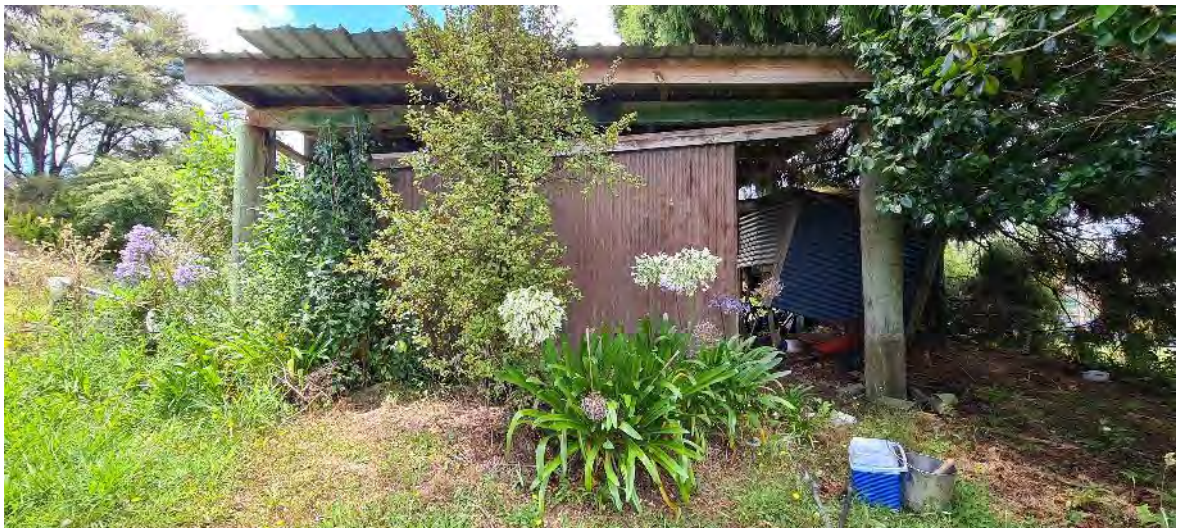
concrete slab suggests that surface runoff, from either heavy rainfall events or intentional hosing down of the concrete slab, discharges from the concrete slab at that point; however, no visual or olfactory evidence of hydrocarbon egress from the concrete slab onto the surrounding soils was noted.

PLATE 12: Northern car port from down gradient (facing east)

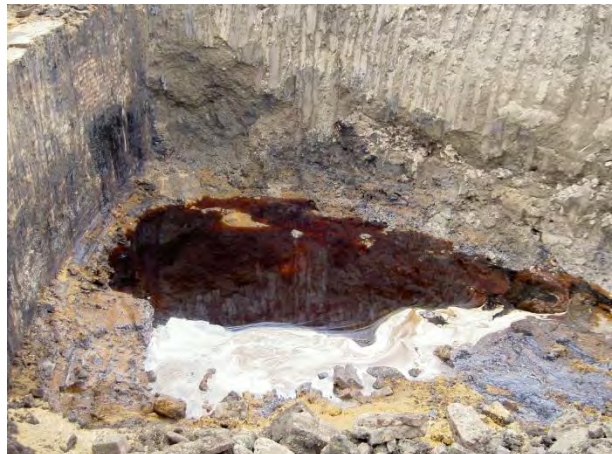
5.1. PETROLEUM HYDROCARBONS

- Petroleum service station
- Vehicle workshop
- Gasworks sites

Pooled hydrocarbon spills can be removed using suitable absorbent materials or collected by a suitably rated vacuum tanker. Spills can also be transferred to a sealed container by an appropriately rated vacuum pump or similar. Hydrocarbon contaminated soil can be placed in a sealed leak proof skip bin or truck for disposal at a facility authorised to receive material of that kind.

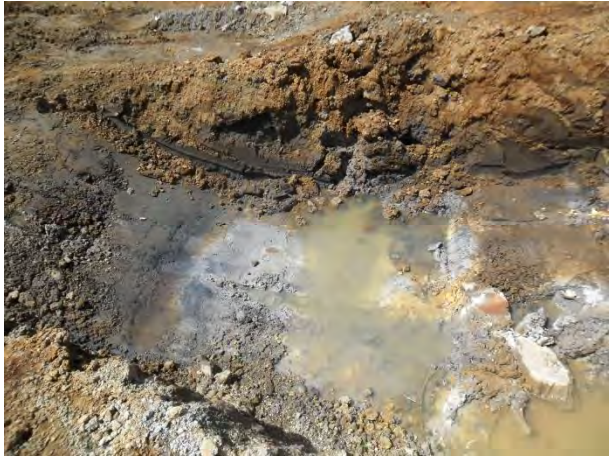
5.2. HEAVY METALS

- Metal workshop
- Metallisation works
- Electroplating industries
- Timber treatment facilities

Heavy metal-contaminated soil can be placed in a truck and covered with tarpaulin for disposal at a facility authorised to receive material of that kind.

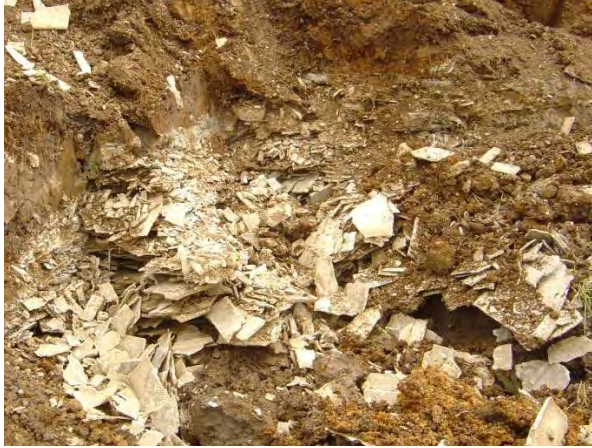
5.5. ASBESTOS

- Improper disposal of asbestos-containing building materials

KEEP DAMP to suppress fibre generation. Large fragments may be collected by hand and place in double skinned plastic bags. Asbestos-contaminated soil can be placed in a sealed skip bin for disposal at a facility authorised to receive material of that kind. Soil of this kind can also be transported via sealed doubled bags or a sealed skip bin.
