## Muriwai Downs Golf Course Project

# Appendix A - Baseline Environmental Monitoring Report

WWLA0321 | Rev. 6

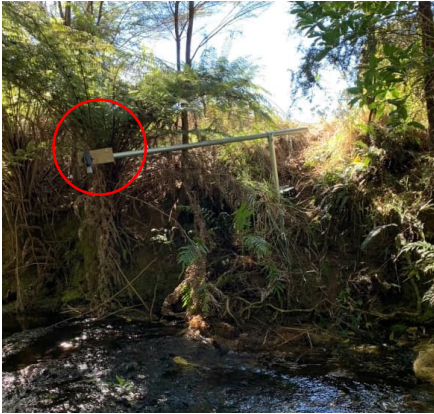
Site Name	Photo	Description
Flow 1

<p>Flow Site 1 was mounted on a steel T-frame. The vertical pole was driven approximately 1.5 metres into the side of the streambank to ensure it remained stable in position. The horizontal bar extended approximately 1.2 metres out towards the centre of the stream.</p> <p>At this location, the streambed is irregular, but generally flat and hard rock. The stream banks are close to vertical, therefore giving a general rectangular cross-sectional profile.</p>
Flow 2

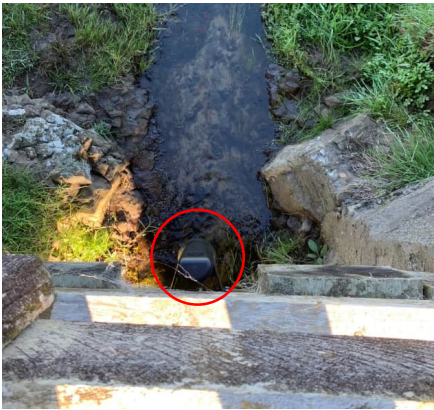
<p>Flow Site 2 was mounted to the downstream side of the small wooden farm bridge near the small, abandoned basalt quarry. The sensor was mounted approximately 2 metres above the streambed.</p> <p>The streambed is irregular and rocky at this location. Under the bridge the stream cross-sectional profile is generally rectangular with an irregular bottom. Downstream of the bridge, the stream cross-sectional profile is trapezoidal.</p>

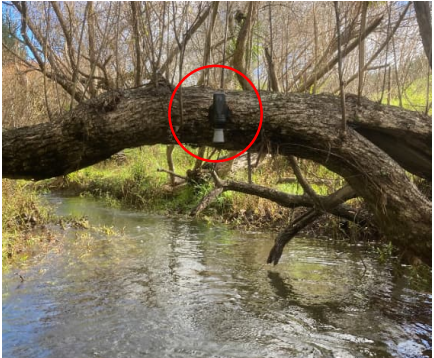
Flow 3

<p>Flow Site 3 was mounted to a large Willow tree branch that has grown across the stream. The sensor was approximately 1.5 metres above the streambed.</p> <p>At this location, the streambed consists of firm compacted granular sediment, and the cross-sectional profile generally trapezoidal. Streambanks were overgrown with grass.</p>

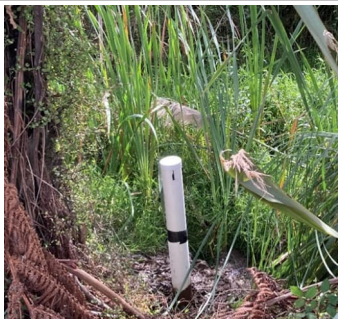
P1 was positioned ~400 m downstream of the sandstone quarry in a fenced off site near an unnamed stream.
P2

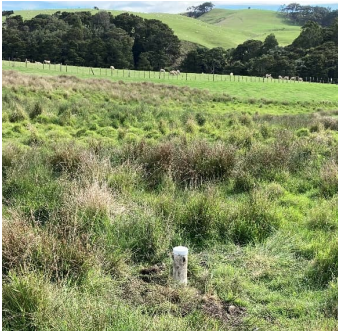
P2 was positioned in the upper reaches of the wetland monitoring site W3, which flows into the Ōkiritoto Stream.

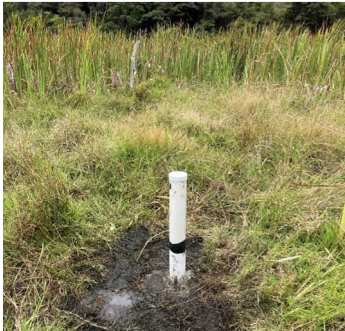
P4 was positioned in the wetland area near stream sampling Site H where water exits the Property.
P5	 	P5 was positioned on the outer edge of the wetland which partly recharges Lake Ōkaihau.

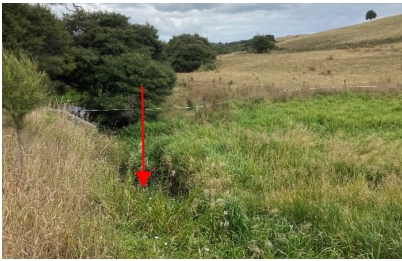
Site A was selected to monitor water quality as it enters the Property through an unnamed stream (pictured), which feeds into the Raurataua Stream. The stream is perennial and contained consistent low flows during each round of sampling. Samples were collected close to the Property boundary under the Manuka trees depicted in the photo (left). The stream is fenced off to livestock along the reach pictured but is not fenced off to livestock in the upstream neighbouring Property.
B

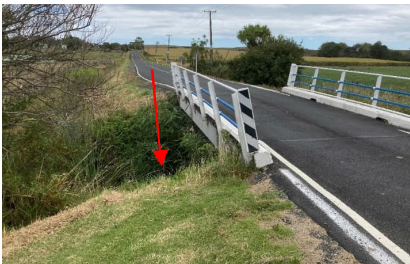
Site B was selected to monitor water quality as it enters the Property through an unnamed stream (pictured), before feeding into the Raurataua Stream. The stream is perennial and is fenced off from livestock. Samples were collected from under the bridge (pictured left) along Muriwai Valley Road.
C

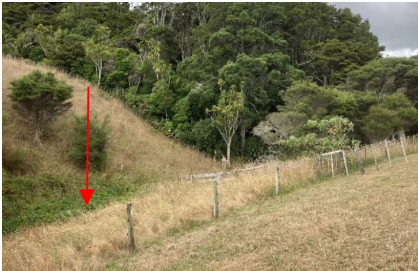
Site D was selected to monitor water quality in the Raurataua Stream, downstream of the septic tank discharges from residents on Hamilton Road. The stream is fenced off from livestock.
E

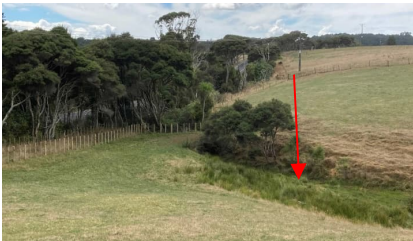
Site E was selected to monitor water quality immediately downstream of the quarry. The unnamed stream is perennial with an observable baseflow.  The first round of sampling found visual indications of hydrocarbons on the outer widths of the stream bed.
F

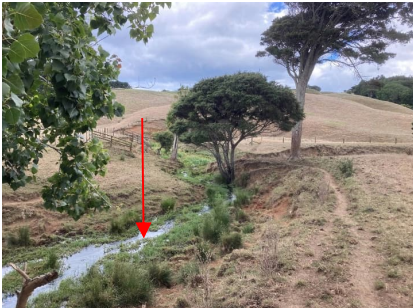
Site F was selected to monitor water quality at the downstream extent of the unnamed tributary before it joins the Ōkiritoto Stream. The stream runs through a heavily grazed paddock, and functions as a source of water for livestock.

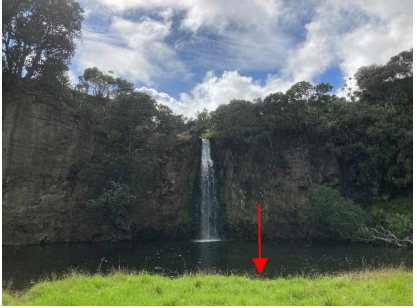
<p>Site G was selected to monitor water quality at Toroanui Falls pool (an important focal point for locals and Iwi).</p> <p>The pool is recharged by the Ōkiritoto Stream.</p>
H

- Sample Site G, the pool below Toroanui Falls, had low TSS levels as the pool acts as a settling pond for sediment.
- The highest TSS concentrations were recorded where loose fine sediments were present close to the water surface. In some cases, fine sediments may have become entrained in the water column due to sampling disturbance (i.e. standing in or near the wetland and placing a sample bottle in the water).

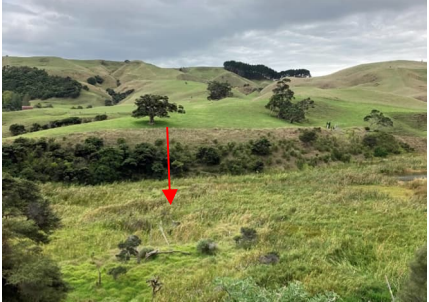
<p>Site H was selected to monitor flow and water quality at the downstream extent of the Ōkiritoto Stream as it leaves the Property. The stream fans out into a wide wetland with no clearly defined channel.</p>
I

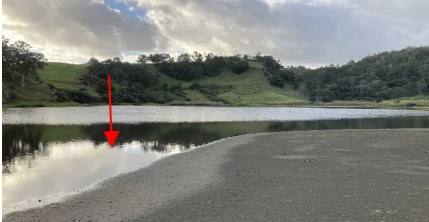
<p>Site I was selected to monitor water quality at Lake Ōkaihou. The lake is fed by stream flow from an unnamed catchment that comprises predominantly mature native bush (see W/8).</p>

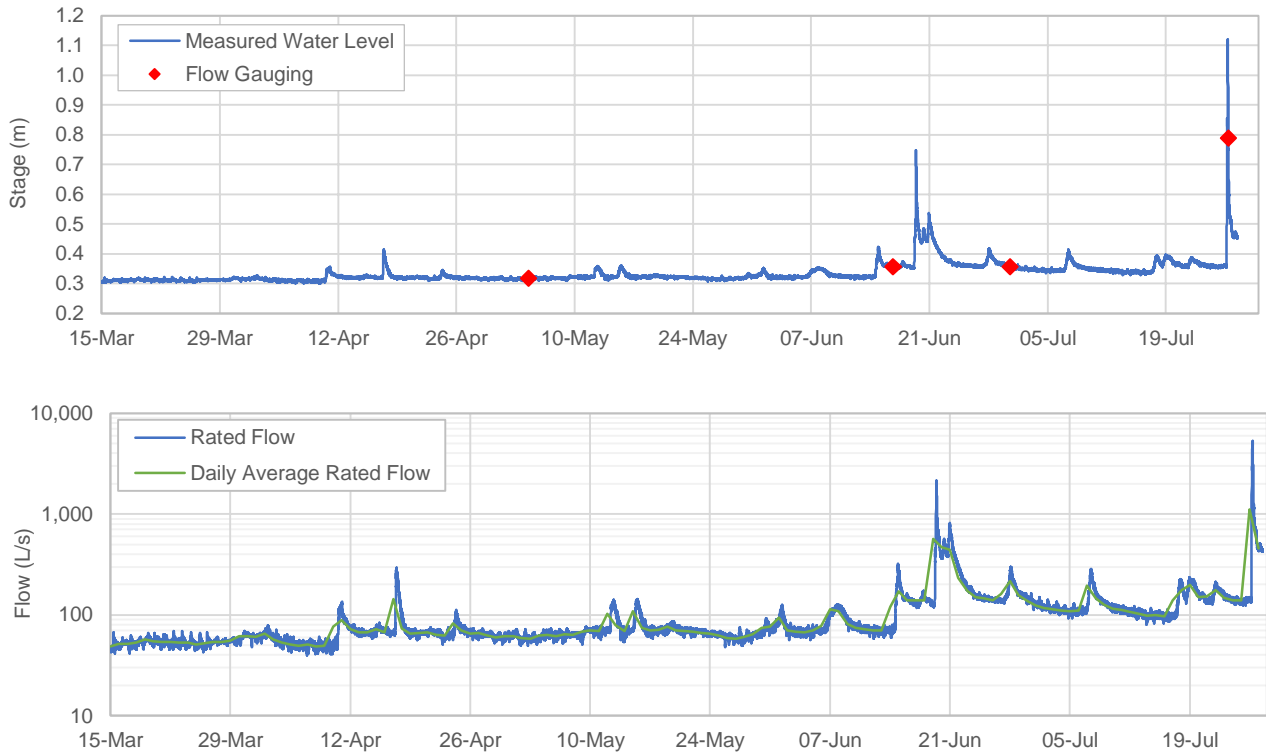
Figure 2. Flow monitoring Site 1 (top – measured stage, bottom – rated flow).

Rated streamflow for the three continuously monitored stream level sites are presented in **Figure 2 to Figure 4**. Monitoring data is unavailable for the first three months for Site 3, due to difficulties and delays in obtaining permission and site access at the initial recommended site, the wooden footbridge approximately 600 m downstream of the eastern Property boundary. Therefore, the location of Site 3 was moved to its present location, attached to a tree approximately 350 m downstream of the Property boundary (**Table 1**).

As expected, streamflow increases with increasing distance downstream along the catchment, as additional tributaries join, and additional groundwater baseflow enters. In general, the three sites were shown to respond quickly to heavy rainfall events, with increased attenuation of the flood peaks generally observed with increasing distance downstream.

A large rainfall event (approximately 40 mm over three hours) occurred on 26 July. This resulted in a rapid rise in water levels at all three monitoring sites. Water levels rose by approximately 1 m and submerged the sensor at Site 3. A manual water level measurement was therefore collected concurrent with the flow gauging at this location.

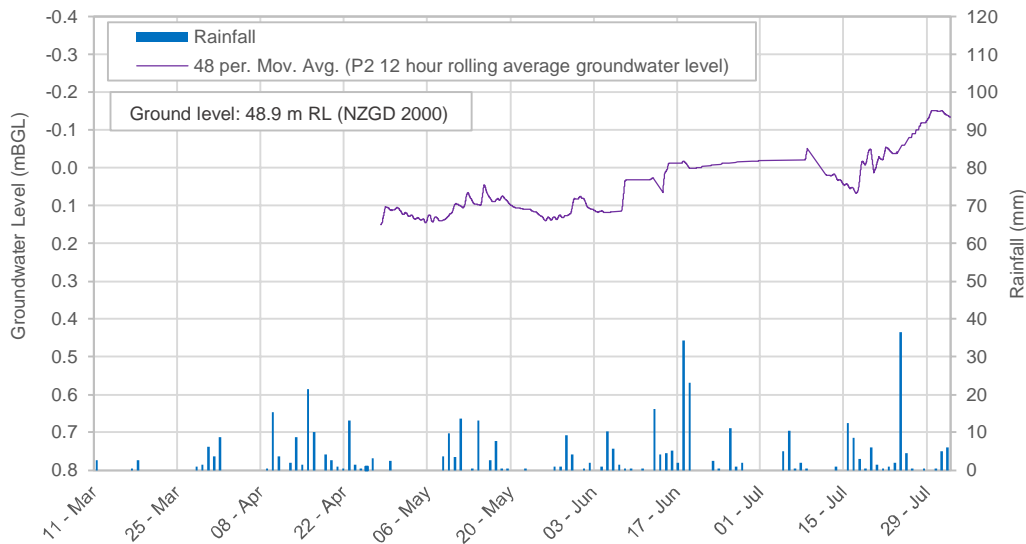
Figure 6. P2 Groundwater level monitoring data and rainfall.

Groundwater levels in Piezometer 2 (P2) are shown in **Figure 6**. The location of P2 was changed in April due to challenges with the telemetry system in the sensor, hence the monitoring in for this site began on 25 April 2021. The new location had improved cellular reception which enabled data to be transmitted to the cloud directly from site.

The data in this wetland location shows a strong relationship between rainfall and groundwater levels. After large rainfall occurred on 19 and 20 June 2021, the shallow groundwater reached the ground surface. The wetland appears to have held the high water levels for over two weeks, before dropping below the ground surface on 12 July 2021 for 5 days until 17 July 2021, when two days of rainfall totalling 21 mm caused the water level in the wetland to rise above the ground level again where it remained until the end of the recording period on 2 August 2021.

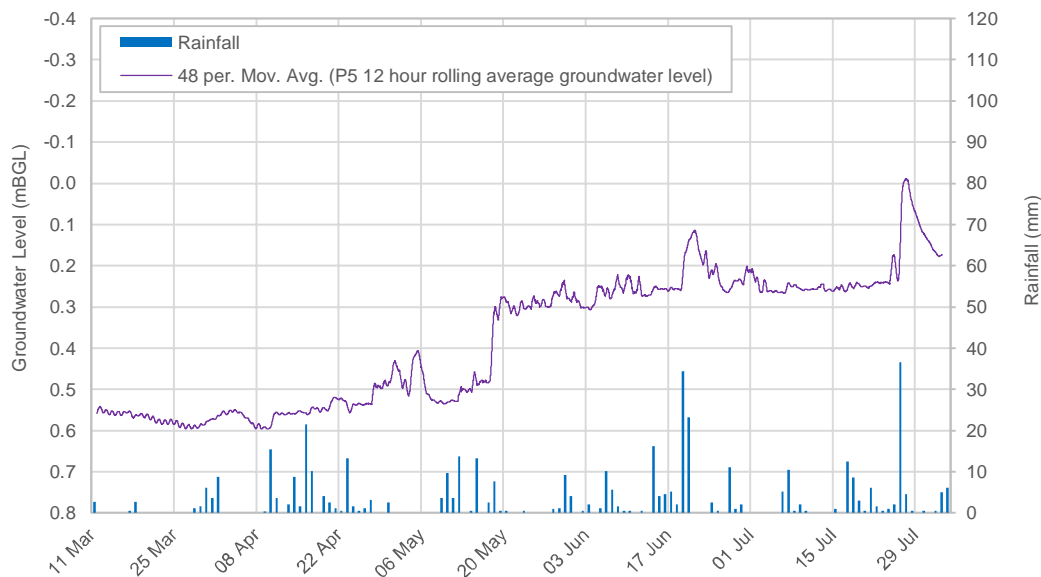
Figure 9. P5 groundwater level monitoring data and rainfall.

Groundwater levels in Piezometer 5 (P5) are shown in **Figure 9**. Groundwater levels at this wetland location show a strong response to rainfall. Similar to P4, the magnitude of the groundwater level fluctuation is generally in proportion to the depth of rainfall, with the exception of the large increase in water levels on 2 and 3 of May, and again on 17 and 18 May. These two anomalous increases in groundwater level were reflected strongly in P4 and more subtly in P1, 2, and 3. This may indicate that appreciable rainfall occurred on and closely preceding these days but was not recorded at the Muriwai Golf Course rain gauge.

Similar to P4, the two largest rainfall events in the monitoring period generated large and rapid increases in shallow groundwater. At P5, the groundwater level briefly reached the ground level on 27 July 2021 before receding over the following 5 days.
