36 SANDSPIT ROAD

WARKWORTH

**SUPPLEMENTARY GEOTECHNICAL
INVESTIGATION REPORT**

AKL2021-0060AD Rev 0

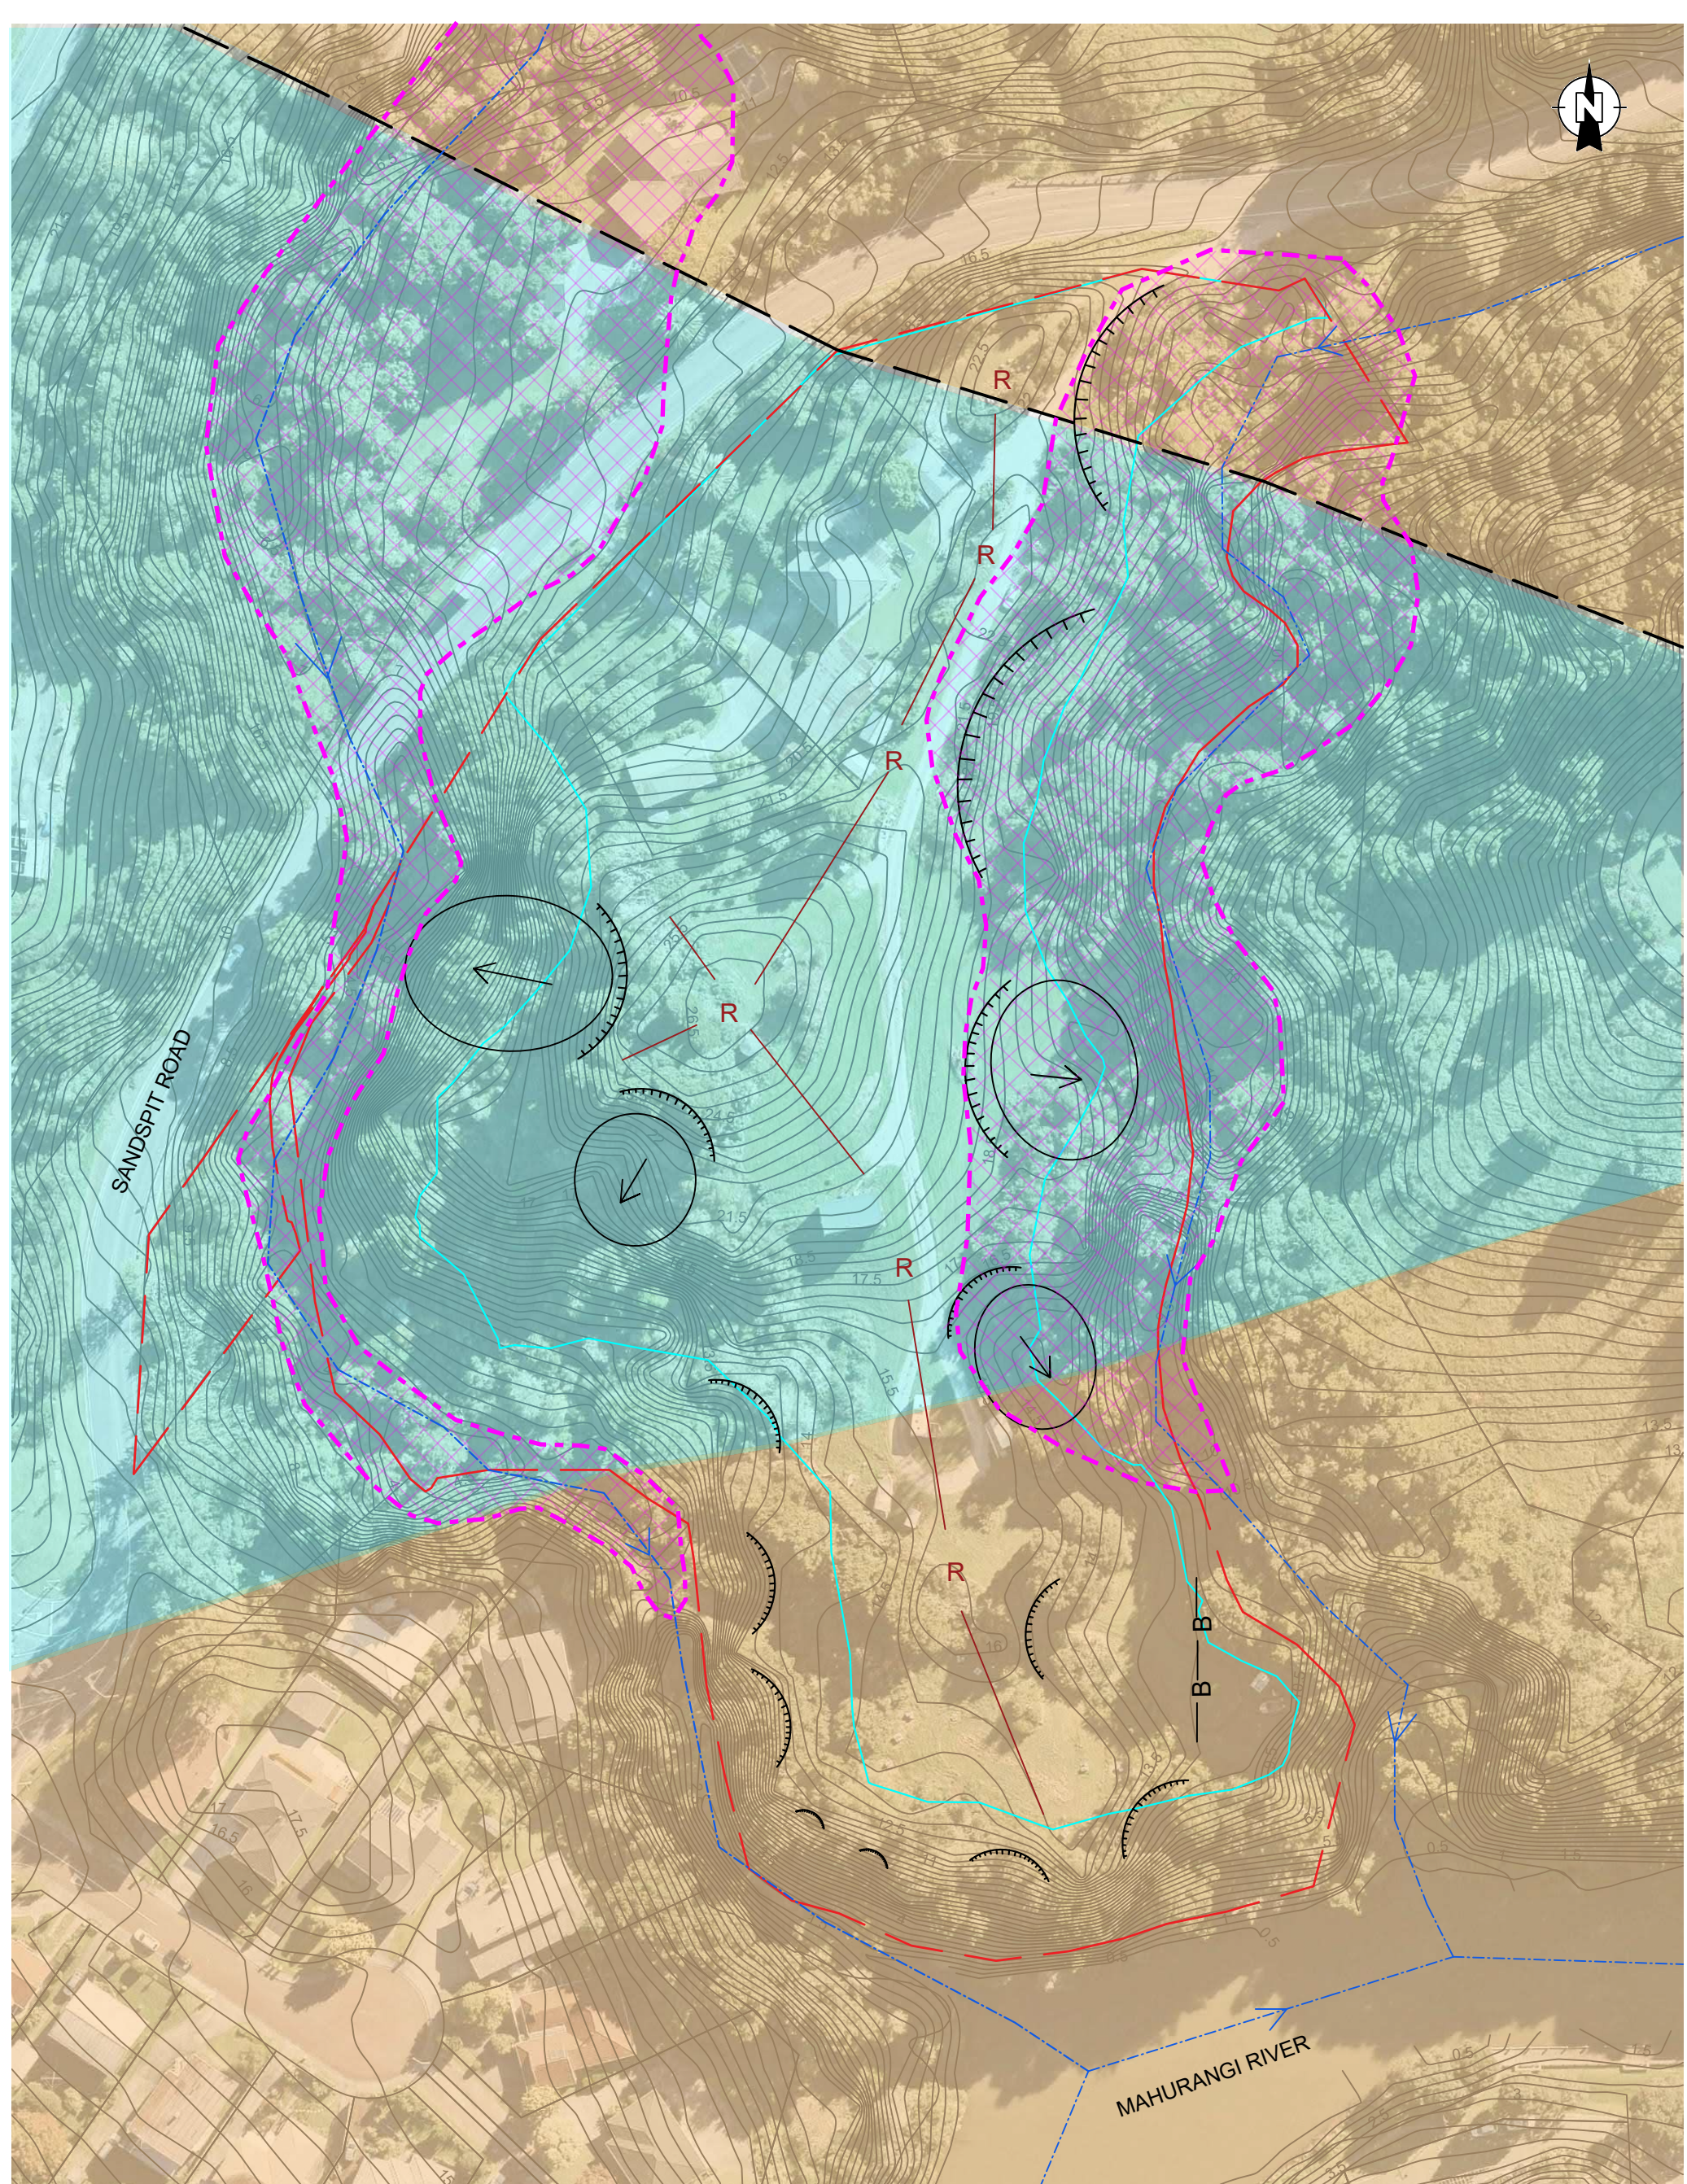
CLIENT:	THE KILNS LIMITED	DRAWN:	TE	PROJECT No:	AKL2021-0060
PROJECT:	36 SANDSPIT ROAD WARKWORTH	CHECKED:	RK	DRAWING:	02
TITLE:	GEOLOGY AND GEOMORPHOLOGY PLAN	REVISION:	1	SCALE:	1:1000
		DATE:	08/03/2022	SHEET:	A3

The subject site is dominated by two north-south trending gullies, the orientation of which is likely to be structurally controlled given that the same orientation is seen in both regional structure and in defects observed. To the south of the site, in the Mahurangi River, sub-horizontal beds of Waitemata Group sandstones and siltstones are visible in the stream bed.

The ground conditions encountered and inferred from the investigation were considered to be generally consistent with the published geology for the area. However, some recent alluvial river deposits and colluvium were encountered, which were not included in the published geology for the area. Geological units are presented on Cross Sections A to D (**Drawing 05 to 08** in **Appendix A**) and can be generalised according to the following subsurface sequences.

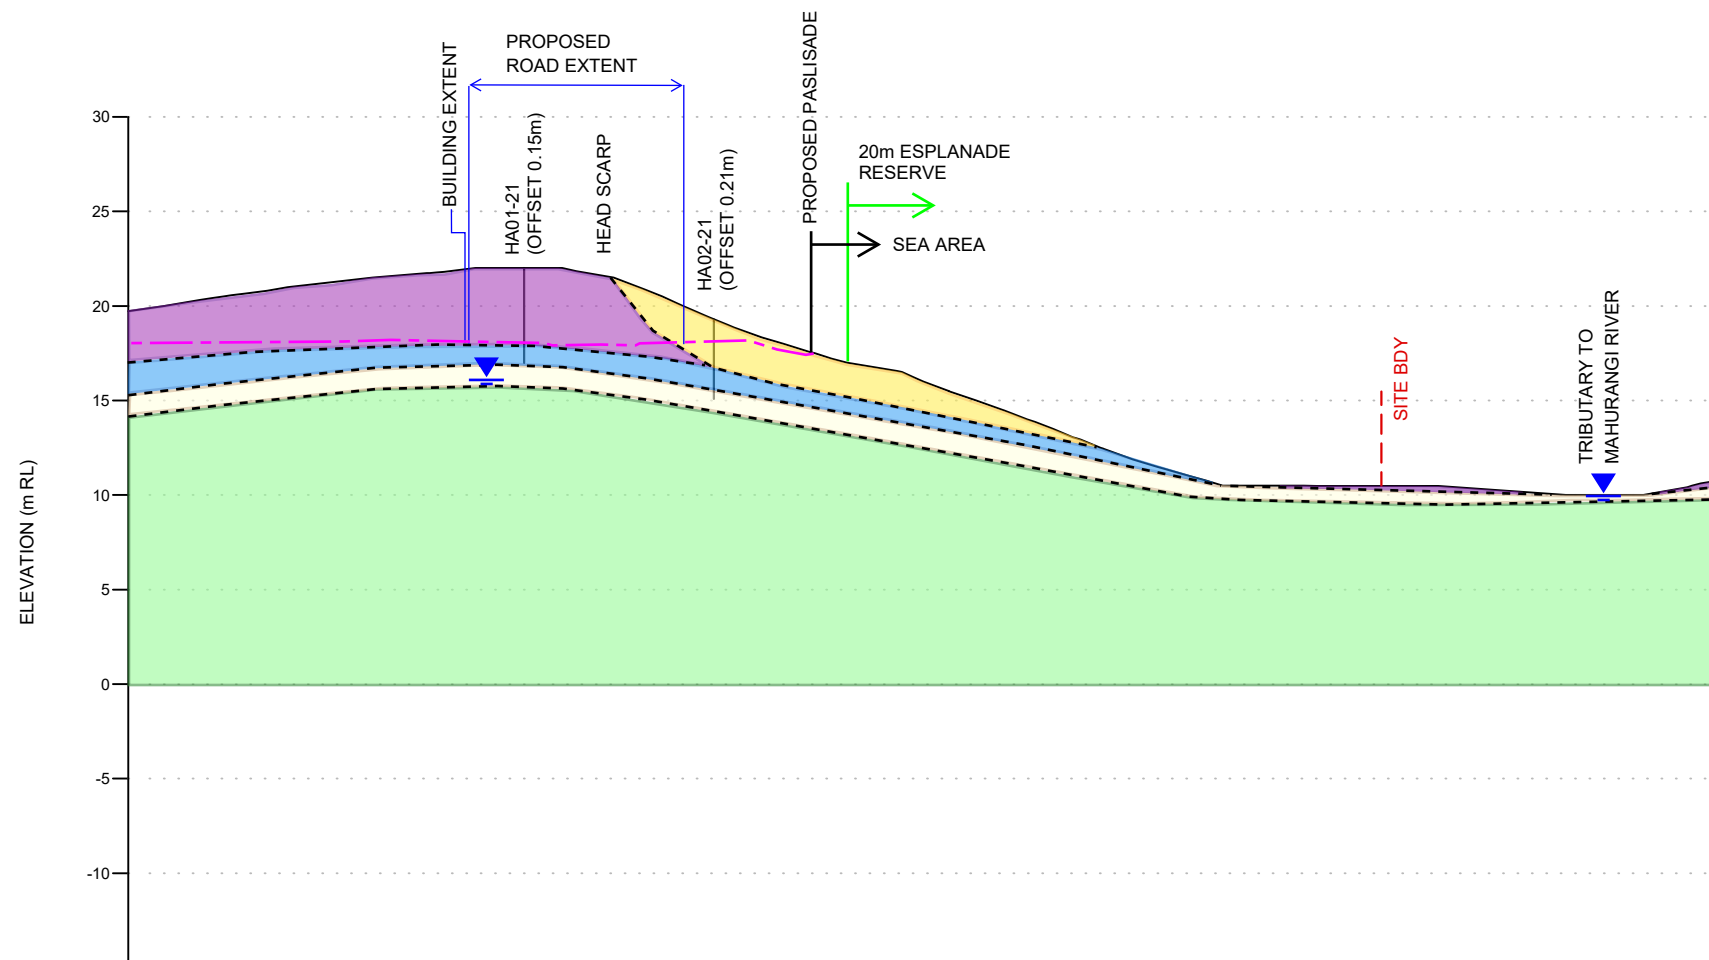
SECTION-A

EXISTING GROUND (m RL)		21.17	22.00	19.72	16.67	13.06	10.49	10.43	10.00	10.83
DISTANCE (m)		10	20	30	40	50	60	70	80	85

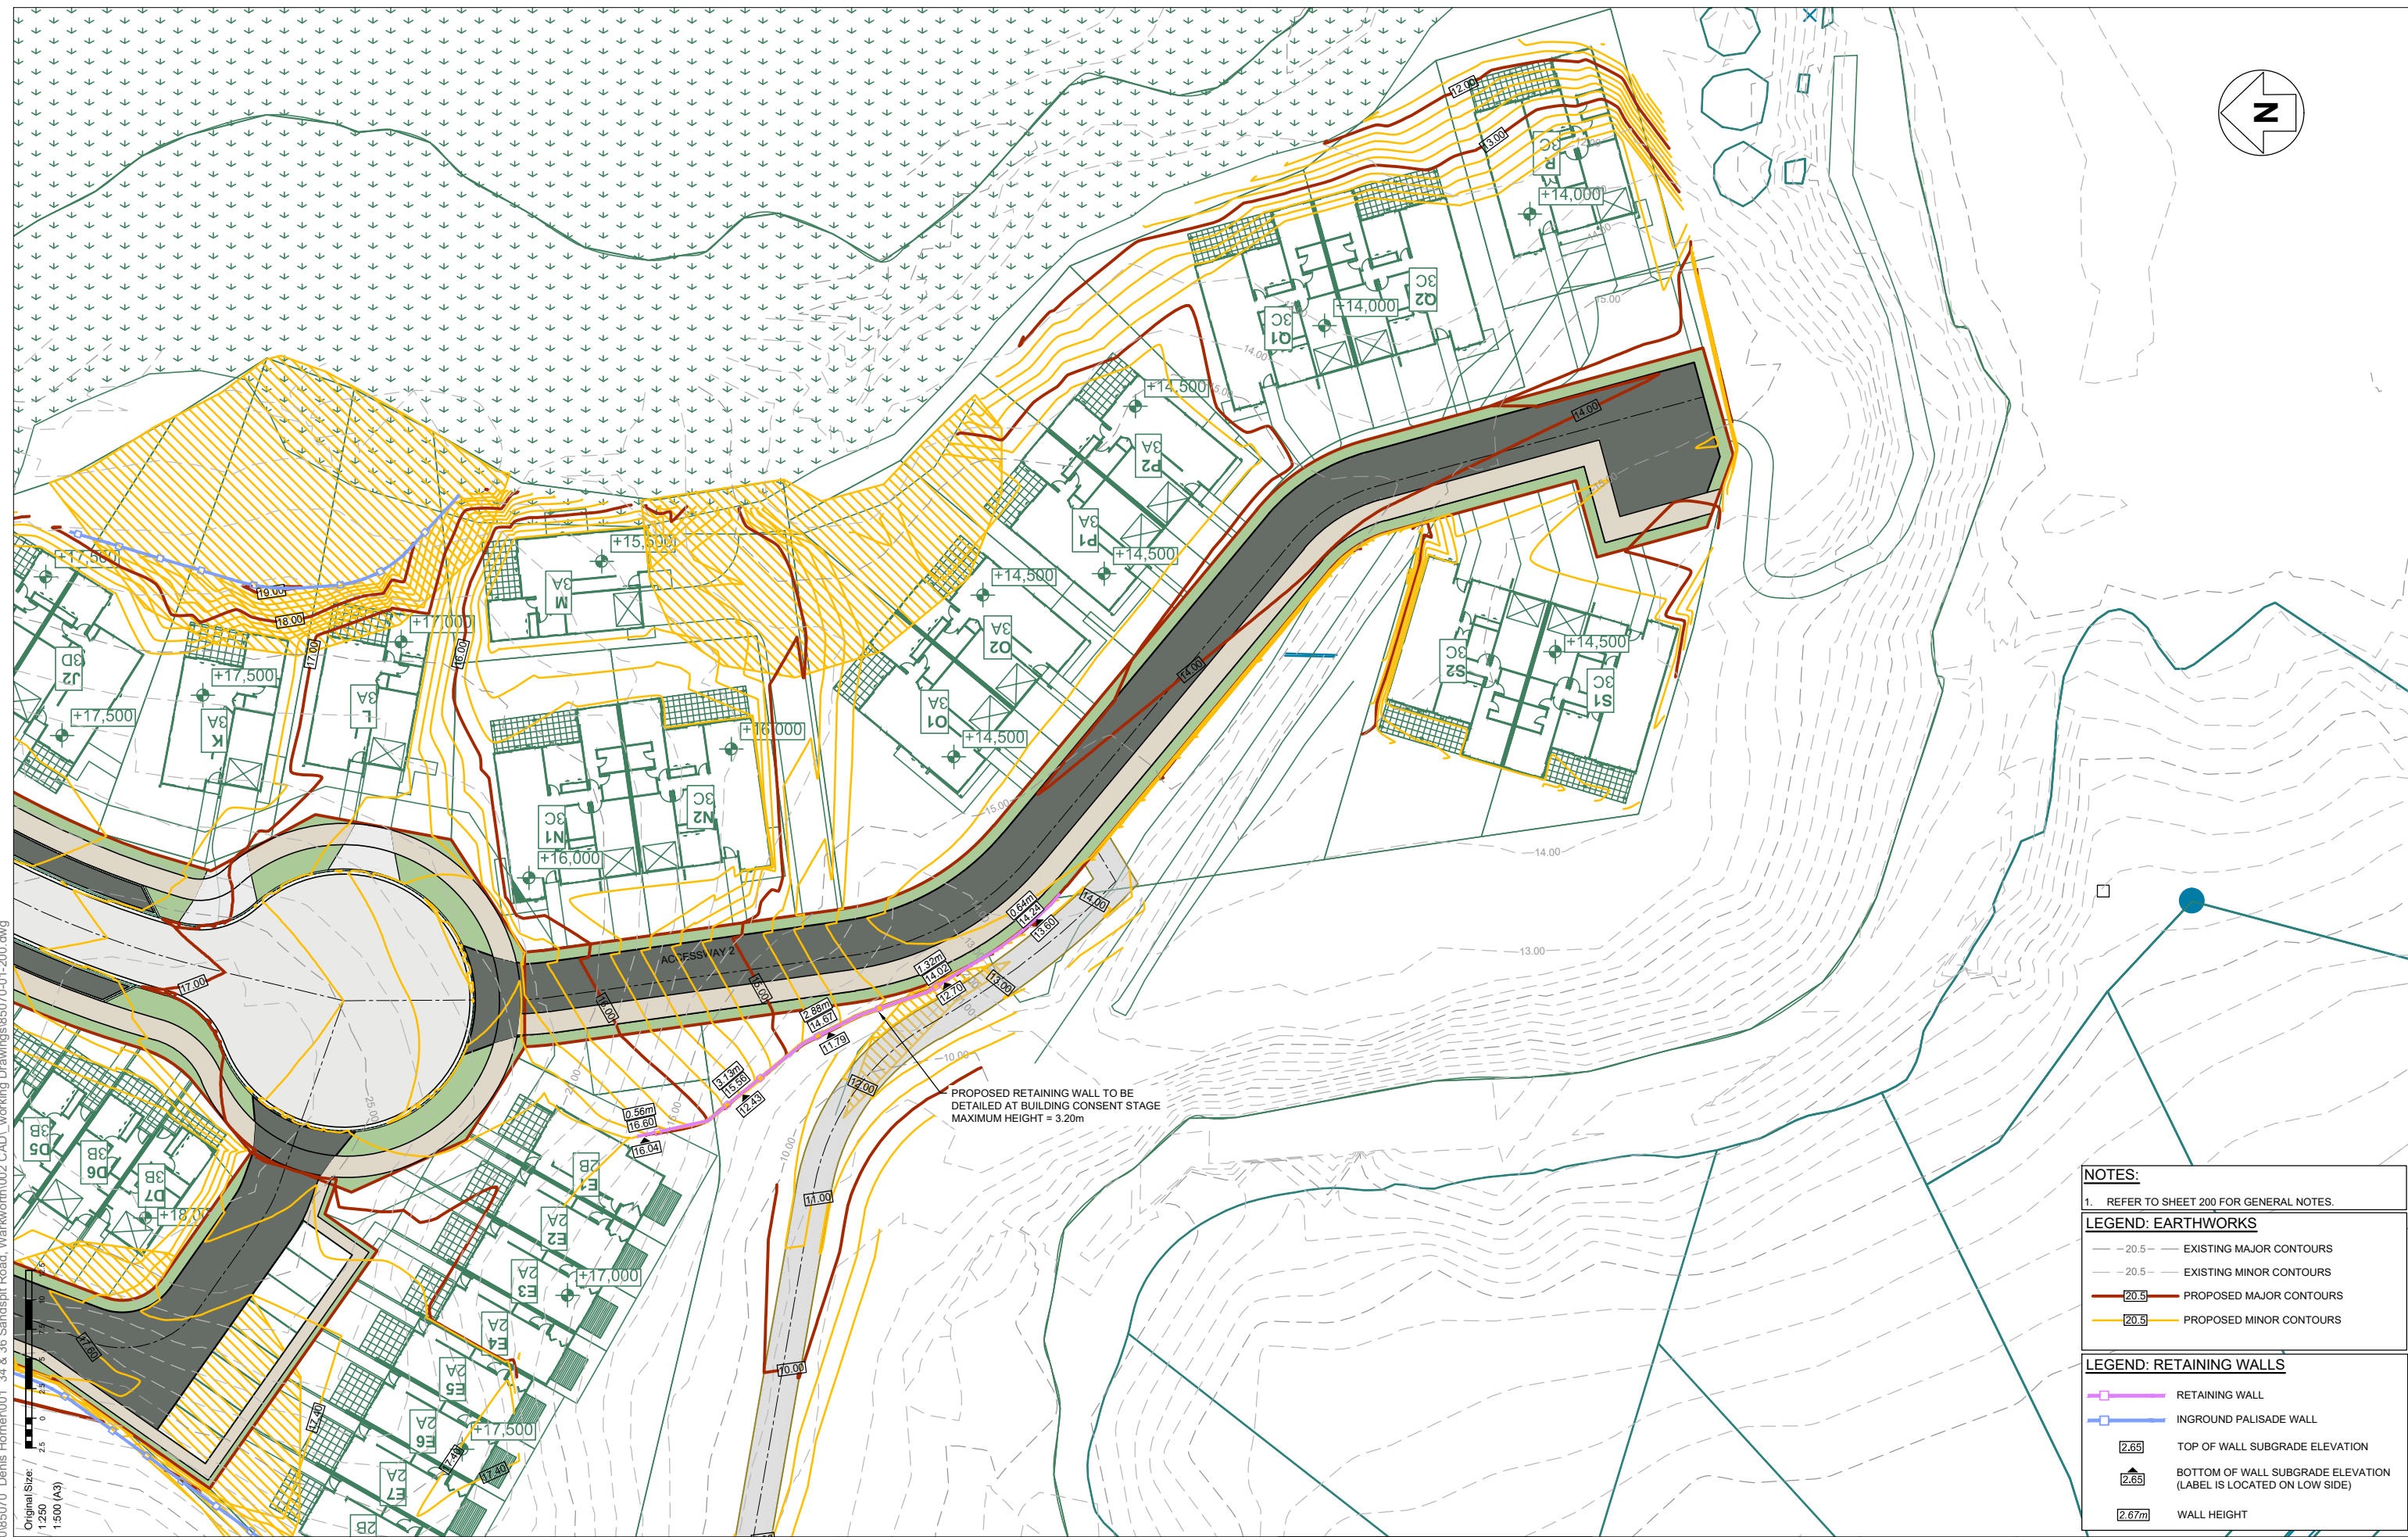
JOB No: 85070-01
SHEET No 201
REV: A

PROPOSED RETAINING WALL TO BE
DETAILED AT BUILDING CONSENT STAGE
MAXIMUM HEIGHT = 3.20m

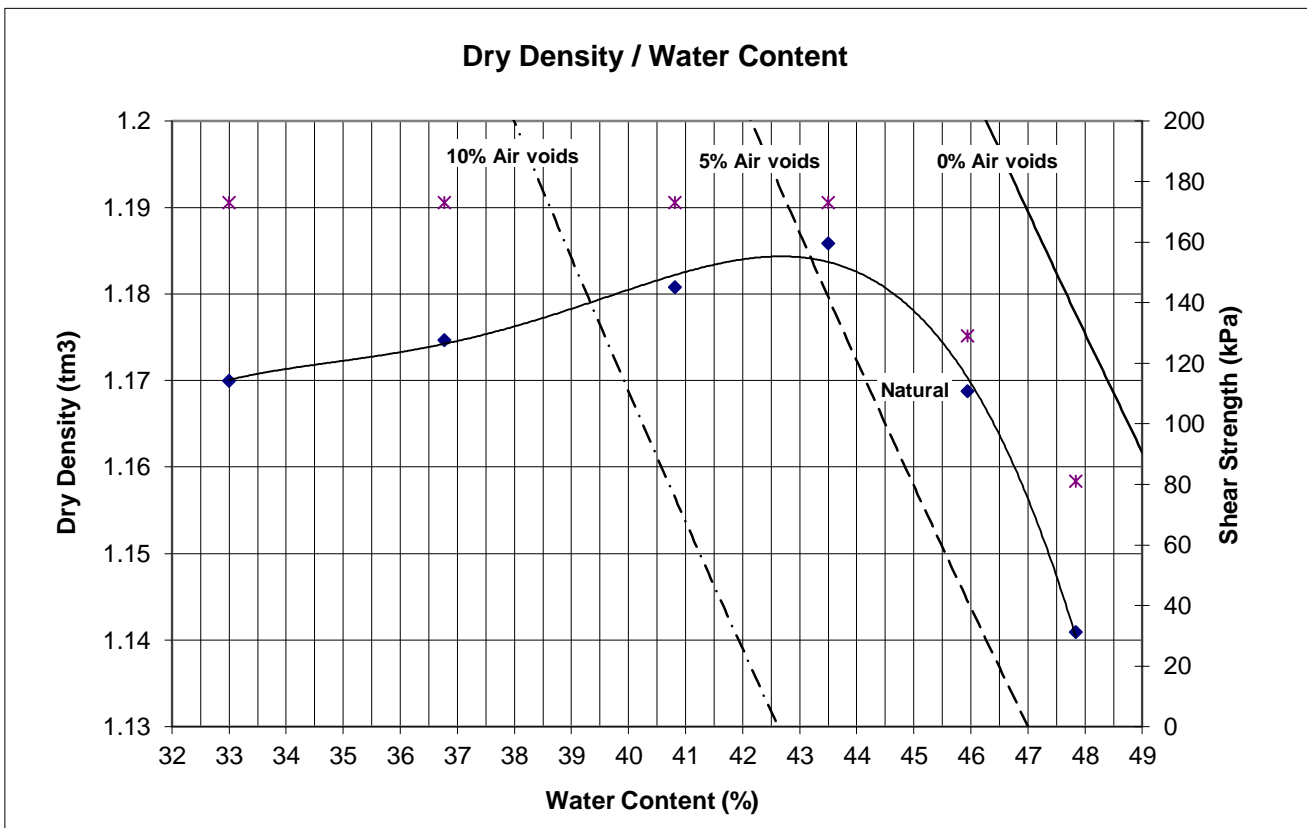
Maximum Dry Density :	1.18	t/m ³	Optimum Water Content :	43.0	%
Natural Water Content :	45.9	%	Assumed		
Solid Density of Soil :	2.70	t/m ³	History of sample :	Natural	
Description of Soil :	-				
Fraction of soil tested :	Passing 19mm sieve				
Comments :	-

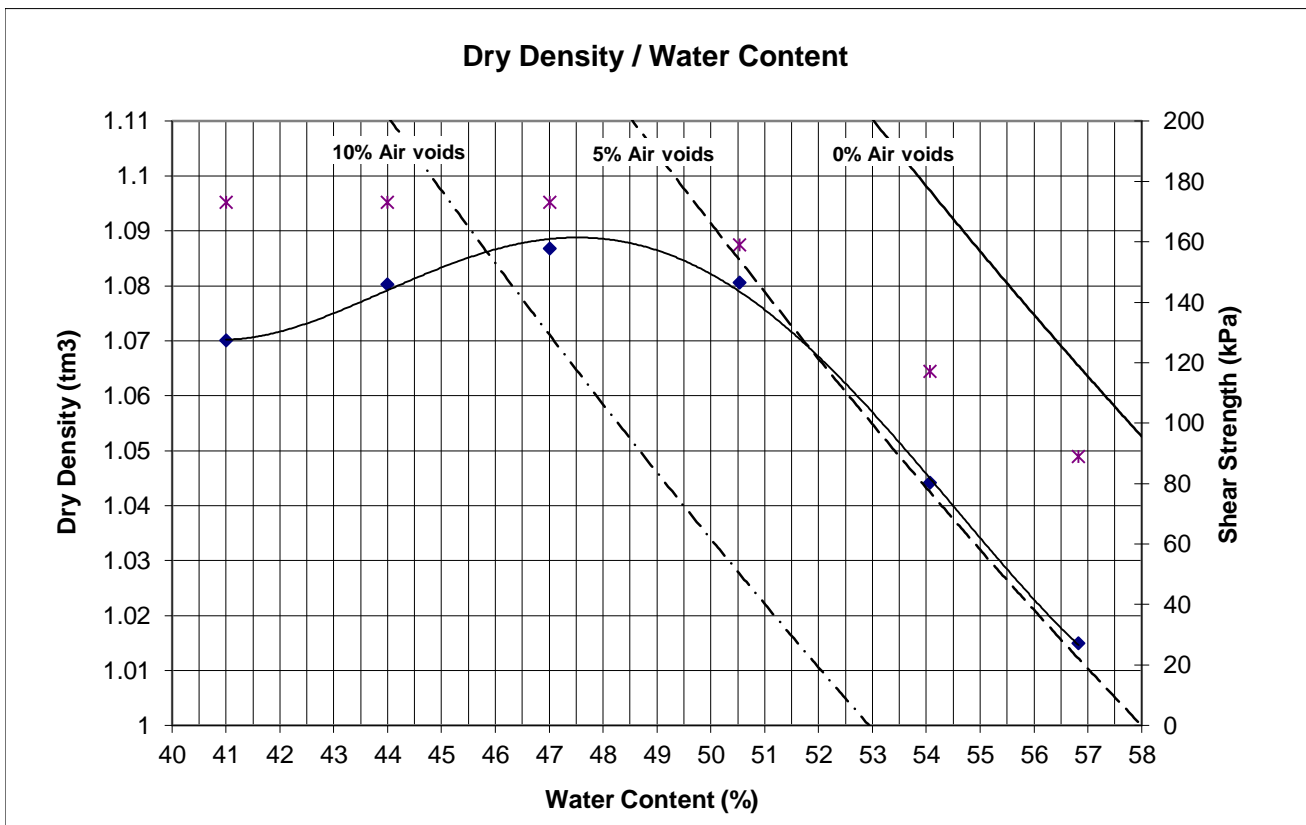
Maximum Dry Density :	1.09	t/m ³	Optimum Water Content :	48.0	%
Natural Water Content :	66.2	%			
Solid Density of Soil :	2.70	t/m ³	Assumed		
Description of Soil :	-				
Fraction of soil tested :	Passing 19mm sieve		History of sample :	Natural	
Comments :	-

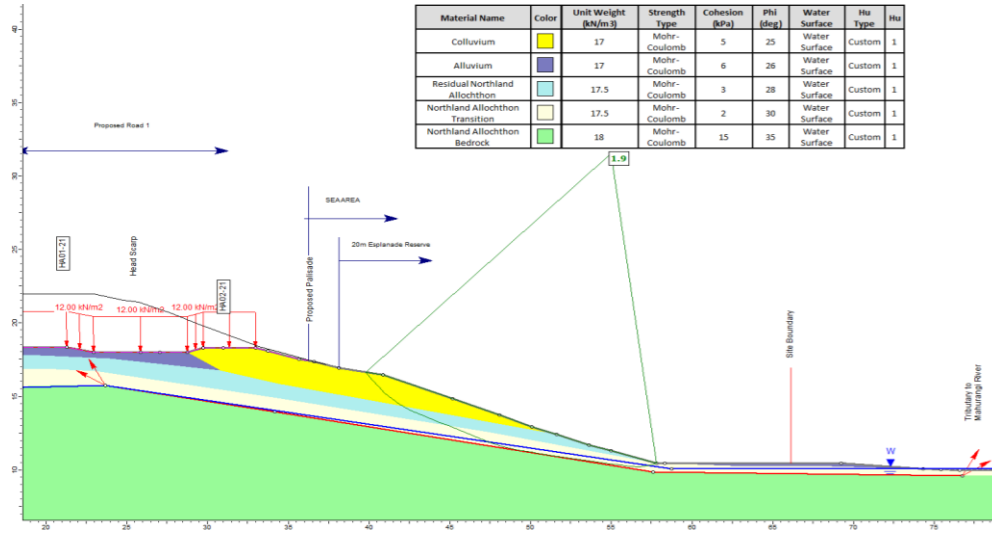
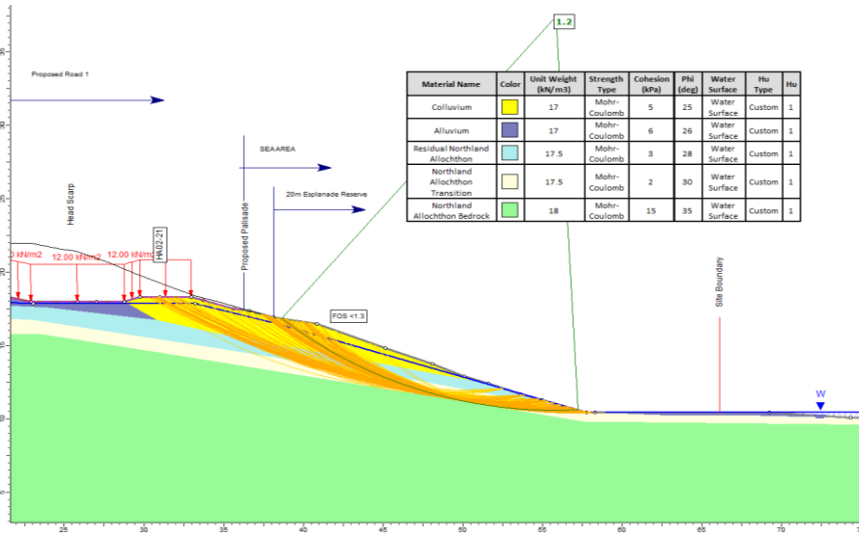
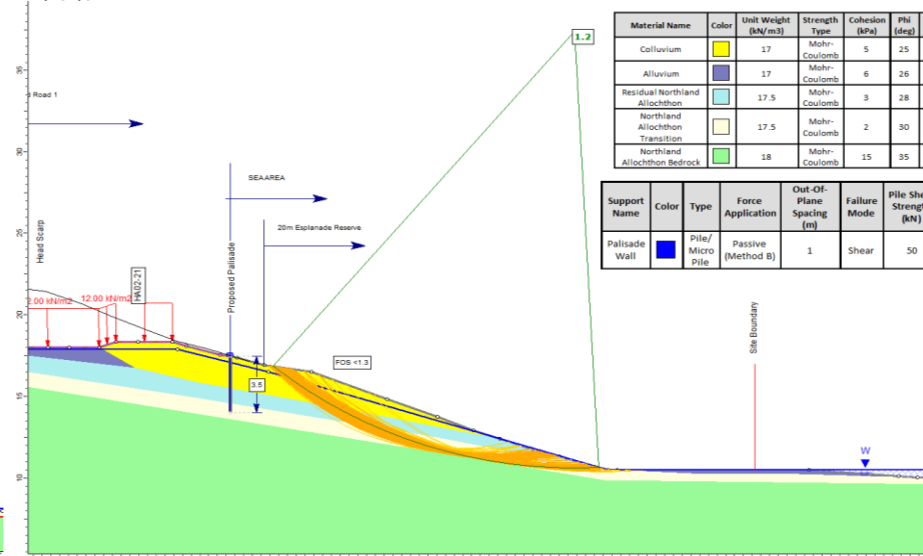
Section	Profile	Analysis	Normal GW	High GW	Seismic	Comments
B (Proposed)	Full Profile	Circular (CA)	1.4	1.1	4.5	
	Full Profile	Planar Block (PB)	1.3	1.1	9.0	
B (Remediated)	Full Profile	Circular	1.6	1.3	4.5	Palisade wall extending to competent bedrock and regrade crest of slope. Min. 0.6m undercut at rock interface - cap with clay fill. Palisade Wall - min 100kN shear, >2.5m depth
	Full Profile	Planar Block	1.6	1.3	9.4

Slope stability analyses were undertaken using the Morgenstern-Price method of slices under both circular and translational failure mechanisms using the proprietary software SLIDE2. Earthquake loads were calculated in accordance with NZS 1170.5 and NZTA Bridge Manual (BM) Section 6.2.2 for earthquake loads for the assessment of slope stability. An ULS design earthquake return period of 150 years as recommended within the Auckland Council Code of Practice (ACCoP) has been assumed in the assessment. The peak ground acceleration (PGA) for stability analyses was calculated as 0.1g.

Results show that for the proposed landform and ground model described above, inadequate slope stability factors of safety are achieved on the steep fringes of the site and will require the implementation of specific remedial earthworks, palisade walls and drainage measures, as described in Section 7 below, with remediated factors of safety presented in Section 7.3.

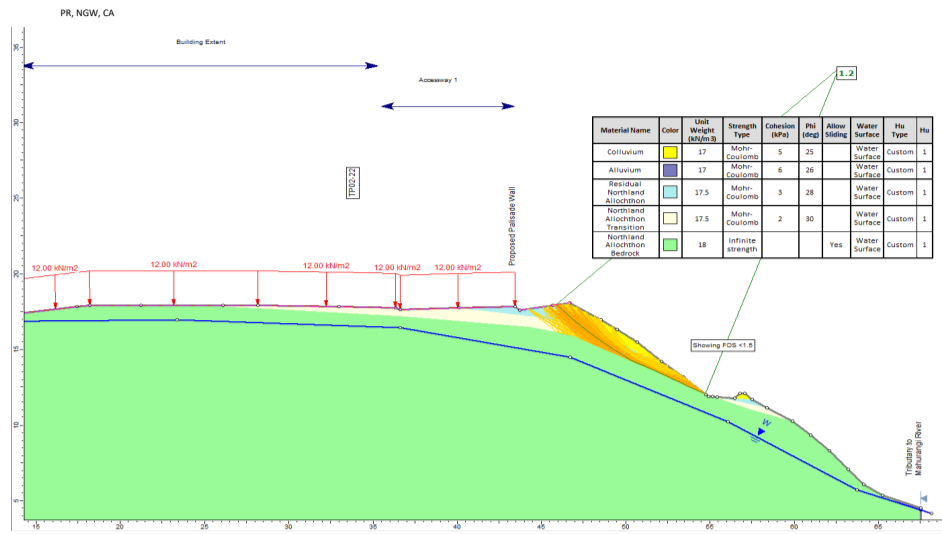
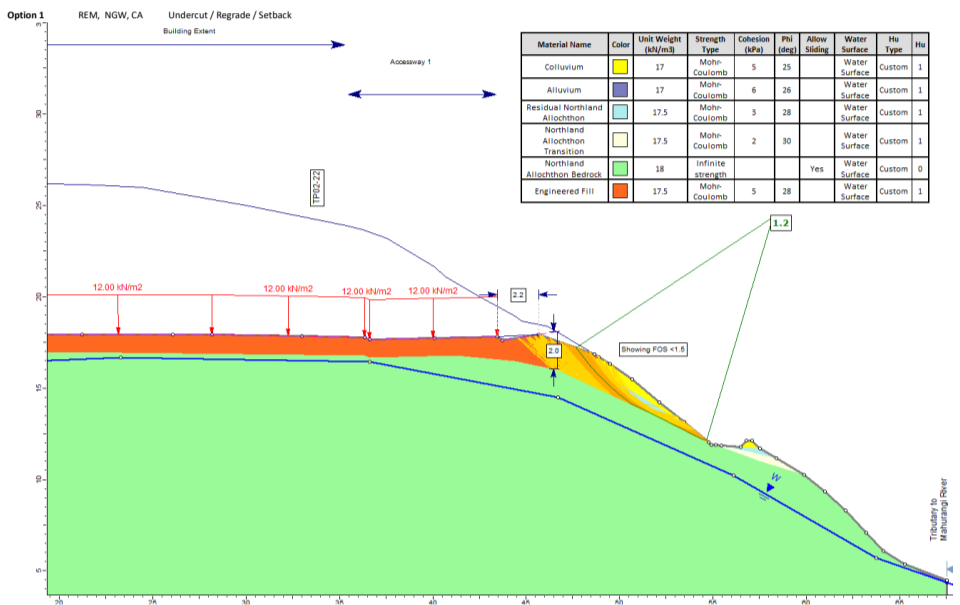
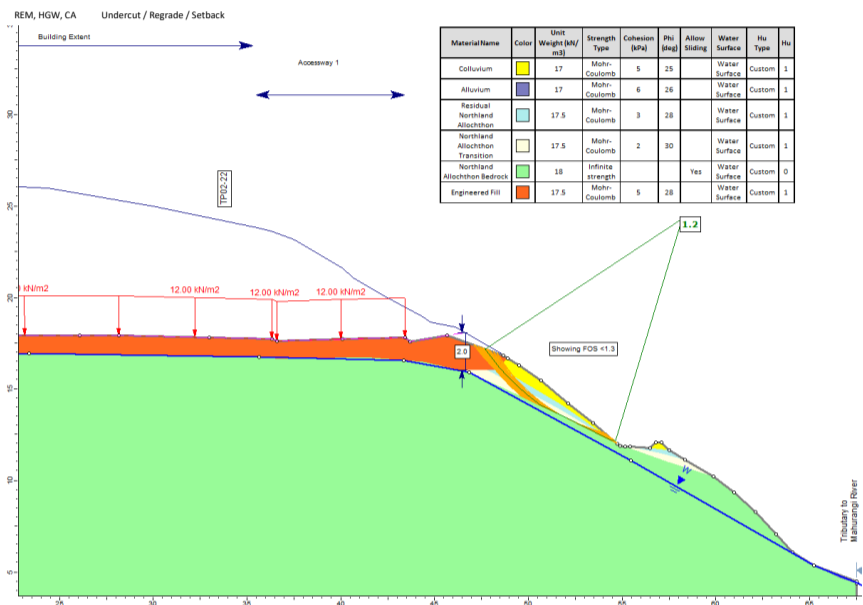
36 Sandpit Road, Warkworth - Stability Analyses Summary

Section	Profile	Analysis	Normal GW	High GW	Seismic	Comments
D (Proposed)	Full Profile	Circular (CA)	1.2	1.2	4.0	
	Full Profile	Planar Block (PB)	1.2	1.2	12.6	
D (Remediated)	Full Profile	Circular	1.2	1.2	3.9	Undercut to rock and replace with Eng. Fill. Regrade crest of slope. Min setback 2.5m from crest/cut slope.
Option 1	Full Profile	Planar Block	1.2	1.2	13.0	
D (Remediated)	Full Profile	Circular	1.2	1.2	3.9	Palisade wall extending to competent bedrock and regrade crest of slope. Min. 0.6m undercut at rock interface - cap with clay fill.
Option 2	Full Profile	Planar Block	1.2	1.2	12.9	Palisade Wall - min 50kN shear, >2.0m depth. Failures located below palisade wall.
