Lake Ōkaihau

## Appendix F - Lake Water Balance Assessment

WWLA0321 | Rev. 5

## Muriwai Downs Golf Project

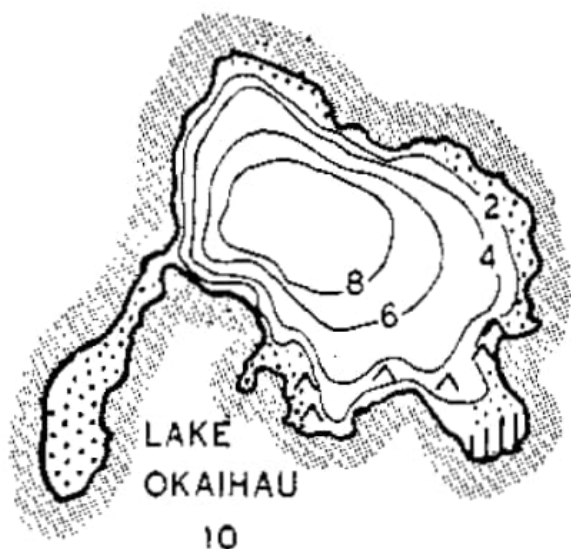
Figure 4. Lake Ōkaihou bathymetric survey (from Cunningham, *et. al.*, 1953).

As alluded to in **Section 2**, Cunningham et al. (1953) undertook a bathymetric survey of the lake in the early 1950's. This survey is presented in **Figure 4**. The survey was collected from a small row boat, using a weighted cord line with sinker to manually measure the depth across survey lines over the lake.

Depths were measured relative to the water level on the day of the survey, and therefore the exact vertical datum is not known. The bathymetric survey was georeferenced, digitised to provide digital lake depth contours, and converted to a raster grid Digital Elevation Model (DEM).

The lake bathymetry DEM was then merged with Auckland Council's 2016 LiDAR DEM. For the purposes of merging the two DEM's it was assumed lake levels were consistent with an average summer water level during the time of the survey, as exact levels were unknown.

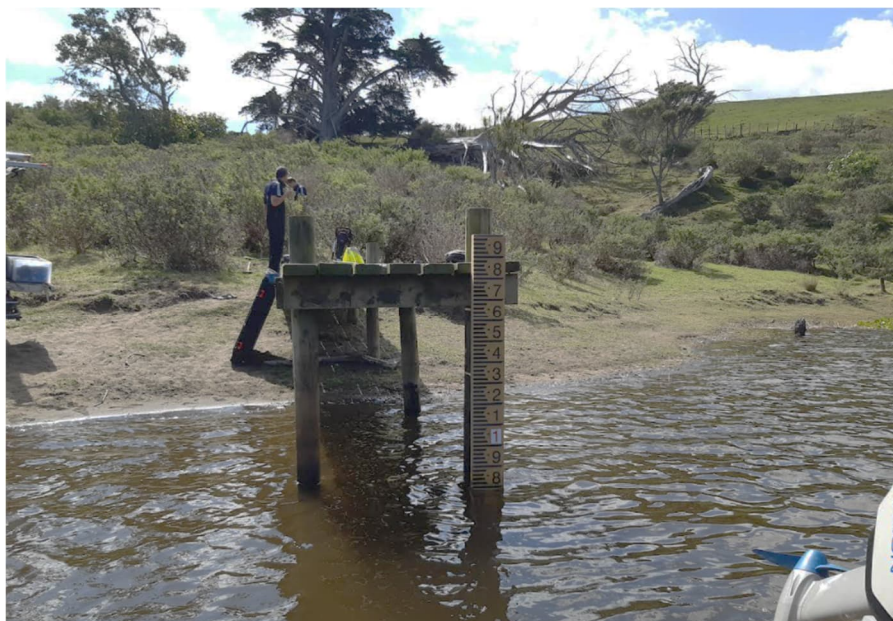
Figure 5. Lake Ōkaihau staff gauge.

Auckland Council installed a staff gauge on the end of the wooden jetty on the north-western shoreline of Lake Ōkaihou (**Figure 5**). The staff gauge is used to monitor and record relative water level change during their routine monthly water quality monitoring visit. The monitoring programme commenced in March 2021. At the time of preparing this report, only four measurements were available (**Table 1**).

Auckland Council confirmed the staff gauge has not been surveyed, therefore the vertical datum of staff gauge zero is unknown. In order to relate staff gauge water levels to the combined lake bathymetry and LiDAR DEM, WWLA estimated the staff gauge vertical datum by spot sampling the elevation at the landward end of the jetty from the LiDAR DEM. Based on this approach, staff gauge zero was calculated as 30.32 m NZVD2016.

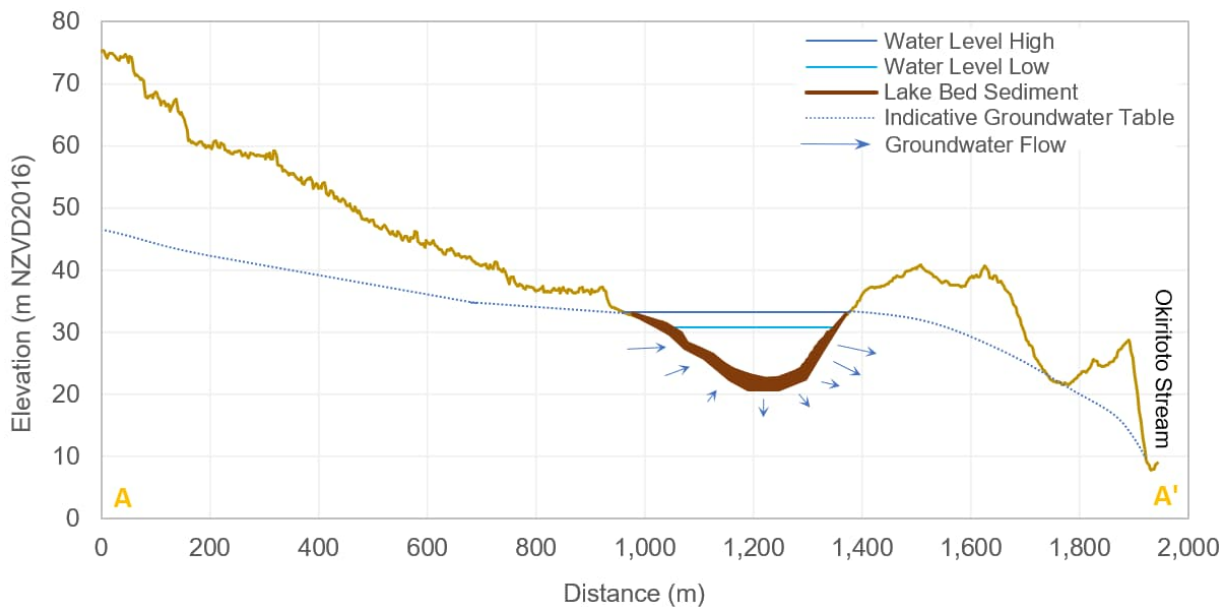
Figure 12. Cross-section conceptual schematic.

As discussed in **Section 4.2.4**, the conceptual understanding of the hydrological functioning of the lake is that the lake bed consists of a deposit of low permeability sediment that varies in thickness radially within the lake, becoming thinner at the extremities (or under the highest lake levels), which results in low seepage losses when

lake levels are low. When lake levels increase above the median lake level, the lake bed profile in the zone above median lake water levels becomes progressively sandy and increasingly permeable, resulting in greater losses from the lake during periods of elevated water levels

To test this conceptual understanding (discussed above and further in **Section 4.2.4**), an “adjusted” seepage curve was developed where seepage was low during periods of low water levels and high during periods of elevated water levels (**Figure 16**). The resulting simulated water levels are presented in **Figure 14**. The simulated water levels demonstrate good agreement to historic estimates of lake water level. This good agreement provides weight and a high degree of validation to our conceptual understanding of the hydrological functioning of Lake Ōkaihau (**Figure 12**).

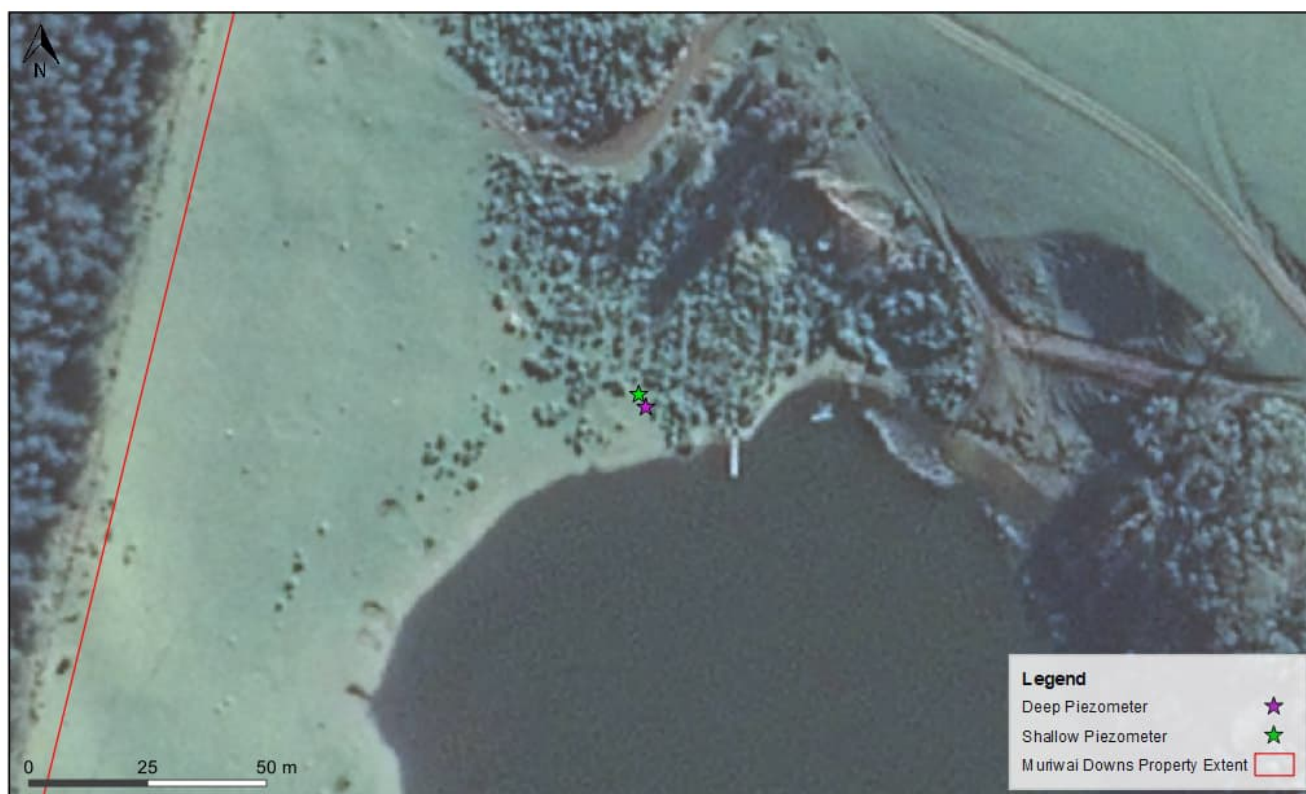
Figure 16. Lake Ōkaihou piezometer locations.

Two shallow monitoring piezometers were constructed ten metres north of the northern edge of the lake on 29 September 2021 (**Figure 16**). The first piezometer was installed to a depth of 5.5 metres, and the second to a depth of 14.5 metres. The purpose of the piezometers was firstly to provide an understanding of below ground material and the identification of any vertical pressure gradients in groundwater levels, which could inform either groundwater seepage loss or inflow to the lake.
