## HISTORIC HERITAGE MONITORING LOG

Project	Location	Attendees	Date	H & S Briefed?
36 Sandspit Road	36 Sandspit Road	Adina Brown (Plan.Heritage Ltd)	14/01/2022	Yes
Resource Consent: LUC60329586	Warkworth	John Brown (Plan.Heritage Limited)		14/01/2022
Exploratory Works	Auckland	Chris Davies (GeoSciences Ltd)		
AUPOP ref id 569		Mate (Machine Driver)		
Archaeological Authority (2021/753: R09/2240).		Jo Hopkins (Buckton surveyors)		
		Chris; Henry (CMW Geosciences Ltd)		
		Mica Plowman (Auckland Council)		
<b>Summary Purpose:</b>				
<ul style="list-style-type: none"> <li>Daily Monitoring log</li> <li>Review next steps for project and timeline</li> </ul>				
<b>New Actions:</b>				
<ul style="list-style-type: none"> <li>This log shall be provided to the Council (Team Leader Compliance Monitoring North West in consultation with the Team Leader Built Heritage), as per Condition 8 of the consent</li> </ul>				
<b>General Comments:</b>				
<p><u>Resource Consent: LUC60378963</u></p> <p>The record for this visit is in Table 1 (below) and log for the on-going compliance with the conditions of this consent are in Table 2 (below).</p> <ul style="list-style-type: none"> <li>Due to H&amp;S con

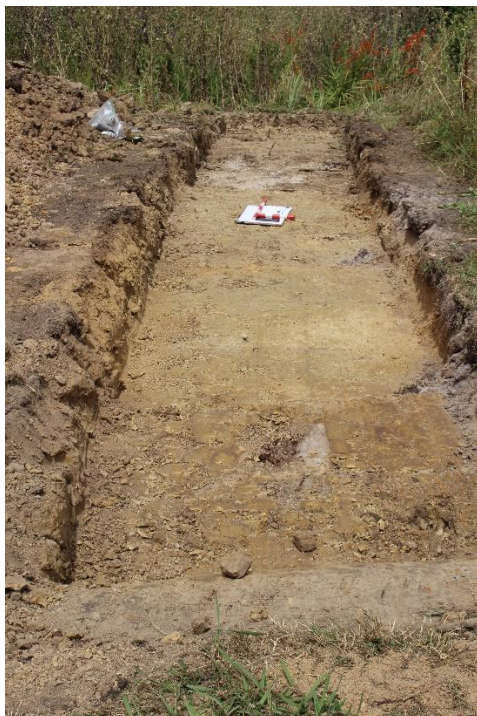
S facing view along trench

Trench 10 – possible pile posts and chimney base remains for probable early 20<sup>th</sup>-century building

- Trench 10 was excavated in the approximate location of the former house site on a slightly different alignment to avoid large tree stumps. A series of posts were revealed below the turf/topsoil layer, driven into natural soils, but truncated higher up as a result of the historical demolition / removal of the house.
- Small fragments of glass, wood, and brick were present mixed in amongst the turf and topsoil on the surface, above the level of the posts. These have been identified as consistent with an early 20<sup>th</sup> century date.
- Probable remains of a chimney base were located approximately 4m NW of trench 10 within the weeds. The feature comprised unfrogged and machine-cut bricks, with coarse aggregate concrete bonding material over some bricks. Some loose bricks were also present on the surface (ex situ)

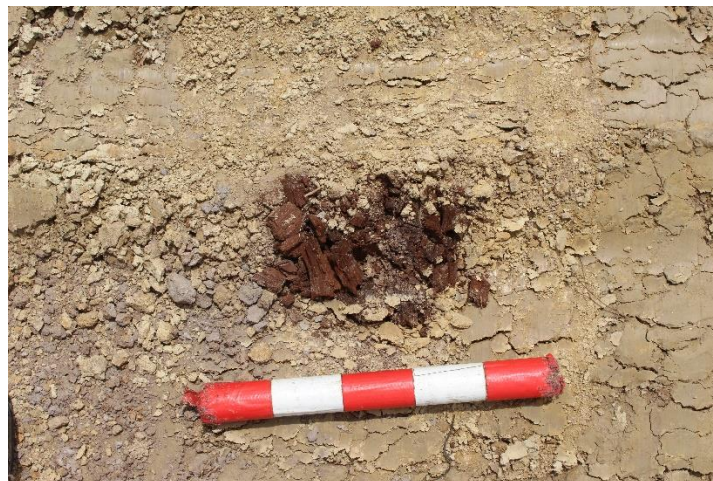
Example possible pile post

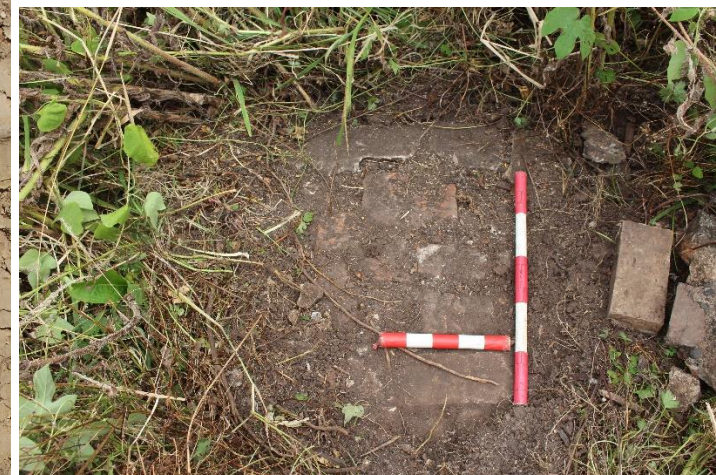
Possible chimney base remains with concrete

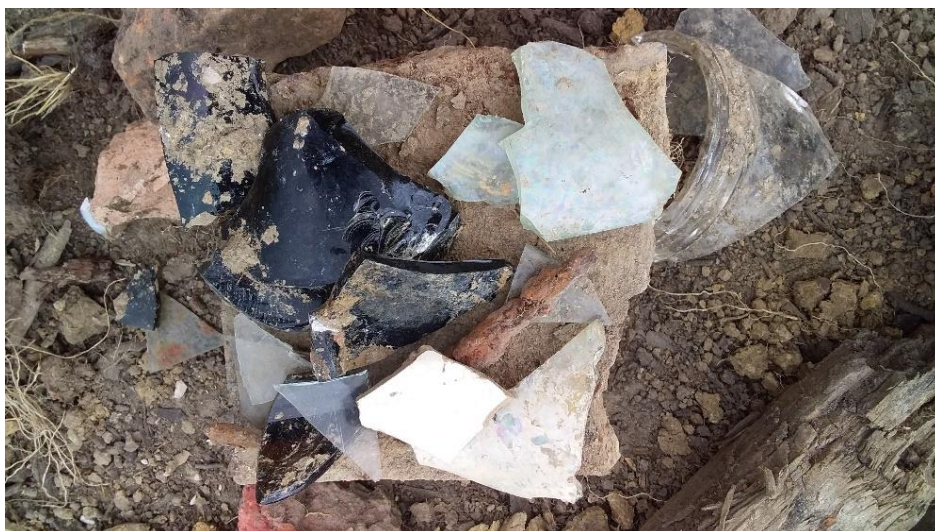
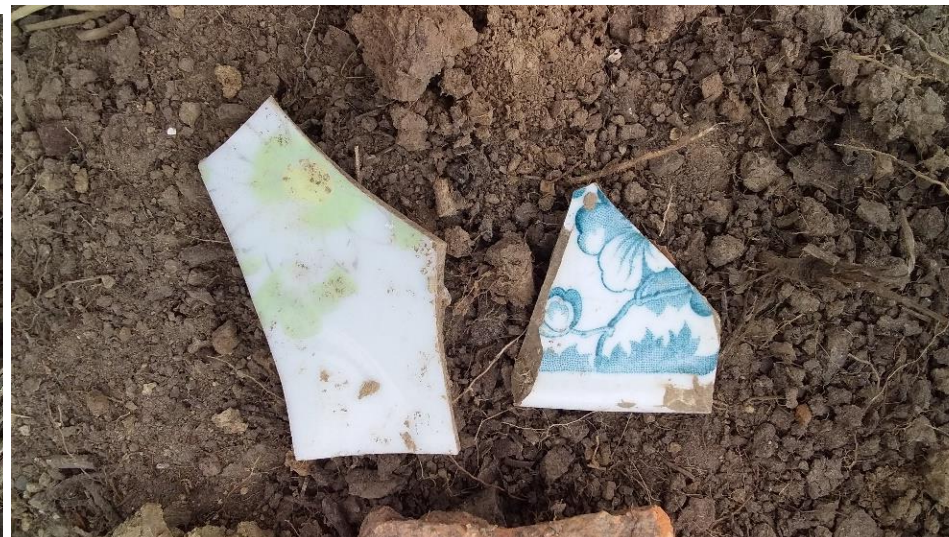
Loose (disturbed/redeposited) surface artefacts from turf/topsoil layer in vicinity of house site T10. Primarily 20<sup>th</sup> century material where date can be confirmed from visual diagnostics.

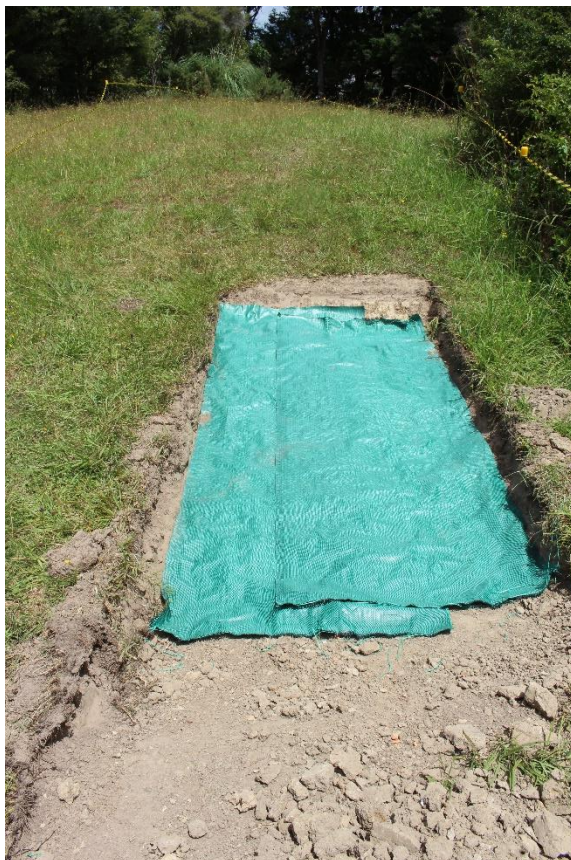
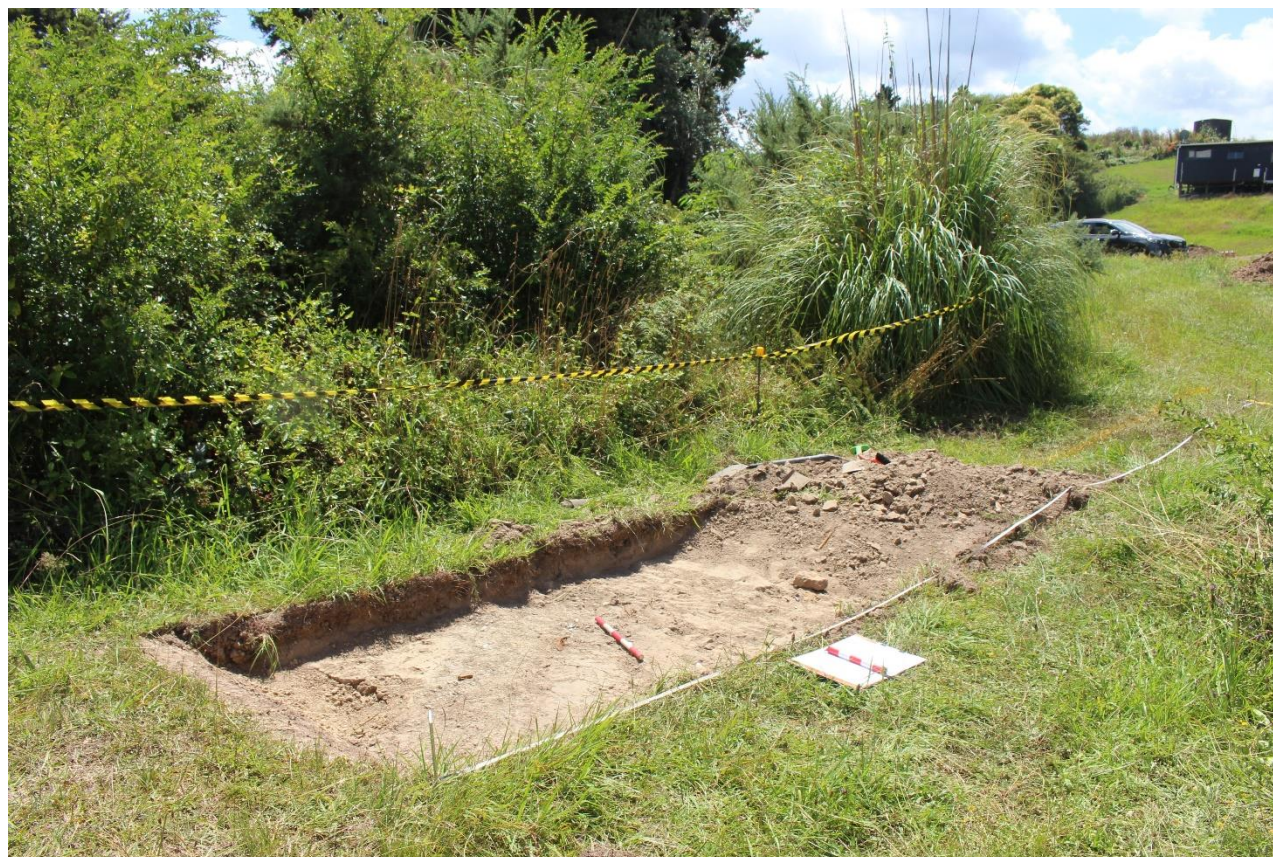
Site protection examples – protection of archaeological deposits (T06) with polypropylene geotextile cloth prior to backfilling as per HHMP. Hazard barrier tape demarcating 'no-travel' zones

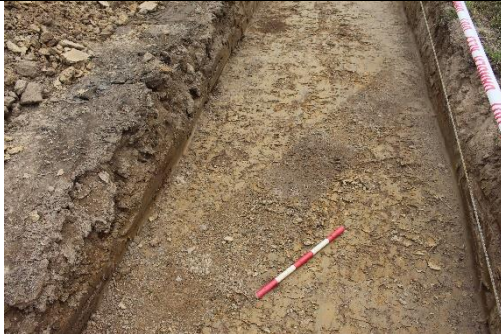
Matter	Subject	Image	Comment	Action	Action Date	Owner	Actioned
Exploratory	Trench 01 –

Outside scheduled area Services trench (historical) observed	Certified to be backfilled by M Plowman	14/01/2022	Kilns Ltd.	TBC
Exploratory	Trench 02 –

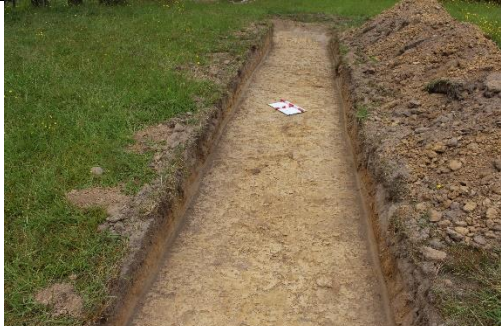
Outside scheduled area natural soils only observed	Certified to be backfilled by M Plowman	14/01/2022	Kilns Ltd.	TBC

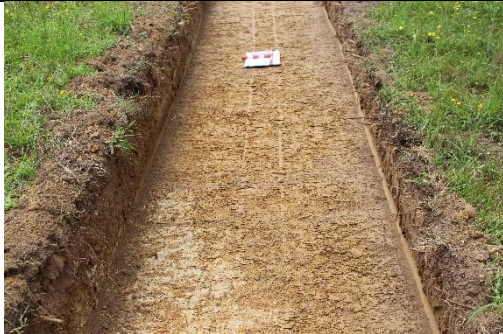
Matter	Subject	Image	Comment	Action	Action Date	Owner	Actioned
Exploratory	Trench 03 –

natural soils only observed certified to be backfilled by M Plowman	Certified to be backfilled by M Plowman	14/01/2022	Kilns Ltd.	TBC
Exploratory	Trench 04 –

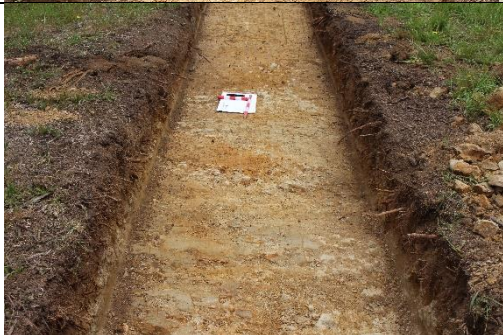
natural soils only observed certified to be backfilled by M Plowman	Certified to be backfilled by M Plowman	14/01/2022	Kilns Ltd.	TBC
Exploratory	Trench 05 –

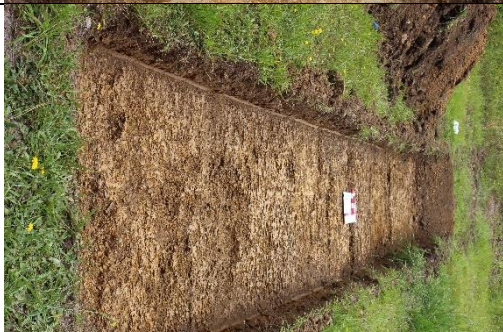
natural soils only observed certified to be backfilled by M Plowman	Certified to be backfilled by M Plowman	14/01/2022	Kilns Ltd.	TBC

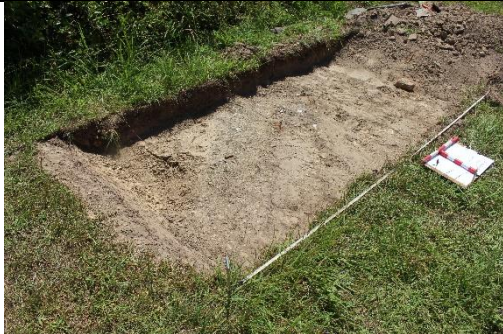
Matter	Subject	Image	Comment	Action	Action Date	Owner	Actioned
Exploratory	Trench 06-

Archaeological deposit observed protected with Geotextile fabric certified to be backfilled by M Plowman	Certified to be backfilled by M Plowman	14/01/2022	Kilns Ltd.	TBC
Exploratory	Trench 07 –

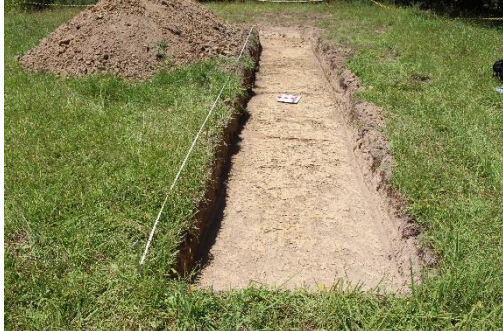
natural soils only observed certified to be backfilled by M Plowman	Certified to be backfilled by M Plowman	14/01/2022	Kilns Ltd.	TBC
Exploratory	Trench 08 –

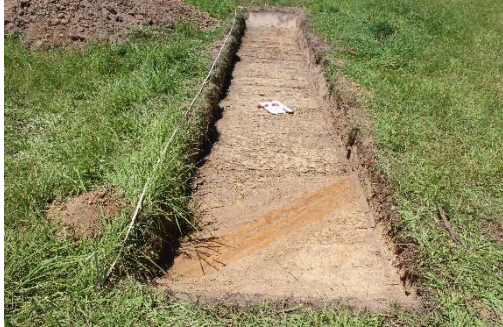
Probable water pipe observed w end (historical) certified to be backfilled by M Plowman	Certified to be backfilled by M Plowman	14/01/2022	Kilns Ltd.	TBC

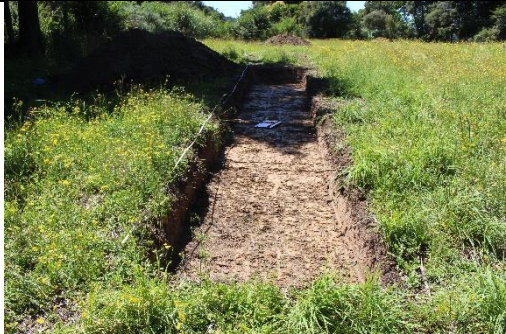
Matter	Subject	Image	Comment	Action	Action Date	Owner	Actioned
Exploratory	Trench 09 –

natural soils only observed certified to be backfilled by M Plowman	Certified to be backfilled by M Plowman	14/01/2022	Kilns Ltd.	TBC
Exploratory	Trench 10 –

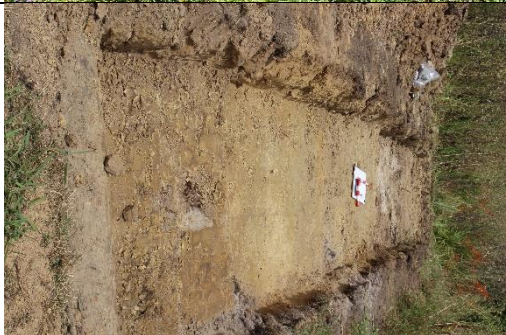
Outside scheduled area Remains of posts observed	Outside Scheduled Area	14/01/2022	Kilns Ltd.	TBC
Exploratory - Geotechnical	Trench 11 –	N/A	Not dug – hand auger	No further works	14/01/2022	Kilns Ltd.	TBC
Exploratory - Geotechnical	Trench 12	N/A	Not hand – hand auger	No further works
