DRAFT STORMWATER MANAGEMENT PLAN (SMP)

610, 614, 670, 697 & 451
Muriwai Road, Muriwai

FEBRUARY 2022

PROJECT: Muriwai Golf Course Development

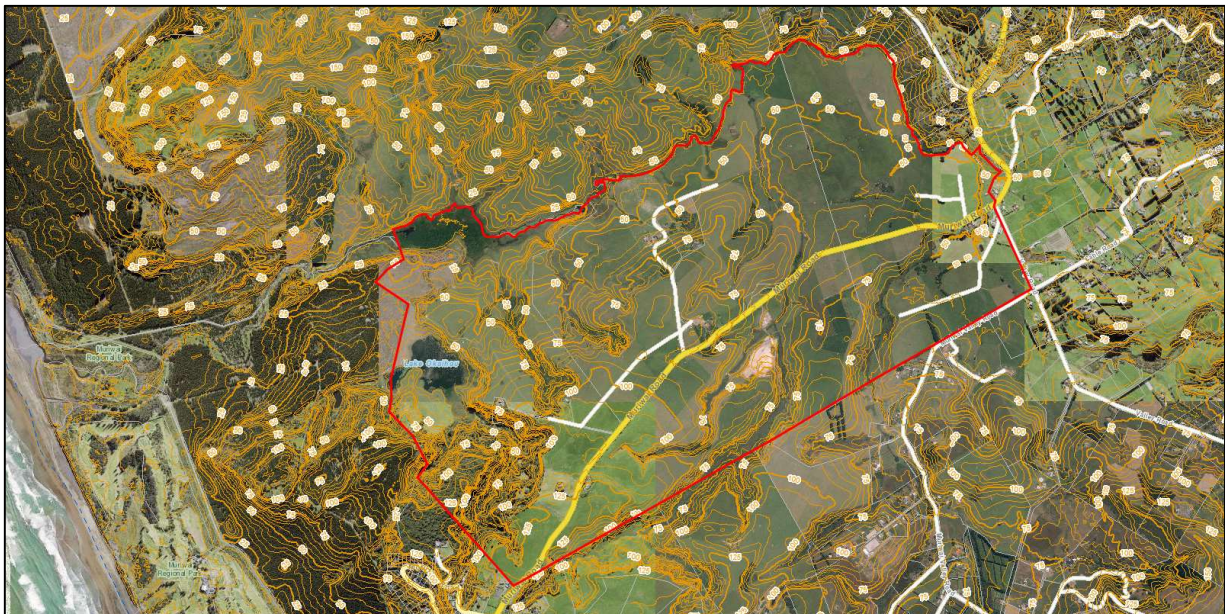
Figure 2 - Topography (Source: Auckland Council GeoMaps)

The combined property area to the south of Muriwai Road comprises also of rolling terrain which falls from the Muriwai Road boundary towards a couple of prominent gully features. The western gully feature traverses in north-east direction past the existing quarry site and under Muriwai Road forming a tributary into the Ōkiritoto Stream. Similarly, the eastern gully feature known as the Raurataua Stream traverses in a north-east to north direction under Muriwai Road to also tribute in the Ōkiritoto Stream. See Figure 2 below.

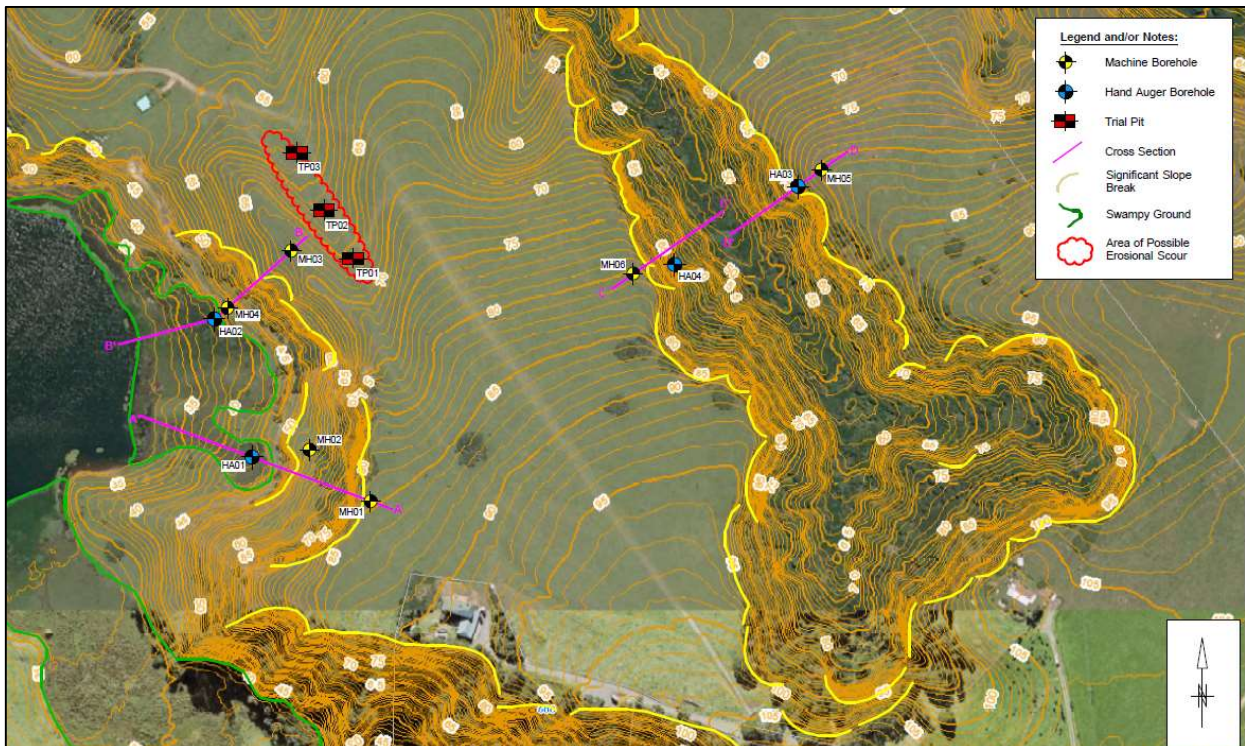
Figure 4 – Site investigation plan (Source: Landers Geotechnical GIR)

Based on the Landers Geotechnical Investigation Report – October 2021 (see Appendix 4 of the AEE), the following results were observed with recommendations following a geomorphic assessment, site walkover, subsoil hand auger and machine bore investigations and stability assessment – refer Figure 4 below for field investigation locations:

- Geometric slope stability assessment carried out indicates slip failure zones encroached into some parts of the proposed building areas hence not meeting minimum factors of safety. The recommendation is to implement a safe building line restriction. Any building encroaching this setback line towards the slope of the gully will require specific design and engineering mitigation (e.g. engineered palisade walls) to meet minimum acceptable factors of safety.

- The central and eastern portions of the site are gentler and do not appear to present the any inherent slope stability risks. The proposed Golf & Property Maintenance Complex (GPMC) is located outside any building restriction line.
- Topsoil was encountered at all test locations ranging up to 0.7m depth but generally averaging 0.3m depth.
- Groundwater was encountered at the time of the investigation within the piezometers installed on the machine boreholes at depths ranging from 2.6m – 15.6m which is below the depths of any anticipated cut level for the development.
- Control of stormwater discharge is essential to minimise slope failure and/ or erosional scour. Discharge from any impervious source should not be concentrated or uncontrolled and the use of engineered diversion channels and energy dissipating outlets are recommended.

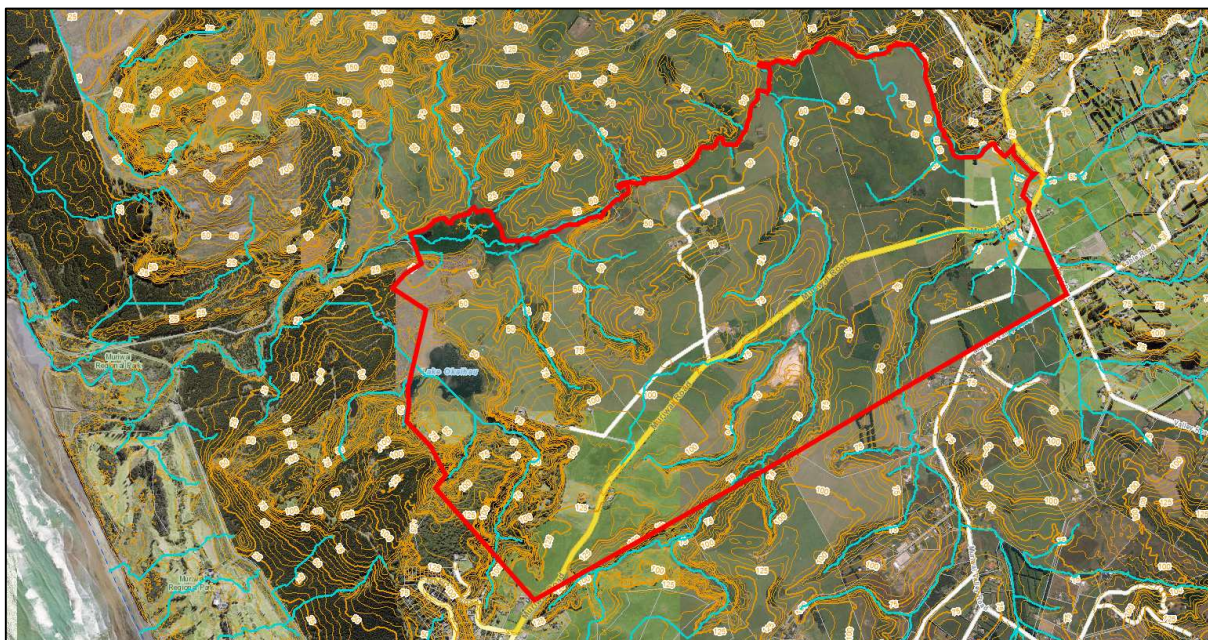
Figure 5 – Existing Rivers and Streams (Source: Auckland Council GeoMaps)

Auckland Council GeoMaps indicate intermittent streams within the site connecting with the Ōkiritoto Stream, which in turn discharges into the Tasman Sea at Muriwai Beach (approximately 1.5km downstream of the site).

The site is also located within Waitemata Aquifer groups. See Figure's 5–7 below.

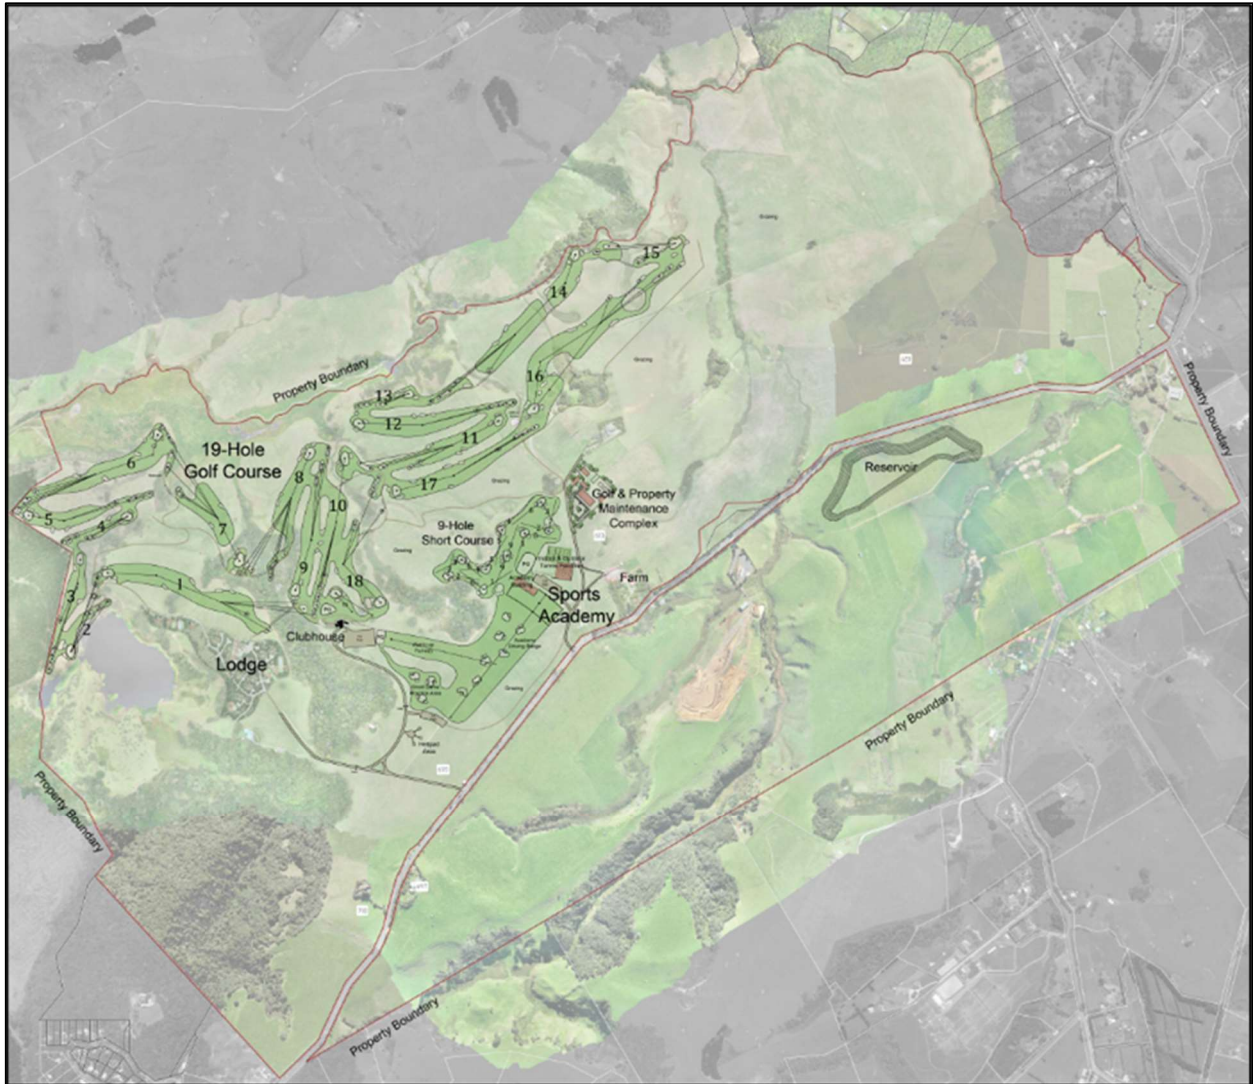
Figure 10 – Proposed Master Plan Layout (Source Kyle Phillips Golf Course Design)

Refer to Figure 11 and the MCCL engineering drawings for the proposed development layout.

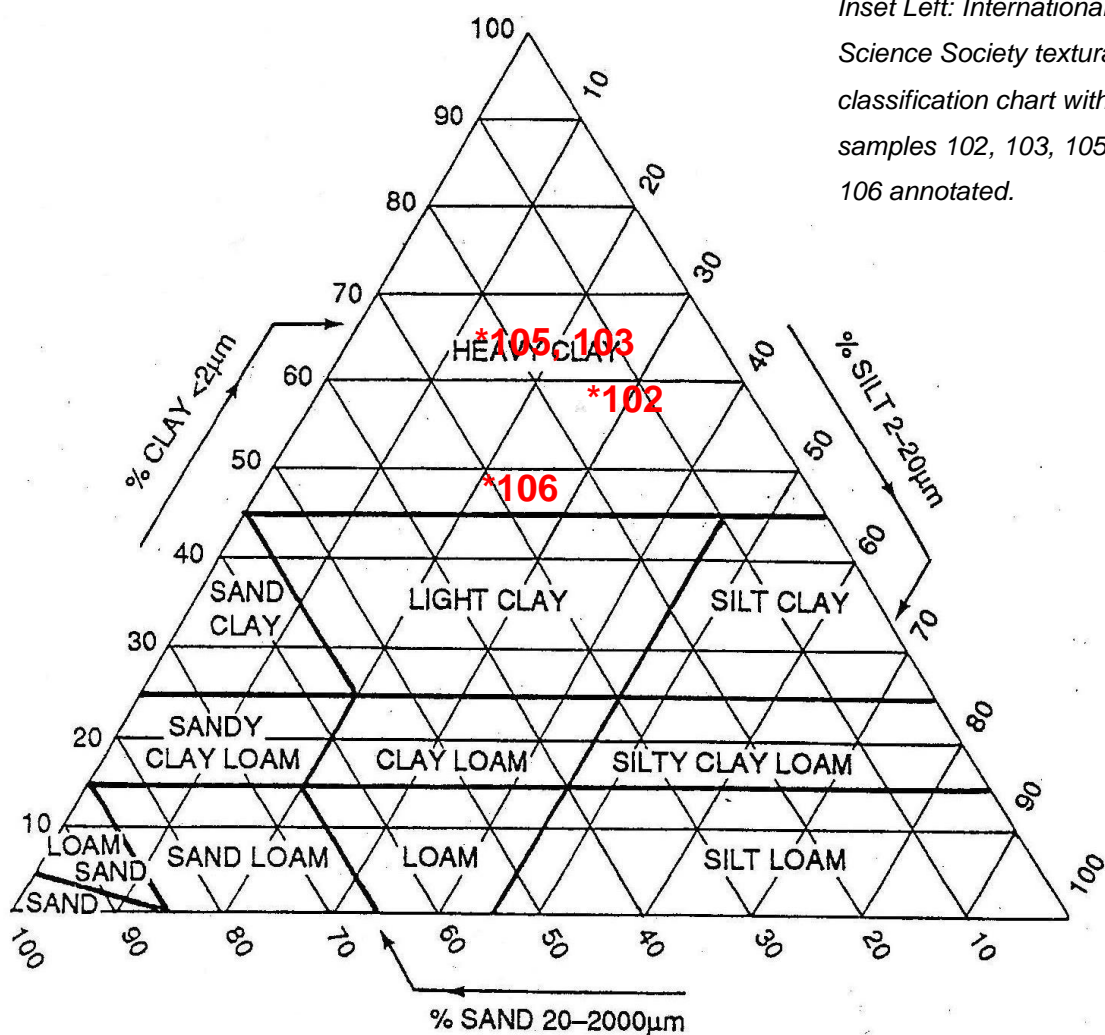
Further, based on laboratory testing, the soils samples recovered fall into the Heavy Clay category according to the International Soil Science Society textural classification chart as shown the inset below with each of samples 102, 103, 105 and 106 annotated.

Inset Left: International Soil Science Society textural classification chart with samples 102, 103, 105 and 106 annotated.

The Auckland Regional Council TR2009/0072¹ (Review of Hydrologic Properties of Soils in the Auckland Region) defines clay soils as having a coefficient of permeability of between 1 and 5 mm per hour (Table 7, Section 3.3 of TR2009/0072).

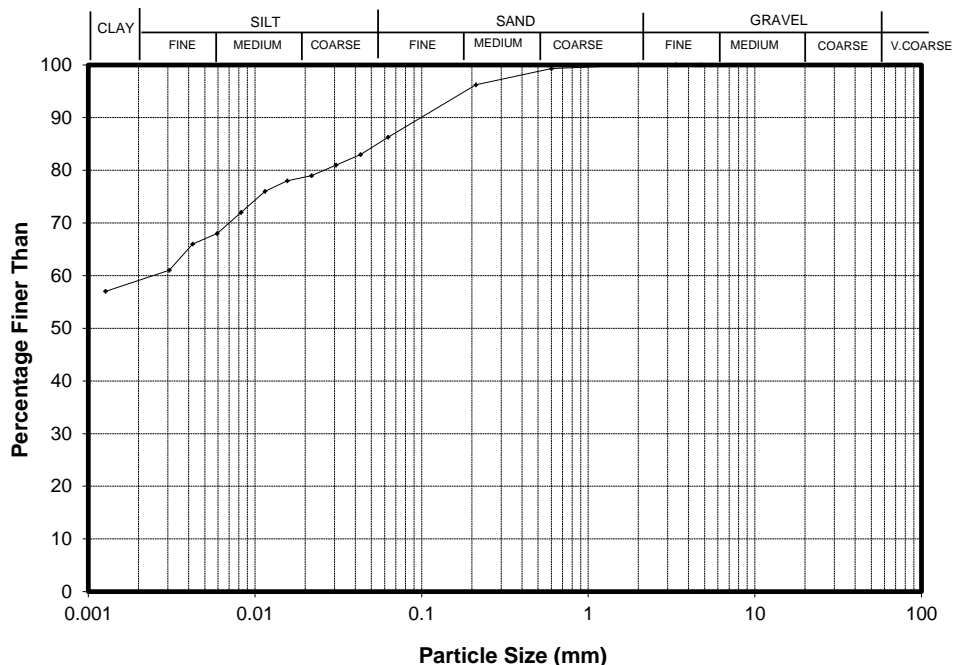
PARTICLE SIZE ANALYSIS

Sieve (mm)	Total % Passing	Sieve (mm)	Total % Passing
4.75	-		
3.35	-		
2.00	100		
0.600	99		
0.212	96		
0.063	86

Equivalent Particle Diameter D (mm)	% of Particles Finer than D
0.0430	83
0.0307	81
0.0219	79
0.0156	78
0.0115	76
0.0083	72
0.0059	68
0.0042	66
0.0031	61
0.0013	57

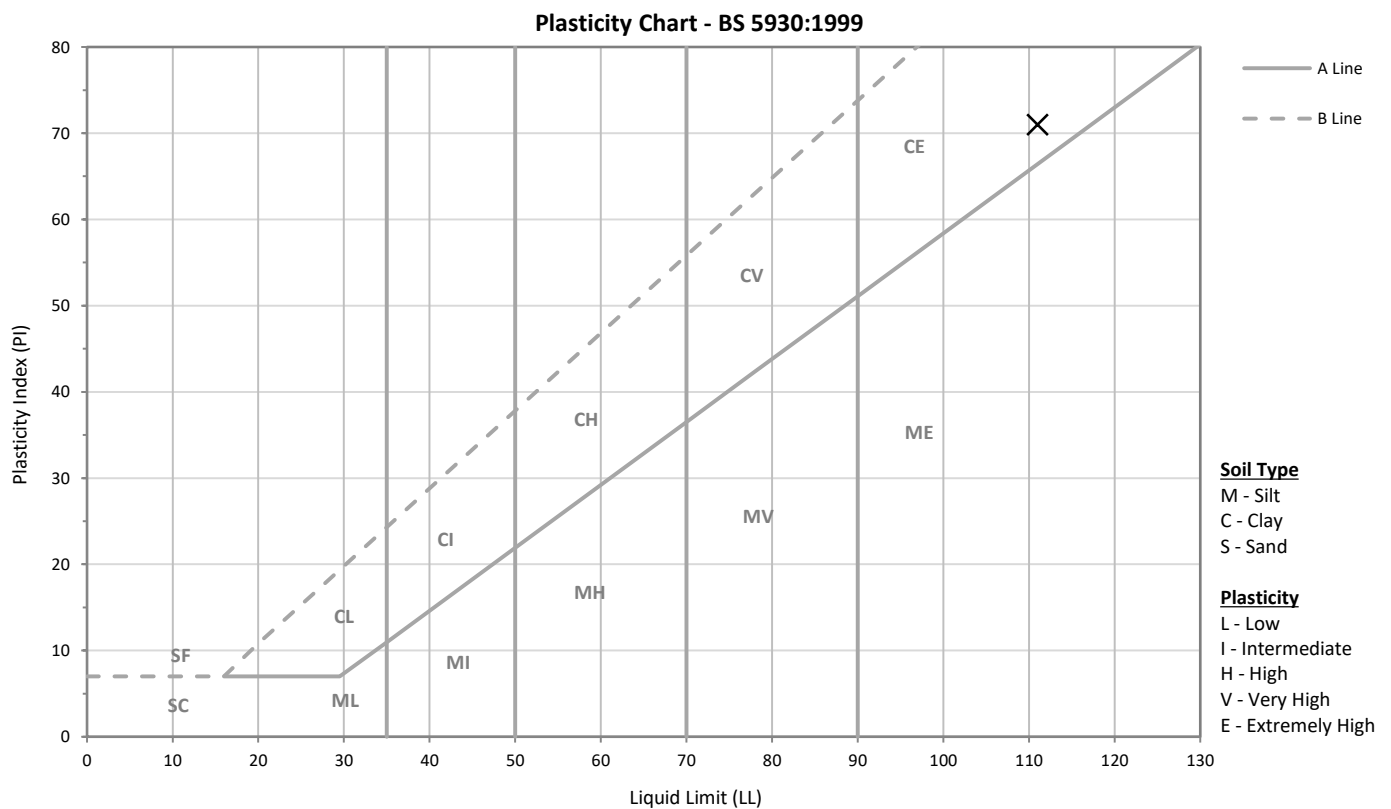
Liquid Limit 111
Plastic Limit 40
Plasticity Index 71
