**PROJECT**  
FORMER CALTEX  
PAKURANGA SERVICE  
STATION

**CLIENT**  
CHEVRON  
NEW ZEALAND

For remediation of a former service station site to remove soils contaminated by petroleum hydrocarbon compounds in and around the historical fuel dispensers and stormwater interceptor locations.

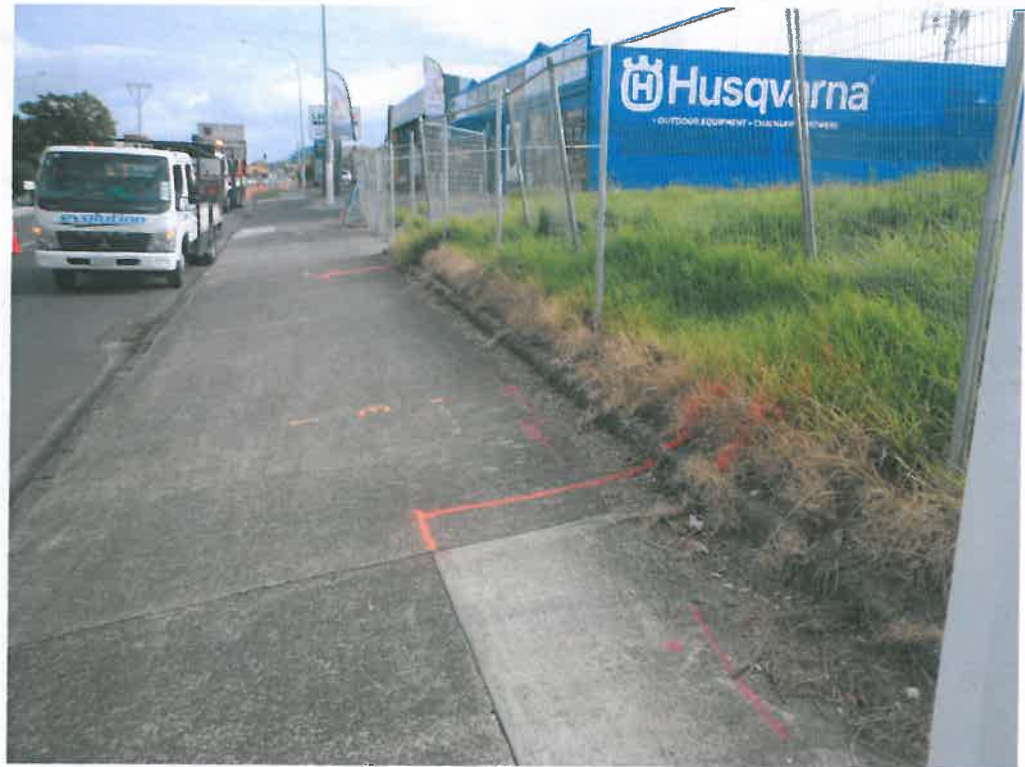
Service mark out along Ti Rakau Drive footpath.  
Two of three exploration trenches visible.

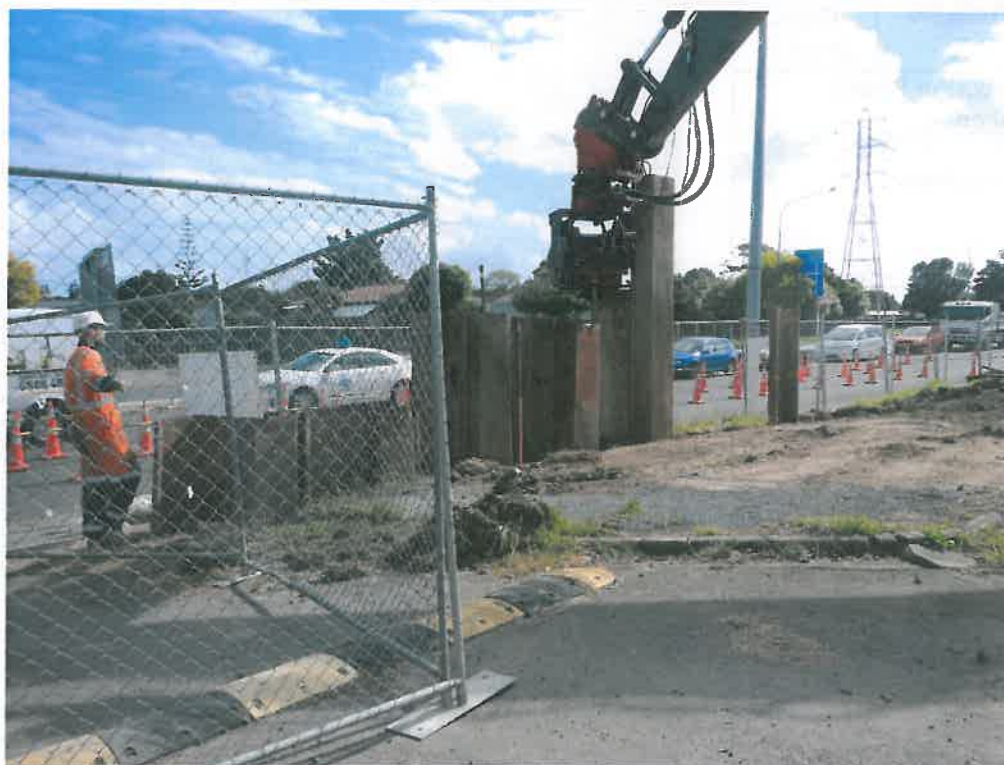
Sheet piling across the south western border.

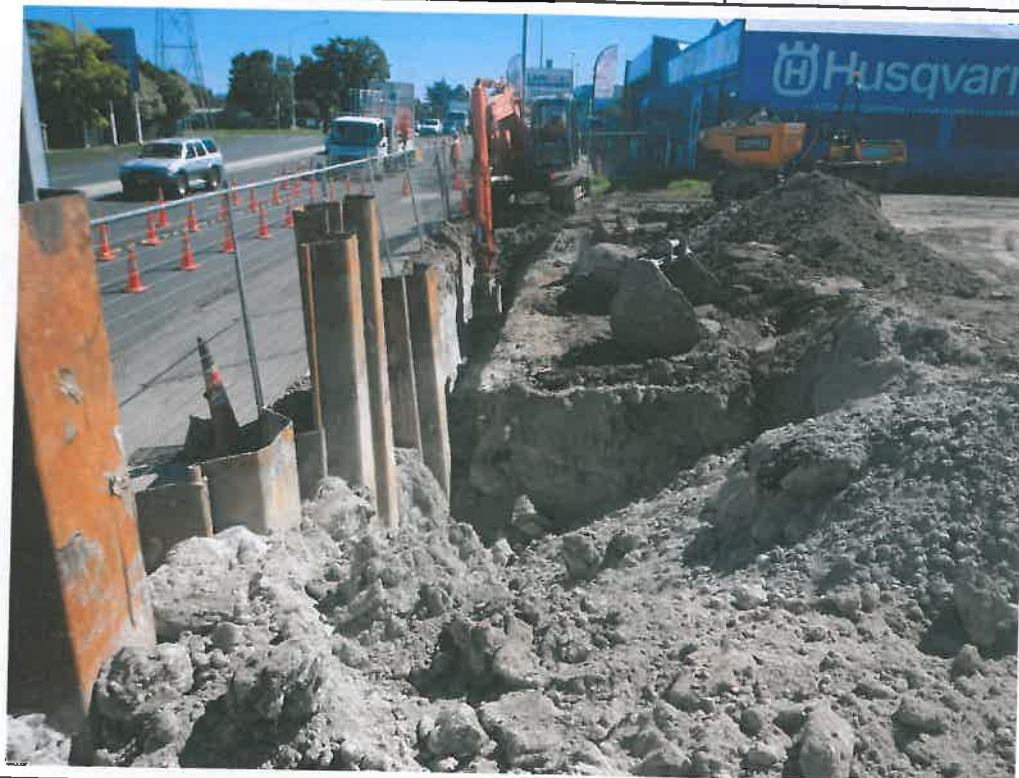
Beginning of excavation and adopted method of sheet piling along south western border.

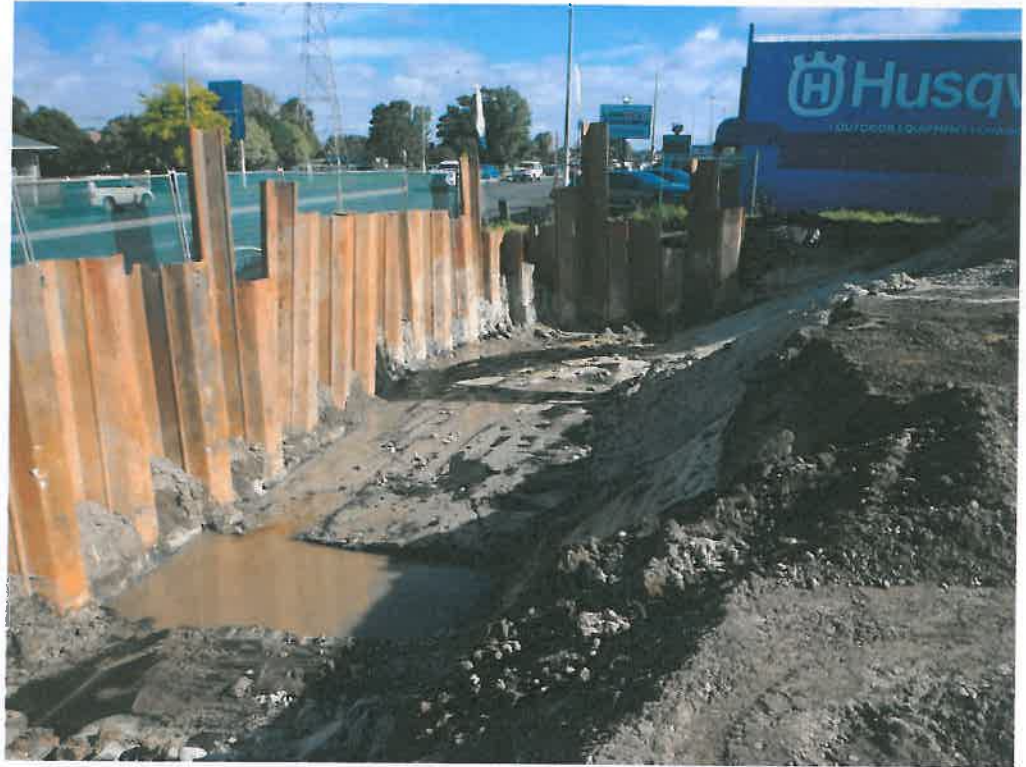
Excavation as at 12-Apr-16. Sump (lower left corner) created to capture groundwater.

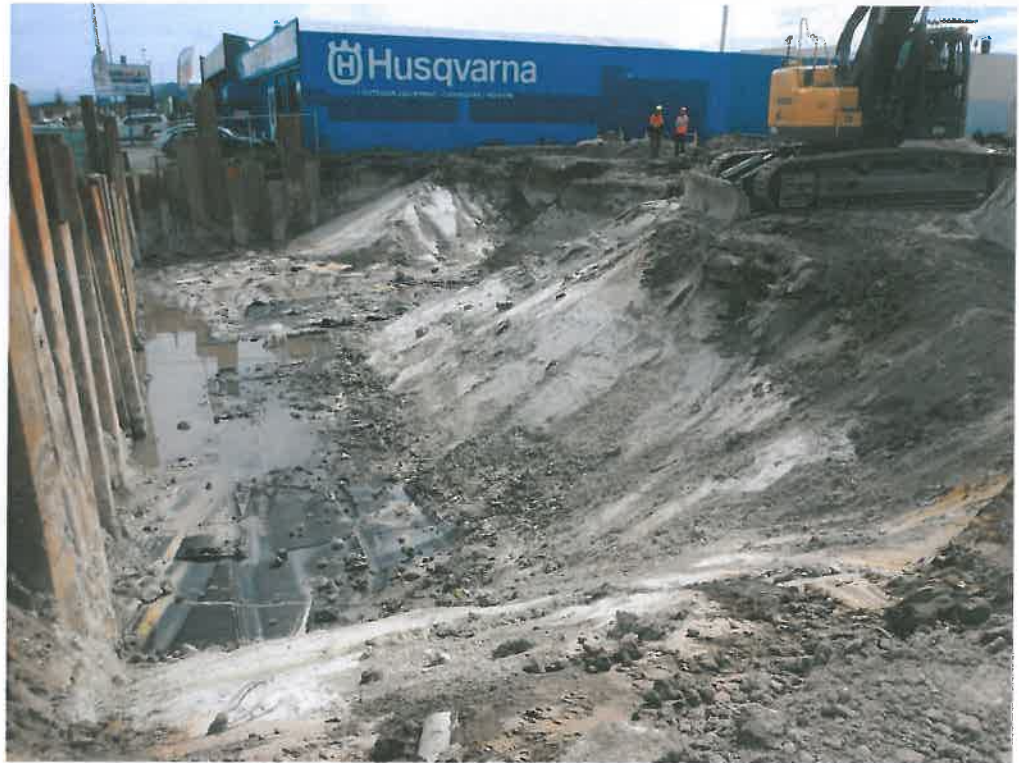
Excavation as at 13-Apr-16. Extension to the east and north.

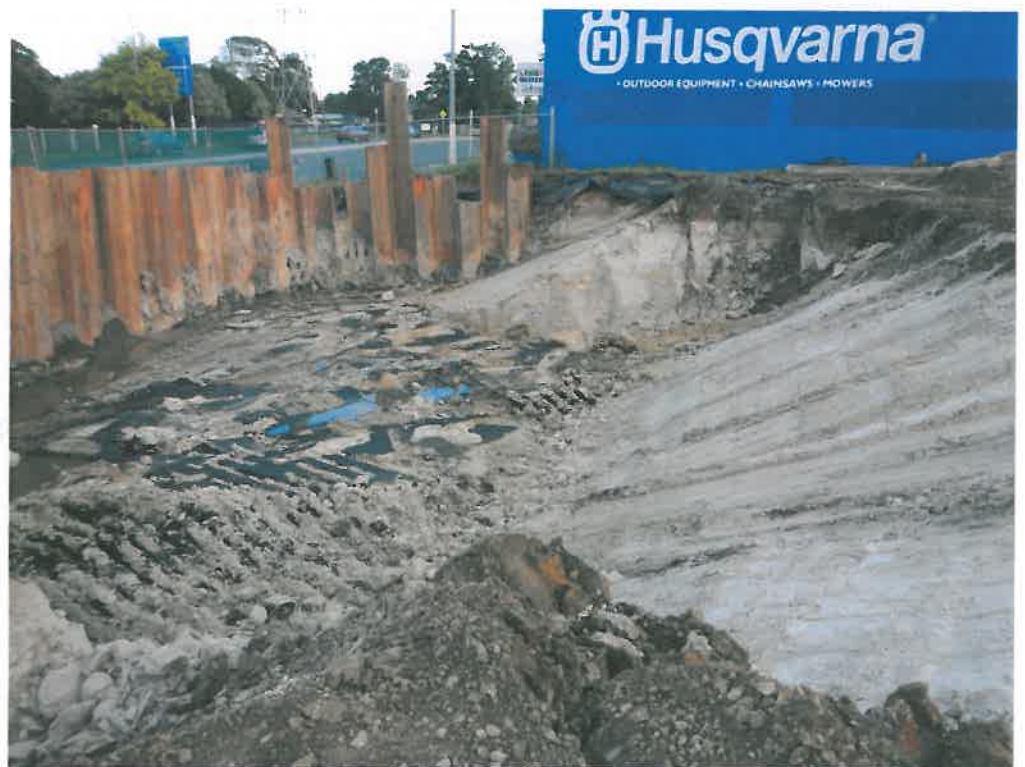
Excavation as at 15-Apr-16. Further extension to the north east.

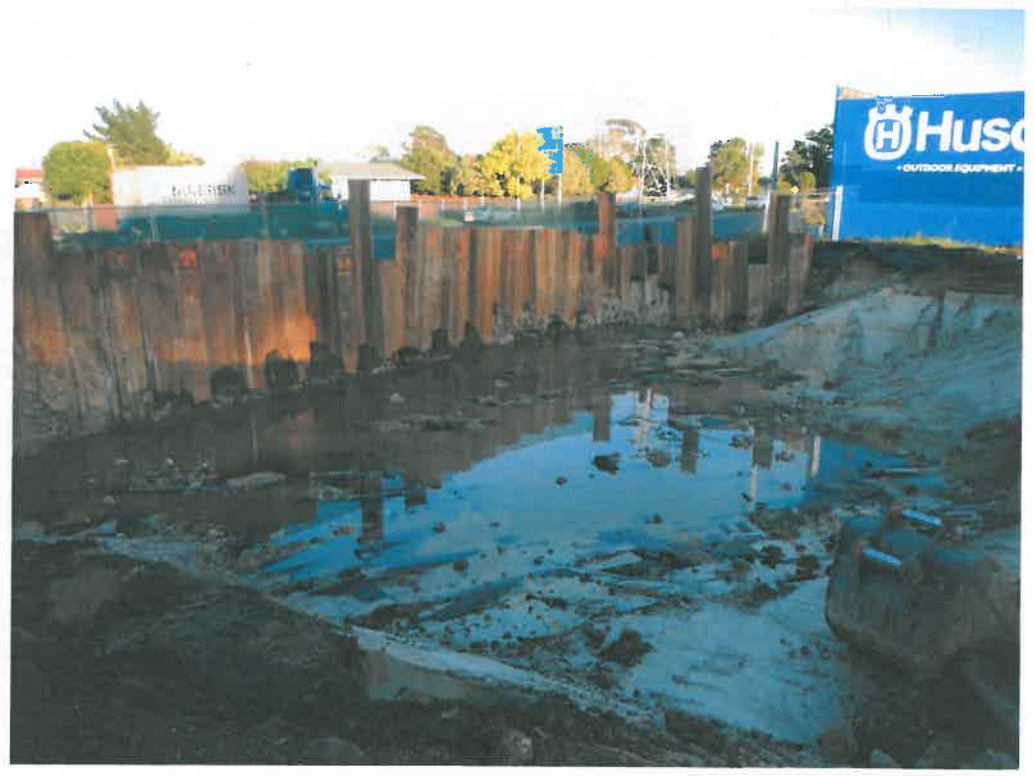
Excavation as at 18-Apr-16. After weekend of moderate rainfall. Water was removed via sucker truck.

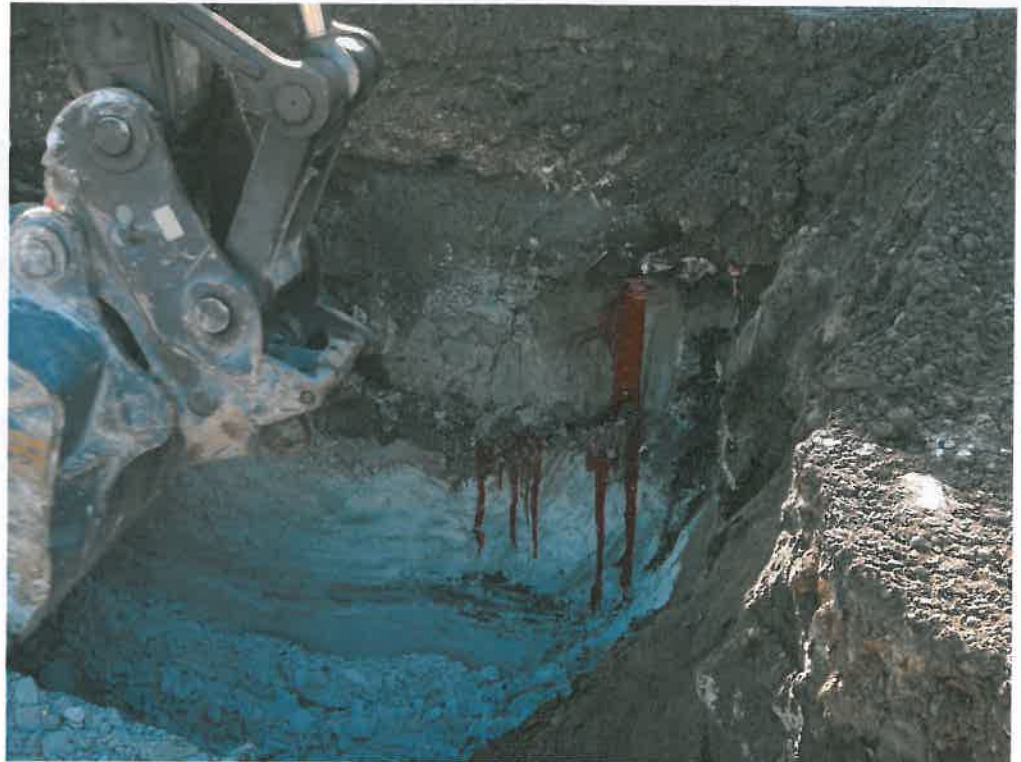
Product lines with residual product. Lines found in the south eastern corner of excavation towards the edge of the former forecourt.

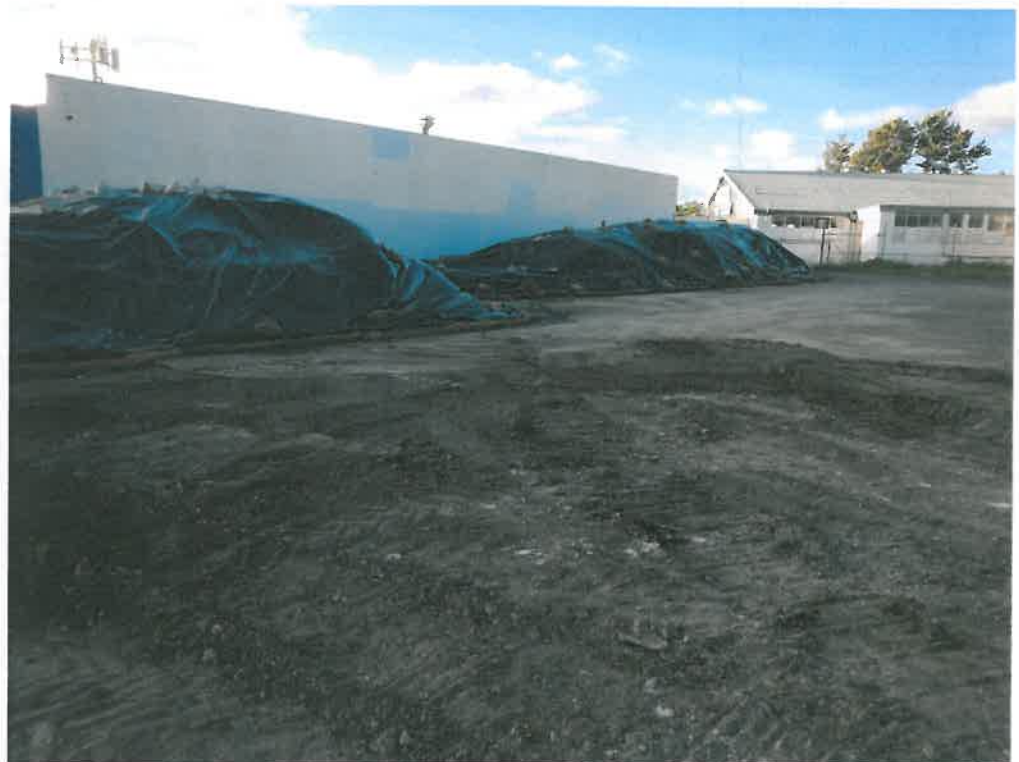
Stockpiles as at 18-Apr-16. Photo showing method of covering.

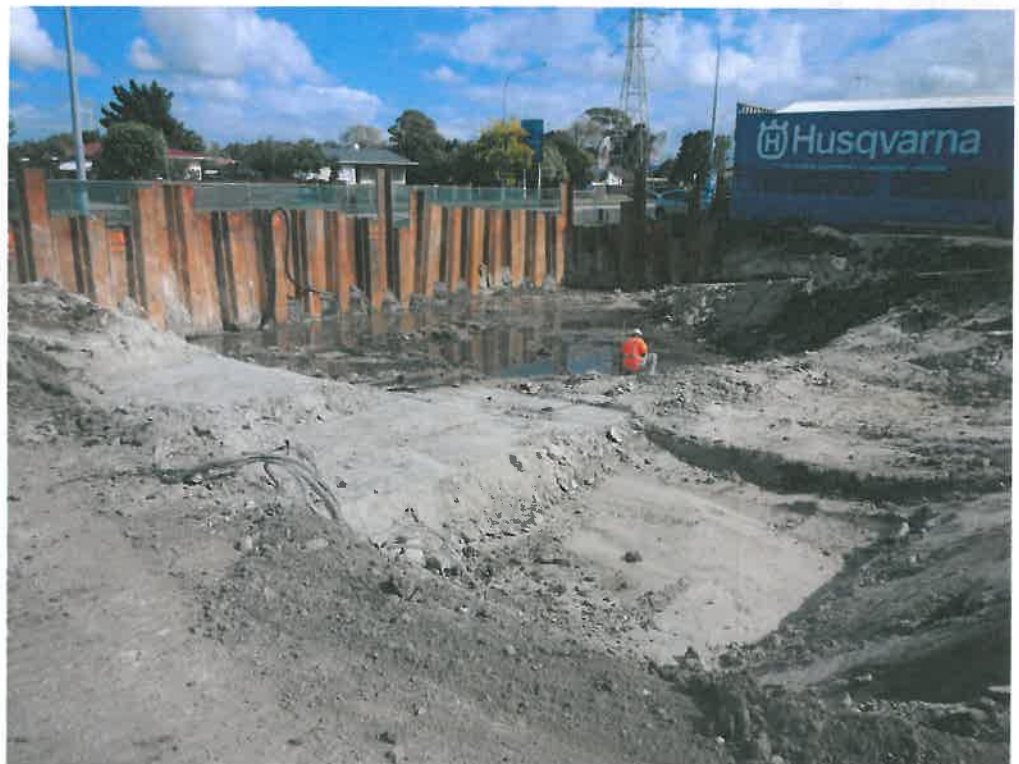
Excavation as at 20-Apr-16. Final extent of excavation.

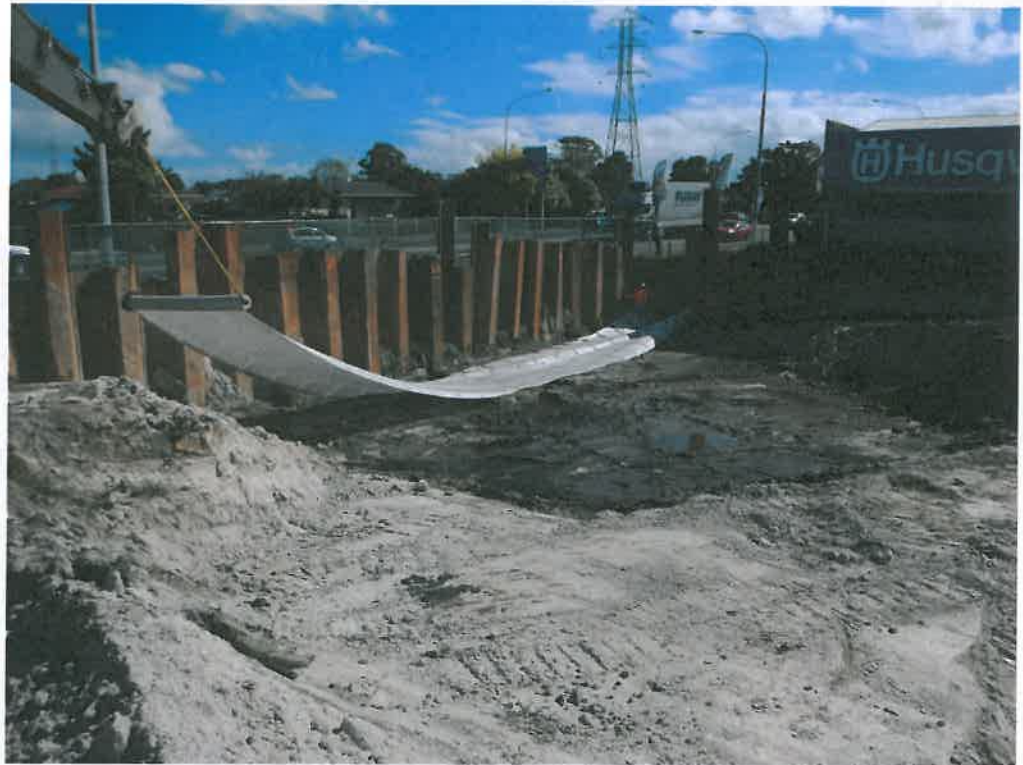
Placing geo-fabric on base of excavation.

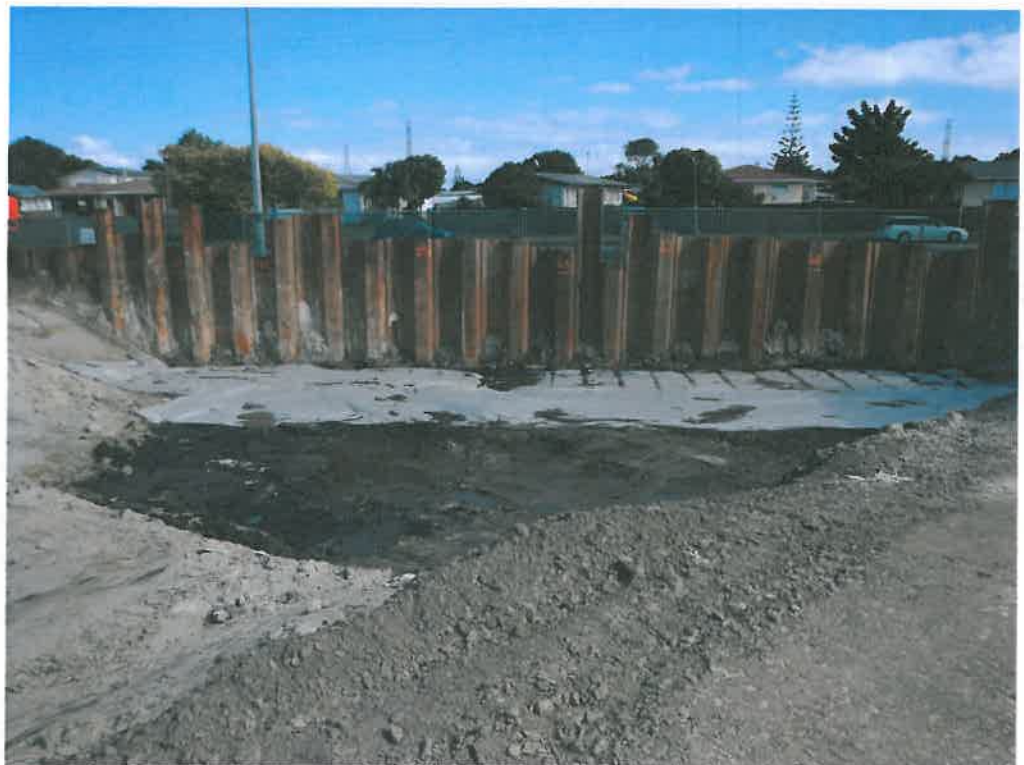
Excavation as at 20-Apr-16. Geo-fabric being laid at depth.

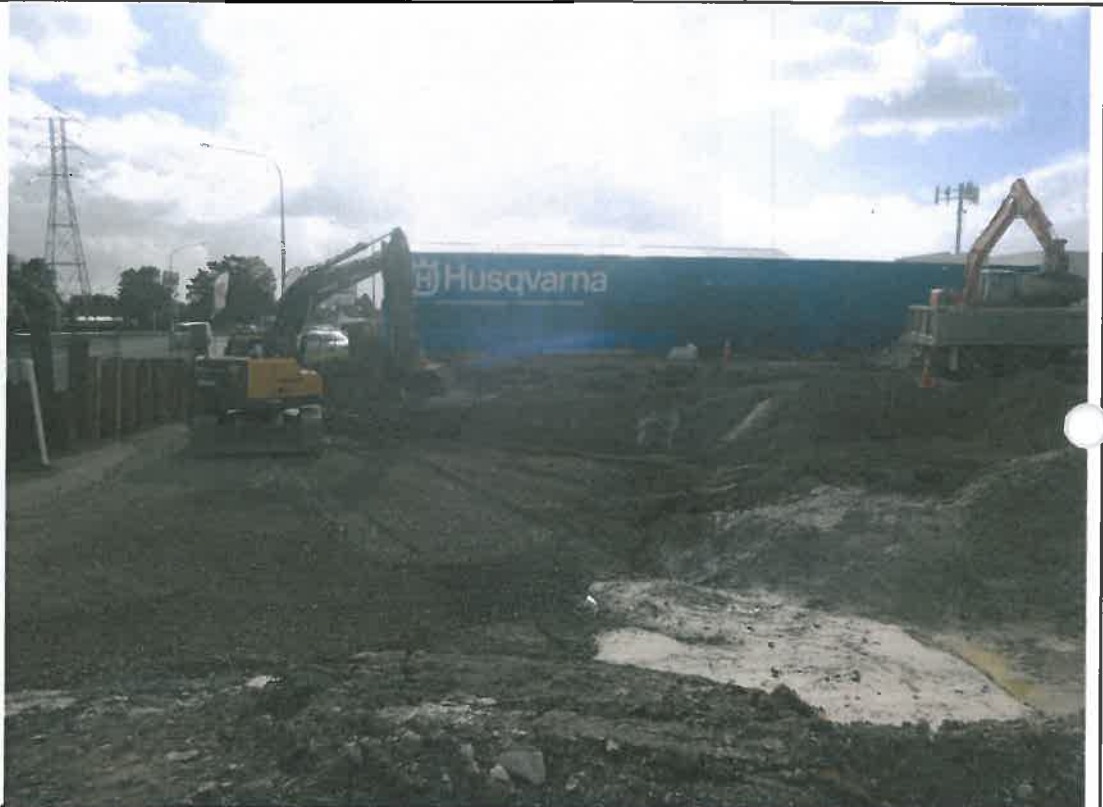
Excavation as at 26-Apr-16. Monitoring well installation in progress to the left of photograph.

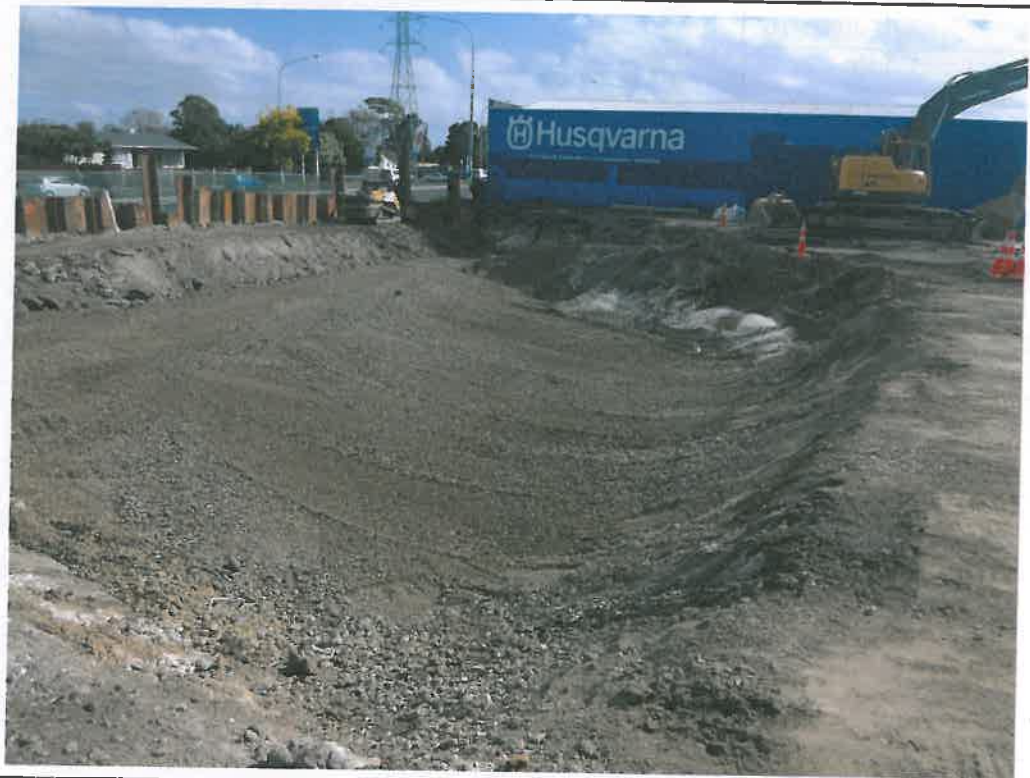
Excavation as at 27-Apr-16. Imported aggregate placed in excavation.

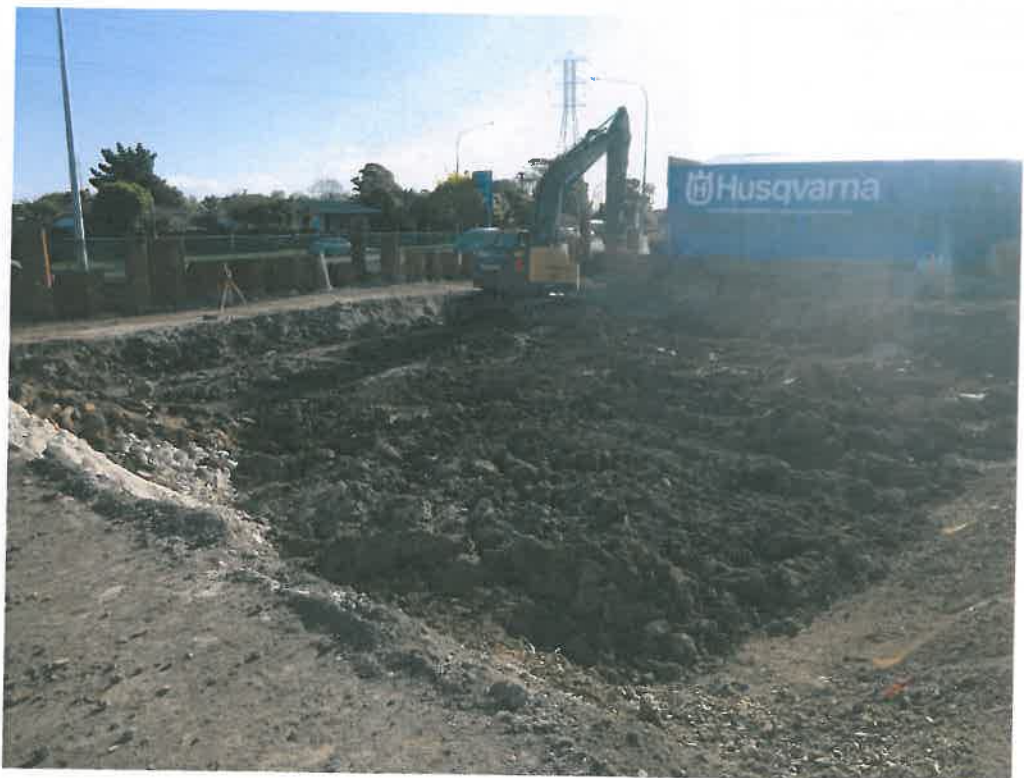
Excavation as at 27-Apr-16. Stockpiled clay material placed at depth.

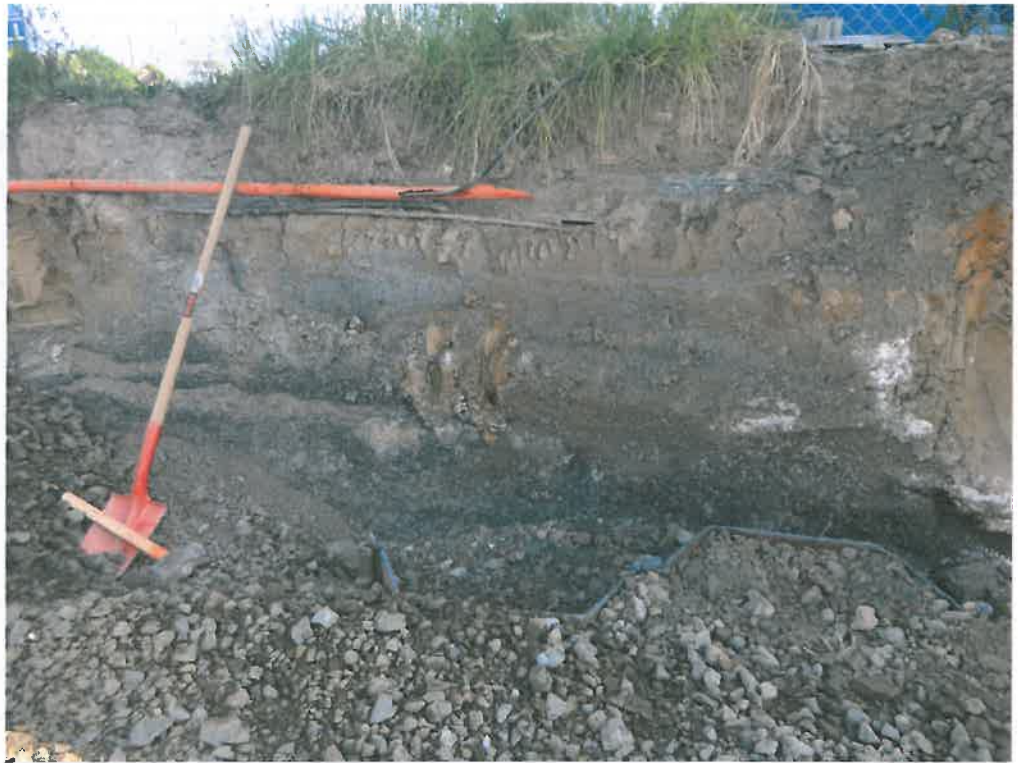
Sheet piling in NW corner cut off at approximately and abandoned in-situ.

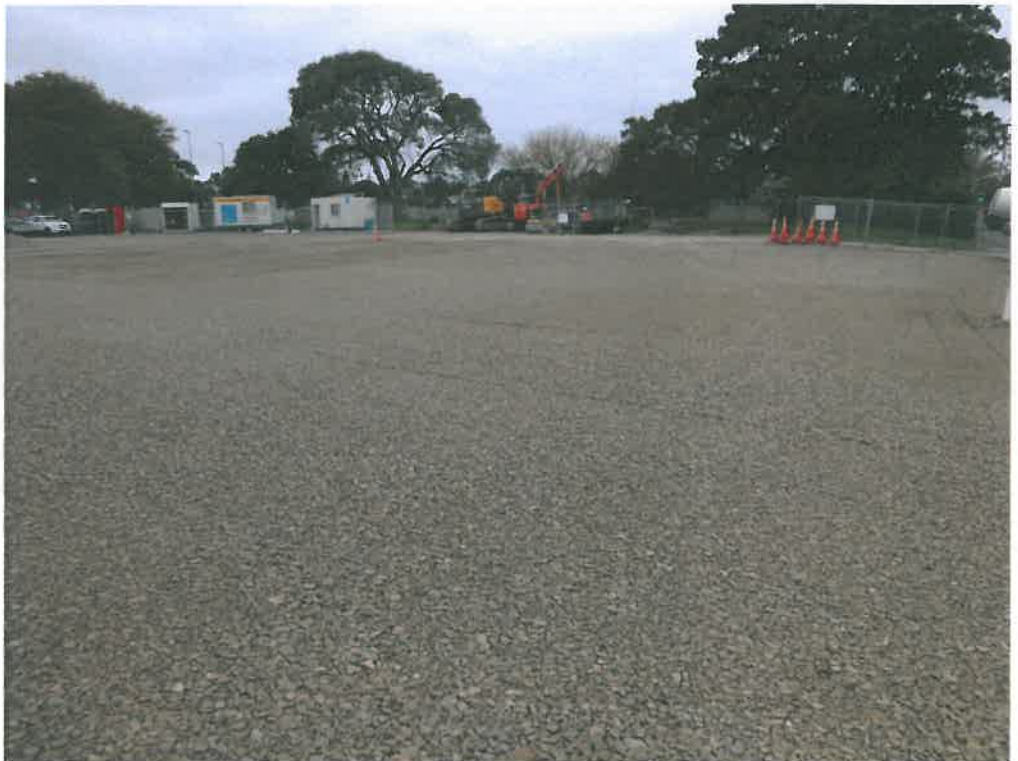
Finished ground conditions.
