Appendix E: Asbestos Discovery at Seven Oaks Drive

Appendix G: Reeves Road Flyover Pile Location Plan

PROJECT: EASTERN BUSWAY ZONE 2
REEVES ROAD FLY OVER

Appendix H: 1R Dale Crescent Soil Quality Assessment

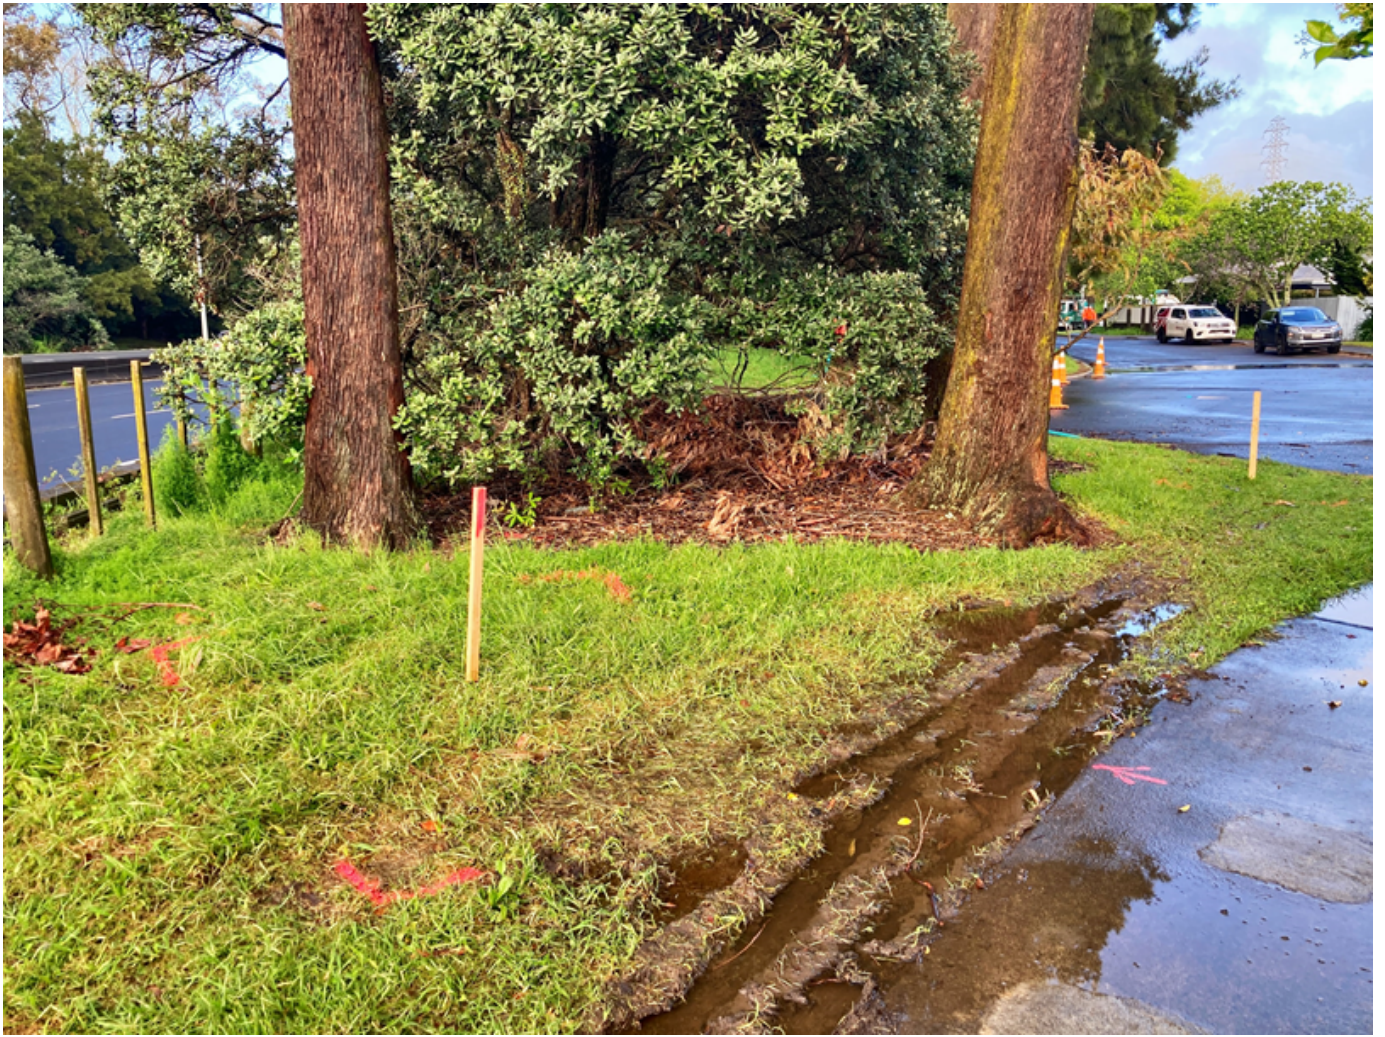
We came across some possible fragments of asbestos board today during the hydrovac of CPT204(E) - located by the public walkway at the end of Seven Oaks Dr.

I double bagged the pieces that were found at approximately 1m deep. There appeared to be some more smaller fragments at the base of the hole but we had stopped work. The hole was then backfilled with pea gravel. I have heard this CPT will now be completed on SEART road corridor under the night works lane closure.

The results from the sample I delivered to Hill Laboratory yesterday detected white and brown asbestos. This sample was found in CPT204(E) @ 1m bgl during hydro excavation.
