Eastern Busway EB2 and EB3 Residential

Arboricultural Effects Assessment

Document Number: EB234-1-PL-RP-Z2-000022

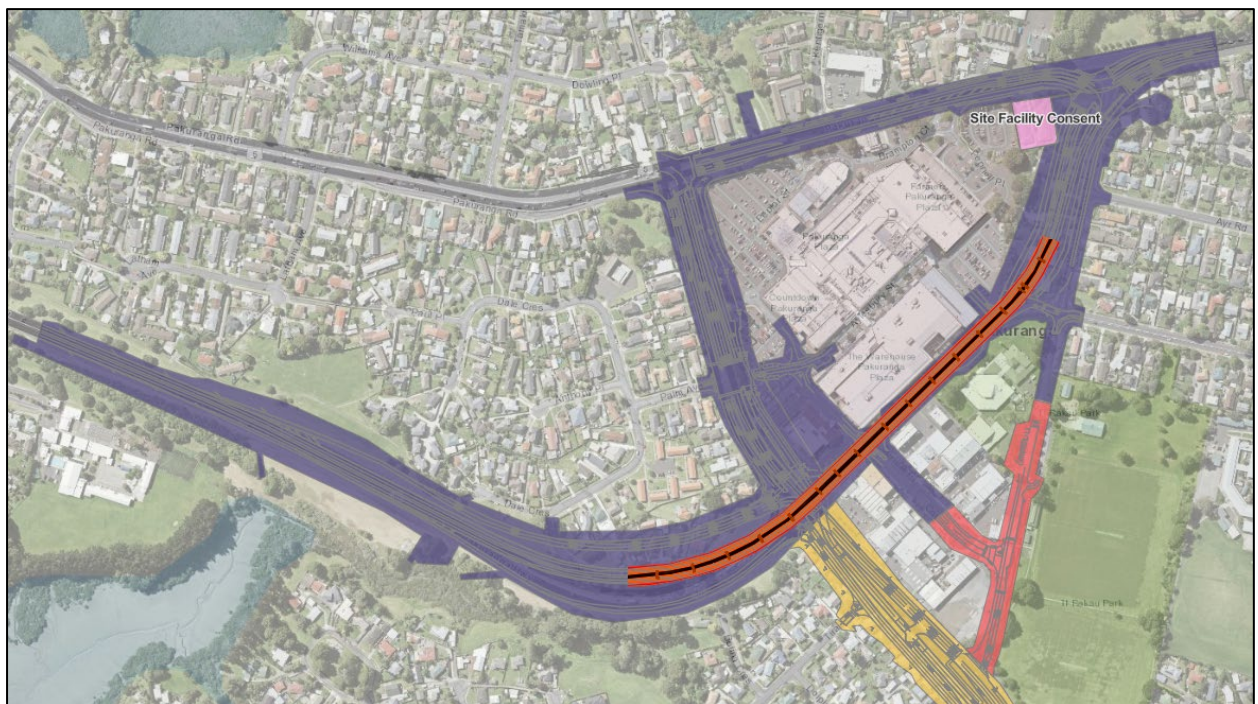
Figure 2 – EB2 is identified by the purple shading while EB3R is identified by the yellow shading. The pink shading in Ti Rakau Park identifies the William Roberts Road Extension, which is dealt with by a separate RMA application package.

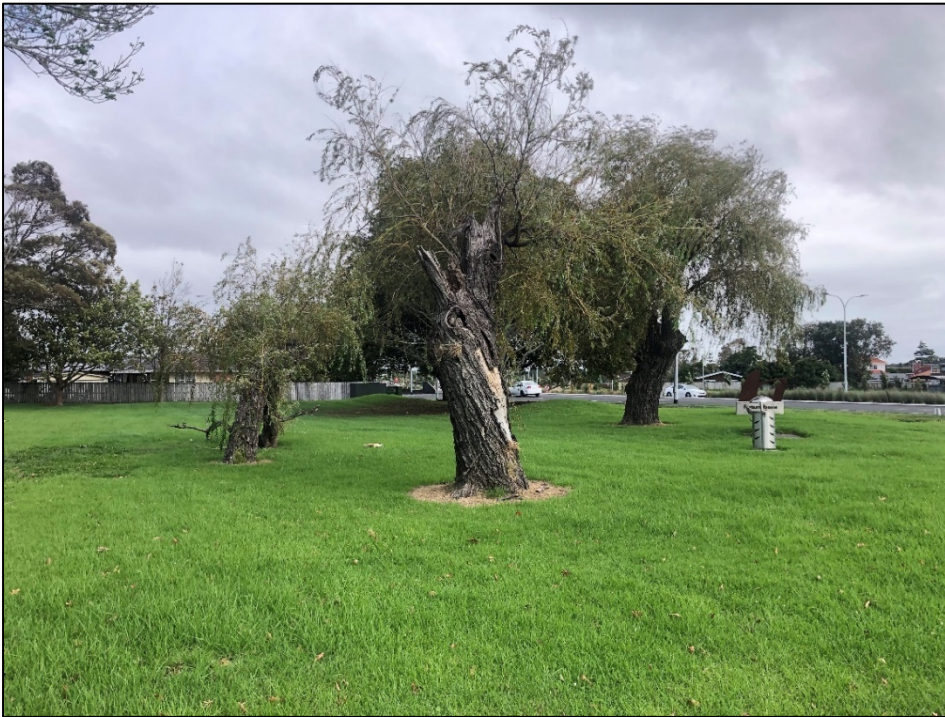
Figure 3 – Three Willow Trees Located within Ti Rakau Corner Reserve (Arborlab April 2022).

Ti Rakau Corner Reserve, at the south-western corner of Ti Rakau Drive and Pakuranga Road, contains a mixed species of mature exotic trees. Included within this reserve are two willow trees identified within the AUP(OP) as notable trees (reference 1495). However, three weeping willows were identified within the reserve, and it is unclear which of the three trees are the two notable specimens (Refer to Figure 3 below). Two of the trees have historically suffered significant storm damage and have been reduced in size. None of these Willow trees will be affected by the proposed works.

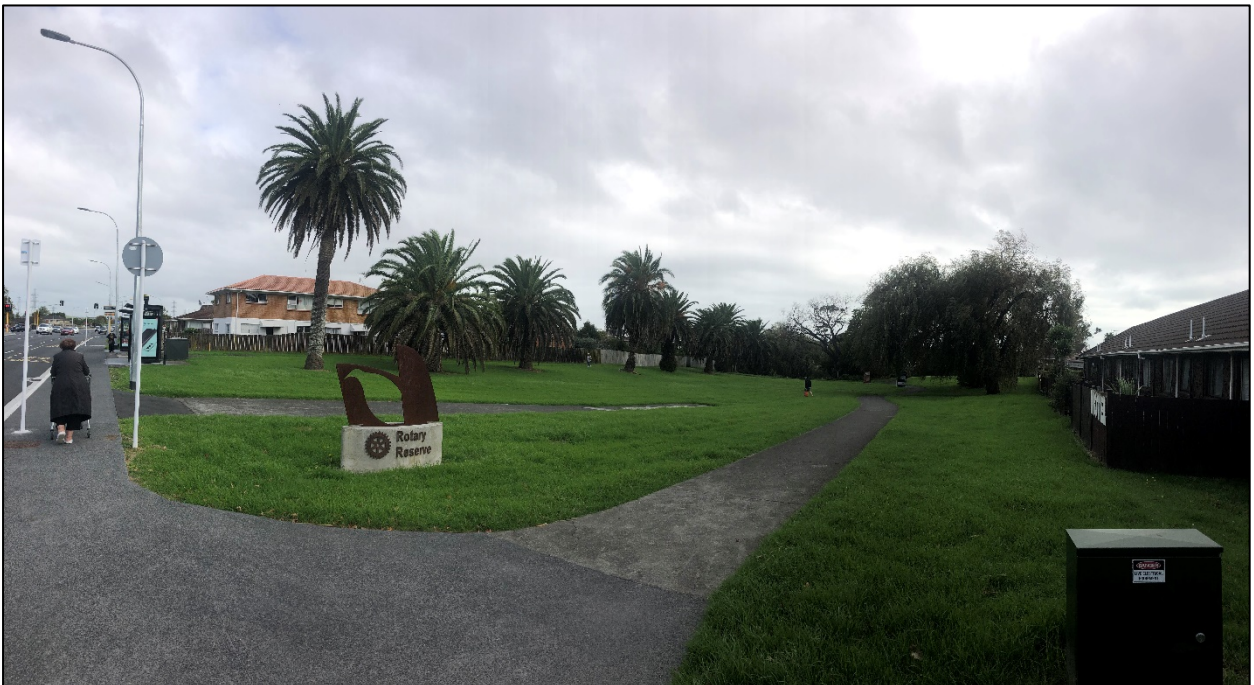
Figure 4 – Rotary Reserve Phoenix Palms (Arborlab April 2022).

A group of Phoenix palms (Trees 220-224) and a weeping willow tree (Tree225) are located within Rotary Reserve where stormwater infrastructure works are proposed to be undertaken (Figure 4).

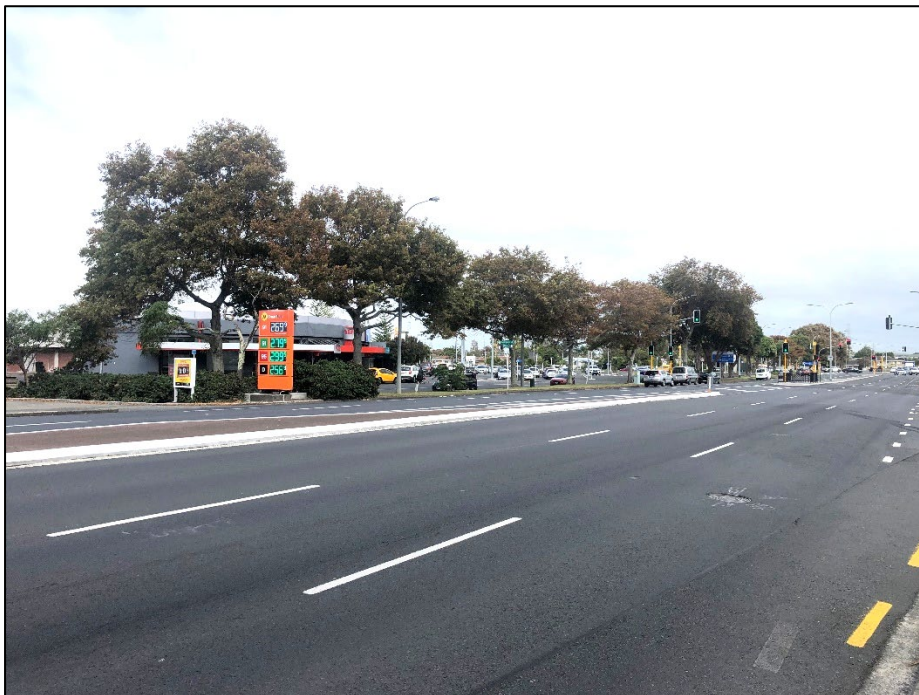
Figure 5 – Pin-oaks along the road reserve of Pakuranga Road, north of Pakuranga Plaza.

The periphery of Pakuranga Town Centre has a mix of tree species including exotic and indigenous specimens (Figure 5). Typically, the planting includes mature specimens located within the road reserve, in grass berms between the footpath and the private property boundaries. Predominant species include; ash (*Fraxinus* sp.), Indian bead (*Melia azedarach*), pin oak, box gum (*Lophostemon confertus*) and Bull Bay magnolia (*Magnolia grandiflora*).

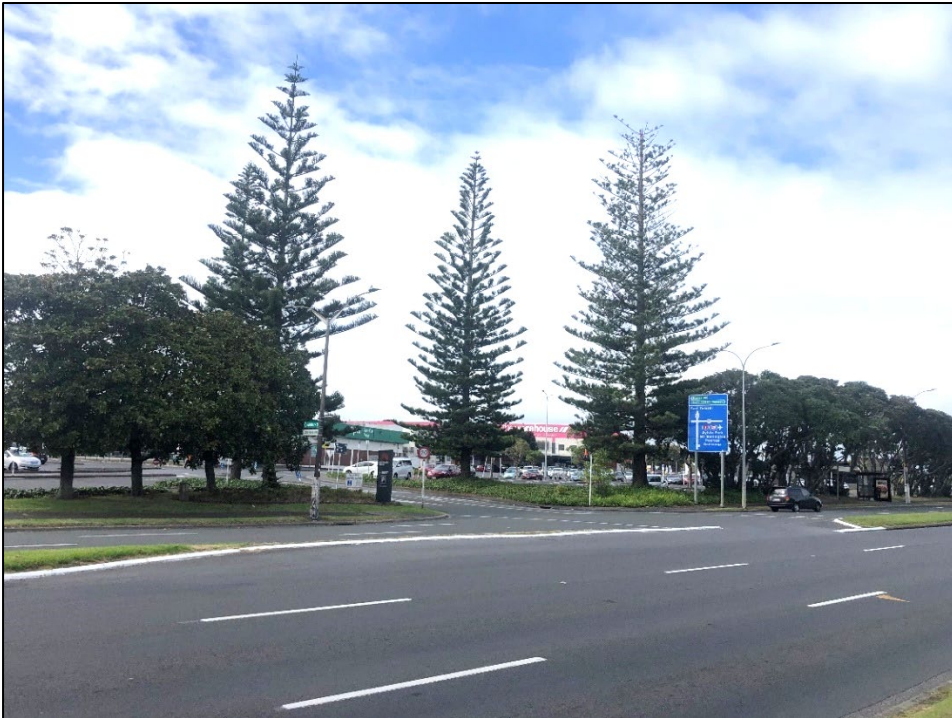
Figure 6 – Norfolk Island pines (Trees 388 – 391) at the entrance to Pakuranga Plaza (on Council utility land) and group of pōhutukawa to the right (Tree 392). (Arborlab - April 2022)

The entry to the Pakuranga Plaza carpark (which is an Auckland Council Utility Reserve) has four mature Araucaria species trees, which consists of three Norfolk Island pine (*Araucaria heterophylla*) and one Cooks pine (*A. columnaris*) (Tree No's 388-391) Figure 6. One of the Norfolk Island pine trees is suffering apical die back (death of the treetop).

To the south of these Araucaria is a row of closely spaced Pōhutukawa (Tree No. 392). These trees are multi-stemmed specimens, which due to their growing location, have had their natural habit of spreading and occasionally subsiding, curtailed by necessary pruning.

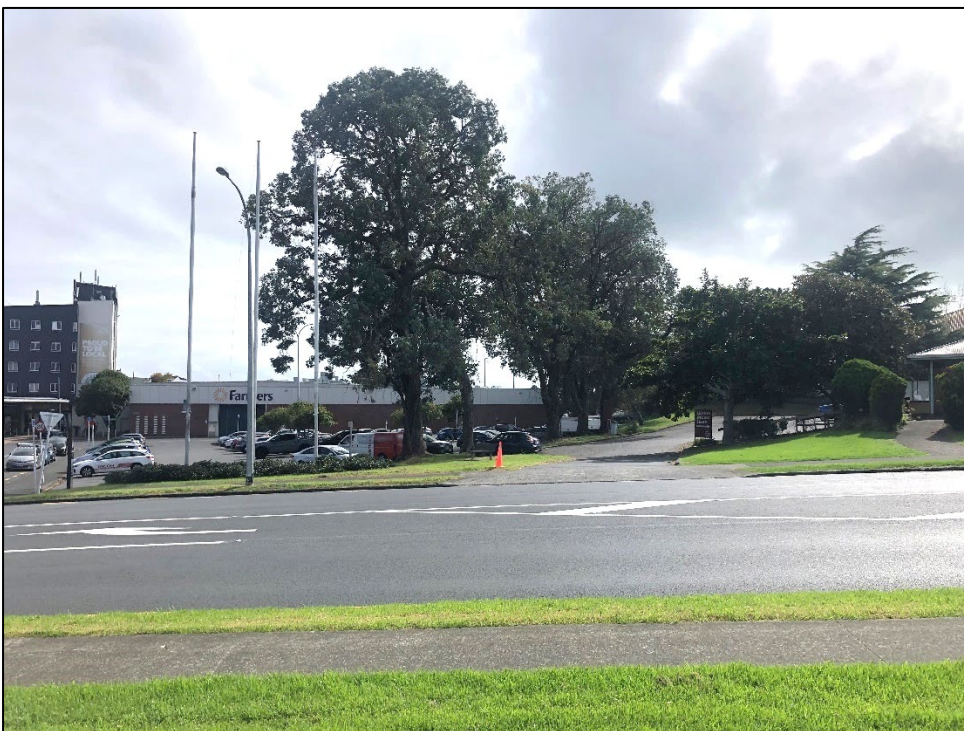
Figure 8 – Southern end of mature tree group circled in Figure 2 above (Arborlab – April 2022)

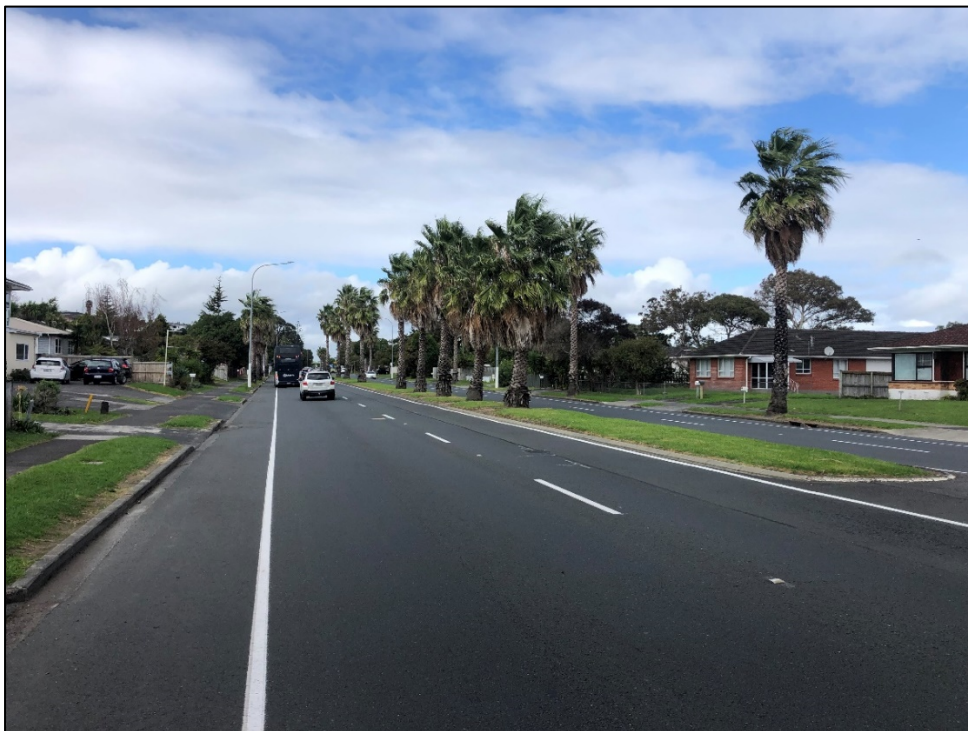
Figure 9 – Example of Streetscape along Ti Rakau Drive in EB3R.

The prominent species of trees within the Ti Rakau Drive road reserve (street trees) includes box gum and Washingtonia palm (Figure 9). Washingtonia palms have been used both in the grass berm between the kerb and the foot path and also as median strip planting.

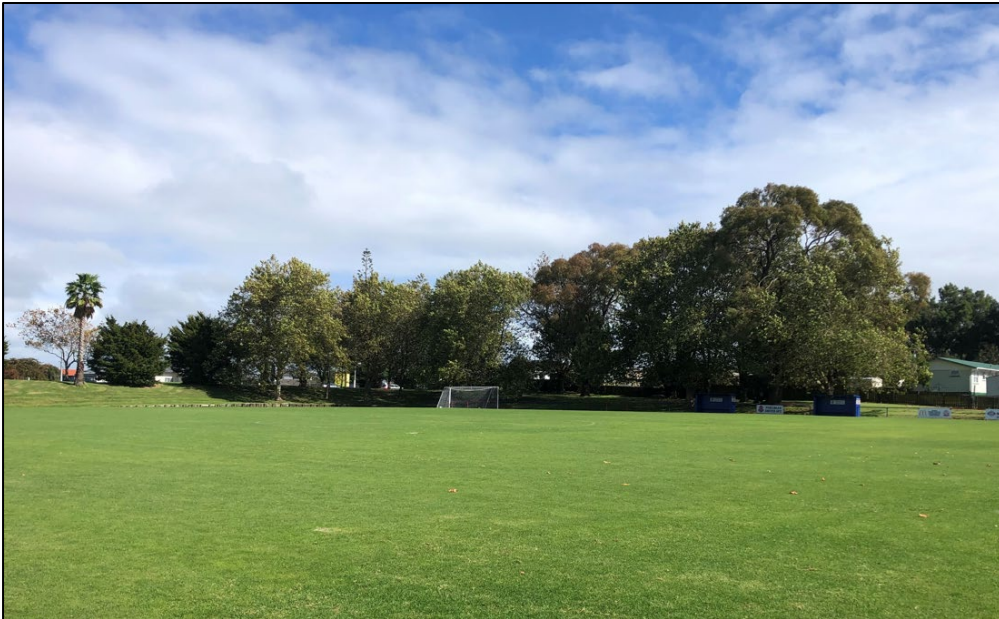
Figure 10 – Mature Exotic Trees within the South-Western corner of Riverhills Park.

Riverhills Park contains a collection of mature trees within the south-western corner (primarily London plane (*Platanus x acerifolia*)) and Eucalyptus (Figure 10). The southern part of Riverhills Park contains groupings of early mature trees consisting of totara (*Podocarpus totara*), mature London plane and Washingtonia palms along its Ti Rakau Drive frontage.

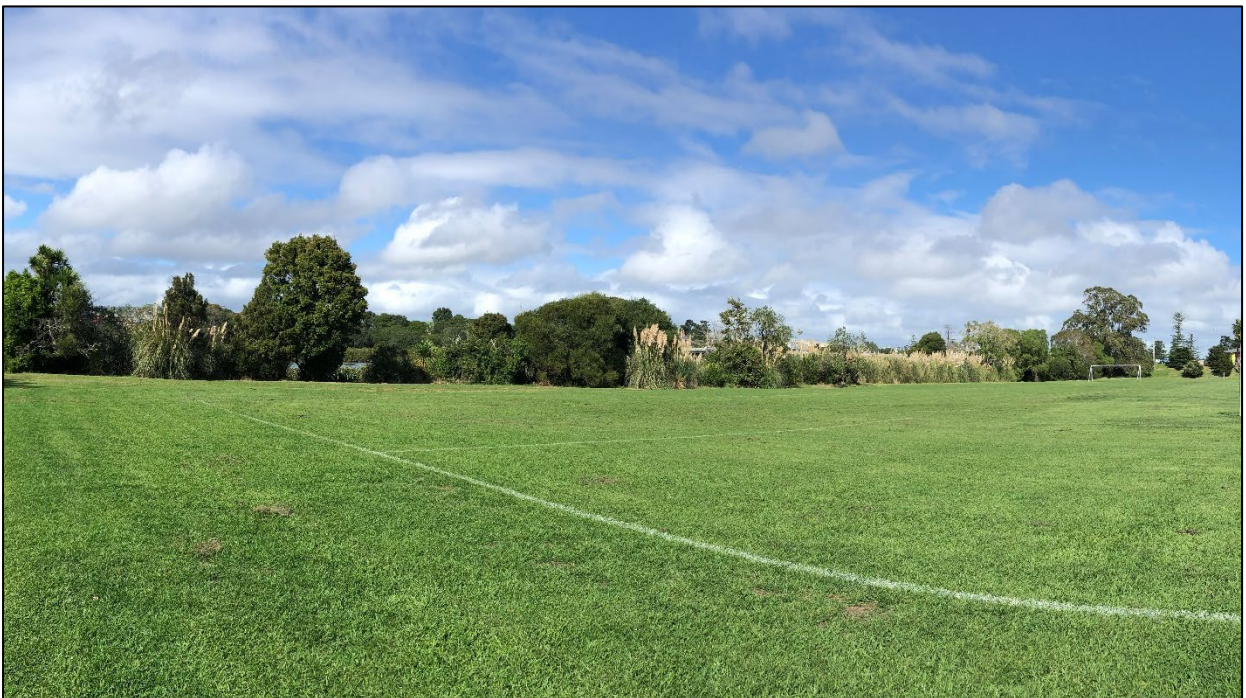
Figure 11 – Foreshore Vegetation at South-Eastern aspect of Riverhills Park.

The south-eastern aspect of Riverhills Park is comprised of a short bank down to the foreshore. The trees present are a mixture of native and exotic, with some sections predominated by pampas grass (refer to Figure 11 below).

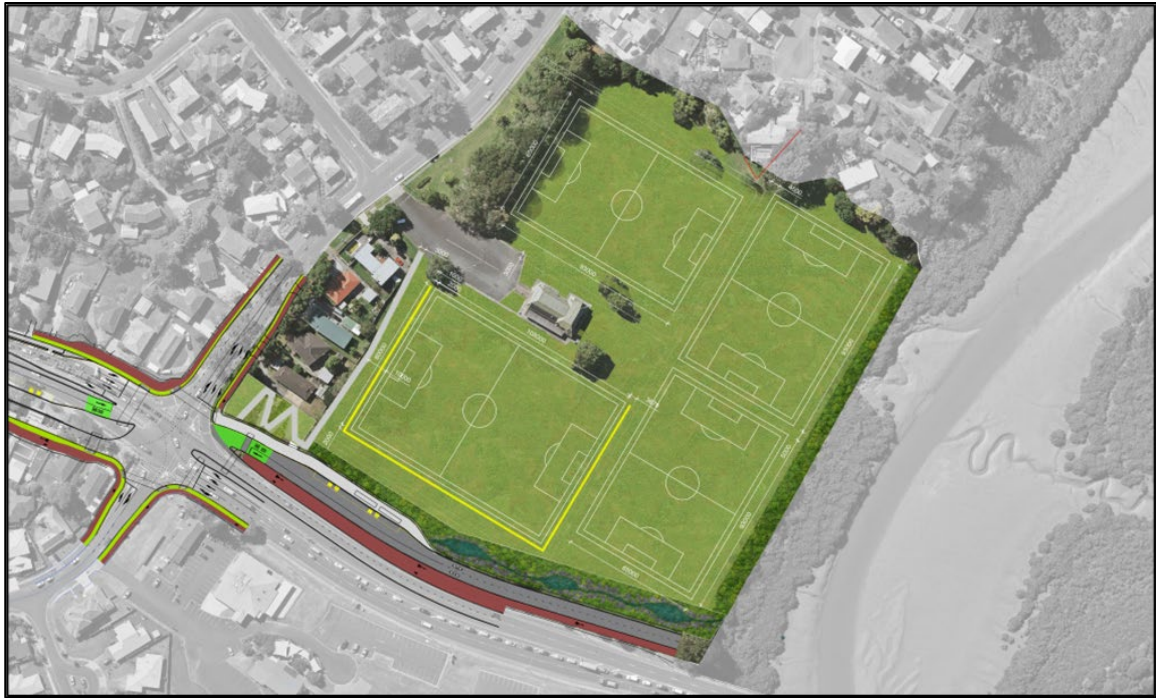
Figure 12 – Options for mitigation at Riverhills Park.
