**Geotechnical and
Contaminated Land Desktop
Assessments**

121 Murphys Road, Flat Bush, Auckland

Prepared for
Ministry of Education

Prepared by
Tonkin & Taylor Ltd

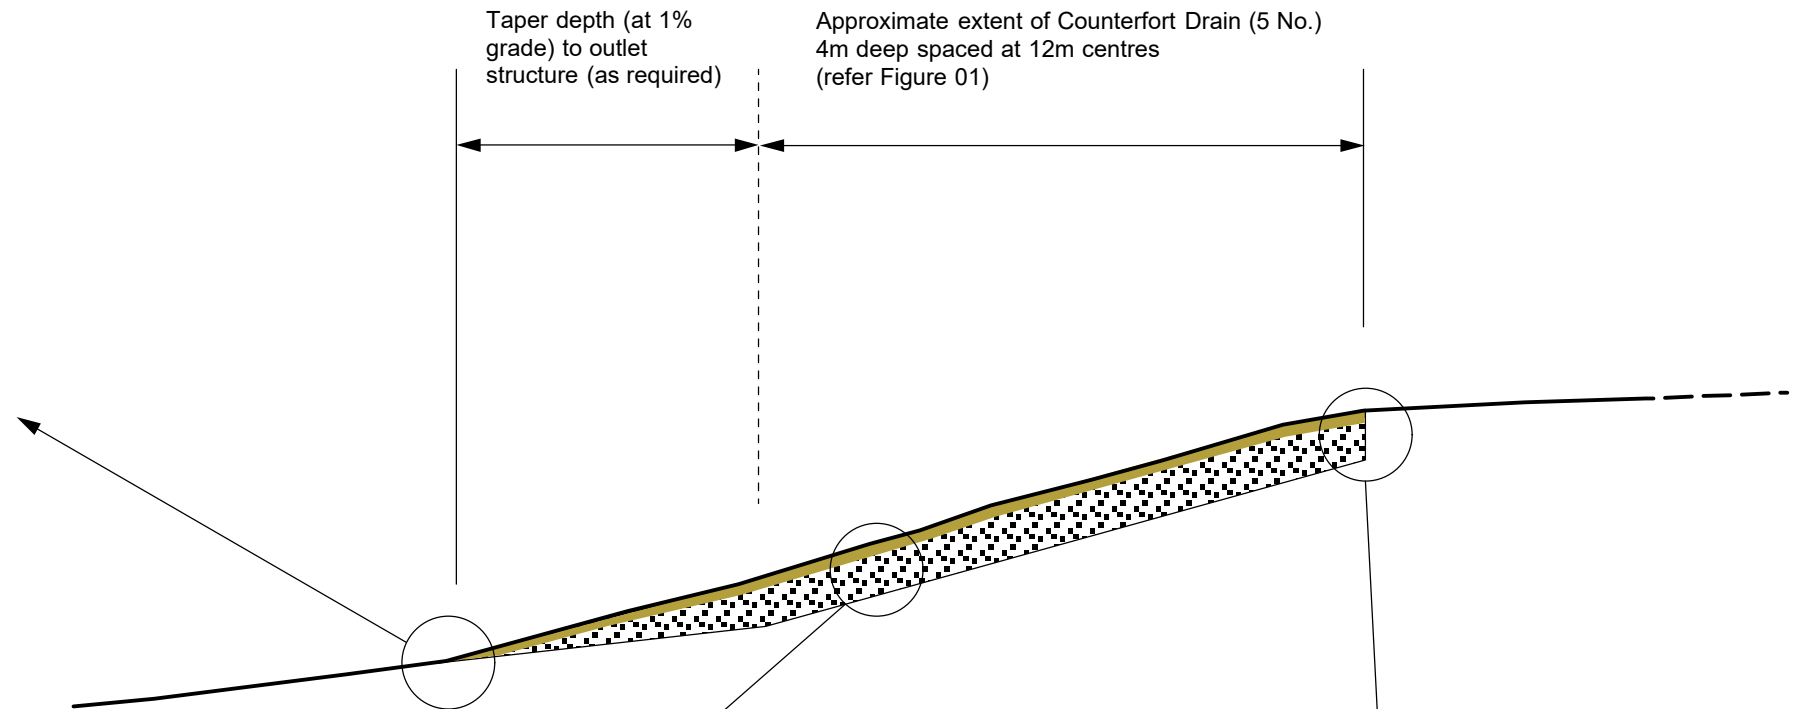
COUNTERFORT DRAIN DETAIL (not to scale)

SCHEMATIC DETAILS OF COUNTERFORT DRAIN OUTFALL STRUCTURE (not to scale)

Taper depth (at 1% grade) to outlet structure (as required)

Approximate extent of Counterfort Drain (5 No.) 4m deep spaced at 12m centres (refer Figure 01)

TYPICAL FLUSHING PORT DETAILS (not to scale)

Geotechnical 'counterfort' drainage improves ground conditions by lowering groundwater levels through drains constructed from a perforated drain coil within self-filtering material such as SAP50, or alternative approved drainage media that is compatible with the self-filtering criteria for subsoil drainage. This concept has been determined as a solution in the vicinity of Section 7-7', to support the park edge road.

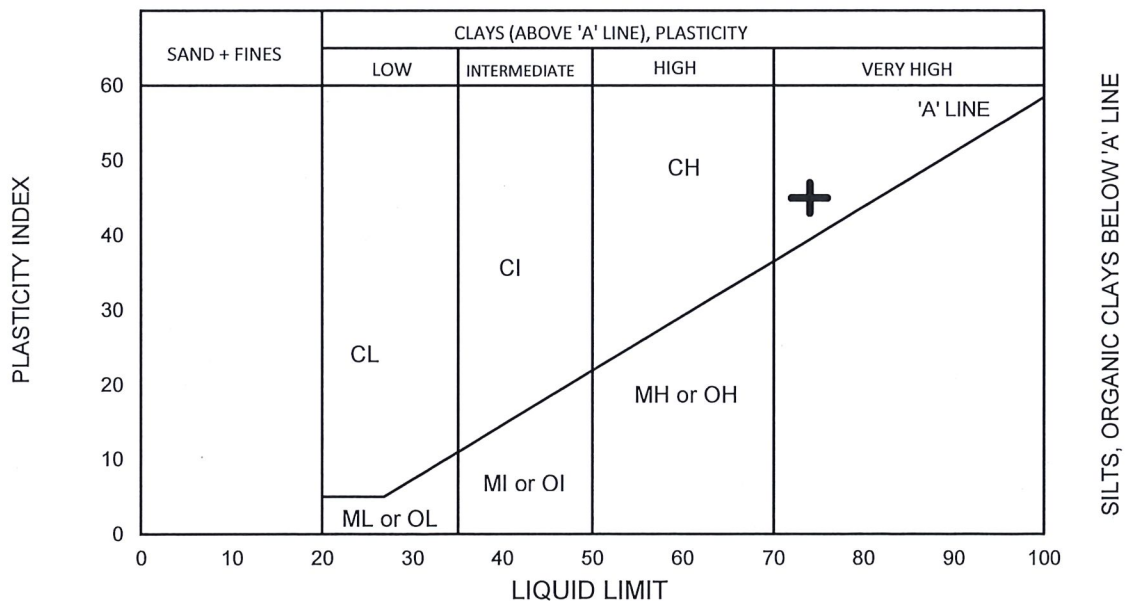
CASAGRANDE PLASTICITY CHART

Liquid Limit	74	Sample History:	Natural state
Plastic Limit:	29	Fraction Tested:	Passing 425µm sieve
Plasticity Index:	45	Material Description:	Disturbed Soil
Linear Shrinkage:	14		
#Liquidity Index (w-PL)/PI	0.0	Moisture Content (%)	29.5

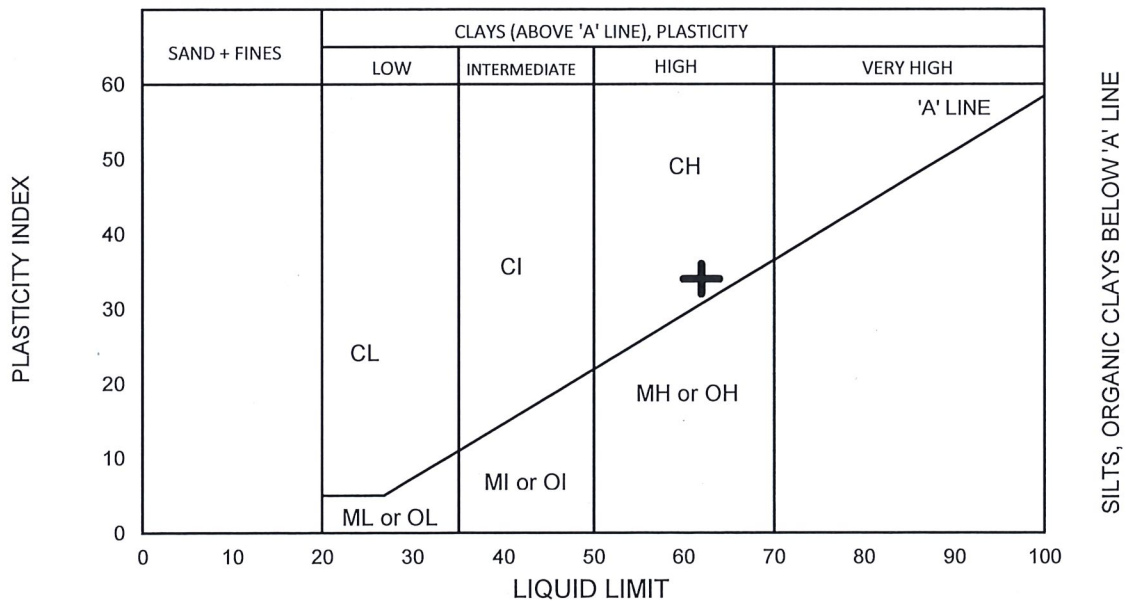
CASAGRANDE PLASTICITY CHART

Liquid Limit	62	Sample History:	Natural state
Plastic Limit:	28	Fraction Tested:	Passing 425µm sieve
Plasticity Index:	34	Material Description:	Disturbed Soil
Linear Shrinkage:	15		
#Liquidity Index (w-PL)/PI	-0.1	Moisture Content (%)	25.8
