Appendix 4

Field Investigation Data

Client : GREEN CITY DEVELOPMENTS LIMITED				Auger Borehole No. HA01					
Project Location : 125 MURPHYS ROAD (STAGE 2), FLAT BUSH				Sheet 1 of 24					
Job Number: J00862				Vane Head: 1750	Logged By: EL/LJ	Processor : LJ	Date: 12.02.18		
Borehole Location:	mN	mE	Ground R.L.	Legend	Depth (m)	Standing Water Level	Vane Shear (kPa) peak / residual	Soil Sensitivity	Sample and Laboratory / Other Test Details
	Description: Refer to site plan								
SOIL DESCRIPTION									
TOPSOIL									
clayey SILT, brown. stiff, moist, low to medium plasticity, with minor limonite [PUKETOKA FORMATION]									Sample 1 Disturbed 0.5-1.0m
becoming red/orange mottled light grey, with minor organic staining					0.5				
becoming very stiff, insensitive					1.0	169/93	1.8		
silty CLAY, orange mottled light grey. Very stiff, moist, medium plasticity, insensitive					1.5	134/73	1.8		
clayey SILT, red mottled light grey. Very stiff, moist, low plasticity, moderately sensitive					2.0	195/71	2.7

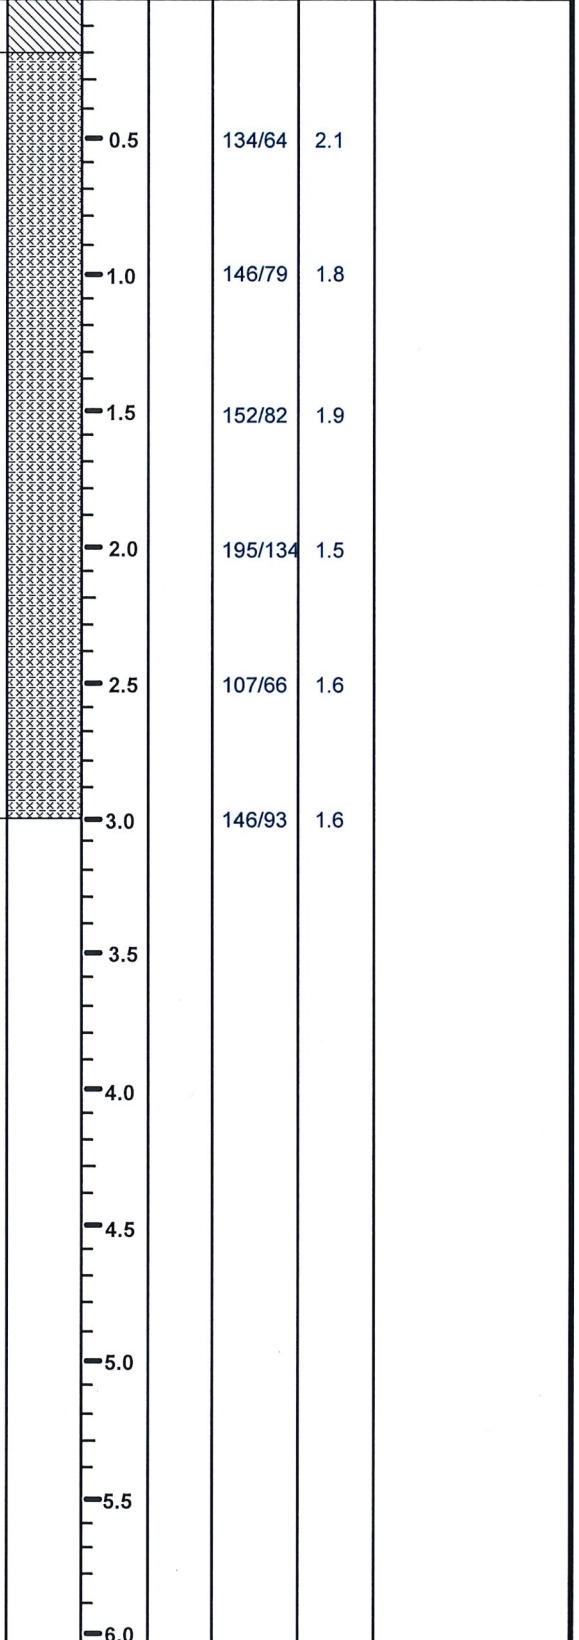
Auger Borehole No. HA04
 Sheet 4 of 24

clayey SILT, orange/brown. Very stiff, moist, low plasticity, moderately sensitive, with minor limonite [PUKETOKA FORMATION]

becoming insensitive at 1.1m, becoming yellow/brown speckled light grey/white, low to medium plasticity, with trace to minor organic staining, without limonite

becoming pink and yellow/brown streaked light grey/white, without organic staining

EOB at 3.0m. Target Depth.

Comments:
 Groundwater not encountered.
 UTP = unable to penetrate.
 EOB = end of borehole.

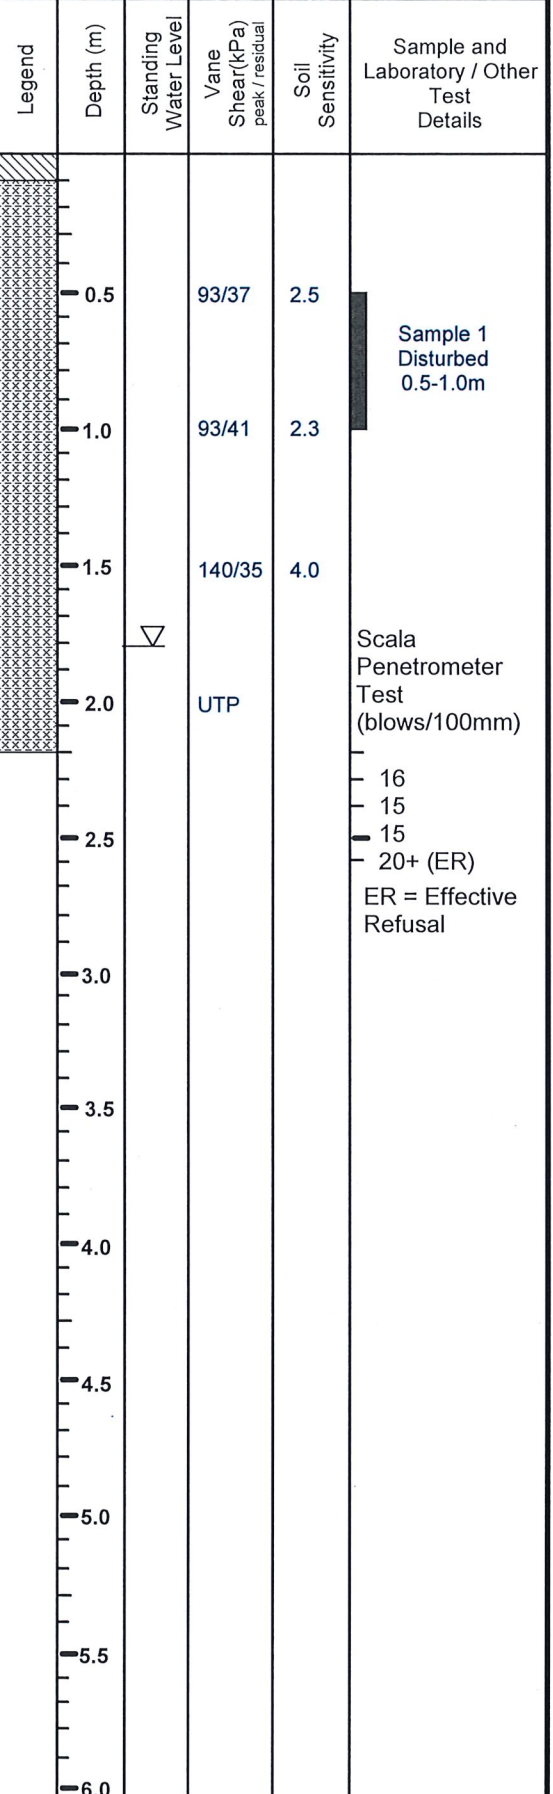
Auger Borehole No. HA21

clayey SILT, orange/brown. Stiff, moist, low plasticity, moderately sensitive, with minor limonite [PUKETOKA FORMATION]

becoming hard

EOB at 2.2m. Too hard to auger further. Scala penetrometer test commenced and found effective refusal at 2.6m.

Comments:
 Groundwater encountered 1.6m.
 UTP = unable to penetrate.
 EOB = end of borehole.
