**Warkworth South Plan Change:
Baseline Ecology
December 2022**

Document title:	Warkworth South Plan Change: Baseline Ecology
Prepared for:	KA Waimanawa Limited Partnership and Stepping Towards Far Limited
Version:	Version 4
Date:	20 December 2022
Document name:	63967 & 64366 Warkworth South Plan Change Baseline Ecology 20Dec22

Reference: Bioresearches (2022). Warkworth South Plan Change: Baseline Ecology. 63588. Report for KA Waimanawa Limited Partnership and Stepping Towards Far Limited. pp 72

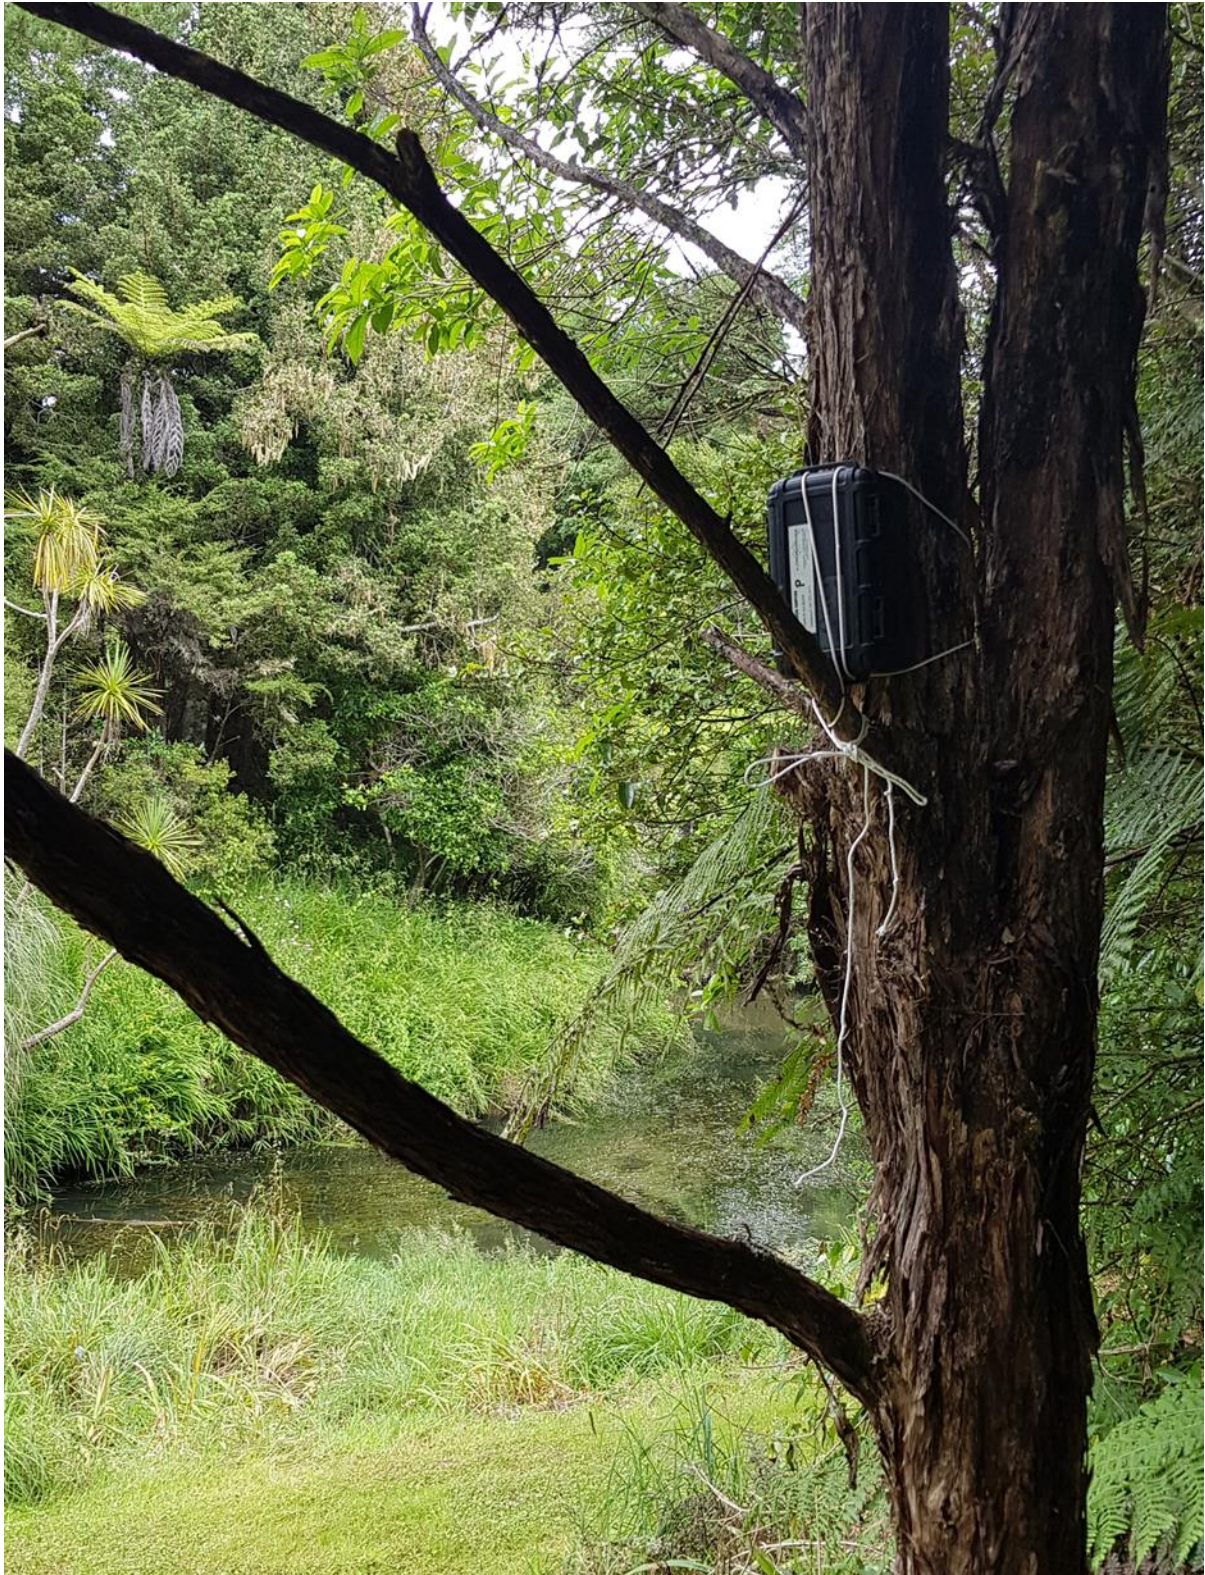
Photo 1. ARD P along stream in the south western corner of the Waimanawa Valley block.

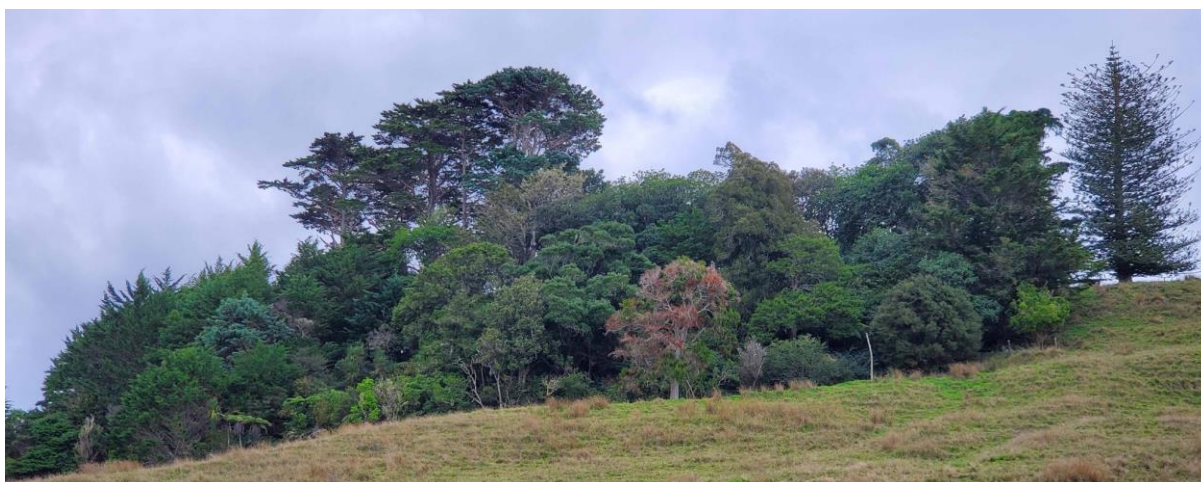
Photo 2. Smaller fragment of native and exotic vegetation.

Approximately 150 m east of this vegetation, is a smaller fragment (approx. 0.6 ha) of mature, mixed native and exotic vegetation that sits at the northern boundary of property at 1773 State Highway 1, and is fenced from stock (Photo 2). This smaller fragment supports a mixture of native podocarp and broadleaved trees, including tōtara (*Podocarpus totara*); rimu (*Dacrydium cupressinum*); kahikatea (*Dacrycarpus dacrydiodes*); pūriri (*Vitex lucens*); and kauri (*Agathis australis*). This fragment has a low level of connectivity to the larger regenerating system described above through a line of hilltop trees (pines and macrocarpa) and weedy scrub, which also feature throughout the fragment. Some of the trees, including a rimu at the edge, appear to be in very poor health.

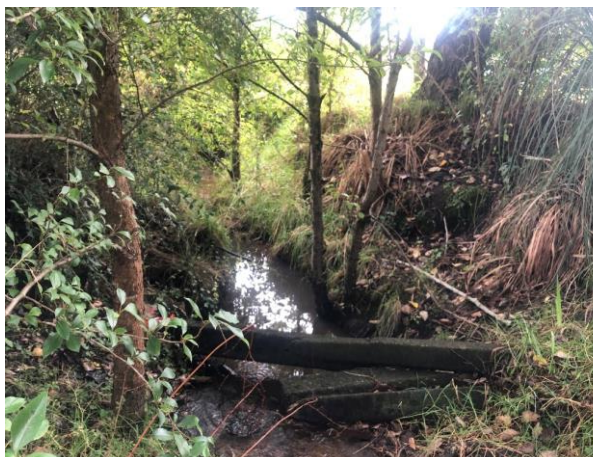
Photo 3: Concrete beams spanning the channel of watercourse 2.

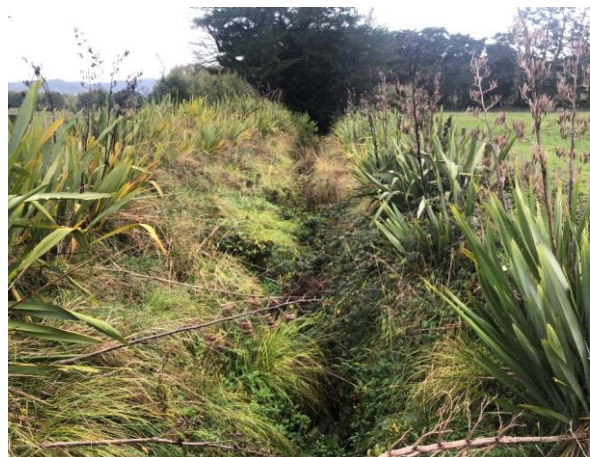
An electric fishing survey downstream of the confluence of watercourses 1 and 2 did not yield any fish (Photo 4). A macroinvertebrate sample collected from watercourse 2 contained only six individuals which is not enough to generate an accurate MCI/QMCI or other index. The six individuals included the New Zealand mudsnail *Potamopyrgus antipodarum*, and chironomids. Both species are highly tolerant of degraded habitat and water quality.

Photo 4: Area downstream of the confluence of watercourses 1 and 2 where fishing occurred.

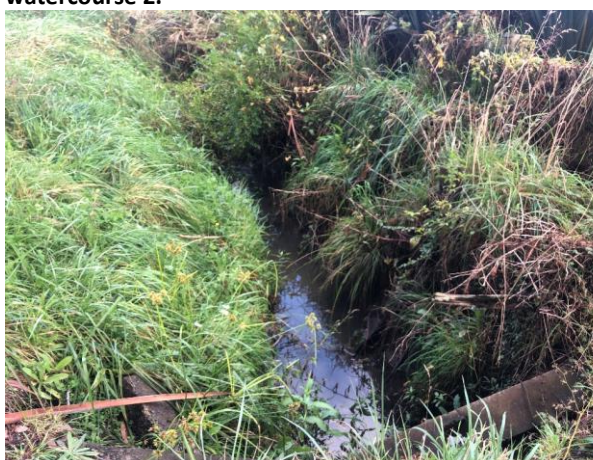
Photo 5: Watercourse 2 downstream of confluence with watercourse 5

Electric fishing near the confluence of watercourses 2, 5 and 6 (Photo 5) found one shortfin eel (*Anguilla australis*, 350mm in length). Table 6 summarises other fish species that have been found in the Mahurangi River catchment.

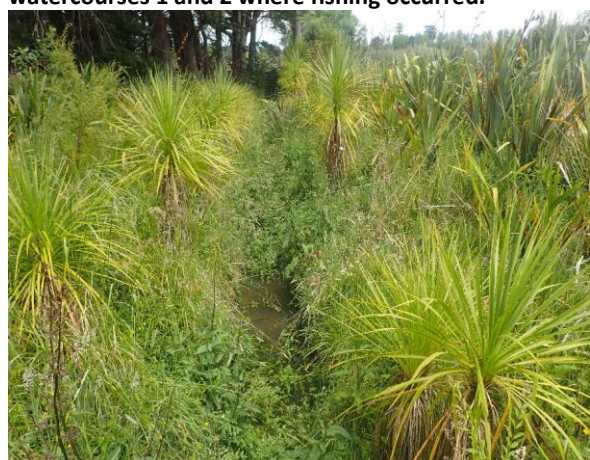
Riparian vegetation around watercourse 12 was contained within a fenced section, approximately 10 m from the wetted edge on both banks. The riparian yard had been recently planted and was in the early stages of succession. Species present included harakeke, cabbage trees (*Cordyline australis*), kānuka, *Carex* sp., giant rush (*Juncus pallidus*), and rank grass (Photo 6).

Photo 6: Watercourse 12, including establishing riparian vegetation.

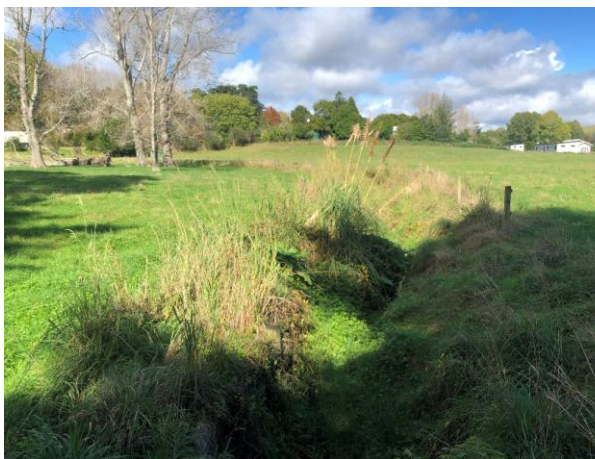
Photo 7: Watercourse 4, looking upstream. Note water flow is present beneath the macrophyte growth.

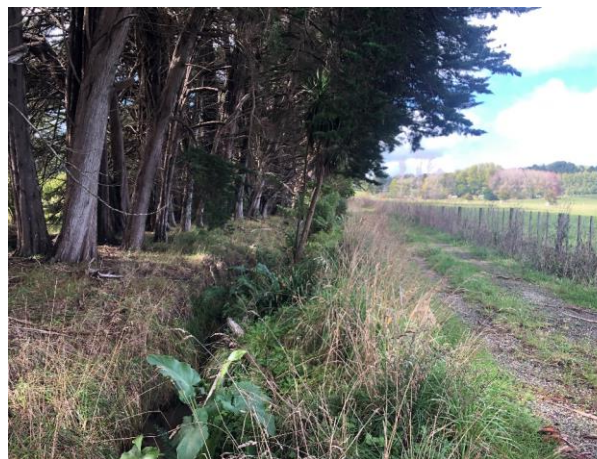
Photo 8: Watercourse 5 looking upstream.

Upstream of watercourse 13 (13a), the banks flatten for a short section and the channel becomes wide and boggy (Photo 8).

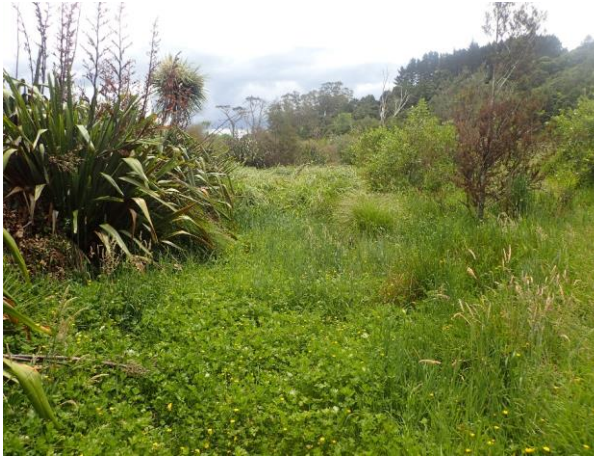
Watercourse 13 is the historic outlet for the natural flow path between the current watercourses 4 and 13. As flow is now diverted through watercourse 5, flow within watercourse 13 is likely to be significantly less than what it was prior to diversion. The channel drains the area of orchard in the north eastern portion of the site. The watercourse was similar to watercourse 12, which was also the receiving environment. Riparian vegetation was dominated by exotic species, however there were sparse planted harakeke, cabbage tree, mānuka and kahikatea (*Dacrycarpus dacrydioides*) present along its length (Photo 9).

Photo 9: Watercourse 13 viewed from the edge of the orchard, looking downstream.

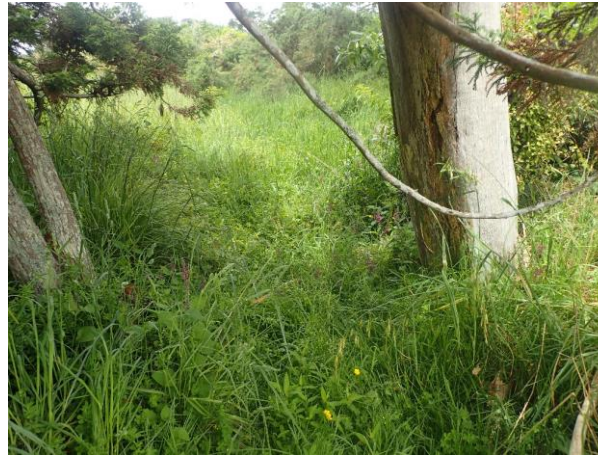
Photo 10. Watercourse 13 looking upstream into the orchard.

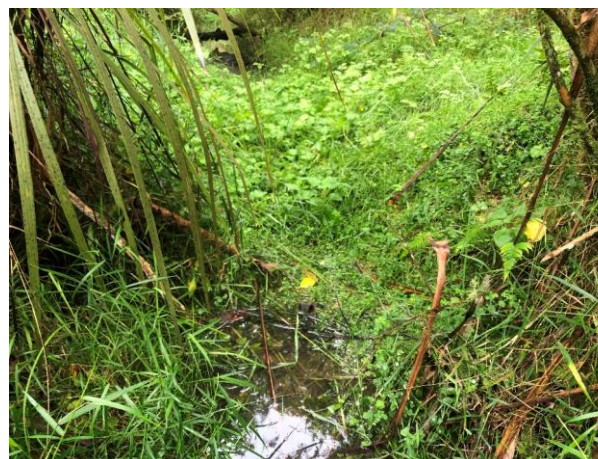
Watercourse 13a represents the original flow path of the what is now watercourse 5. Only part of this original flow path remains present (as indicated on Figure 5). Upstream of this area, there is a depression that indicates where the rest of the path would have been, however this is no longer considered to be a waterway in any form. The remaining channel contained areas where there was no water, however were highly incised (Photo 11), shallow and wide (3-4m in width) (Photo 12), and disconnected pools at various locations along the length. Where no water was present, buttercup and mercer grass (*Paspalum distichum*) were present.

Photo 12: Wider shallower portion of watercourse 13a with some surface water present.

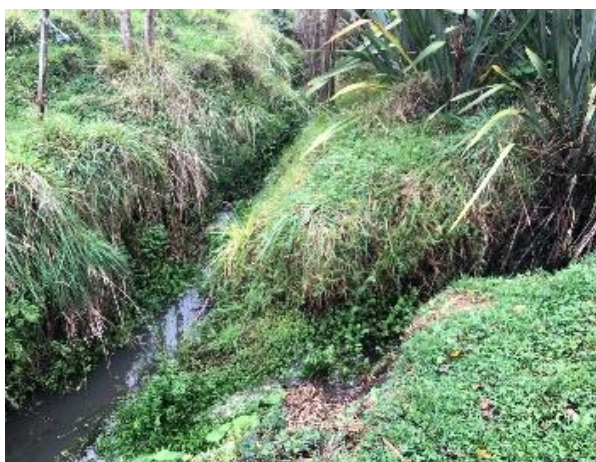
A watercourse forms the north eastern boundary of the site. This watercourse flows from under SH1, draining adjacent rural lifestyle properties within the Waimanawa Hills (a) Block (Photo 13). The channel was approximately one metre in width, relatively incised, and there were areas of bank undercutting and erosion along its length. The substrate was soft, and there was a reasonable amount of leaf litter and woody debris within the channel, creating fish and macroinvertebrate habitat. Shading was variable. Where there was established riparian vegetation in the lower reaches of the watercourse, shading levels were high (Photo 14), however in the upper reaches, riparian vegetation was limited to rank grass, providing limited shading. Vegetation in the lower reaches included arum lily (*Zantedeschia aethiopica*), privet, willows, gorse (*Ulex europaeus*), cabbage tree, poplars and flax, among others. Macrophytes were present in patches, including water pepper, water celery (*Apium nodiflorum*) and buttercup.

Photo 13: The true left waterway (channel on the right of the image) shows where watercourse 36 from the Waimanawa Hills (a) Block on the other side of SH1 flows into the eastern boundary watercourse.

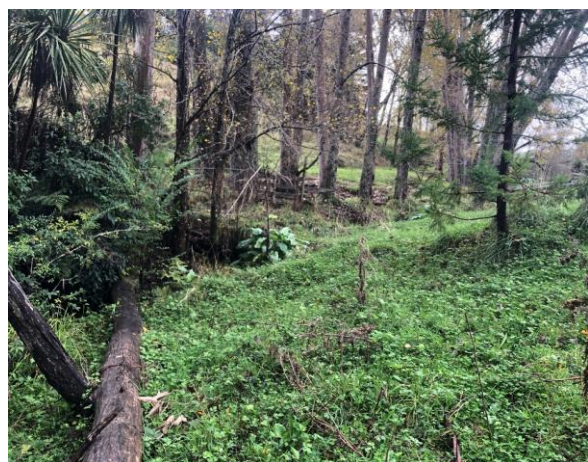
Photo 14: The eastern boundary watercourse flowing through the vegetated area at the downstream extent.

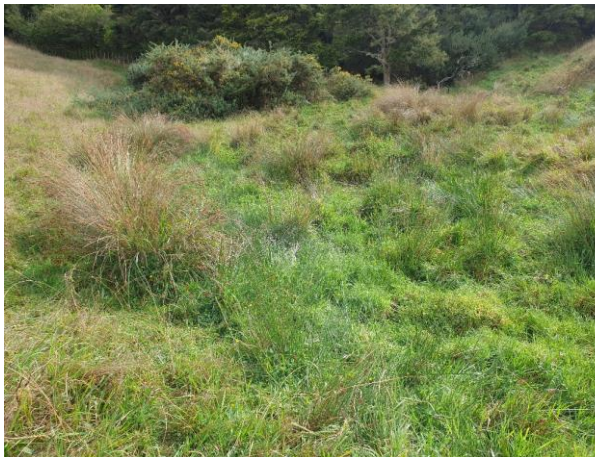
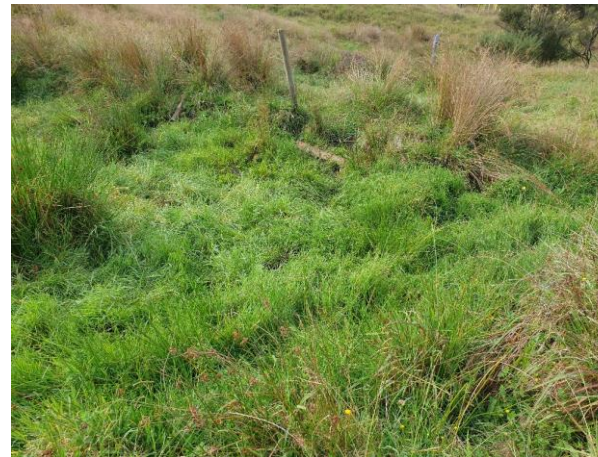
Photo 15: The wetland was dominated by mercer grass. Photo 16: The farm track split the wetland in two.

At the base of the gully, an area dominated by mercer grass, with soft rush, broom rush and budding clubrush (*Isolepis prolifera*) growing sparsely throughout (Photo 15). Yorkshire fog, common bent (*Agrostis capillaris*), buttercup and were also present, predominantly on the edges of the wetland. Native vegetation biodiversity and abundance was low. A farm crossing was observed running through the area with a small culvert present (Photo 16). Aquatic habitat was limited to boggy ground among vegetation.

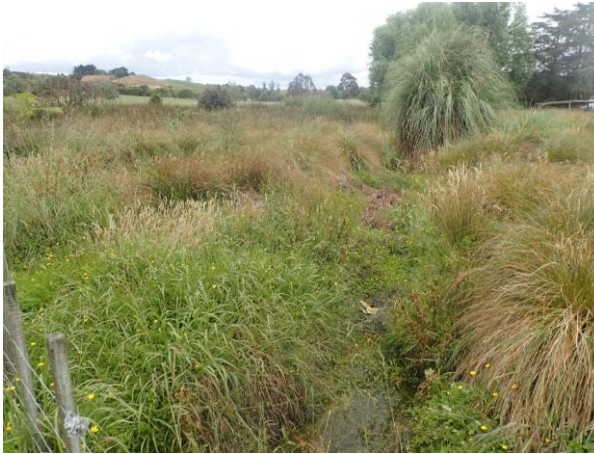
Watercourse 15 acts as the receiving environment for a number of artificial watercourses (6, 8-11). This watercourse appeared to have a small meander and contours show that this flow path is the low point of the surrounding area, suggesting water flow through here is likely to be natural (Photo 17). Water from the channel flows into a man-made pond (Photo 18), then into a narrow, well-defined channel. Below the pond, the watercourse continued to flow through a well vegetated and shaded channel before discharging into watercourse 19 (Photo 19). The channel itself, as well as the pond, is likely to provide habitat for fish such as eels. The substrate was predominantly soft-bottomed, with runs and pools was present along its length.

Photo 17: Watercourse 15 within the wetland area.

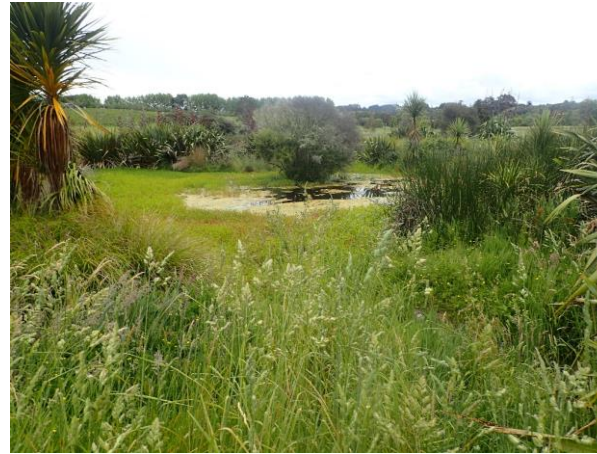
Photo 18: The pond at the downstream end of the constructed wetland.

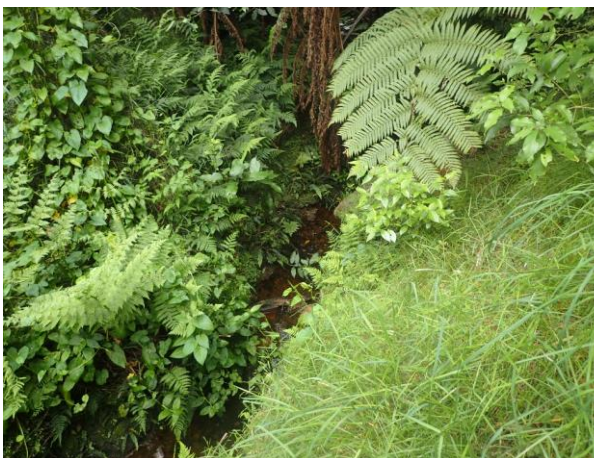
Photo 19: Watercourse 15 downstream of the wetland area, before it discharges into watercourse 19.

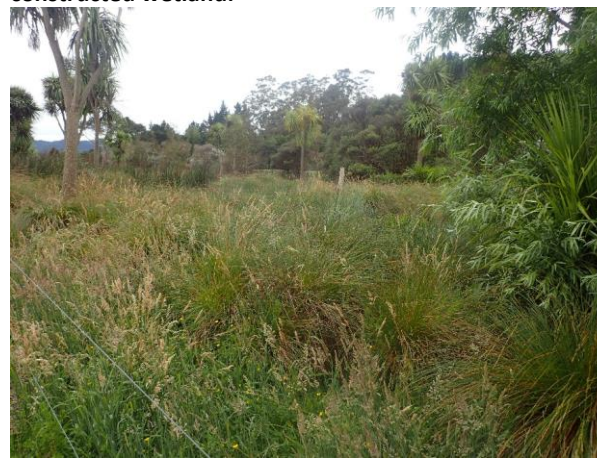
The riparian area of the waterway is part of a well vegetated, constructed and fenced wetland area (Photo 20). Approximately 15 years ago, the area surrounding watercourse 15 consisted of dry pasture. A small dam was constructed on the watercourse in order to slow flow (the man-made pond is the outcome of this dam). The surrounding area was then fenced and planted with wetland vegetation. Vegetation in this area included carex (*Carex* spp.), kahikatea, flax, pampas grass (*Cortaderia selloana*), Yorkshire fog (*Holcus lanatus*), giant rush (*Juncus pallidus*), broom rush (*Juncus sarophorus*), water pepper (*Persicaria hydropiper*) and crack willow (*Salix fragilis*). Despite the constructed nature of the wetland, it provides important habitat and buffering functions to the watercourse. Despite being constructed, it is a relatively rare example of wetland habitat in an area where it would have historically been much more prevalent.

Photo 20: Wetland area surrounding watercourse 15.

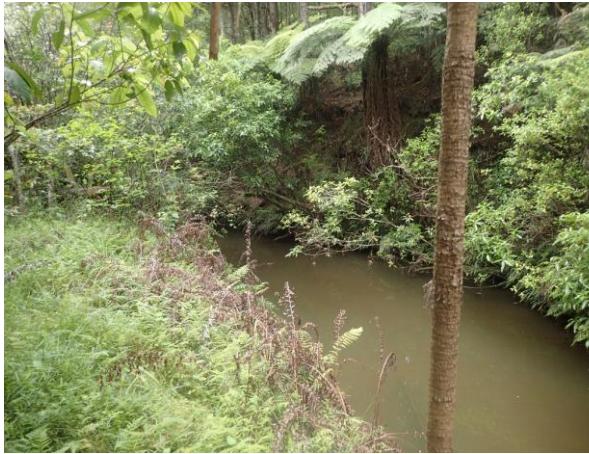
Watercourse 19 is the receiving environment for the majority of the watercourses within the Waimanawa Valley and Waimanawa Hills (a) Blocks. It was wide (5-10m in width), and deep enough that it was not wadeable for the entire width (Photo 21). Substrates were dominated by soft fine sediment, and there was a reasonable amount of leaf litter and woody debris. Undercut banks and erosion were present periodically throughout its length. The waterway provides good habitat for fish and macroinvertebrates, and it is considered likely that 'At Risk – Declining' longfin eel (Dunn *et al.* 2017) are present in the waterway, at least intermittently. The watercourse discharges to the north branch of the Mahurangi River, to the north west of the site.

Photo 21: Watercourse 19, just upstream from the confluence with watercourse 15.

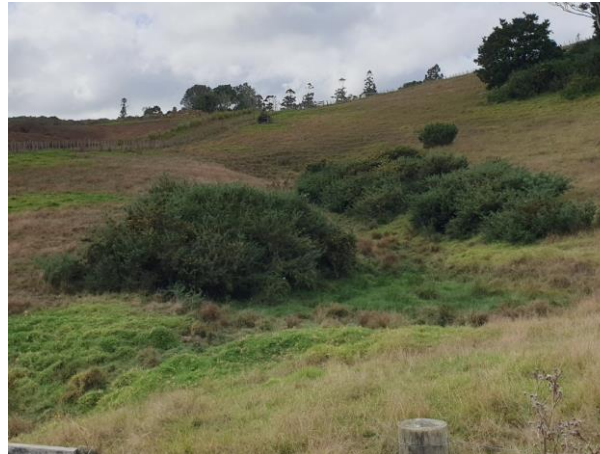
Photo 22. Watercourse 24, darker green vegetation indicated a hydric area.

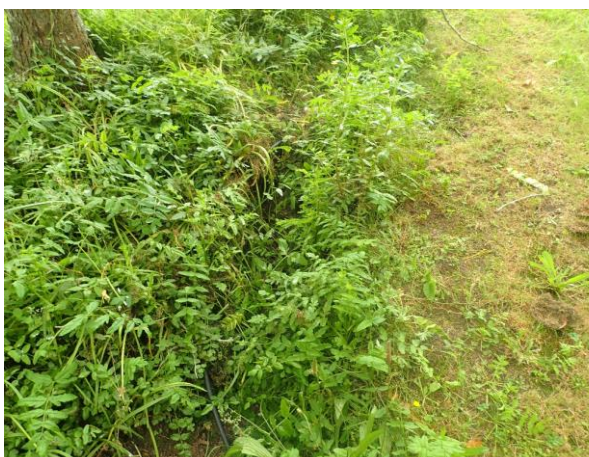
Watercourse 18 is an intermittent waterway that flows directly into the right branch of the Mahurangi River. At the time of the site visits, no flow was present in the channel, however the presence of rooted macrophytes (water celery) throughout the channel suggests it does frequently contain water (Photo 23). A pipe discharges to the top portion of the channel and it is considered this pipe provides the main source of water (Photo 24).

Photo 23: Water celery within watercourse 18.

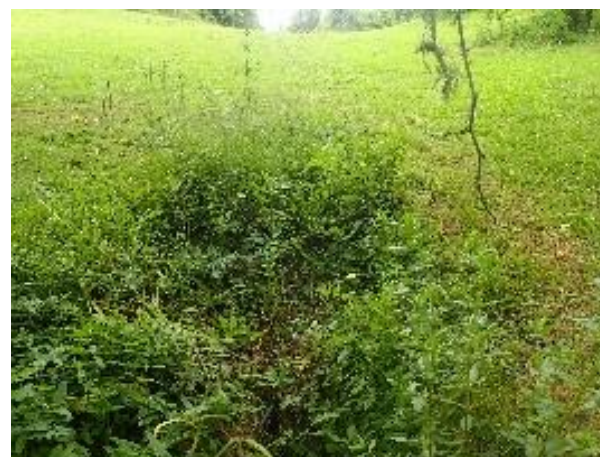
Photo 24: The top of watercourse 18 where a pipe discharges to the channel.

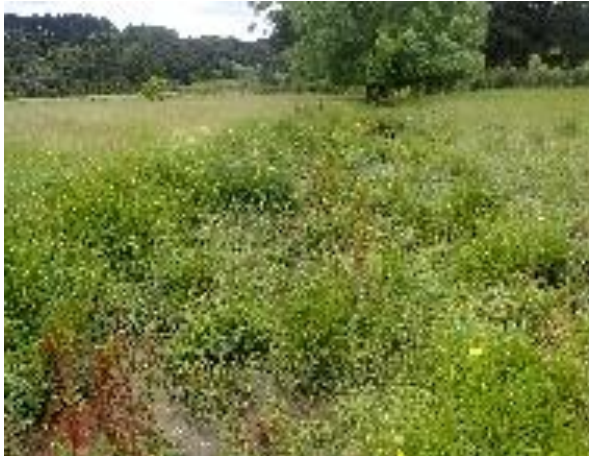
Watercourse 7 is an intermittent stream that flows into watercourse 2 through a culvert. The channel flows along the boundary of a pasture filled paddock, starting from approximately halfway along its north western boundary. The channel has been subject to pugging, and therefore is considered to be wider and shallower than it would naturally be (Photo 25). The channel contained some water during the site visit, however no flow was discernible in many places. The substrate was soft, and partially vegetated with macrophytes including starwort (*Callitriche stagnalis*), water pepper and watercress. Shading of the channel was low, except in the lower reaches were a small number of willows (*Salix* sp.) were present on the true left bank (Photo 26). The channel is unlikely to provide any fish habitat or habitat for macroinvertebrates that are not tolerant of degraded habitat conditions.

Photo 25: Watercourse 7 at the upper end showing shallow boggy ground and macrophytes.

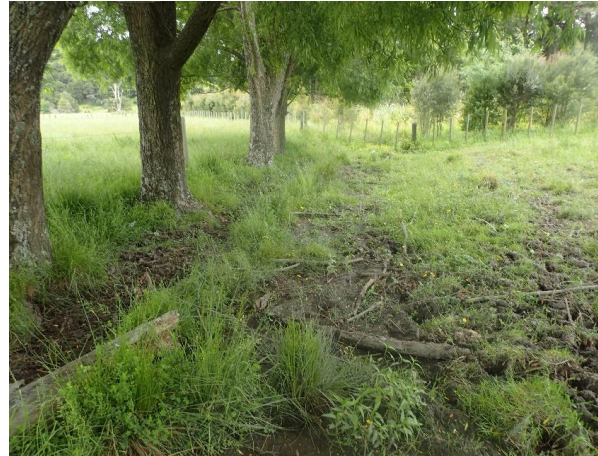
Photo 26: Intermittent watercourse 7 at the downstream end, looking downstream.

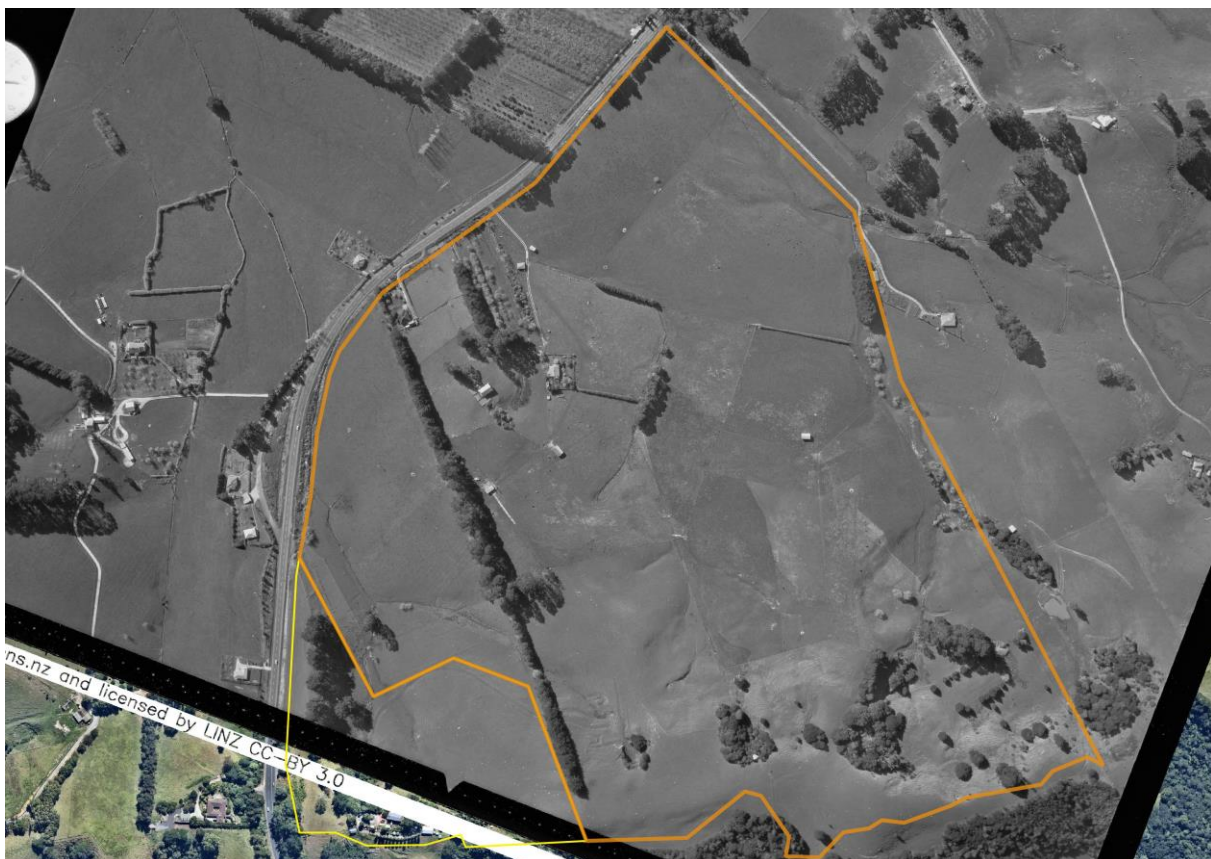
Figure 7. Historic aerial image from 1970 showing the site to be void of native vegetation

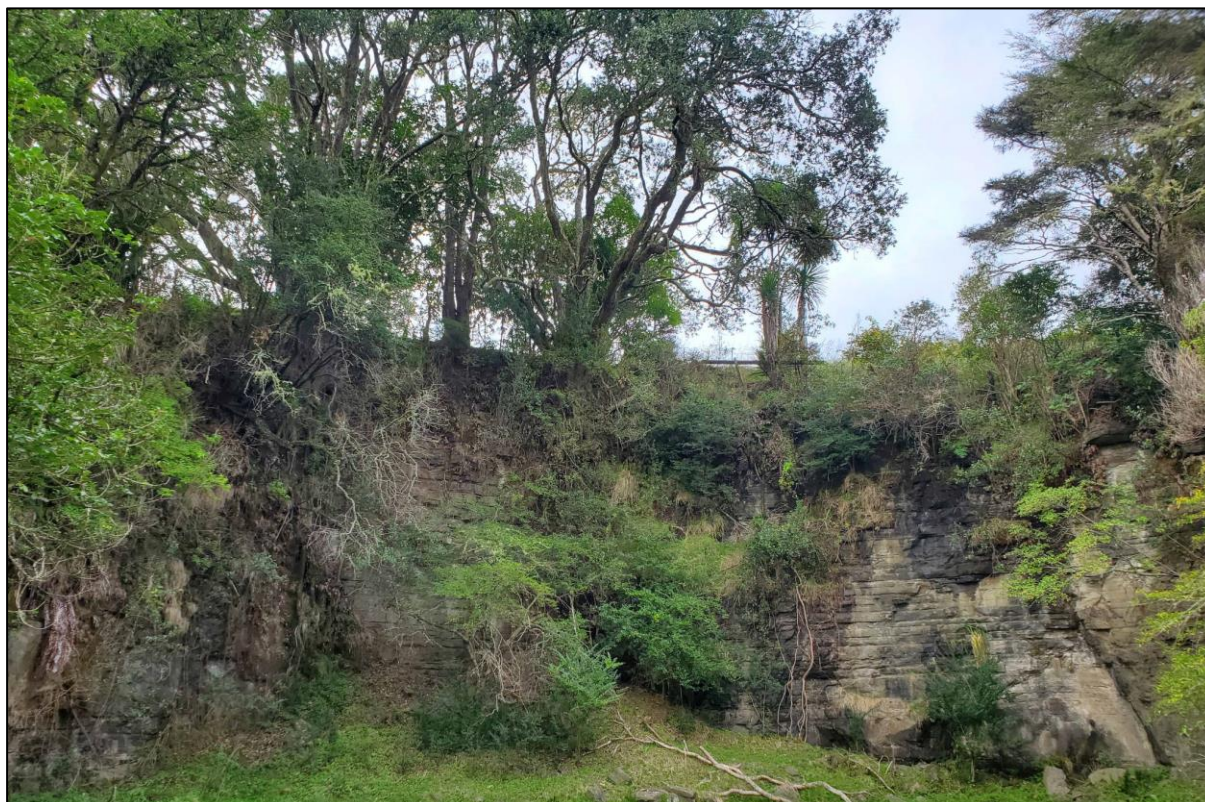
This fragment of vegetation is fenced around a rock face. The fence encloses a very narrow (1 – 5 m wide) strip of predominantly indigenous vegetation around the rock face, and possibly serves to prevent stock causalities than vegetation protection (Photo 27). However, the vegetation supports mature pōhutukawa (*Metrosideros excelsa*) and pūriri, as well as māhoe, nīkau and other indigenous shrubs. The vegetation is not identified with any current ecosystem overlay on Auckland Council databases, and it probably best matches regenerating broadleaved species scrub (VS 5, Singers *et al.* 2017).

Photo 27. ‘Thin ‘ring’ of fenced vegetation around a rock face edge.

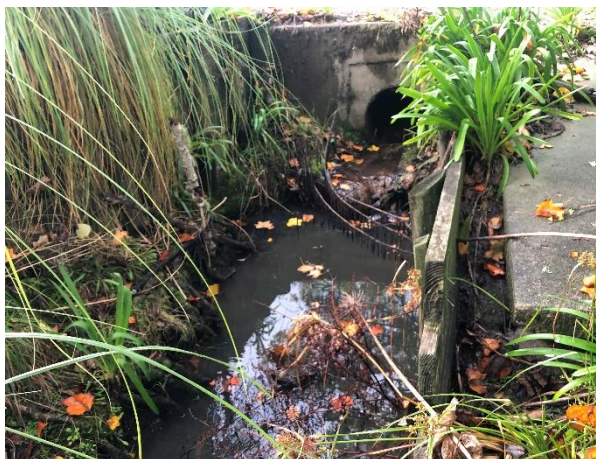
Photo 29. Watercourse 25 drained through a culvert with a vertical drop at the concrete apron.

eel would be able to utilise the site. The ecological value of Watercourse 25 was assessed as low due to the highly degraded catchment, unnatural loading of fine sediment and low oxygen reducing processes, limiting the quality of aquatic habitat to pollutant tolerant taxa.

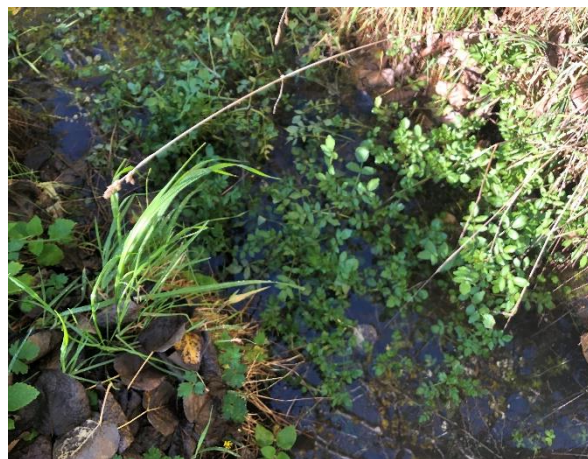
Photo 30. High biomass of instream macrophytes in Watercourse 25.

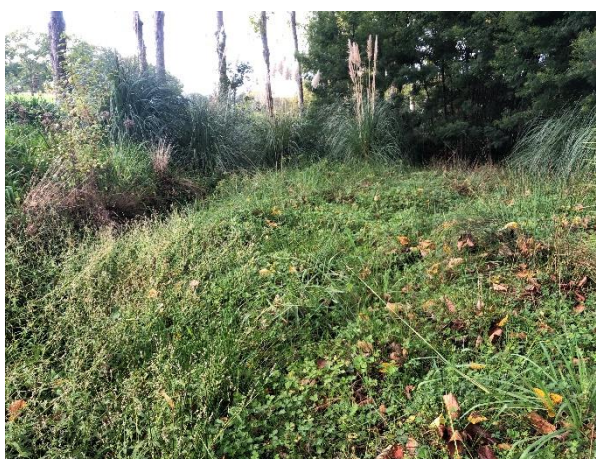
Photo 31. Wetland 1 was dominated by exotic vegetation and lacked complex riparian vegetation.

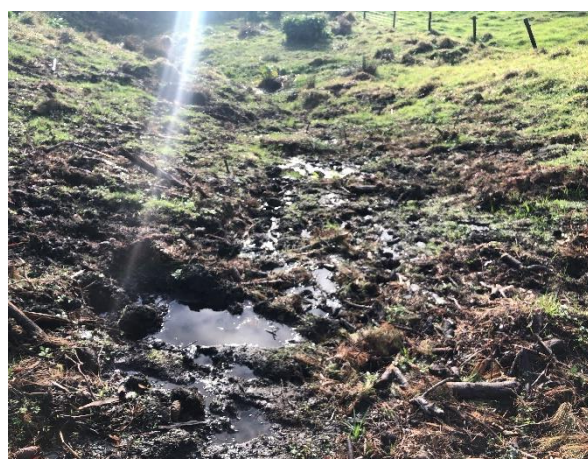
Photo 32. Upper reach of Watercourse 26 appears to have been recently in-filled or mulched.

One of the intermittent tributaries identified draining into Watercourse 25 was Watercourse 26. The headwaters of Watercourse 26 form a Y-confluence with ephemeral channels. The True Left arm contained no flowing water with boggy ground and puddles. Within this area, starwort was observed and occasional soft rush. The top of the channel appears to have been either recently infilled or mulch spread throughout (Photo 32) with standing puddles of water observed with mosquito larvae, however no channel was present. The True Right arm contained defined channels and water, however the upper reaches contained rooted kikuyu and water was not present.

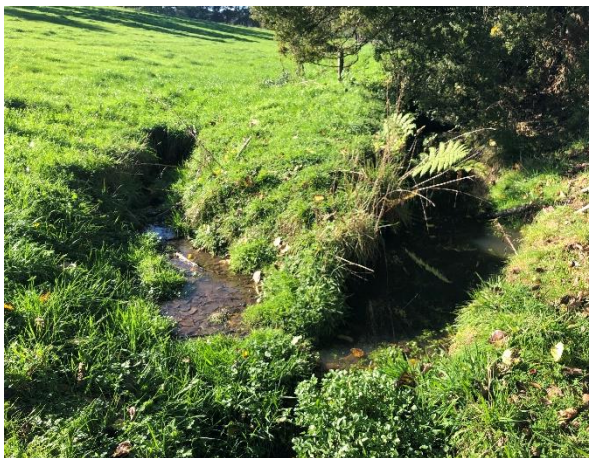
Photo 33. Confluence of Watercourse 25 and small intermittent tributary of Watercourse 27

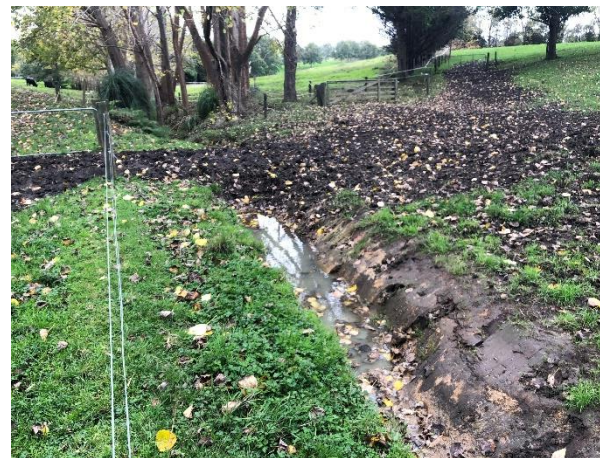
Watercourses 28 and 29 formed the upper headwaters for Watercourse 25. Watercourse 28 was classified as an intermittent reach as it contained well-defined banks, flowing water, and had evidence of scour and deposition. A farm track was present crossing over Watercourse 28 and the stream was classified as ephemeral above this. Watercourse 29 was classified as an intermittent stream due to the presence of surface water, a well-defined channel and lack of rooted terrestrial vegetation established within the channel base. Sections of Watercourse 29 were ill-defined and dry in some places with the channel recently deepened and/or straightened (Photo 34). Riparian vegetation along Watercourse 28 and 29 was lacking, consisting solely of short grasses and a single row of exotic trees, providing low shade and filtration functions.

Watercourses 28 and 29 were assessed to be of low ecological value due to the degraded catchment, lack of complex native riparian vegetation and unnatural loading of fine sediment. Riparian functions of the intermittent streams including a low to moderate amount of shade, however ground filtration and bank stability were limited due to the shallow root systems. Additionally, several farm crossings and piped outlets/inlets were present within the intermittent streams acting as a barrier to fish passage.

Photo 34. Intermittent channel of Watercourse 29

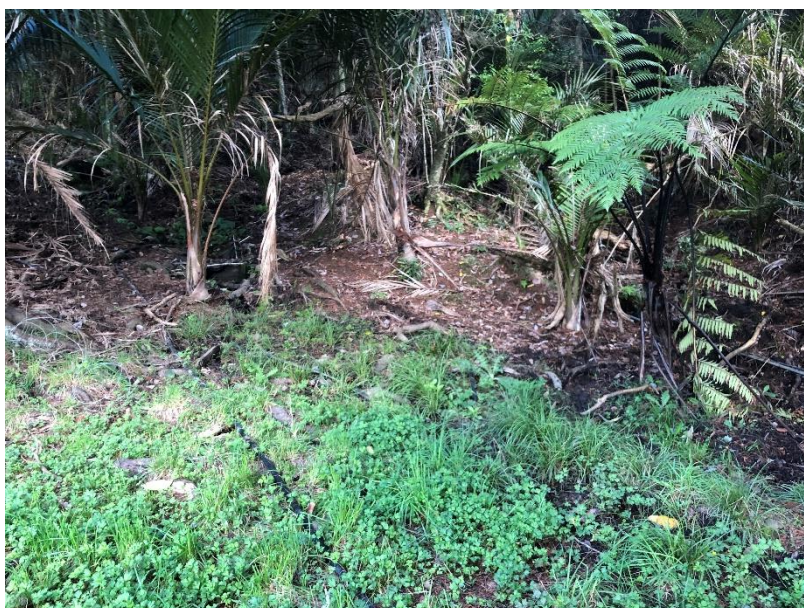
Photo 35. Wetland 7 with native riparian planting established around the edges

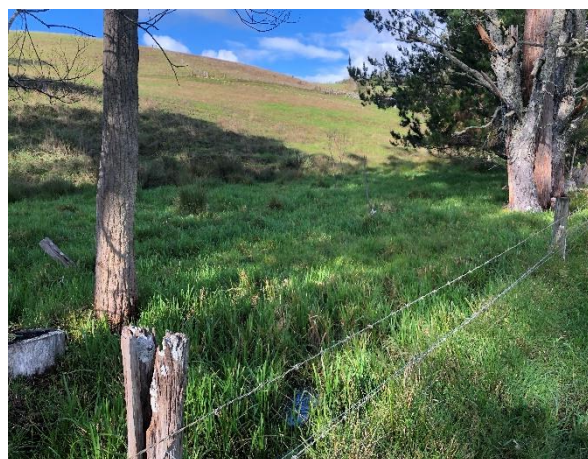
Photo 37. Three glyceria wetlands were located within the floodplains of the Eastern system.

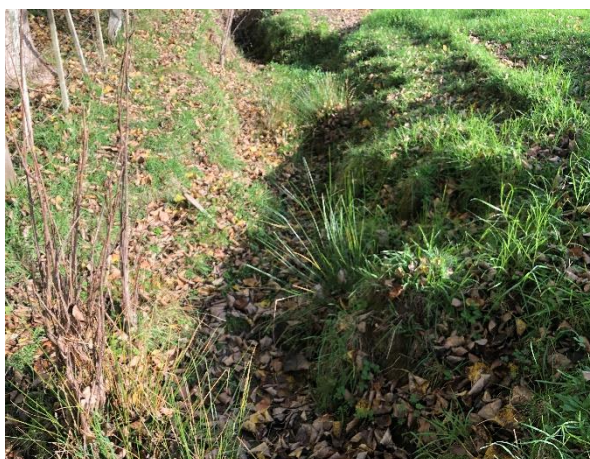
Two intermittent tributaries drained into Watercourse 35. The true right tributary is outside of the site boundaries. The True Left intermittent tributary was identified as Watercourse 36, and met the intermittent criteria due to well-defined banks, substrate sorting processes and no rooted terrestrial vegetation. Watercourse 36 contained no standing water and as such did not provide aquatic habitat at the time of assessment, however evidence of previous water flow could be seen and the channel has recently been re-contoured (Photo 39). Riparian vegetation along Watercourse 36 was lacking, with kikuyu and poplars providing moderate shading in the lower reach while the upper reach consisted of bare banks. The ecological value of Watercourse 36 was assessed to be of low ecological value due to the complete lack of aquatic habitat, low quality riparian vegetation and corresponding function (i.e. filtration, bank stability, shade) and highly modified, degraded channel.

Photo 38. Watercourse 36 lower reach, which drains into Wetland 6.

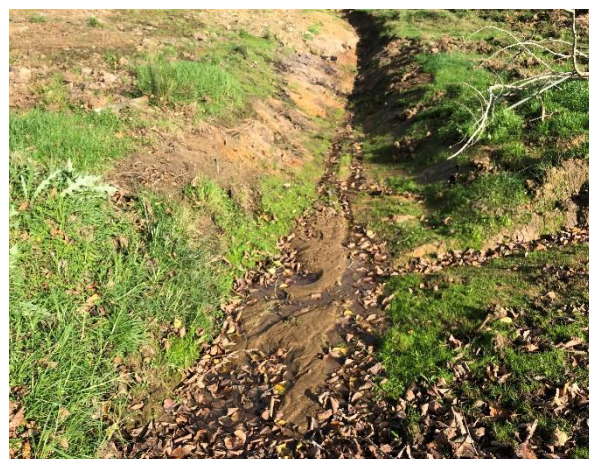
Photo 39. No water was observed in Watercourse 37, however previous flow patterns could be seen.

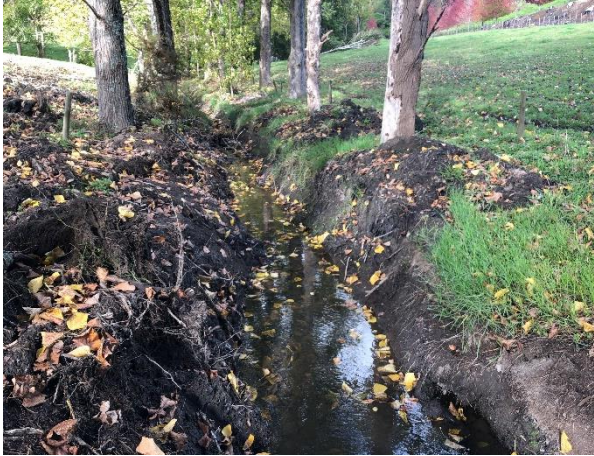
Photo 40. Watercourse 30 contained highly incised banks and lacked complex riparian vegetation. Note substrate on banks.

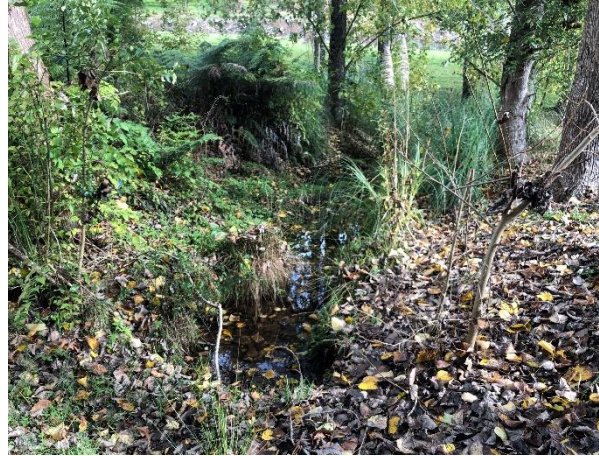
Photo 41. Degraded instream habitat of the lower reach Watercourse 31.

Watercourse 31 formed the upper reach and contributing headwaters of Watercourse 30 and was classified as an intermittent stream due to the presence of well-defined banks, no rooted terrestrial vegetation and some scour, however the channel had recently been straightened and deepened. Riparian vegetation was largely limited to pine trees providing low shade functions and limited filtration and bank stability capacity (Photo 41). No water was present in the channel in the upper reach, and aquatic habitat was generally limited to shallow, isolated pools containing silt and leaf litter. Watercourse 31 was considered to be of low ecological value due to the lack of aquatic habitat through much of the reach and lack of riparian vegetation.

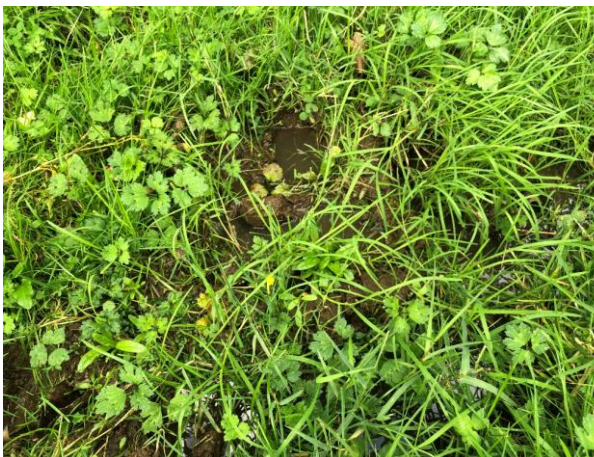
Wetland 8 was located upstream of the upper reach of Watercourse 31 and was connected to the watercourse by an ephemeral overland flow path. Hydrophytic vegetation within Wetland 8 was dominated by floating sweet grass (*Glyceria fluitans*), with occasional low bulrush (*Isolepis cernua*), buttercup and mercer grass. The wetland was surrounded by a tall cliff in a semi-circle shape, and a farm track at its downstream end appeared to limit flow out of the area.

Photo 42. Wetland 8 contained standing water and obligate wetland vegetation.

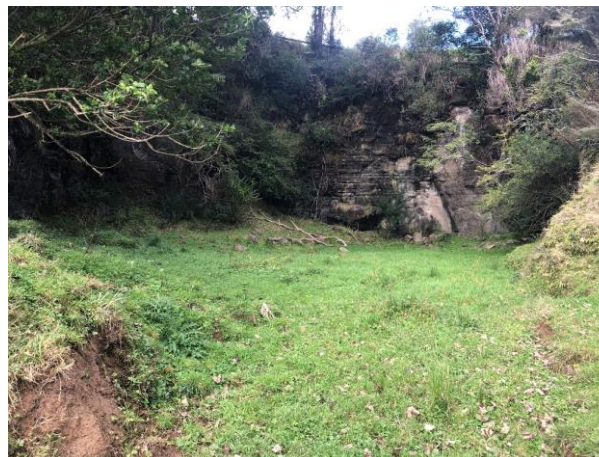
Riparian vegetation was largely limited with pasture grass, however the cliff and cliff-top vegetation provided moderate to high shading. Hydrology within Wetland 8 consisted of standing water within pugged depressions and boggy ground under vegetation which would provide habitat to tolerant dispersal macroinvertebrates. Fish are not expected to be present as there is no aquatic connectivity to the wetland. Wetland 8 was considered to have low ecological value due to the dominance of exotic wetland vegetation, low indigenous biodiversity and low quality aquatic habitat.

Photo 43. Wetland 8 was shaded by a rock cliff.

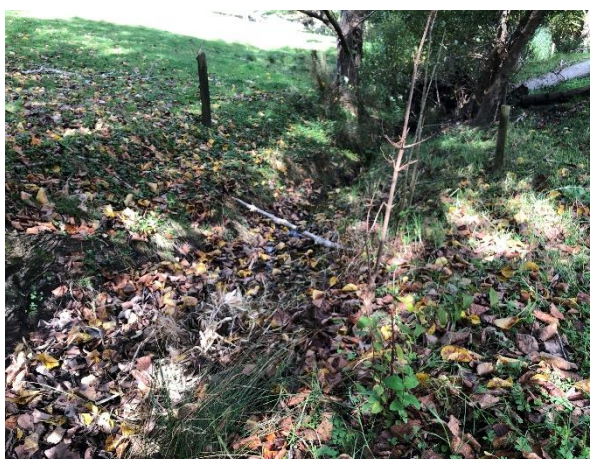
Watercourse 32 drained into Watercourse 30 and was classified as an intermittent tributary due to the presence of well-defined banks and lack of rooted terrestrial vegetation. The upper reach of Watercourse 32 formed a Y confluence, with the True Right confluence approximately 45m long, with the headwaters forming an ephemeral overland flow path. The True Left confluence of Watercourse 32 was approximately 120 m long and entered the site from the neighbouring property. Within the main stem of Watercourse 32, shallow water was present within the channel, however above a farm track crossed the stream and no water was present in a few areas of the channel (Photo 44). There was a high amount of dry leaf litter covering the channel base indicating no substantial flow had occurred for some time, despite the catchment containing water. Wetland 9 was located on the True Right bank of Watercourse 32 and was dominated by mercer grass and soft rush with occasional buttercup and lotus. Wetland 9 was approximately 125 m² in size and contained standing water, however the ground was highly pugged (Photo 45). Wetland 9 was considered to be of low ecological value due to the degraded habitat due to livestock access and dominance of exotic vegetation.

Photo 44. Degraded instream habitat of Watercourse 32.

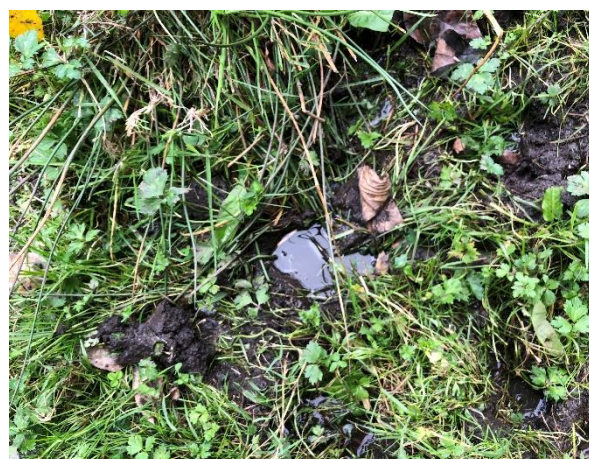
Photo 45. Pugging depression observed in Wetland 9.

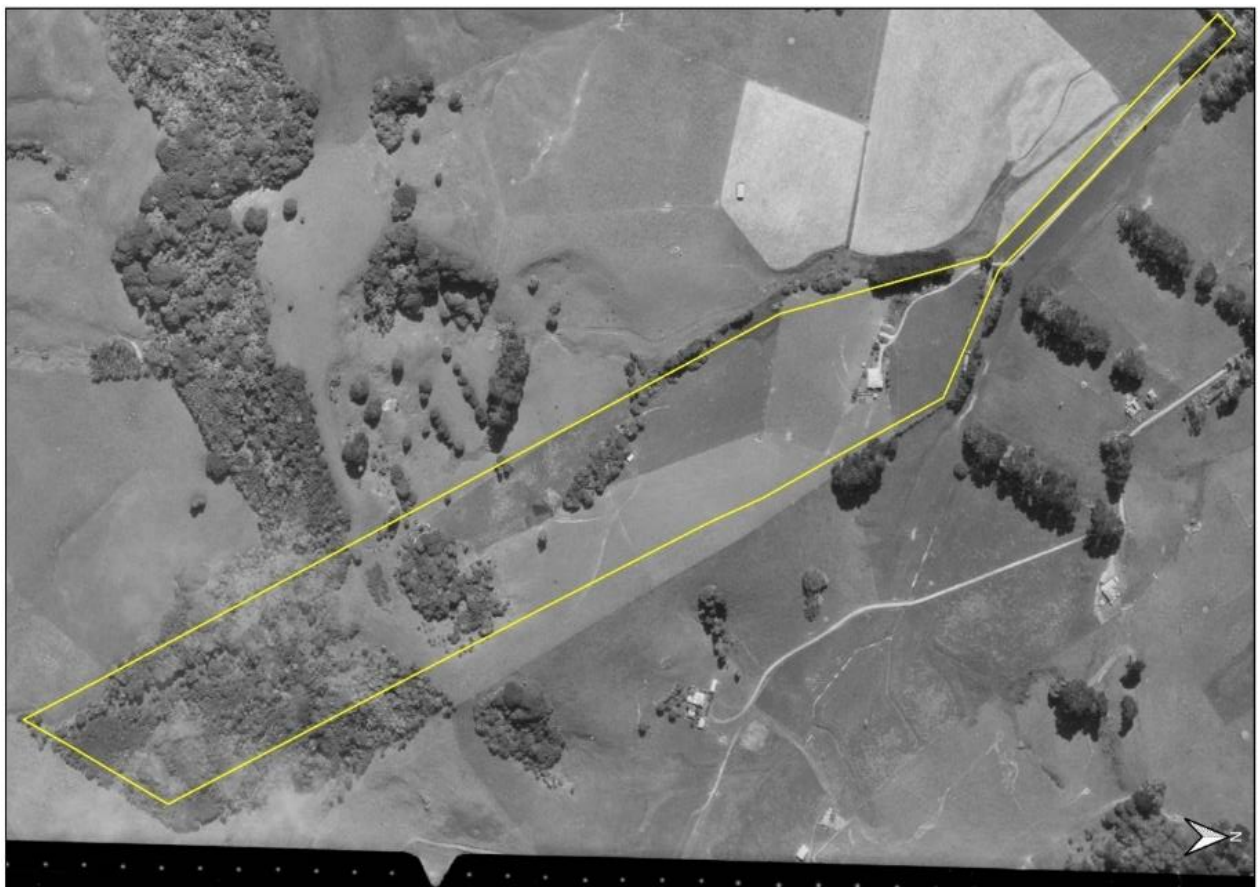
Historically, the site would have likely comprised of the ecosystem type 'Kauri, podocarp, broadleaved forest' (WF11; Singers *et al.*, 2017). Well prior to 1970 (as indicated by historical aerial photography, Figure 9) a large proportion of the site was largely cleared of indigenous native vegetation, with dense sections of native vegetation retained on the southern aspect of the property.

Figure 9. Historic aerial image of the site from 1973 showing much of the site to be cleared of indigenous bush

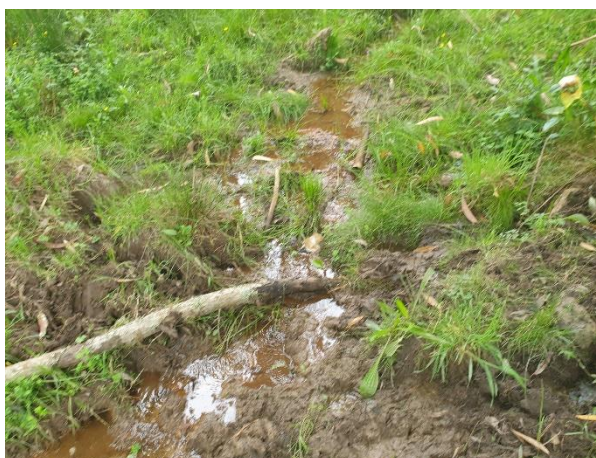
Watercourse 37 was located on the southern side of the property and formed the headwaters to the stream that flows through the site. Watercourse 37 was classified as an intermittent stream as it contained standing water 48 hours after rainfall, deep pools relative to stream depth and debris on the floodplain (Photo 46). Sections of Watercourse 37 contained flattened banks and rooted terrestrial vegetation, however the stream bed had been impacted by pugging and it is likely the watercourse would contain defined banks if no livestock access had occurred. Within the watercourse, iron floc and bacterial sheens were observed on the water surface (Photo 47). Riparian vegetation of Watercourse 37 consisted of pasture grass with tall trees such as pine (*Pinus sp.*) with ground cover largely consisting of arum lily (*Zantedeschia aethiopica*), buttercup (*Ranunculus sp.*), and Yorkshire fog (*Holcus lantus*).

Photo 46. Watercourse 37 was classified as an intermittent watercourse.

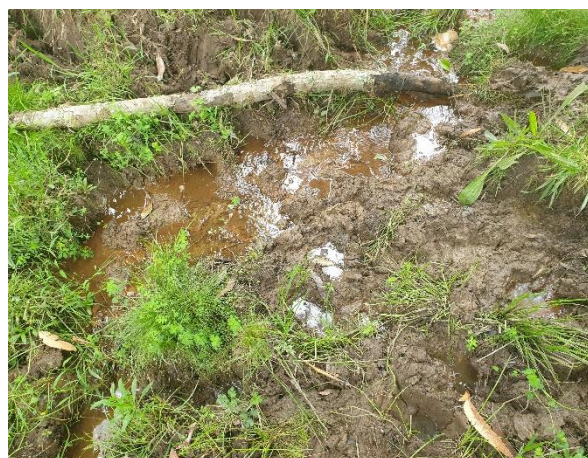
Photo 47. Iron floc and bacterial sheens were observed on the water surface.
