**Warkworth South Plan Change:
Baseline Ecology
December 2022**

Document title:	Warkworth South Plan Change: Baseline Ecology
Prepared for:	KA Waimanawa Limited Partnership and Stepping Towards Far Limited
Version:	Version 4
Date:	20 December 2022
Document name:	63967 & 64366 Warkworth South Plan Change Baseline Ecology 20Dec22

Reference: Bioresearches (2022). Warkworth South Plan Change: Baseline Ecology. 63588. Report for KA Waimanawa Limited Partnership and Stepping Towards Far Limited. pp 72

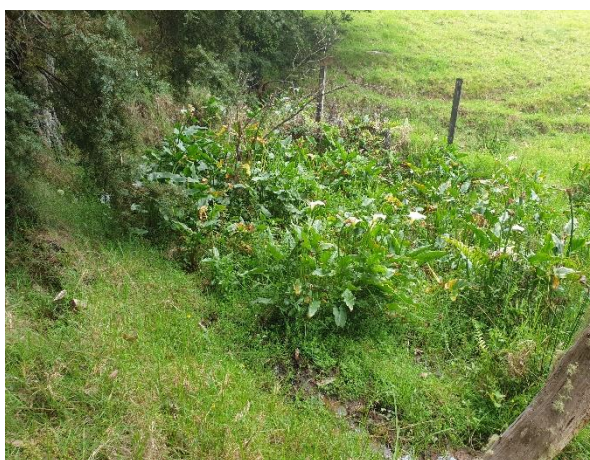
Photo 48. Wetland 10 was small and contained pugging depressions.

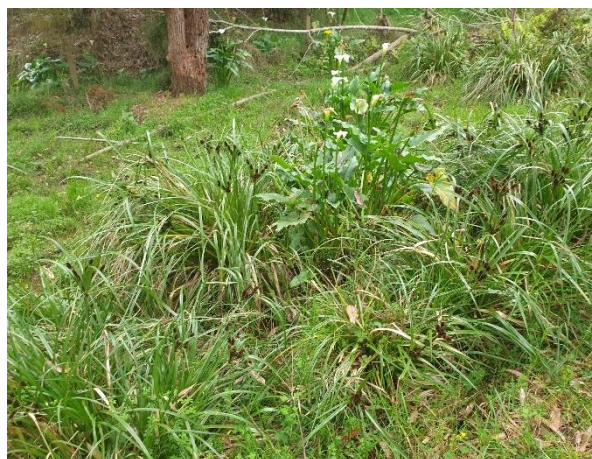
Photo 50. Wetland 11 contained giant umbrella sedge and arum lily.

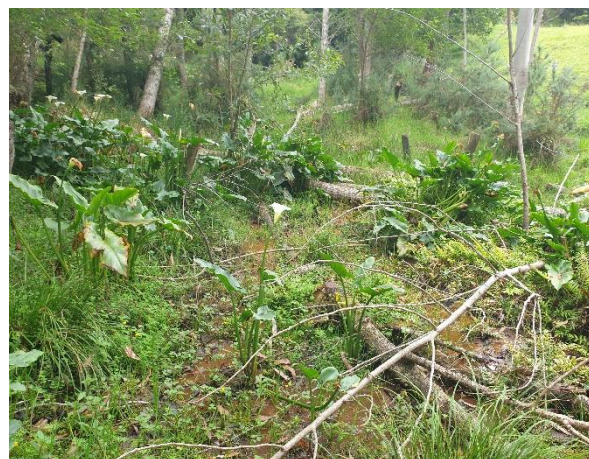
Photo 51. Riparian vegetation consisted of rank grass, gorse and few tall trees.

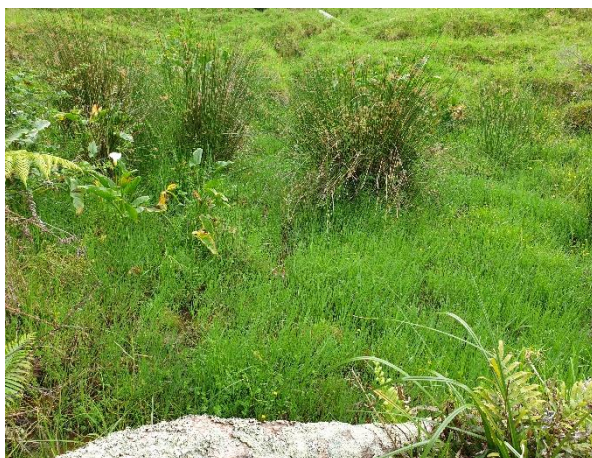
Wetland 12 was located downstream of the dam and was approximately 20 m² in size, and was dominated by exotic hydric vegetation (Photo 52). The dominant vegetation observed within Wetland 12 included mercer grass (*Paspalum distichum*) and soft rush, with spearwort (*Ranunculus flammula*), giant umbrella sedge and arum lily present (Table 20). Within Wetland 9, the ground was boggy and

Photo 52. Wetland 12 was dominated by mercer grass.

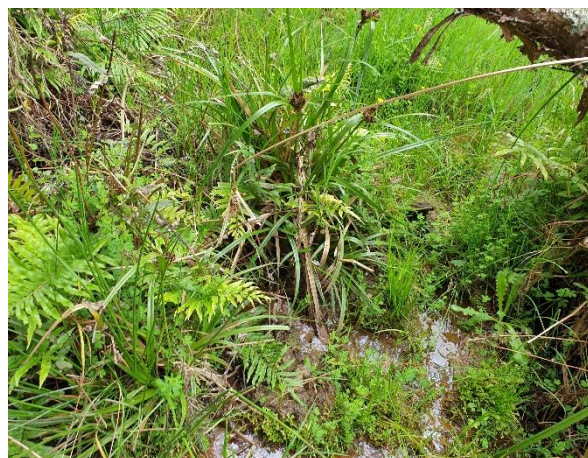
occasional pools could be observed within pugging depressions (Photo 53). Wetland 12 was of low ecological value due to the low diversity of indigenous vegetation, small size and lack of riparian yard.

Photo 53. The ground was boggy with occasional pools observed within the wetland.

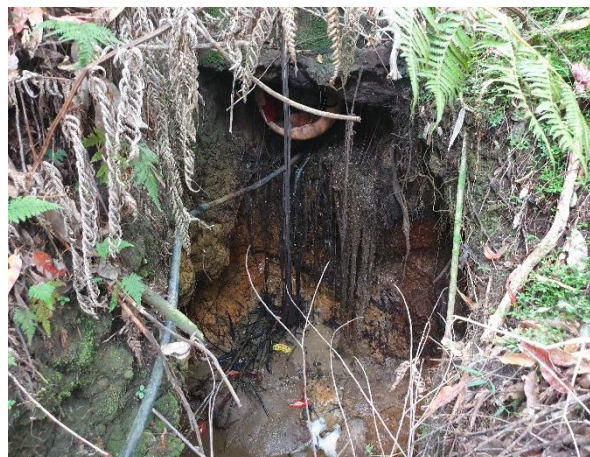
Wetland 3, the stream contained a tall drop (>2 m) with root mats trailing down the banks (Photo 55). This drop likely acts as a barrier to fish passage due to its vertical banks.

Photo 55. A tall drop was present within Watercourse 38 acting as a barrier to fish passage.

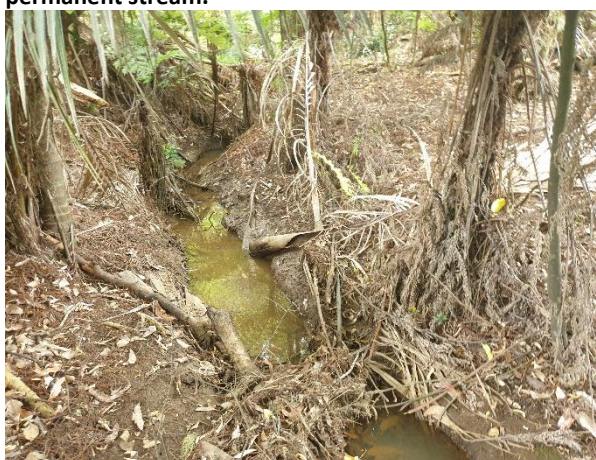
The dominant substrate throughout Watercourse 38 consisted of fine sediments with a high abundance of organic debris, root mats and leaf litter within the stream bed (Photo 56). Riparian vegetation throughout Watercourse 38 consisted of a diverse range of indigenous vegetation (Photo 57), including tōtara, kānuka (*Kunzea ericoides*), māhoe (*Meliactylus australis*) and nikau (*Rhopalostylis sapida*), with white rata (*Metrosideros albiflora*) observed growing on pōnga (*Cyathea dealbata*) trucks. The riparian vegetation and incised banks provided a high level of shading with periphyton and macrophytes low due to the high shade. Ground cover predominantly consisted of bare ground with a dense layer of leaf litter and organic debris, with occasional patches of African clubmoss (*Selaginella kraussiana*) and ground ferns.

Photo 56. The dominant substrate consisted of fine sediment with high organic matter inputs.

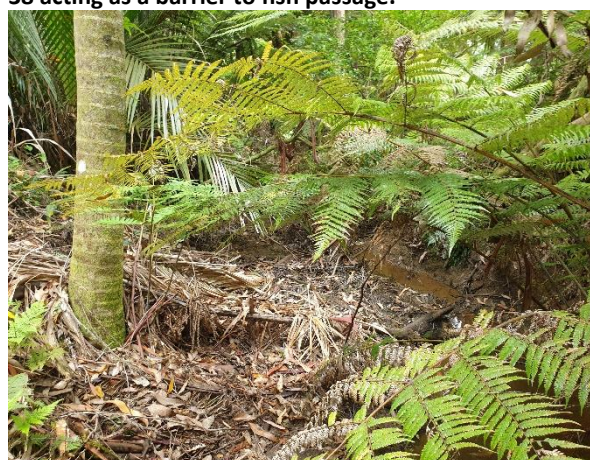
Photo 57. The riparian margin consisted of a diverse range of indigenous vegetation.

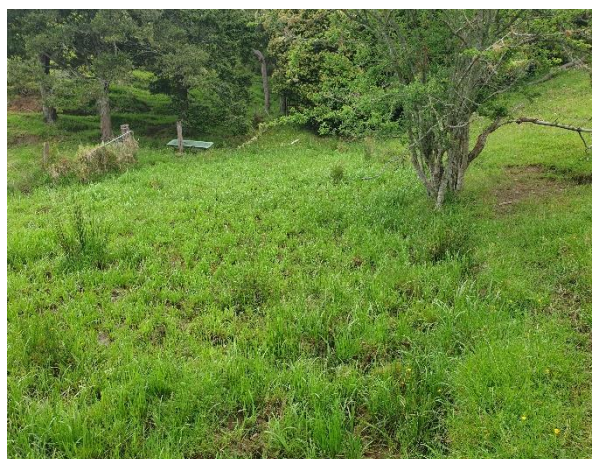
Wetland 13 was located downstream of Watercourse 38, with the stream channel dissipating as it flows through the wetland. Wetland 13 was approximately 316 m² in size and dominated by reed-sweet grass (*Glyceria maxima*) with additional vegetation observed within the wetland consisting of soft rush, swamp millet (*Isachne globosa*) and water purslane (*Ludwigia palustris*). Within the wetland body, the ground was highly pugged and the hydric vegetation appeared to have been recently grazed. Standing water and boggy ground was observed with deep pools present within the wetland. Riparian vegetation was limited to pasture grass with sparse trees. Wetland 13 was considered of low ecological value due to the dominance of exotic hydric vegetation, an aggressive weed species, lack of riparian vegetation and impacted state due to stock access.

Photo 58. Wetland 13 was dominated by exotic vegetation.

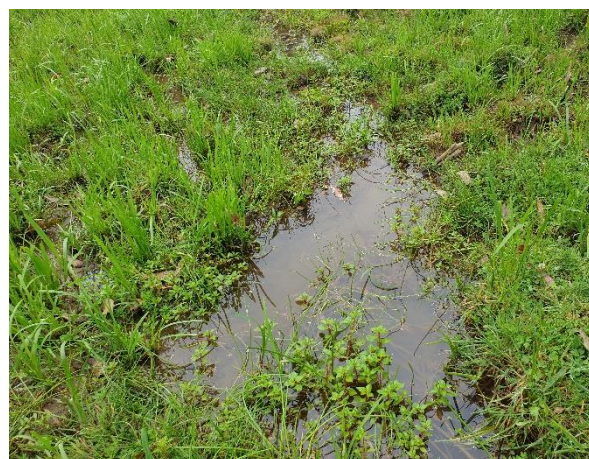
Photo 59. Standing water and deep pools were present within the wetland.

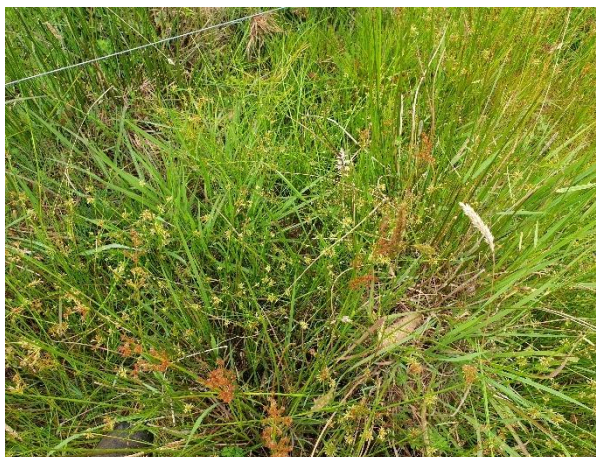
Wetland 14 was located immediately downstream of Wetland 13, with a wire fence dividing the two wetlands. Wetland 14 was delineated as a separate wetland due to this barrier and changes in hydric vegetation (Table 22). Wetland 5 was approximately 410 m² in size and dominated by budding club-rush (*Isolepis prolifera*), with additional hydric vegetation consisting of umbrella sedge, soft rush and swamp millet (Photo 60). No standing water was observed within the wetland; however, the ground was boggy, with no obvious signs of livestock impacts such as pugging depressions or grazing observed. Riparian vegetation was mainly limited to pasture grass with lines of crack willow (*Salix x fragilis*) present on the true right bank on the riparian margin providing low shading functions to the wetland area (Photo 61). The ecological value of Wetland 14 was considered to be low due to the low diversity of indigenous hydric vegetation and the lack of aquatic habitat and riparian yard.

Photo 60. Wetland 14 was dominated by budding club-rush

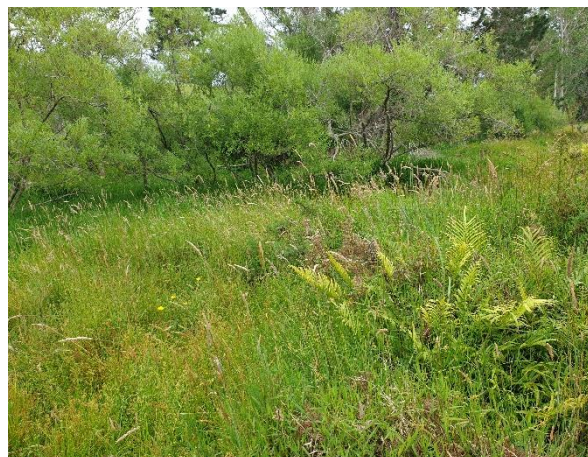
Photo 61. A line of willows was present on the riparian yard.

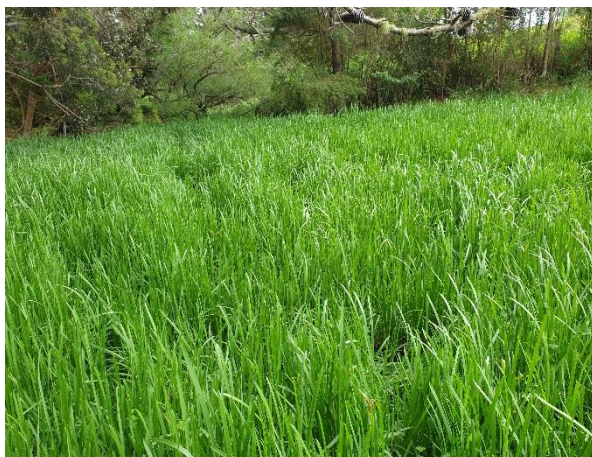
Wetland 15 was present immediately downstream of Wetland 14, and was delineated as a separate wetland due to changes in hydric vegetation. Within Wetland 15, the dominant hydric vegetation consisted of reed-sweet grass, with sparse sharp spike-sedge, soft rush, and lotus present throughout (Photo 62). Within the wetland, the ground was boggy and a large pool of standing water was observed towards the downstream extent (Photo 63). Wetland 15 was approximately 1,850 m² in size, with the downstream portion of the wetland becoming a complete monoculture of reed-sweet grass. The riparian vegetation of Wetland 15 consisted of rank pasture grass on the true left bank, and rows of

Photo 62. Wetland 15 was dominated by reed-sweet grass.

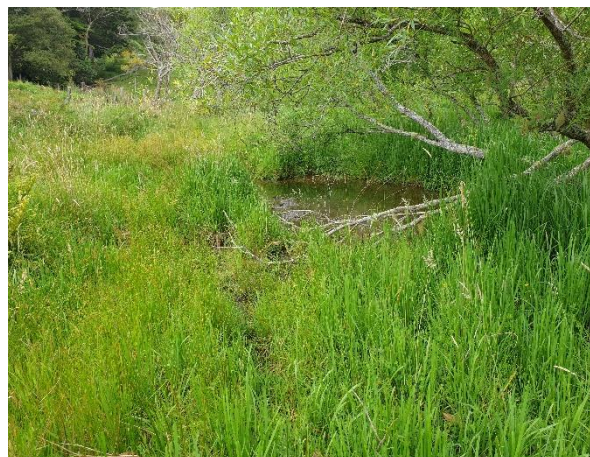
Photo 63. A large pool was observed within Wetland 15.

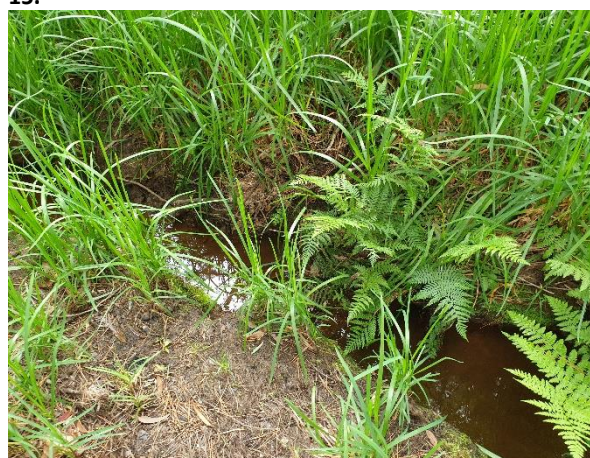
pine (*Pinus radiata*) trees on the true right bank (Photo 64). Within the lower extent, defined channels could be observed within the wetland (Photo 65), which formed a confluence and transitioned into a permanent stream, previously described as Watercourse 35 within the Waimanawa Hills (a) Block.

Photo 65. Defined channels were apparent at the downstream extent of the wetland.

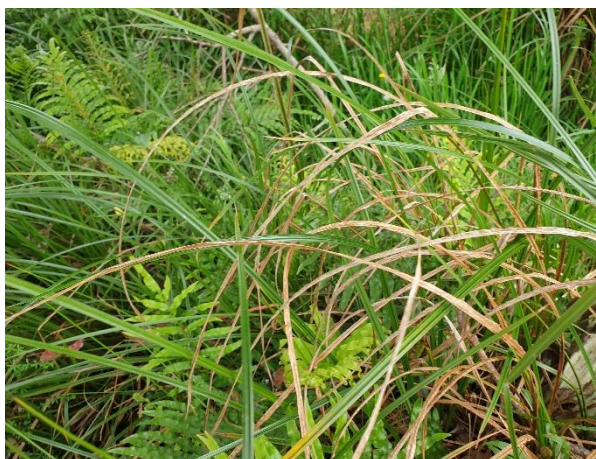
Wetland 16 was located within Wetland 15, and was delineated as a separate wetland due to obvious changes in hydric vegetation (Table 24). Wetland 16 was approximately 30 m² in size and contained standing water, with a deep pool located on the northern boundary. Hydric vegetation observed within Wetland 16 included rautahi, with reed-sweet grass and Yorkshire fog (Photo 66). The riparian vegetation of Wetland 16 consisted of the hydric vegetation observed within Wetland 16, predominantly reed-sweet grass with one crack willow present (Photo 67). Wetland 16 was considered to be of low ecological value due to the small size and low diversity of indigenous hydric vegetation.

Photo 66. Wetland 16 was dominated by Rautahi with swamp kiokio and Yorkshire fog.

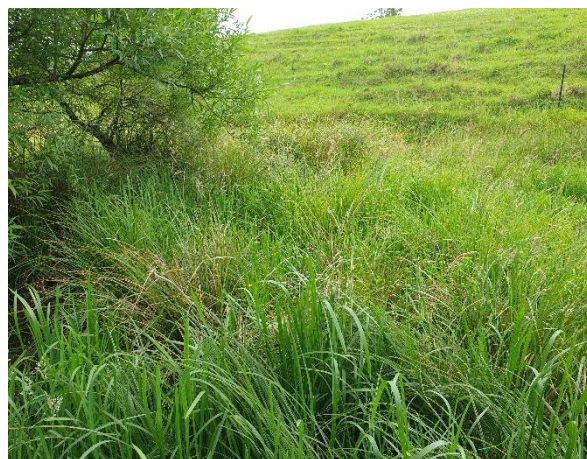
Photo 67. Riparian vegetation consisted of one crack willow and hyric vegetation described in Wetland 16.
