**TE TUPU NGĀTAHI**  
SUPPORTING GROWTH

# North West Redhills Riverhead Assessment of Effects on Heritage / Archaeology

December 2022

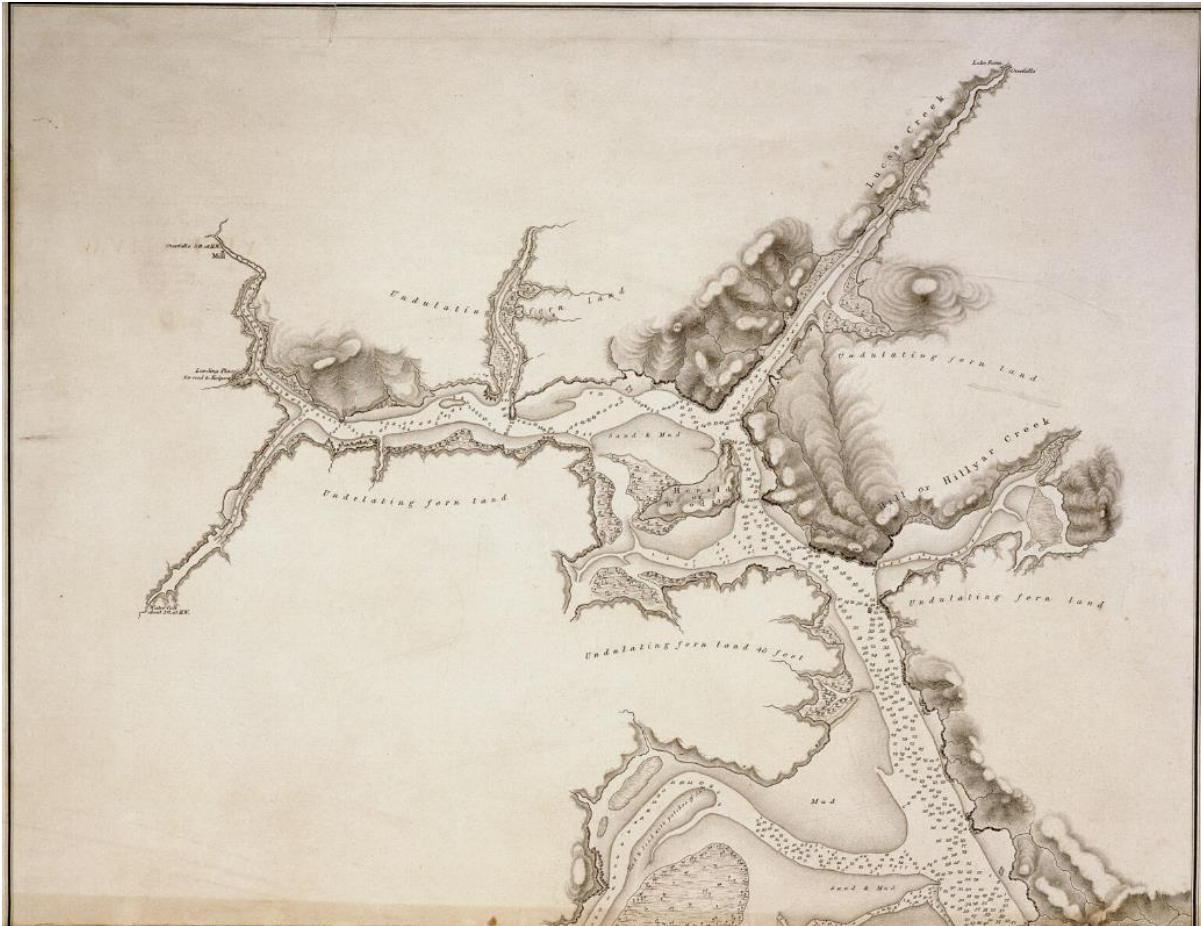
Figure 4-2: Detail of: 'Waitemata River from Kauri Point Auckland Harbour to its sources, surveyed by Comr. B. Drury and the officers of H.M.S. Pandora 1854'-(Auckland Libraries Heritage Collections Map 3909).

Historically the area was covered in Kauri forest like the rest of West Auckland, but with contact since European settlement this forest has given way to 'undulating fern lands' (Figure 4-2).

An early map of the harbour survey (Figure 4-2) shows a canoe landing area, presumably the start of an “ara” (pathway) from the upper harbour to the Kumeū River (Figure 8-3). This potential pathway would cross NoR R1. Nonetheless pathways are rarely recognised in the archaeological record.

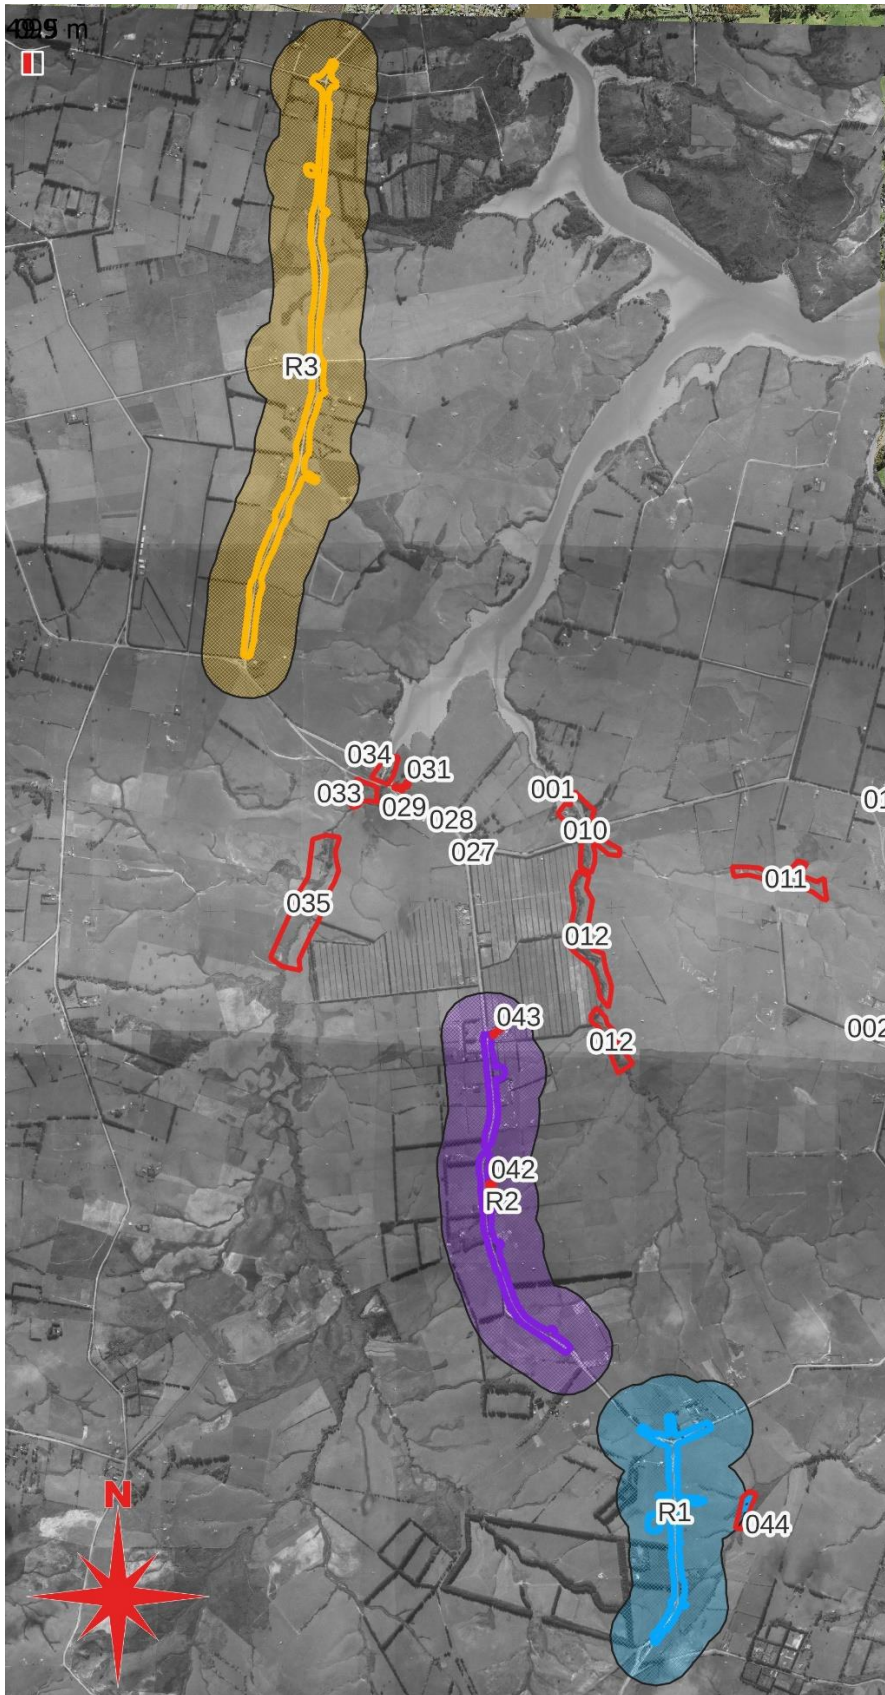
Figure 4-7: Rural character of the study area in 1940. Many shelterbelts of orchards can be seen as well as large areas of grazing.

Another investigation focused on the homestead and its development of one of the early settlers in the area, the Ocklestons (Foster and Felgate 2011). It paints a vivid picture of the changes and continuations of the rural life on the edge of Auckland, which is today replaced by suburbia. The 1940 aerial shows the study area dominated by orchards and grazing (Figure 4-7).

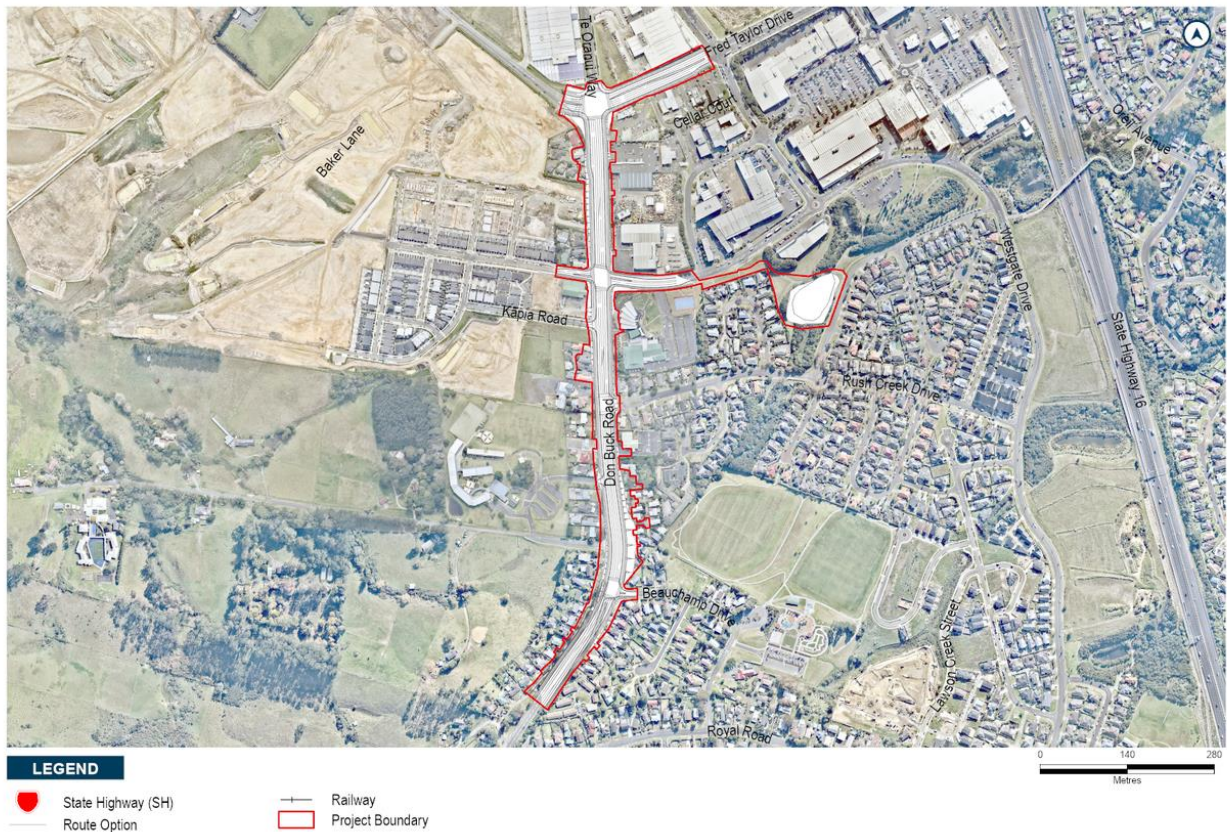
Figure 6-1: Overview of the Don Buck Road FTN Upgrade

It is proposed to submit a NoR (NoR RE1) to designate the land required to implement the upgrade of Don Buck Road to a four-lane local arterial with bus priority lanes and separated cycle lanes and footpaths on both sides of the corridor.

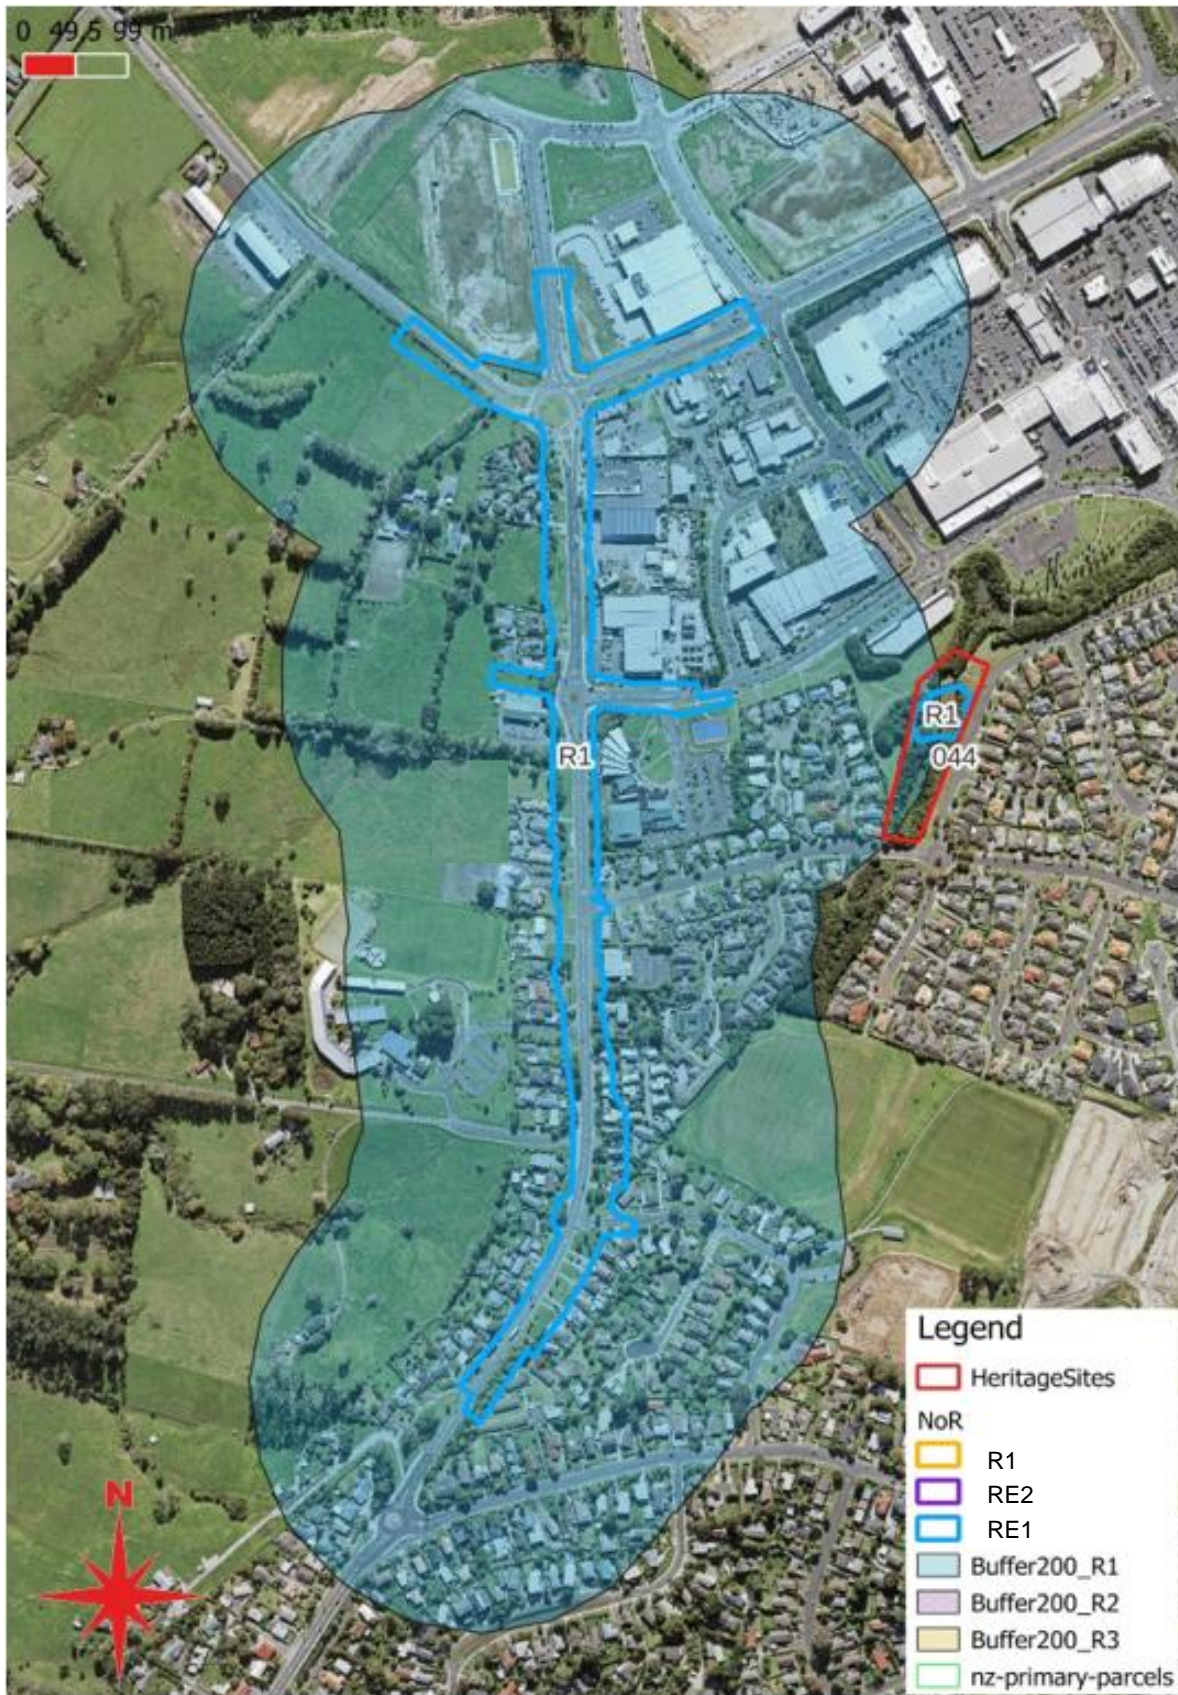
Figure 6-2: NoR RE1. The risk area around the stream is shown as 044. The picture also shows the 200 m buffer zone around the NoR of the road.

Within NoR RE1 and the 200 m buffer zone no archaeological sites are recorded. No notable trees are recorded in this part of the study area, nor are any historic overlays, structures or buildings recorded in the AUP:OP or the CHI.

The only heritage item within the study area of NoR RE1 is a possible risk zone whereas yet unrecorded archaeological features may be encountered around a small stream / wetland identified above. However, the site visit and the comparison of the modern aerial to the 1940 aerial shows that major modifications of the stream and surrounding the stream have taken place. It is therefore less likely that any intact archaeology would have survived those modifications.

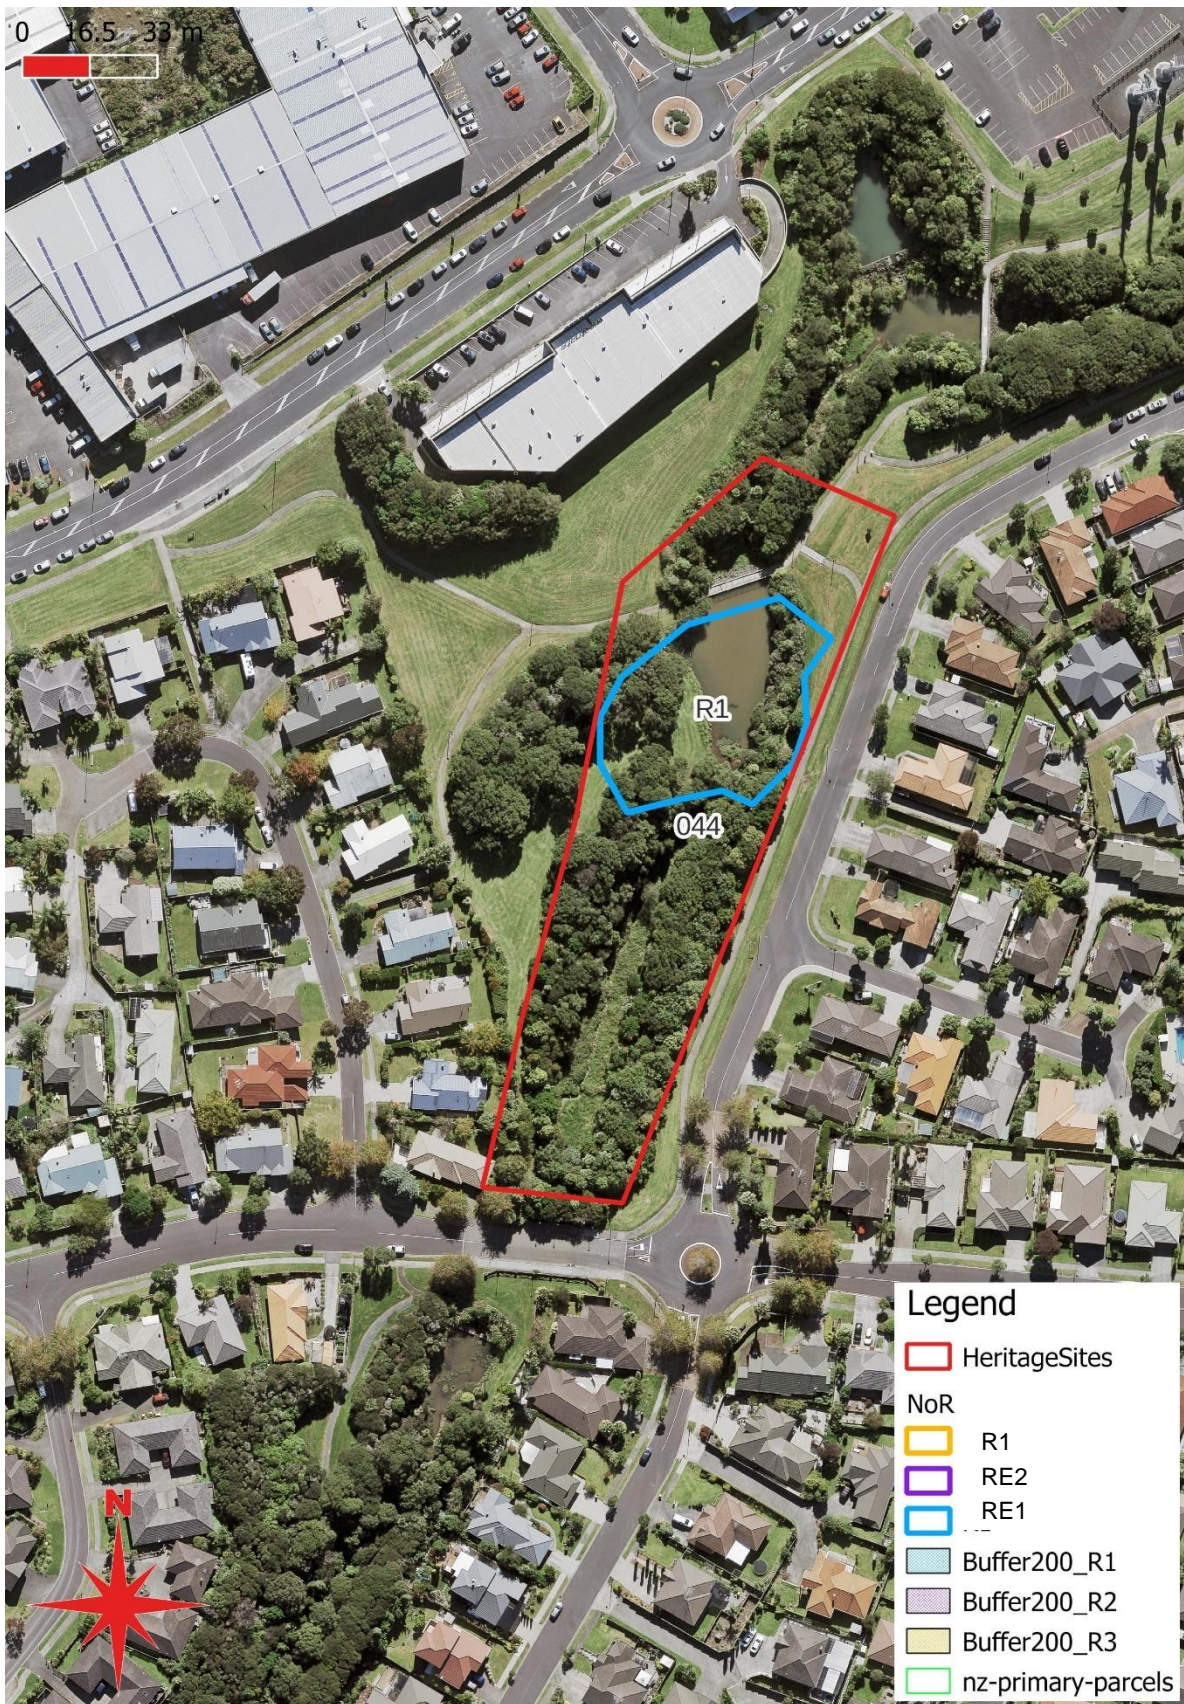
Figure 6-3: Risk area 044 overlaid onto a modern aerial.

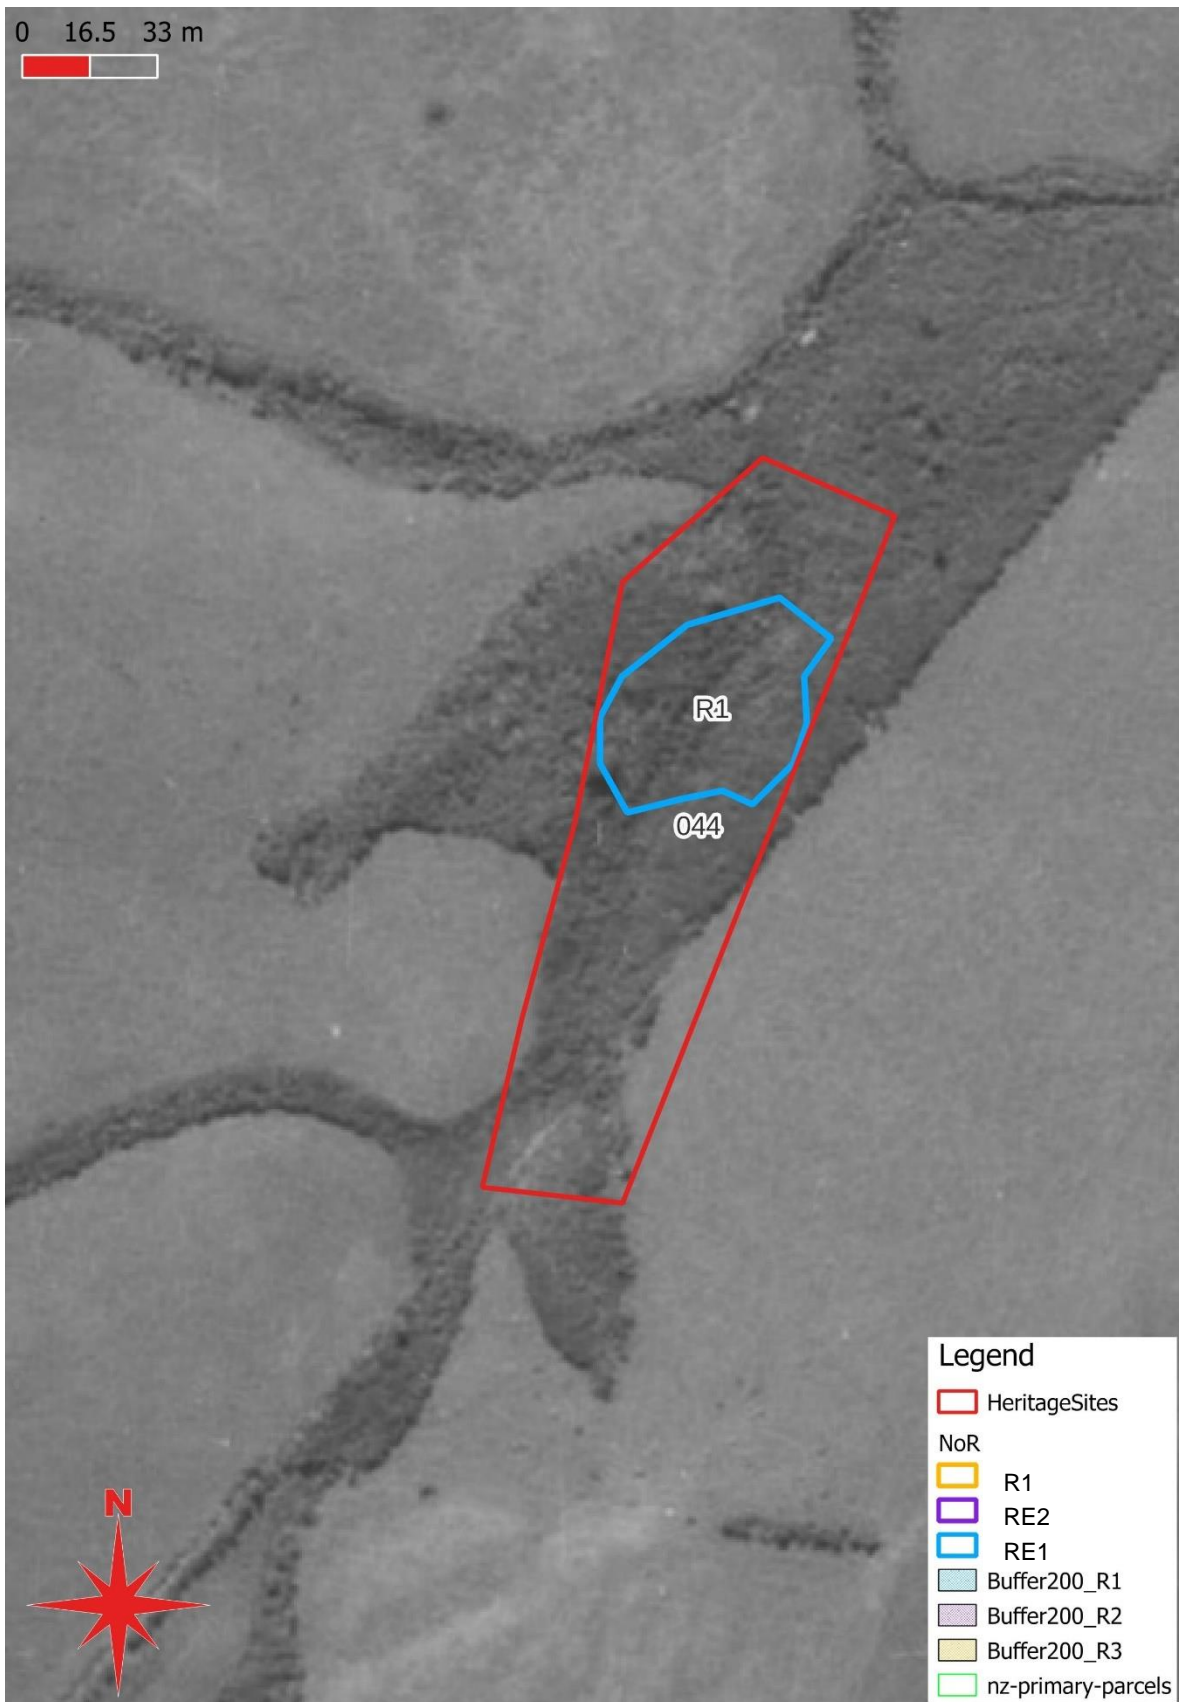
Figure 6-4: Risk area 044 overlaid onto the 1940 aerial. It shows a largely unmodified wetland and small stream surrounded by grazing fields.

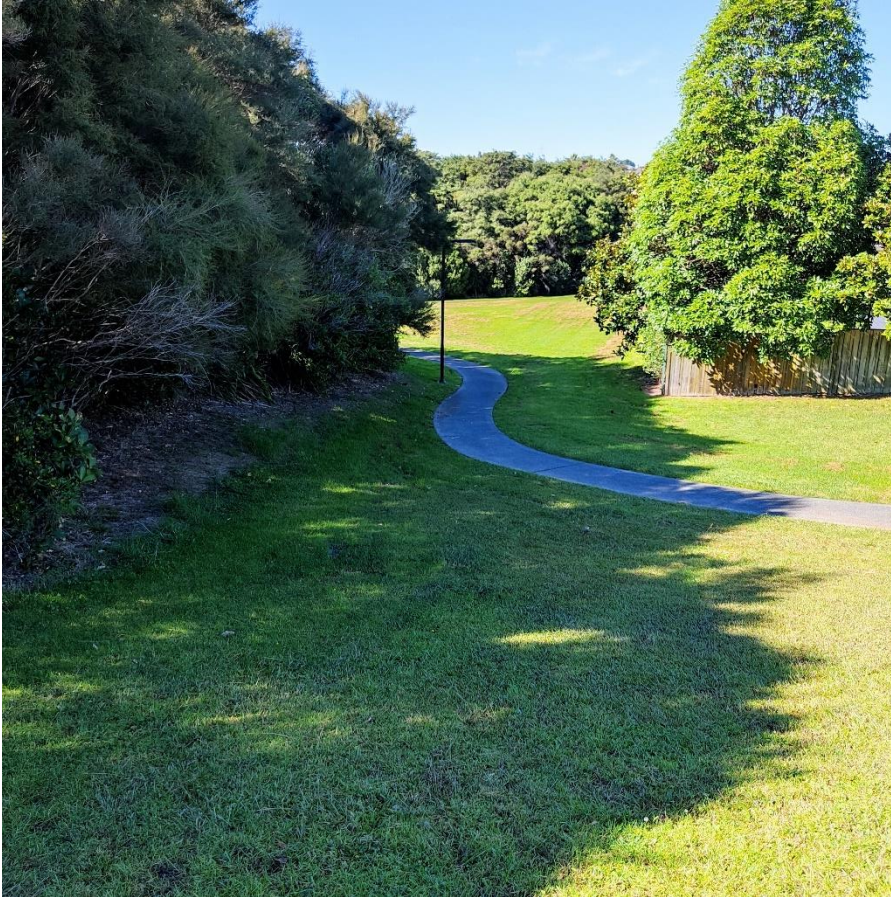
Figure 6-5: View onto largely modified park area looking towards risk area 044. It shows the highly modified nature of the modern environment.

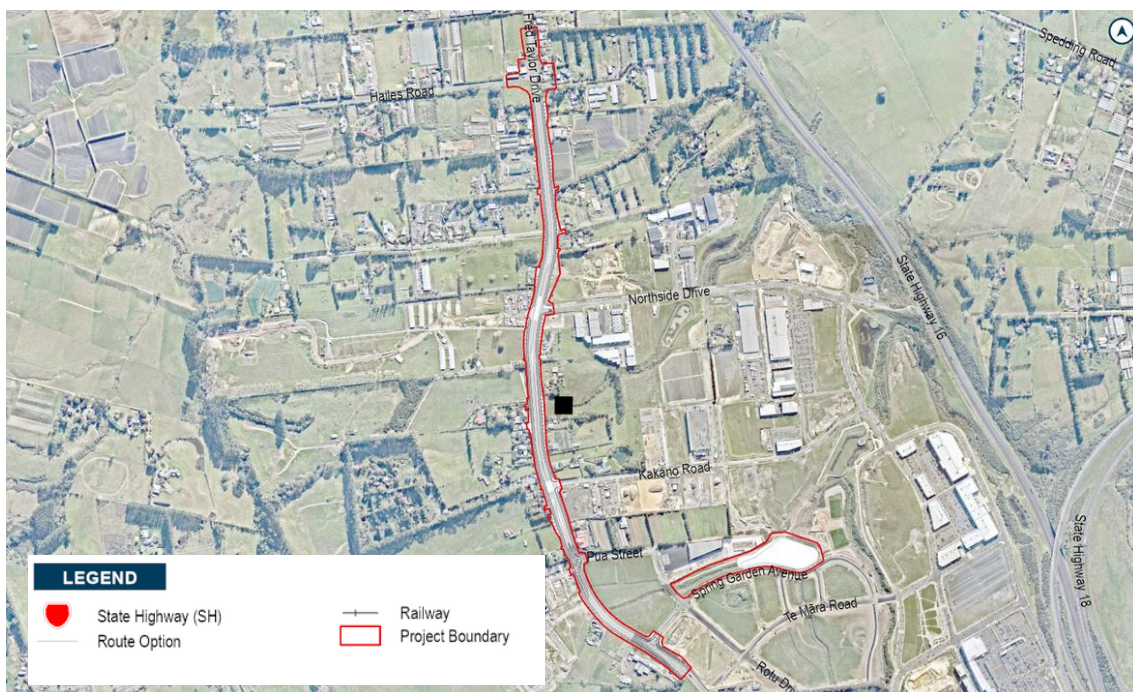
Figure 7-1: Overview of Fred Taylor Drive FTN Upgrade

The upgraded Fred Taylor Drive corridor will have multiple purposes. These are to provide access from Redhills to both a future rapid transit station and the strategic highway network; and the FTN facilities will provide a multimodal corridor into Westgate metropolitan centre. The proposed corridor will also support an active mode shift with separated cycle lanes and footpath on both side and public transport priority lanes. An overview of the proposed design is provided in Figure 7-1 below.

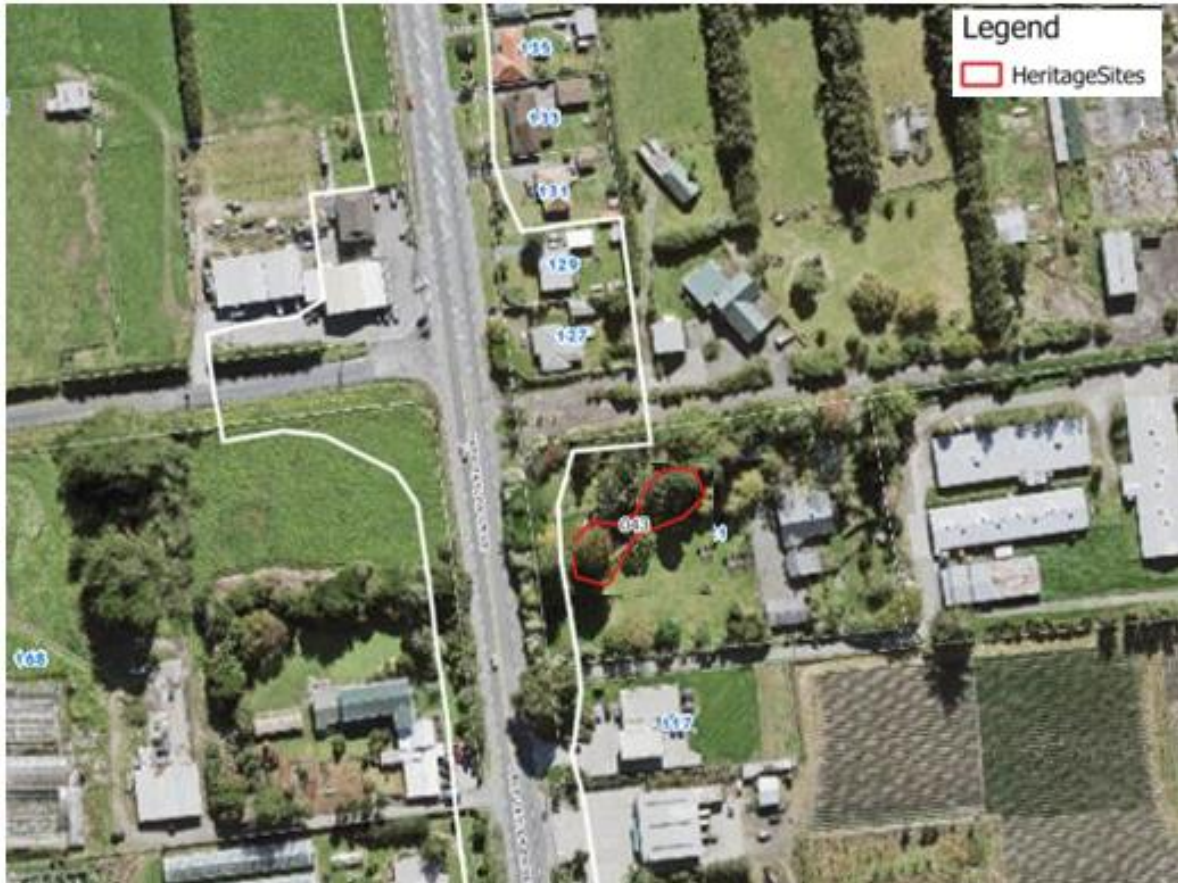
Figure 7-3: Two trees recorded as CHI 2164 and 2165. They are not on the notable tree list of the AUP:OP.

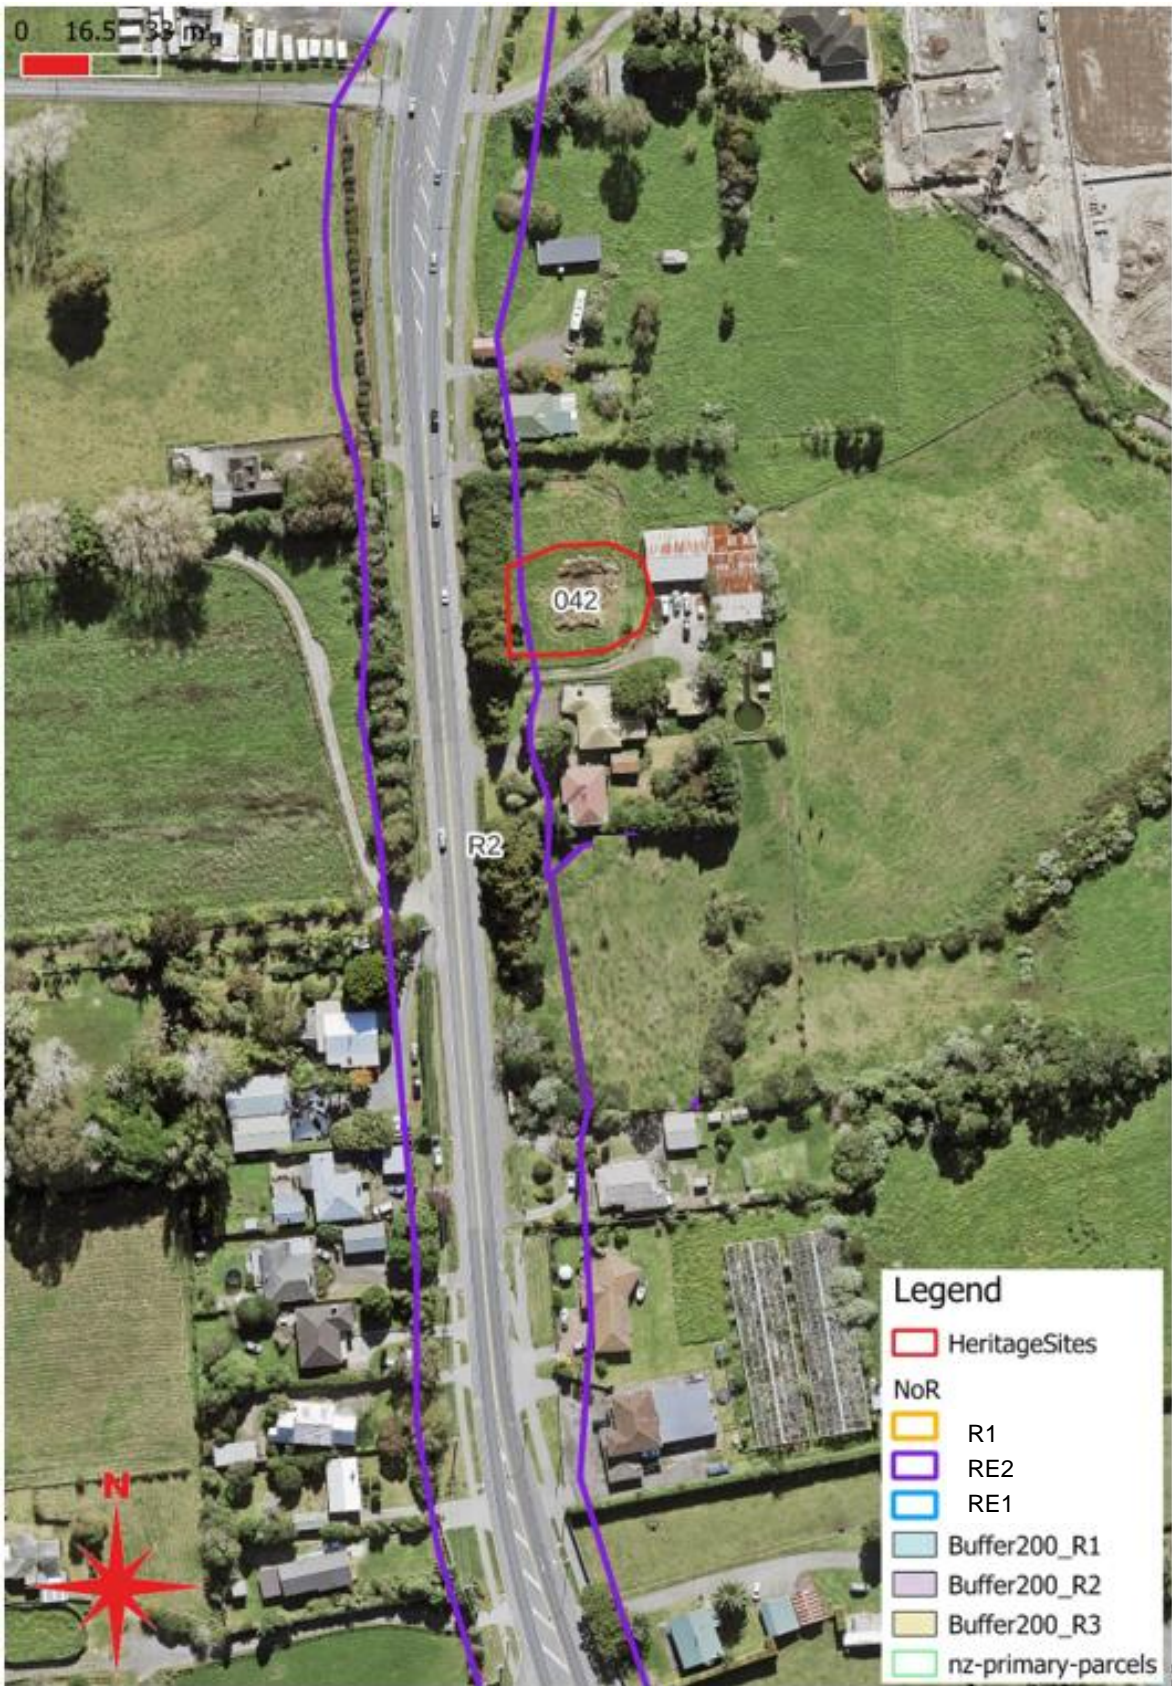
Figure 7-4: Recorded crash site of a B17 bomber (042).

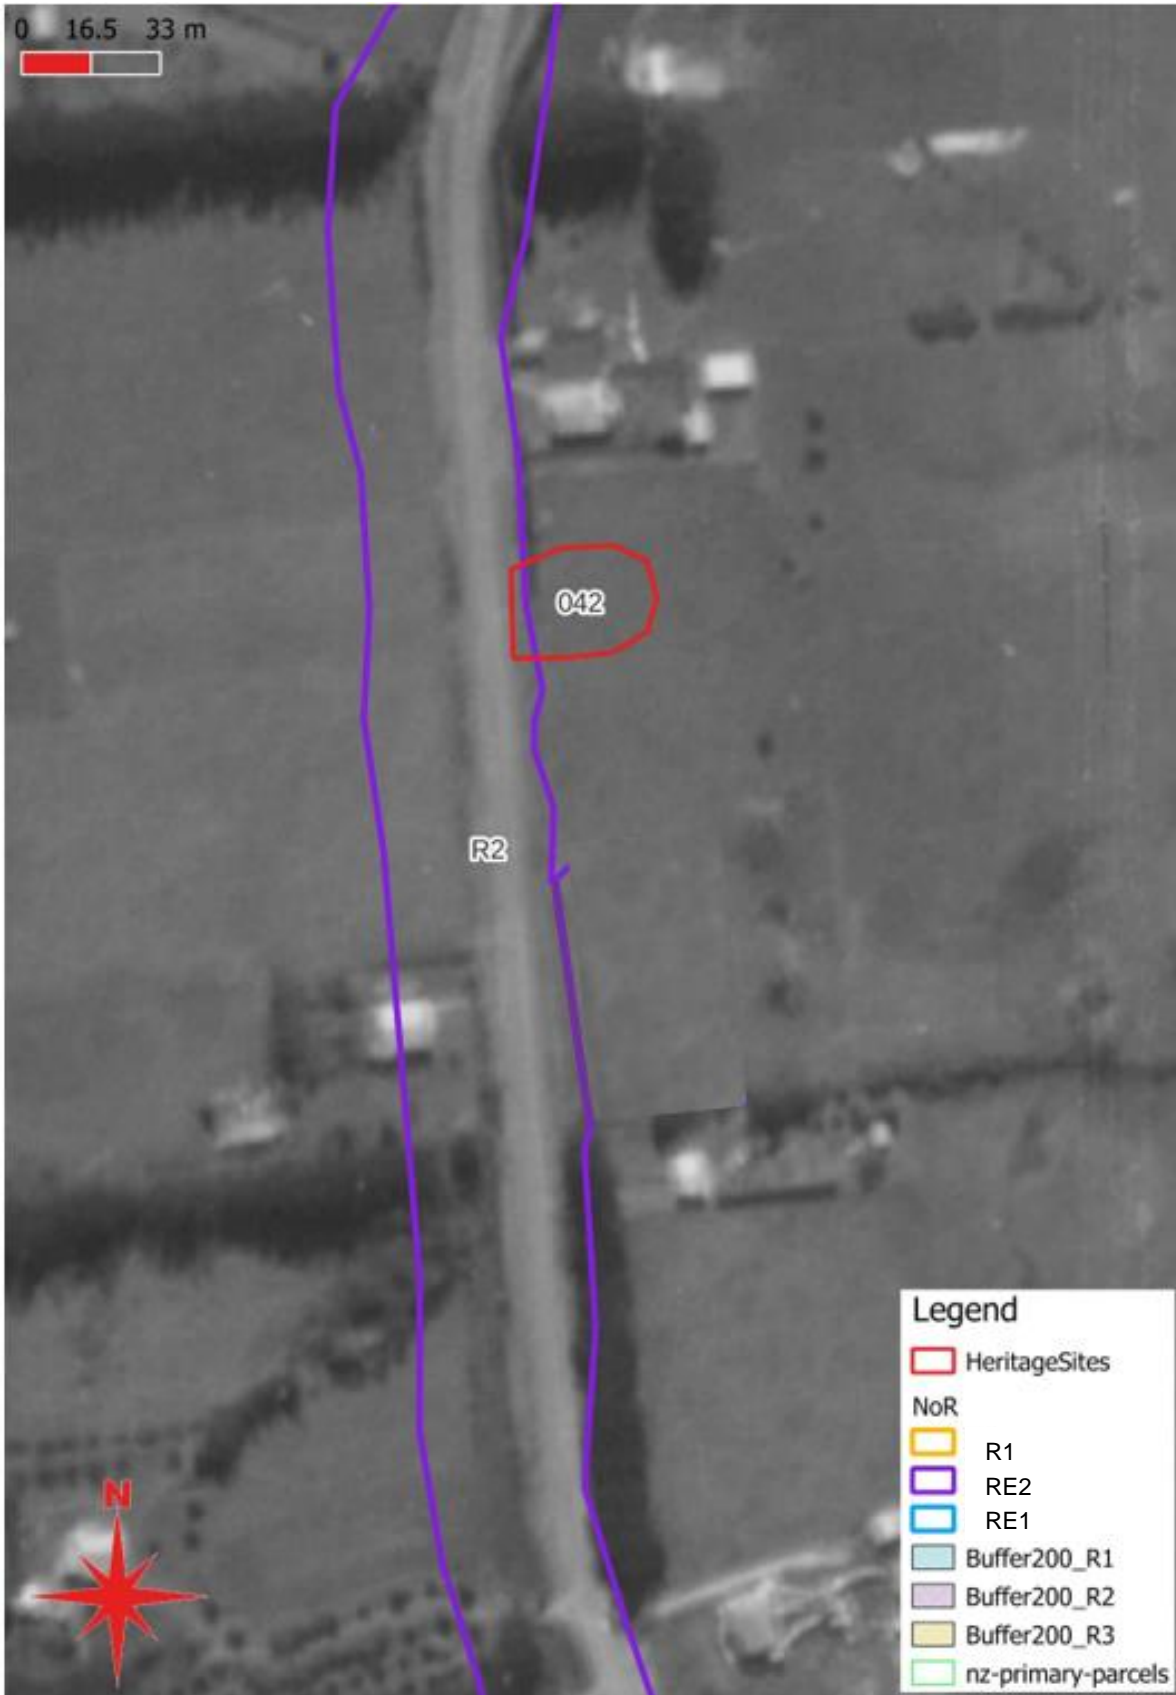
Figure 7-5: Crash site overlaid onto 1940 aerial, two years before the crash occurred.

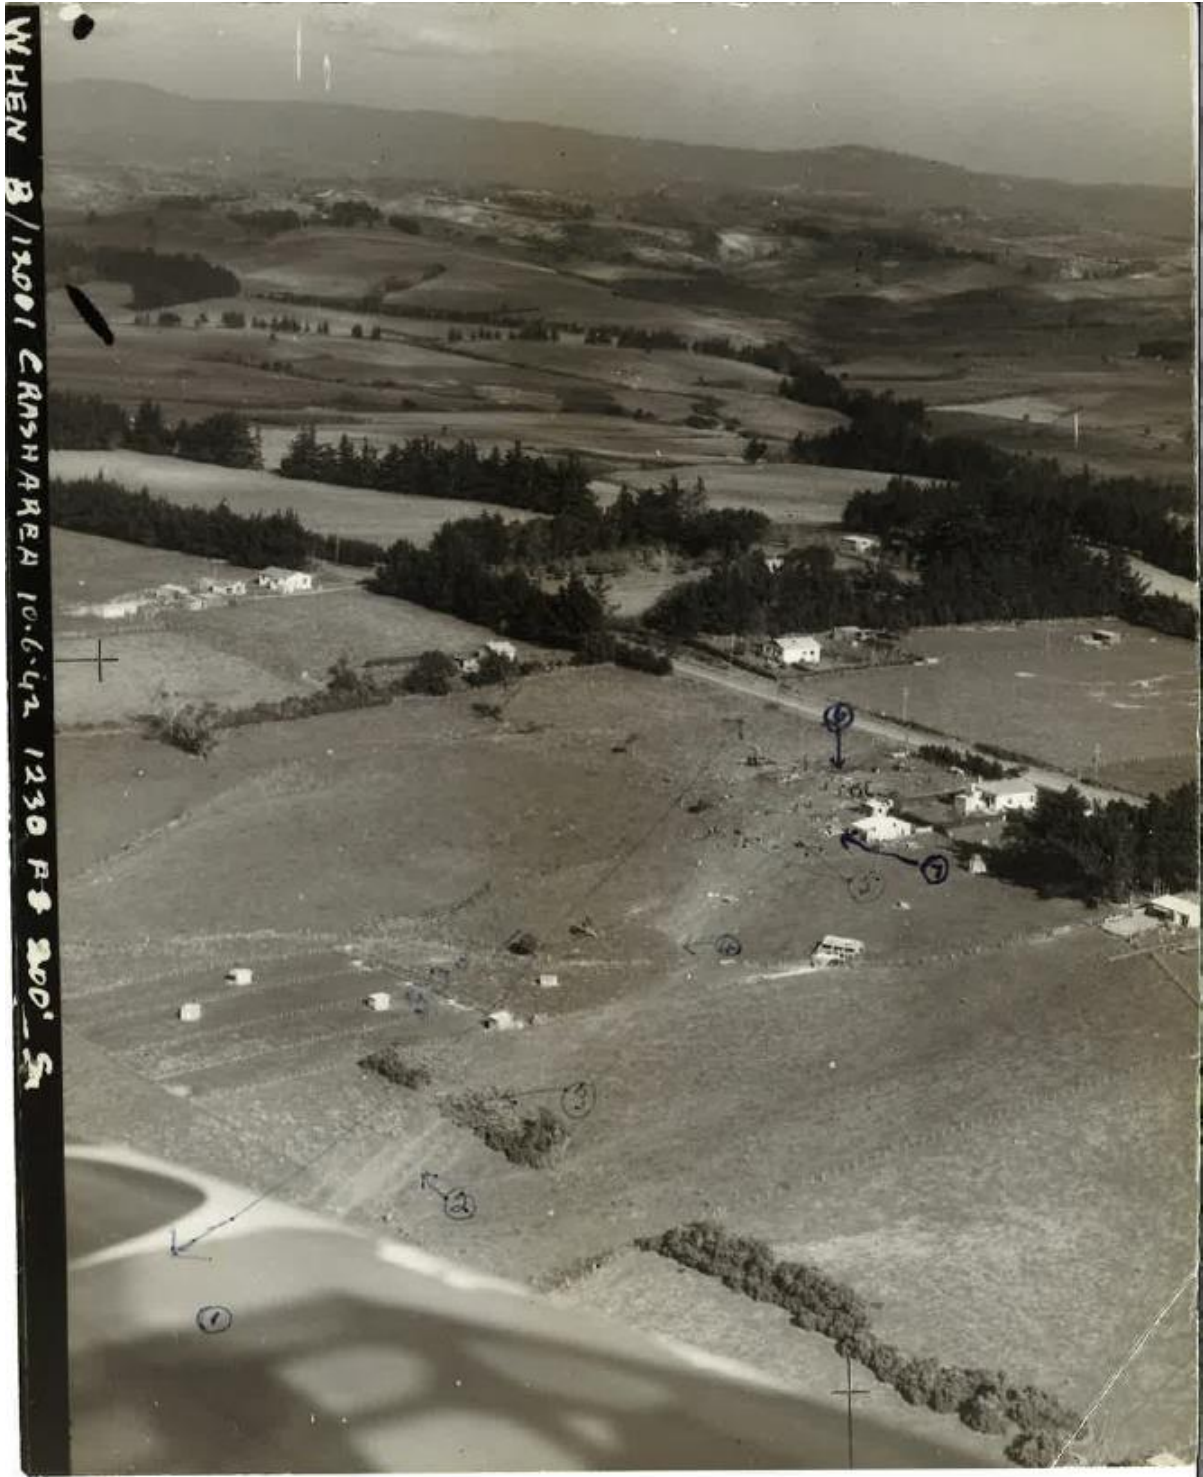
Figure 7-6: Photo from the inquiry into the crash showing the extent of the debris field (CHI archives).

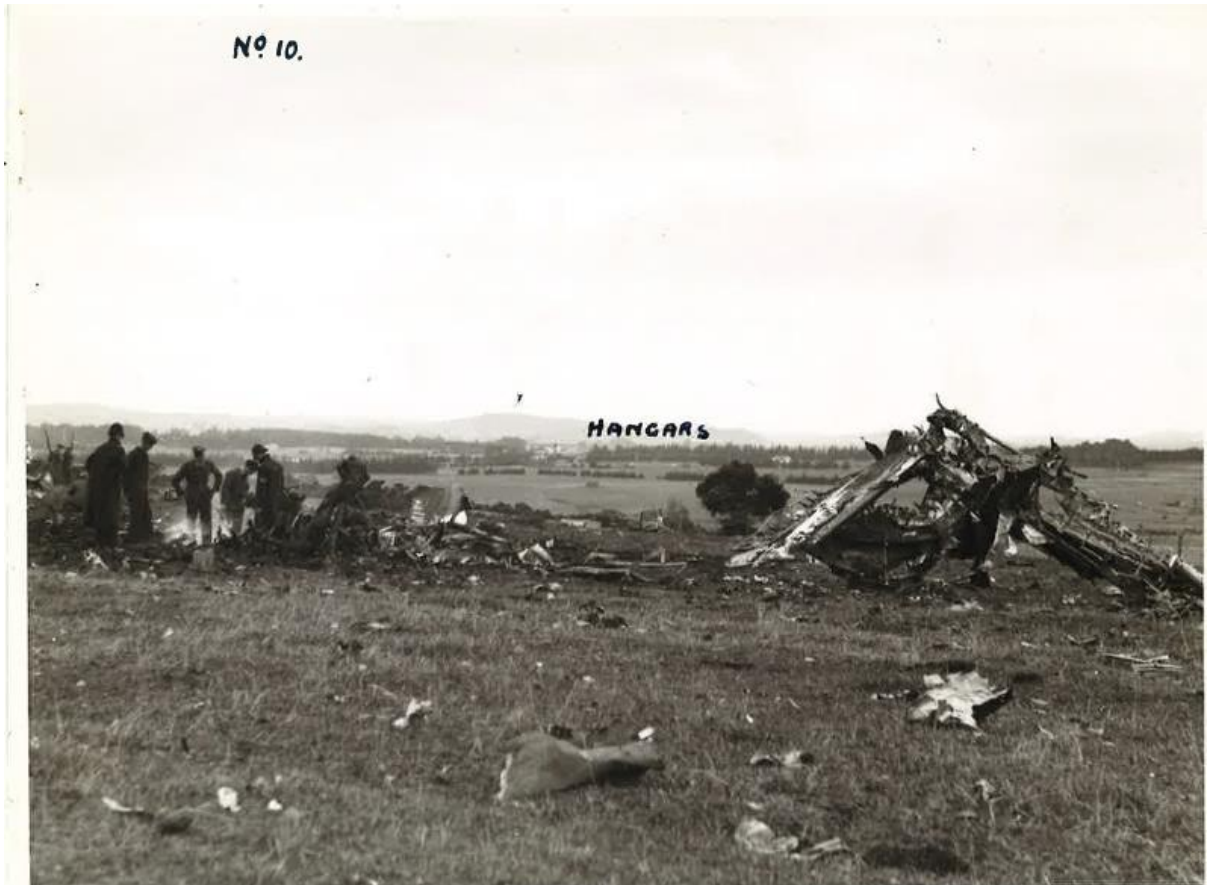
Figure 7-7: View onto the crash site from the ground (CHI archives).

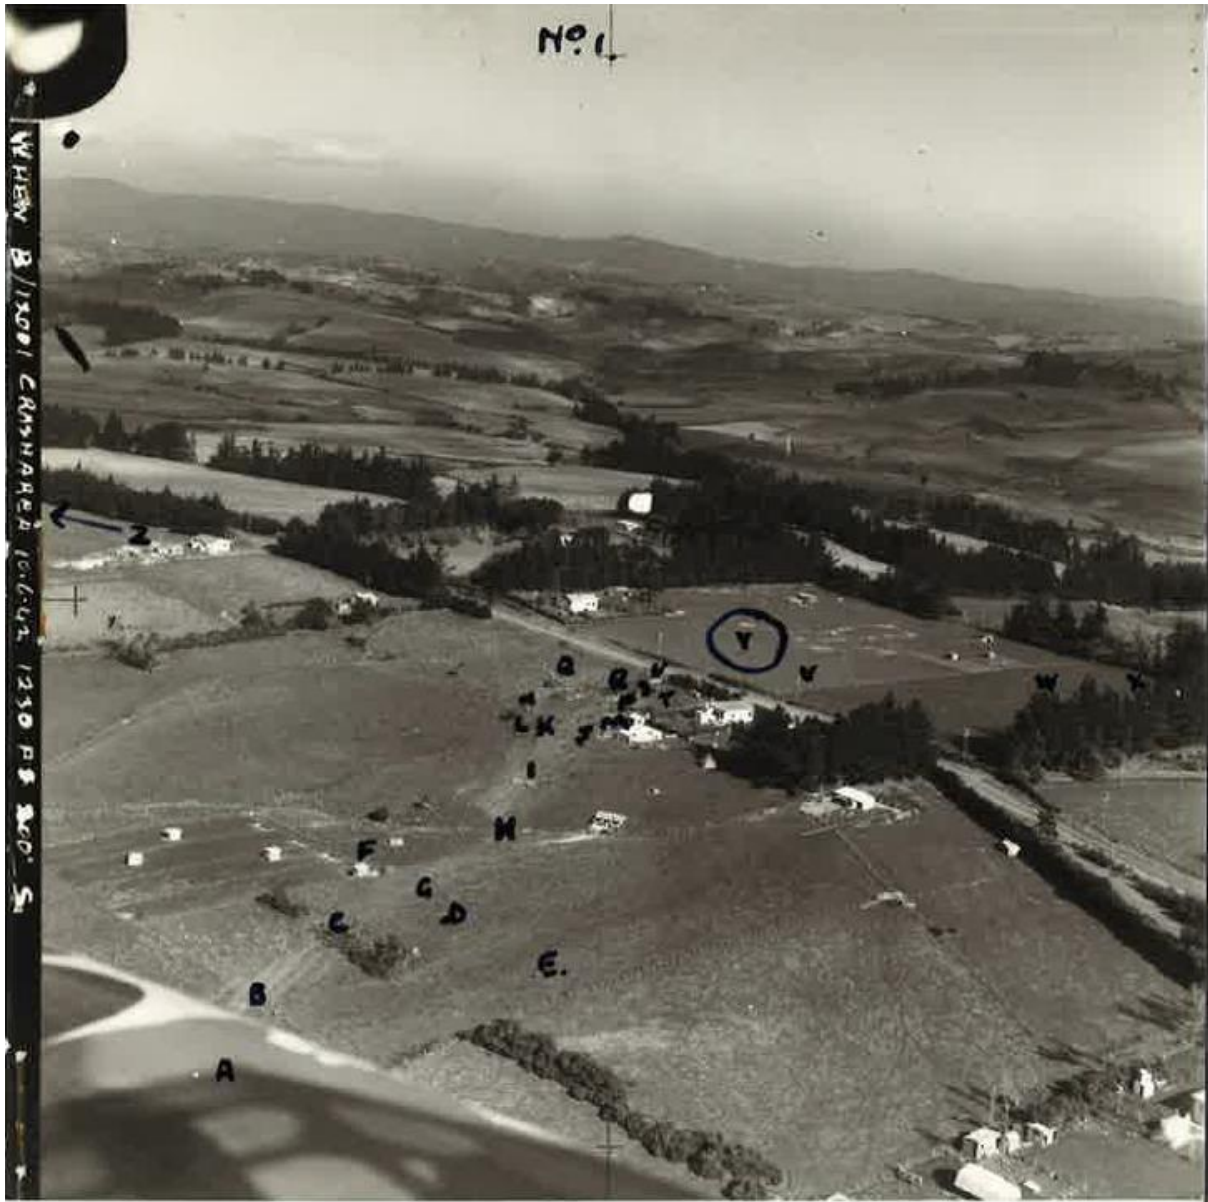
Figure 7-8: Marked up view over the debris field used for the official inquiry into the crash (CHI archives). It clearly shows that the debris field extends across Fred Taylor Drive.

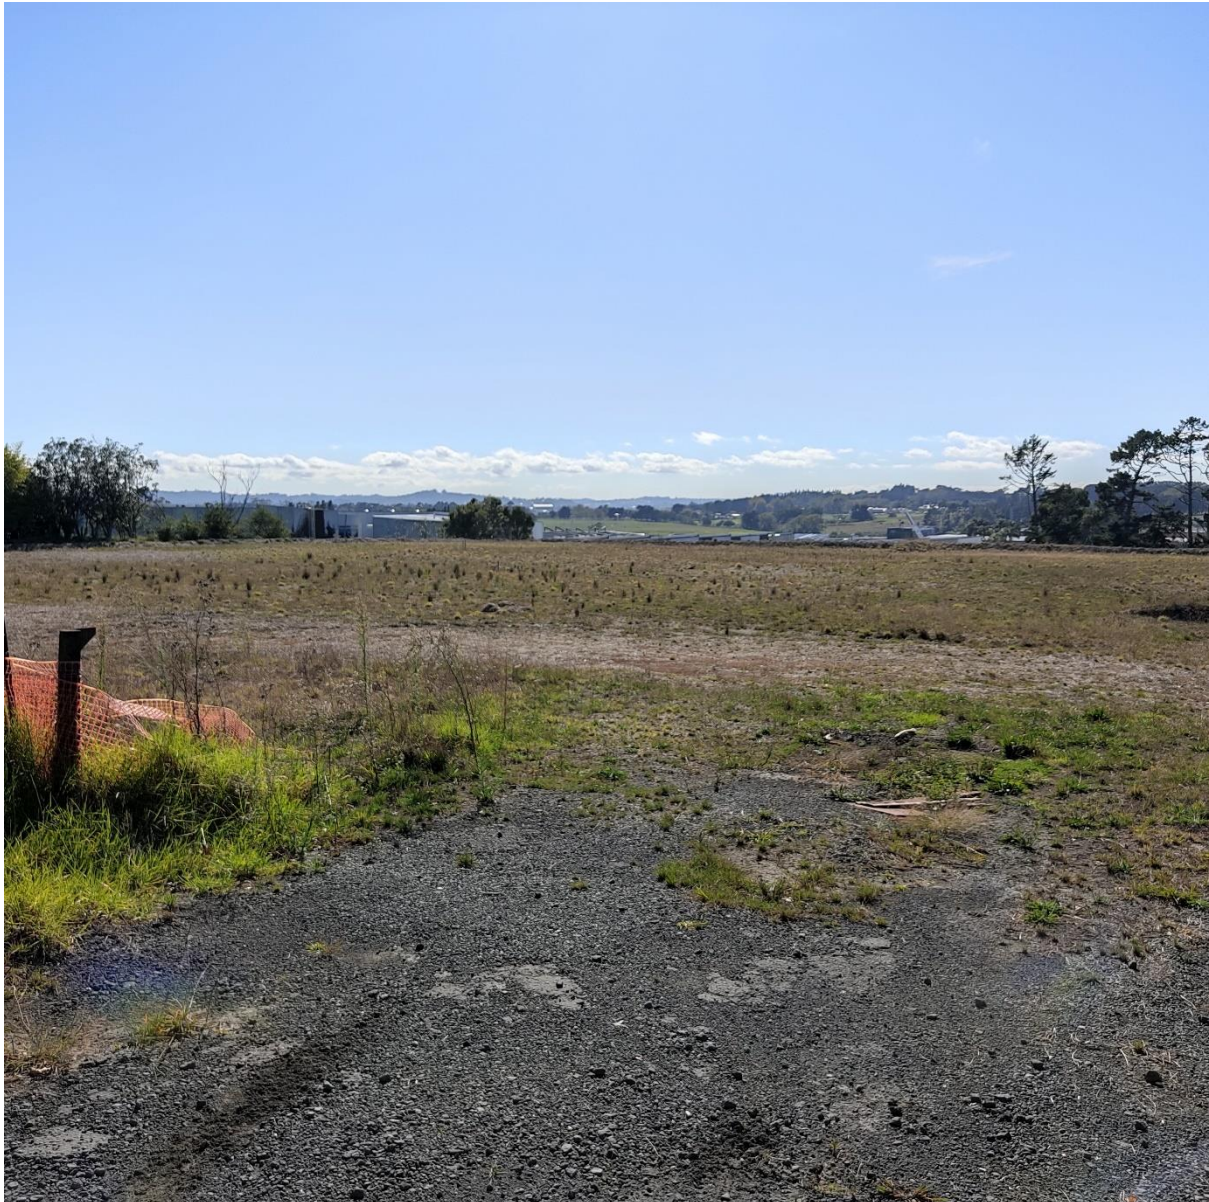
Figure 7-9: Large scale earthworks over the archaeological site to the east of Fred Taylor Drive. There is nothing left of the archaeological site on the eastern side of the road.
