**TE TUPU NGĀTAHI**  
SUPPORTING GROWTH

# North West Redhills Riverhead Assessment of Effects on Heritage / Archaeology

December 2022

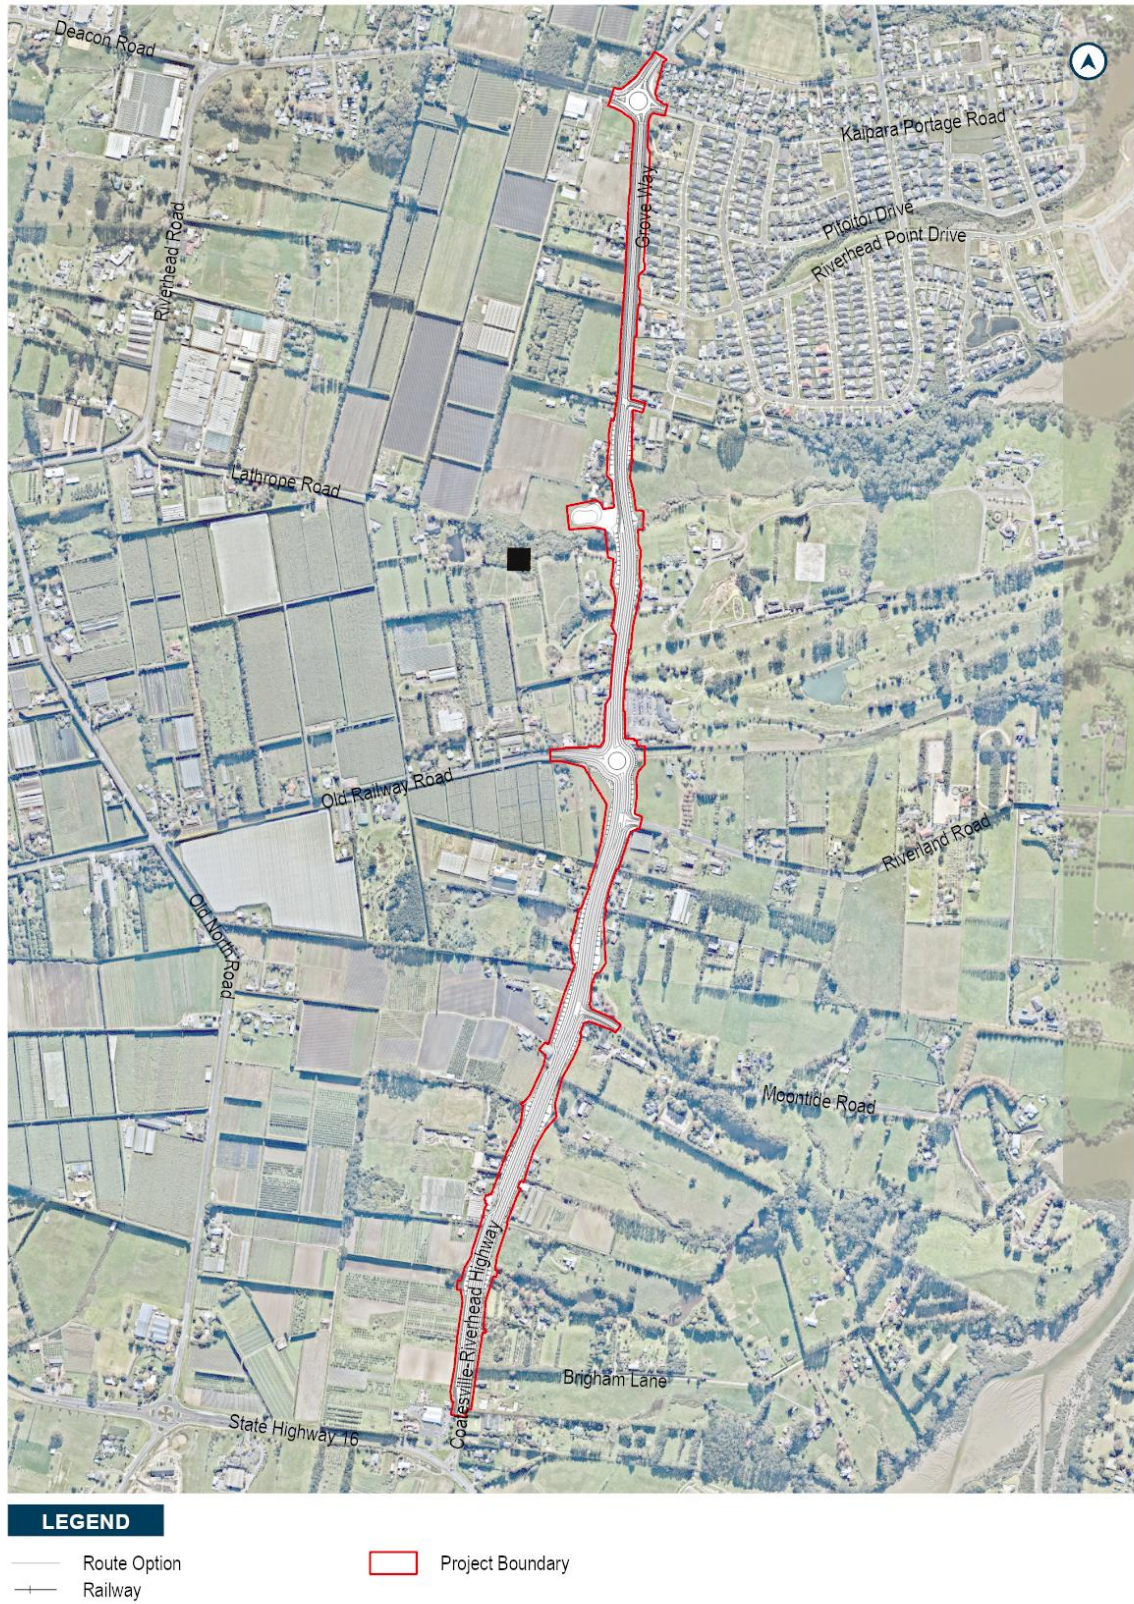
Figure 8-1: Overview of the Coatesville-Riverhead Highway Upgrade

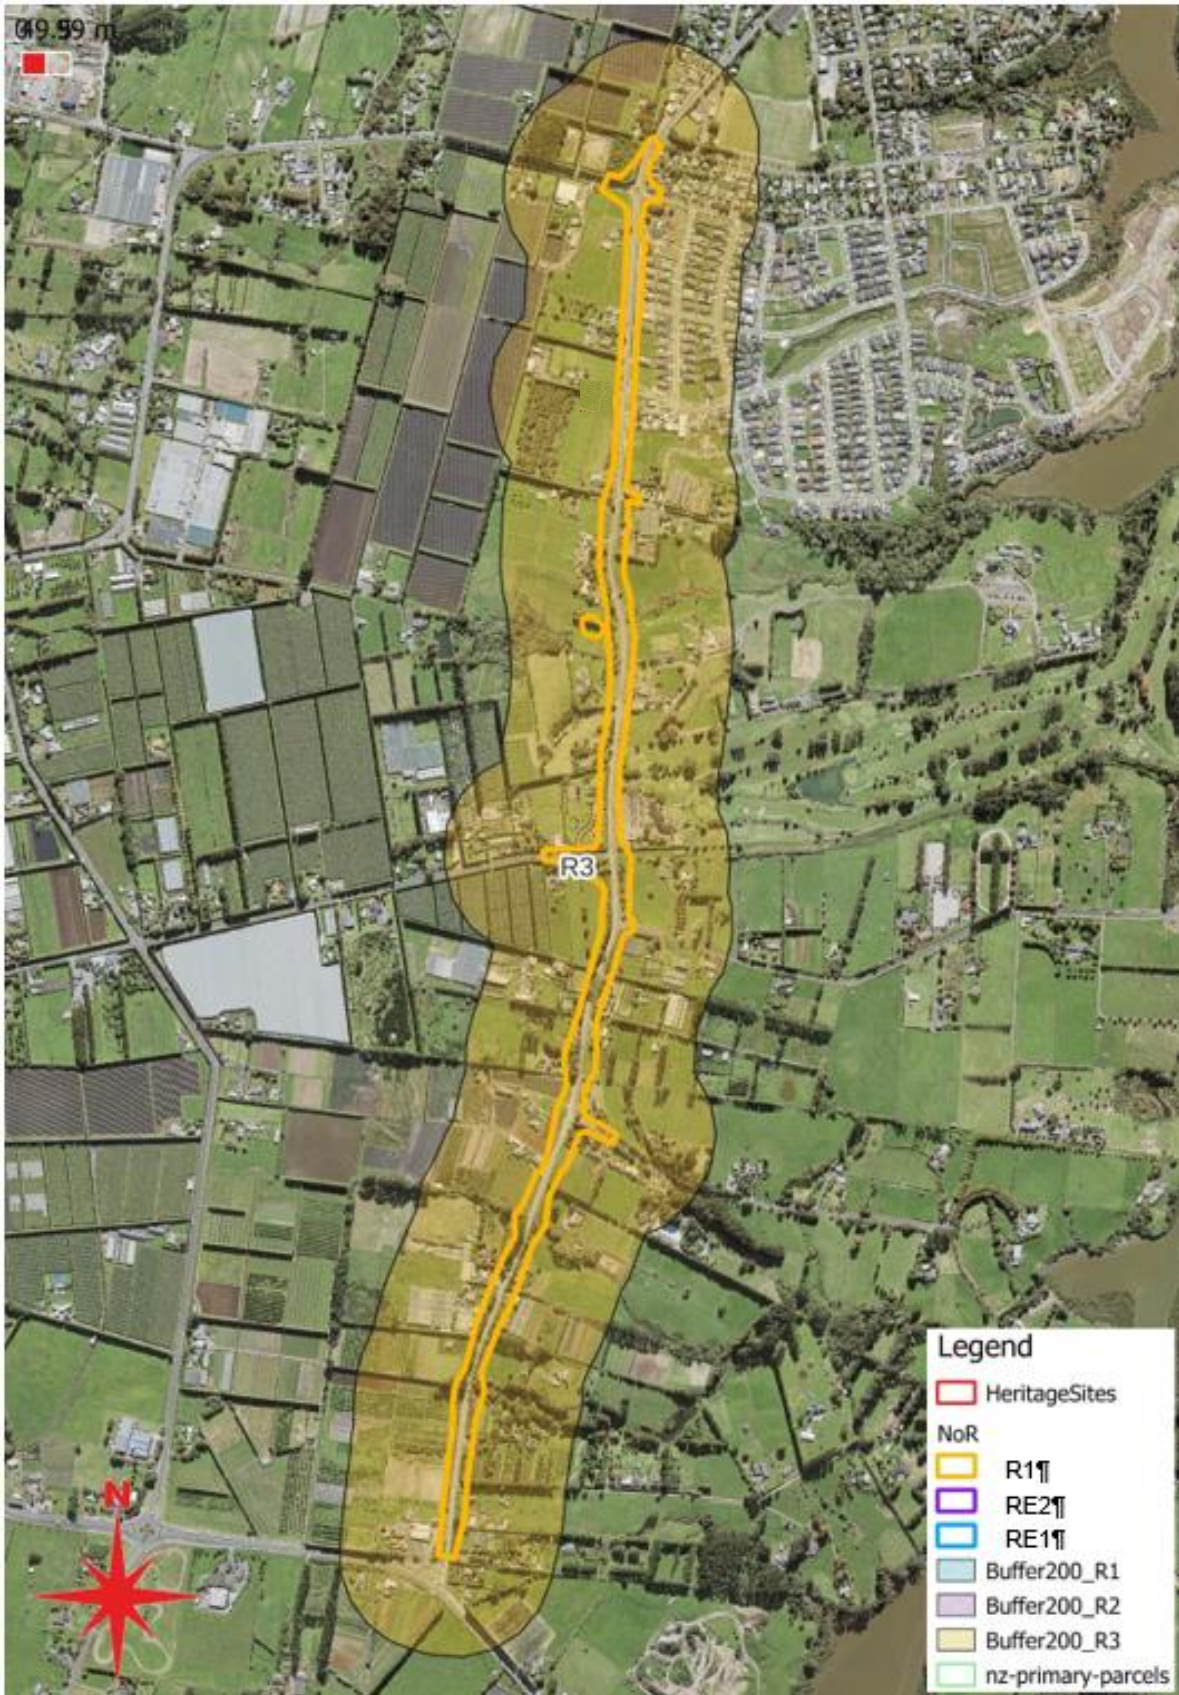
Figure 8-2: Extent of NoR R1 and 200 m buffer zone. No heritage sites and no high risk areas are within the NoR or the buffer zone or in the vicinity.

There are no recorded archaeological sites or historic overlays recorded in the AUP:OP. No CHI sites are shown either.

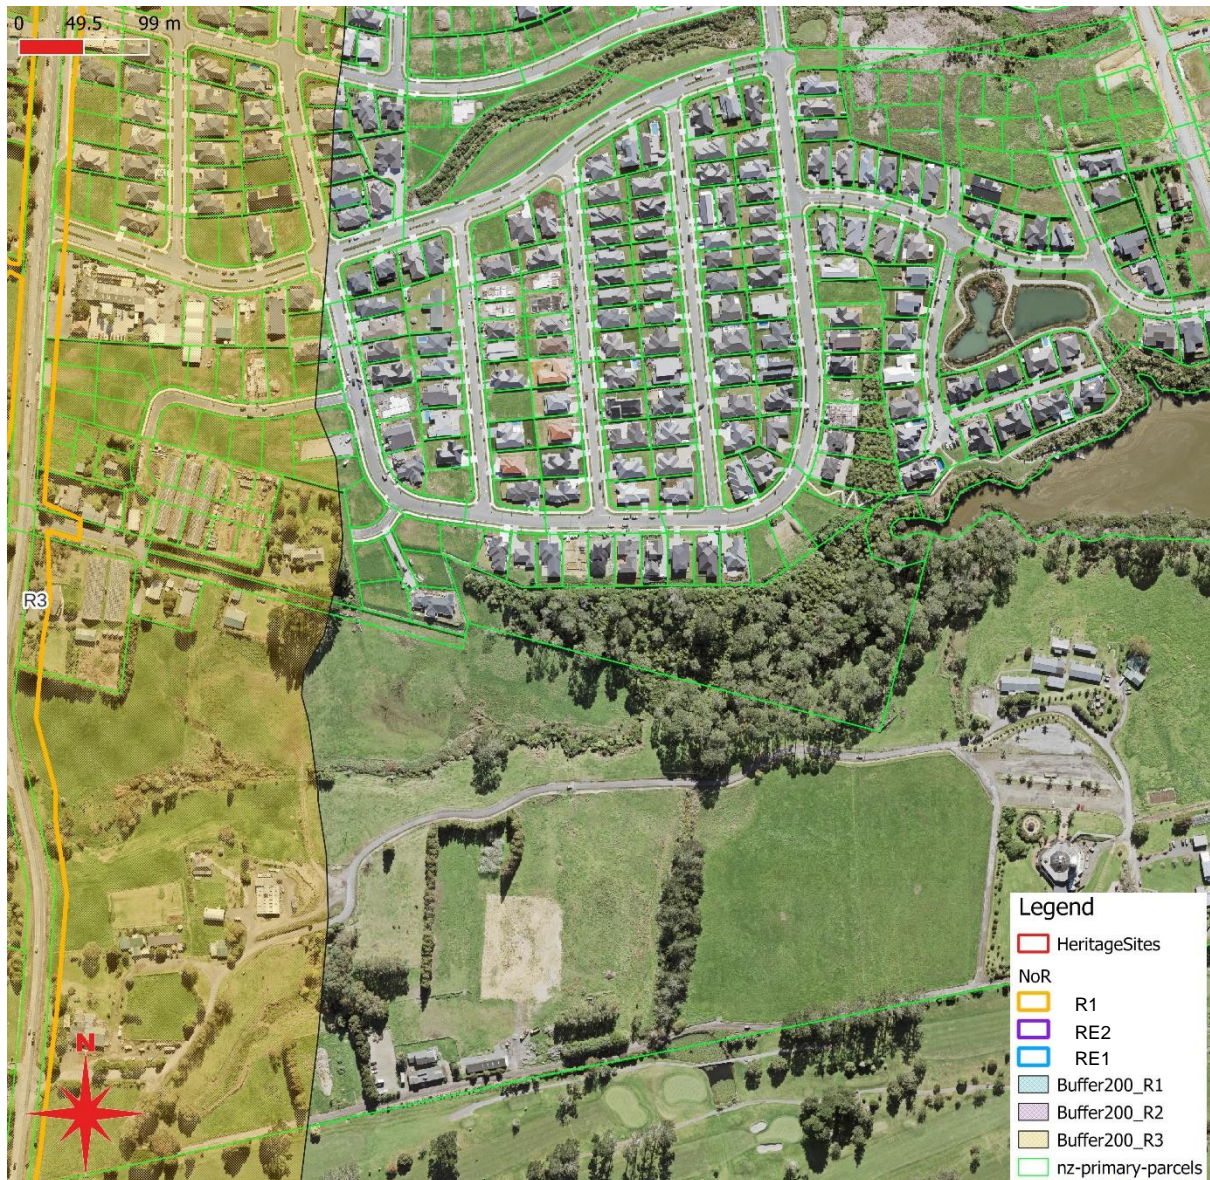
Figure 8-3: On the right-hand side of the picture a small creek of the upper harbour is shown. This is the location of a canoe landing. Any potential pathway would lead west towards the Kumeū River.

An early map of the harbour survey (Figure 4-2) shows a canoe landing area, presumably the start of an “ara” (pathway) from the upper harbour to the Kumeū River (Figure 8-3). This potential pathway would cross NoR R1. Nonetheless pathways are rarely recognised in the archaeological record.
