Eastern Busway EB3 Commercial and EB4 Link Road

Archaeological Effects Assessment

Document Number: EB-RP-3C4L-PL-000004

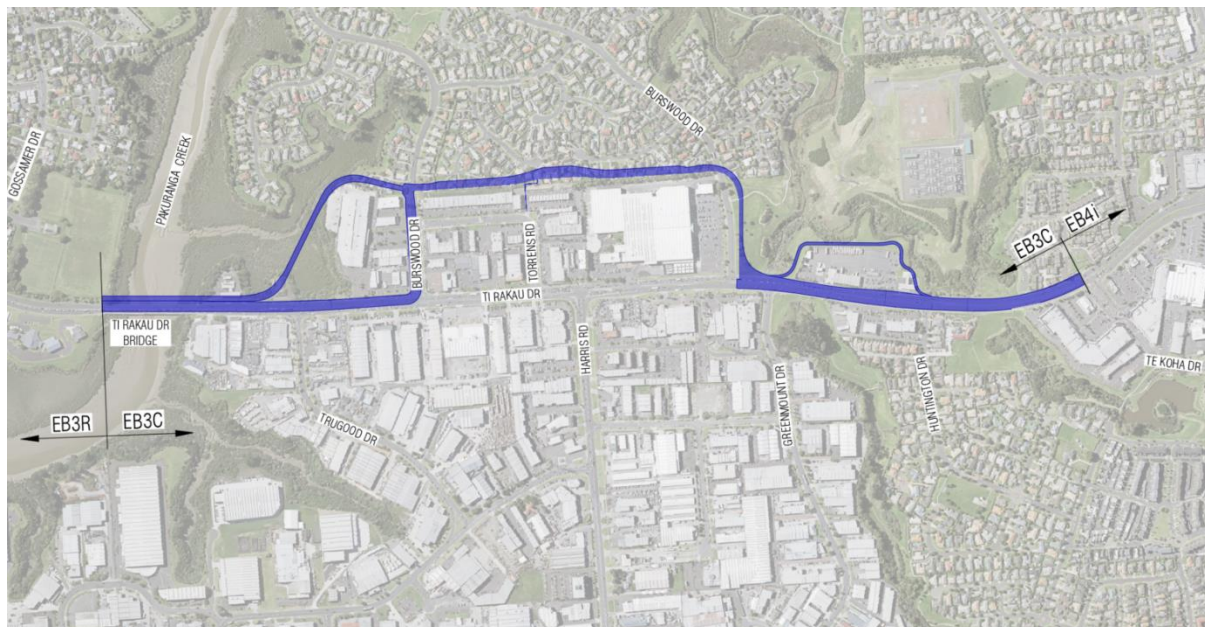
Figure 2-2 Eastern Busway 3 Commercial Project Area

The proposed EB3C works will involve the establishment of an ‘off-line’ busway, cycleway, and associated stormwater upgrades. These works will take place within existing road reserves, Council reserves¹ and privately held land within the proposed works footprint (refer Figure 2-1). The extent of works for EB3C runs between Riverhills Park (i.e., adjacent to the terminus of the earlier EB3R package) in the west to Guys Reserve in the east, through the suburbs of Burswood and East Tāmaki.

The busway will be largely off-line (i.e., outside the current Tī Rākau Drive corridor), first crossing Pakuranga Creek by way of a new two-lane bridge (Bridge A) including abutments² and scour protection. It will then cross a coastal headland at 242 Tī Rākau Drive (a Mobil branded service station), and then an embayment within which a retaining wall, and a 4m² coastal reclamation will be constructed. The busway will cross a second headland at 254 Tī Rākau Drive (currently occupied by a pet store), before crossing a mangrove filled bay to the west of 262 Tī Rākau Drive (the ‘Chinatown’ retail business) via a second bridge (Bridge B). Bridge B will include two abutments with scour protection. Bridge B will require construction of a reinforced embankment at its northern end which includes imported fill, rip rap and permanent wick drains, and a 549m² coastal reclamation. In parallel, a retaining wall will be constructed to the eastern side of the embankment. Following this, the busway runs between the commercial area and residential area north of Tī Rākau Drive, crossing several residential sites. The busway also crosses Burswood Drive twice, with raised signalised crossings established to control both the busway and road traffic.

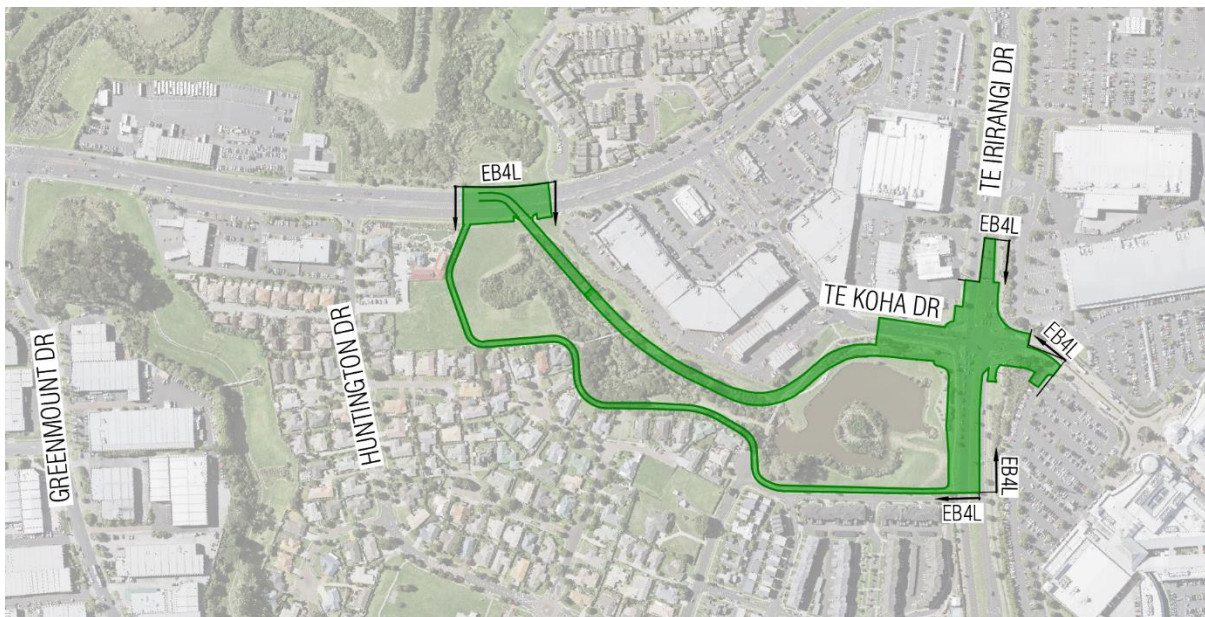
Figure 2-3 Eastern Busway 4 Link Road Project Area

The EB4L works will involve the establishment of an ‘off-line’ dedicated two-way busway, shared pathway and stormwater upgrades. These works will take place in Guys Reserve, Whaka Maumahara Reserve, existing road reserve and Botany Town Centre land for the intersection improvements on Town Centre Drive.

EB4L commences south of Tī Rākau Drive, crossing through Guys Reserve, Whaka Maumahara Reserve and ending at the intersection of Te Irirangi Drive/Town Centre Drive.

The works will primarily involve the construction of a new two-way busway corridor which will run along the eastern side of Guys Reserve and Whaka Maumahara Reserve to provide access for bus services between Pakuranga and Botany. The two-way busway is designed to integrate with EB3C and be a continuation of the EB3C busway.

This section of the busway will feature a bridge (Bridge C) approximately 350m long. This bridge is needed due to the sloping topography of the Reserves.

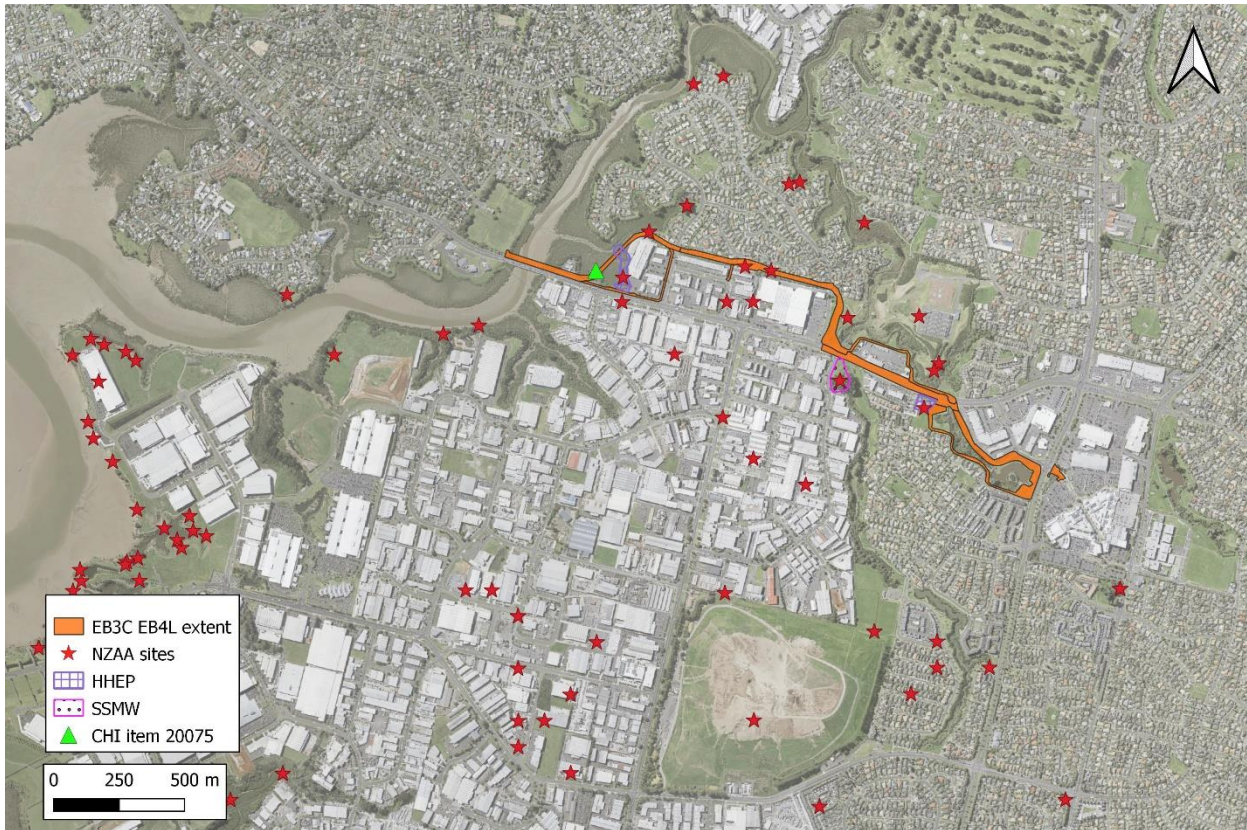
Figure 3-1 Archaeological sites, CHI items, sites of significance to mana whenua and historic heritage scheduled extents of place near and within EB3C and EB4L project areas.

Figure 3-1 below shows archaeological sites, CHI items, sites of significance to mana whenua and scheduled extents near and within the EB3C and EB4L project area.

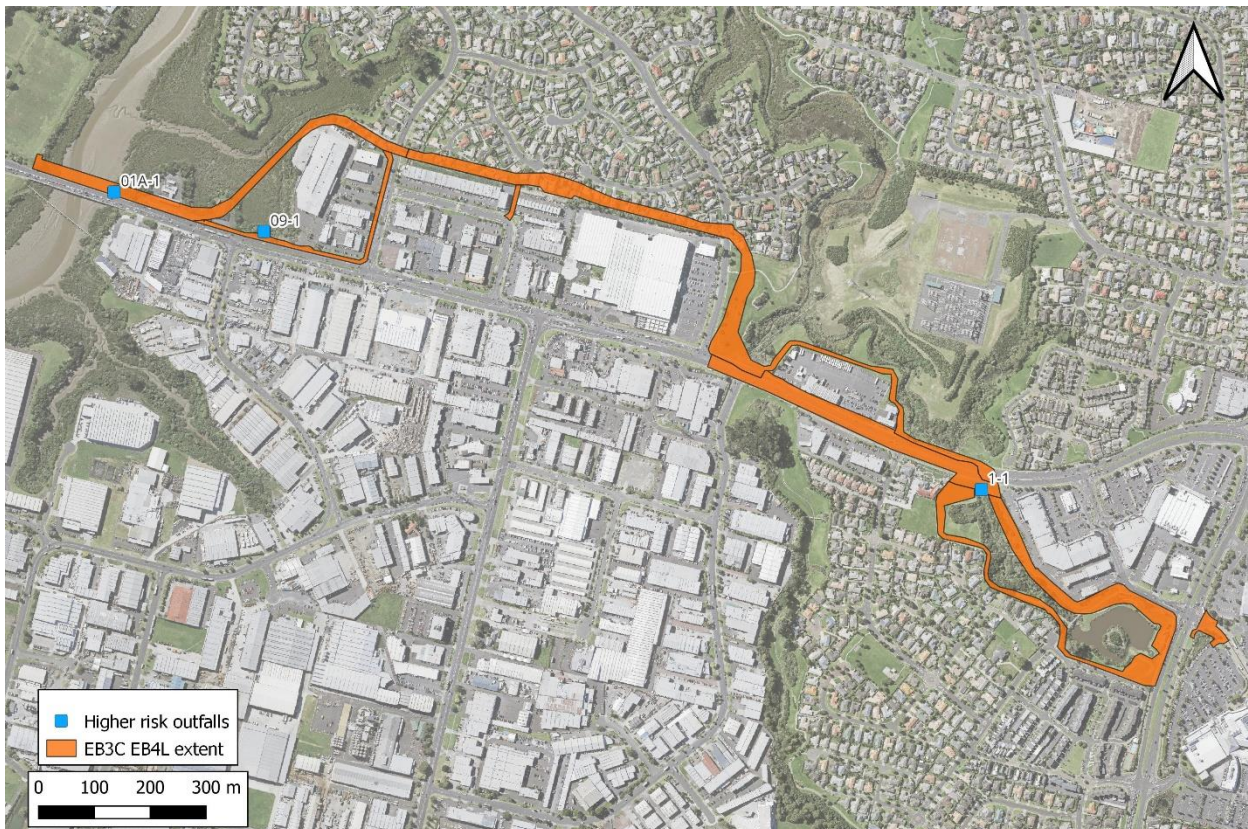
Figure 4-3 location of higher archaeological risk stormwater outfalls.

There are two new stormwater outfalls in the CMA (Outfall 01A-1 and Outfall 09-1), and one new outfall (Outfall 1-1) in a tributary of the Pakuranga Creek (Figure 4-3) identified during desk top analysis which had a higher risk of encountering previously unrecorded archaeological sites due to their proximity to water. These areas were later surveyed, and no archaeological features were identified at these locations, but they have also been heavily modified, and it is possible that sub-surface archaeological features may be obscured. Outfall 09-1 was originally going to be located within the HHEP for Donnelly’s Quarry but during the design process it was moved 5 m north of the HHEP to avoid it (Figure 6-1). It should be noted that there are no noticeable features associated with the quarry visible near this outfall, or its original location. The remainder of the proposed stormwater design will be utilising existing infrastructure which will be upgraded. There is also the potential for sub-surface archaeological features to be exposed during the upgrading of this infrastructure.

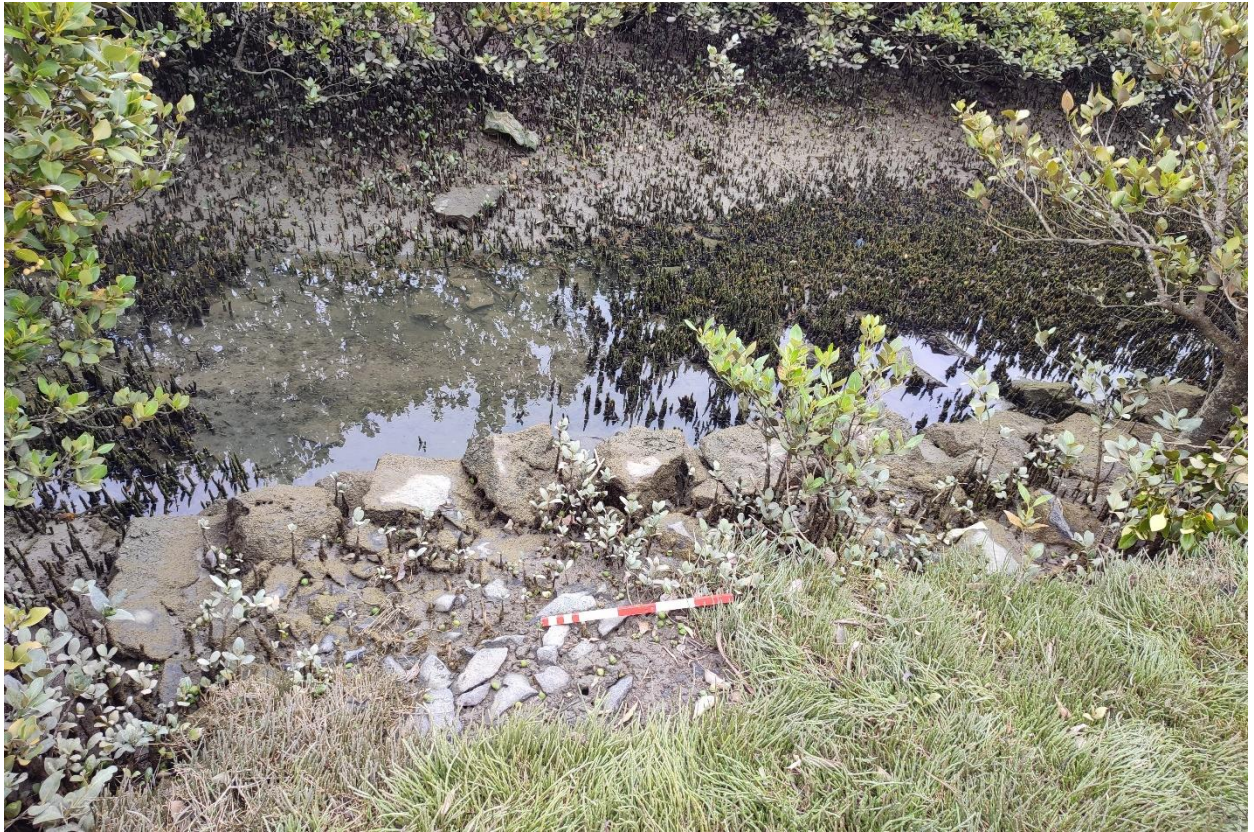
Figure 4-5 View west from northern quay showing dry stone construction. Photo scale = 0.5m.

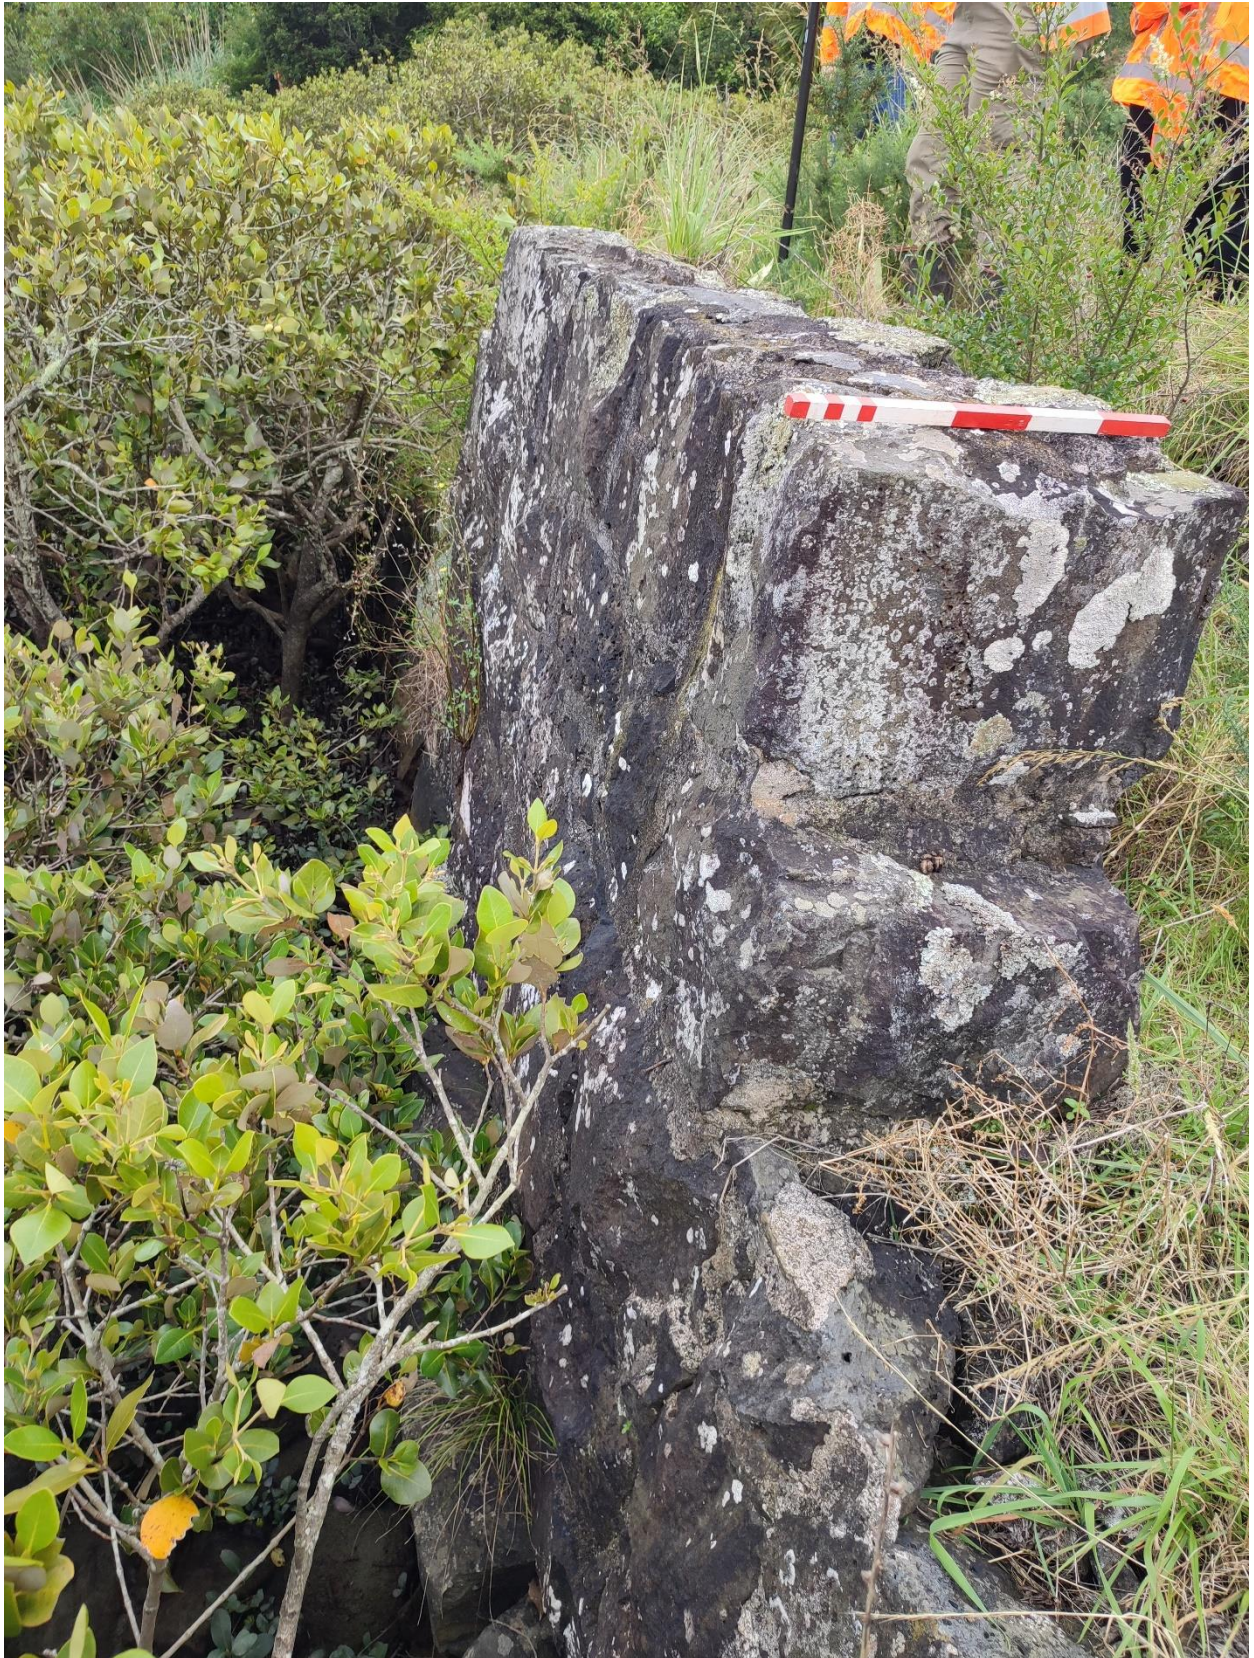
Figure 4-6 View north of central quay. Photo scale = 0.5m.

This is a distinctive stone structure that is different to the northern and southern quays and the seawall. Whereas those elements consisted of drystone construction, this has been concreted together and sits on top of the seawall. It is approximately 2.5 m high from the creek bed and the front (west) face of it is in good condition. Large regular sized blocks were used, averaging around 0.5 x 0.5 m in size. Behind the well-preserved face is a hollowed-out gap, where it looks like part of the quay structure has been removed. The eastern extent of the quay could not be determined, but it looks like there was probably a platform and ramp made from rubble. This appears to postdate the other stone structures and due to its height compared to the other elements, may have been constructed to service a larger vessel.

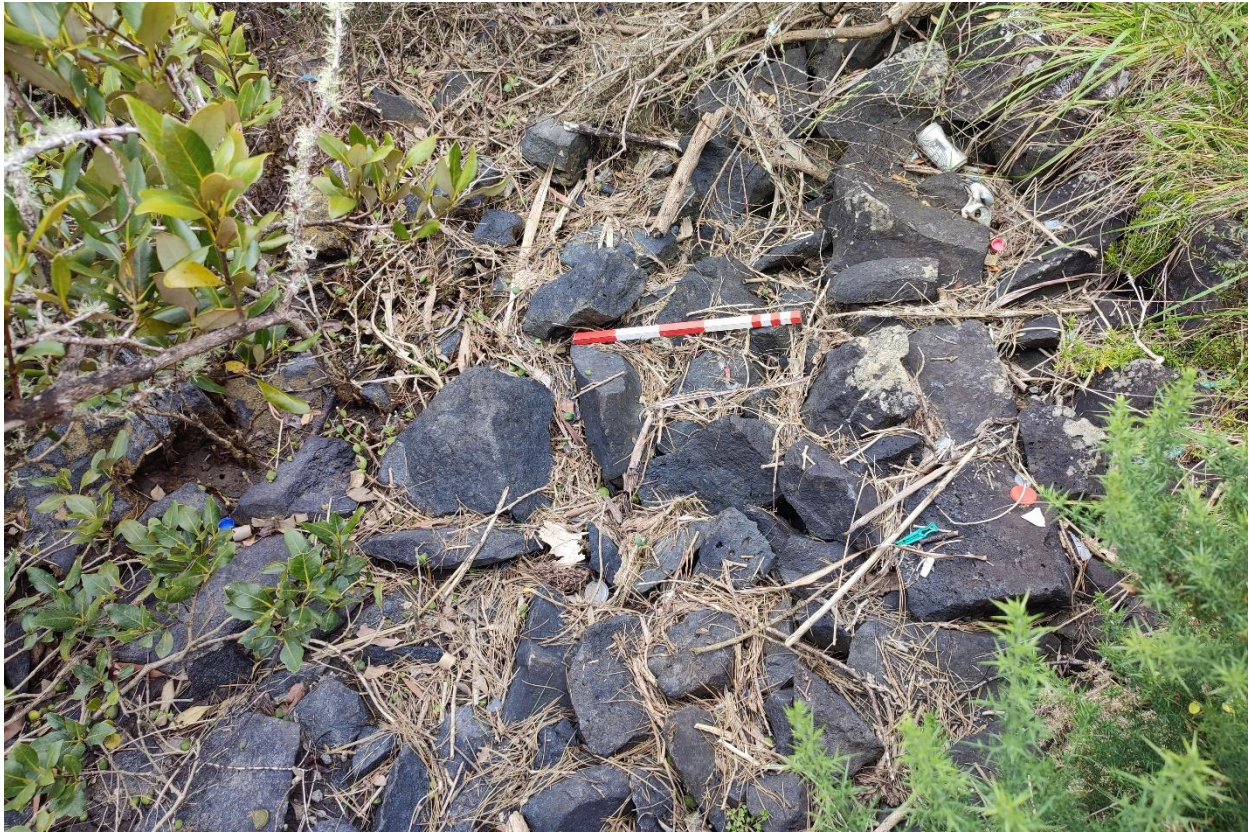
Figure 4-7 Northernmost stockpile of rock. note some are semi dressed. photo scale = 0.5 m.

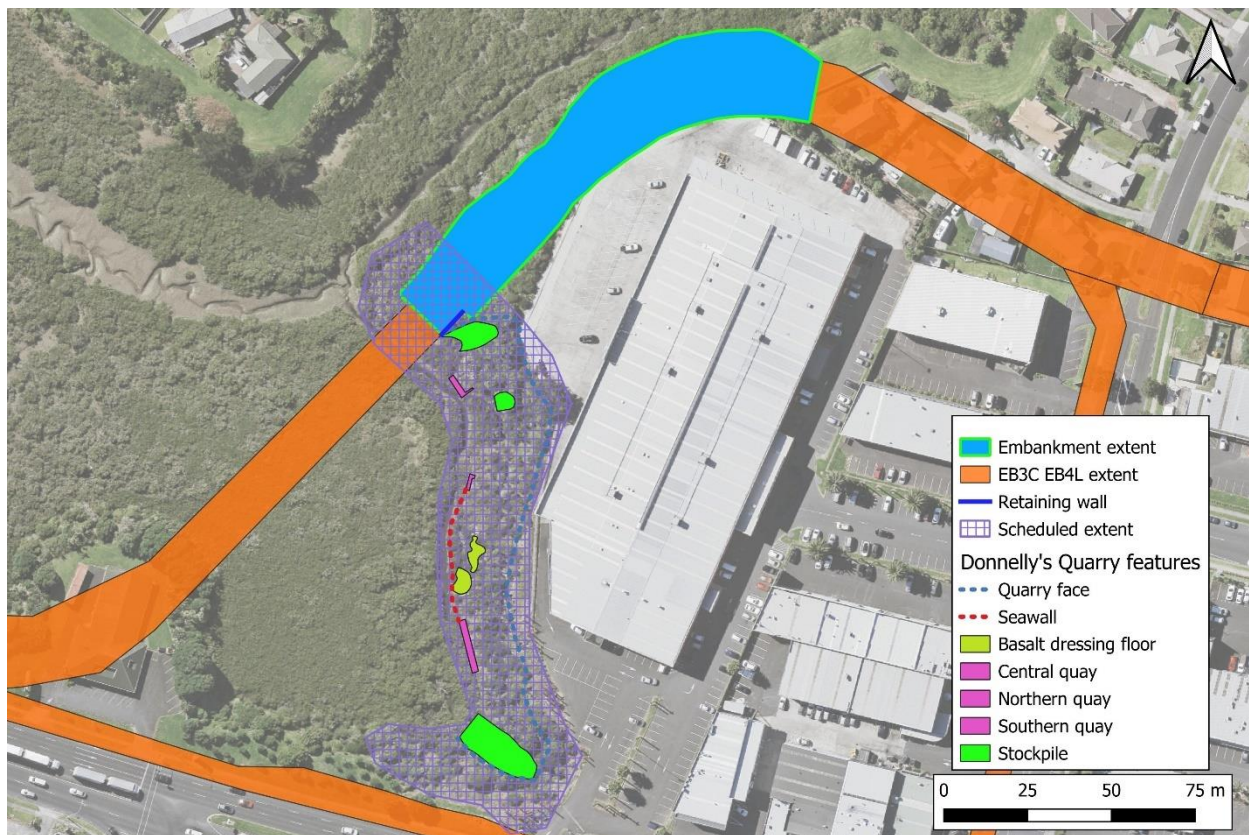
Figure 6-1 Extent of works near R11/1263 Donnelly's Quarry.

A retaining wall has been designed for the embankment to minimise the ground disturbance near the recorded features of the quarry. This has kept the extent of works outside the recorded extent of the northernmost stockpile of stone. The retaining wall will be built using driven sheet piles and will form part of the northern abutment of Bridge B.

As described earlier in this report, stormwater outfall 09-1 was initially designed within the scheduled extent, but this has been shifted west of the scheduled extent (Figure 6-1) to avoid disturbance and discharge in the scheduled extent.

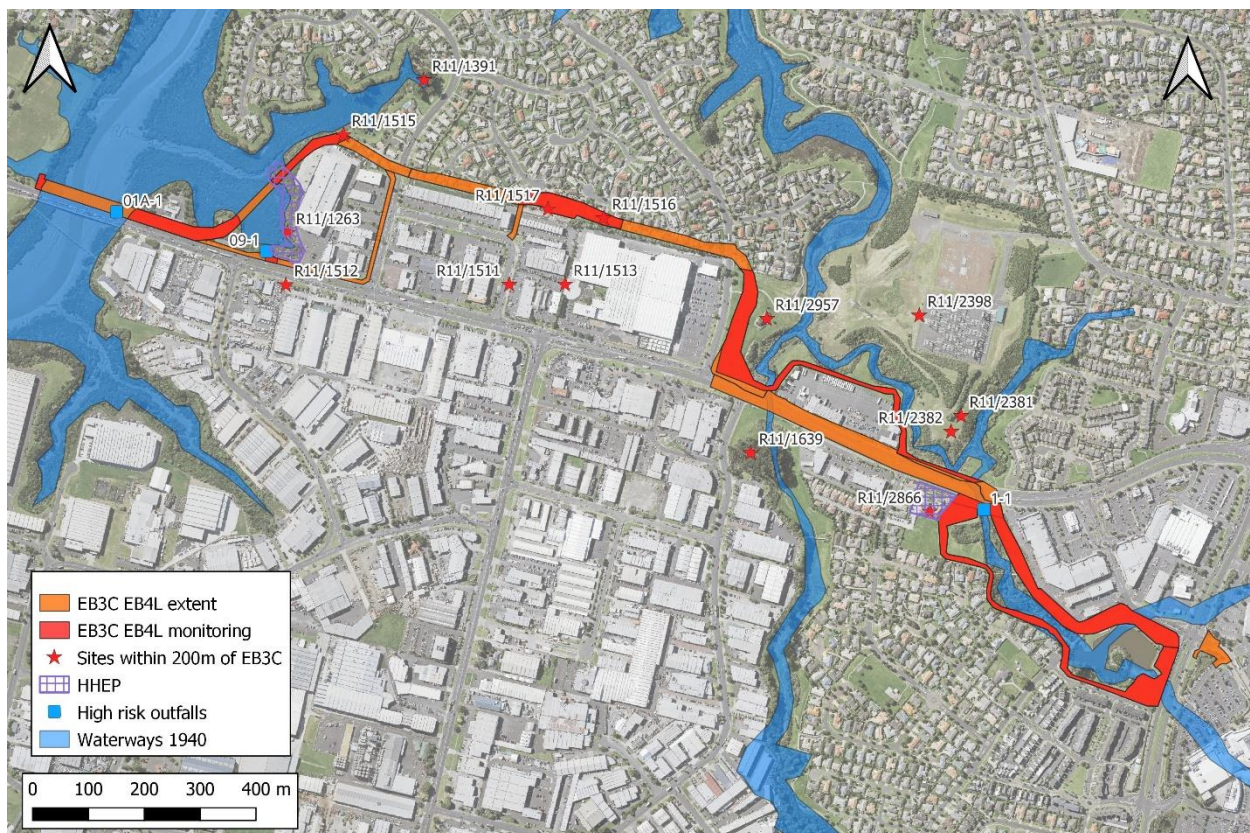
Figure 7-1 Map showing areas where archaeological monitoring or investigation should be undertaken during works.

Any earthworks undertaken near to previously recorded archaeological sites, inlets or previous coastline obscured by reclaimed land should be closely monitored by an archaeologist to ensure any potential sub-surface archaeological features are not missed. Any archaeological material encountered within the EB3C and EB4L project area during construction that cannot be avoided can be mitigated by undertaking archaeological investigation and recording utilising standard archaeological practice. This would include detailed notes and photographic recording, as well as stratigraphic drawings, maps, and sampling of artefacts / material to be retained for analysis where necessary.
