## Geotechnical Investigation

41-43 Brigham Creek Road

Whenuapai

18614.000.001\_02

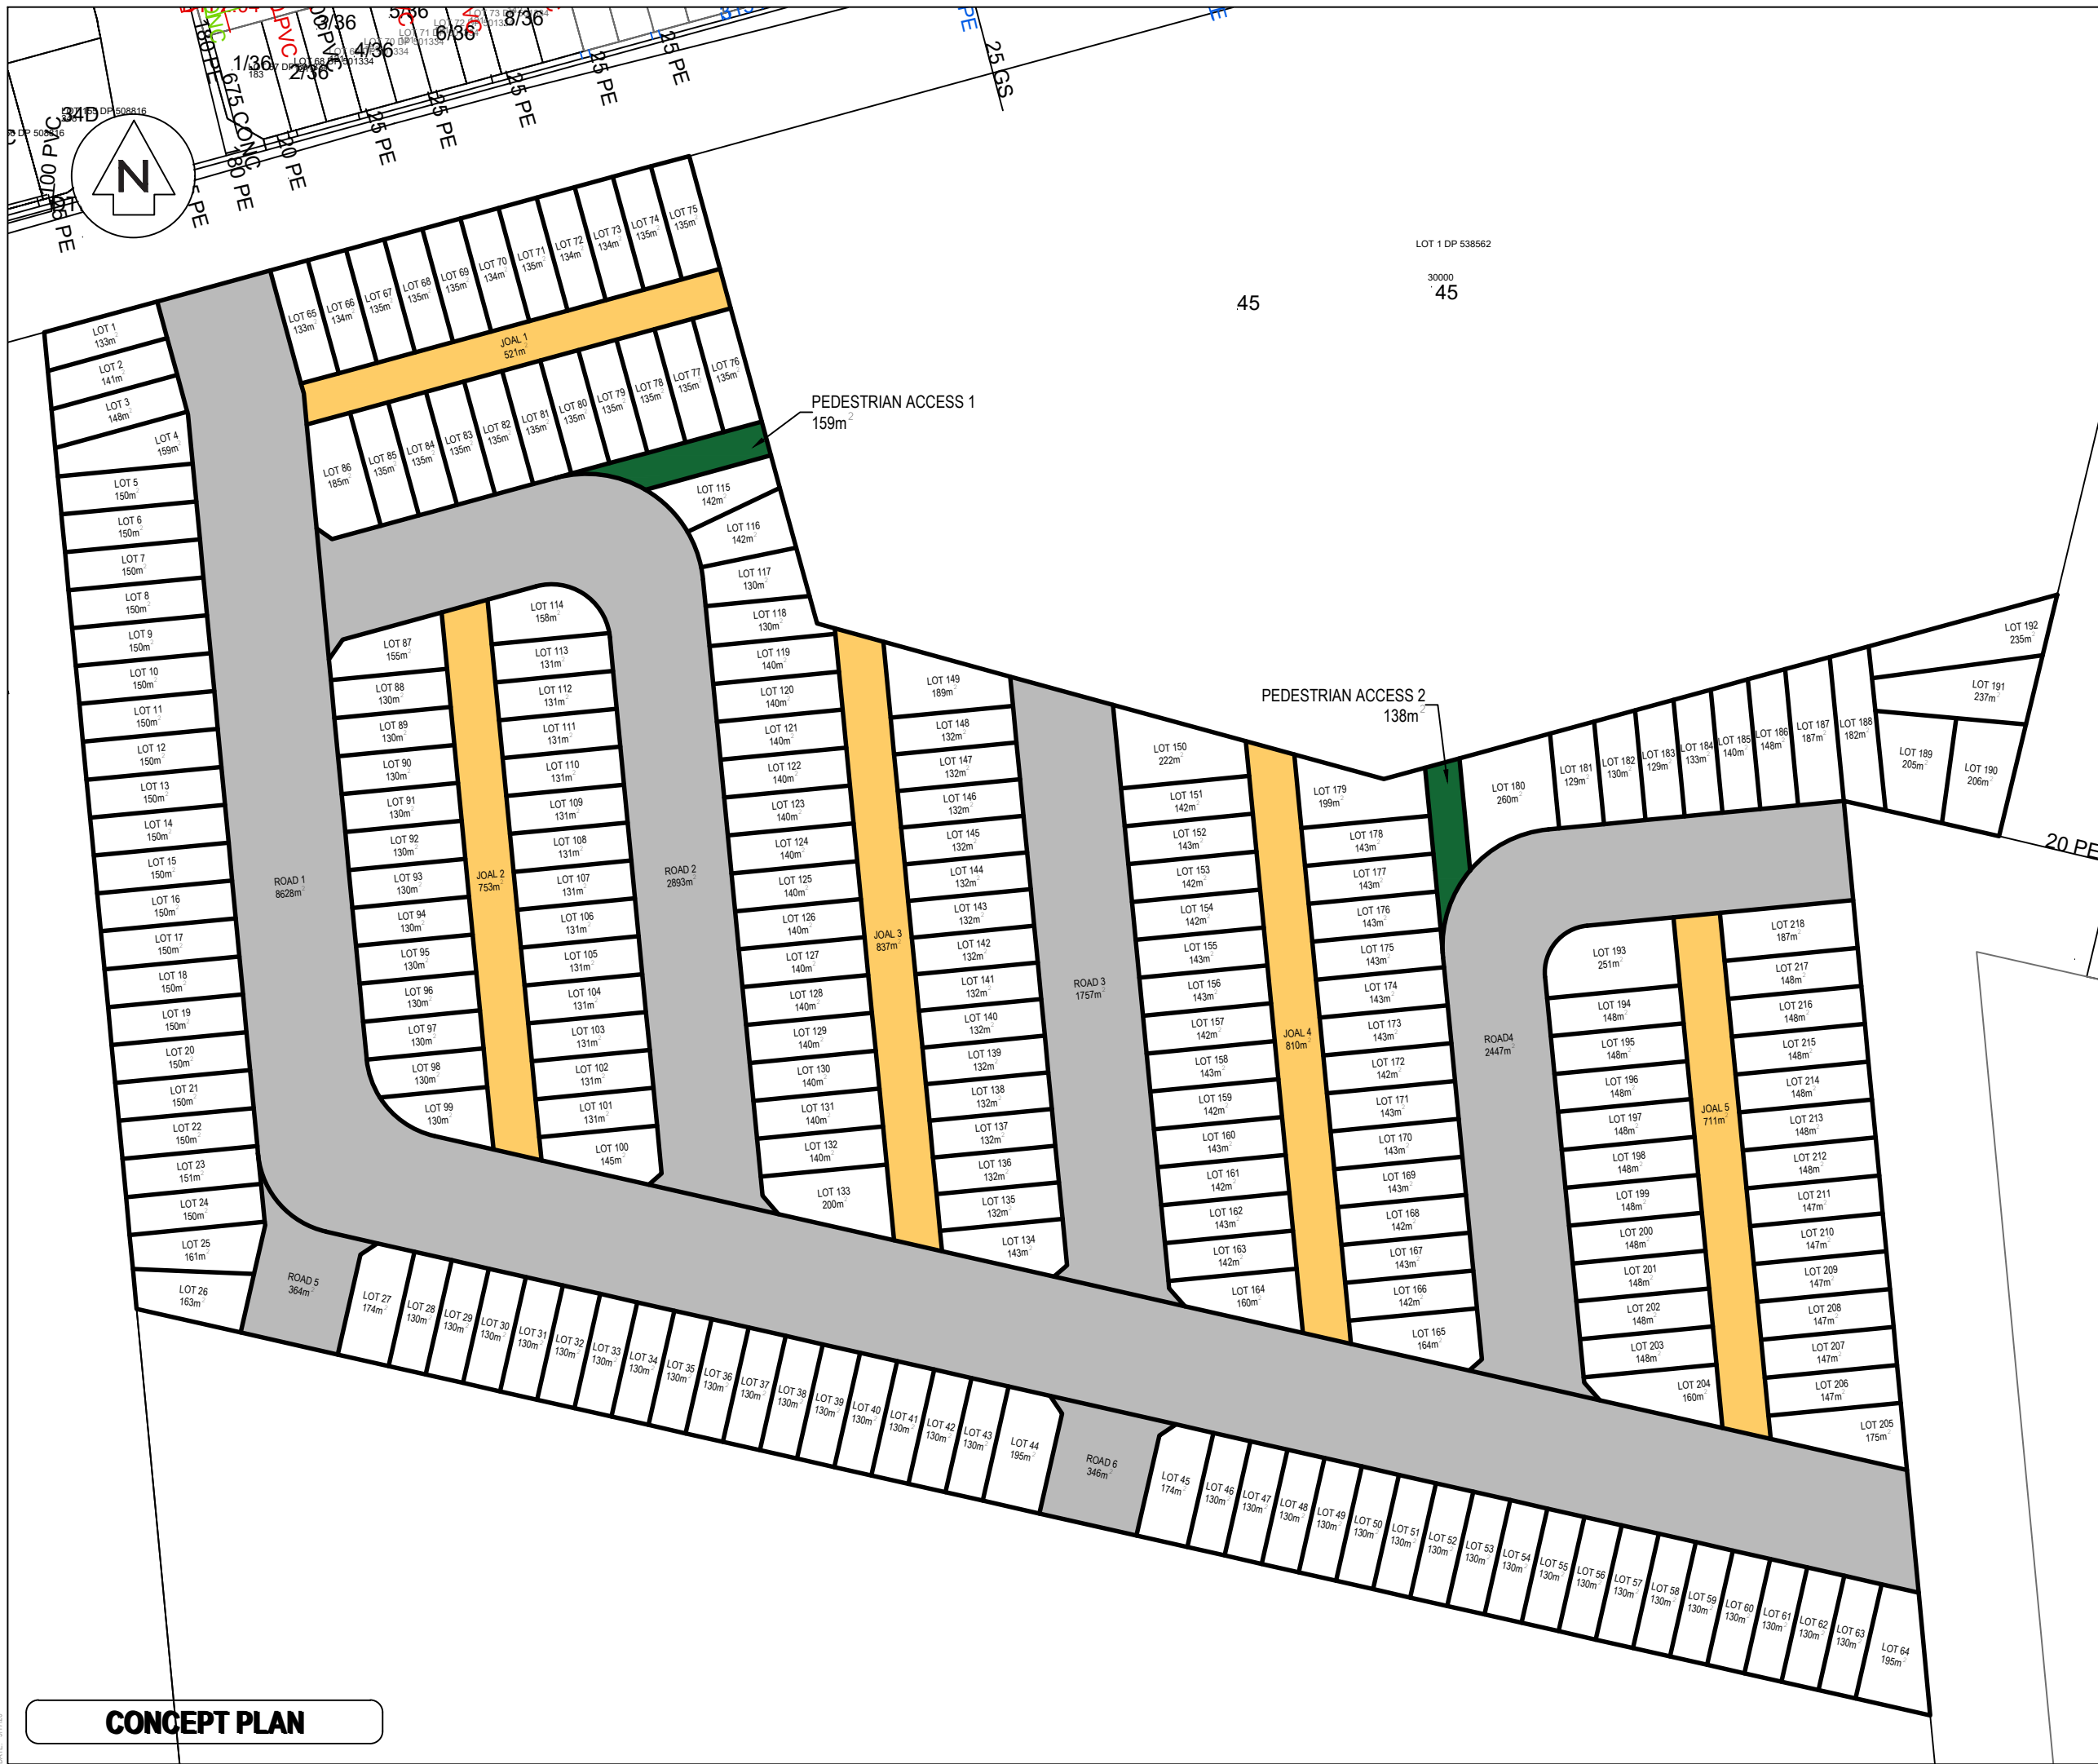
**APPENDIX 1:**  
Maven Associates Concept Plans

Maven Associates Ltd have prepared a concept plan for the 41 – 43 Brigham Creek Development dated September 2020. This plan depicts a high-density subdivision made up of 218 approximately 130 m<sup>2</sup> to 260 m<sup>2</sup> residential lots accessed by a central road with various additional roads and JOALs. This concept plan is attached in Appendix 1. We have not been provided with plans detailing levels for the dwellings, a retaining wall layout plan or a cut and fill earthwork plan for this subdivision.

At the time of preparing this report we have not been provided with plans showing finished levels or a preliminary cut / fill plan for this development. However, based on our discussions and understanding of the proposed development, it is intended to found the residential developments on shallow foundations roughly at grade.

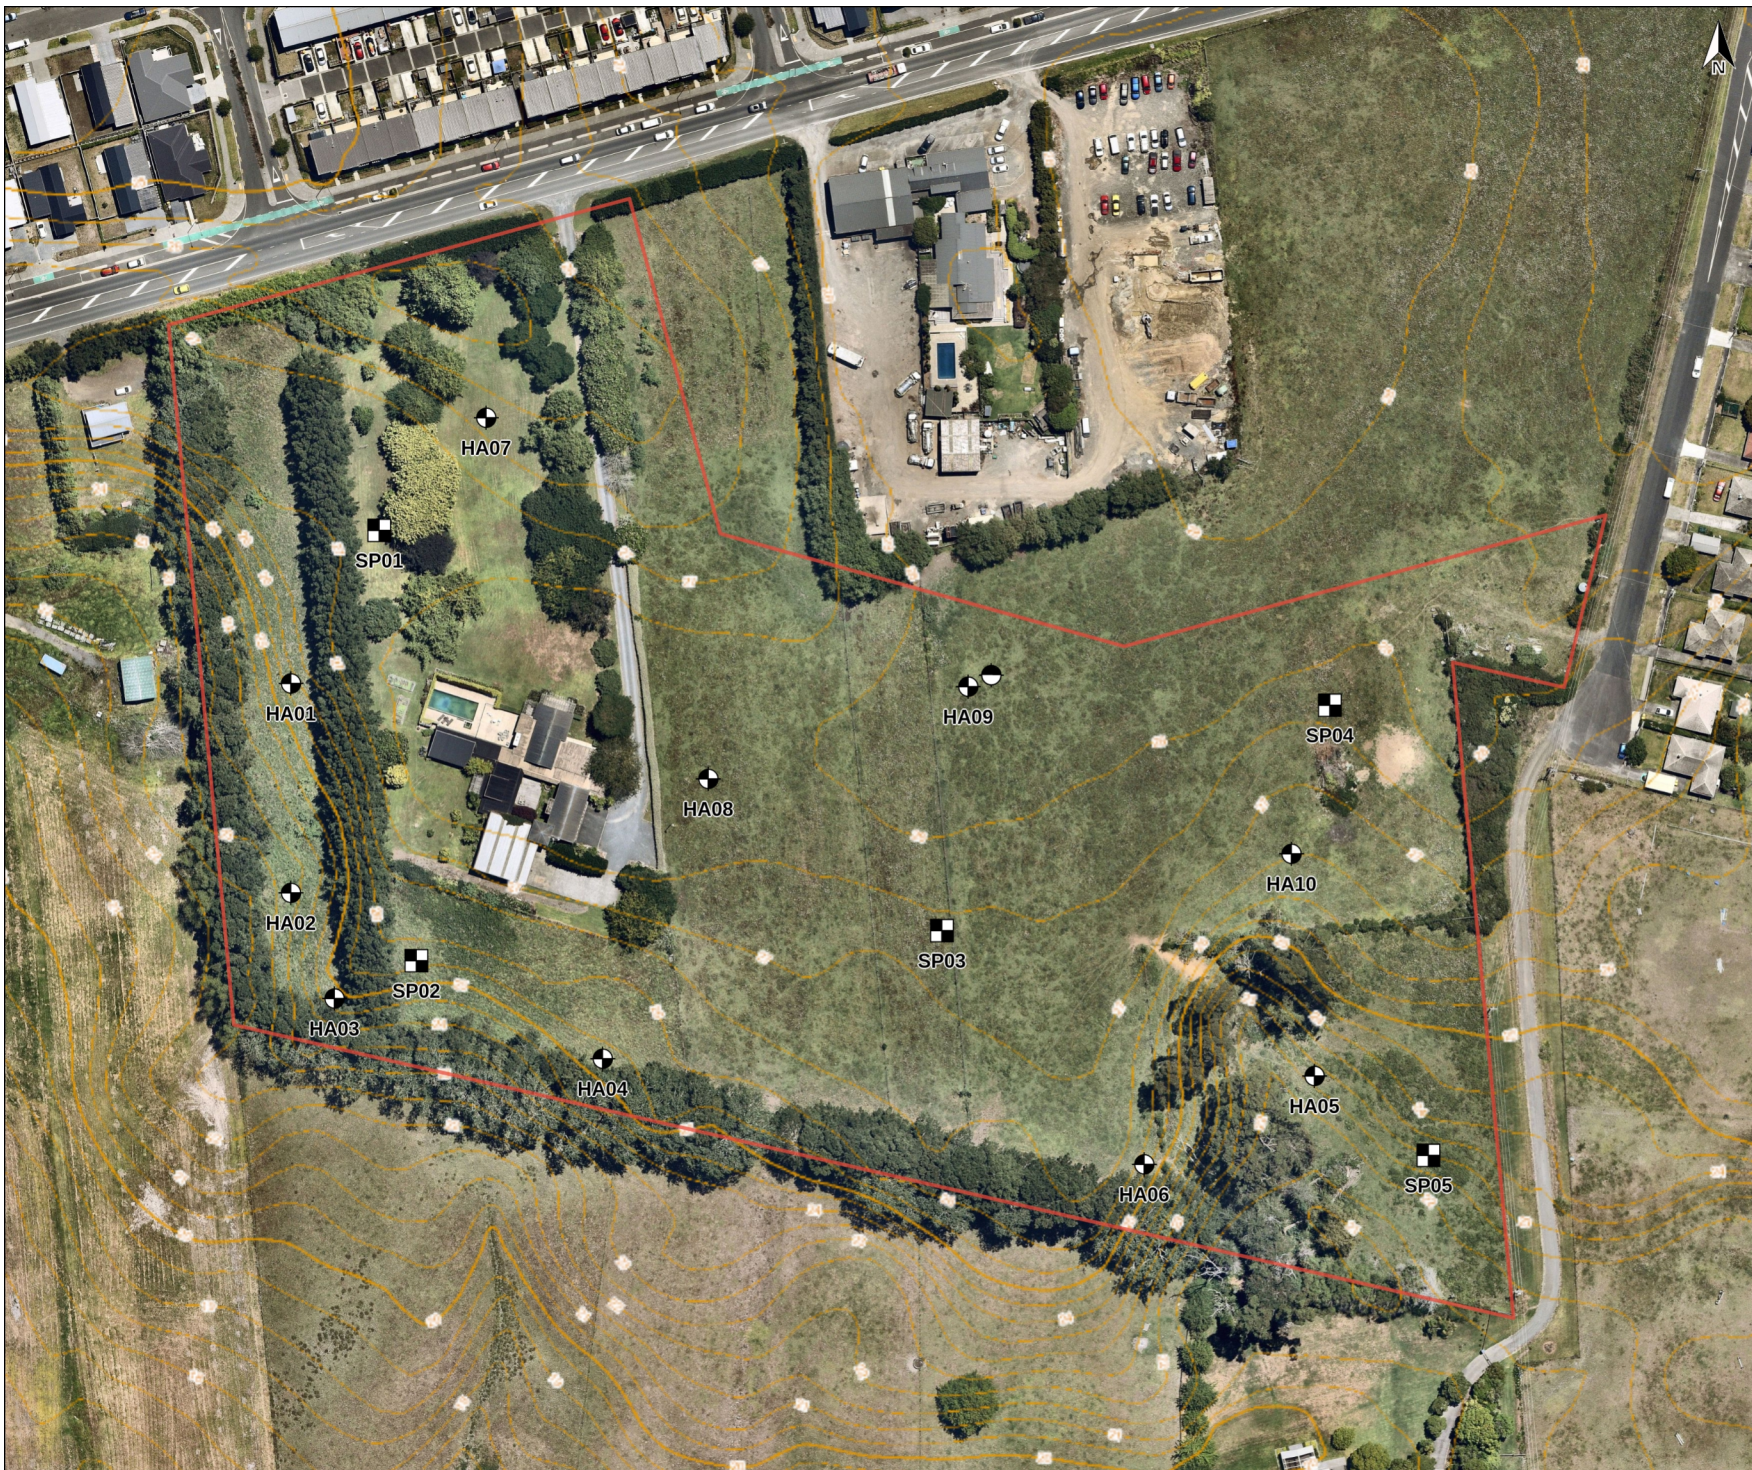
**APPENDIX 2:**  
Investigation Location Plan

ENGEO attended site on 13 August 2020 to undertake an intrusive site investigation. This geotechnical investigation comprised ten hand auger boreholes, five Scala penetrometer tests, recovery of one soil sample for shrink swell testing, and installation of one groundwater measuring piezometer. Test locations are shown in Appendix 2.

Ten hand auger boreholes (HA01 to HA10), with associated soil strength testing (shear vane), were drilled to between 1.6 m depth and 5.0 m depth. Hand auger boreholes HA01, HA02, HA03, HA04 and HA10 encountered practical refusal. Full borehole records are presented in Appendix 3.

Five Scala penetrometer tests were performed within the proposed carpark and driveway areas to gather data for indicative California Bearing Ratio values for pavement design. Testing was undertaken from the existing ground surface and extended to 0.9 m depth. The results of this testing can be seen in Appendix 4.
