Wiri to Quay Park Project

Preliminary Site Investigation

IA233800-A.CS.EV.P1ENV-NW-RPT-0001 | 01

5 June 2020

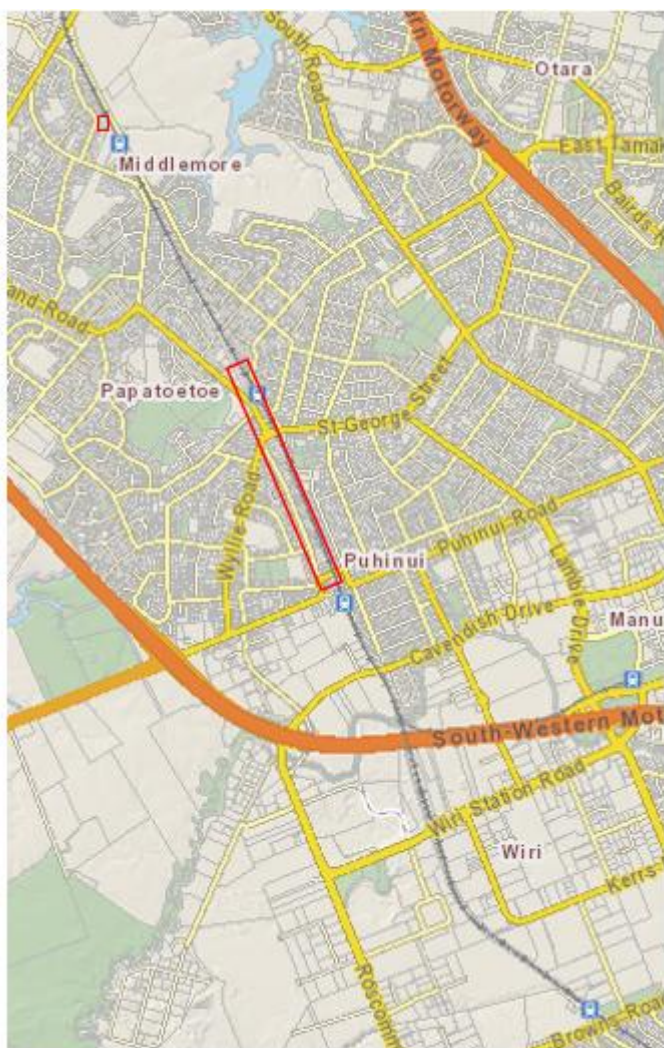
Figure 2.1: Site Location

The PSI covers properties located adjacent to the rail corridor between Rosella Road, Mangere East in the north and Bridge Street, Papatoetoe to the south, over a distance of approx. 3.6 km, as shown on Figure 2.1. The properties are listed and described in Table 2.1, broken down for ease of discussion into four parts (Part One, Part Two, Part Three, and Part Four). They largely comprise residential properties, in addition to some reserve land, on or close to the western side of the railway corridor. Information on the areas of land within each property potentially affected by the improvements is also presented, including land required for construction access, rail infrastructure and retaining walls.. Further information is provided in Appendix A.

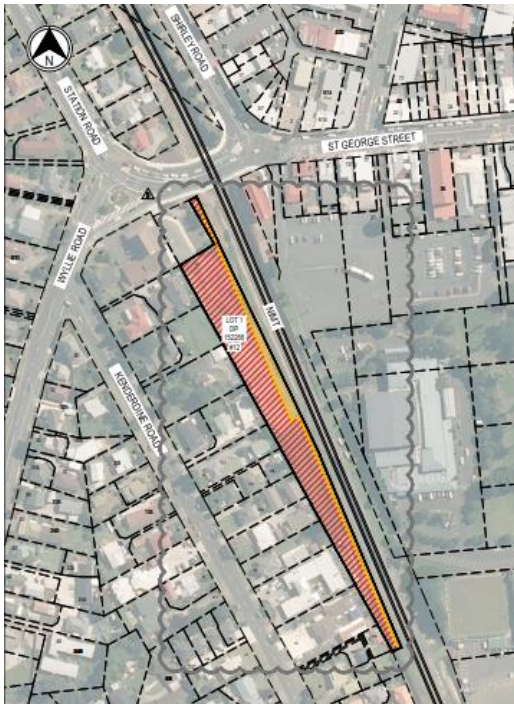
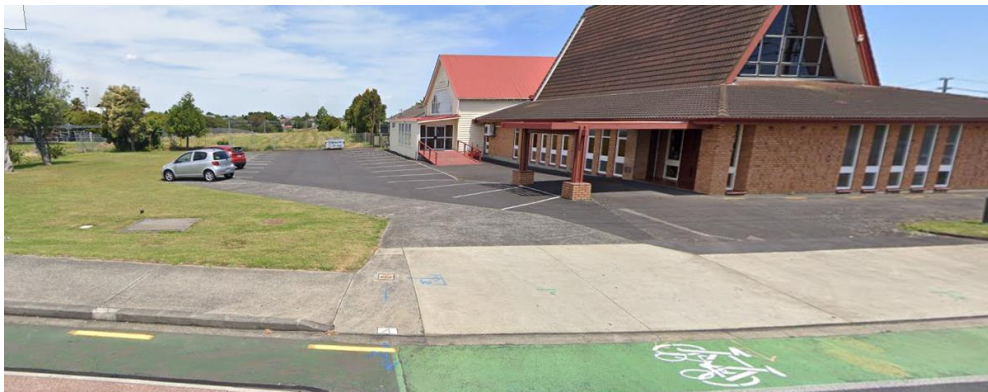
12 & 14 Wyllie Rd

12 Wyllie Rd -strip of land in background (Presbyterian Church not affected). Church car park/lawn at 14 Wyllie Road required for construction access.

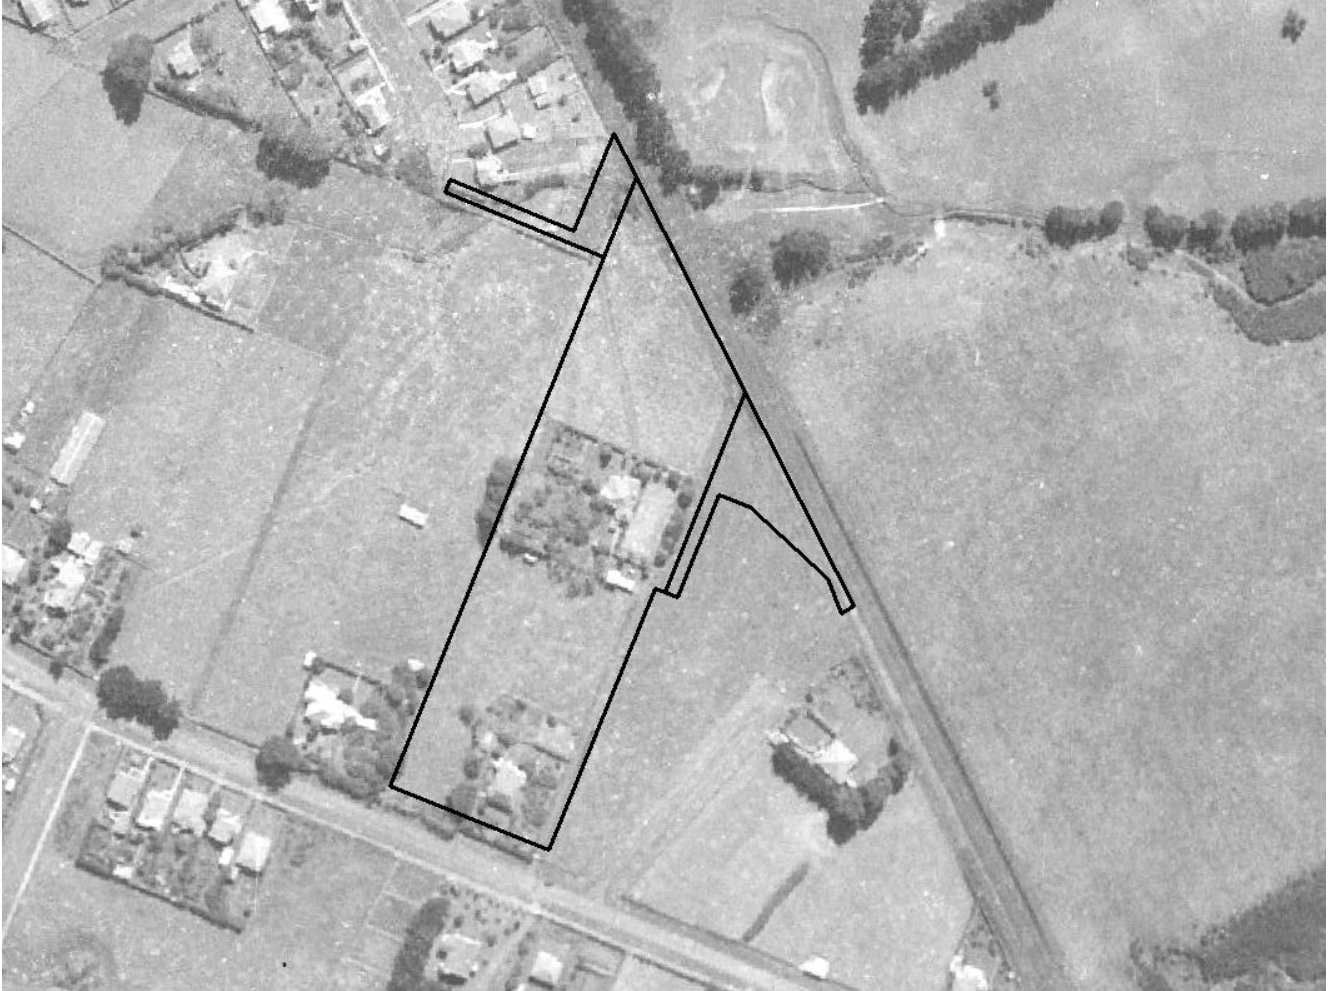
Historical aerial imagery from 1940 (Sourced from Retrolens). Approximate boundary of land parcels of interest is shown in black.

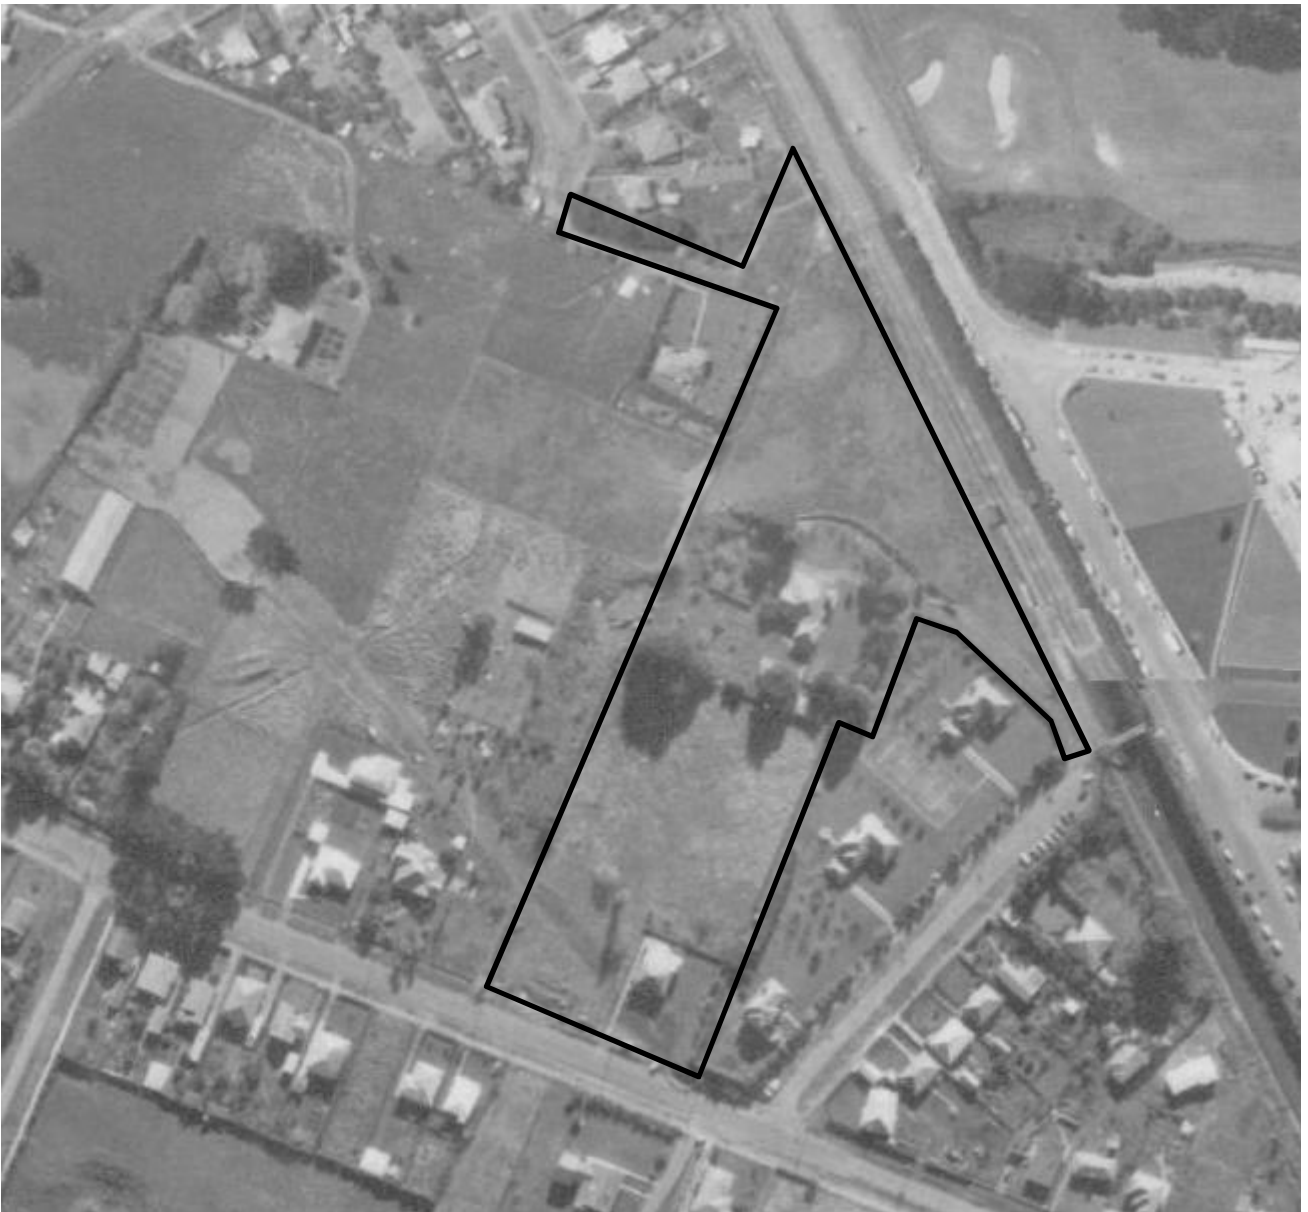
Historical aerial imagery from 1959 (Sourced from Auckland Council GEOMAPS). Approximate boundary of land parcels of interest is shown in black.

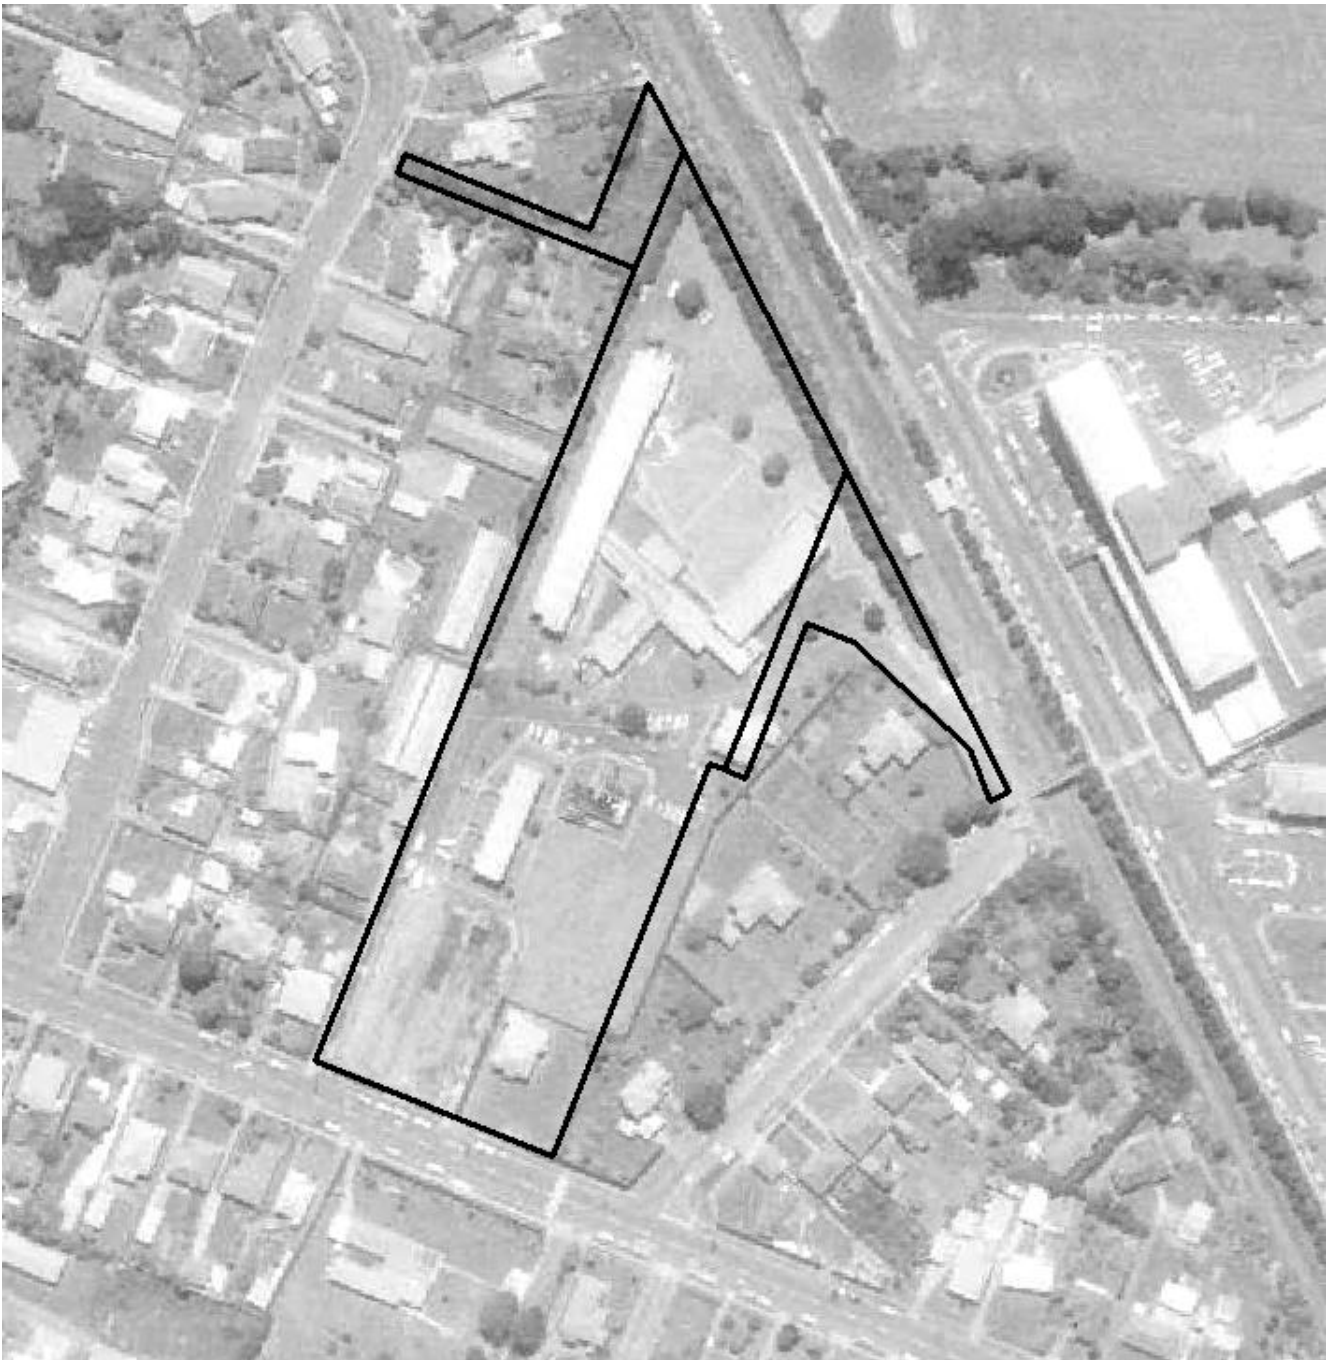
Historical aerial imagery from 1980 (Sourced from Retrolens). Approximate boundary of land parcels of interest is shown in black.

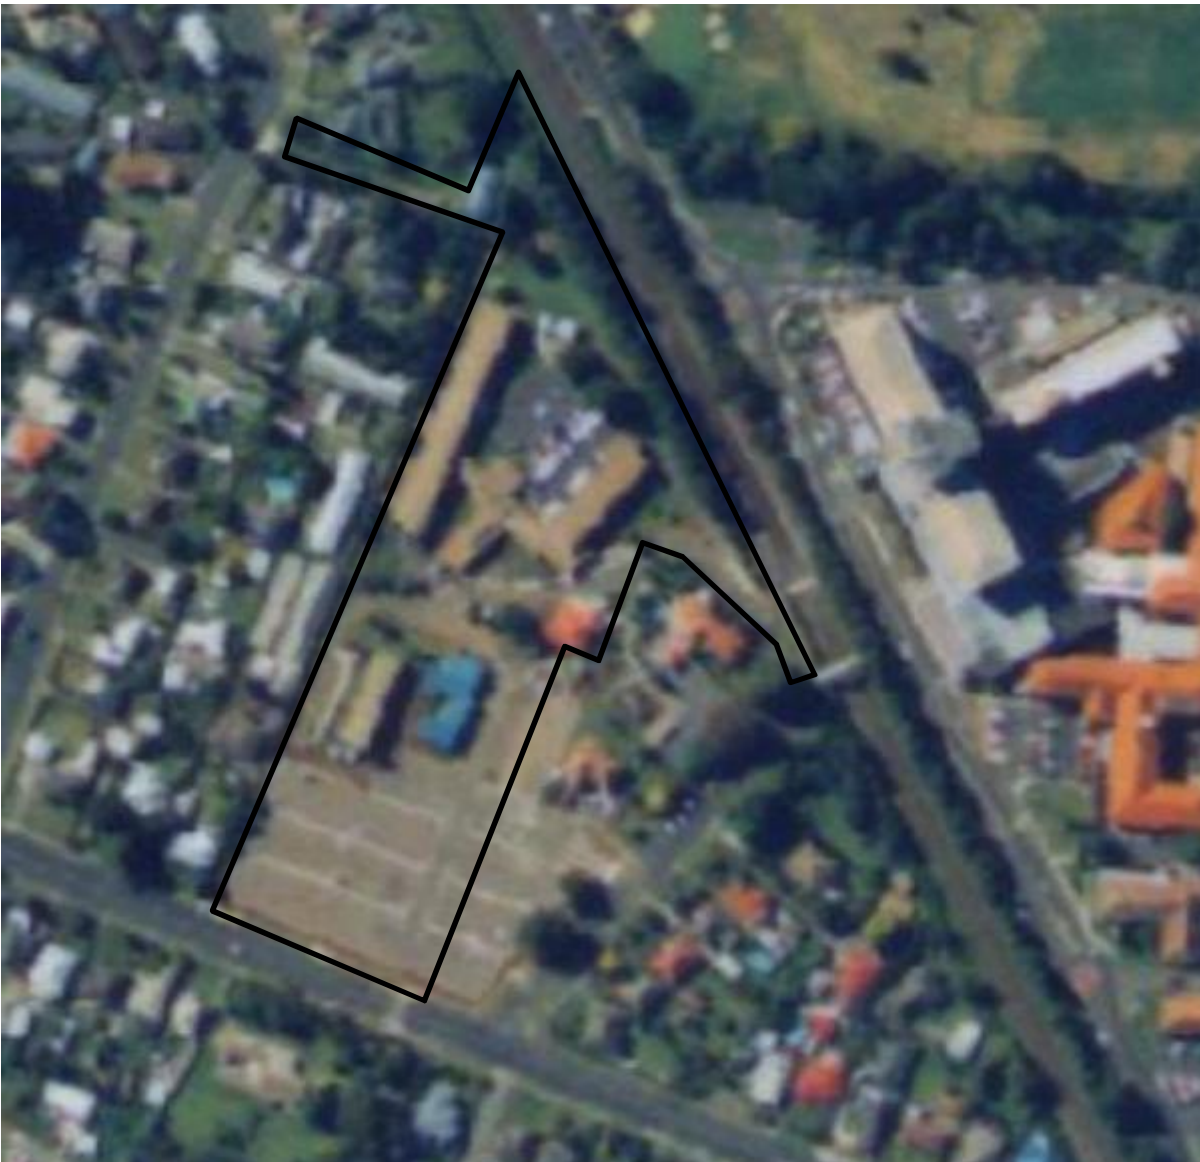
Historical aerial imagery from 1996 (Sourced from Auckland Council GEOMAPS). Approximate boundary of land parcels of interest is shown in black.

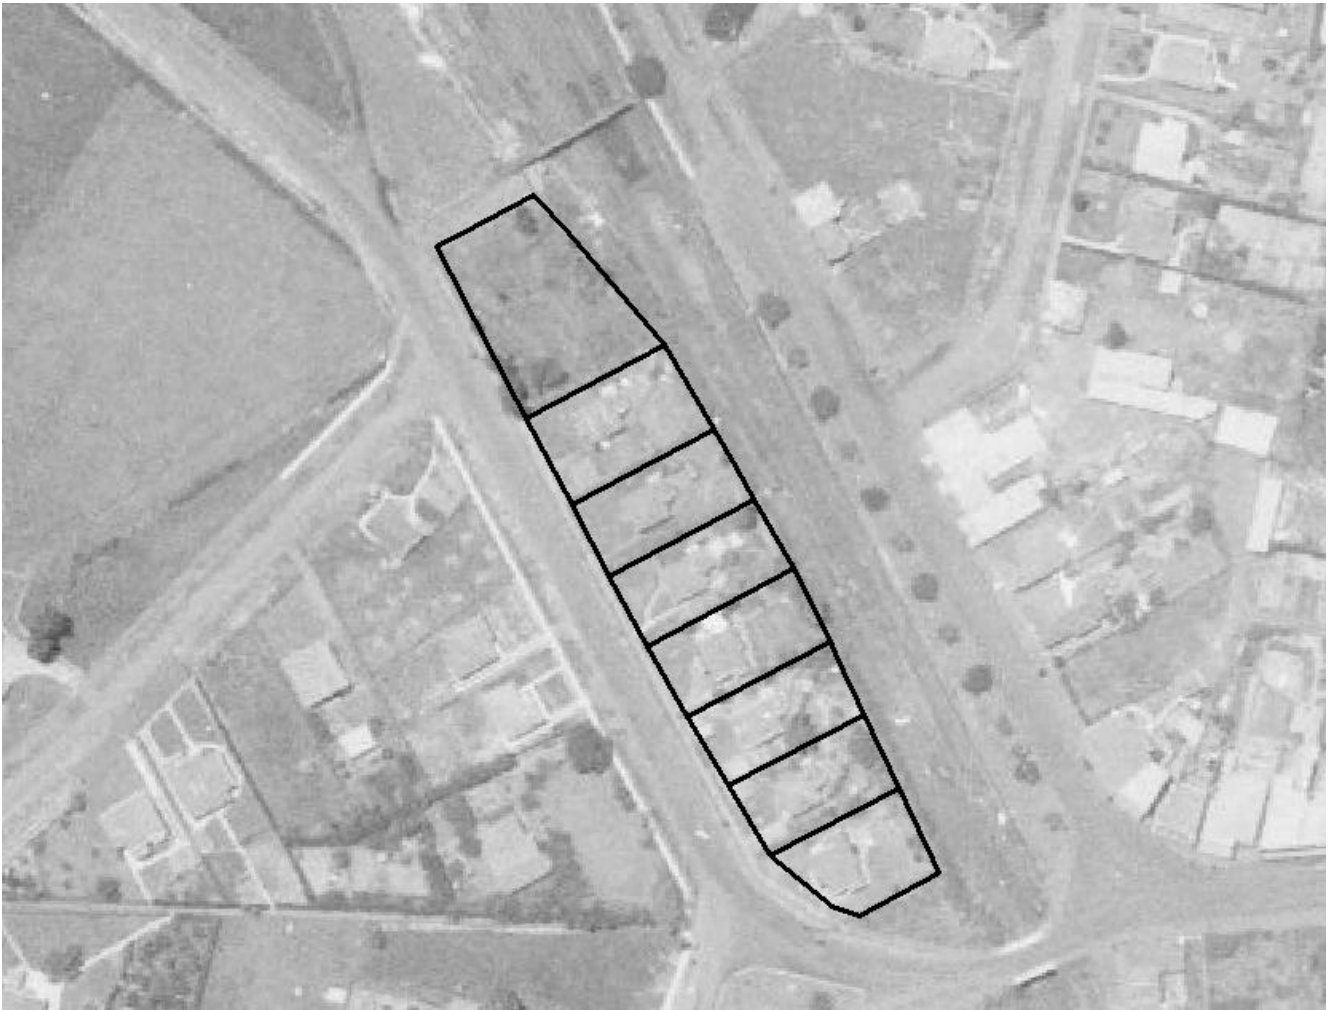
Historical aerial imagery from 1939 (Sourced from Retrolens). Approximate boundary of land parcels of interest is shown in black.

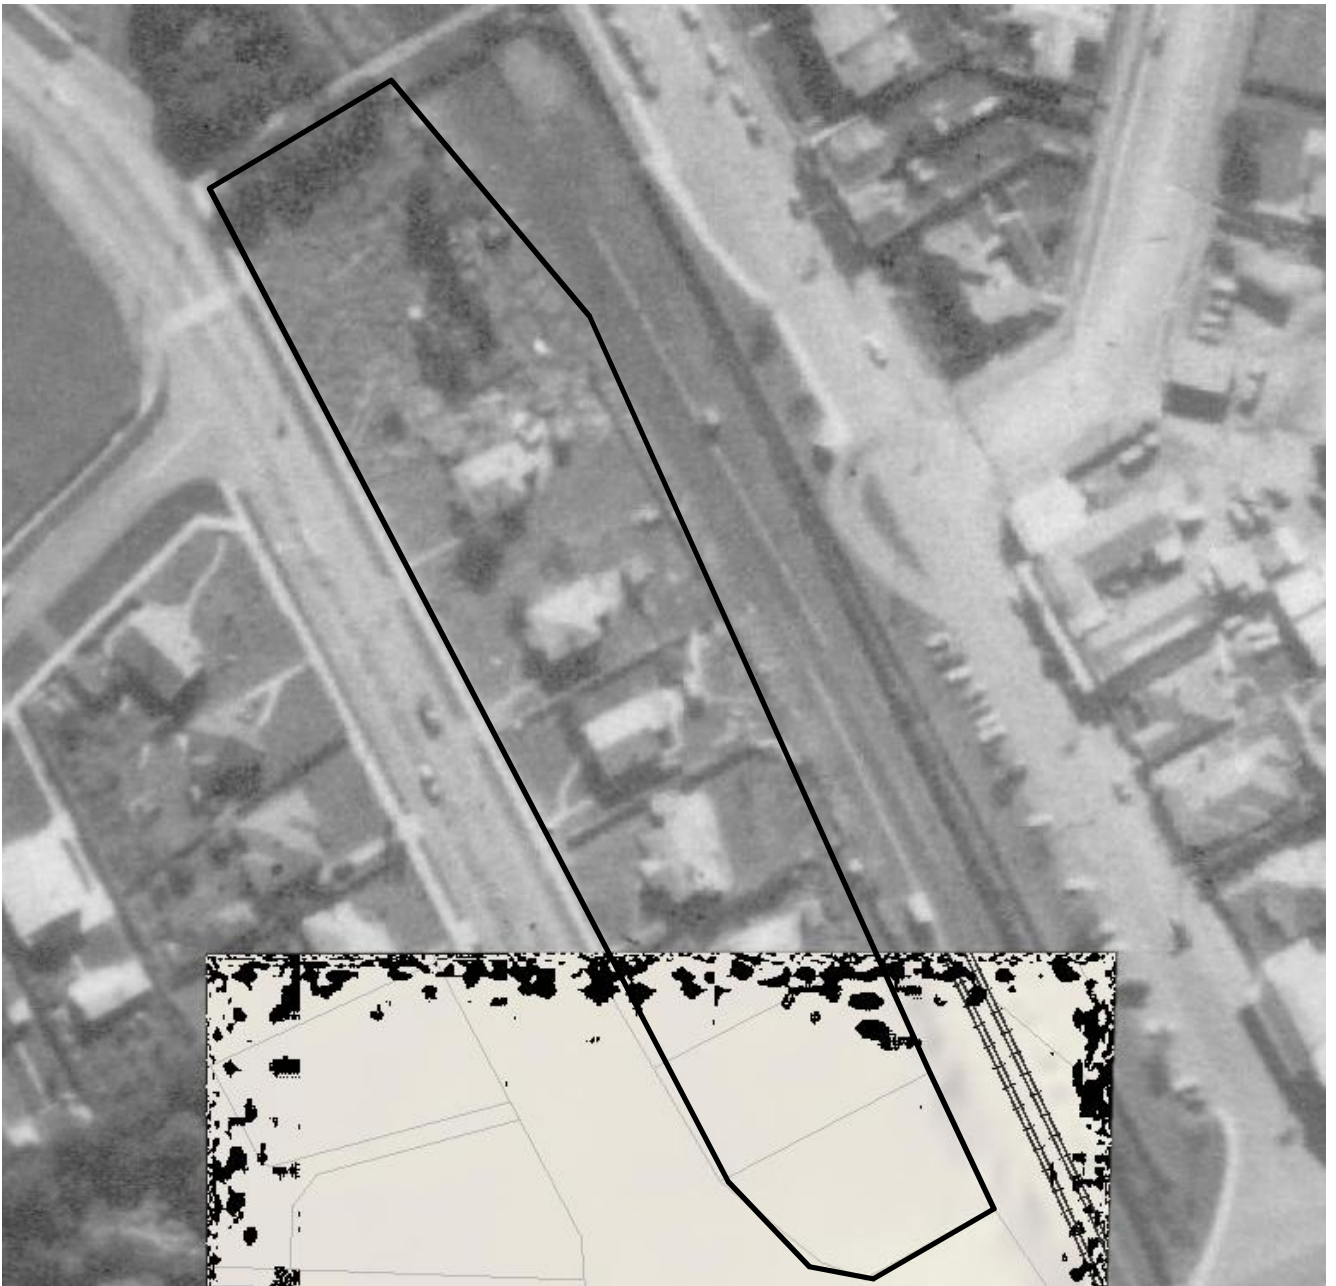
Historical aerial imagery from 1959 (Sourced from Auckland Council GEOMAPS). Approximate boundary of land parcels of interest is shown in black.

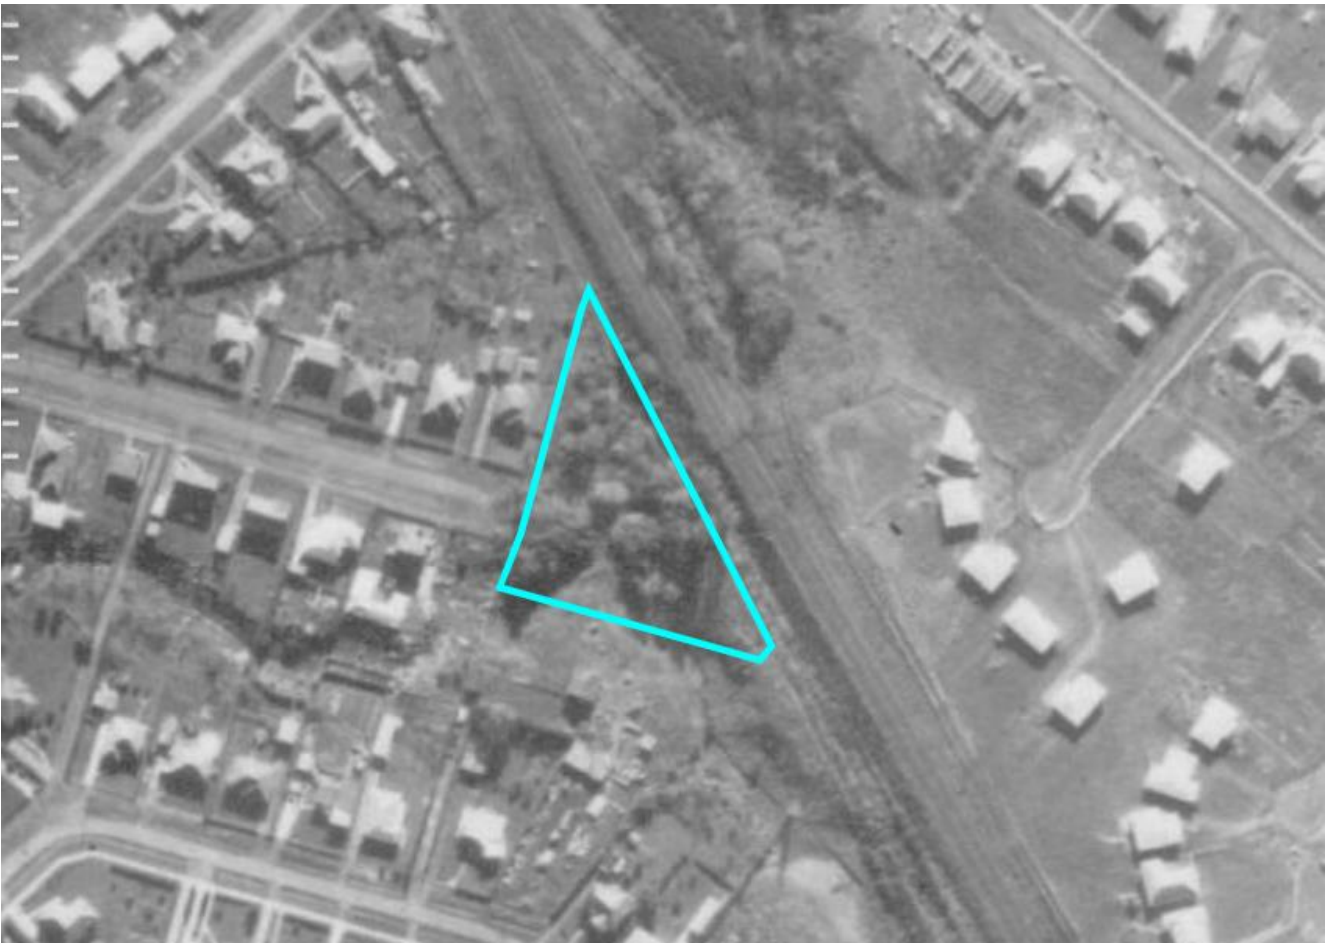
Historical aerial imagery from 1959 (Sourced from Auckland Council GEOMAPS). Approximate boundary of 18R Gordon Road shown.

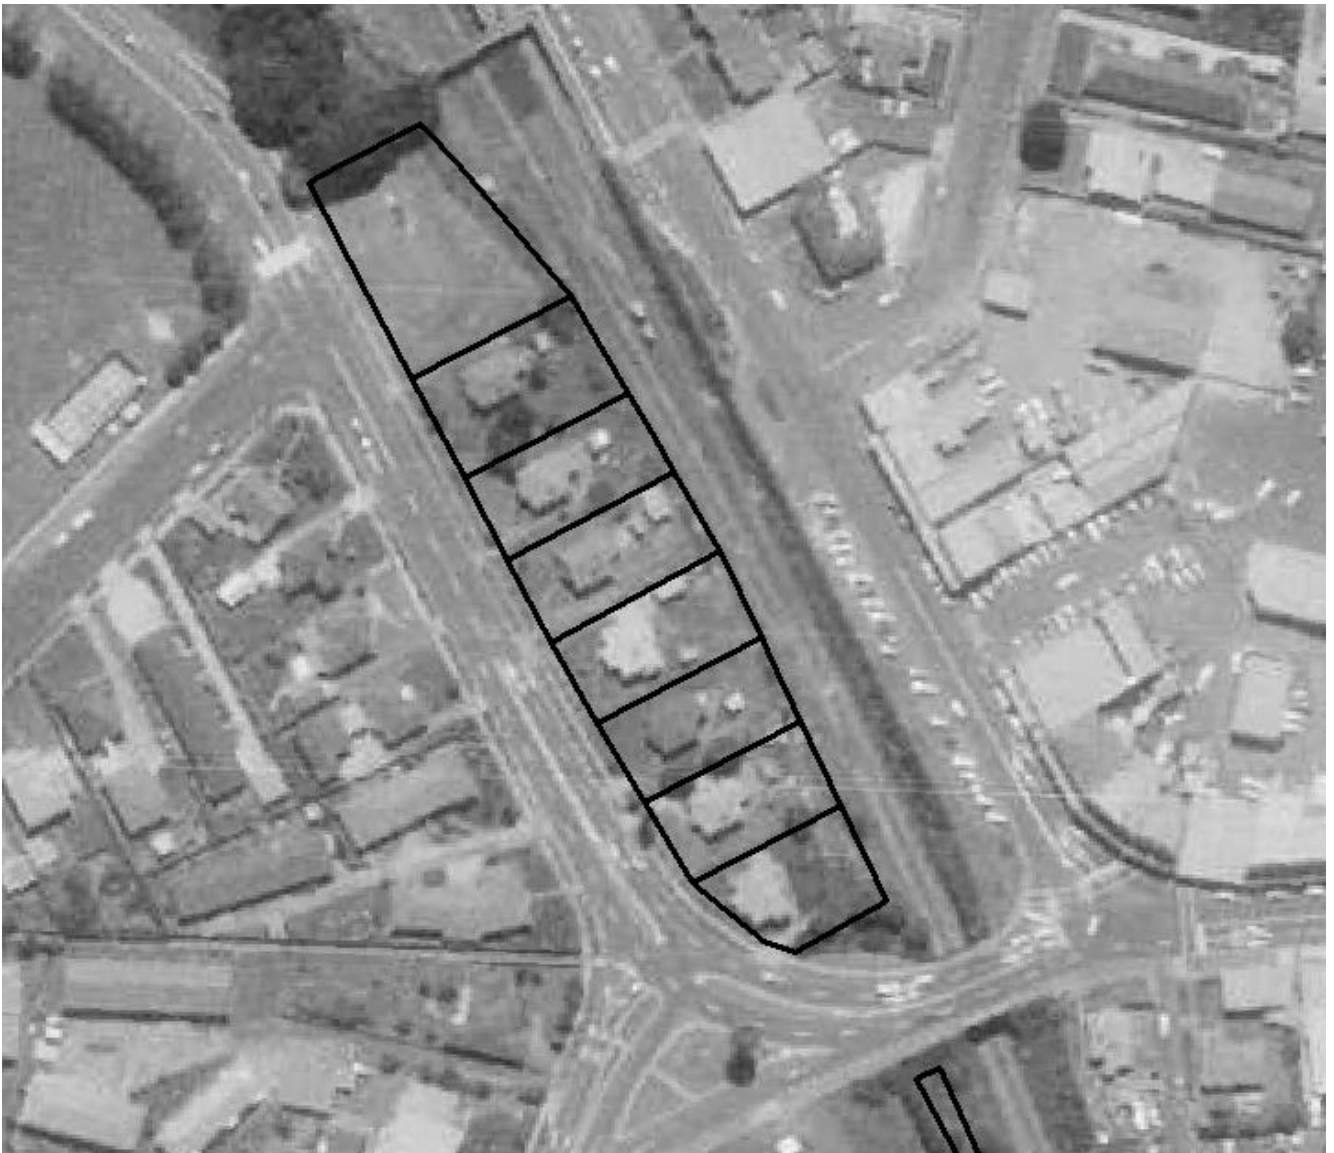
Historical aerial imagery from 1980 (Sourced from Retrolens). Approximate boundary of land parcels of interest is shown in black.

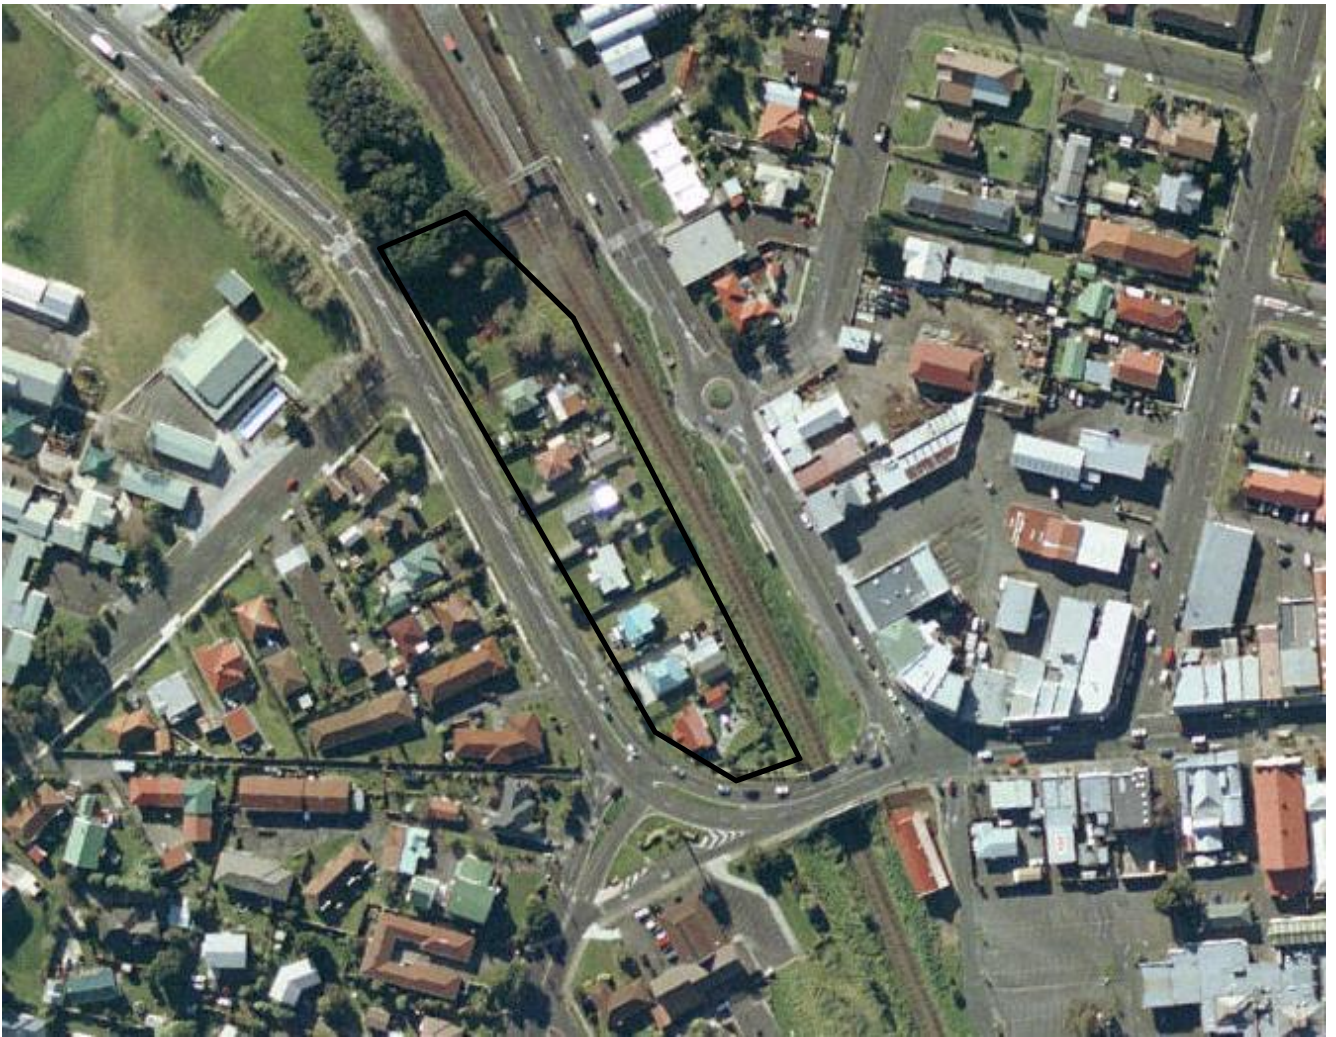
Historical aerial imagery from 2001 (Sourced from Auckland Council GEOMAPS). Approximate boundary of land parcels of interest is shown in black.

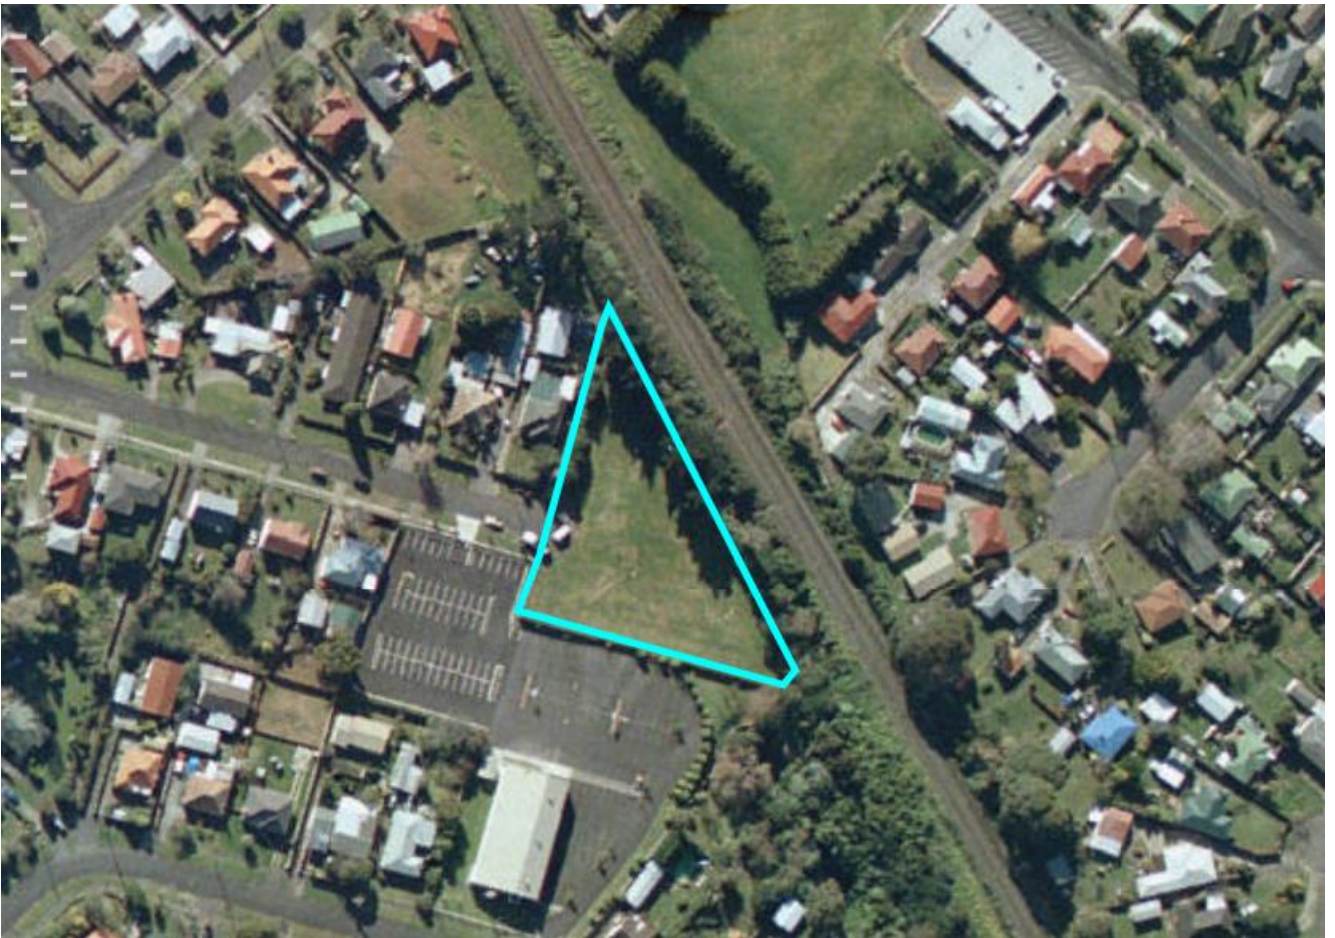
Historical aerial imagery from 2001 (Sourced from Auckland Council GEOMAPS). Approximate boundary of 18R Gordon Road shown.

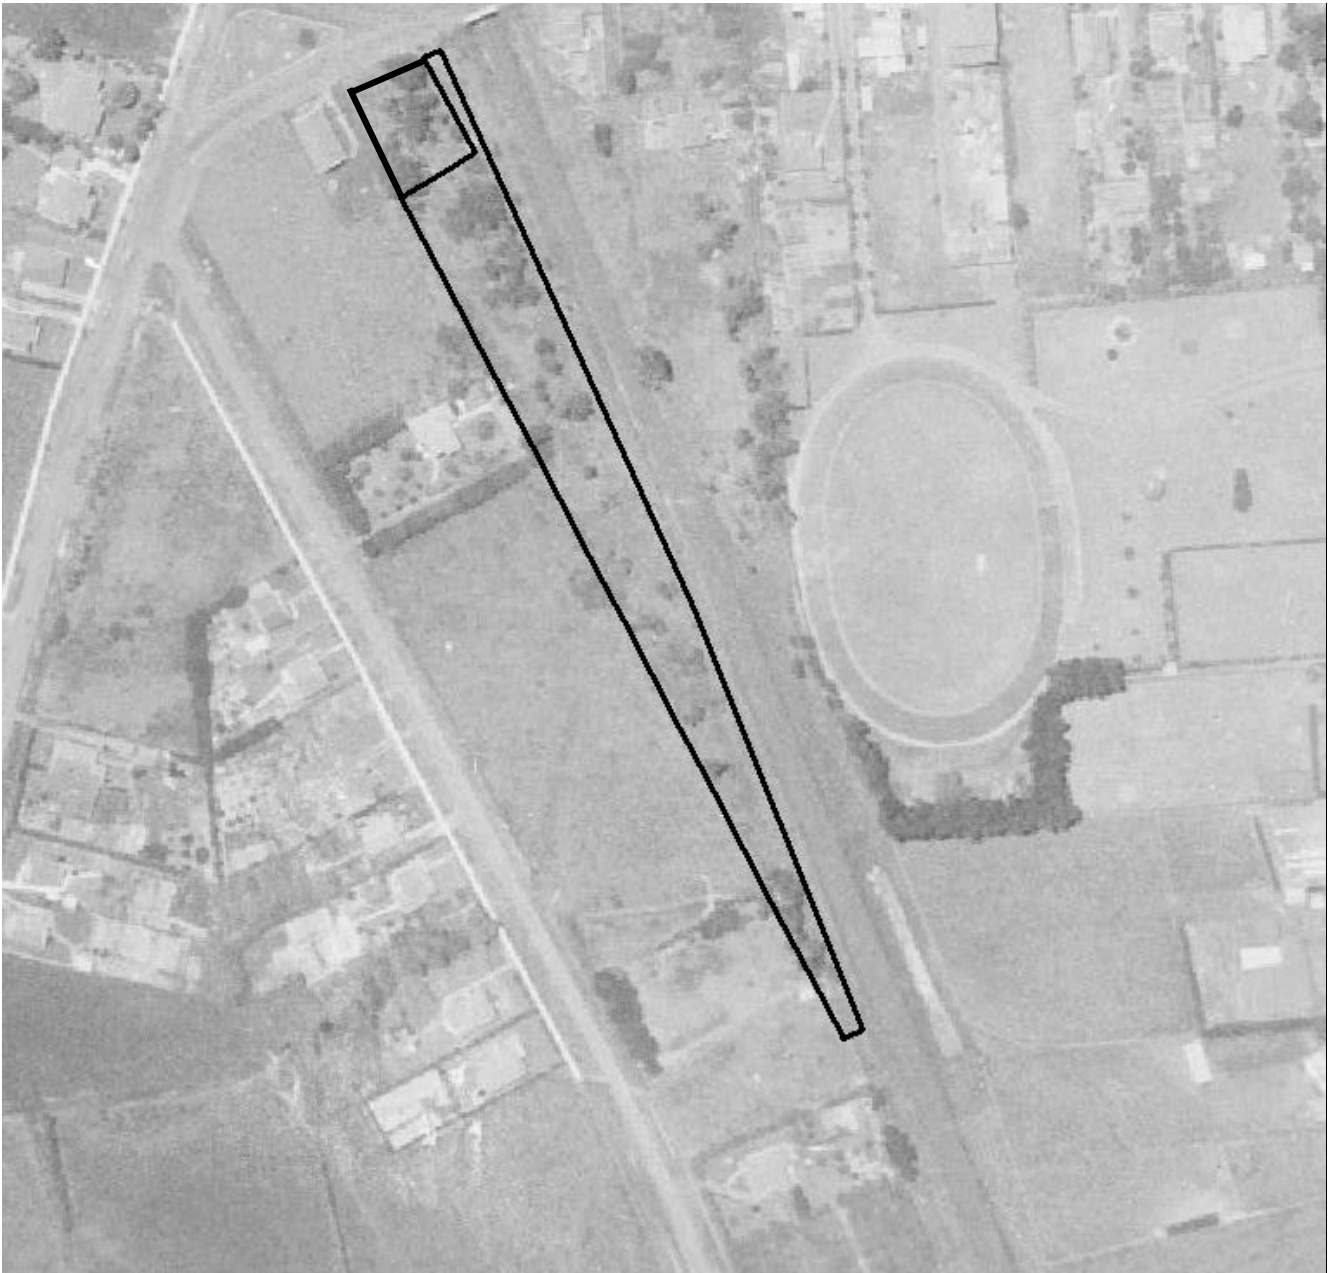
Historical aerial imagery from 1939 (Sourced from Retrolens). Approximate boundary of land parcels of interest is shown in black.

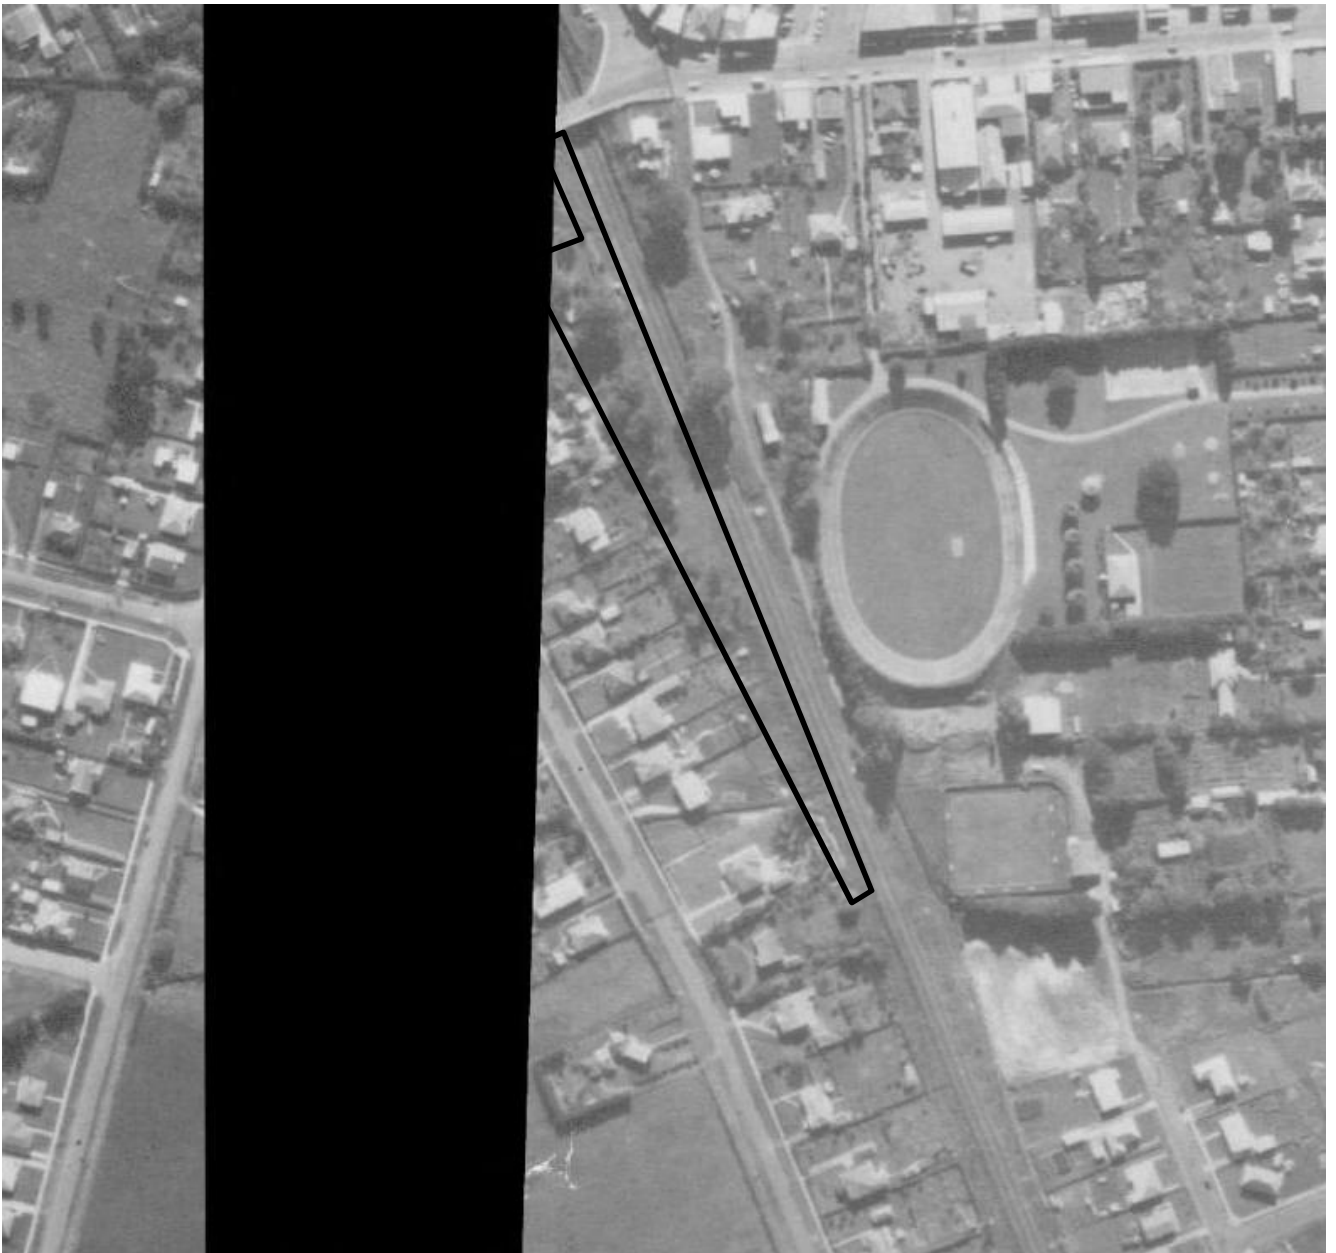
Historical aerial imagery from 1956 (Sourced from Auckland Council GEOMAPS). Approximate boundary of land parcels of interest is shown in black.

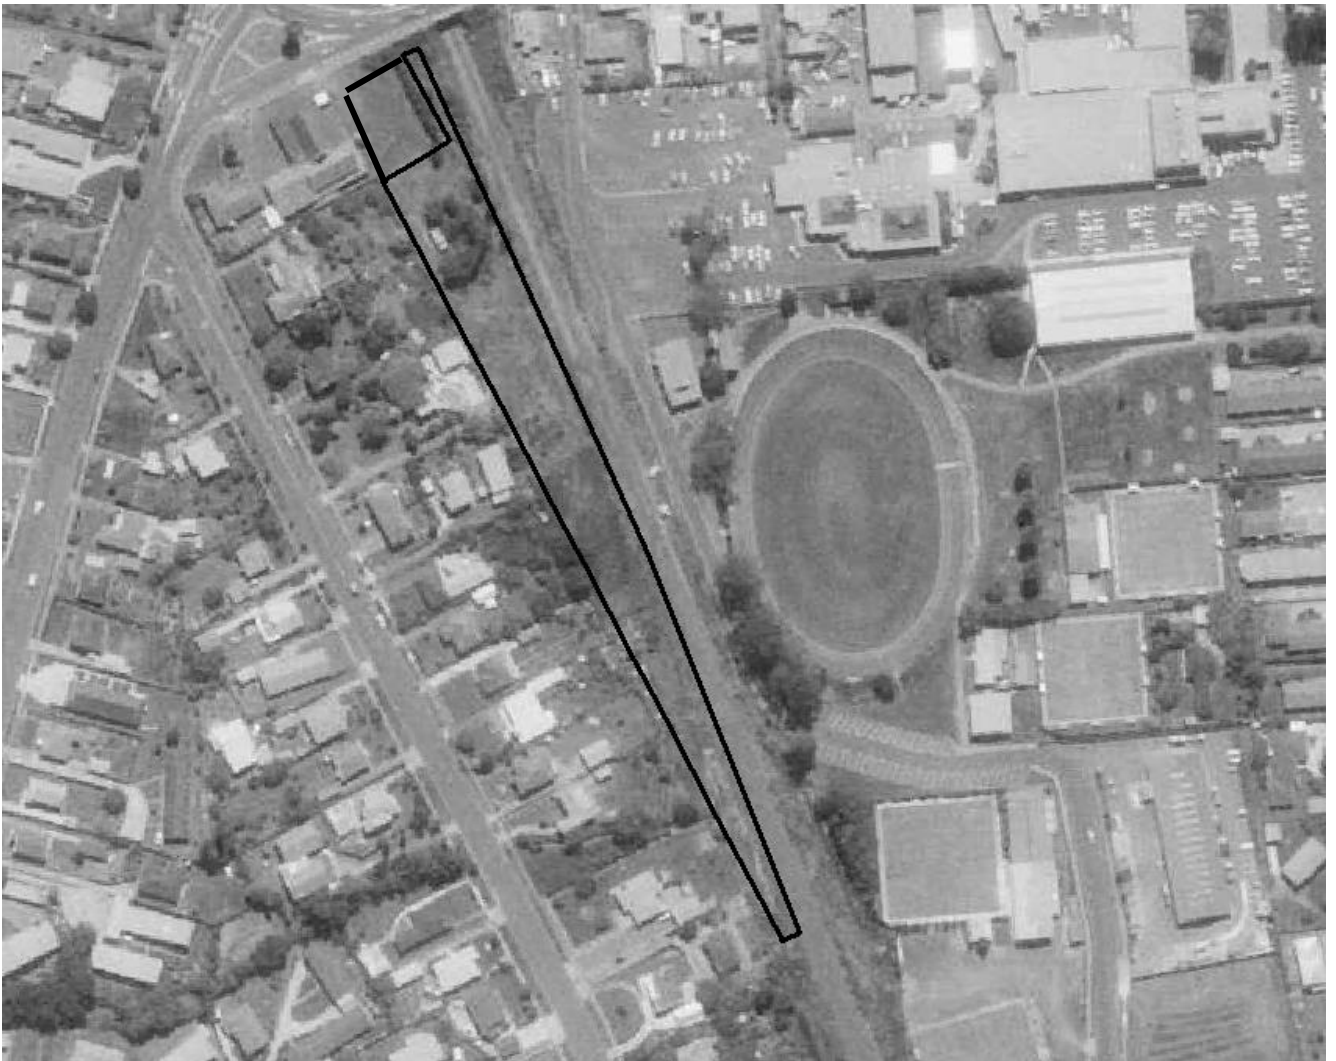
Historical aerial imagery from 1980 (Sourced from Retrolens). Approximate boundary of land parcels of interest is shown in black.

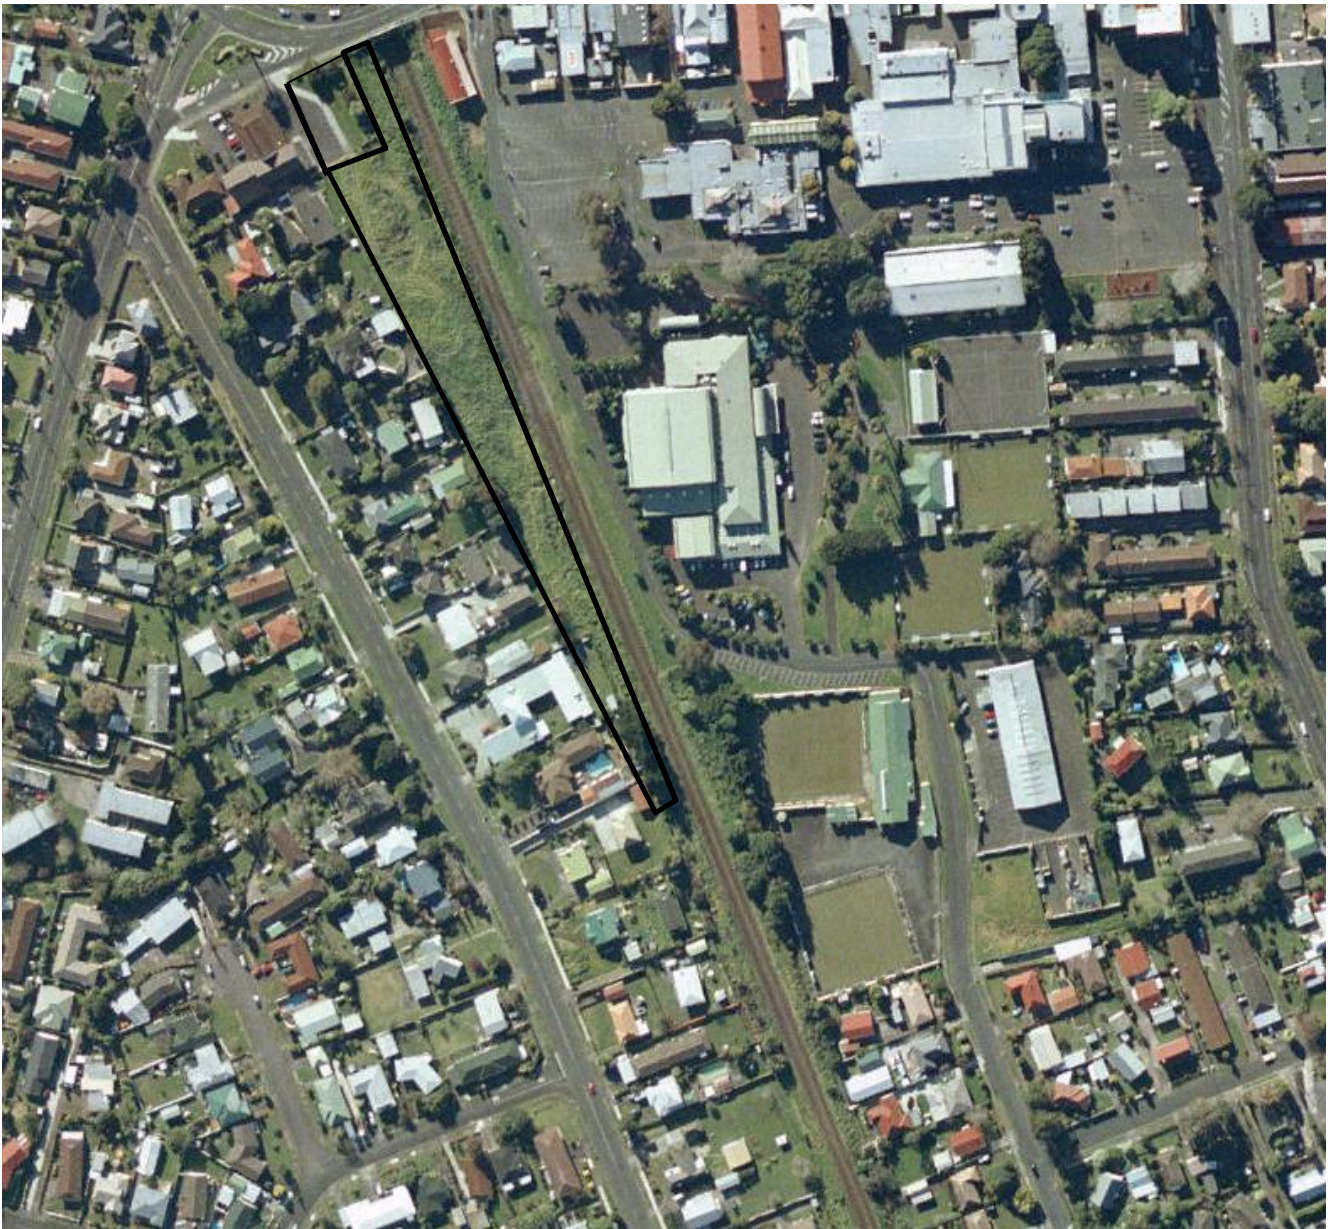
Historical aerial imagery from 2001 (Sourced from Auckland Council GEOMAPS). Approximate boundary of land parcels of interest is shown in black.
