Wiri to Quay Park Project

Preliminary Site Investigation

IA233800-A.CS.EV.P1ENV-NW-RPT-0001 | 01

5 June 2020

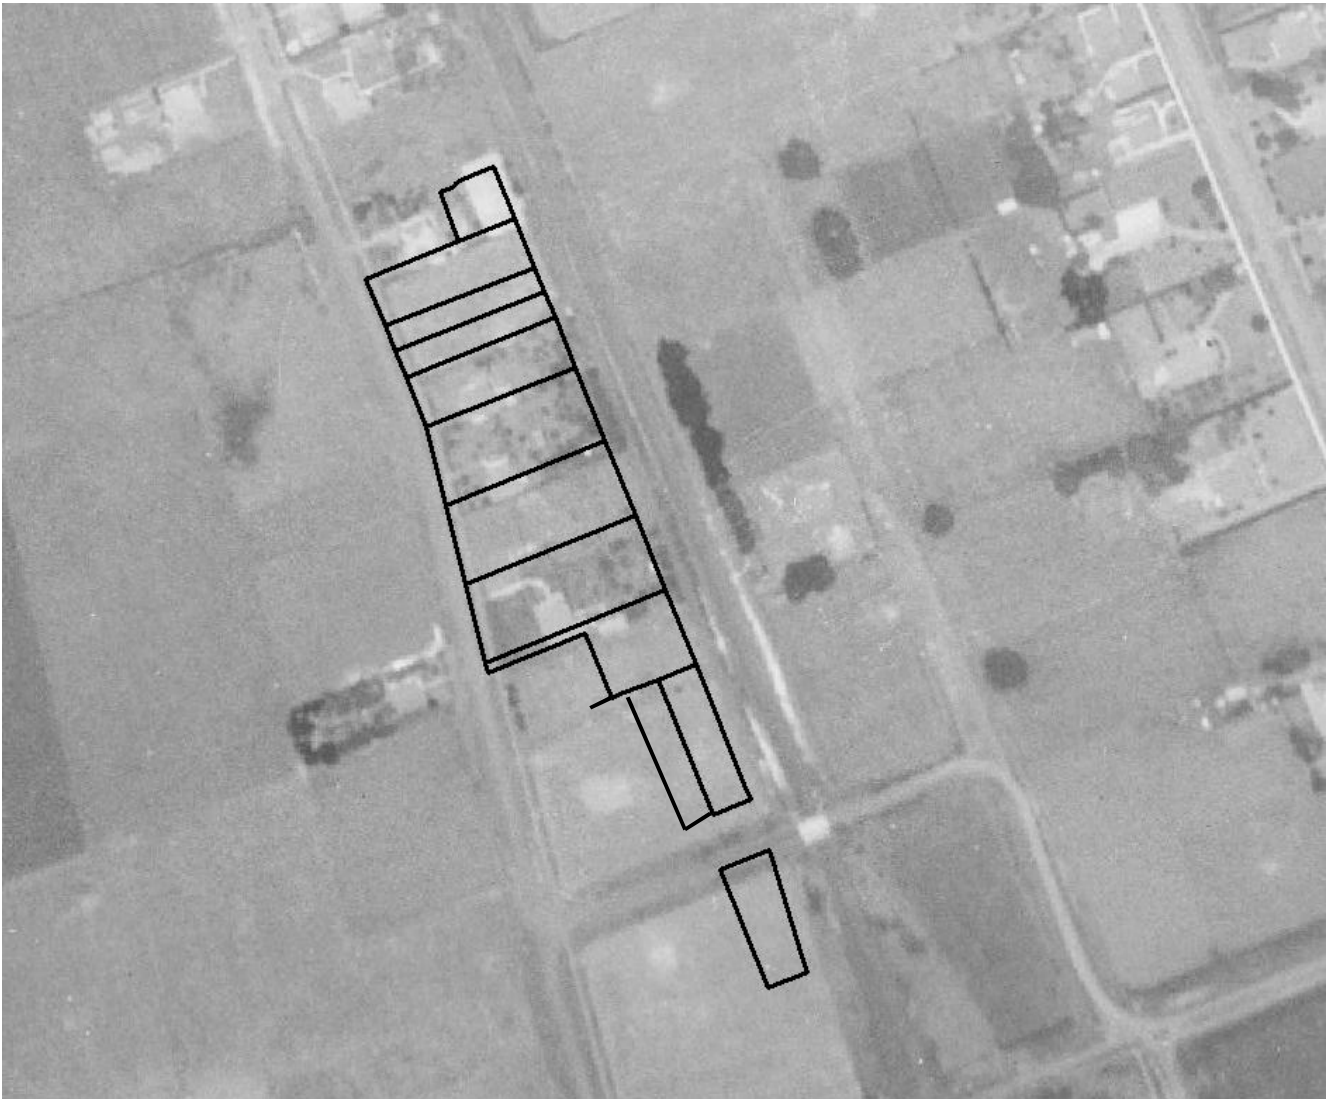
Historical aerial imagery from 1939 (Sourced from Retrolens). Approximate boundary of land parcels of interest is shown in black.

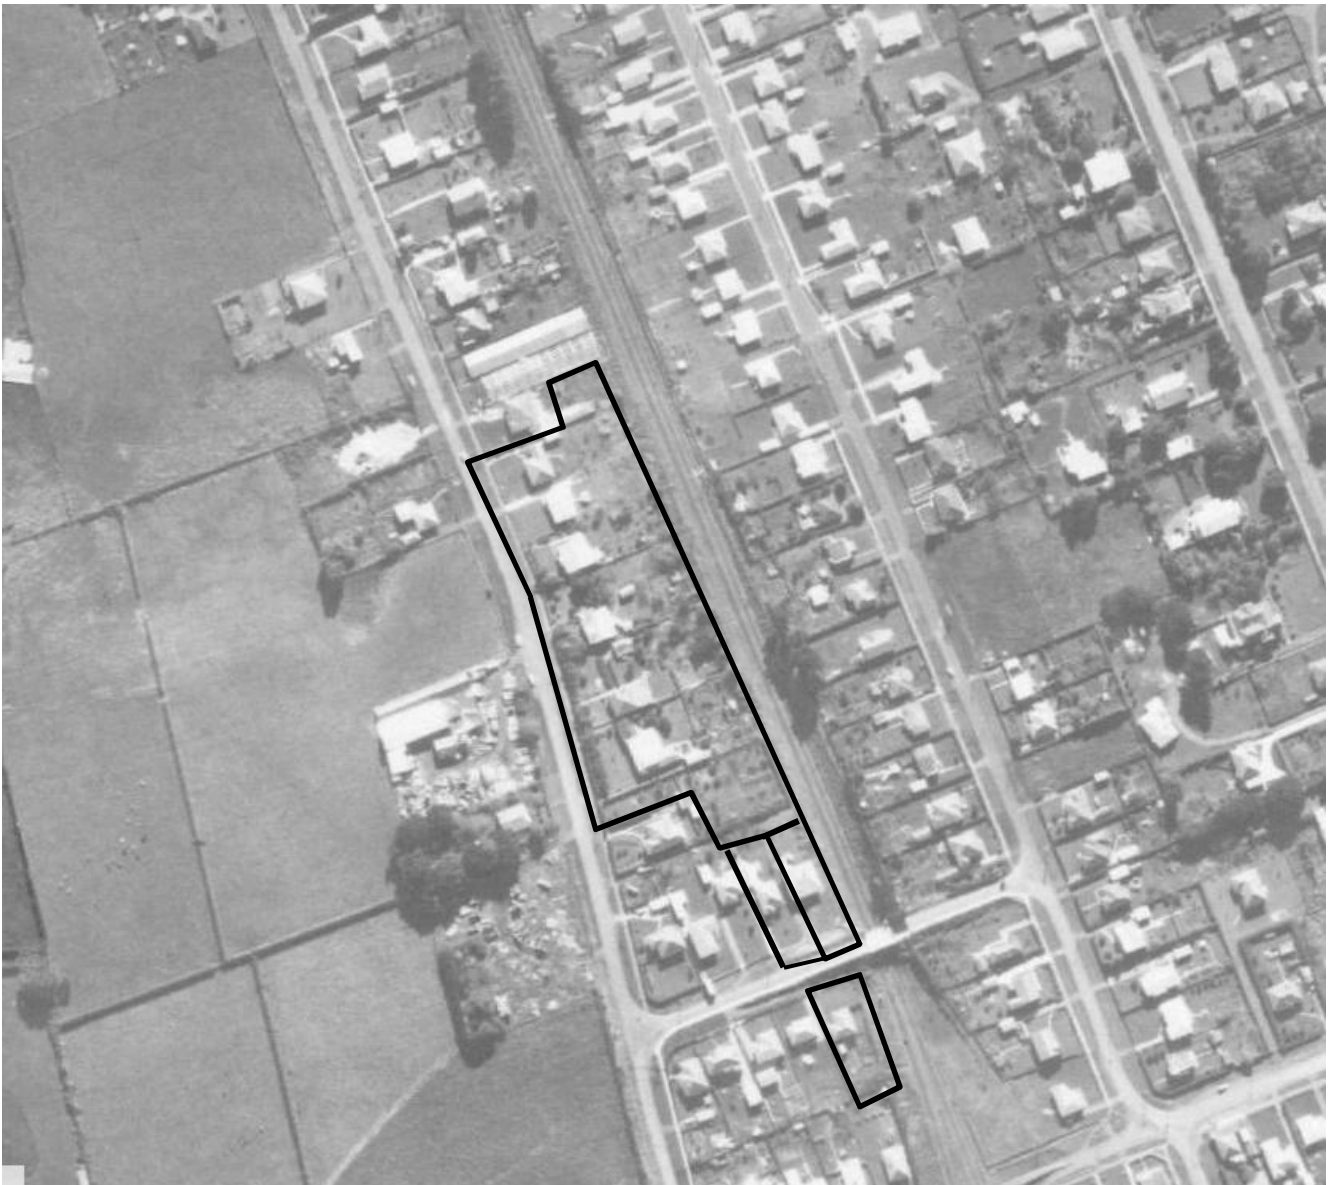
Historical aerial imagery from 1959 (Sourced from Auckland Council GEOMAPS). Approximate boundary of land parcels of interest is shown in black.

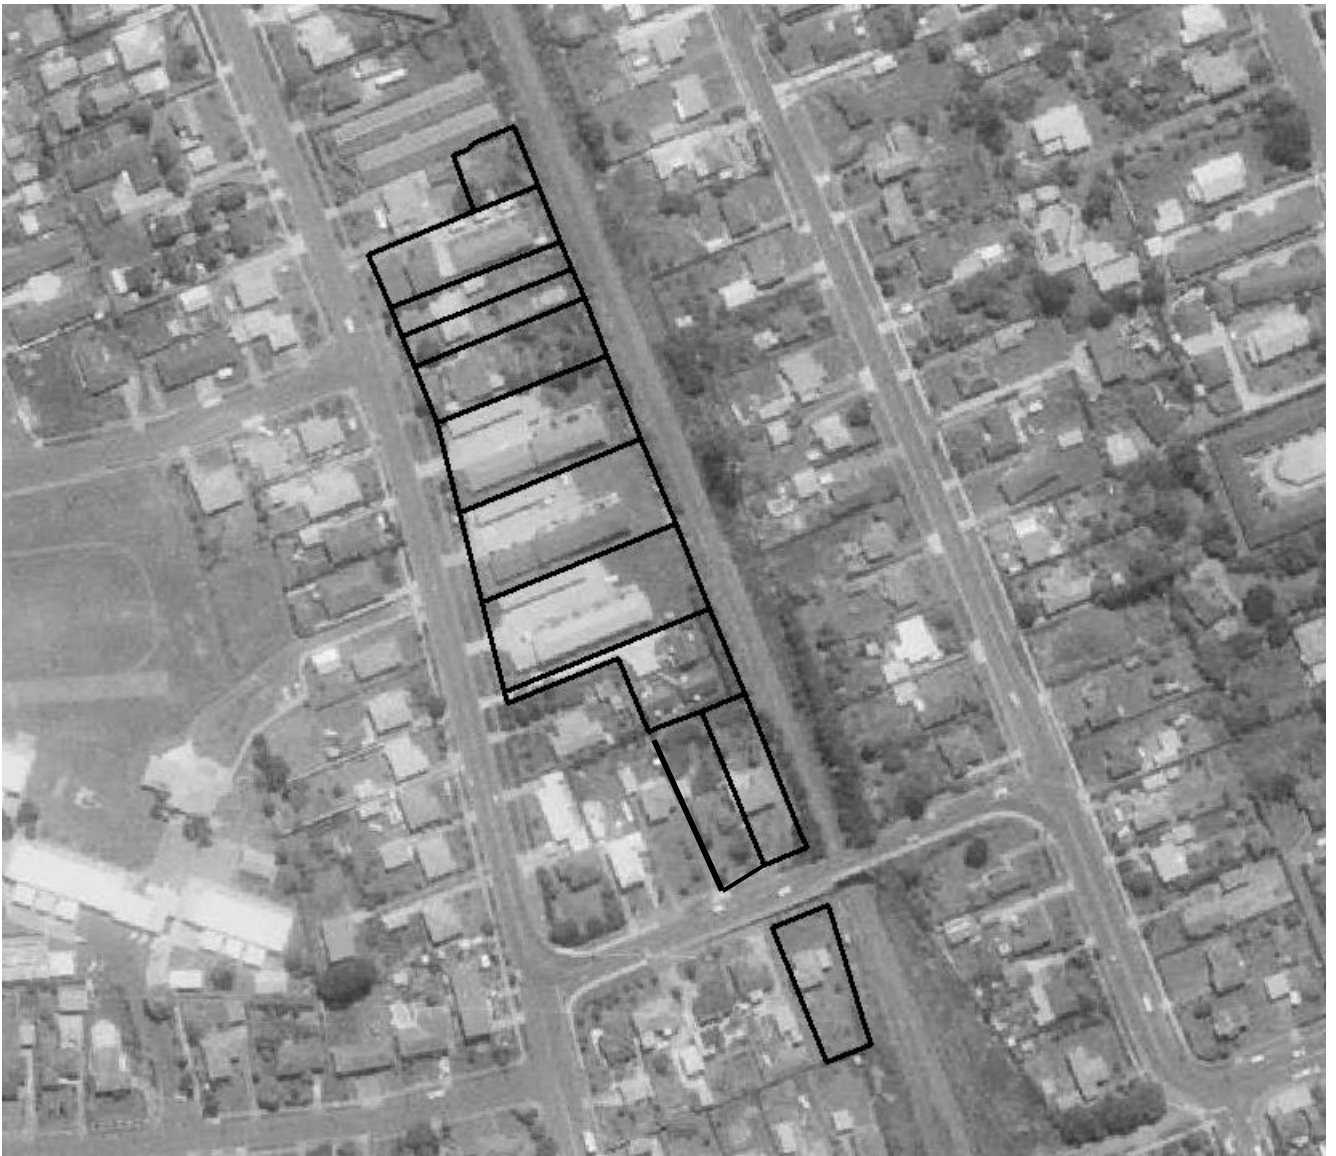
Historical aerial imagery from 1980 (Sourced from Retrolens). Approximate boundary of land parcels of interest is shown in black.

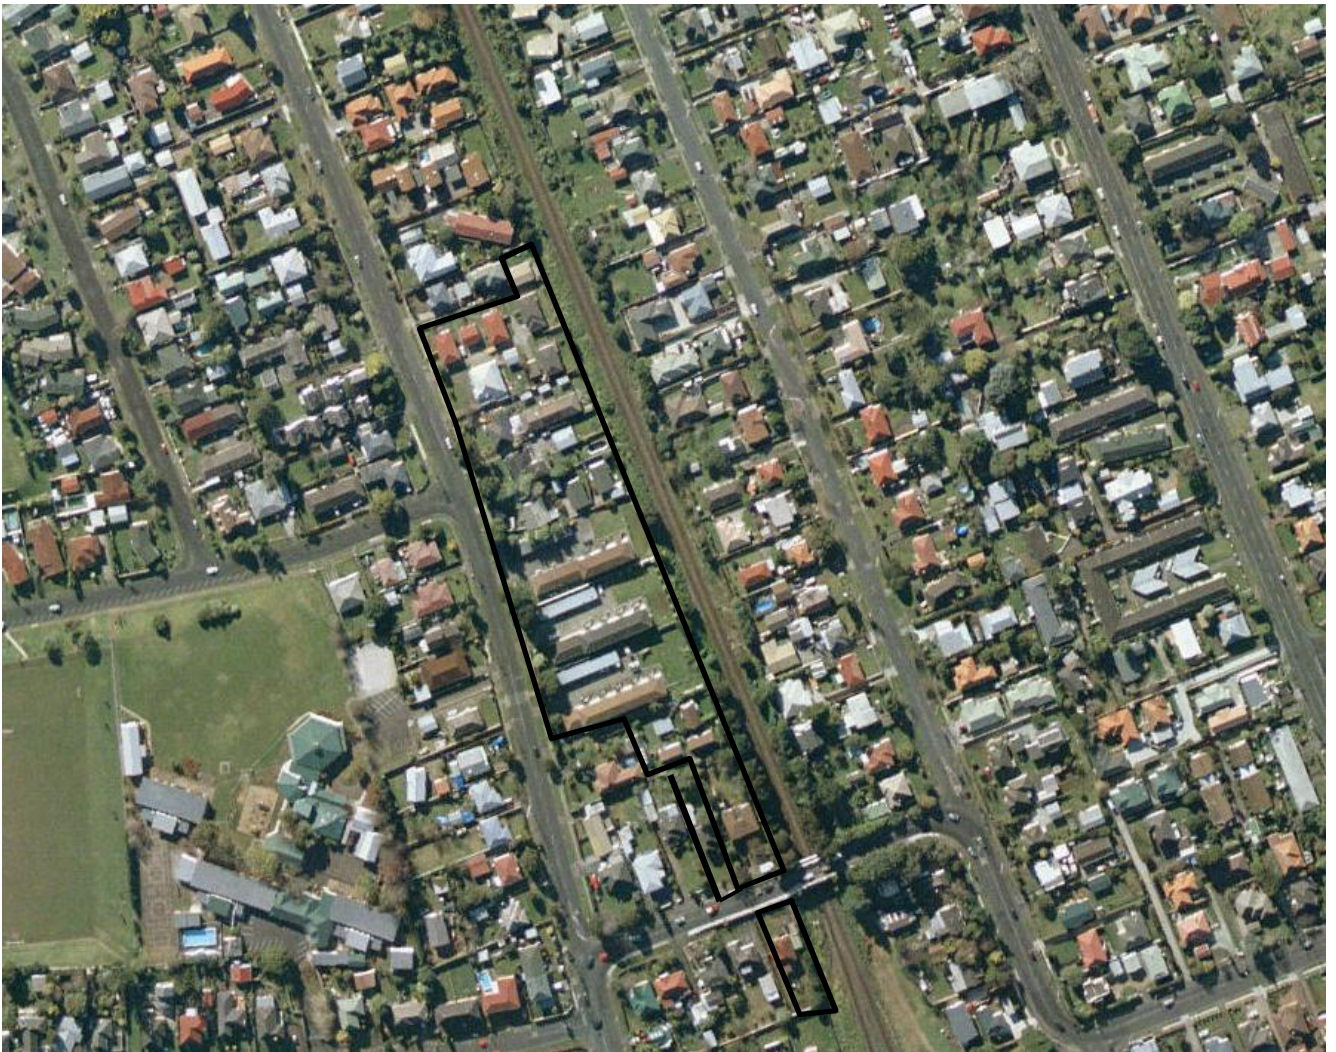
Historical aerial imagery from 2001 (Sourced from Auckland Council GEOMAPS). Approximate boundary of land parcels of interest is shown in black.

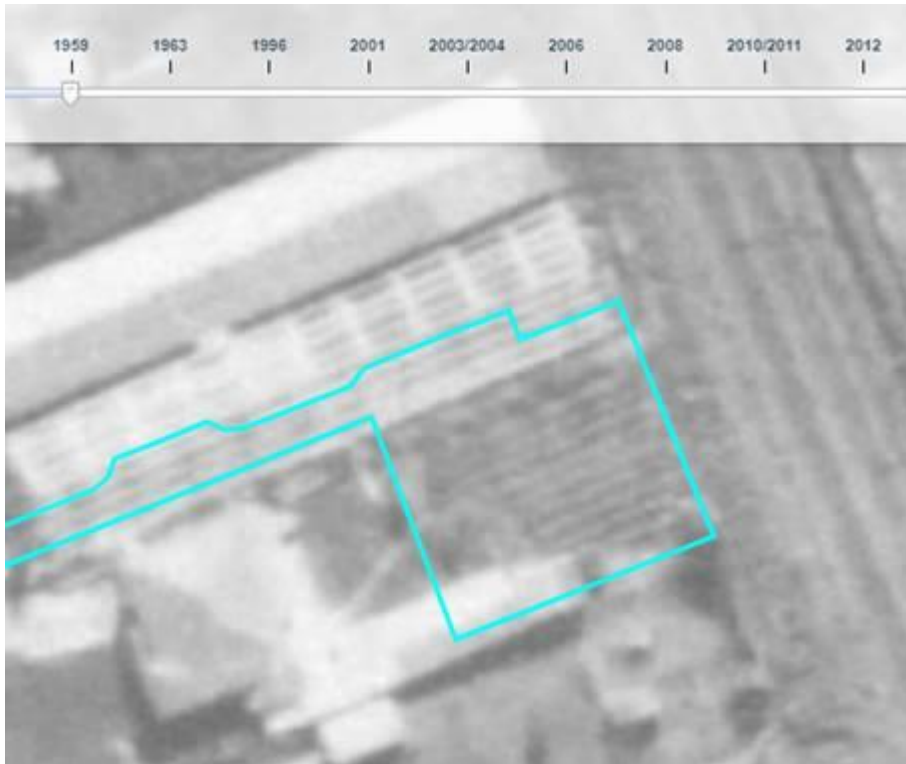
There is no contamination information held within our records for the site 74D Kenderdine Road, Papatoetoe. However, due to the adjacent railway there is potential for uncertified/non-engineered fill to be present on site. Due to the age of the dwelling on site the potential for presence of asbestos and/or lead paint may need to be considered. In addition to this, Council's GIS aerial records indicate possible horticultural activity on site.

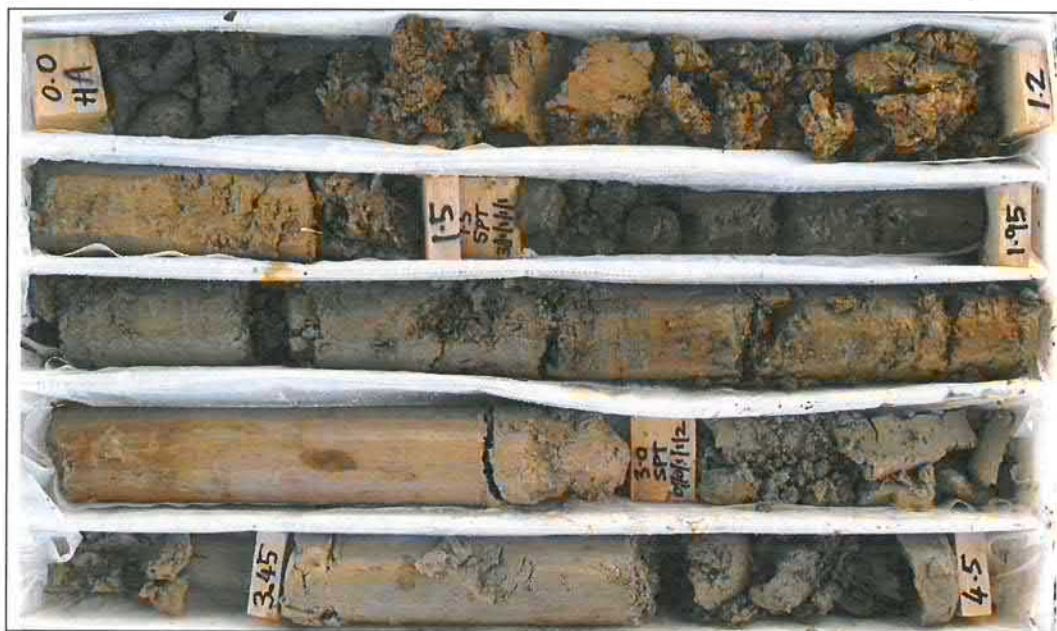
Box 1. - Depth: 0.00m to 4.50m.

DH Reference: DH101 Date Drilled: 25/06/10 - 30/06/10
Photographed By: HH Date Photographed: 25/06/10 - 30/06/10

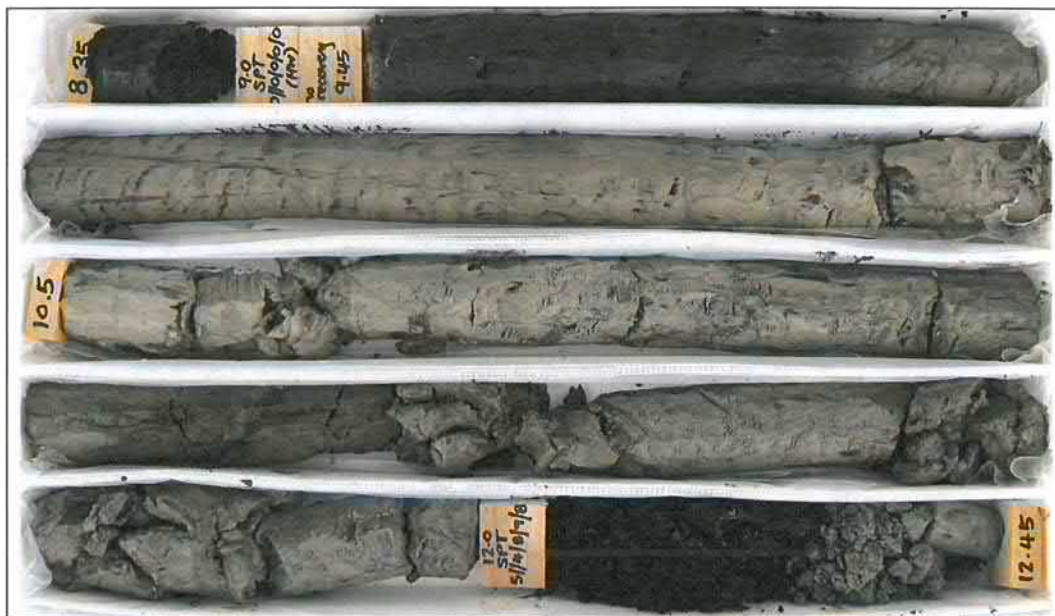
Box 3 - Depth: 8.35m to 12.45m.

DH Reference: DH101 Date Drilled: 25/06/10 - 30/06/10
Photographed By: HH Date Photographed: 25/06/10 - 30/06/10

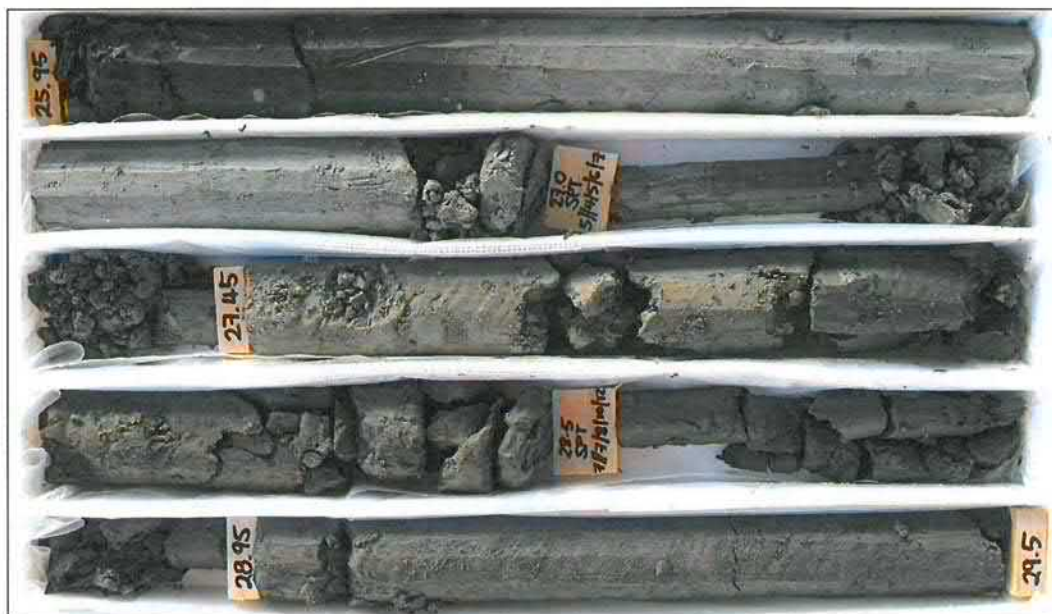
Box 7. - Depth: 25.95m to 29.50m.

DH Reference:	DH101	Date Drilled:	25/06/10 - 30/06/10
Photographed By:	HH	Date Photographed:	25/06/10 - 30/06/10

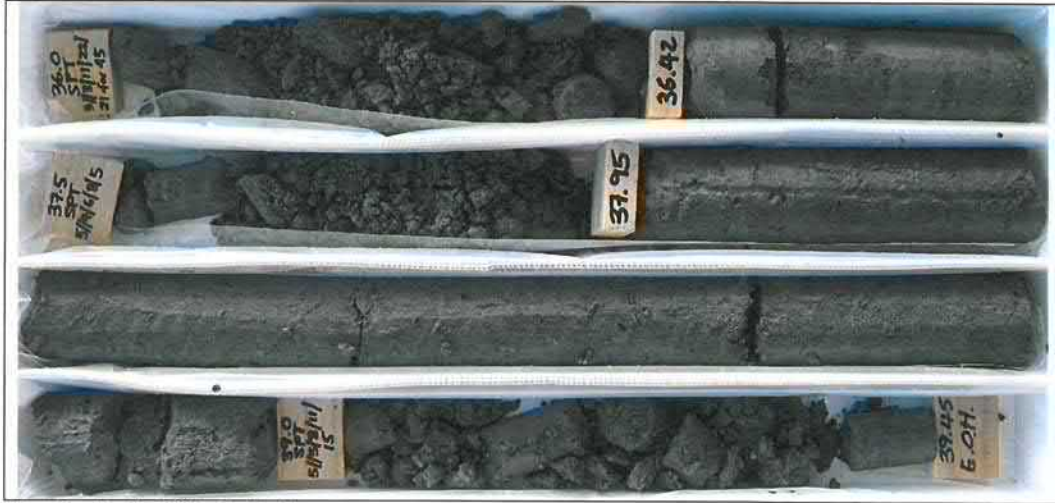
Box 9. - Depth: 36.0m to 39.45m.

DH Reference:	DH101	Date Drilled:	25/06/10 - 30/06/10
Photographed By:	HH	Date Photographed:	25/06/10 - 30/06/10

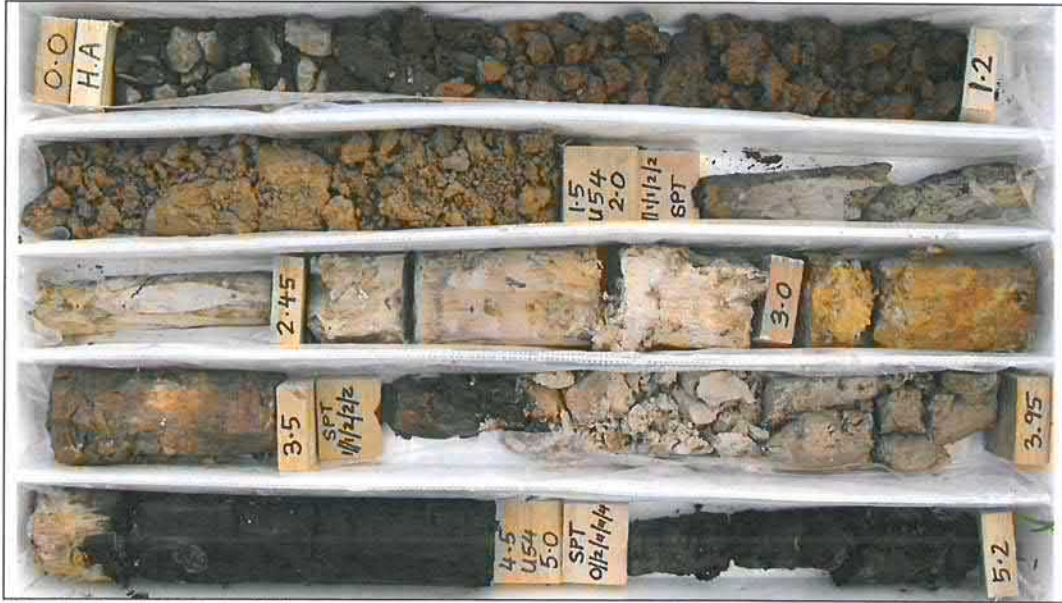
Box 1. - Depth: 0.00m to 5.20m.

DH Reference: DH105 Date Drilled: 10/06/10 – 11/06/10
Photographed By: HH Date Photographed: 10/06/10 – 11/06/10

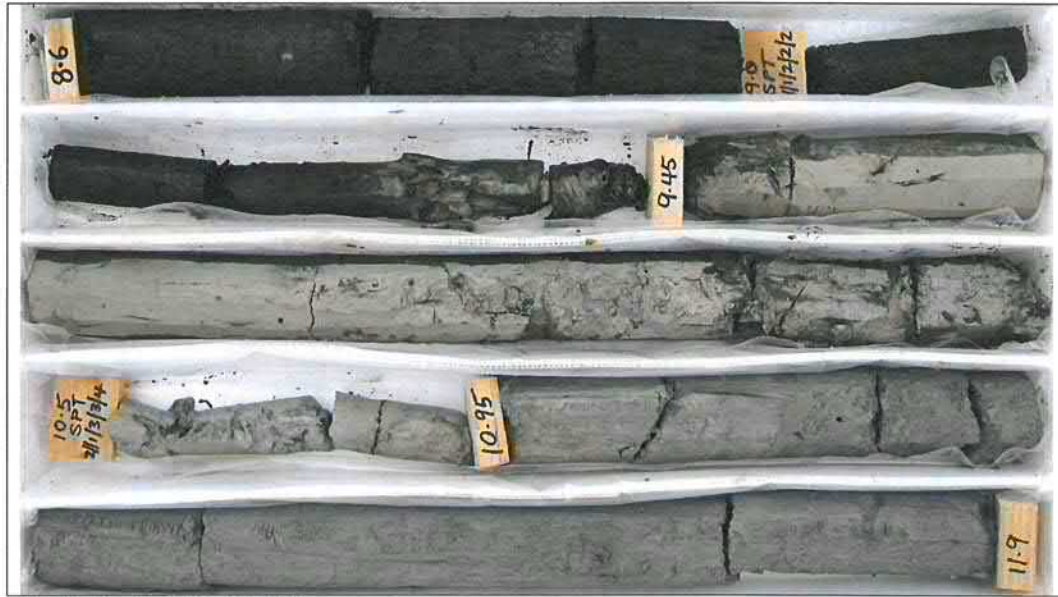
Box 3. - Depth: 8.60m to 11.90m.

DH Reference: DH105 Date Drilled: 10/06/10 – 11/06/10
Photographed By: HH Date Photographed: 10/06/10 – 11/06/10

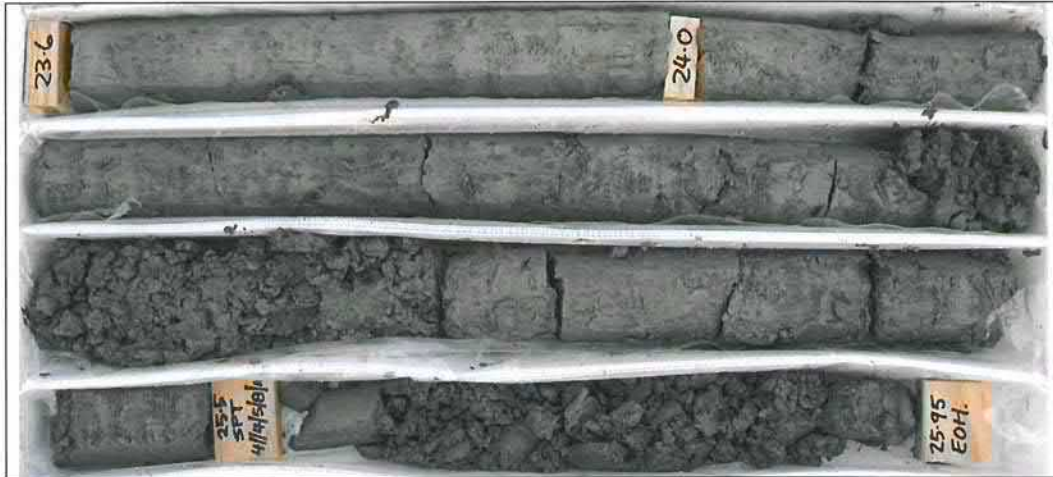
Box 7. - Depth: 23.60m to 25.95m.

DH Reference:	DH105	Date Drilled:	10/06/10 – 11/06/10
Photographed By:	HH	Date Photographed:	10/06/10 – 11/06/10

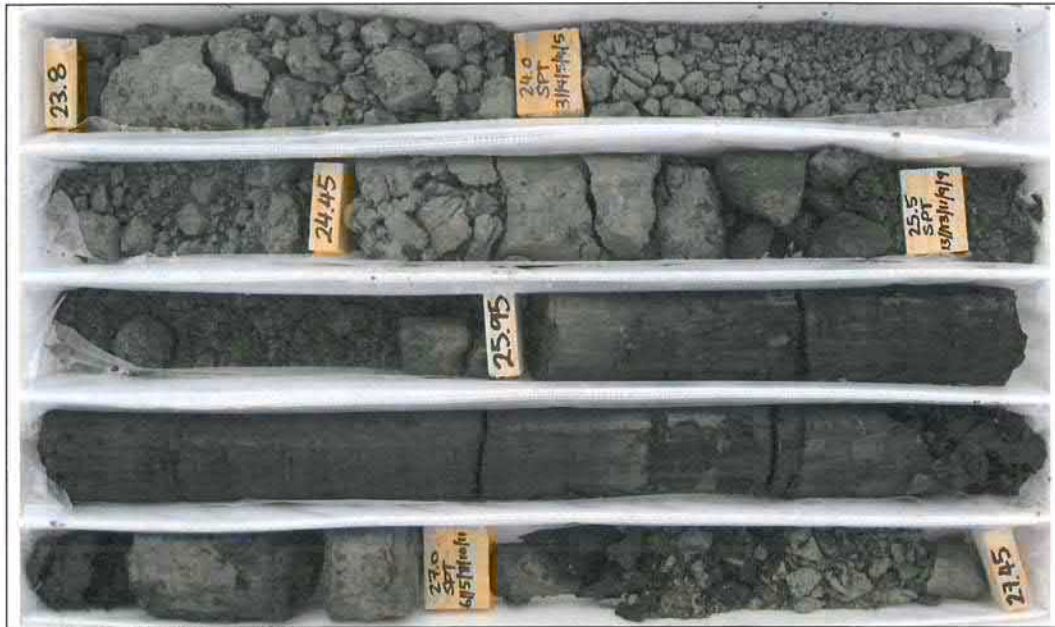
Box 7. - Depth: 23.80m to 27.45m.

DH Reference: DH106
Photographed By: HH
