MOE Drury West Due Diligence - Geotechnical Assessment Report

Prepared for Ministry of Education (NZ)

Prepared by Beca Limited

7 September 2018

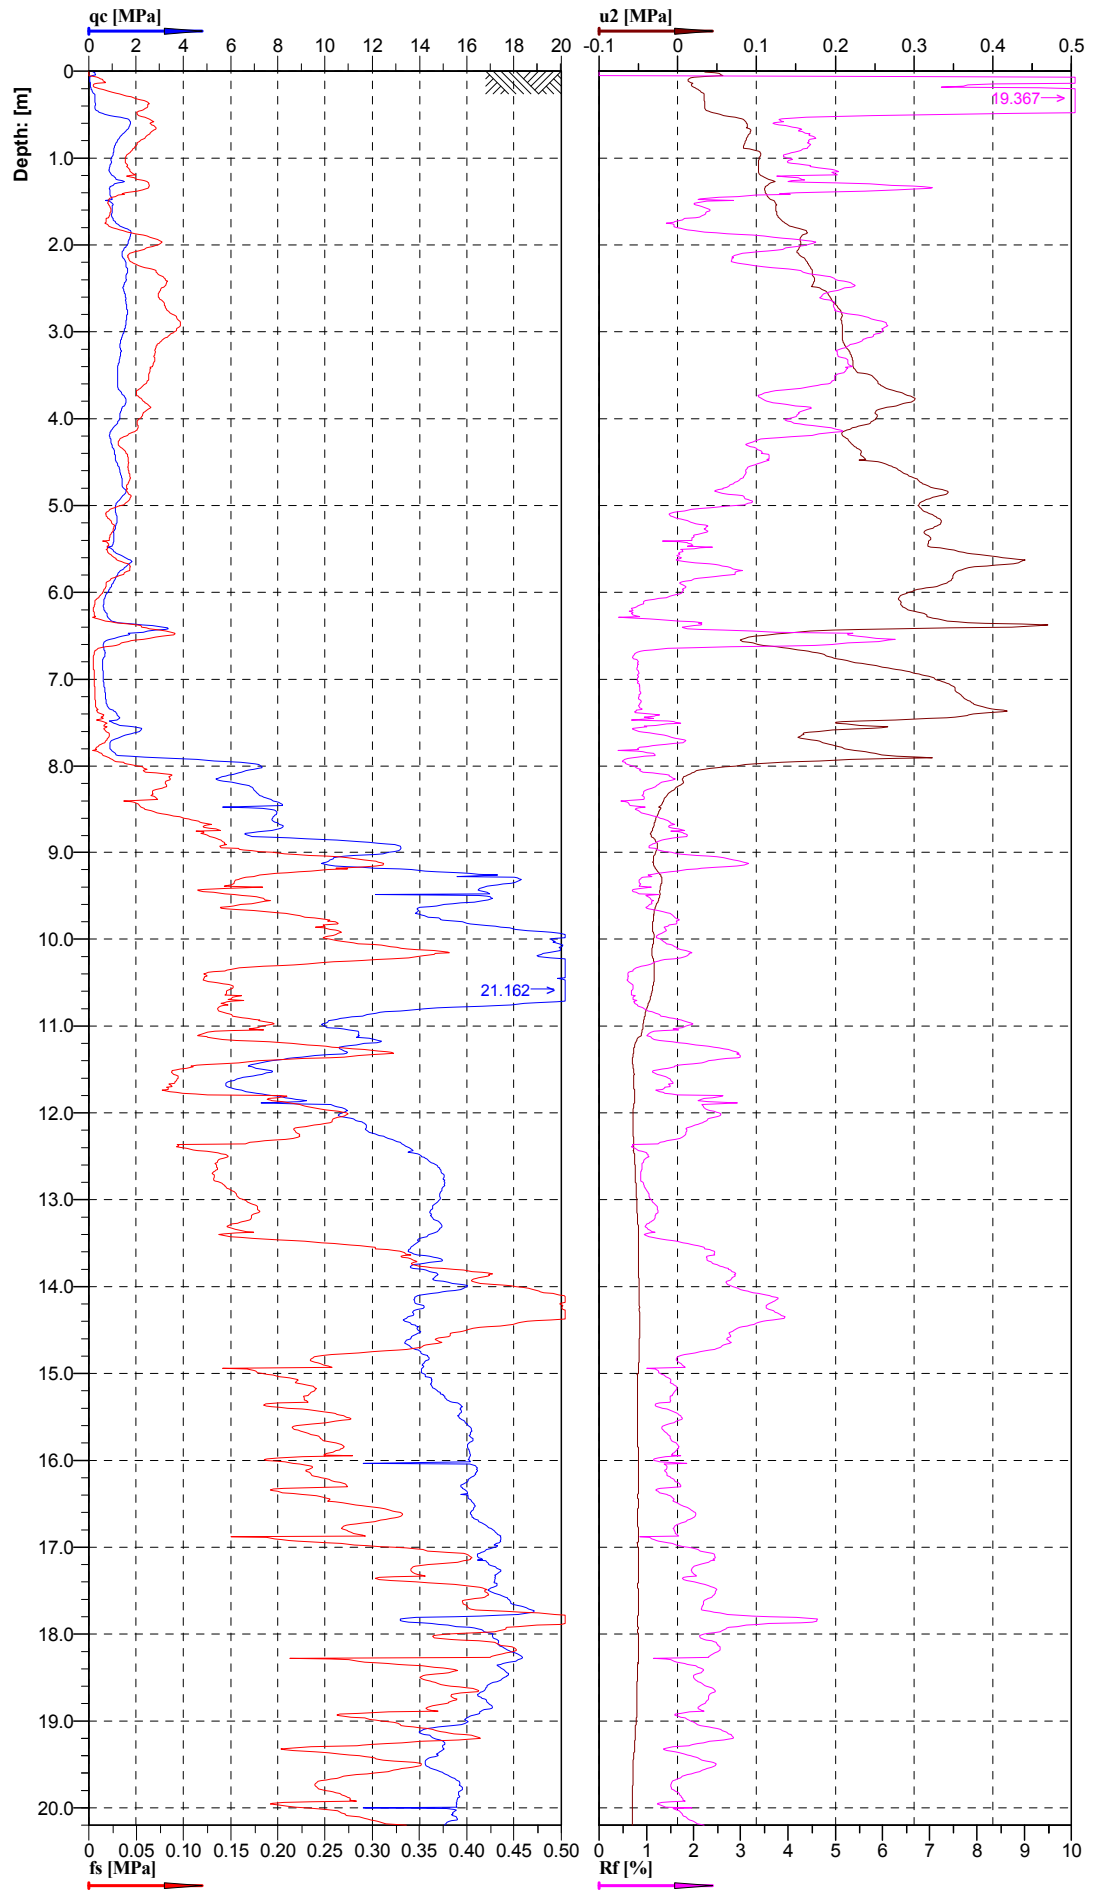
Location: Jesmond Rd Drury	Position: X: 0 m, Y: 0 m	Ground level: 0.000	Test No.: CPT01
Project ID: Beca281-401JesmondRd	Client: BECA	Date: 10/08/2018	Scale: 1 : 87
Project: Beca281-401JesmondRd		Page: 1/2	Fig.:
		File: Beca281-401JesmondRd_CPT01.GEF

**Classification by
Robertson 1986**

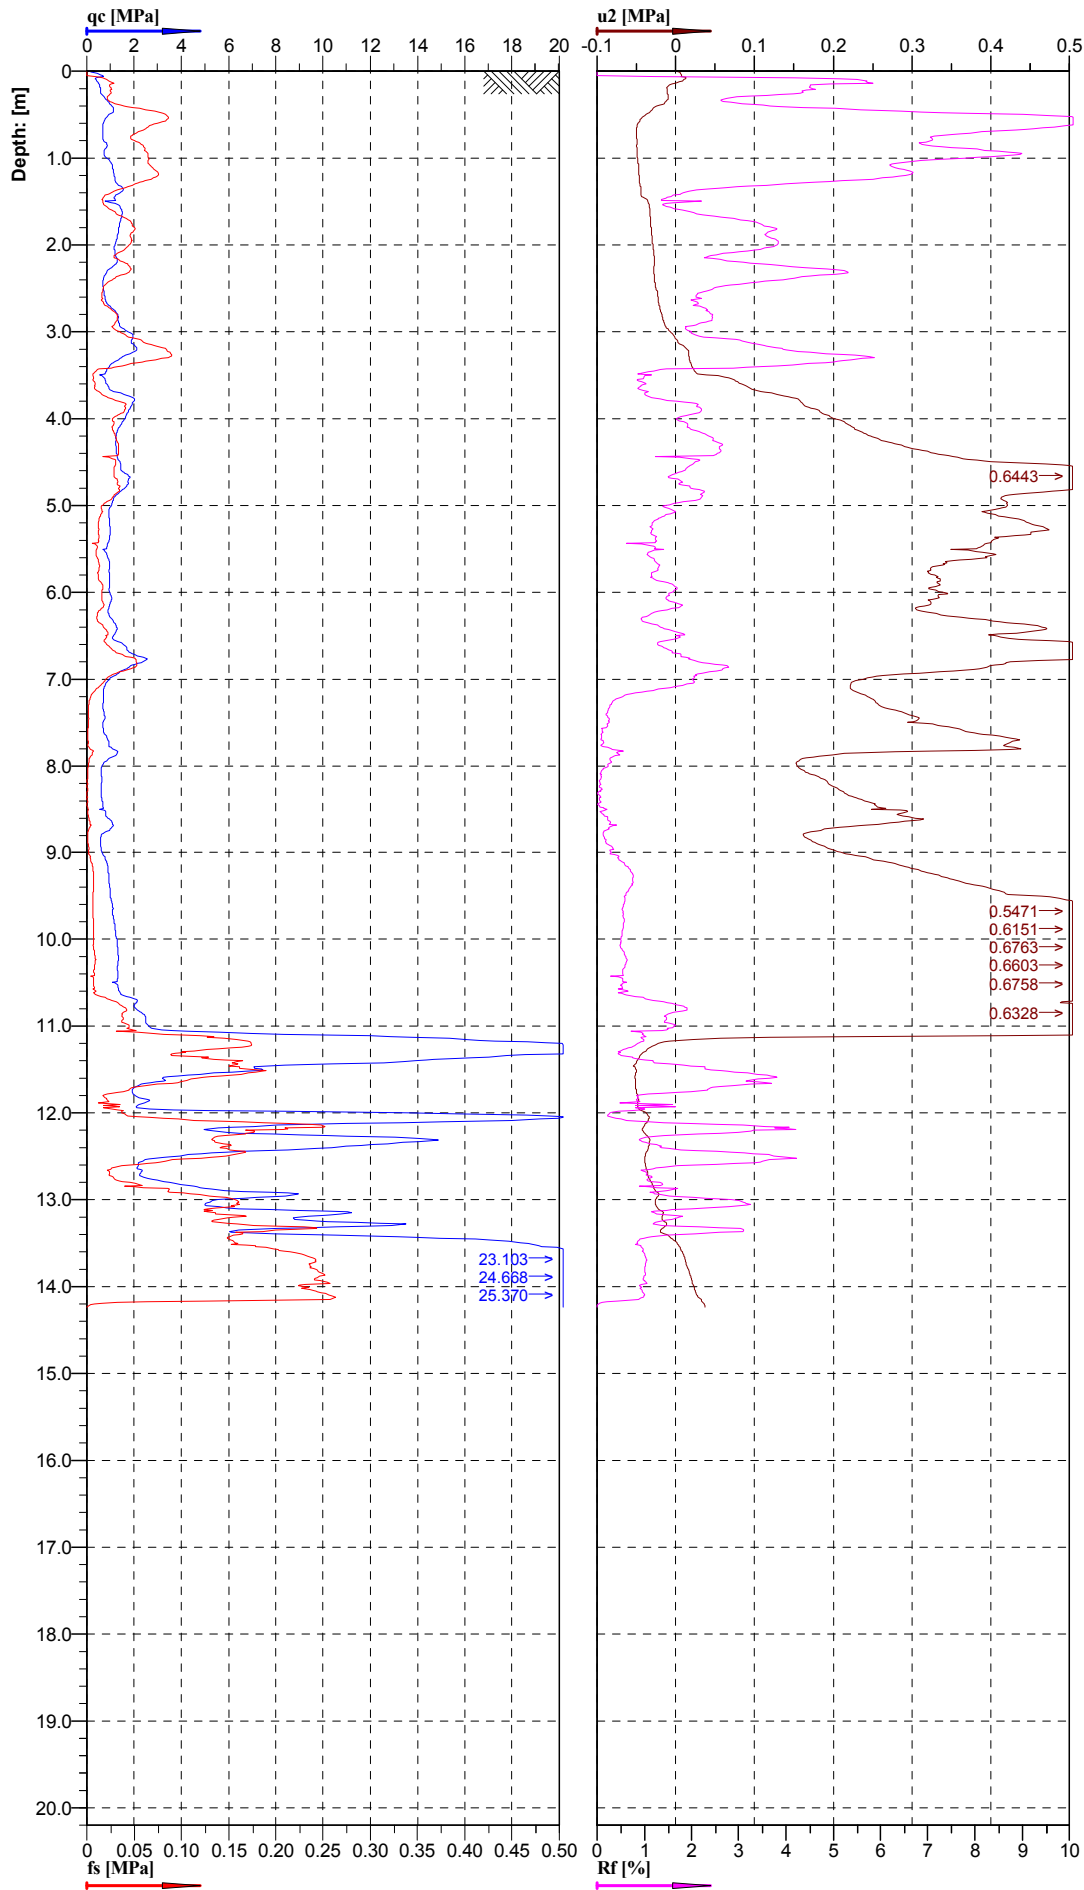
Location: Jesmond Rd Drury	Position: X: 0 m, Y: 0 m	Ground level: 0.000	Test No.: CPT02
Project ID: Beca281-401JesmondRd	Client: BECA	Date: 10/08/2018	Scale: 1 : 87
Project: Beca281-401JesmondRd		Page: 1/1	Fig.:
		File: Beca281-401JesmondRd_CPT02.GEF

Classification by Robertson 1986

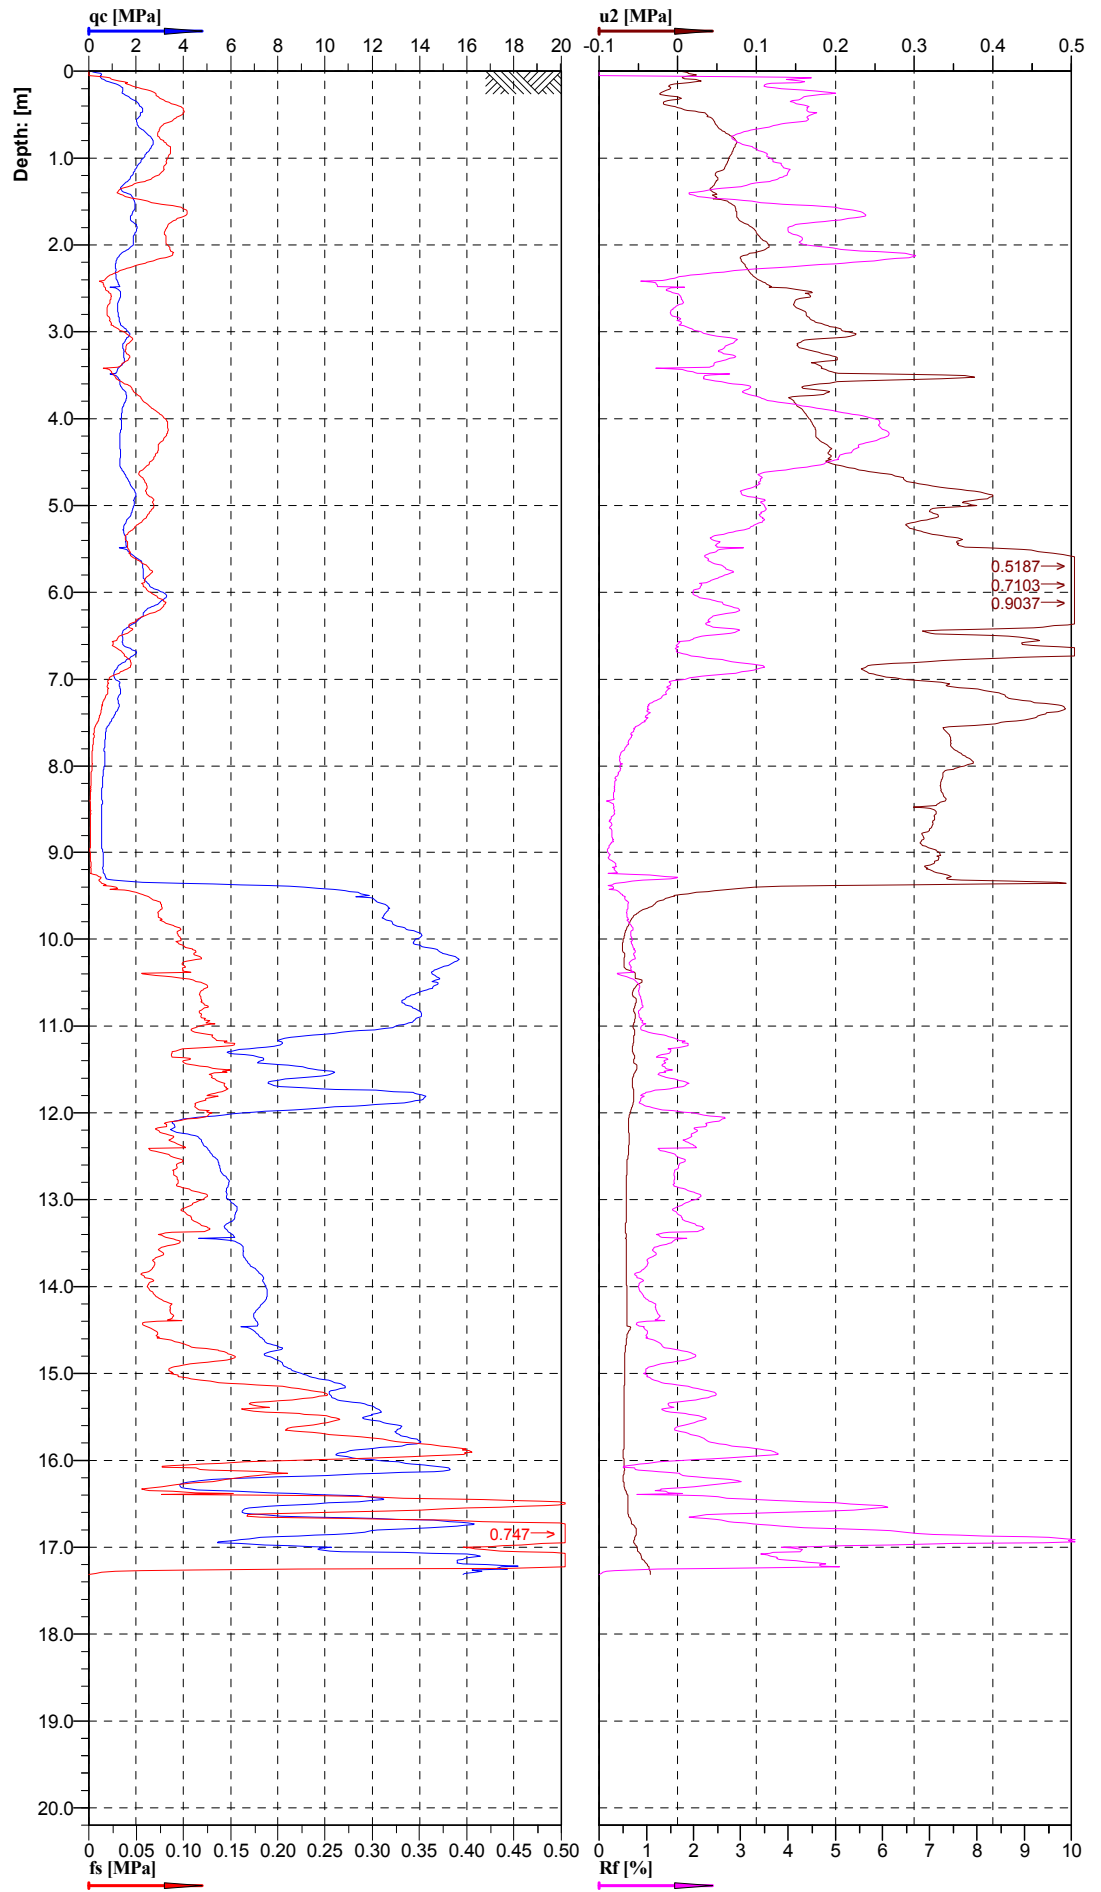
Location: Jesmond Rd Drury	Position: X: 0 m, Y: 0 m	Ground level: 0.000	Test No.: CPT03
Project ID: Beca281-401JesmondRd	Client: BECA	Date: 10/08/2018	Scale: 1 : 87
Project: Beca281-401JesmondRd		Page: 1/1	Fig.:
		File: Beca281-401JesmondRd_CPT03.GEF

**Classification by
Robertson 1986**

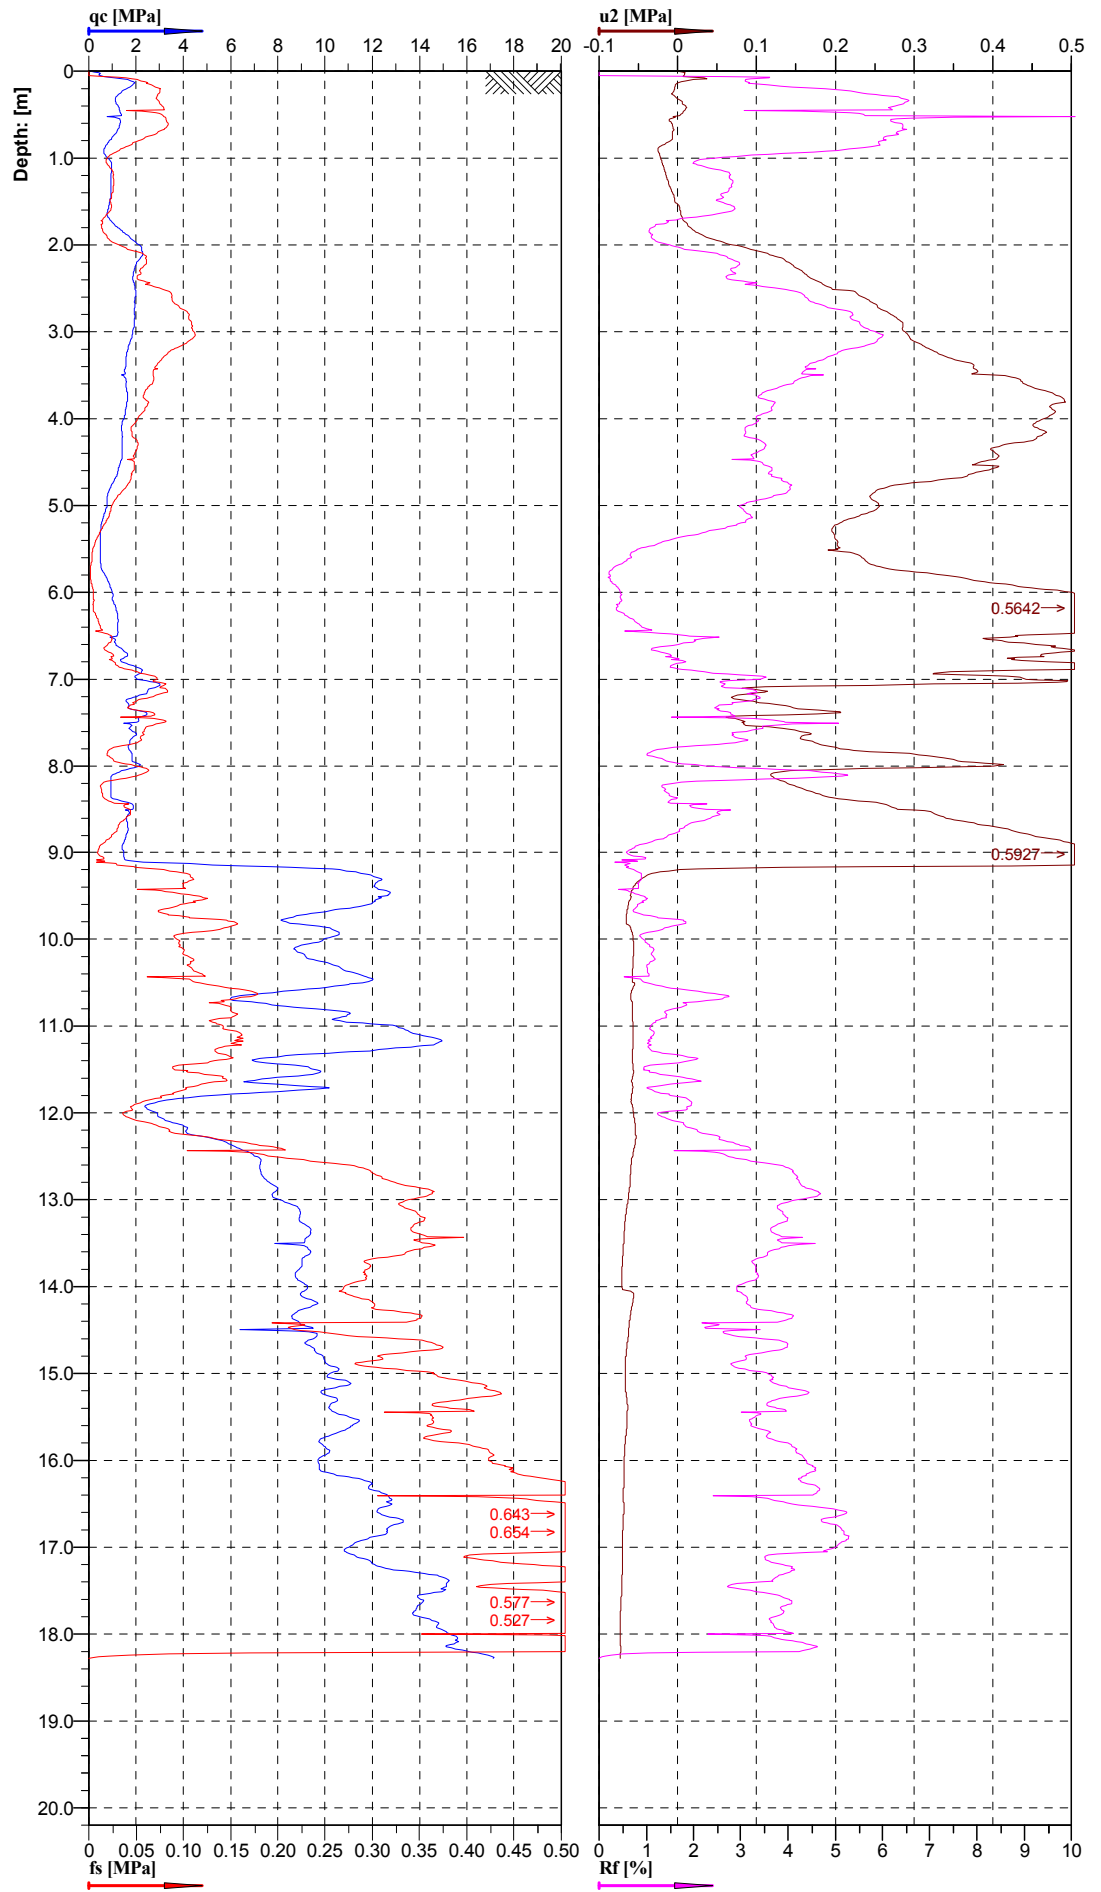
Location: Jesmond Rd Drury	Position: X: 0 m, Y: 0 m	Ground level: 0.000	Test No.: CPT04
Project ID: Beca281-401JesmondRd	Client: BECA	Date: 10/08/2018	Scale: 1 : 87
Project: Beca281-401JesmondRd		Page: 1/1	Fig.:
		File: Beca281-401JesmondRd_CPT04.GEF

Classification by Robertson 1986

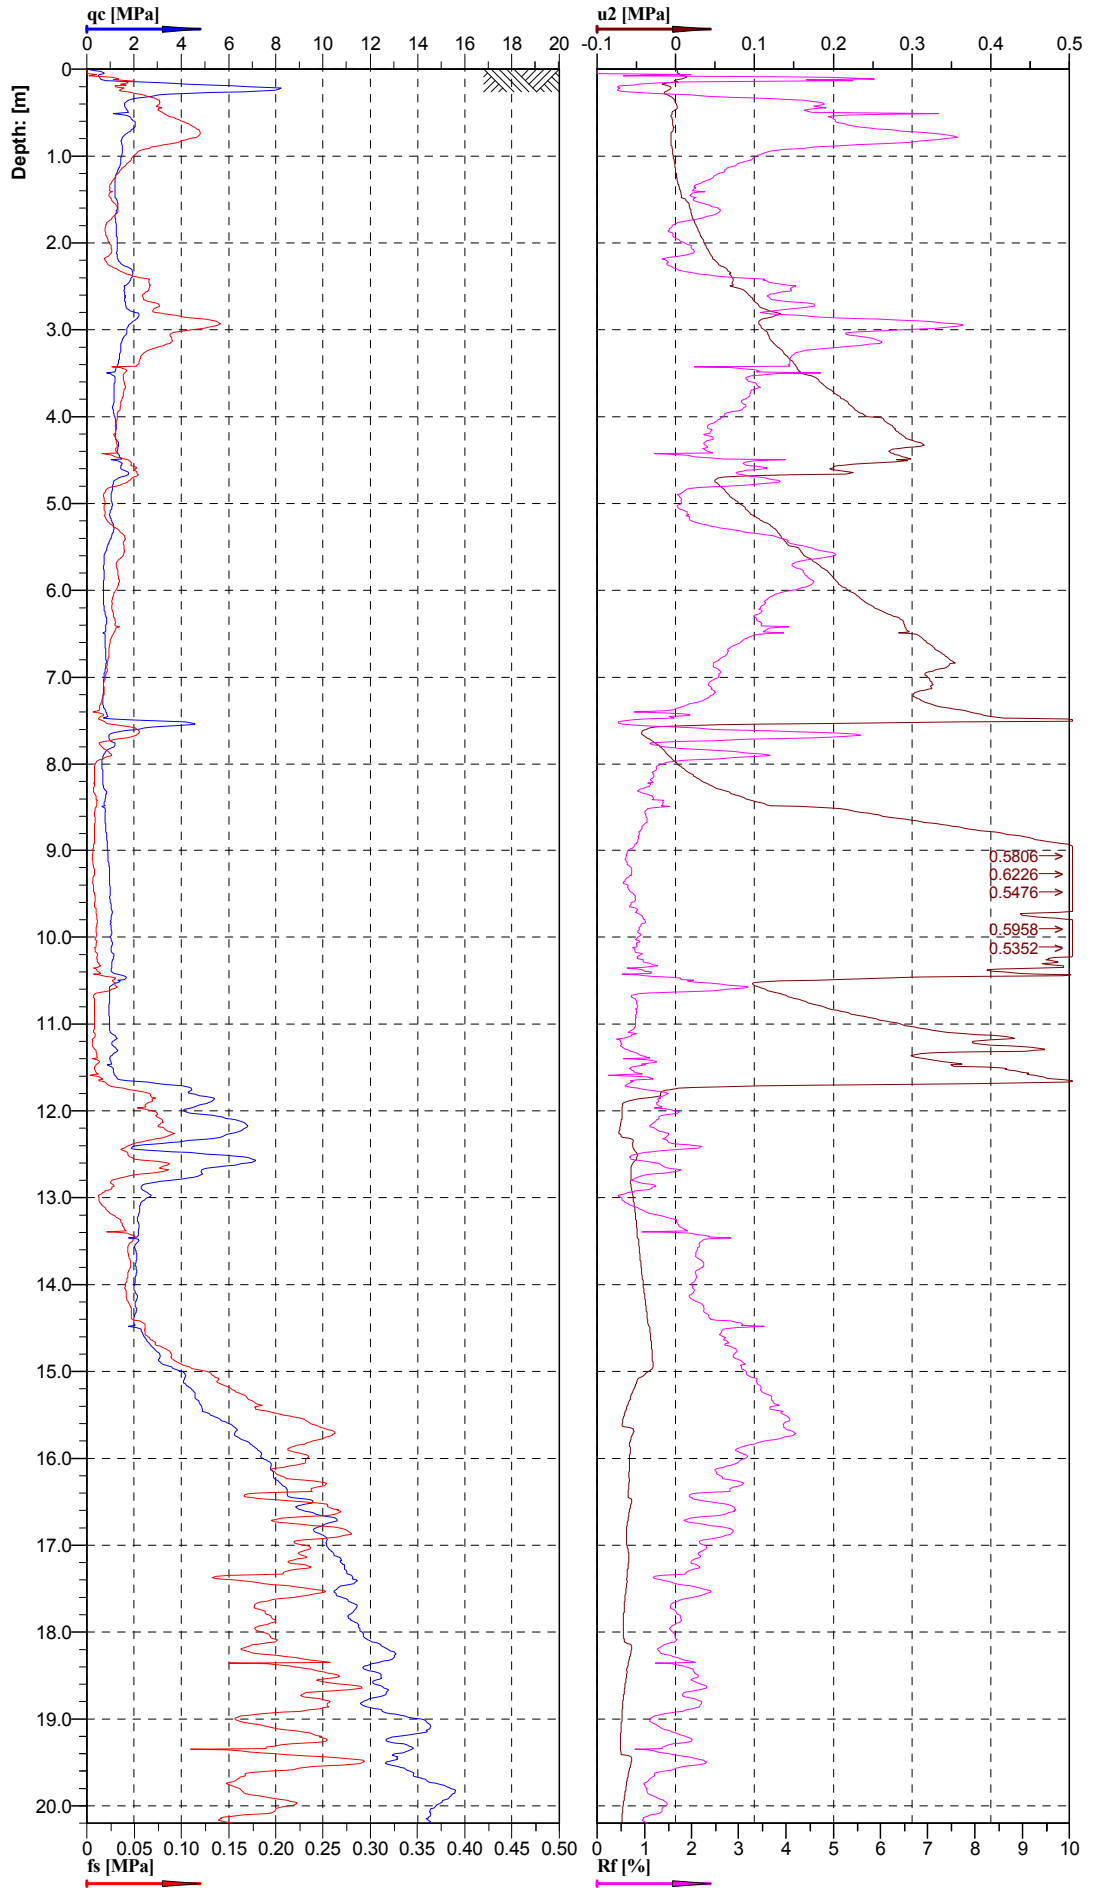
Location: Jesmond Rd Drury	Position: X: 0 m, Y: 0 m	Ground level: 0.000	Test No.: CPT05
Project ID: Beca281-401JesmondRd	Client: BECA	Date: 10/08/2018	Scale: 1 : 87
Project: Beca281-401JesmondRd		Page: 1/2	Fig.:
		File: Beca281-401JesmondRd_CPT05.GEF

**Classification by
Robertson 1986**

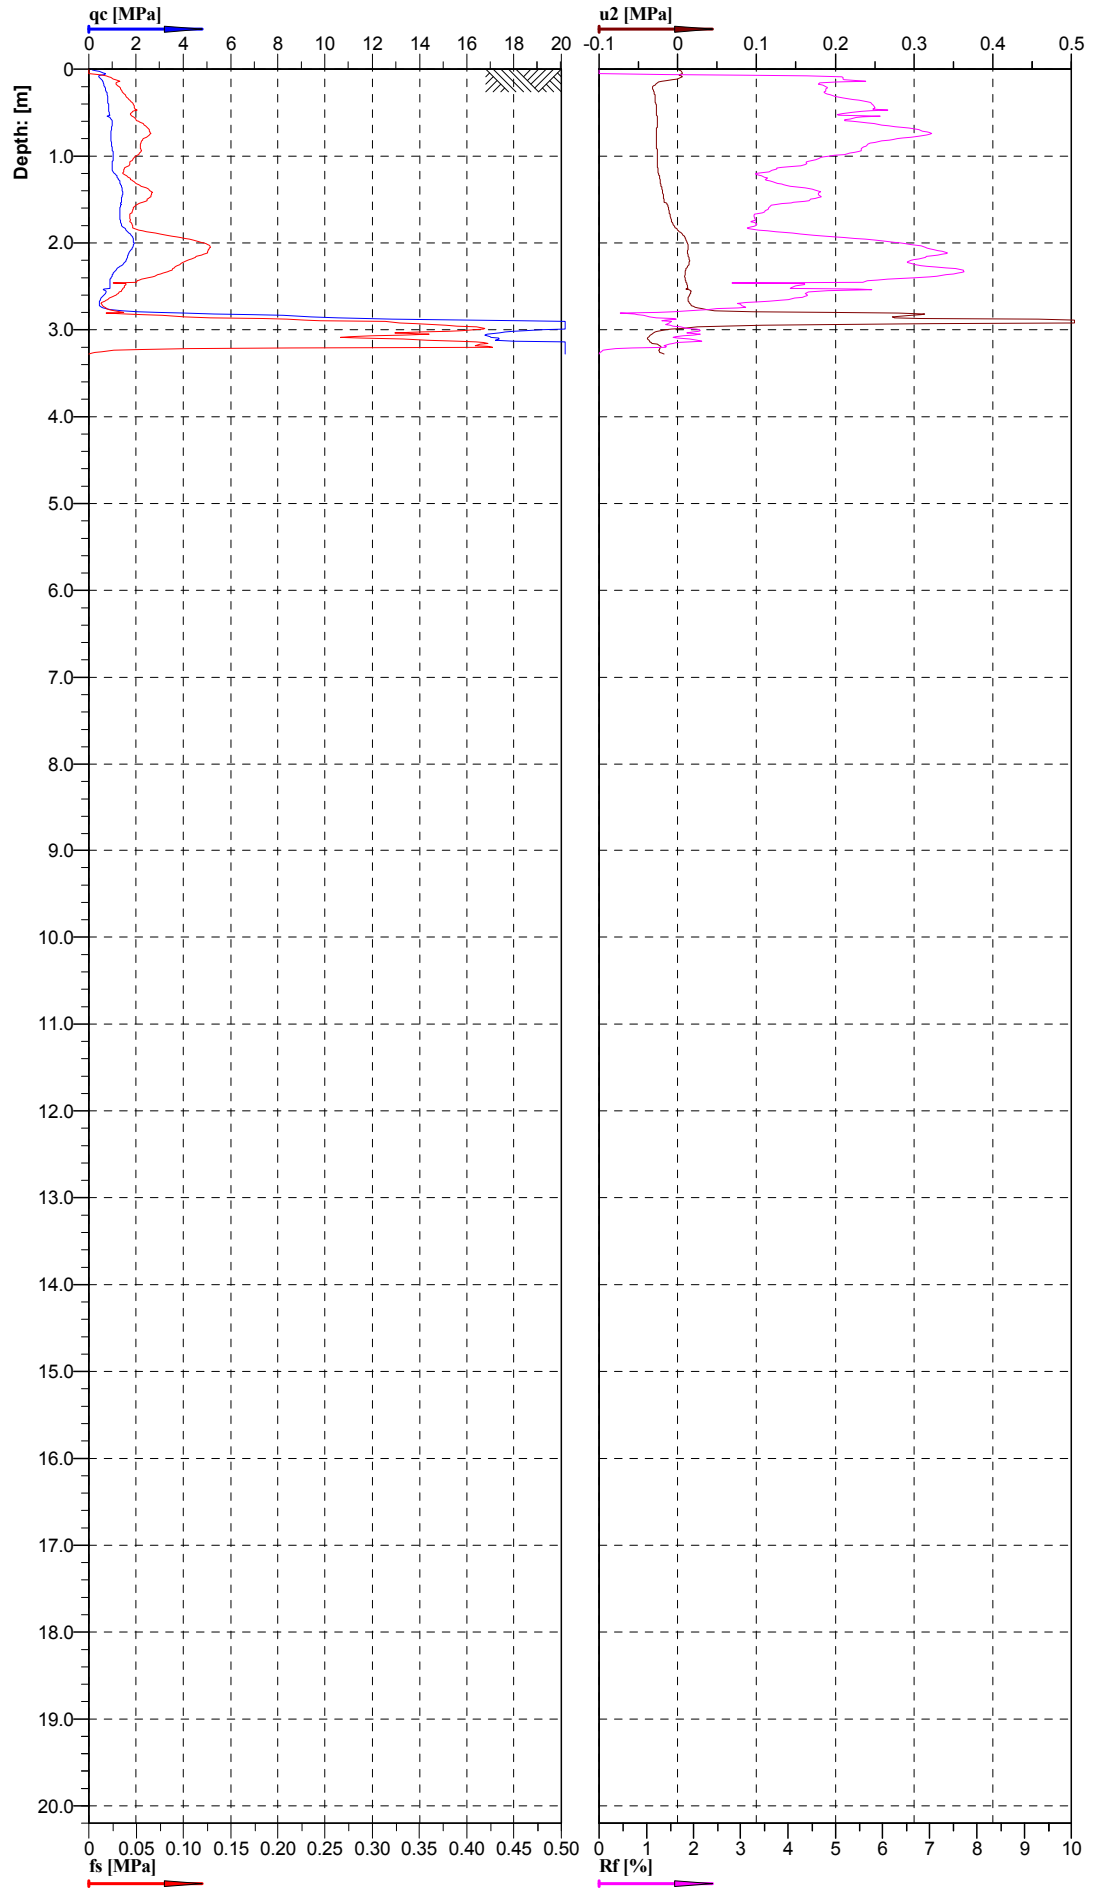
Location: Jesmond Rd Drury	Position: X: 0 m, Y: 0 m	Ground level: 0.000	Test No.: CPT06
Project ID: Beca281-401JesmondRd	Client: BECA	Date: 10/08/2018	Scale: 1 : 87
Project: Beca281-401JesmondRd		Page: 1/1	Fig.:
		File: Beca281-401JesmondRd_CPT06.GEF

Classification by Robertson 1986

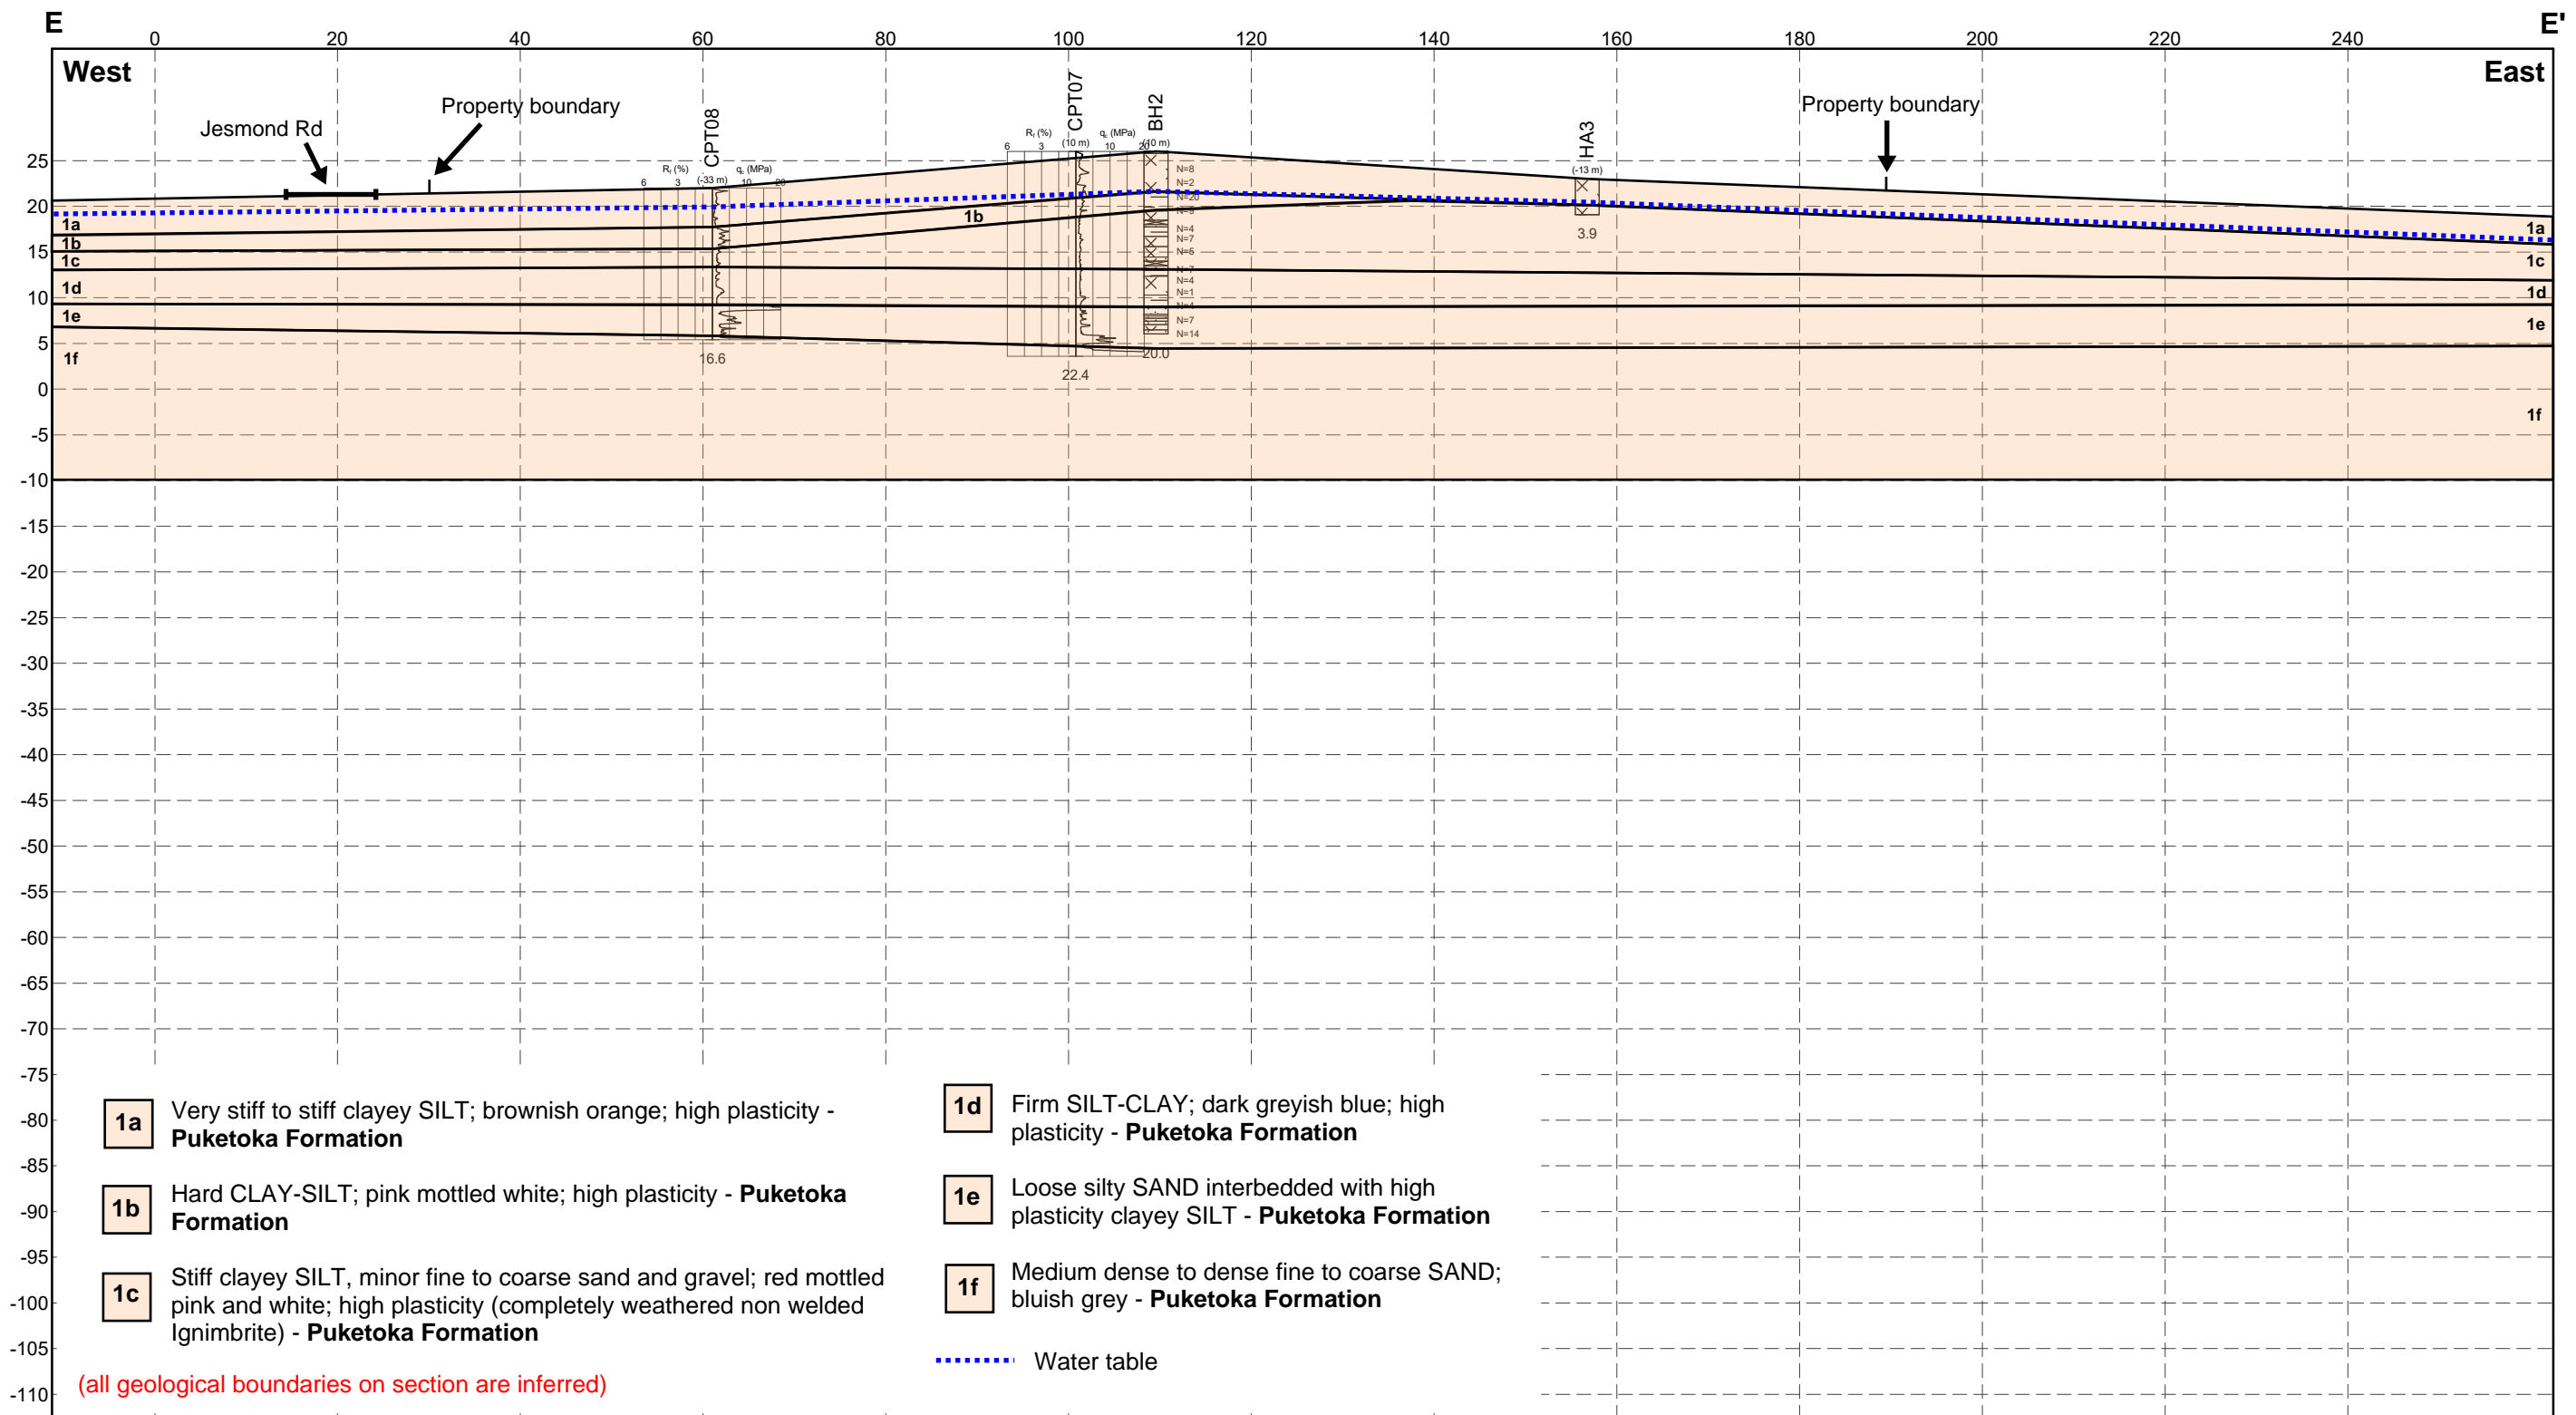
- 1a** Very stiff to stiff clayey SILT; brownish orange; high plasticity - **Puketoka Formation**
 - 1b** Hard CLAY-SILT; pink mottled white; high plasticity - **Puketoka Formation**
 - 1c** Stiff clayey SILT, minor fine to coarse sand and gravel; red mottled pink and white; high plasticity (completely weathered non welded Ignimbrite) - **Puketoka Formation**
 - 1d** Firm SILT-CLAY; dark greyish blue; high plasticity - **Puketoka Formation**
 - 1e** Loose silty SAND interbedded with high plasticity clayey SILT - **Puketoka Formation**
 - 1f** Medium dense to dense fine to coarse SAND; bluish grey - **Puketoka Formation**
- Water table
- (all geological boundaries on section are inferred)

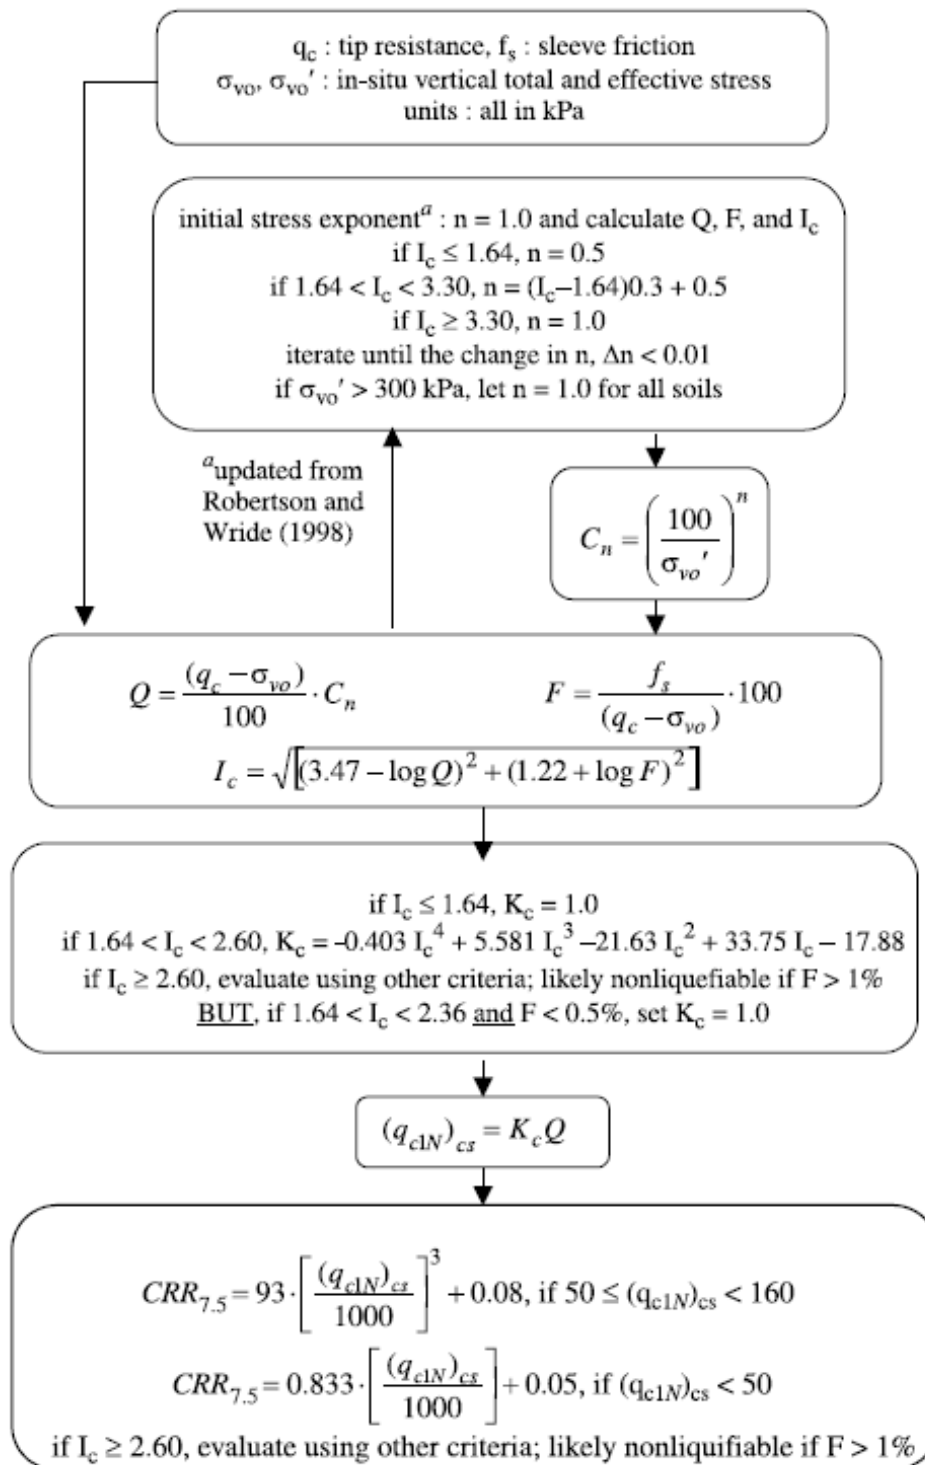
Calculation of soil resistance against liquefaction is performed according to the Robertson & Wride (1998) procedure. The procedure used in the software, slightly differs from the one originally published in NCEER-97-0022 (Proceedings of the NCEER Workshop on Evaluation of Liquefaction Resistance of Soils). The revised procedure is presented below in the form of a flowchart¹:

Procedure for the evaluation of soil liquefaction resistance (all soils), Robertson (2010)

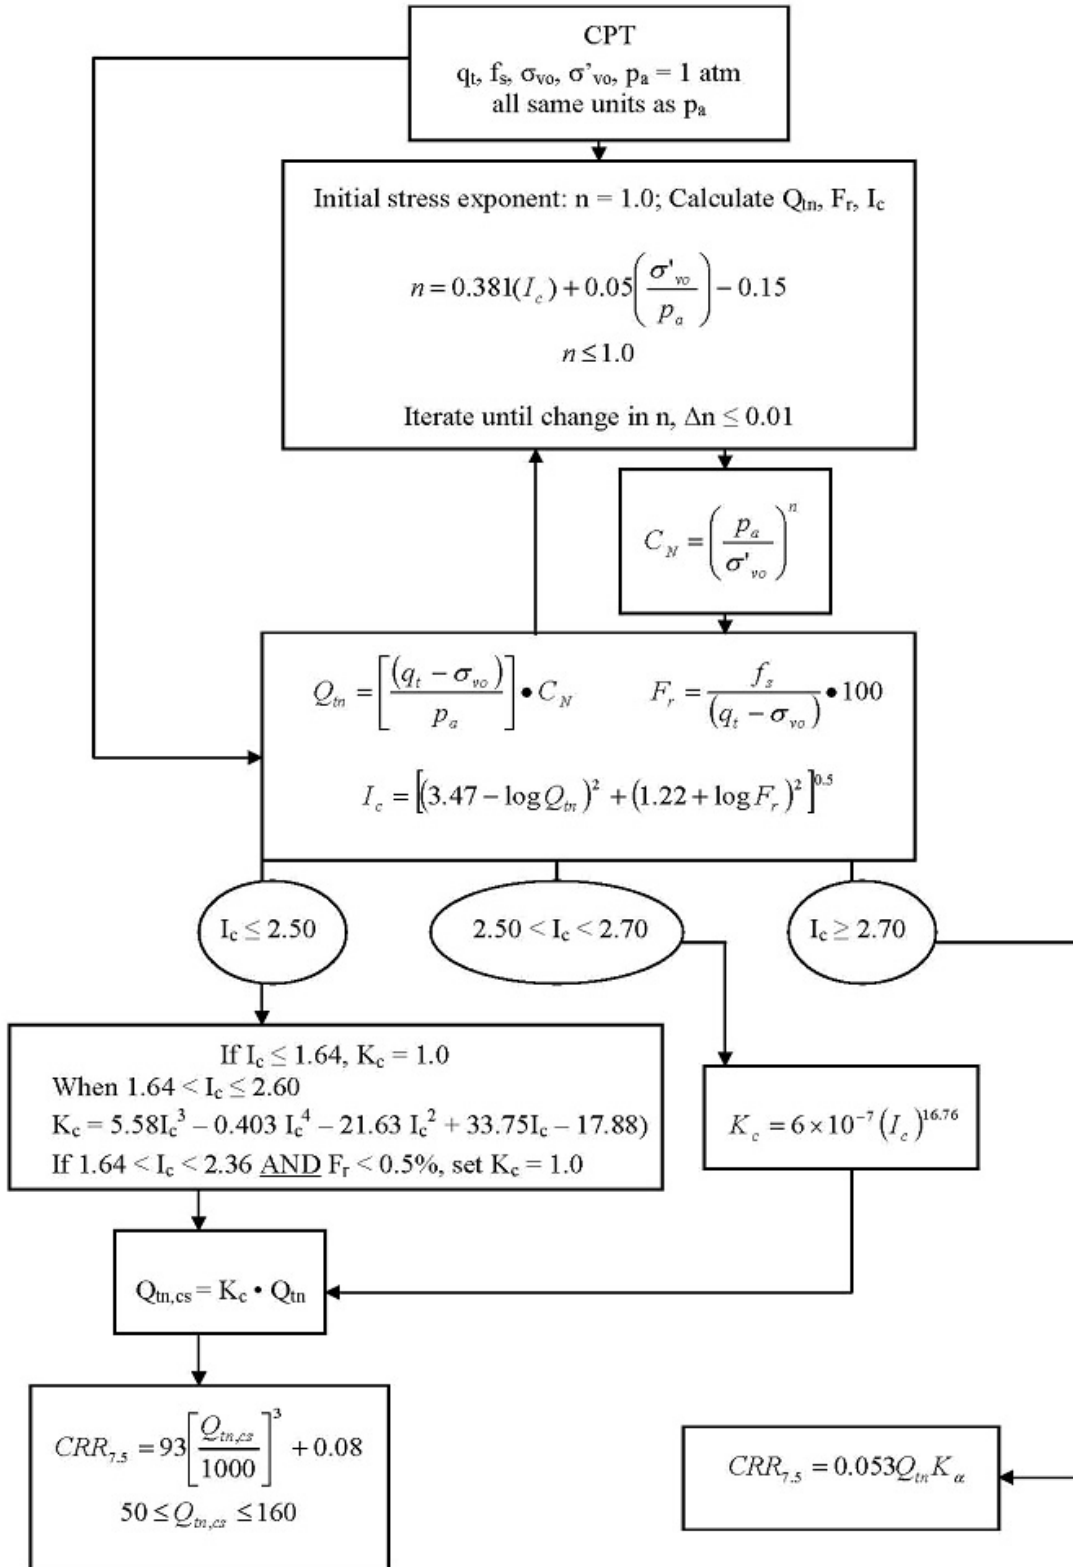
Calculation of soil resistance against liquefaction is performed according to the Robertson & Wride (1998) procedure. This procedure used in the software, slightly differs from the one originally published in NCEER-97-0022 (Proceedings of the NCEER Workshop on Evaluation of Liquefaction Resistance of Soils). The revised procedure is presented below in the form of a flowchart¹:

Procedure for the evaluation of soil liquefaction resistance, Idriss & Boulanger (2008)

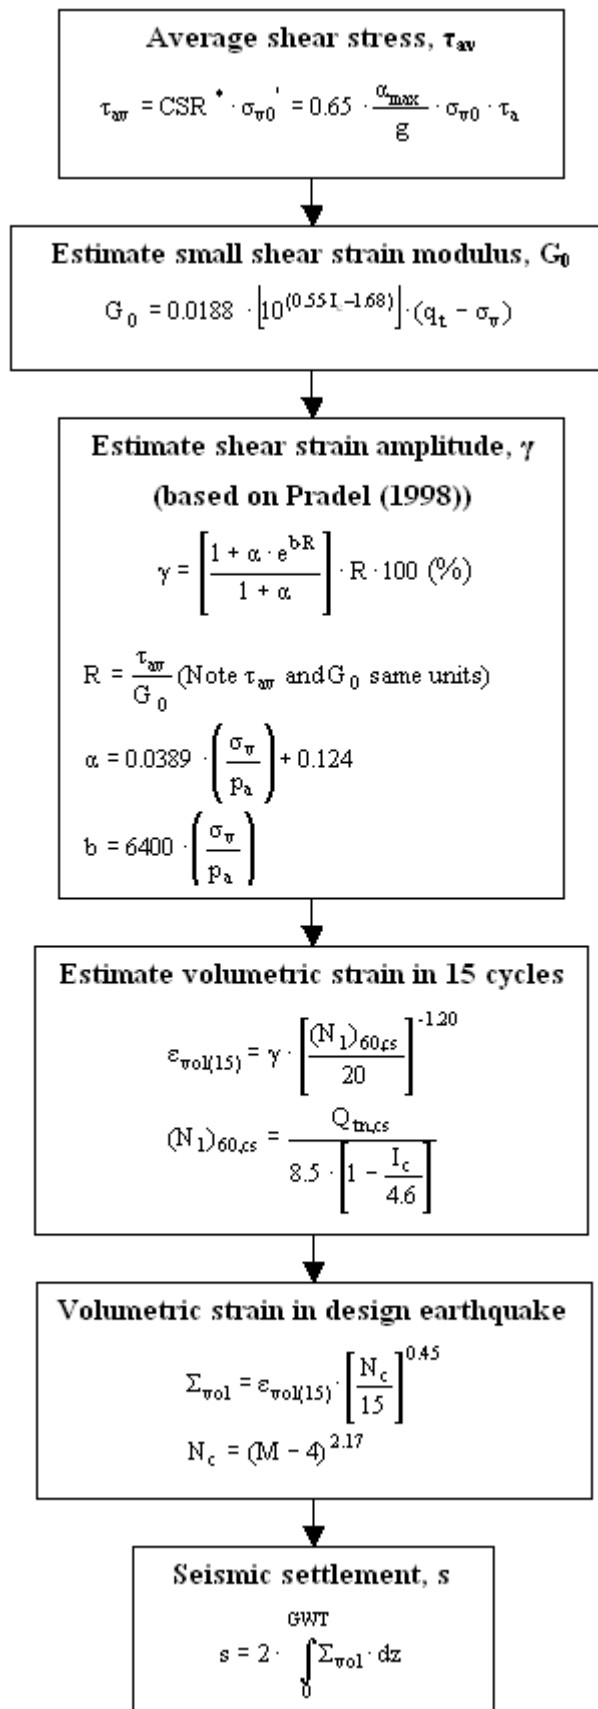
Procedure for the estimation of seismic induced settlements in dry sands

Robertson, P.K. and Lisheng, S., 2010, "Estimation of seismic compression in dry soils using the CPT" FIFTH INTERNATIONAL CONFERENCE ON RECENT ADVANCES IN GEOTECHNICAL EARTHQUAKE ENGINEERING AND SOIL DYNAMICS, Symposium in honor of professor I. M. Idriss, San Diego, CA
