**ASSESSMENT OF ECOLOGICAL EFFECTS
FOR A PLAN CHANGE APPLICATION AT
57 AND 57A SCHNAPPER ROCK ROAD,
SCHNAPPER ROCK**

Contract Report No. 5676

February 2021

KBS Design Group Ltd,
PO Box 127
Albany Village, Auckland 0755

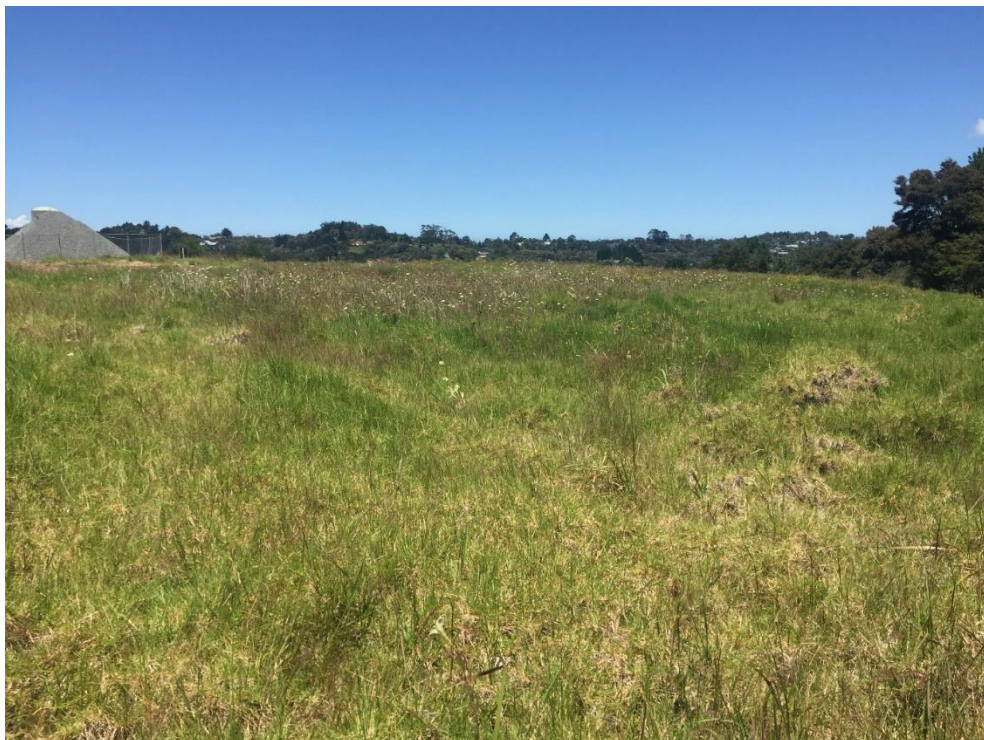
Plate 1: Exotic grassland (Vegetation Type 1). 15 December 2020.

Most of the property is characterised by rank exotic grassland (Plate 1). The grassland is dominated by kikuyu (*Cenchrus clandestinus*) and other pasture grasses including Yorkshire fog (*Holcus lanatus*) and sweet vernal (*Anthoxanthum odoratum*). Herbs including selfheal (*Prunella vulgaris*), red clover (*Trifolium pratense*), broad-leaved dock (*Rumex obtusifolius*), and broad-leaved plantain (*Plantago major*) are scattered throughout, and montbretia (*Crocasmia ×crocosmiiflora*) and gladioli (*Gladiolus* sp.) are locally common close to Schnapper Rock Road.

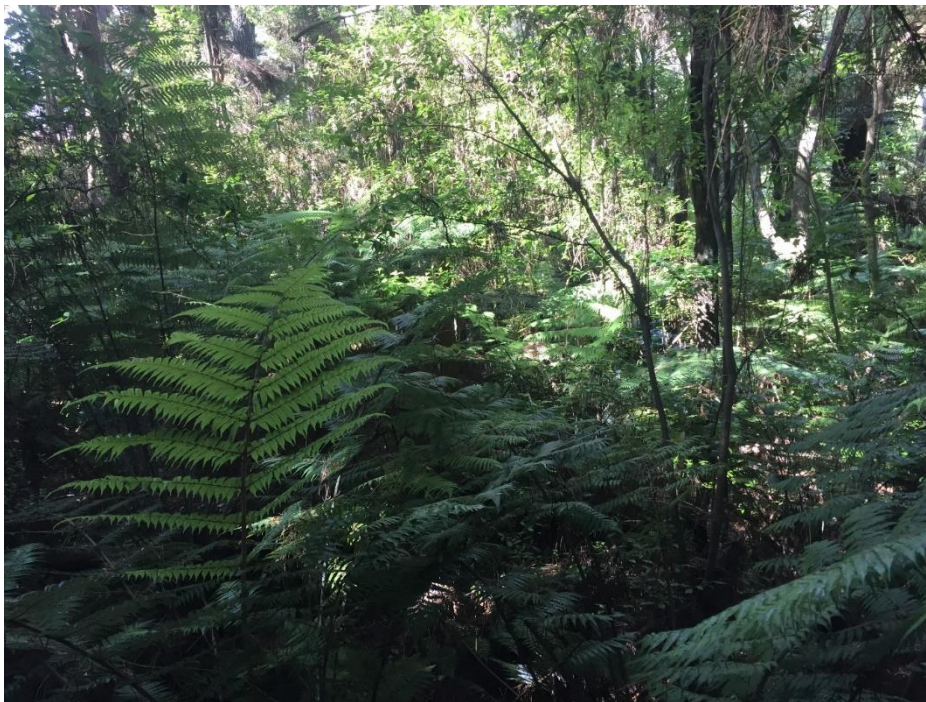
Plate 2: Understorey vegetation within the kānuka forest (Vegetation Type 2). 15 December 2020.

The SEA vegetation on the western boundary of the site comprises kānuka forest with emergent maritime and radiata pines (*Pinus pinaster* and *P. radiata* respectively). The kānuka canopy is approximately 8-10 metres tall and the pines are over 20 metres tall. The kānuka forest is bordered by gorse (*Ulex europaeus*)-blackberry (*Rubus fruticosus* agg.)-kikuyu shrubland (Section 4.2.3). The 2-4 metre tall understory contains a diverse range of indigenous species including māpou (*Myrsine australis*), māhoe (*Meliccytus ramiflorus*), karamū (*Coprosma robusta*), hangehange (*Geniostoma ligustrifolium*), and ponga (*Cyathea dealbata*) (Plate 2). Mamaku (*Cyathea medullaris*) is common along the watercourse channel and some tōtara were observed. Dense infestations of kahili ginger (*Hedychium gardnerianum*) and montbretia are locally common. Pine needles form the main groundcover through much of this vegetation type and seedlings of tōtara, climbing asparagus (*Asparagus scandens*), and Chinese privet (*Ligustrum sinense*) were observed.

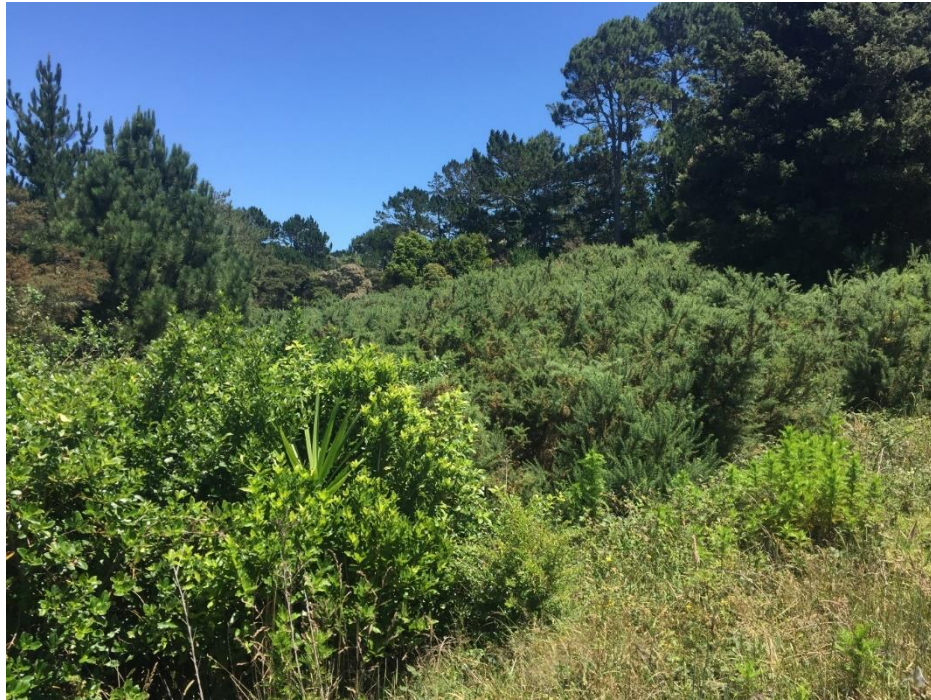
Plate 3: Gorse-blackberry-kikuyu shrubland (Vegetation Type 3).
15 December 2020.

Much of the steeper terrain to the east of the property has been colonised by gorse and blackberry, with rank kikuyu present throughout (Plate 3). Single or small groups of woolly nightshade (*Solanum mauritianum*), pines, kānuka, karamū, and tī kōuka (cabbage tree; *Cordyline australis*) are also present.

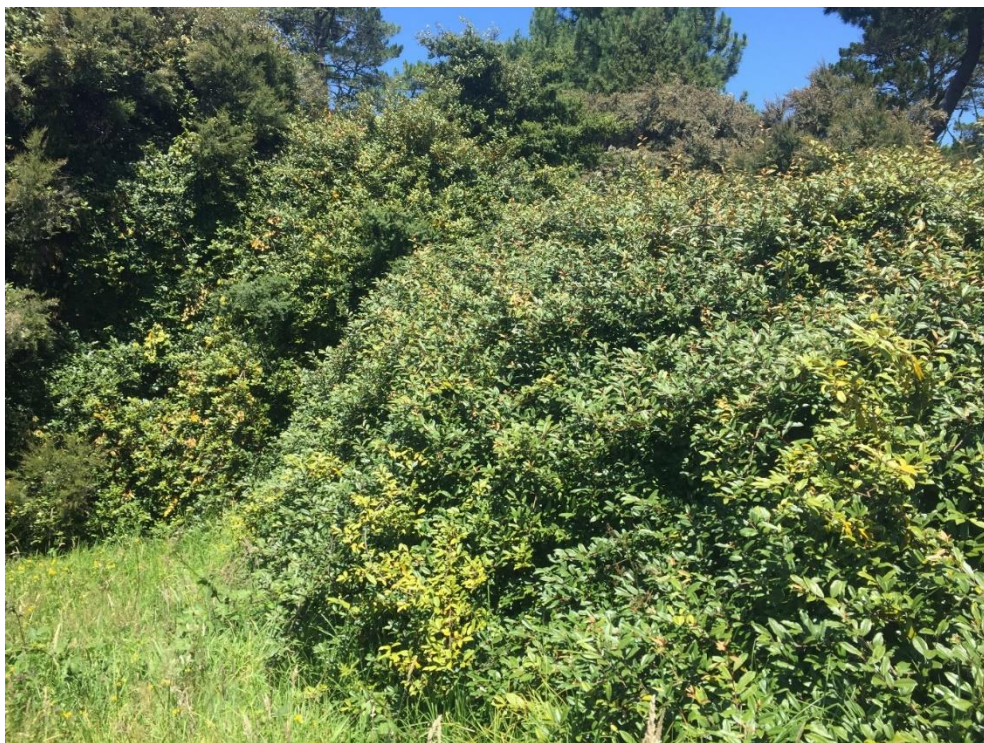
Plate 4: *Elaeagnus* infestation (Vegetation Type 4). 15 December 2020.

A large infestation of *elaegnus* (*Elaeagnus ×reflexa*) is present on the western edge of the SEA vegetation (Plate 4). *Elaeagnus* was also recorded growing in the understory on the edge of Vegetation Type 2.

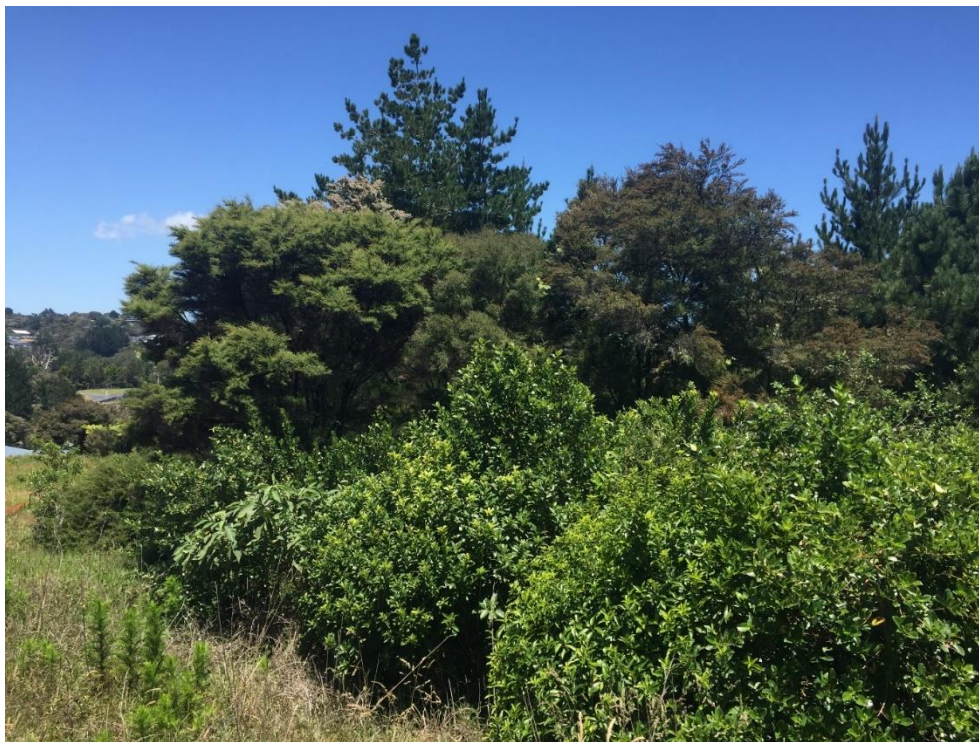
Plate 5: Kānuka-karamū-māhoe scrub (Vegetation Type 5).
15 December 2020.

Two small discrete patches of kānuka-karamū-māhoe scrub are present on the edge of the pasture (Plate 5). Woolly nightshade and gorse are also present within this vegetation type.

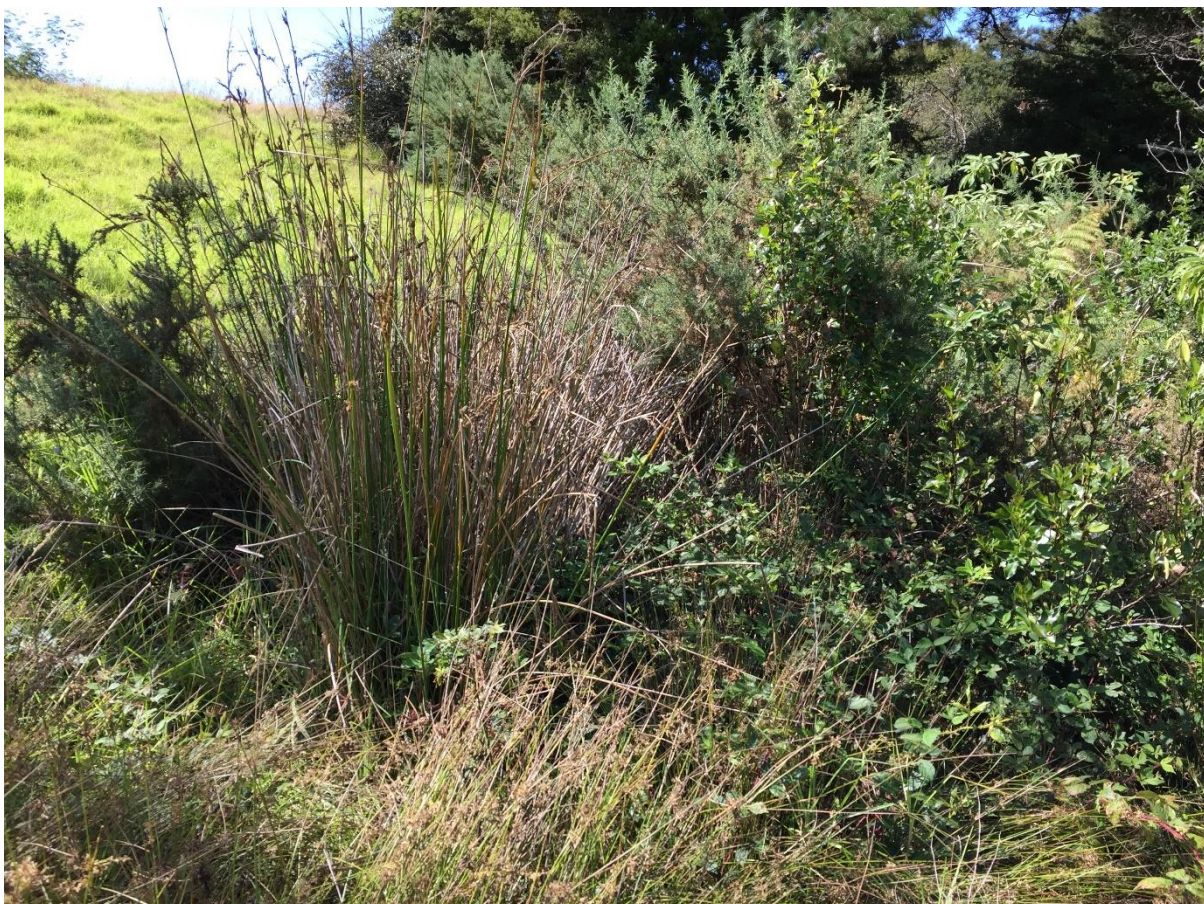
Plate 6. Vegetation at the head of Watercourse A. 18 February 2021.

The intermittent reach of Watercourse A originates outside the SEA (Figure 1) and then flows through the SEA in a roughly southerly direction. The uppermost point of the stream is well shaded with scrubby vegetation including karamū, māhoe, gorse, and blackberry (Plate 6). Arum lily, wild ginger, and a single ponga were observed further downstream.

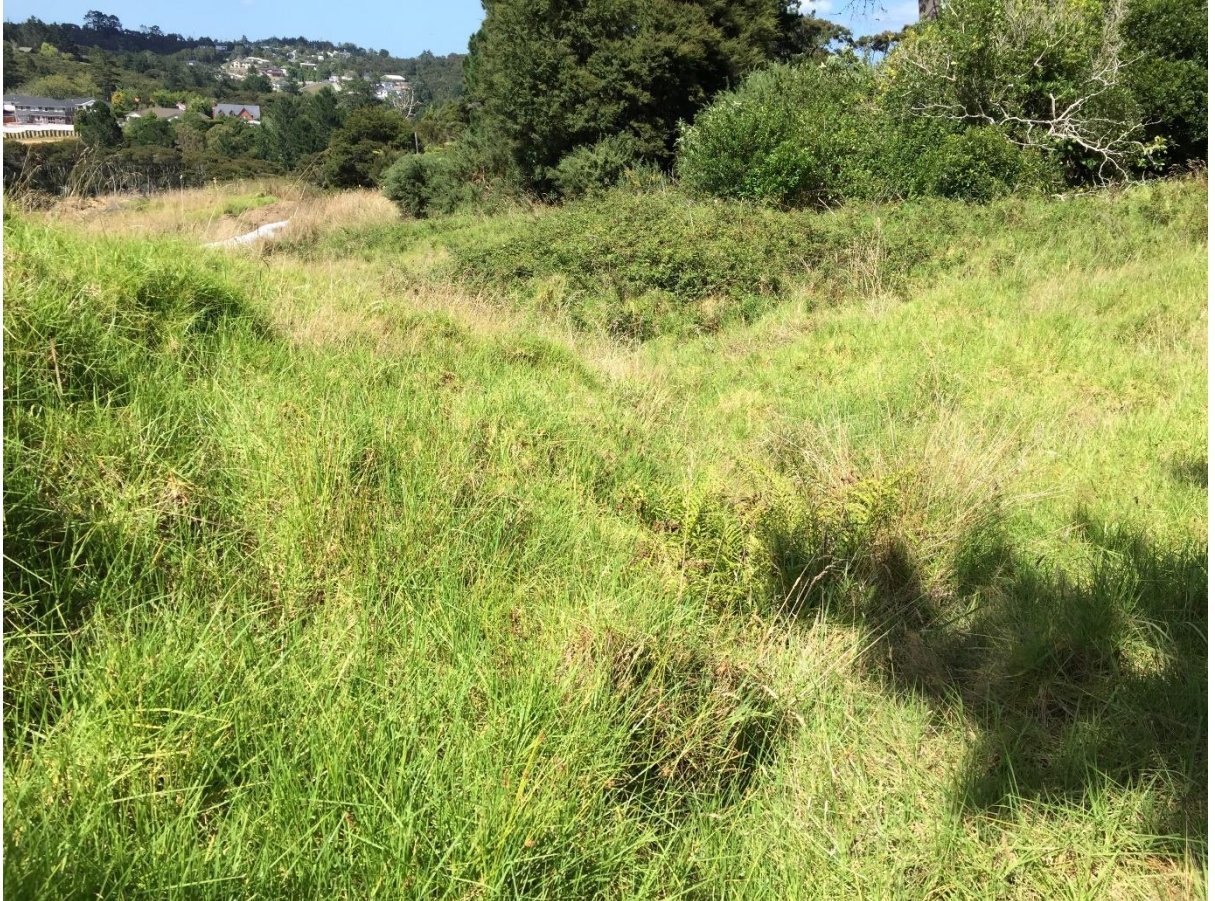
Plate 7. View of Watercourse B looking downstream towards the adjoining property.
The channel is entirely overgrown with kikuyu and other pasture grasses.
18 February 2021.

Watercourse B flows through flows through gorse-blackberry-kikuyu shrubland in the southeastern corner of the site (Figure 1). The watercourse was classified as “intermittent” by Freshwater Solutions Ltd (2020); however, the watercourse appears more ephemeral in character and a second assessment is recommended in winter 2021.

On 18 February 2021, a small muddy depression was observed at the uppermost point of the channel identified as intermittent by Freshwater Solutions (2020). The remainder of the channel was dry and rooted kikuyu and other grasses were growing in the channel along its entire length (Plate 7). This assessment took place after around 40 millimetres of rain was recorded on 15 and 16 February 2021. Watercourse B has been reclaimed on the adjoining property and there is likely to be no connectivity to larger watercourses downstream of 57 and 57A Schnapper Rock Road.

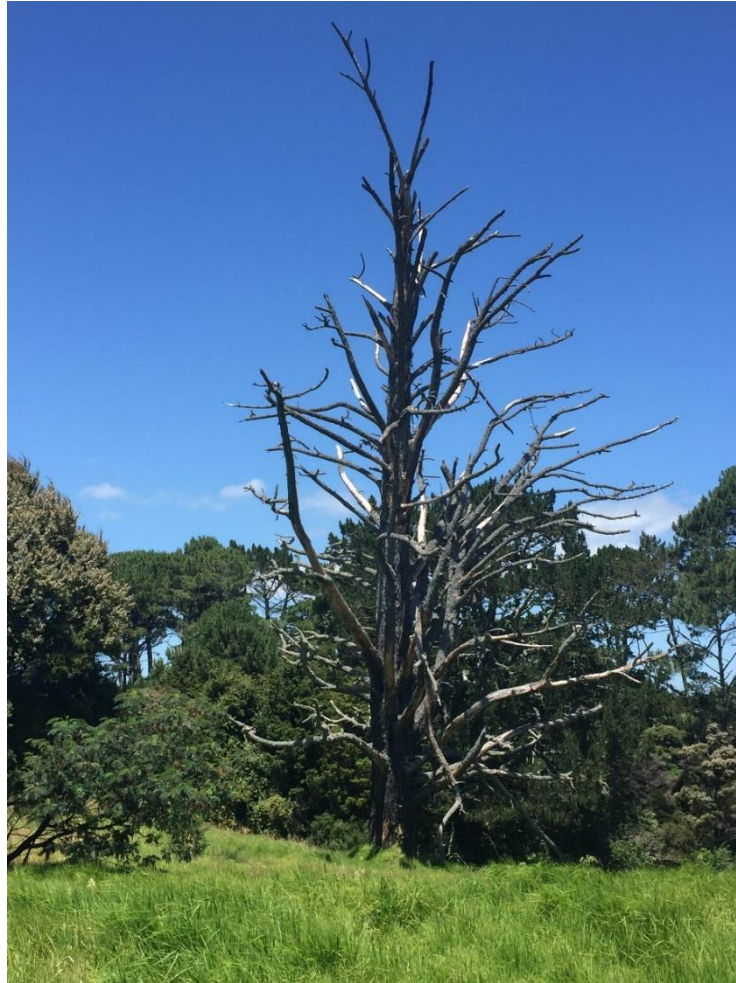
Plate 8: Dead pine tree providing potential roosting habitat for long-tailed bats. 15 December 2020.

The Department of Conservation bat distribution database (July 2020 version) holds records of long-tailed bats at Riverhead Forest approximately nine kilometres east of the site. The home range span of long-tailed bats is up to 19 kilometres (O’Donnell 2001) and the site is therefore within the home range of known populations. A large dead pine tree close to the western corner of the property (Figure 1, Plate 8) provides suitable roosting habitat for long-tailed bats, and it is possible that bats also forage at the site. However, surveys undertaken within one kilometre of the site have failed to detect long-tailed bats and it is considered unlikely that bats use habitats at the property.

Suitable foraging and roosting habitat for long-tailed bats exists at the property, but their presence is considered unlikely. A bat survey using acoustic bat monitors should be undertaken by a suitably-certified ecologist prior to any vegetation clearance. If bats are detected, a Bat Management Plan should be prepared and implemented prior to and during vegetation clearance.

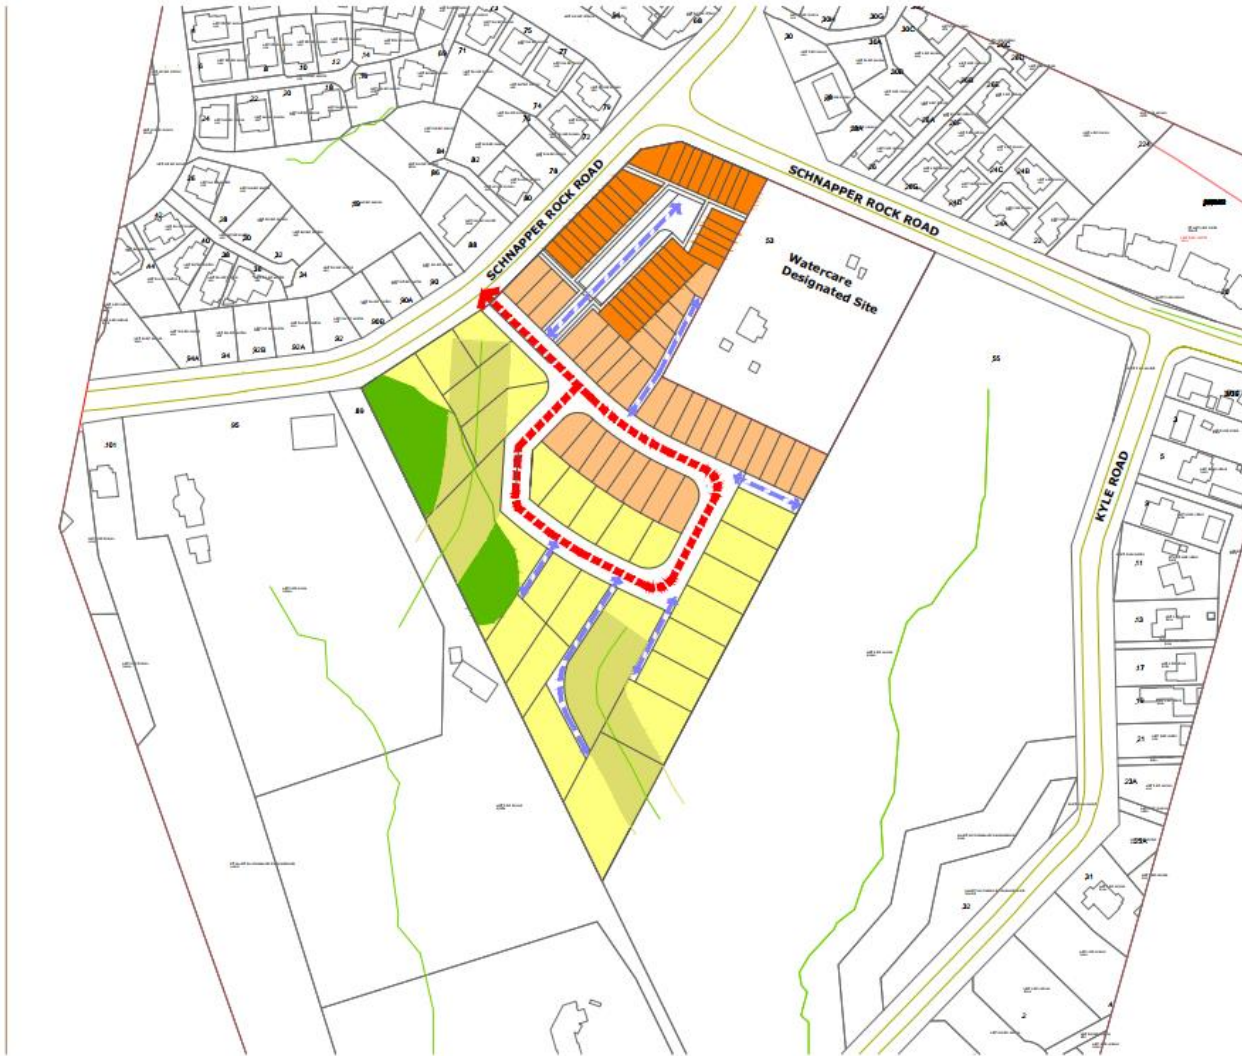
CONCEPT MASTER PLAN
21 DECEMBER 2020

CONCEPT MASTER PLAN

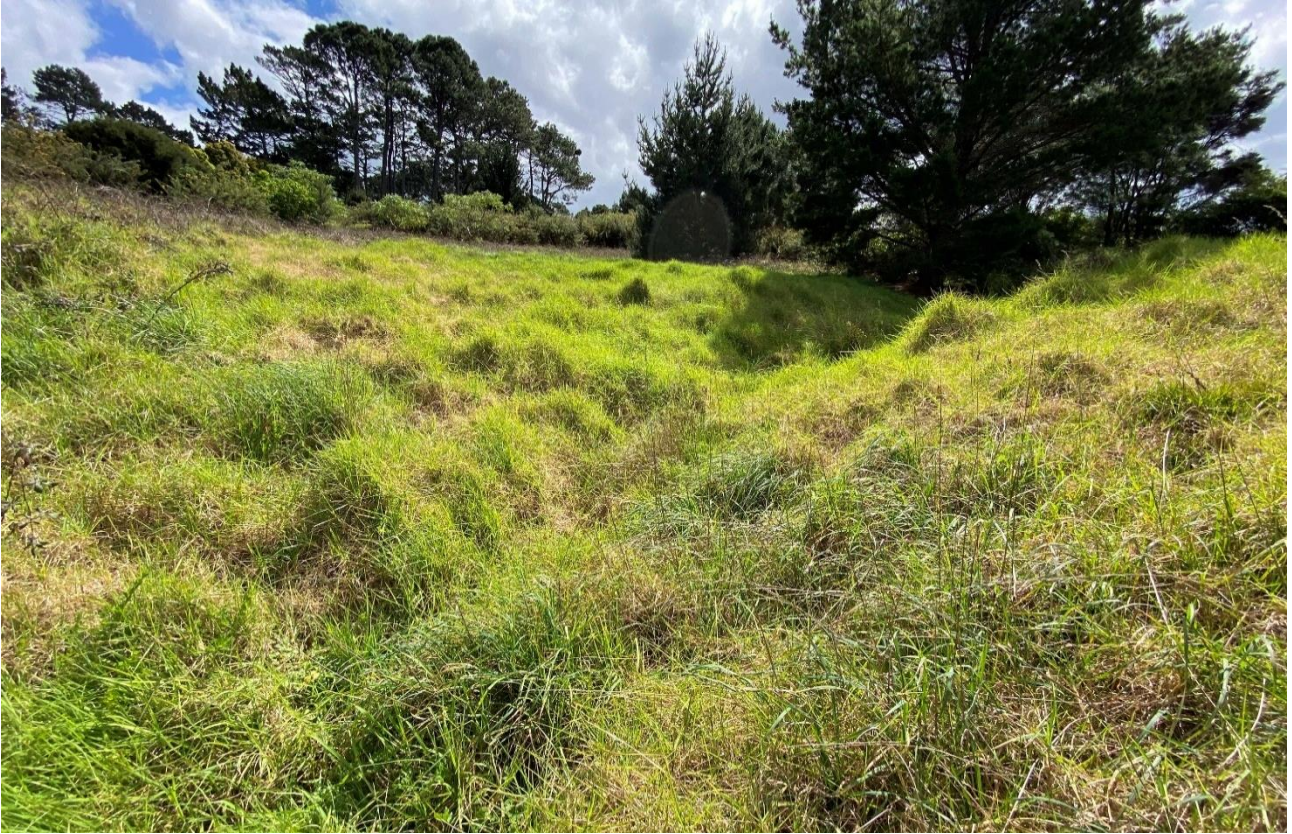
Figure 3: View of upper reach of Watercourse B.

Although the watercourse had no water present at the time of survey, Watercourse B was classed as 'intermittent' as it met three of the six criteria in the AUP for defining intermittent streams (minimum required = 3 criteria):

- It has a well-defined channel, such that the bed and banks can be distinguished.
- Rooted terrestrial vegetation is not established in the channel.
- There is evidence of substrate sorting processes, including scour and deposition.

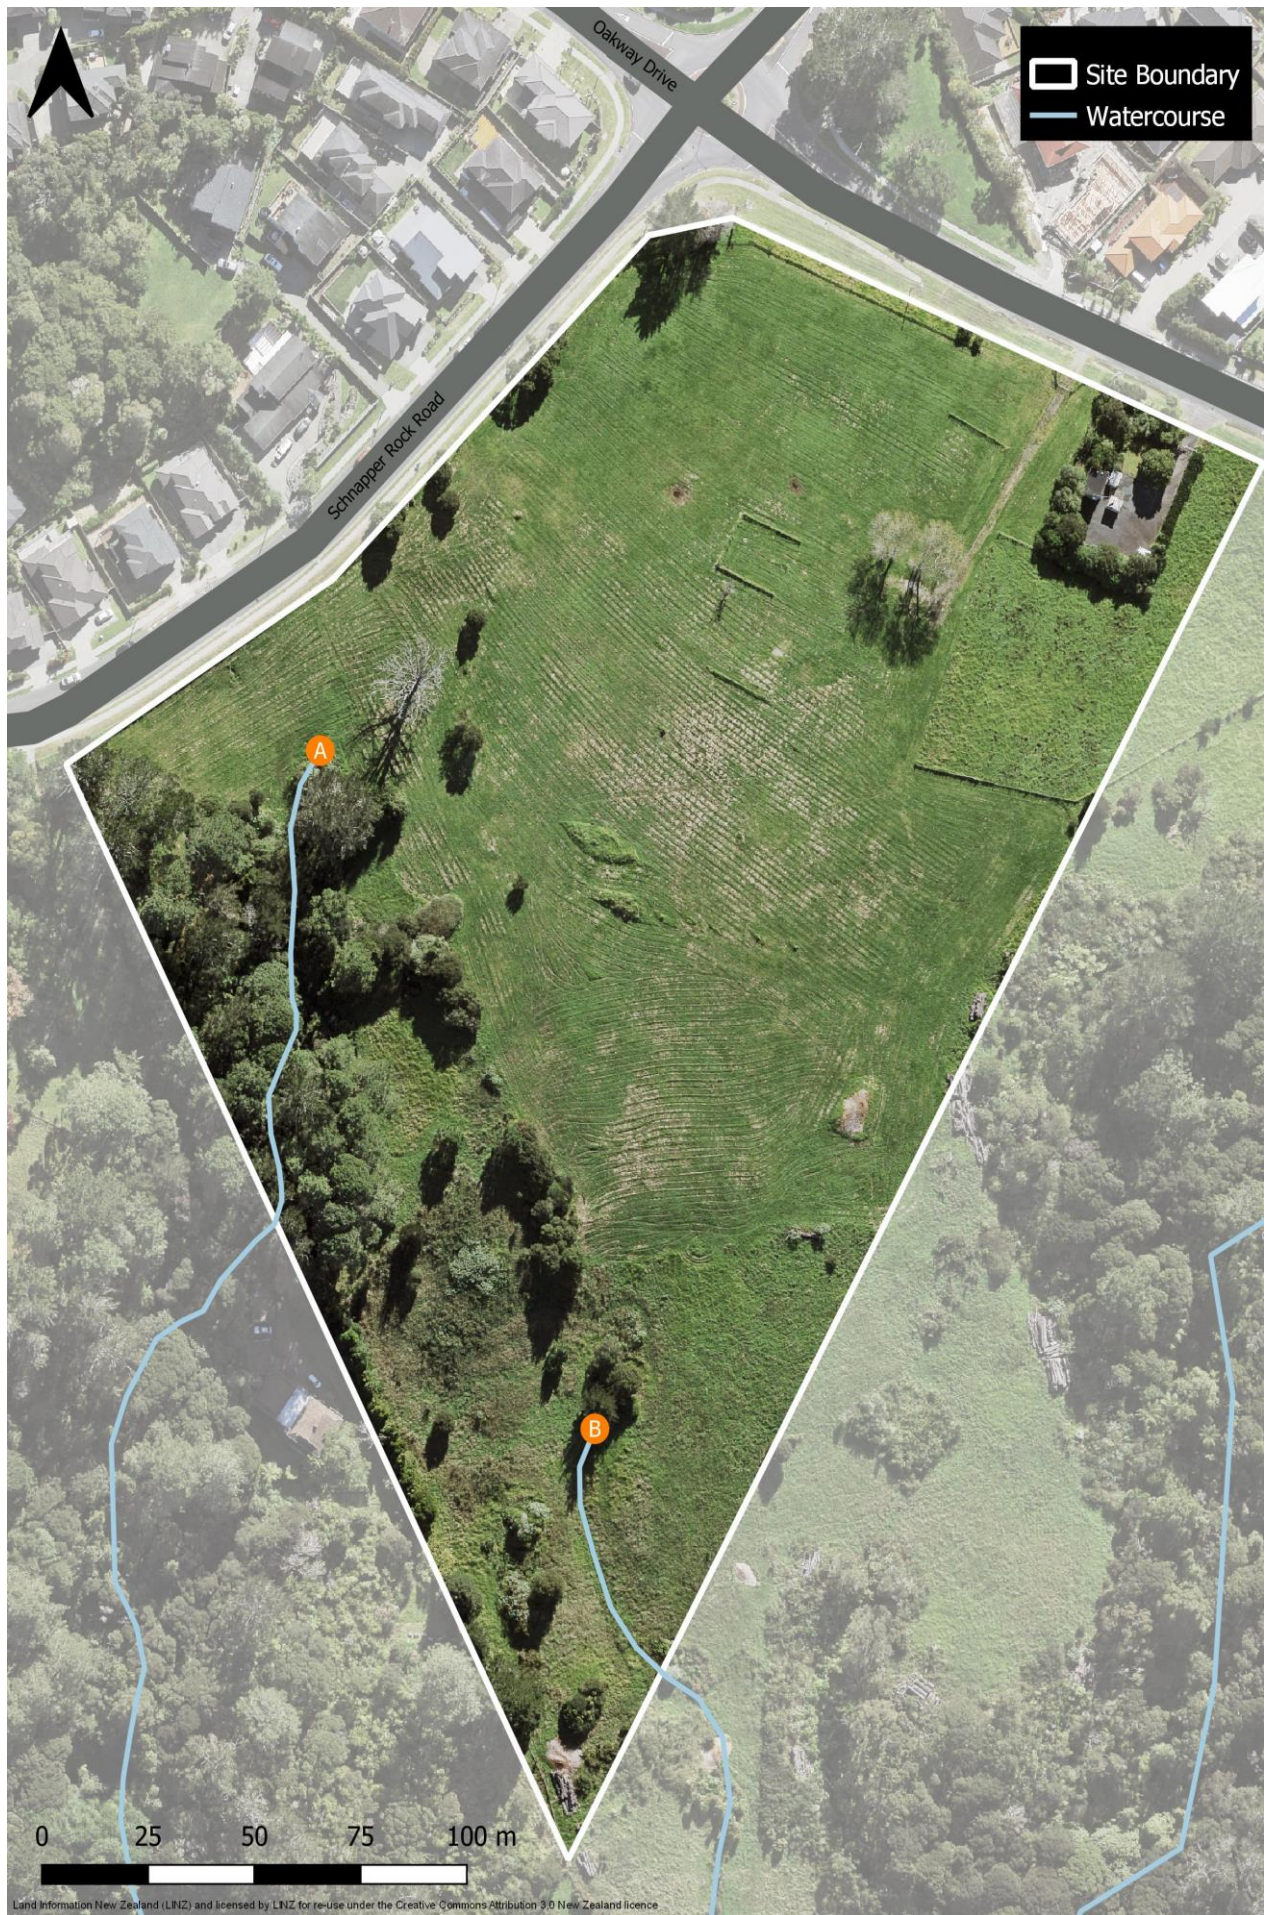
Attachment 2 – Plan showing watercourses

- naturally occurring watercourses.
