Natural Knowledge Ltd
environmental consulting

LAND USE CAPABILITY AND SOIL ASSESSMENT – CONSTABLE RD, WAIUKU

Dr Peter Singleton

10/03/2022

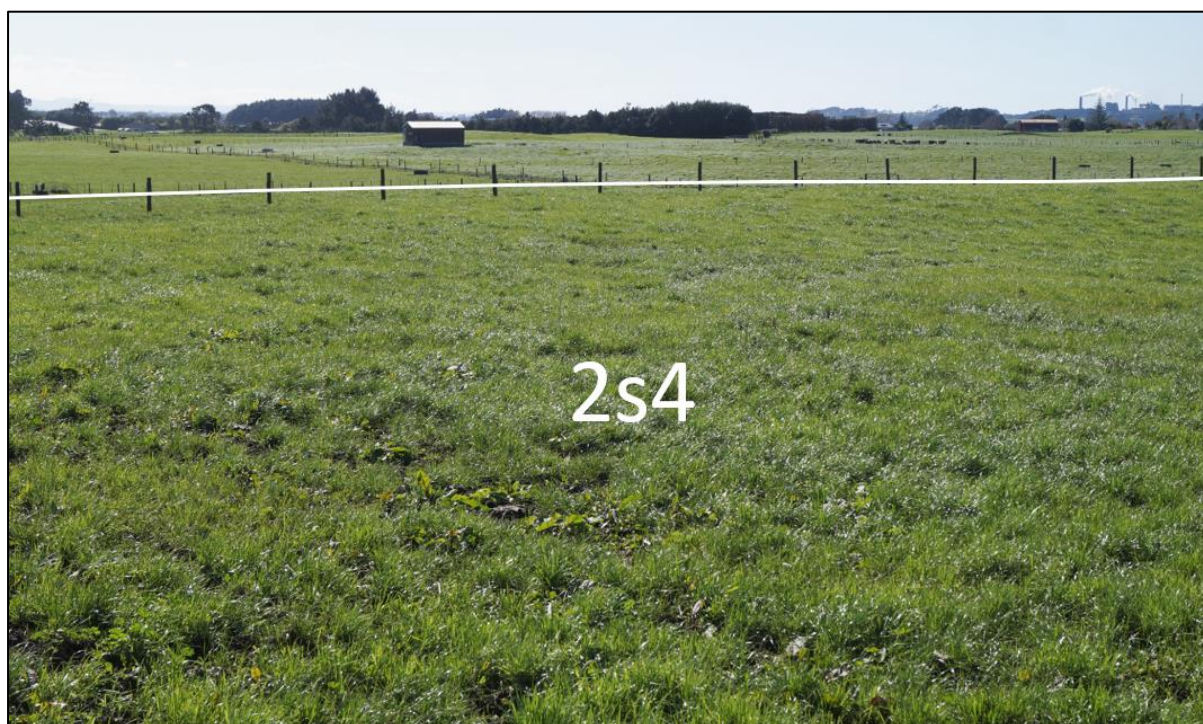
LUC unit 2s4 land was well drained and occurred on flat to gently undulating (0 to 3 degrees, Figure 3) higher ground which had Karaka soils from ash and loess on ancient alluvium. Undulating slopes (4 to 7 degrees) with Karaka soils were LUC class 2e4 and a mixture of well or moderately well drainage classes. Both these LUC units were friable soils with nil to negligible erosion hazard when cultivated.

Figure 3. LUC Class 2s4 land looking north.

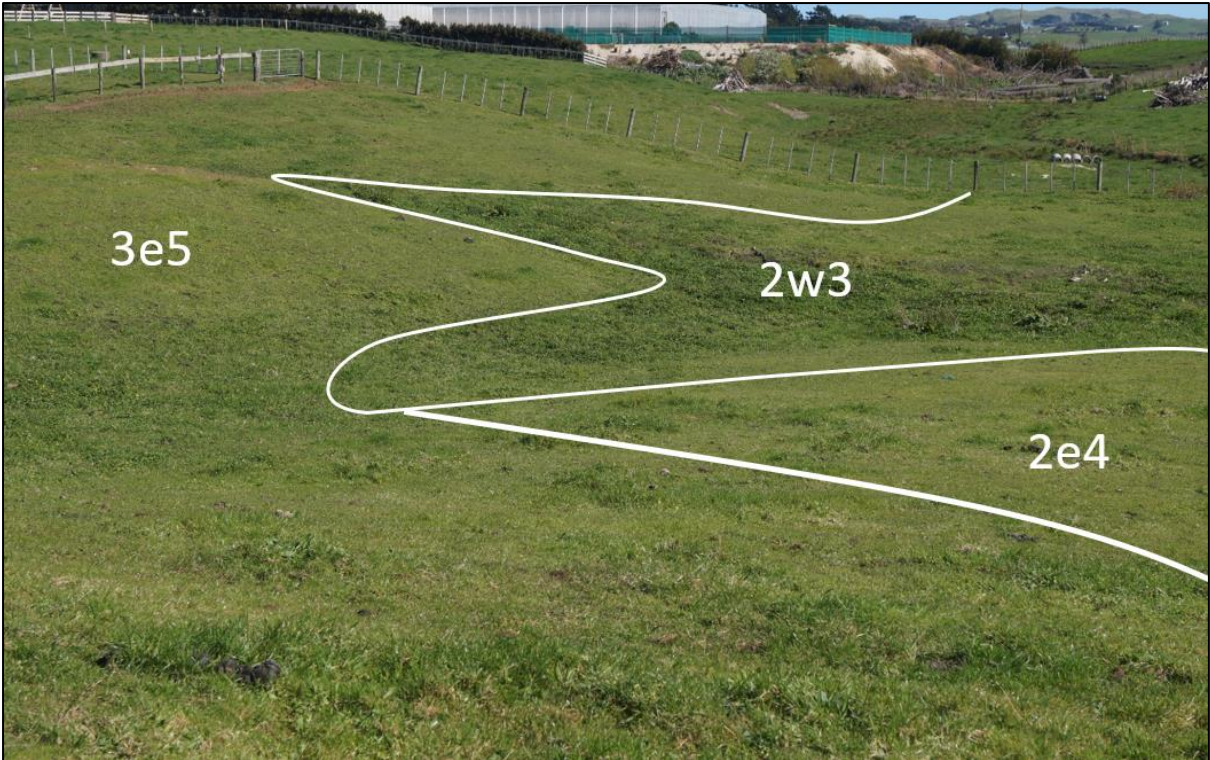
LUC class 3e5 land (Figure 4) was Karaka soil on rolling slopes and has a slight to moderate sheet and rill erosion hazard when cultivated. LUC class 3w2 land (Figure 5) was Aka Aka peat and occurred in wet low areas with a moderately high water table and poor internal drainage. Any crops are limited by soil wetness and this can delay planting and harvesting.

Figure 4. A mixture of LUC classes at the base of rolling slopes in the northeast corner of the site.

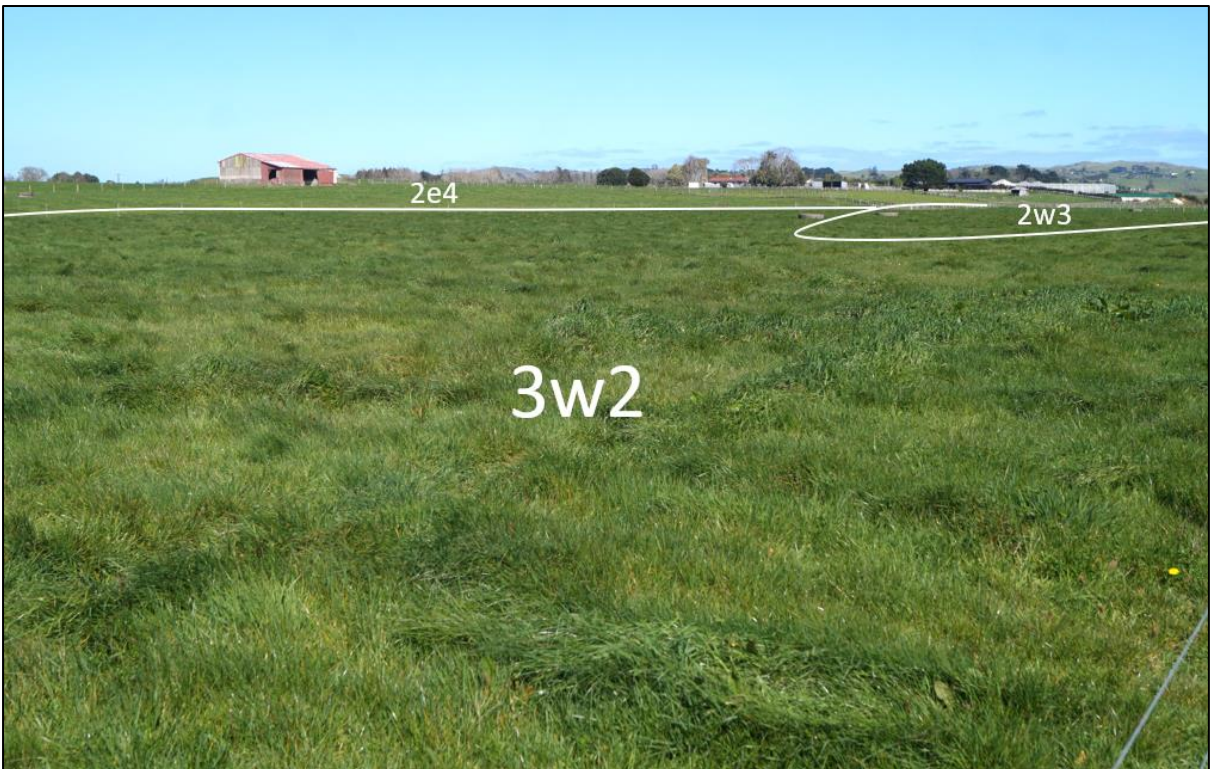
Figure 5. LUC Class 2 and 3 land looking south toward Constable Road.
