Private Plan Change, Constable Road, Waiuku

Ecological Values Assessment
Prepared for Gardon Trust

9 March 2022

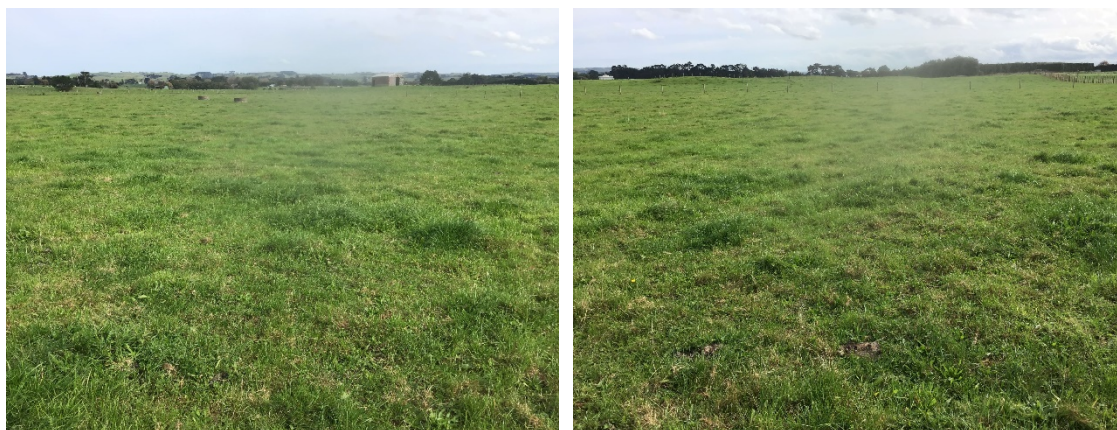
Figure 1: View north across 92 Constable Rd property.

The entire subject property is actively maintained and managed for pastoral grazing, including regular pasture renewal. No remnant indigenous vegetation or habitat is present on the site (Fig. 1). No significant native flora populations were observed.

Trees present on the site include small groups of exotic amenity plantings and single trees around the existing dwellings and farm buildings at 92 and 130 Constable Rd.

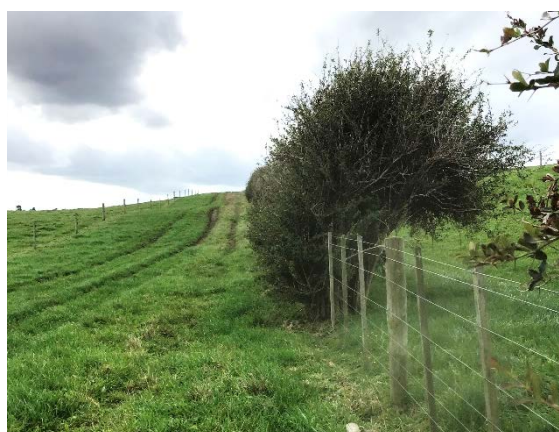
Figure 2: Short section of barberry hedge.

The subject property contains no patches of naturalised vegetation cover suitable for native lizards or other fauna. Short sections of barberry hedge are present (Fig. 2), but these are well pruned so that foliage provides poor cover for ground-dwelling or arboreal lizards, and connectivity with other prospective habitat is poor. A small patch of herbaceous ground cover is present on the eastern property boundary where rolls of old fencing and miscellaneous materials have been set aside to make way for earthworks on the adjacent land (Fig. 3), however reference to aerial photographs indicates that use of the area as a storage/ debris yard is recent, and therefore unlikely to provide a refuge for native lizards.

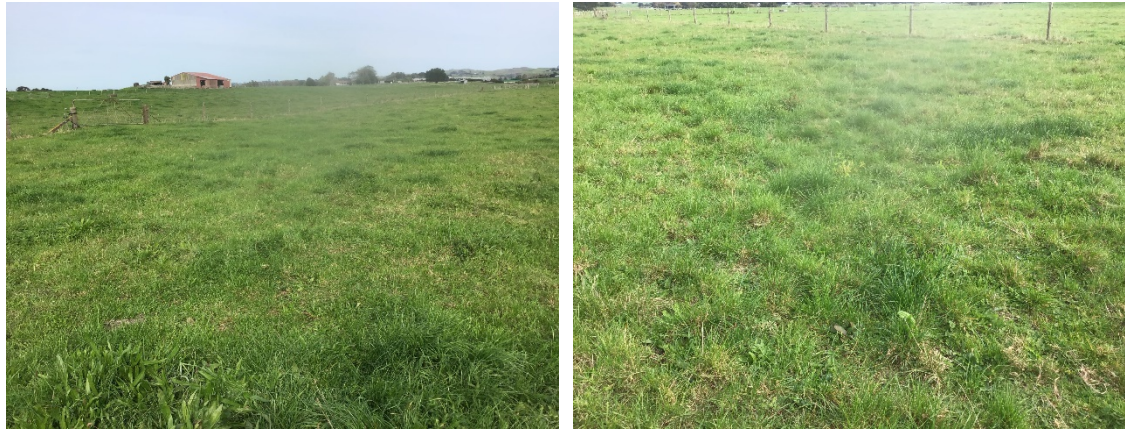
Figure 4: Areas mapped as overland flowpaths in 92 & 45a Constable Rd properties.

Other than constructed drains described below, no visible natural flow paths were noted on the site, though hydrological modelling (from Auckland Council Geomaps spatial layer) shows several small tributaries intersecting much of the property and soil profiles identified patches of peat soils in these parts of the site.

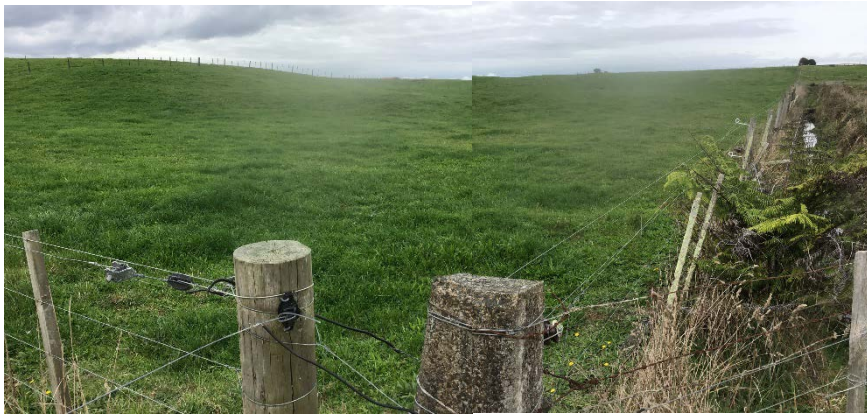
Figure 5: Area mapped as overland flowpath in western quarter of 92 Constable Road.

Figure 5 in the ecological values assessment showed the location of the modelled OLFP as indicated on Auckland Council’s Geomaps at the time of the survey. The Geomaps hydrology layer has subsequently been updated, and realigned this OLFP slightly southwards to coincide with the feature referred to in E3.

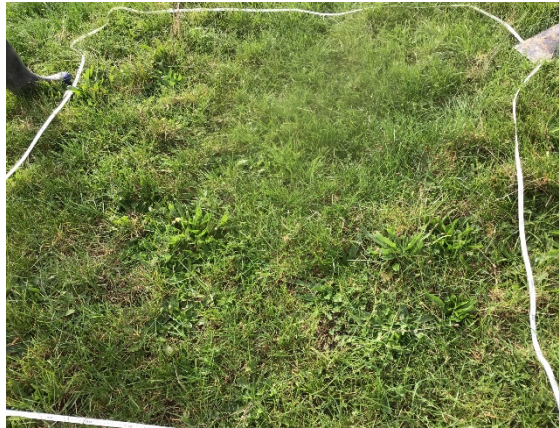
Figure 6: Sample plot within modelled flow path (92 Constable Rd).

Pasture vegetation within low-lying areas was assessed using NPS-FM wetland delineation protocols (MfE, 2020) and confirmed to be dominated by ryegrass (a grass species commonly sown for pasture production) and plantain (Figs. 4-6), with no evidence of ponding or periodic wetness, though peat soil was present (Fig. 7). Therefore, no natural wetlands are present within the subject site, according to the NPS-FM definition.

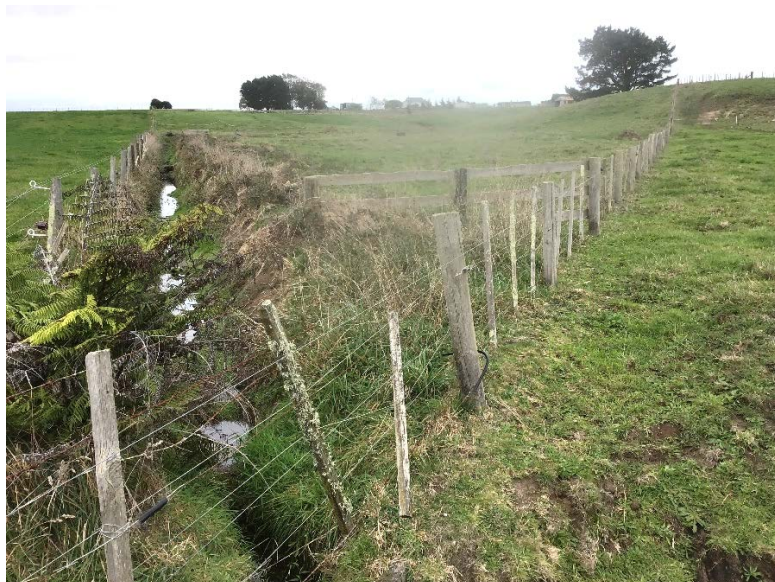
Figure 8: Constructed drain on boundary of 130 Constable Rd (92 Constable Rd to left of image).

Constructed drainage channels intersect low-lying areas in the north-western corner of the site (Fig. 8), and discharge to Rangiwheea Creek on the neighbouring properties to the north-west. Well-maintained ryegrass-dominated pasture covers the land surrounding drainage channels.

Small patches of aquatic macrophytes were present within drainage channels, however as constructed features, drainage channels meet exclusion (a) to the definition of a natural wetland in the NPS-FM.

Watercourses within the subject property are confined to drainage channels in the northwestern corner of the site. Drains appear to be regularly graded and maintained as they are largely free of silt and vegetation, containing only sparse, patchy growths of emergent aquatic plant species including willow weed, watercress, and starwort. Drains had pools of standing water was observed in drainage channels (refer Fig. 8), though no flow was observed.

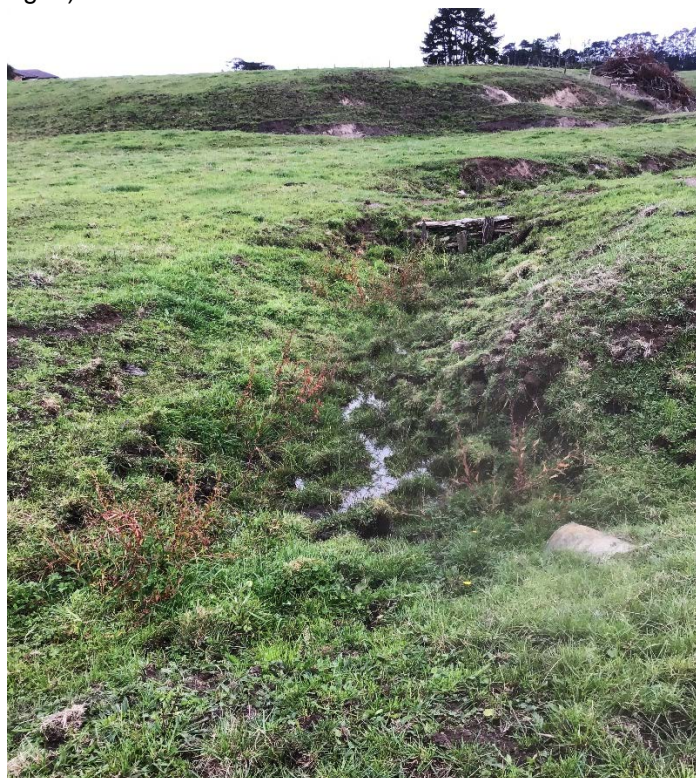
Figure 9: Immediate receiving environment on adjacent property to northwest (tributary in foreground, Rangiwheea Creek in background).

The immediate aquatic receiving environment downstream of the subject property is in poor condition. Neither the tributaries or riparian margins of the Rangiwhea Creek on adjacent properties have any riparian cover other than close-cropped pasture, and both are largely

unfenced. Watercourse margins are heavily trampled with slumping and erosion scars in places (Fig. 9).

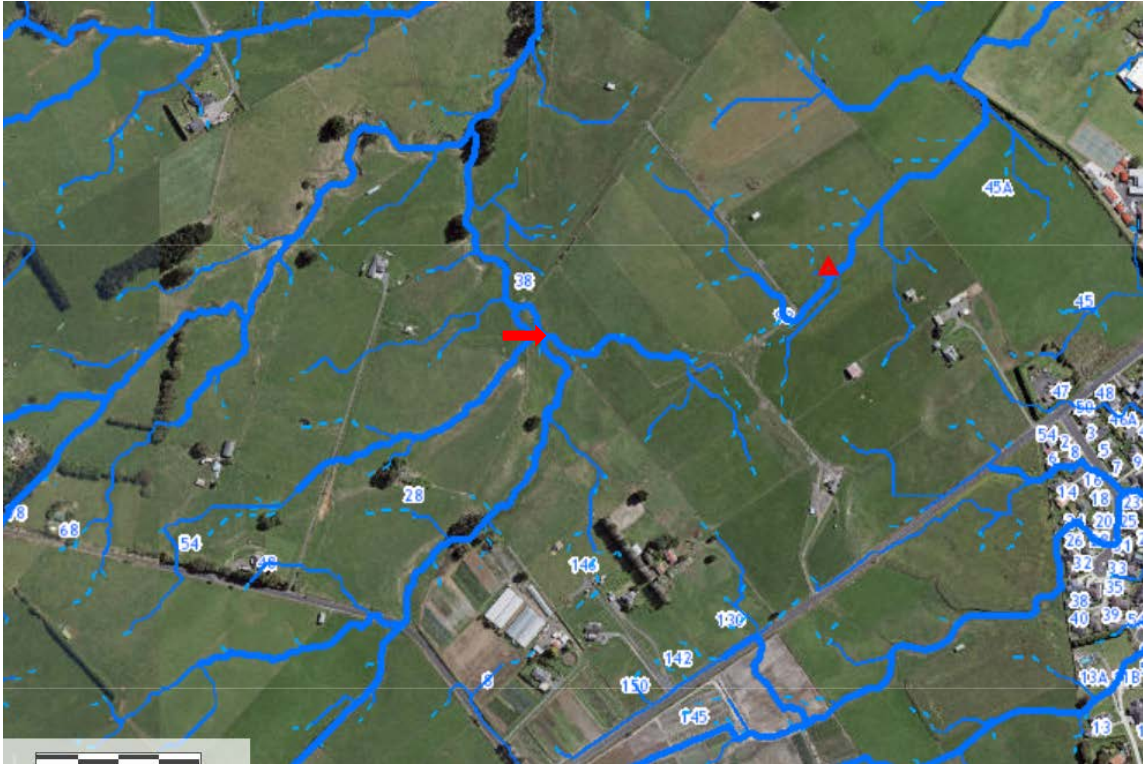
Appendix 2: Map of overland flow paths

Modelled flow paths (from Auckland Council Geomaps) in the vicinity of 92 Constable road. Arrow indicates view shown in fig. 5. The red triangle marks sample plot within modelled flow path (fig. 6).

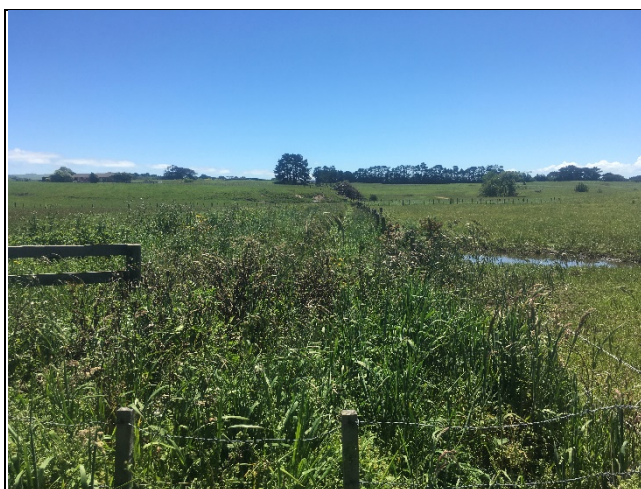
The 'constructed drains' located in the north-western corner of the site are considered to be modified natural features. The channel is connected upstream to a degraded wetland and downstream to a degraded stream channel (refer to map of drainage features). Historic aerial imagery indicates that the modified drains have been maintained since at least 2001 (AC GeoMaps). They drains are cleared of vegetation and silt approximately every five years.

At the time of the survey (9 November 2021) there was abundant water celery (*Apium nodiflorum*) growing within the channel and the water up was up 0.2m deep in places. The water was flowing.

Drainage channel – view north-west

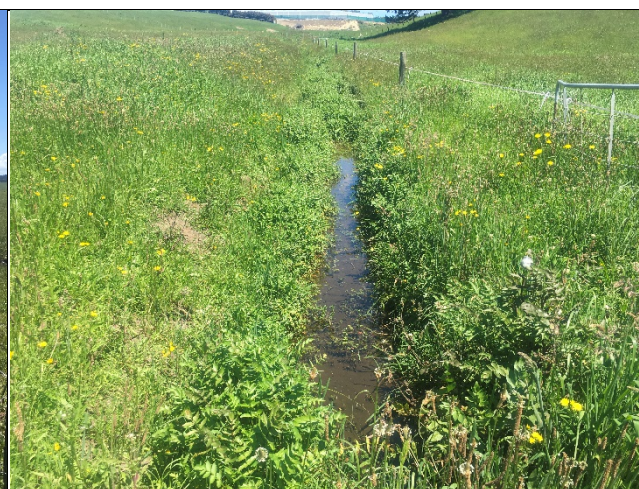
Drainage Channel – view south-west.

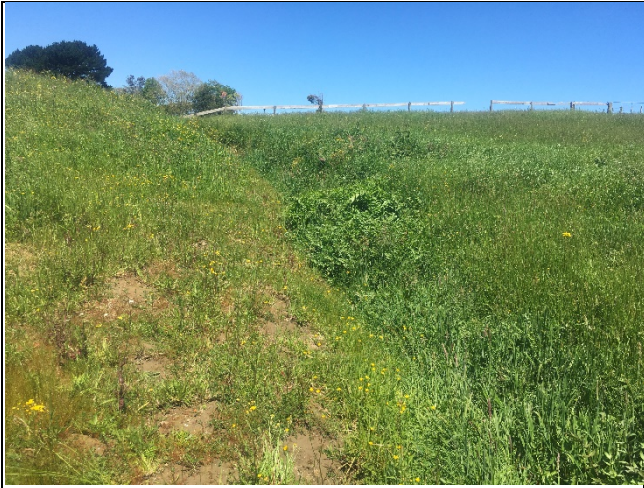
At the time of the 9 November 2021 survey the upper reaches were dry, standing water was evident in the mid-reaches and there was pooling and some slow-flowing water present in the lower reaches. Water celery, Yorkshire fog (*Holcus lanatus*) and buttercup dominated vegetation within the channel. There was some evidence of sediment sorting, and a well defined channel.

Drainage feature – view south east, or upstream.

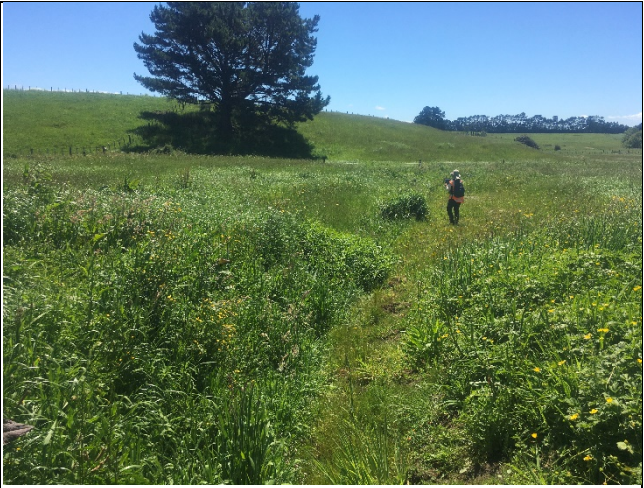
Drainage feature – view north-west, or downstream towards the confluence with the modified natural drainage channel.

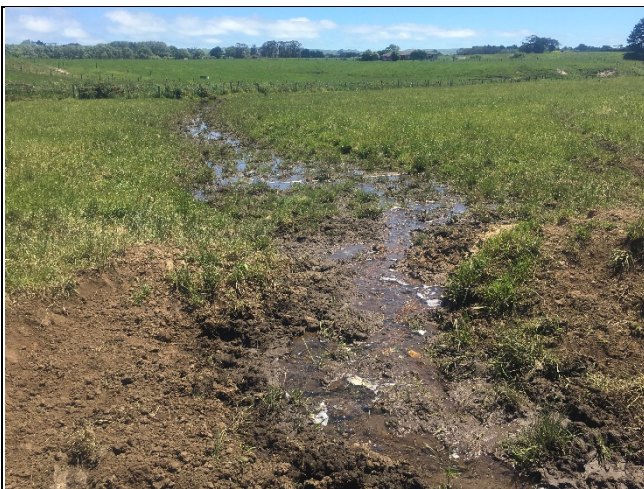
The drainage feature located on the north western corner of 92 Constable Road is a constructed drainage channel that receives the outflow of a sub-surface drainage pipe that extends beneath pasture across 92 Constable Rd. This sub-surface drain was installed in the late 1980’s and typically stops flowing around January for the dry summer period, according to the landowner. The drainage channel itself was of poor quality with heavy pugging by livestock, sparse vegetation cover of pasture grasses (mainly ryegrass), and limited fauna habitat.

Drainage feature – looking north-west towards confluence with drainage channel.

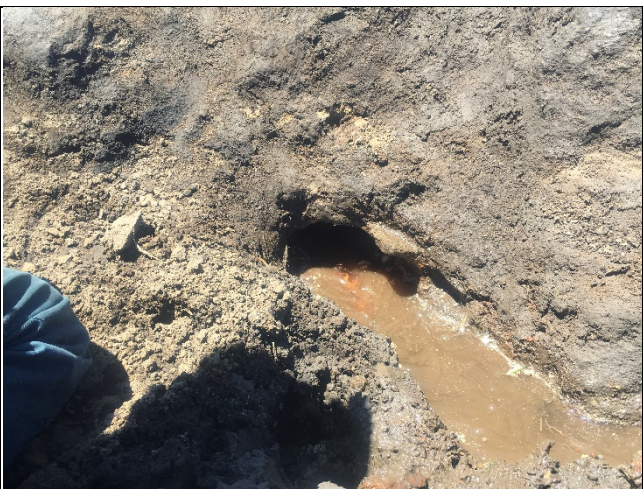
Drainage feature outlet showing the visible pipe.

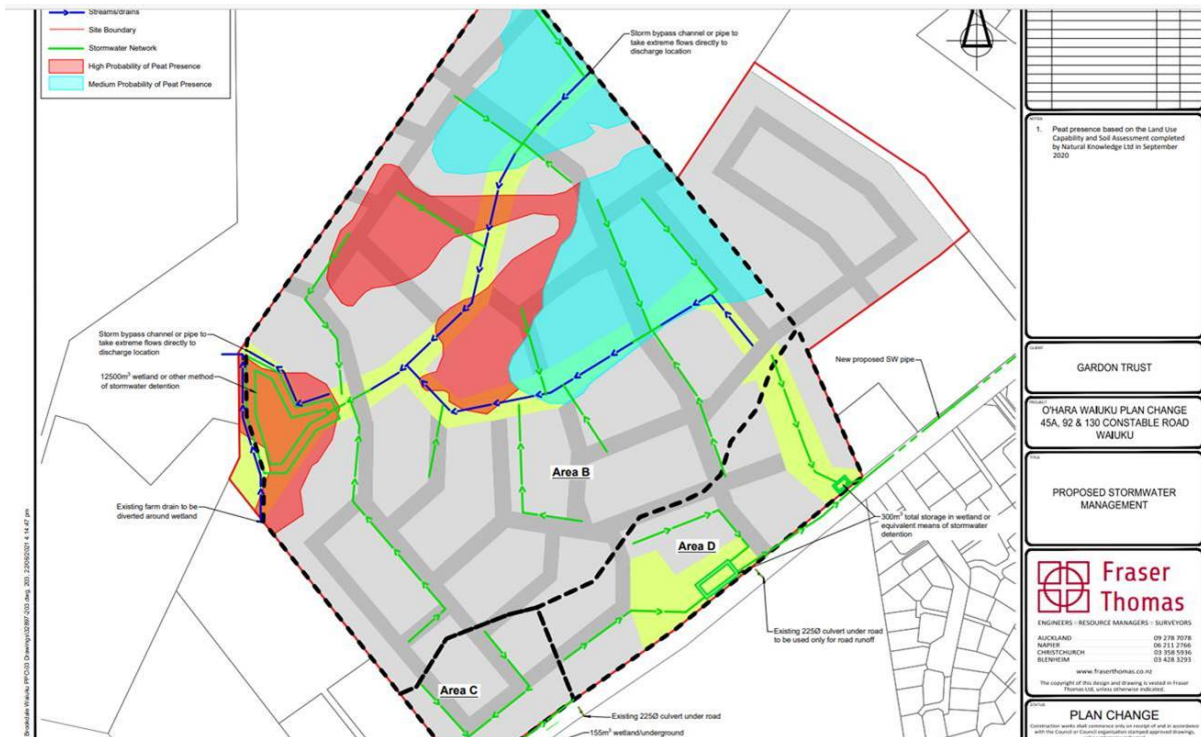
I've had a look at the request below, and I assume the diagram Mark refers to is the one below from the engineering report.

My reference to the area identified below for stormwater management being intended for "*open space and wetland restoration, not drainage or diversion*" was in the context of NES-F provisions, in response to the S92 question about impacts on neighbouring wetlands. My understanding is that this figure is conceptual, and that the intention for this area is that it will be developed as a combined stormwater wetland/ amenity feature, ensuring that groundwater recharge & clean water flows into the natural watercourses are maintained. This area will be enhanced as a 'wet feature' rather than being reclaimed and developed, and therefore won't have any adverse effect on the water table of neighbouring wetlands.

I acknowledge that there will be earthworks within this area and it's likely that the existing drainage channels will be realigned which may result in some change in overall length, but this can be achieved without draining adjacent wetland features, while impacts and required mitigation for stream diversions will be assessed at the resource consent stage.
