O'HARA WAIUKU PLAN
CHANGE

45A, 92 & 130 CONSTABLE
ROAD, WAIUKU

PRELIMINARY SITE
INVESTIGATION-
CONTAMINATION

Project No.	32897	Approved for Issue	
Version No.	1	Name	Sean Finnigan
Status	Final	Signature	 
Authors	E.Bish	Date	01 November 2021
Reviewer	S Finnigan

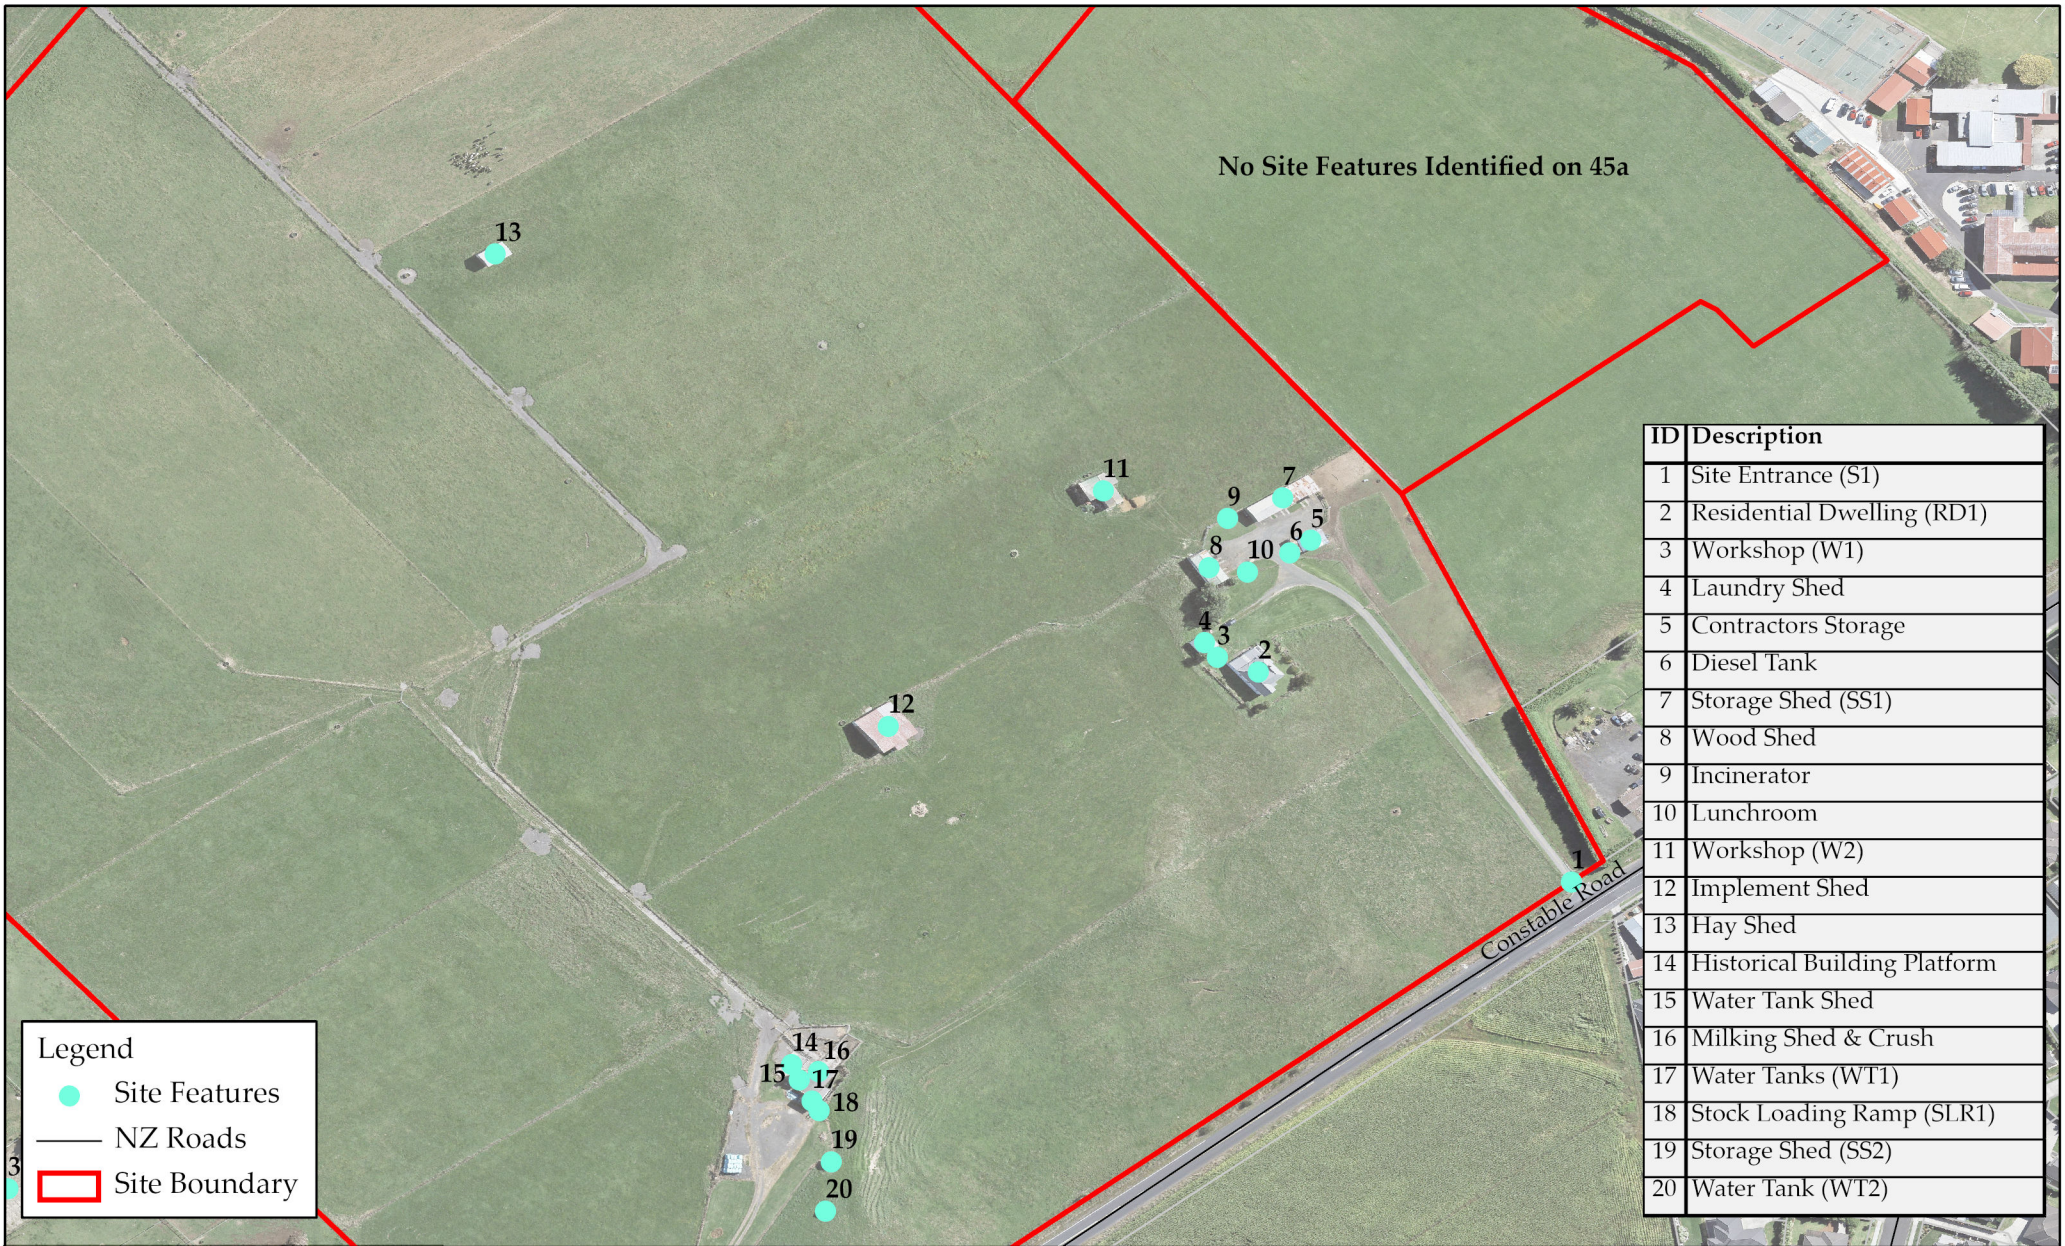
A site walkover of the subject site was undertaken by FTL Intermediate Environmental Scientist, Elliot Bish, on 28th January 2020. The site was accessed from 92 Constable Road, from the southern portion of the property. The southern portion of the site was observed in an overgrown state, with some minor grass discolouration. The features referred to below are shown in Figure 2-1.

ID	Description
1	Site Entrance (S1)
2	Residential Dwelling (RD1)
3	Workshop (W1)
4	Laundry Shed
5	Contractors Storage
6	Diesel Tank
7	Storage Shed (SS1)
8	Wood Shed
9	Incinerator
10	Lunchroom
11	Workshop (W2)
12	Implement Shed
13	Hay Shed
14	Historical Building Platform
15	Water Tank Shed
16	Milking Shed & Crush
17	Water Tanks (WT1)
18	Stock Loading Ramp (SLR1)
19	Storage Shed (SS2)
20	Water Tank (WT2)

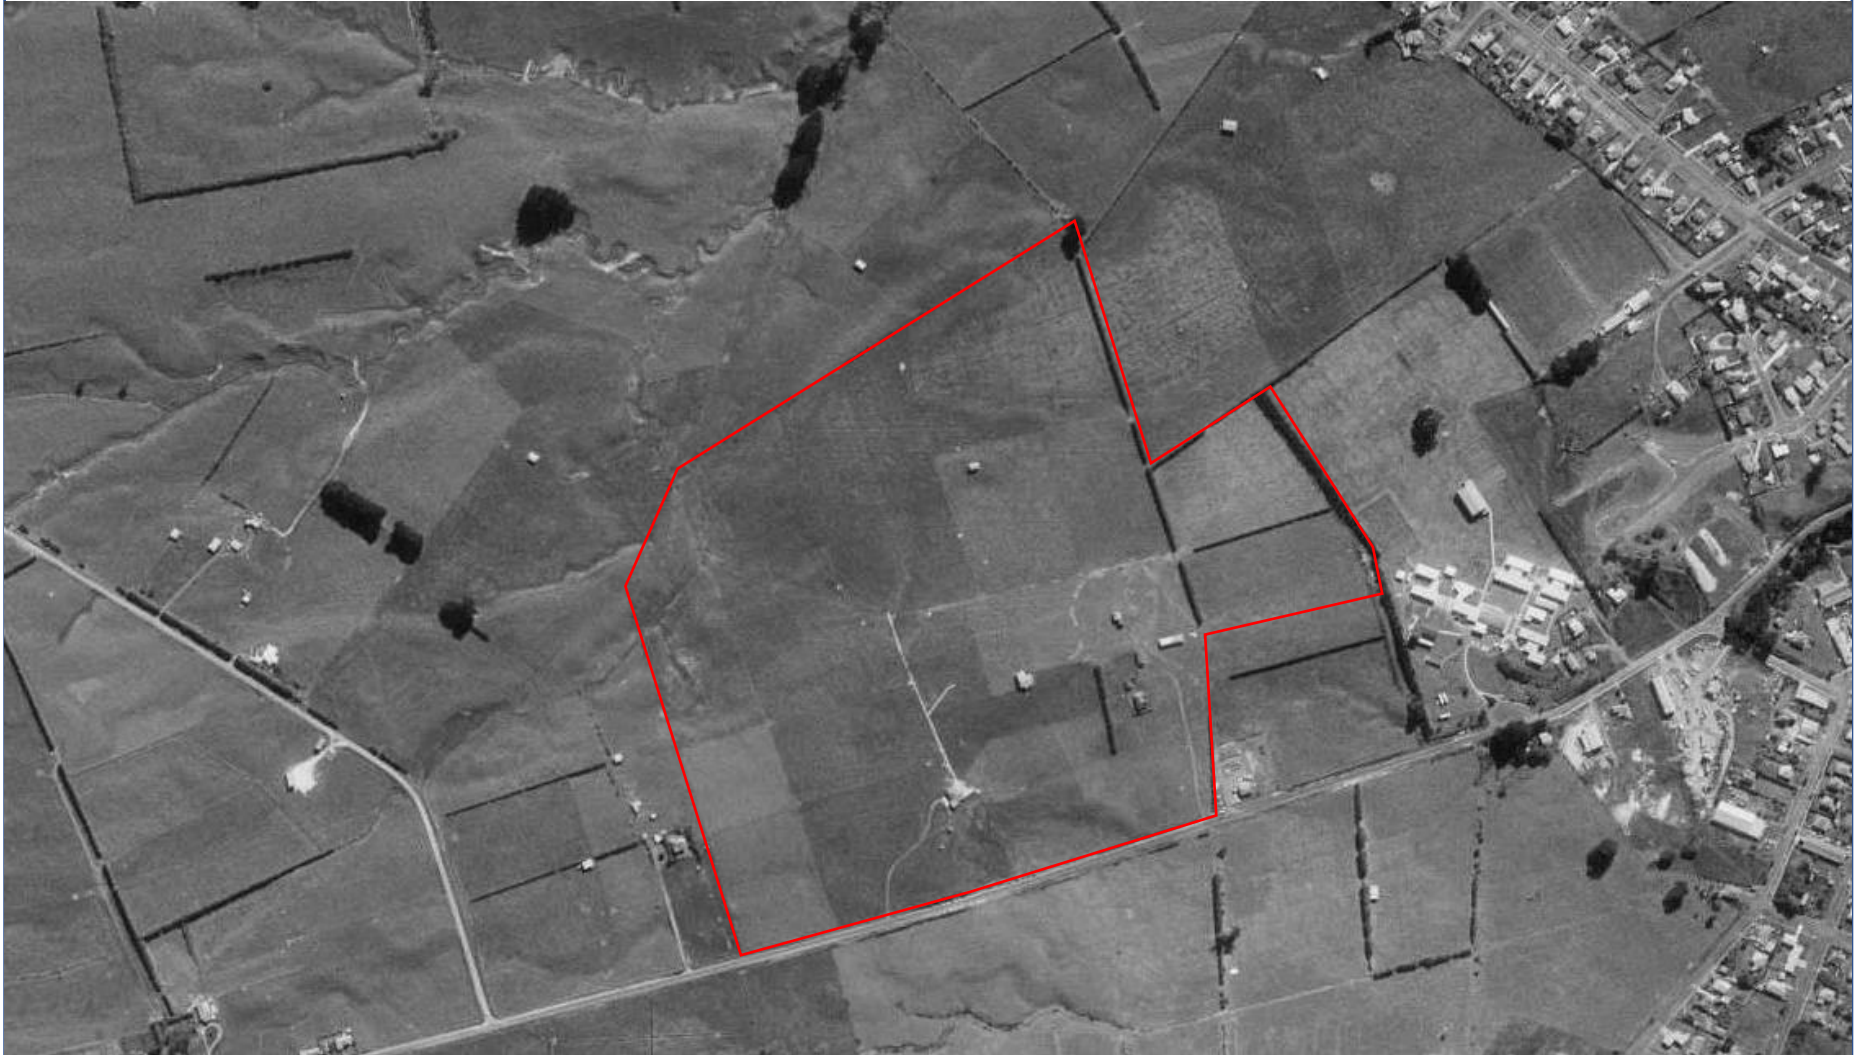
The 1975 aerial photograph shows the site in similar condition to the previous year's photographs. The only discernible change is the removal of the partial tree shelter belt along the northern portion of the western boundary.

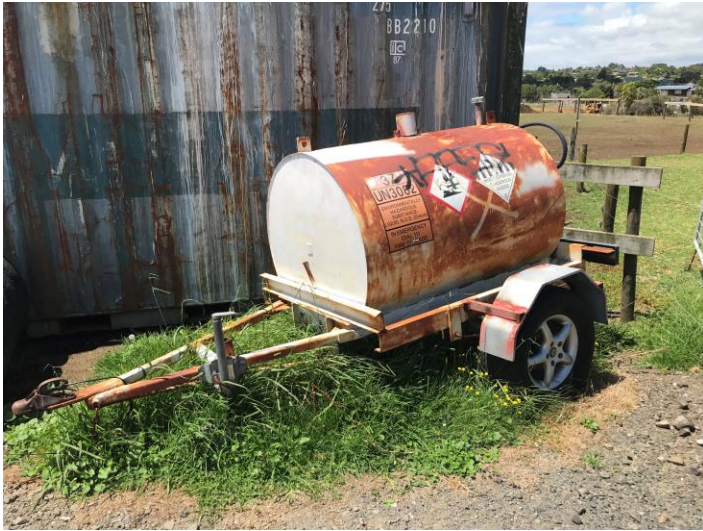
North-east of the laundry shed, a contractor's storage area and portable diesel storage tank were encountered. The contractor's yard contained two freight containers, access to these containers was not granted during the site walkover, however the tenants advised sewing supplies and farming tools were stored inside. The diesel storage tank was observed in relatively good condition, no cracks in the tank were noted, no signs of staining were observed on the surrounding soils.

Diesel Tank adjacent to Contractor Storage

The above ground fuel storage tank has not been considered in the above assessment given the good condition of the tank and lack of any visual staining on the underlying soils.

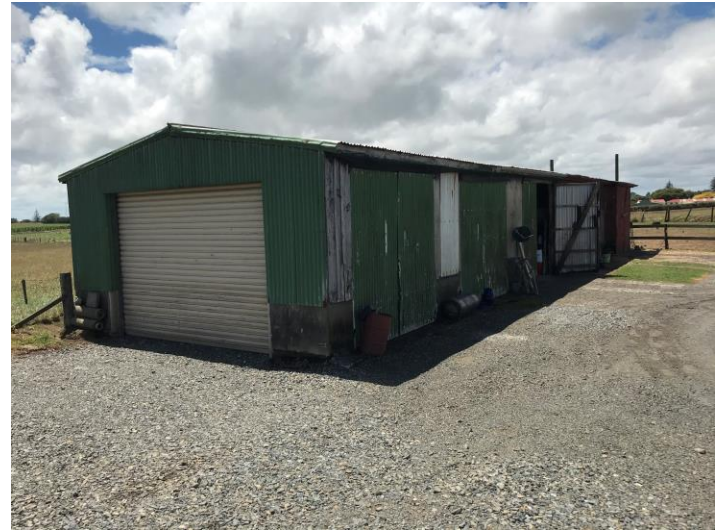
Adjacent to the contractor's storage area, a large storage shed (SS1) was encountered. The storage shed was constructed with a tin roof, corrugated iron and PACM cladding and was built on a concrete base, storing jet boats, tools, compressed gasses & chemicals. No signs of cracks or staining were observed on the concrete cover.

Storage Shed (SS1)

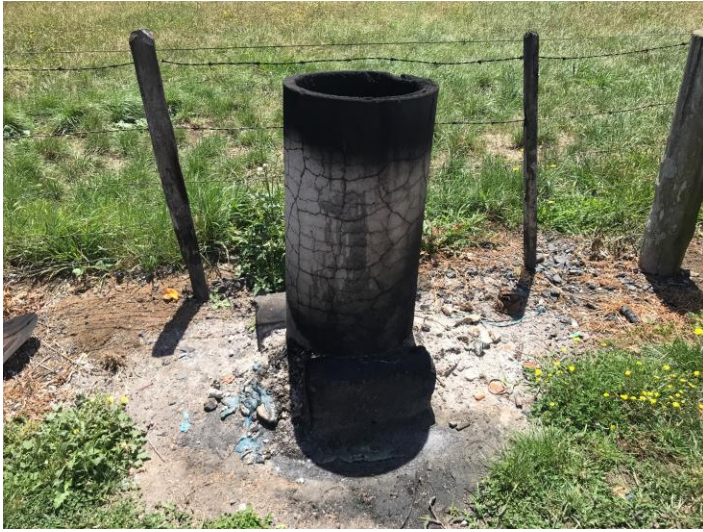
On the western façade of the storage shed (SS1), a small incinerator was encountered, staining and burnt material debris was observed surrounding the incinerator. The potential for soil contamination from the burning of unknown materials was identified in this area of the site.

Incinerator

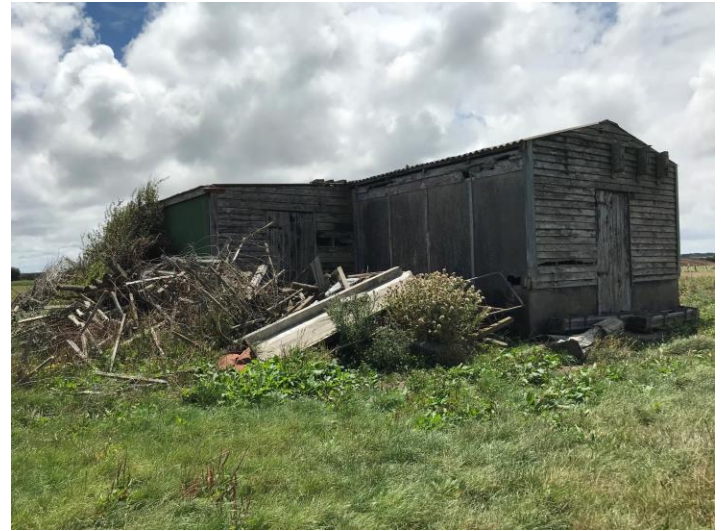
North of the wood shed and lunchroom, the workshop (W2) was encountered. The workshop (W2) was constructed with a tin roof, partially wood and partially PACM cladding and was constructed on a concrete base. The workshop (W2) was observed storing a tractor and empty

Workshop (W2)

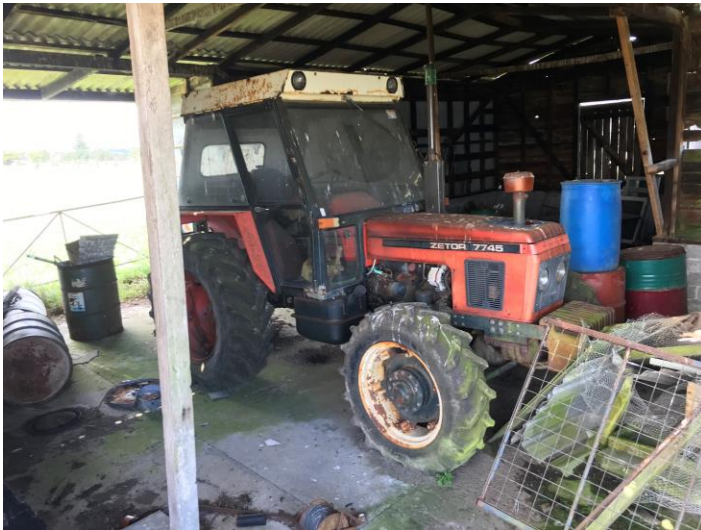
oil drums. Minor staining was observed on the concrete floor; however, no cracks were observed. Broken PACM cladding in a deteriorated state was observed inside the workshop (W2) and surrounding the western façade of the workshop (W2) in direct contact with the underlying soils. The potential for asbestos ground contamination was identified in this area of the site.

Interior of Workshop (W2)

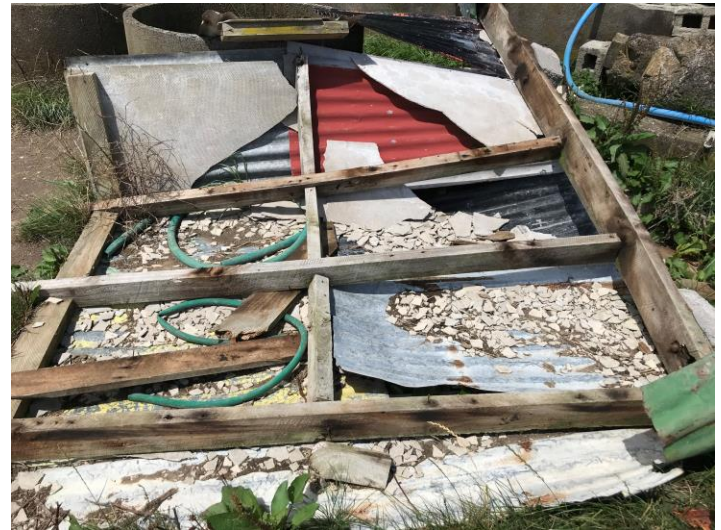
Broken PACM Sheeting outside Workshop (W2)

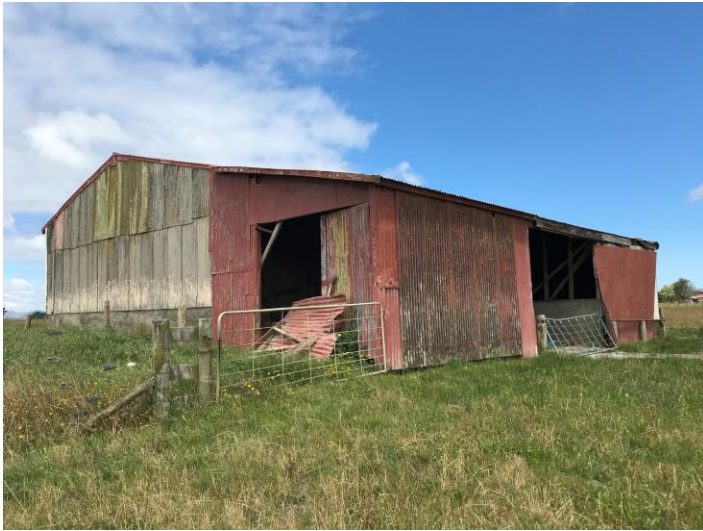
South-west of the workshop (W2), in the central portion of the site, the implement shed was encountered. The implement shed was constructed with a tin roof, partial tin and partial PACM cladding, with a partial concrete/hardstand base and was storing fencing supplies and a hay bailer. Broken PACM pieces were observed in contact with the soils both inside and outside of the implement shed.

Implement Shed, PACM Clad

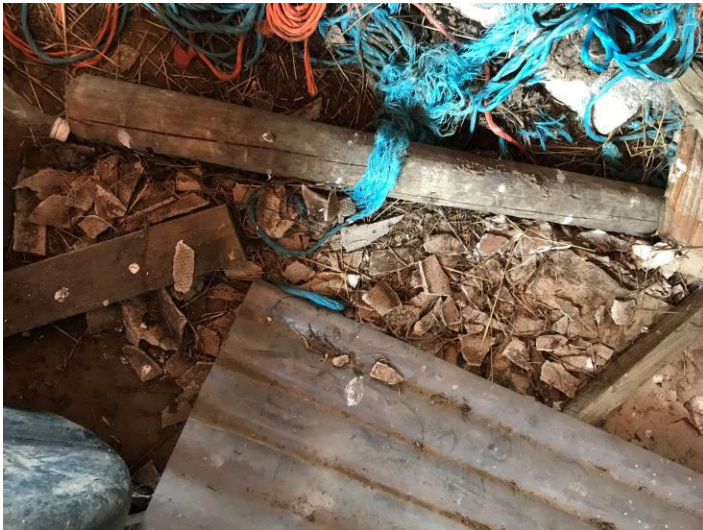
Broken PACM Sheeting

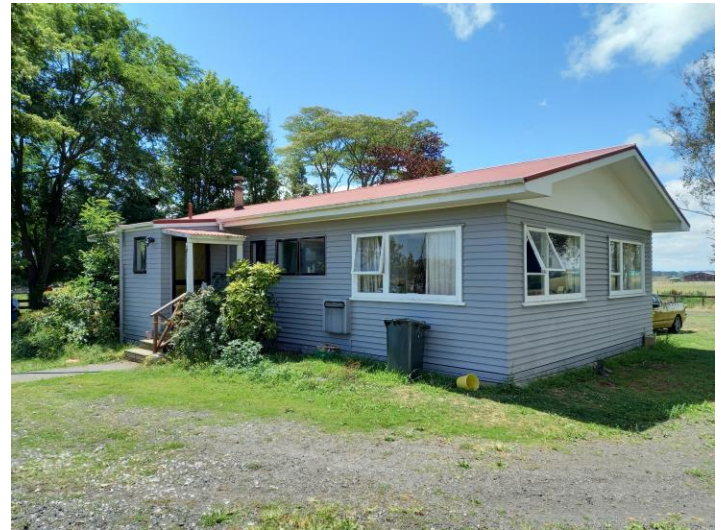
A gravel driveway led through the southern portion of the site to the residential dwelling (RD2), storage shed (SS3) and areas of burning (AOB2 – 4). The residential dwelling (RD2) was constructed with a tin roof, PACM gable ends and soffits and wooden cladding. All material appeared painted and in good condition. The storage shed was constructed with a tin roof,

PACM gable ends, soffits and cladding, storing equestrian equipment. All materials appeared painted and in good condition. The residential dwelling (RD2) was constructed on raised piles, while the storage shed (SS3) was constructed on a concrete slab. The potential for ground contamination from the historical application of lead-based paints was observed in this area of the site.

Residential Dwelling (RD2)

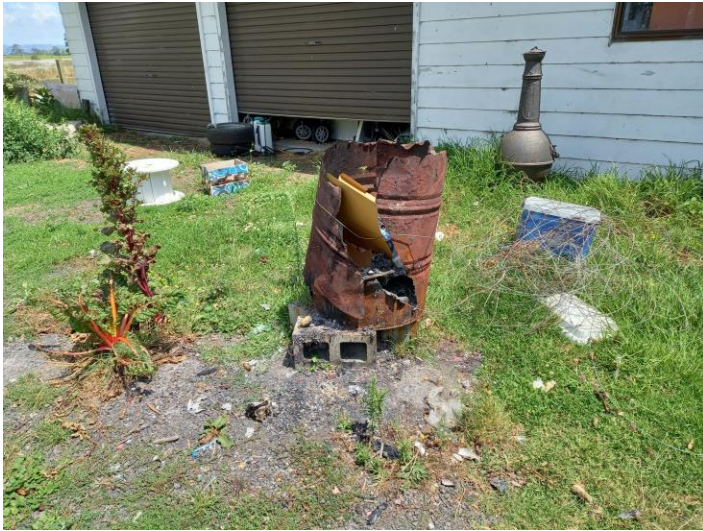
Between the residential dwelling (RD2) and storage shed, two areas of burning were encountered (AOB2 & AOB3). On the northern façade of the residential dwelling (RD2), an additional area of burning (AOB4) was encountered. Staining of the soils surrounding these site features was observed. The potential for soil contamination from the burning of unknown materials was observed in this area of the site.

Area of Burning (AOB2)

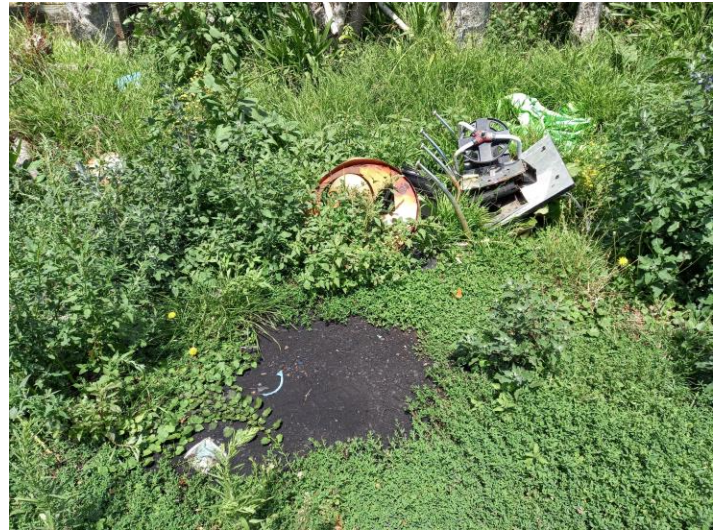
Area of Burning (AOB3)

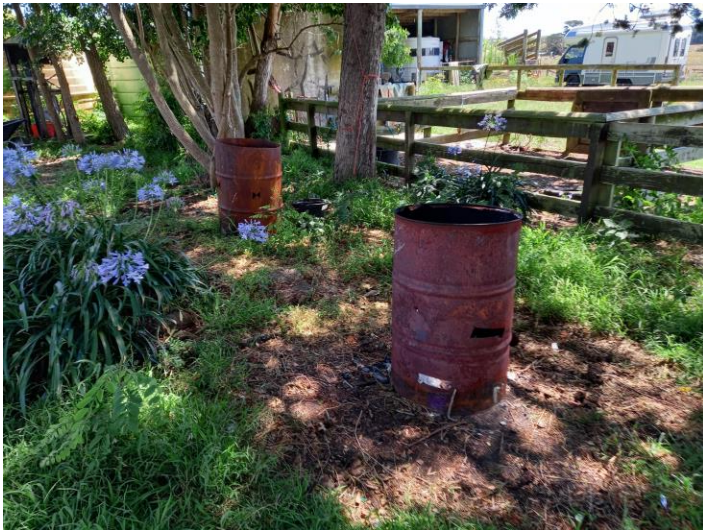
Area of Burning (AOB4)

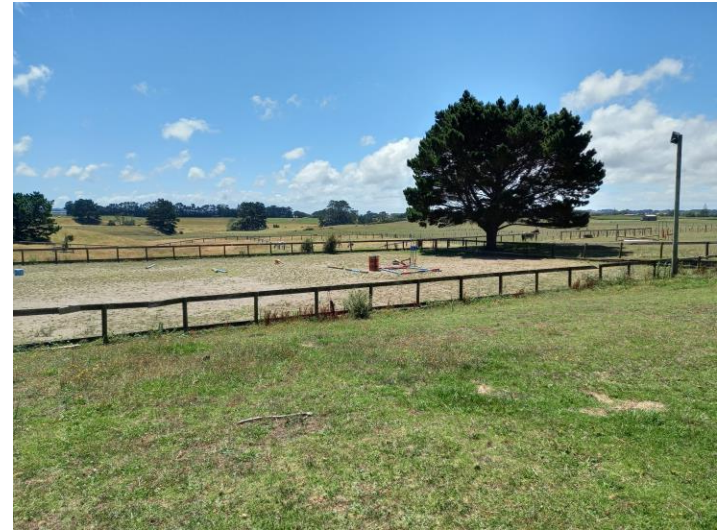
Further north of the area of burning (AOB4), an equestrian shed, stock loading ramp (SLR2) and equestrian arena were encountered. The equestrian shed was constructed with a tin roof and tin cladding, with no base. The shed was storing equestrian equipment and a horse float. No signs of staining were observed. The non-engineered fill referred to in the Fraser Thomas geotechnical investigation report is considered to be typical equestrian arena base materials and not to be of concern from a contamination perspective.

Equestrian Arena

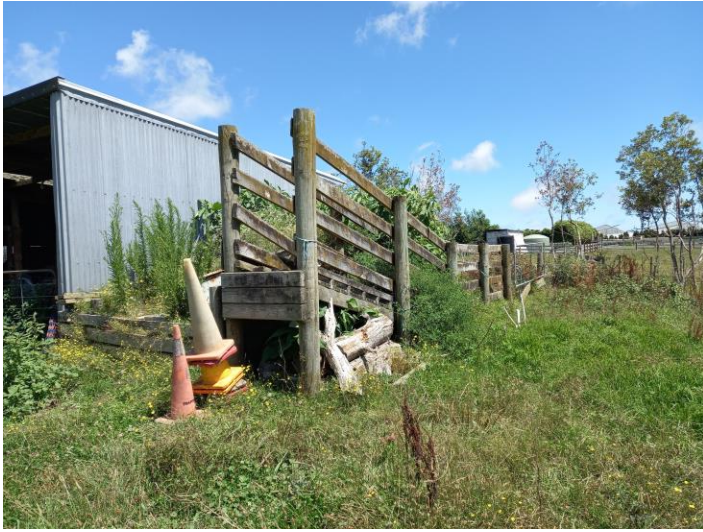
On the northern façade of the equestrian shed, a stock loading ramp (SLR2) was encountered. The potential for ground contamination from the historical use of stock loading ramps as spray races was observed in this area of the site.

Stock Loading Ramp (SLR2)
