# Historic Heritage Evaluation

Wilson's Portland Cement Company dam  
Sandspit Road, Warkworth

Prepared by Auckland Council Heritage Unit

# **Historic Heritage Evaluation**

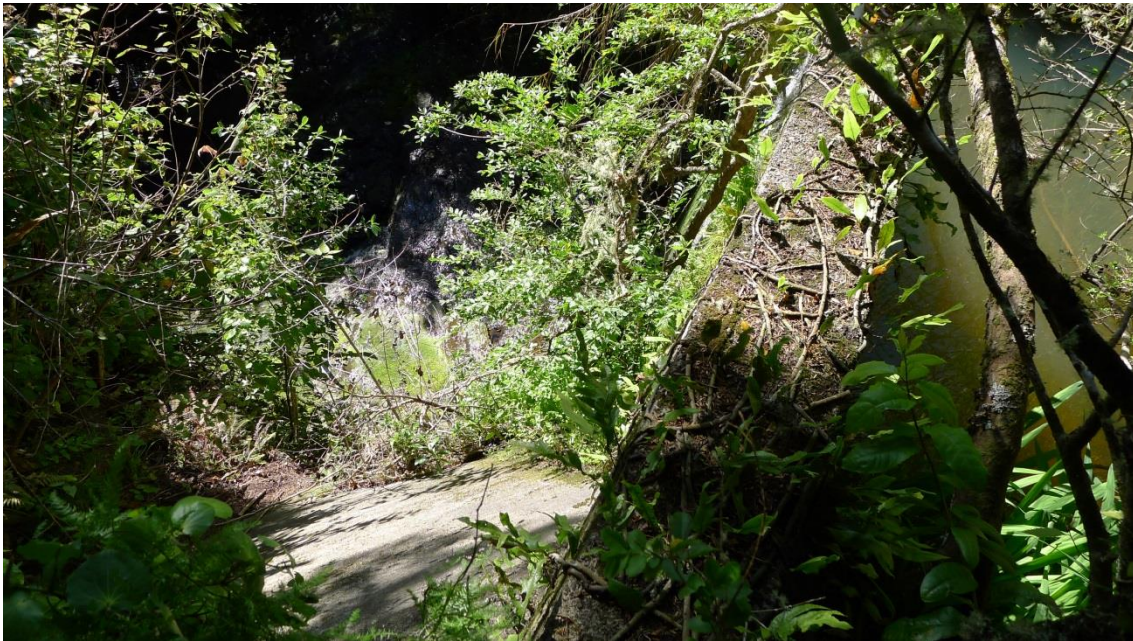
It is likely that the reported dam height measurement is to the spillway level, in which case the crest height at the abutments should be 18 feet/5.5 metres. The dam appears to be higher than this - closer to eight metres high at the front/downstream elevation (Figure 39). It is unclear why this is but it is possibly because the dam was built on a waterfall and the height measurement is from the stream bed behind the dam at the top of the falls.

Figure 9. View from eastern abutment showing impounded stream (right), crest of dam, face of eastern buttress, and waterfall below dam (partially obscured by vegetation).

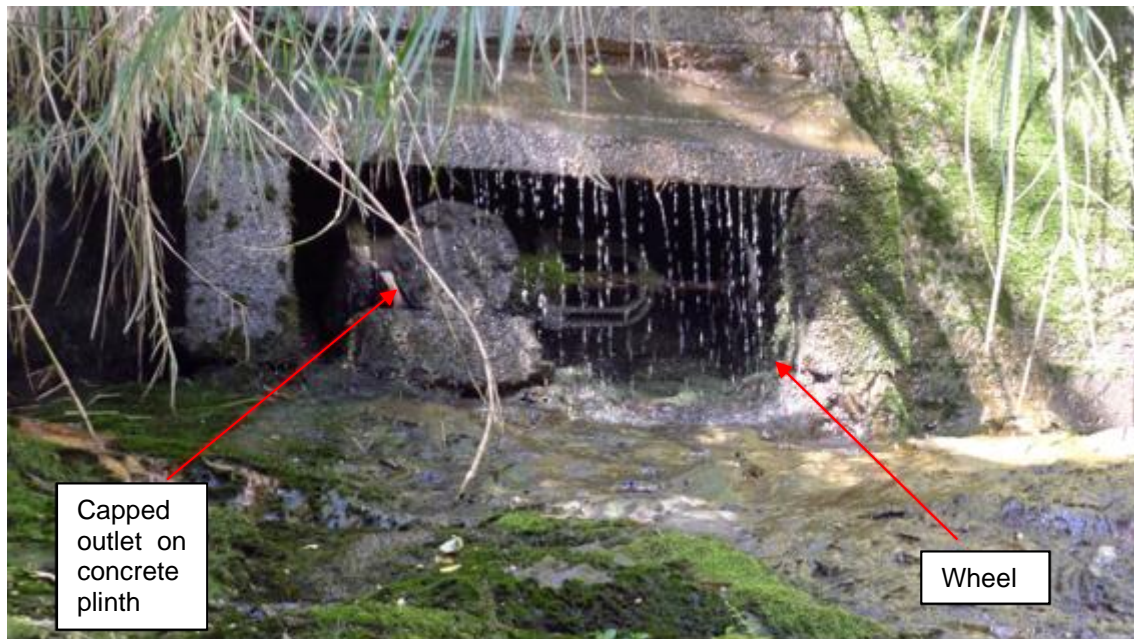
Figure 11. Outlet valve at base of dam. The pipe attachment flange has been capped with a metal plate, indicating that the pipeline was dismantled and removed upon decommissioning.

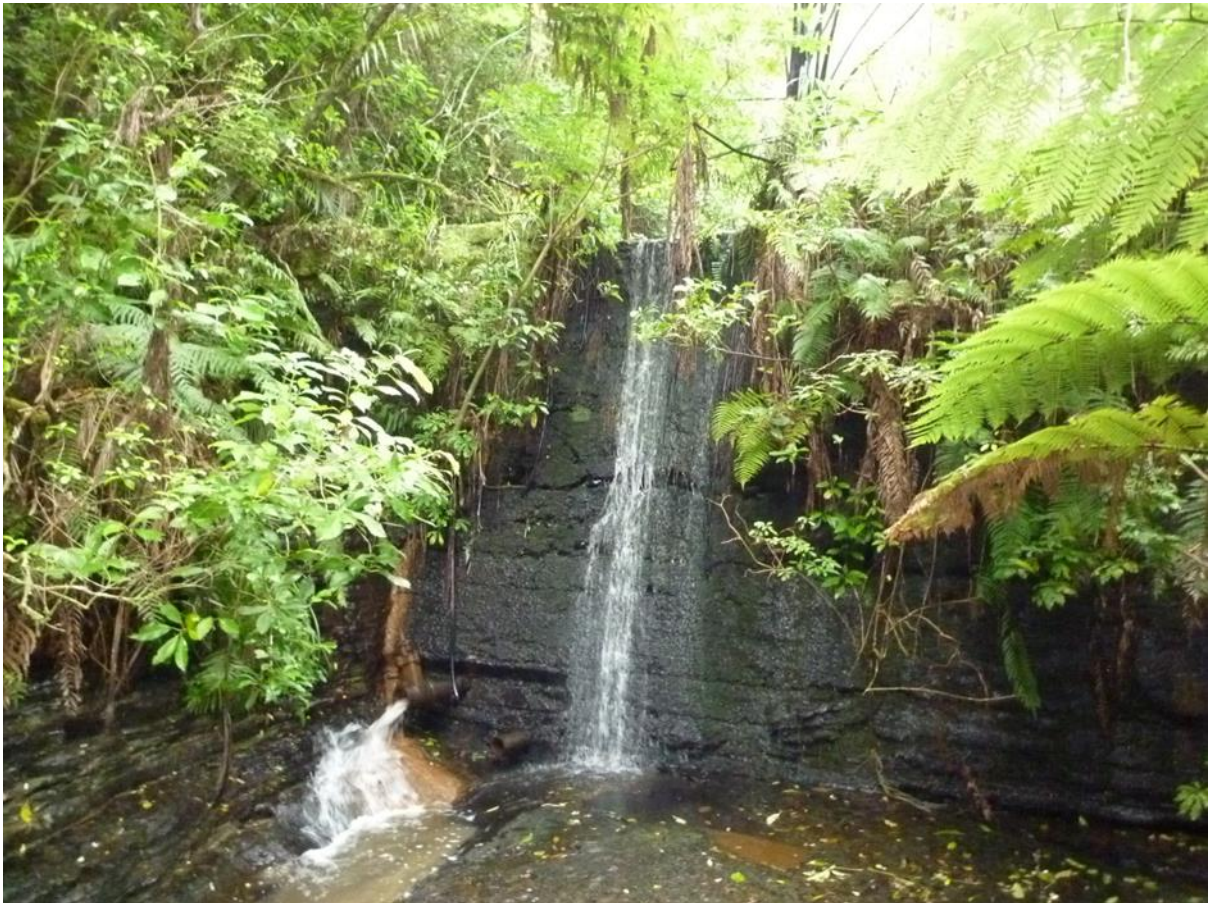
Figure 14. Dam 5 on the Mangakura Stream. WCS.

This dam has negligible storage and significant leakage paths through the structure.

This dam is constructed differently from the Warkworth dam and while it contributes to the portfolio of extant dams designed by Wilson, it is not directly comparable to the Wilsons cement company dam.

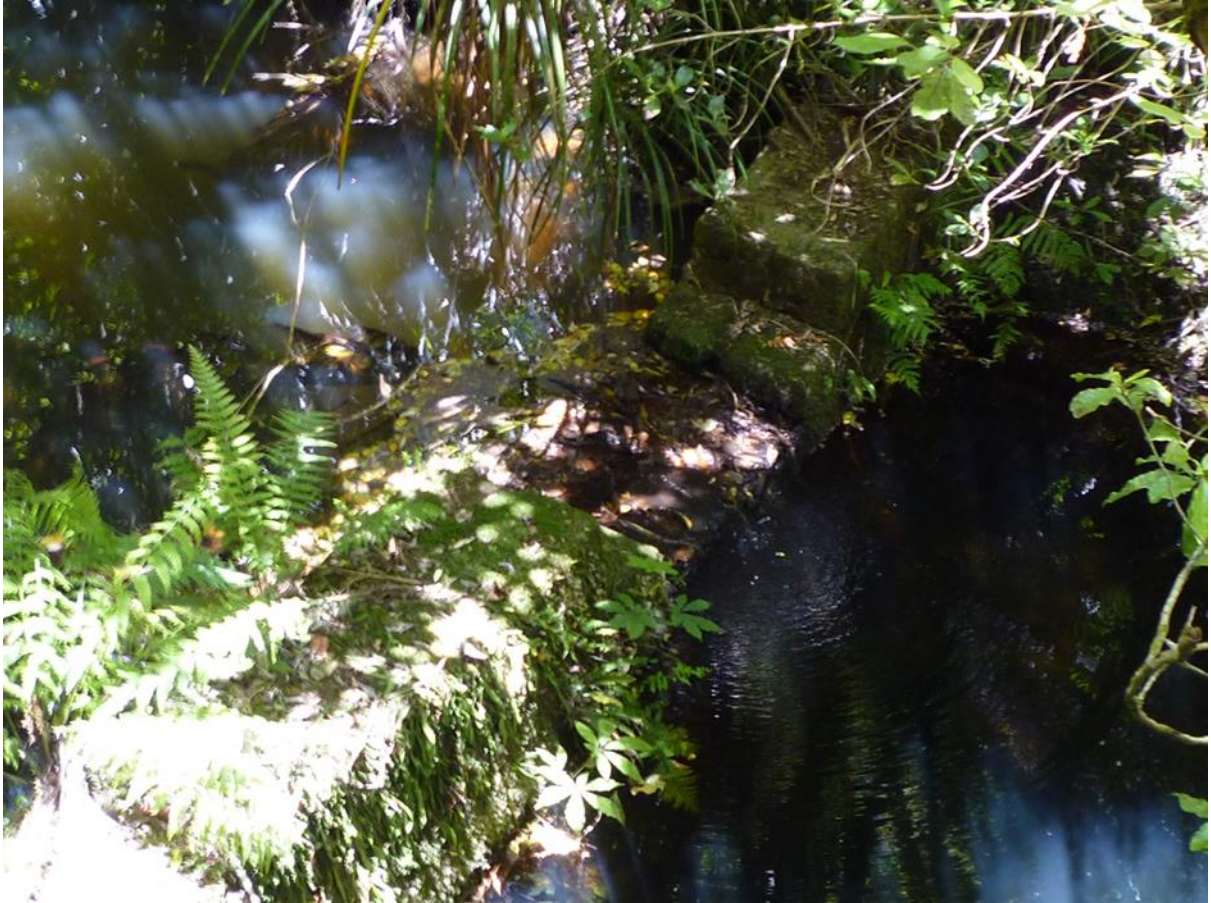
Figure 15. Crest and spillway of Mangakura Dam 4. WCS

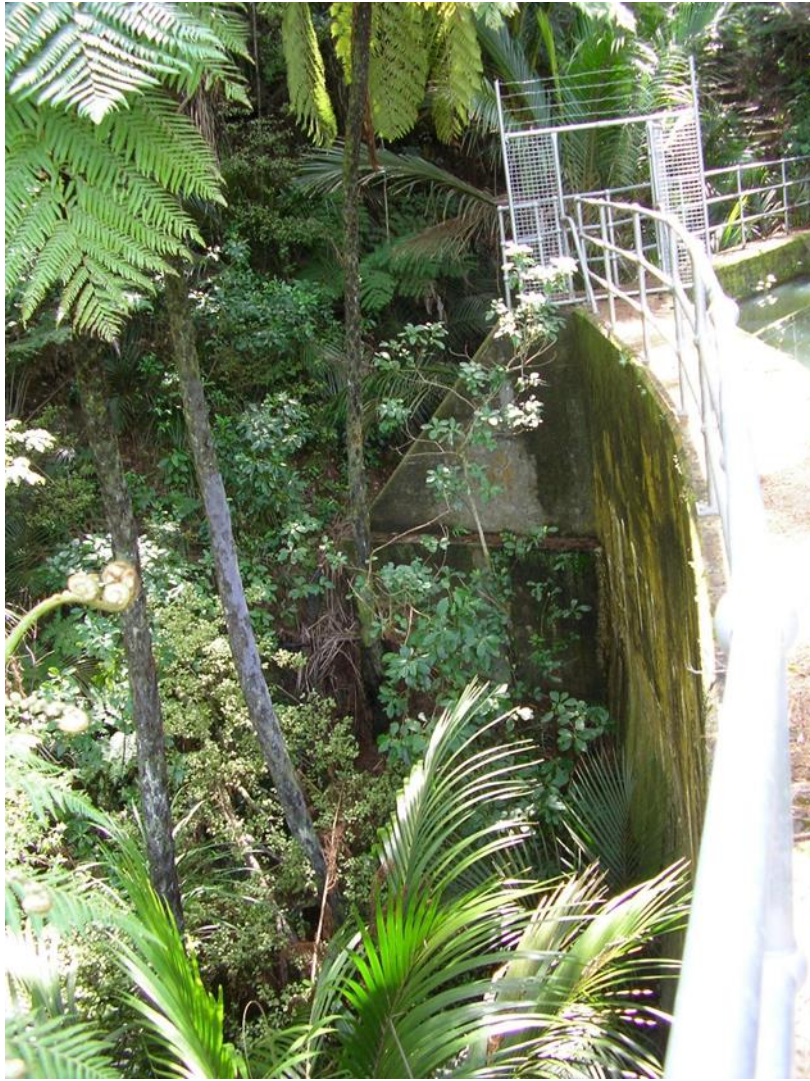
This dam, which Hugh Munro Wilson did the preparatory design for, was built in 1934<sup>32</sup>. It is a concrete arch-gravity dam with a heavy buttress on the eastern abutment, apparently a later modification to the earlier design. It is designated 'Dam 3' by WaterCare. It still exists and is in use.

Figure 16. Right abutment of dam 3, showing buttress. WCS

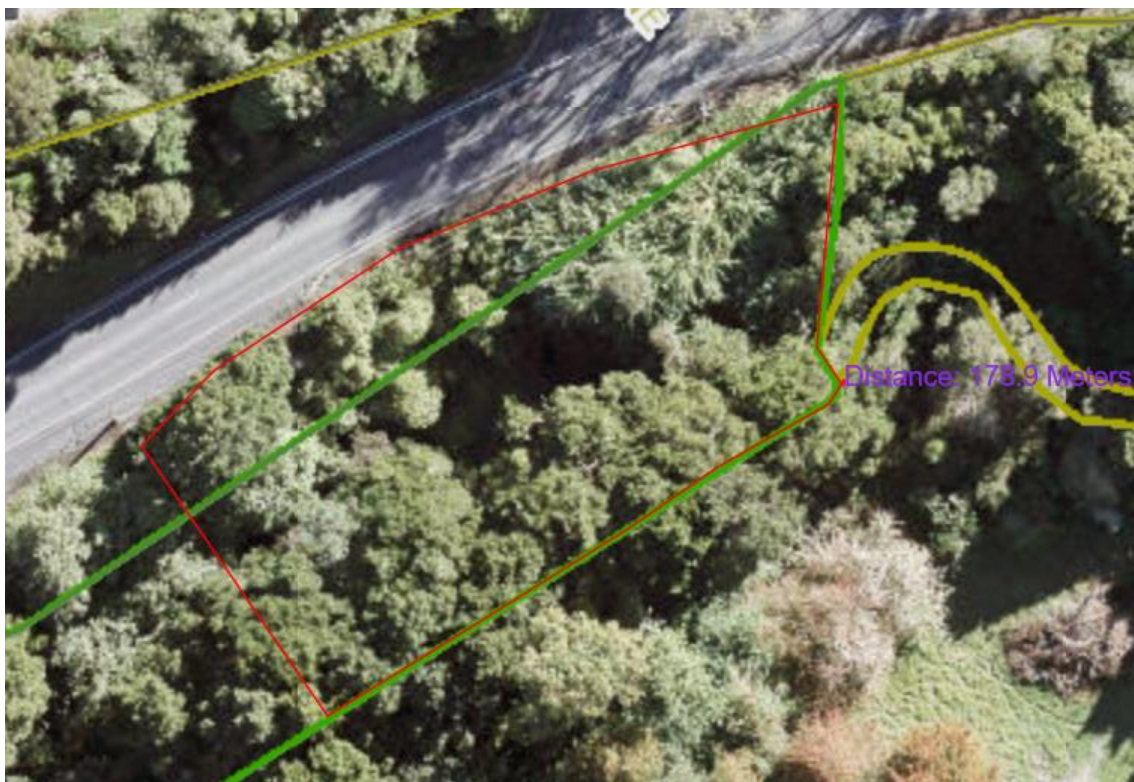
Figure 17. Proposed extent of place (outlined in red).

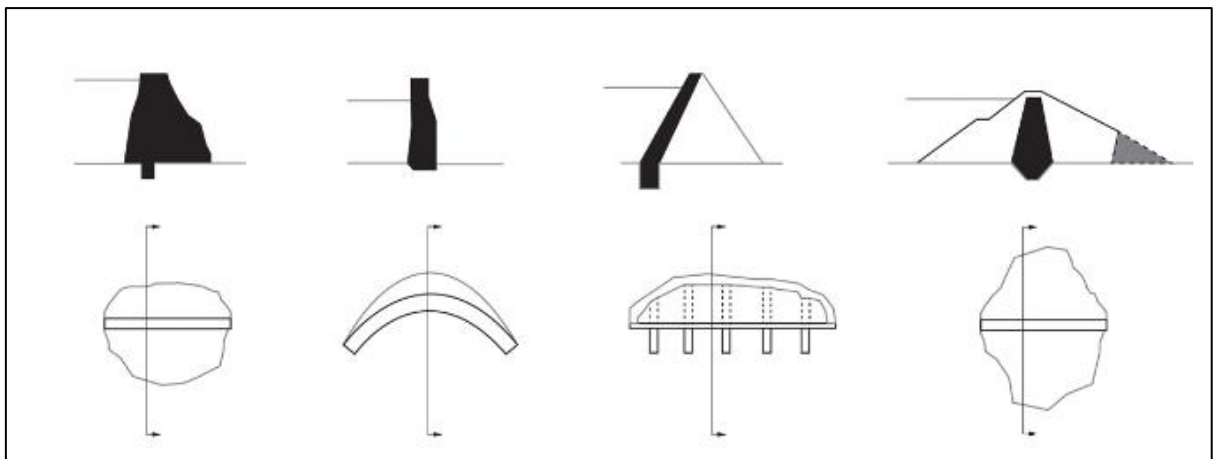
Dam designs comprise three main types: **gravity** dams relying on their weight for stability, **arched** dams which transfer the force of the impounded water to the abutments, and **buttress** dams, where the forces are transferred to the dam foundations through sloping or vertical buttresses. Within each category there are several sub types, but not all of these are represented in New Zealand.

Figure 18. The three main dam types: From left to right: Gravity; Arch; Buttress. Far right: Gravity earth dam (with core).

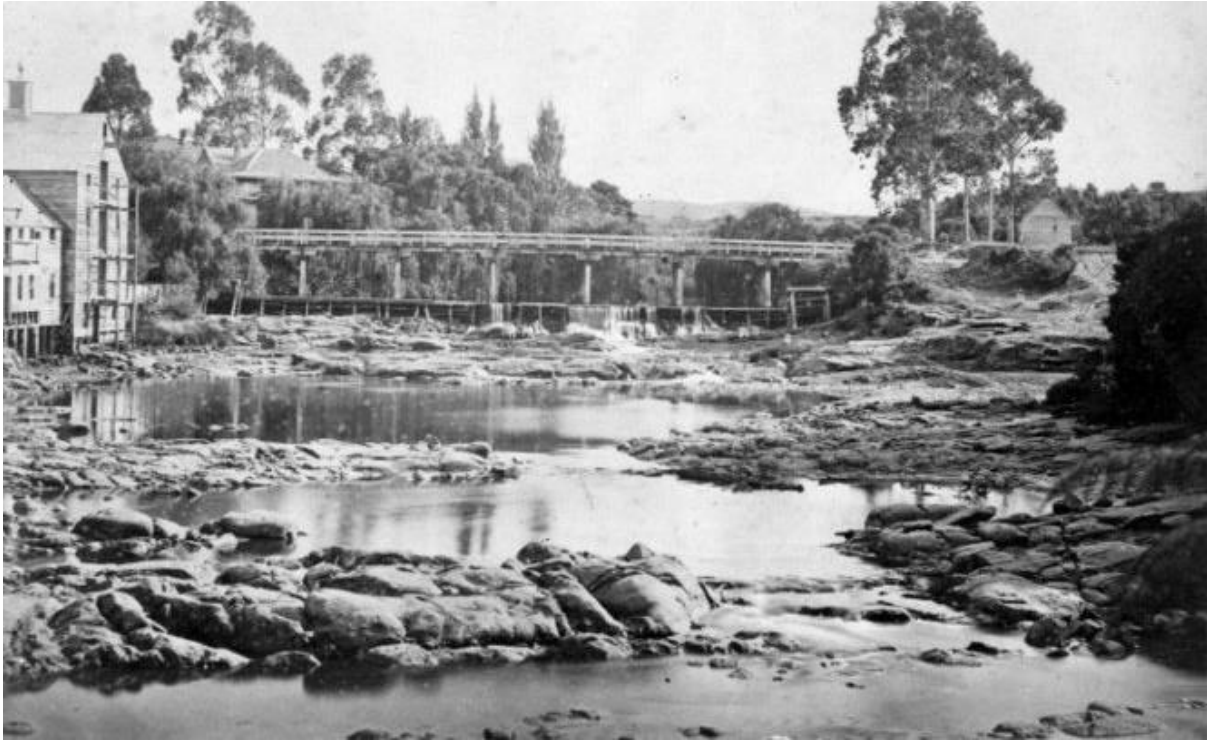
Figure 19. A braced timber dam/weir across the Mahurangi River. Water from the dam drove the flour mill to the left via a flume and waterwheel. In 1905 the Wilsons cement company concrete weir replaced this structure. Source unknown.

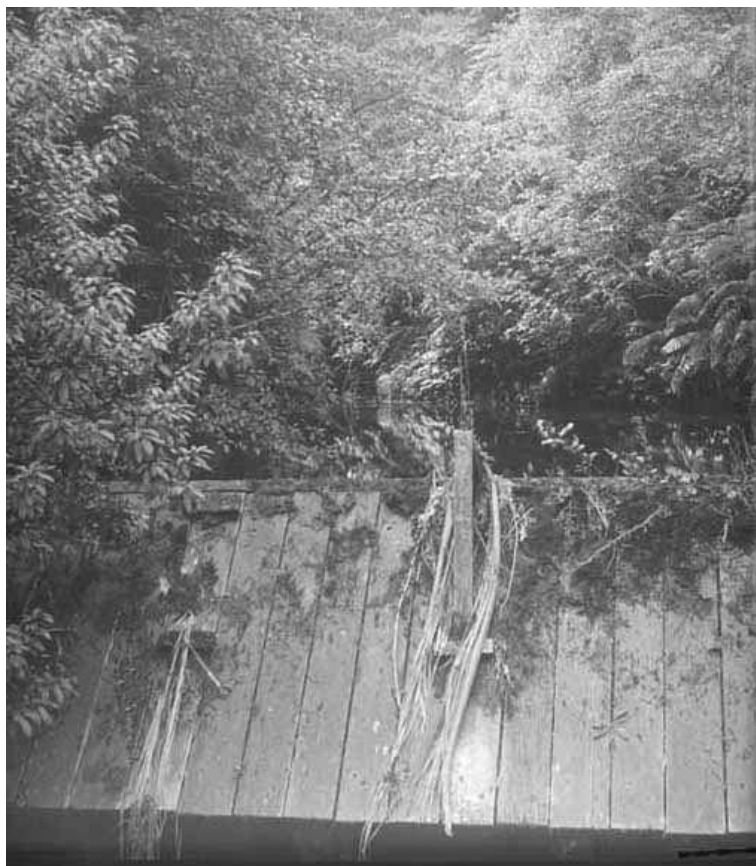
Figure 23. The Quinn's Creek dam in January 1919. James Richardson photograph. Auckland Libraries Heritage Collections 4-8665.

Type: Timber rafter water supply dam (temporary)

Current state: Unknown. Residual remains may be present

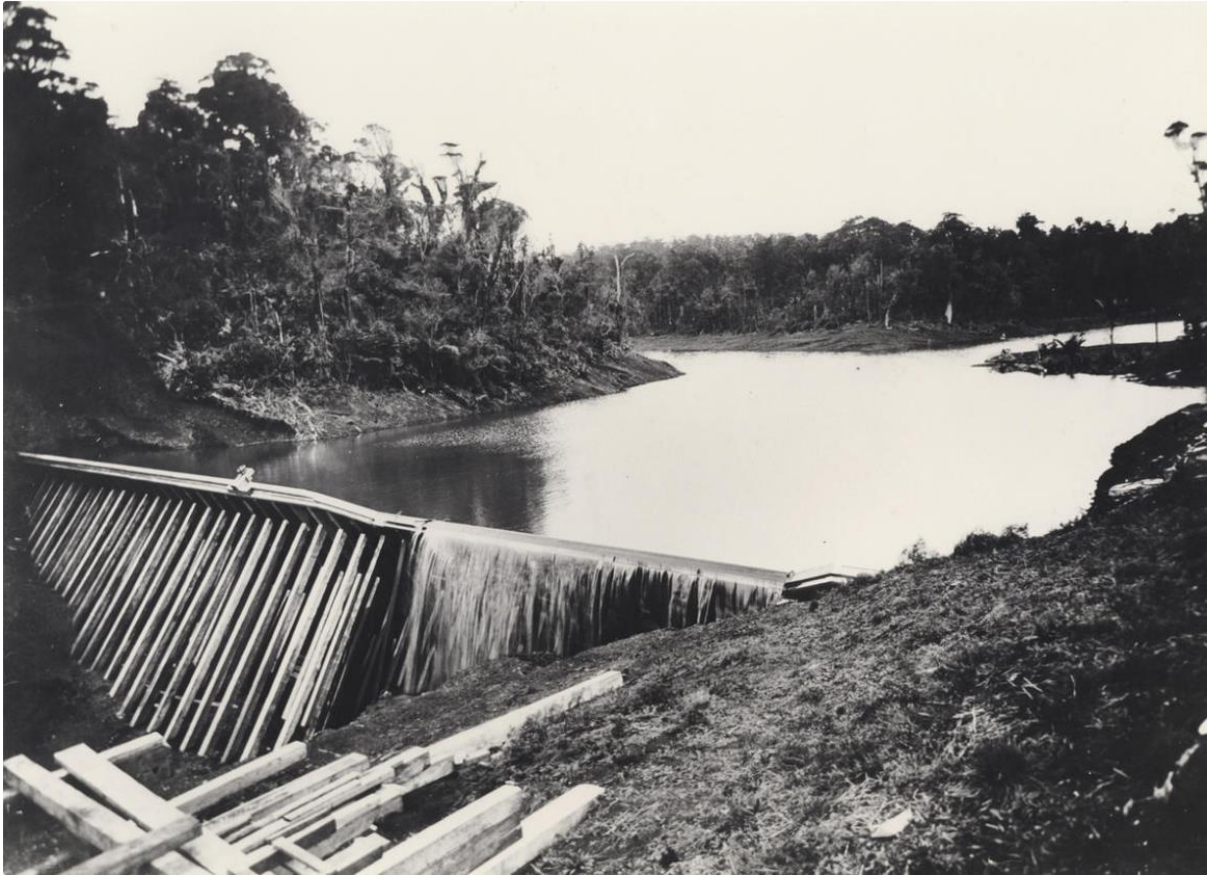
Figure 24. The timber auxiliary dam upstream from the Waitakere dam. Source: Walsh Memorial Library, The Museum of Transport and Technology (MOTAT) 06-655 (see also Offer p40).

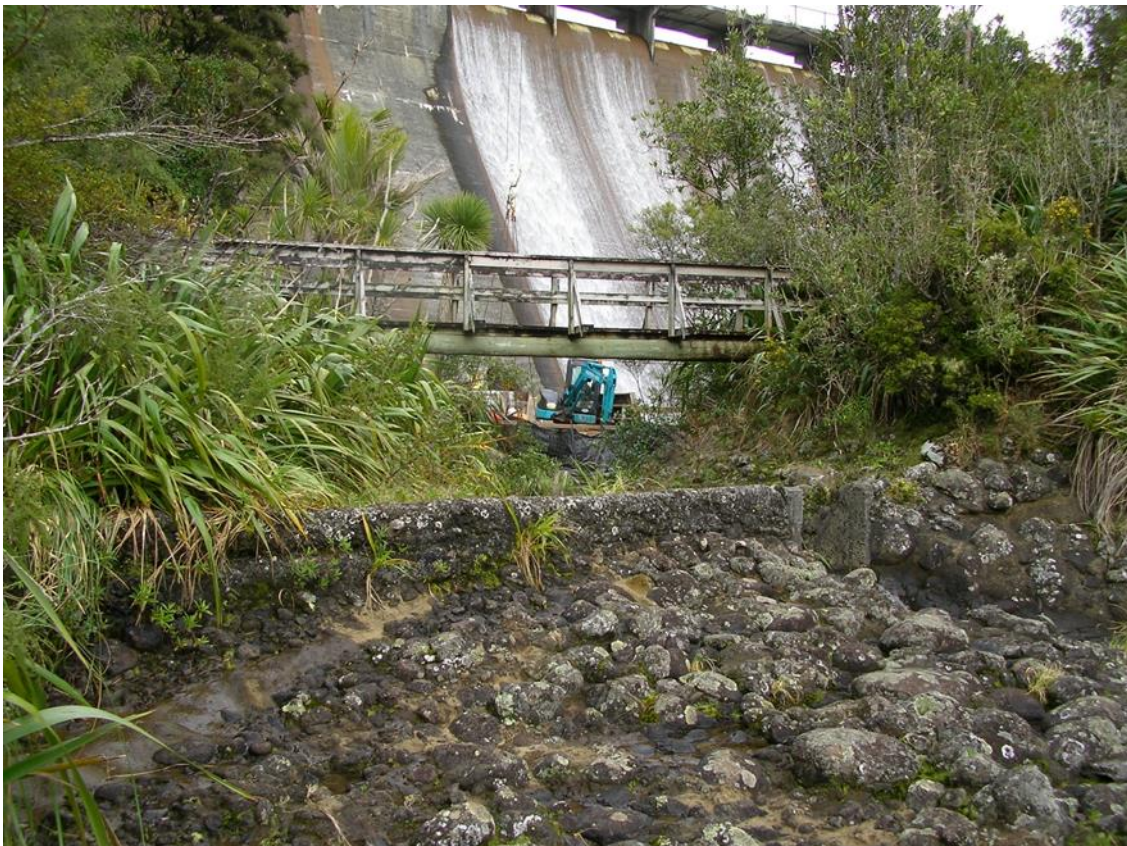
Figure 27. Weir with cutting on right hand side, Waitakere dam in background. WCS.

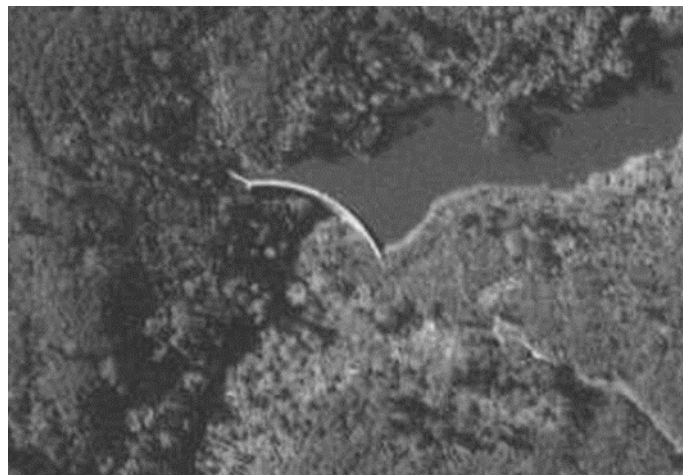
Figure 32. A 1940 aerial image of the sixth (1934) dam built on the Mangakura Stream (Dam 3). Source: Retrolens.

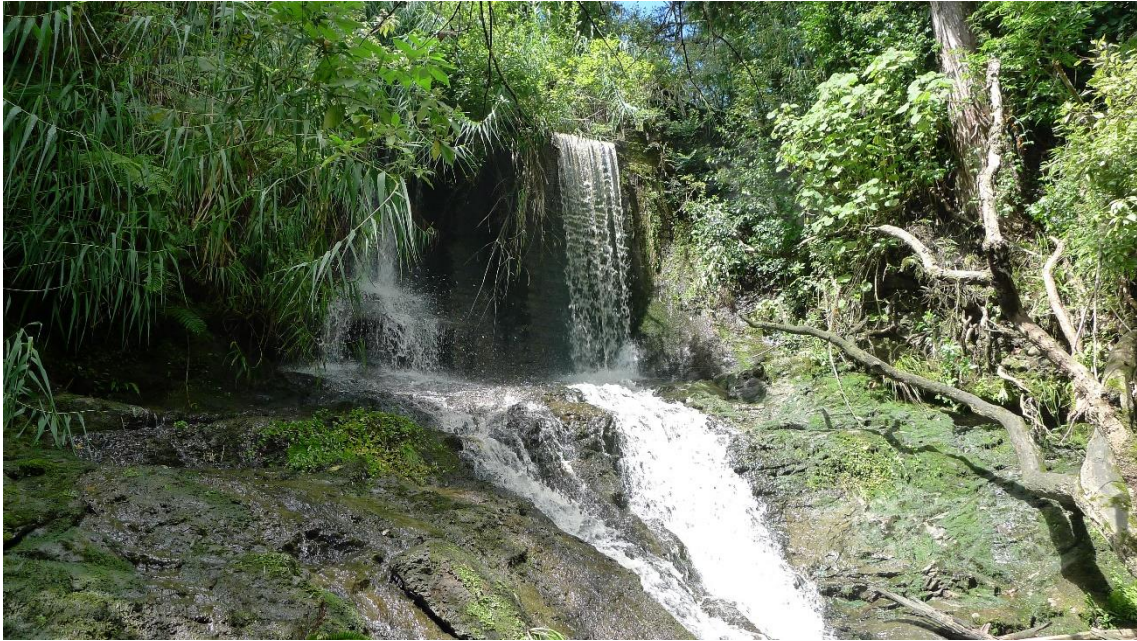
Figure 34. Downstream face of dam with water flowing over spillway into stream below.

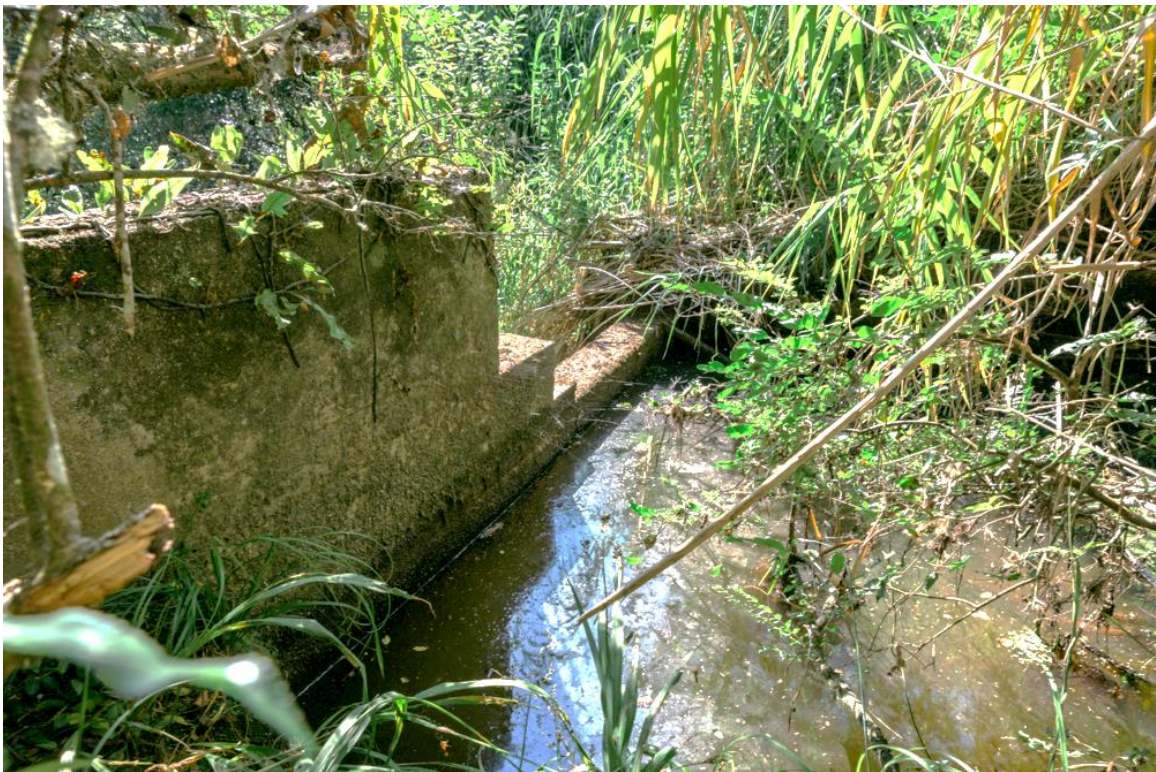
Figure 35. Rear/upstream face of the dam with water in reservoir below spillway level. Photograph: Jay Farnsworth.

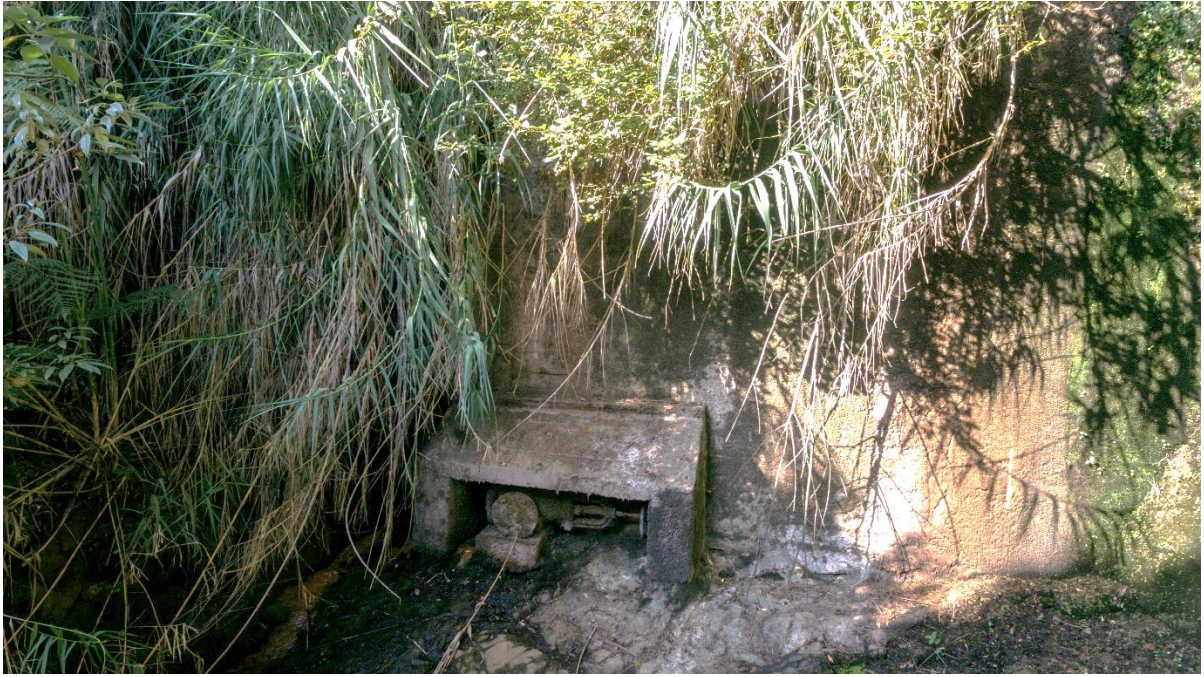
Figure 36. Front/downstream face of dam showing outlet valve and housing. Photograph: Jay Farnsworth (drone photo).

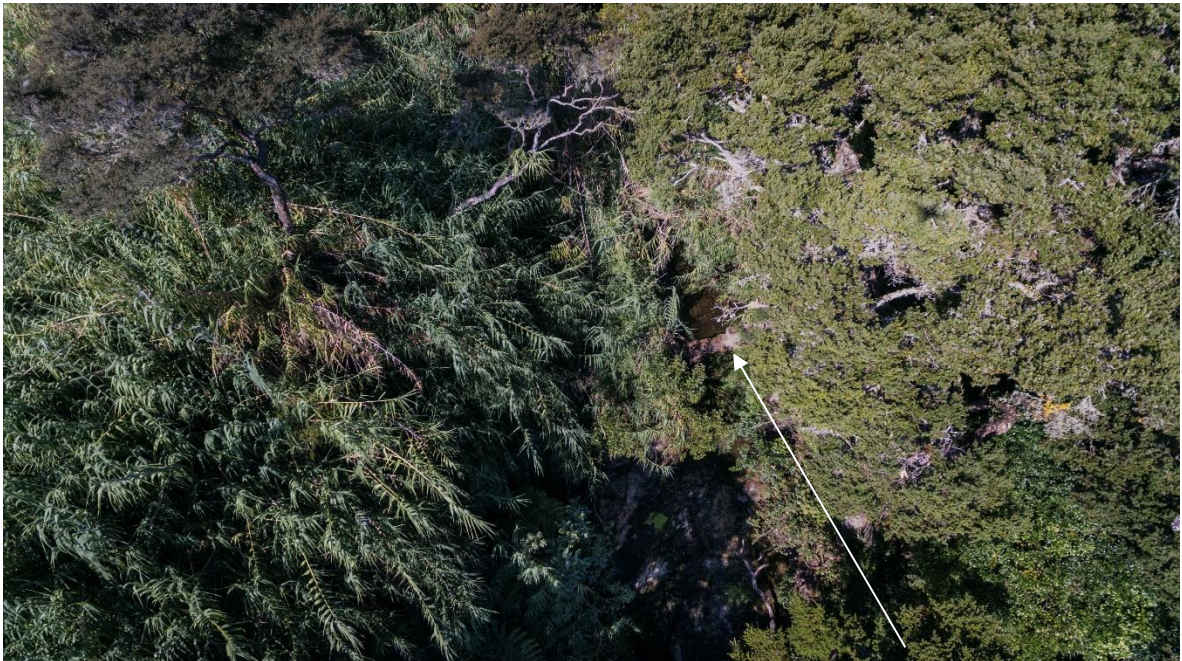
Figure 37. Aerial view of dam site showing extent of vegetation cover, spillway arrowed. Photograph: Jay Farnsworth (drone photo).

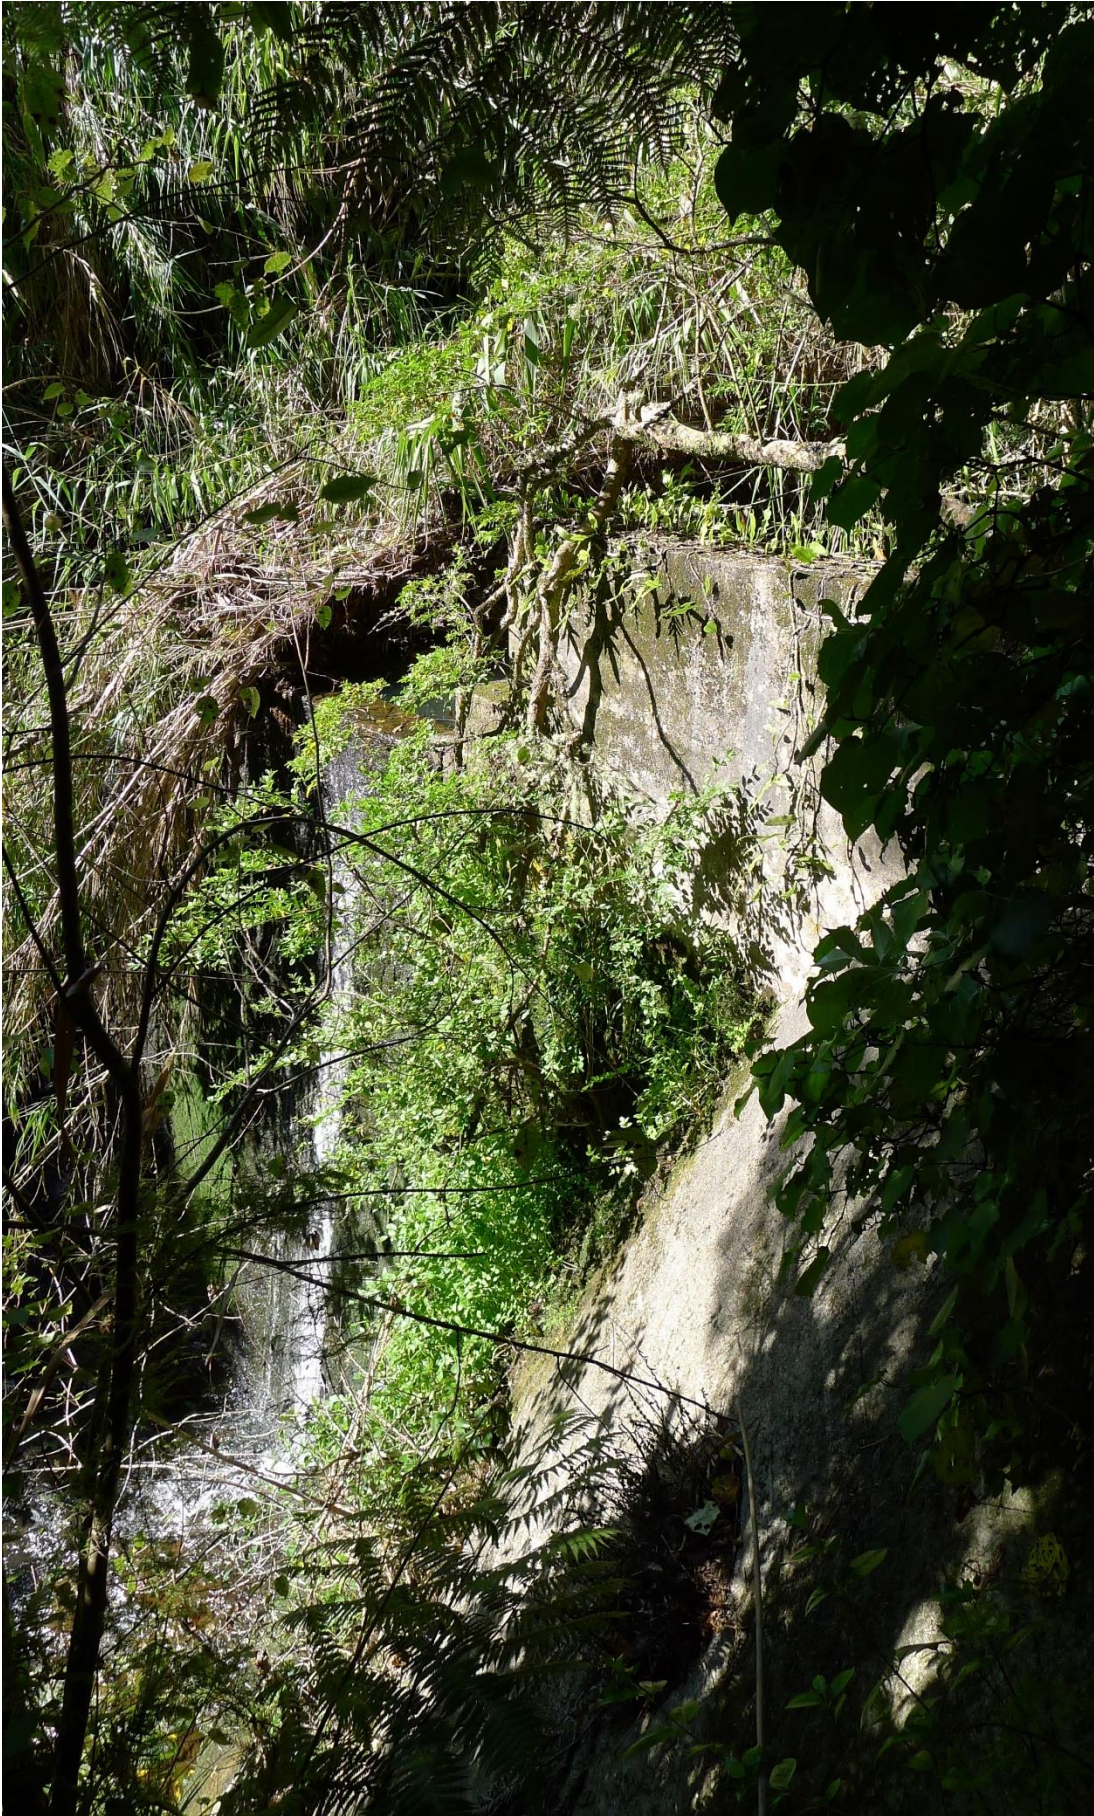
Figure 39. View towards downstream face of dam across eastern buttress

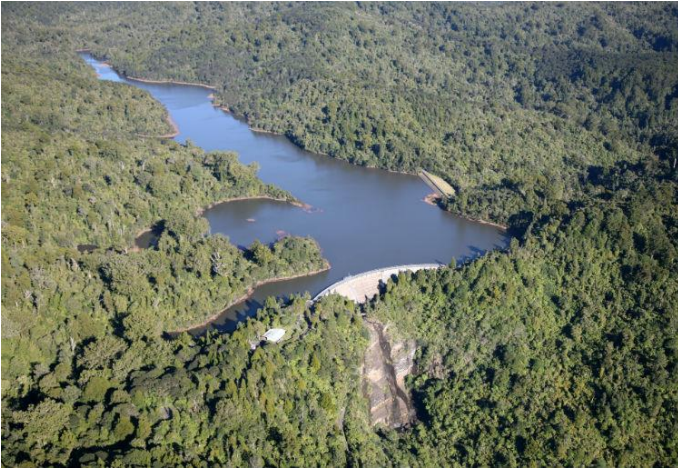
<p>Date of construction: 1906-10 Type: Urban water supply. Very large curved mass concrete dam with plums. 535ft (175m) long, 25-26m high [originally 19.5m from base of foundation, 16m above stream bed]. Modifications: Height increased by 16ft (4.0m) in 1926-8 to double capacity. Seismic strengthened, &amp; structural upgrade early 2000s Current state: Extant and still in use</p> <p>This is the largest and most significant dam designed by Wilson and was at the time of construction New Zealand's largest by far. It is considerably (12 times) larger than the Wilsons dam. It is an earlier design and is of unreinforced mass concrete.</p>

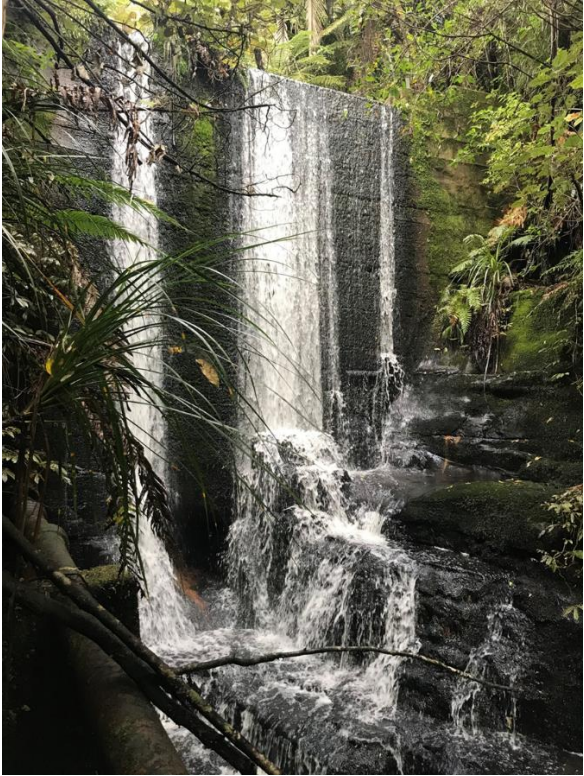
<p>Date of construction: 1912-14 Type: Urban water supply. Curved concrete gravity dam. Crest length 14m, dam height 6 m Current state: Extant. Dam face visible, but most of the reservoir has been infilled by a past landslip.</p> <p>This dam appears to be very similar to the Warkworth dam. It is slimmer in profile and differs in the treatment of the abutments (it is not buttressed), likely reflecting the site characteristics. It is also currently unknown if Dam 2 incorporated reinforcing and what materials were used in the concrete. It was built at around the same time and would provide a useful comparison with the Warkworth dam.</p> <p>The Mangakura dams have an element of collective significance as a group of dams that are the work of Hugh Munro Wilson.</p>

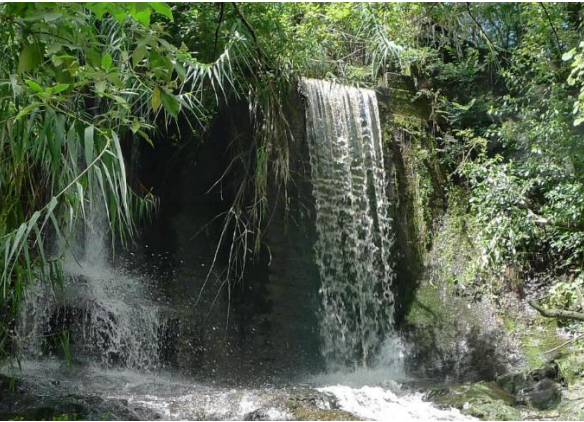
<p>Date of construction: 1913 Type: Industrial water supply. Curved reinforced concrete gravity dam, with buttresses at abutments. Crest length (reported) 14m, dam height ca 8m wide Current state: Extant, disused, reservoir silted up. Unmodified.</p> <p>While this does not have the same level of significance as the Waitakere dam and associated works, it is a good representative example of Wilson's concrete dam designs in unmodified condition.</p>

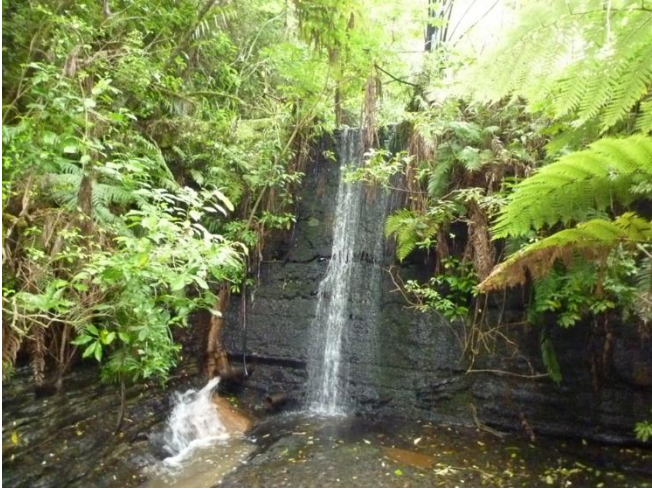
<p>Date of construction: 1920-21 Type: Urban water supply auxiliary dam. Rubble concrete or plastered stone masonry gravity dam. No further details. Current state: negligible storage and significant leakage paths through the structure.</p> <p>This dam is constructed differently from the Wilsons dam. While it contributes to the portfolio of extant dams designed by Wilson, it is not directly comparable to the cement company dam. It contributes to the collective significance of the Mangakura dams as a grouping of dams that are the work of Hugh Munro Wilson (<b>HMW</b>).</p>
<p>Mangakura Dam 4</p>	<p>Mangakura Stream, Helensville. Not visited or recorded  [Not visible, Location requested from WCS (WaterCare Services)]</p>	<p>Nil</p>

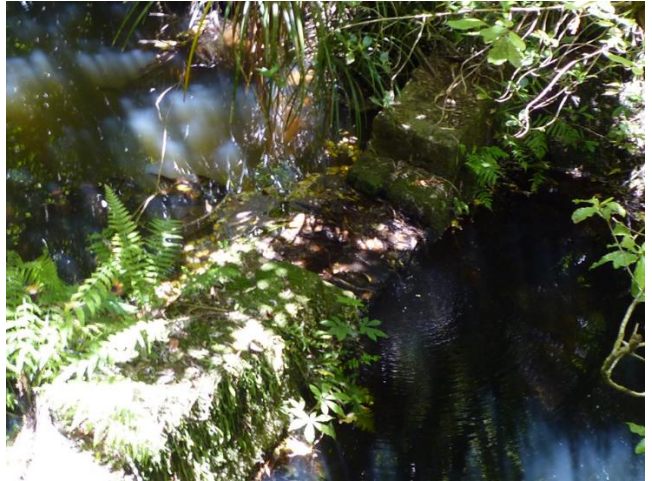
<p>Date of construction: ca. 1926. This dam appears to have been designed in 1919 and built in or around 1926. Type: Urban water supply. Concrete gravity dam. Dimensions unknown. Current state: Dam 4 is almost completely drowned in the Dam 3 reservoir.</p> <p>This is not a useful comparative example as it is substantially underwater with only the crest and spillway visible. The Mangakura dams do however have an element of collective significance as a group of dams that are the work of HMW.</p>

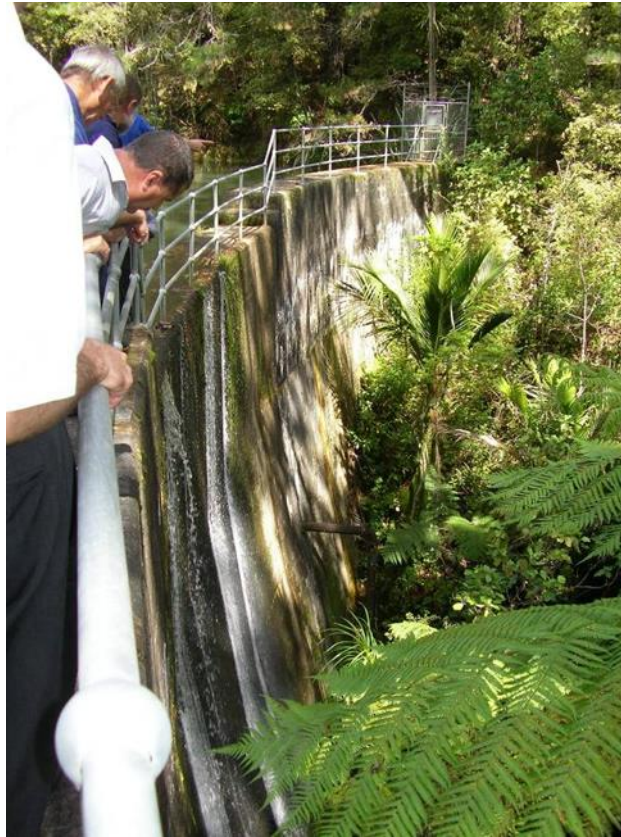
<p>Date of construction: 1934 Type: 14m high concrete arch-gravity dam with a substantial buttress and straight extension on the right/eastern abutment. Reservoir capacity ca 29,000m<sup>3</sup> Current state: Extant and still in use</p> <p>HMW did the preparatory design (in 1921) which formed the basis of the final construction drawings for Dam 3. It was</p>

completed five years after his death. It appears that the constructed dam differs significantly from the original drawings – possibly due to conditions encountered during construction.

This dam appears to be a later hybrid form with characteristics of both gravity and arch dam types and as such is not directly comparable to the Wilsons dam. It contributes to the collective significance of the Mangakura dams as a grouping of dams that are the work of HMW. In this case the final design appears somewhat different from the preparatory one.
