Preliminary Site Investigation

303 Buckland Road,
Buckland, Pukekohe

111010820

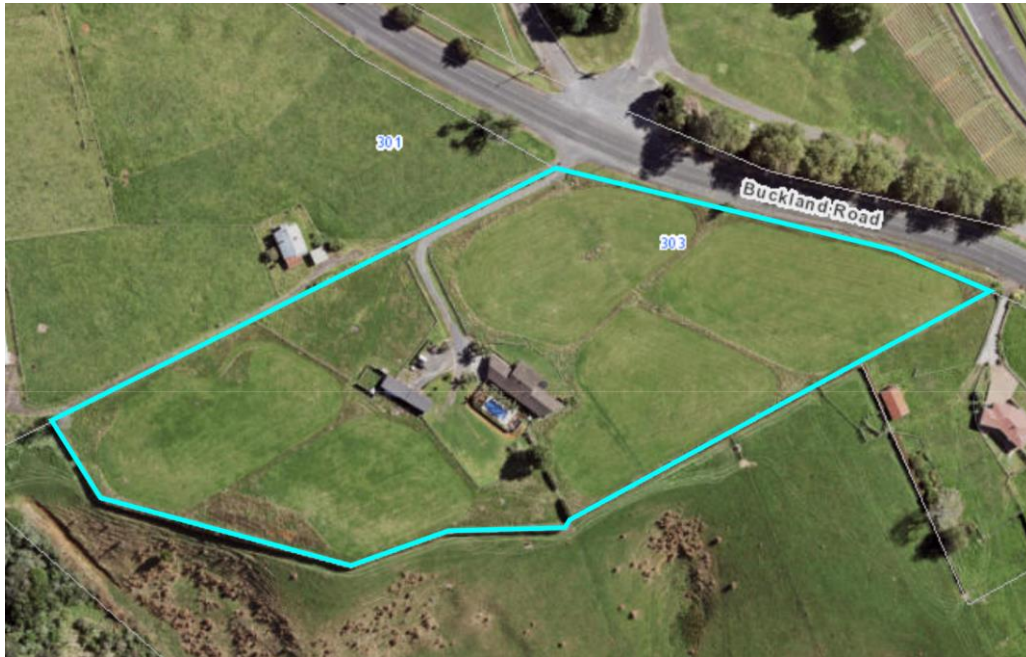
Figure 2: Aerial photograph of site

The topography of the site is gently sloping towards the north east. A residential dwelling constructed of brick and concrete is located in the centre of the site and an accessway connects it with Buckland Road in the north east. There is also a fibreglass swimming pool located to the south-west of the dwelling. A stable building constructed of iron with a concrete foundation is located to the west of the residential dwelling. The remainder of the land is currently pastoral land used for low intensity grazing for sheep, cattle and horses.

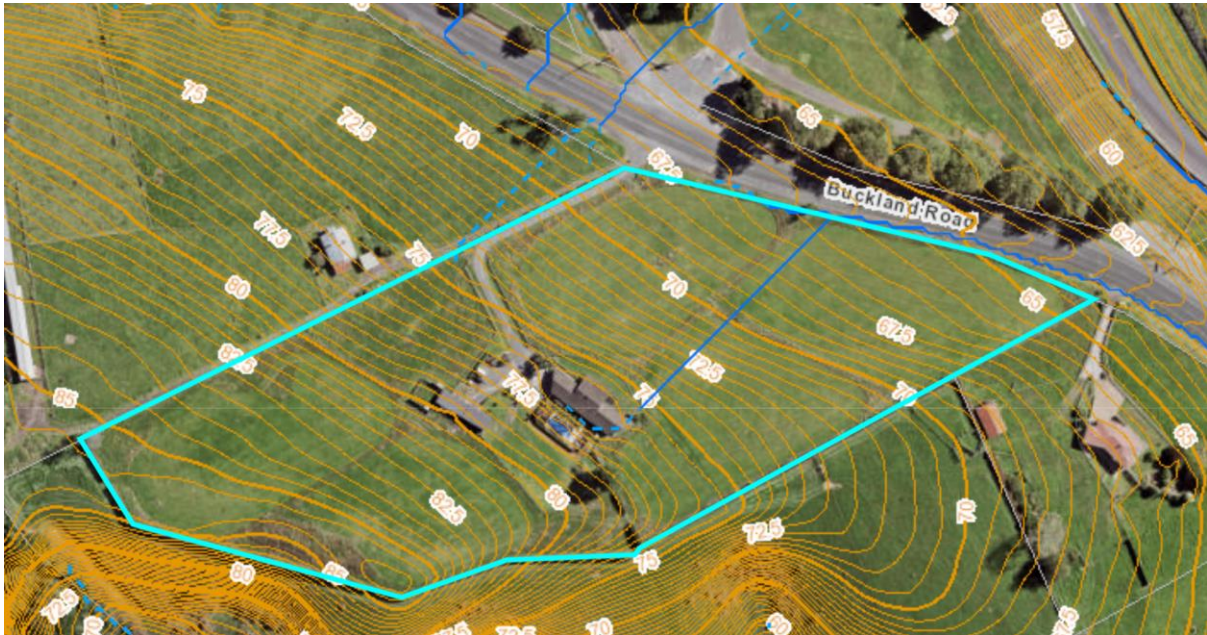
Figure 3: Site contours

An overland flow path runs from the centre of the site to Buckland Road in the north east (see Figure 3 below). Surface water flow is expected to be via sheet flow in a south west to north east direction off the site. No groundwater bores exist on site.

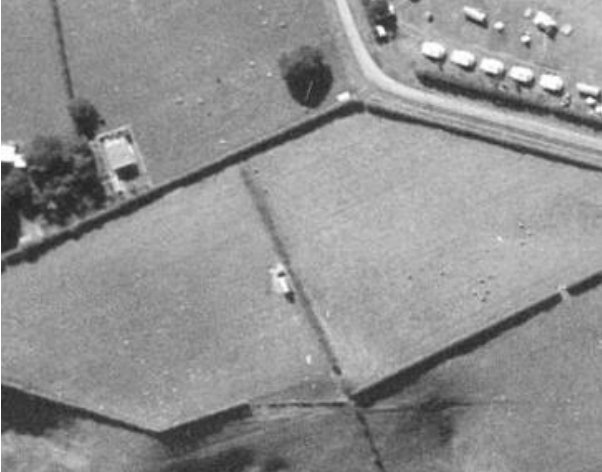
<p>Site appears pastoral with a small building in the centre of the site. The property is bounded by large hedges.</p>	Retrolens 2020.
1961

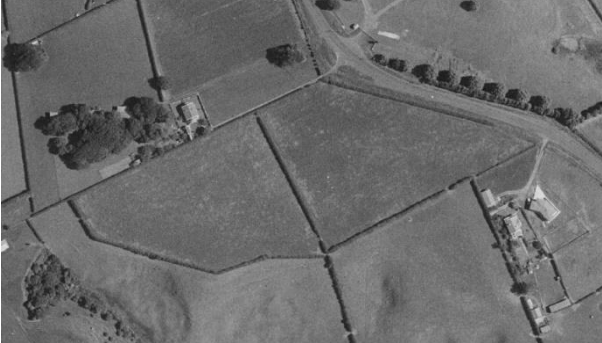
<p>Site appears as it did in 1942, however the structure in the centre of the site appears to have been removed. The surrounding land appears to be pastoral.</p>	Retrolens 2020.
1975

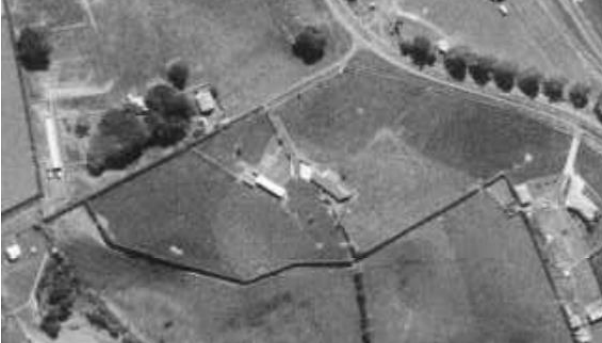
<p>Two structures have been constructed in the location of the existing dwelling and stables. An accessway connects these with the road in the north east. The remainder of the land appears to be pastoral.</p>	Retrolens 2020.

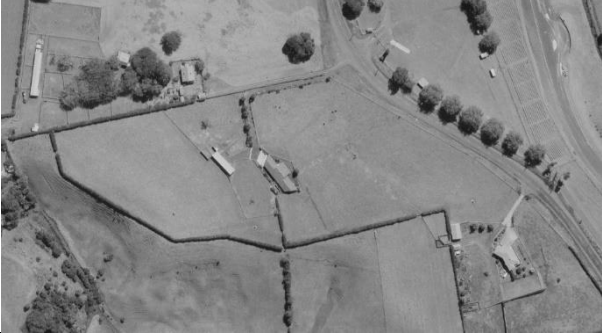
1978

Site appears generally as it did in 1975.	Retrolens 2020.
1981

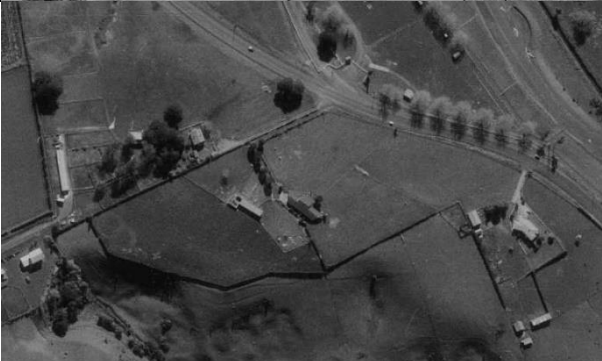
Site appears generally as it did in 1978.	Retrolens 2020.
1988

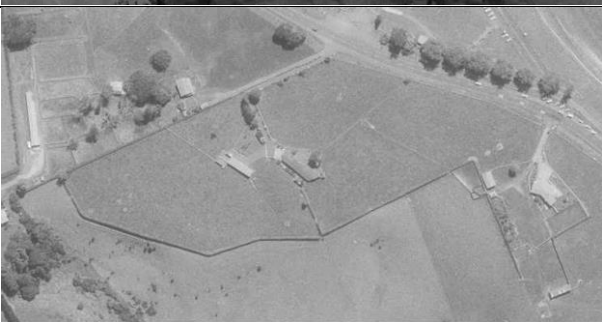
Site remains pastoral land. Structures still present in the centre of the site. The majority of the surrounding land is pastoral.	Retrolens 2020.
2001

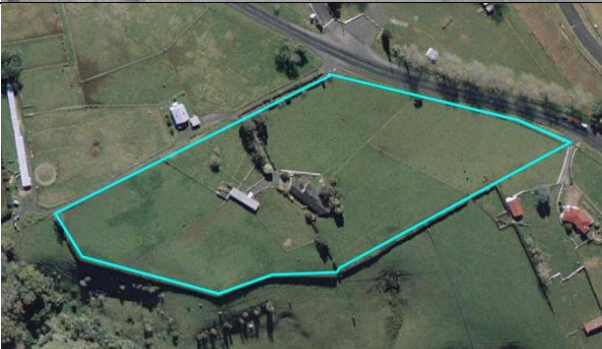
Structures remain apparent in the centre of the site. The majority of the site appears to be pastoral.	Auckland Council GeoMaps 2020.

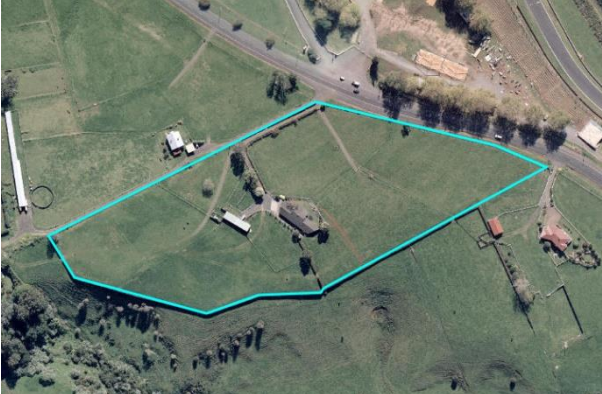
2006

<p>Site remains pastoral as it did in 2001. No change to the structures on the site.</p>	<p>Auckland Council GeoMaps 2020.</p>
2008

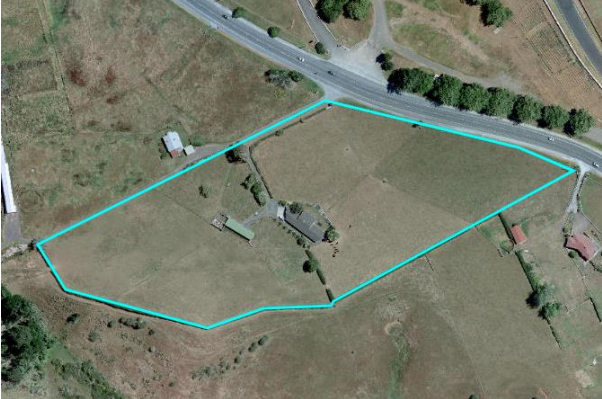
<p>Site appears as it did in 2006.</p>	<p>Auckland Council GeoMaps 2020.</p>
2011

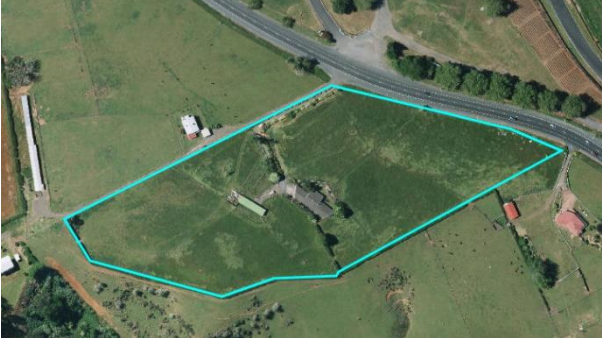
<p>Site appears as it did in 2008.</p>	<p>Auckland Council GeoMaps 2020.</p>
2017

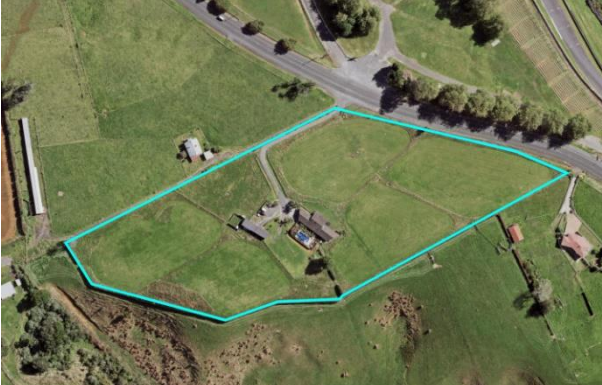
<p>The majority of the site appears to be pastoral. Structures still present in the centre of the site. A swimming pool is apparent to the south-west of the dwelling.</p>	<p>Auckland Council GeoMaps 2020.</p>

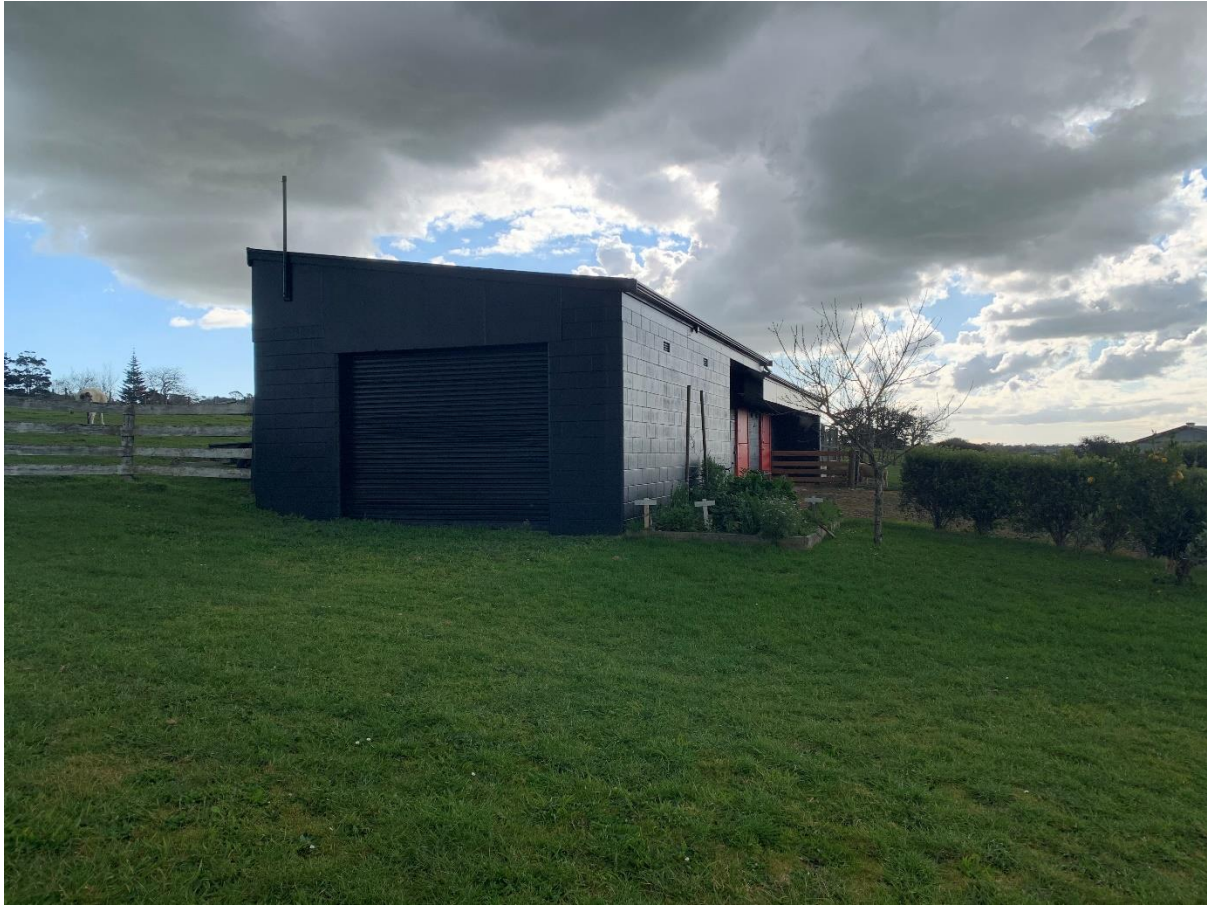
Image 1: Stable block

An interview with Jason Woodyard, the current owner, was conducted by Kelly Deihl of Environmental Management Solutions. He confirmed that the land has always been used for low intensity pastoral grazing. The stable building on site was constructed in 1971 from iron and concrete block (refer image below). Mr Woodyard confirmed that his family reside in the dwelling. The dwelling is constructed of brick and concrete over block and stands on a concrete foundation. Mr Woodyard was not aware of any fuel or chemical storage or farm dumps on the property.

Council records indicated the potential for Asbestos Containing Material and leaded paint to have been used within the buildings on site. The buildings are of block and iron construction and brick with concrete over block construction. Both are in good condition. It is considered that neither meet the criteria of a HAIL activity.

The potential for Asbestos Containing Material to have been used within the construction of the dwelling and stable building was identified, however these structures are of brick and block construction, respectively and are to be retained through this development. Any future development of these will require an Asbestos Demolition Survey to be carried out by a suitably licensed asbestos contractor, prior to removal.

Should removal of buildings be proposed in the future, then prior to removal, an Asbestos Demolition Survey shall be prepared by a suitably licensed asbestos contractor and recommendations of this survey shall be followed by the developer.
