15 July 2022

Job No: 64872#BEE2

## HIGHBROOK PRIVATE PLAN CHANGE REQUEST – PRELIMINARY LAND CONTAMINATION REVIEW

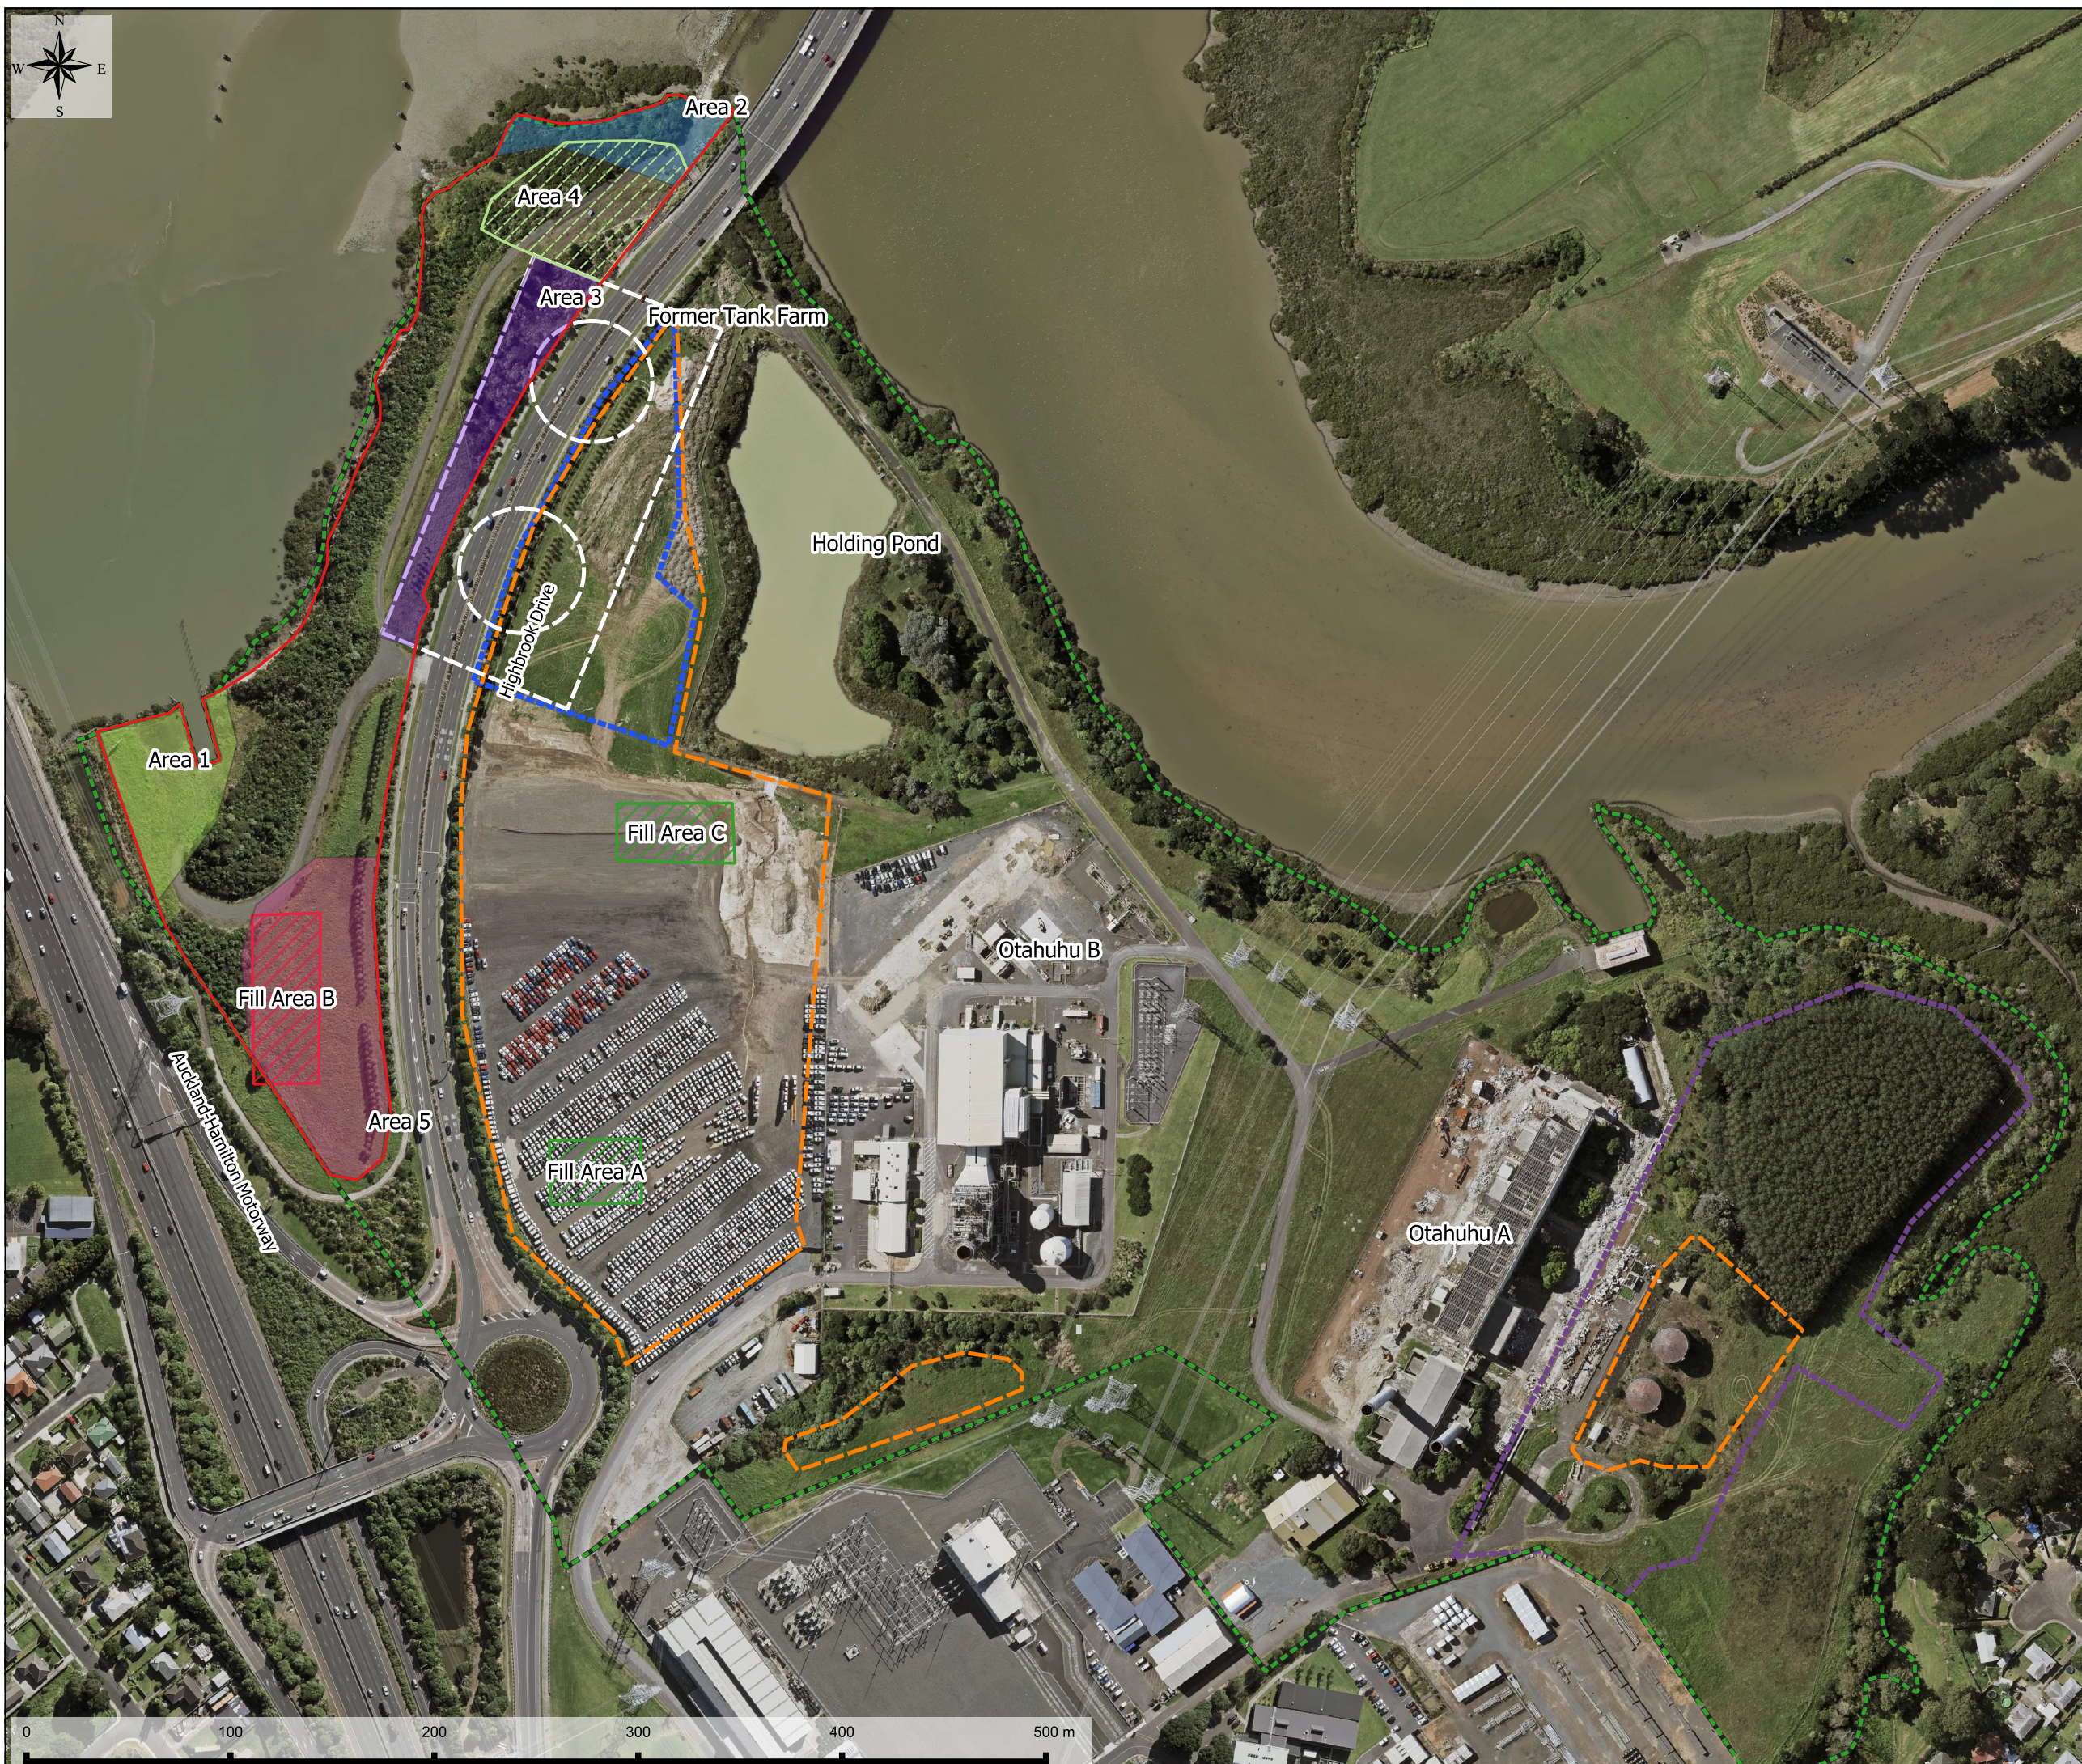
MAP NO.  
**64872#BEE02 01**

Babbage notes that the site requested to be rezoned has not had an intrusive environmental investigation performed on it. Based on the records and historical aerial photographs reviewed, Babbage has identified five areas that have potentially impacted soil from previous site activities. The areas, potential constituents of concern within each area, commentary on soil impacts, and probability of impacts to soil are presented in Figure 1 and Table 2 below.

- 8 Sparky Road Site
- Highbrook Site Boundaries
- Potential Contaminated Land Areas - Highbrook Site**
  - Area 1 - Reclamation (1969 - 1979)
  - Area 2 - Reclamation (1967)
  - Area 3 - Former Tank Farm (1967 - 2003)
  - Area 4 - Former Construction Yard Area (2006)
  - Area 5 - Soil/Fill Material Stockpiled (2006)
- Former Intrusive Investigations**
  - Areas of T&T 2011 Investigation
  - T&T 2011
  - T&T 2011
  - Not Investigated
  - Area of GSL2018 DSI Investigation
  - Area of GSL2019 Investigation

**Table 2. Probability of contaminated areas with exceedances above the NESCS SCS for residential land use and AUP PA criteria.**

Area	Potential contaminants of concern	Commentary on potential soil impacts	Probability of exceedances in soil
Area 1 – South-western portion (reclaimed land 1969-1979)	Unknown source and quality of reclamation fill material. Potential contaminants: Metals, PAH, TPH, polychlorinated biphenyls (PCB), and asbestos containing material (ACM).	Estimated reclaimed land area cover is approximately 8% of the total site area. T&T 2015 estimated the depth is likely to be between 0.5-5 m based on topography. Based on the constituents of concern, soil impacts can be managed or remediated if encountered.	High-medium likelihood considering the uncontrolled practices of waste disposal during that period.
Area 2 – North-eastern portion (reclaimed land 1967)	Unknown source and quality of reclamation fill material. Potential contaminants: Metals, PAH, TPH, PCB, and ACM.	Estimated reclaimed land area cover is approximately 6% of the total site area with depth estimated between 0.5-5 m (T&T 2015). Based on the constituents of concern, soil impacts can be managed or remediated if encountered.	High likelihood considering the uncontrolled practices of waste disposal during that period and visual observation of potential ACM.

Area 3 – Former tank farm within the site (1967-2003)	Unknown source and quality of fill material for containment berm and historical spills from ASTs. Potential contaminants: Metals, PAH, TPH and ACM.	Estimated area cover is approximately 9.5% of the site near the northern border of Highbrook Drive. T&T (2011) and GSL (2019) investigation at the southern border of the road showed concentrations were below the applicable proposed land use criteria and no groundwater have been affected by soil contamination. T&T (2015) mentioned that extensive earthworks (19,000 m <sup>3</sup> of imported cleanfill and 3,000 m <sup>3</sup> of cut) was undertaken for proposed reshaping the northern border of the road which falls within the site. Based on the constituents of concern, soil impacts can be managed or remediated if encountered.	Low likelihood based on the investigations on nearby areas and earthworks undertaken on site for Highbrook Drive construction.

Area 4 – Former construction yard area (2004-2008)	Surficial soil contamination from stored material and hazardous substances. Potential contaminants: Metals, PAH, and TPH.	Estimated area covers approximately 10% of the total site area. Estimated period of this activity comprised 4 years (2004-2008) based on T&T 2015 report. Based on the constituents of concern, soil impacts can be managed or remediated if encountered.	Low likelihood considering the short period of exposure and legislative requirements on storage and handling of hazardous materials.

Area	Potential contaminants of concern	Commentary on potential soil impacts	Probability of exceedances in soil
Area 5 – Southern area (Fill Area B placed 2006)	Burn off area for domestic waste and dump area of Ōtāhuhu site for general and industrial waste and hardfill (T&T 2015). Potential contaminants: Metals, PAH, TPH, PCB, organochlorine pesticides (OCP), volatile organic compounds (VOC), semi-volatile organic compounds (SVOC) and ACM.	Estimated area cover is approximately 19.5% of the total site area. Investigations carried out by T&T 2011 in dump sites A and C nearby showed concentrations of contaminants detected below the applicable proposed land use criteria. Due to the public access made available to this dump area, there may be other constituents of concern not tested for in previous environmental assessments. Based on the constituents of concern, soil impacts can be managed or remediated if encountered.	Medium-low likelihood based on the nearby investigations and relatively recent (2006) use as dump site.

This table above shows that the five areas that have potentially impacted soil from previous site activities cover approximately half of the site area, however approximately 33% of the site area has medium or high likelihood to present soil contamination which may exceed the applicable human health and environment guidelines. These areas comprise of reclaimed land areas (Areas 1 and 2) near the Tamaki River bank and the Fill Area B (Area 5). It is anticipated that the other two areas (Areas 3 and 4) will have a low likelihood of encountering soil impacts above the applicable proposed land use criteria

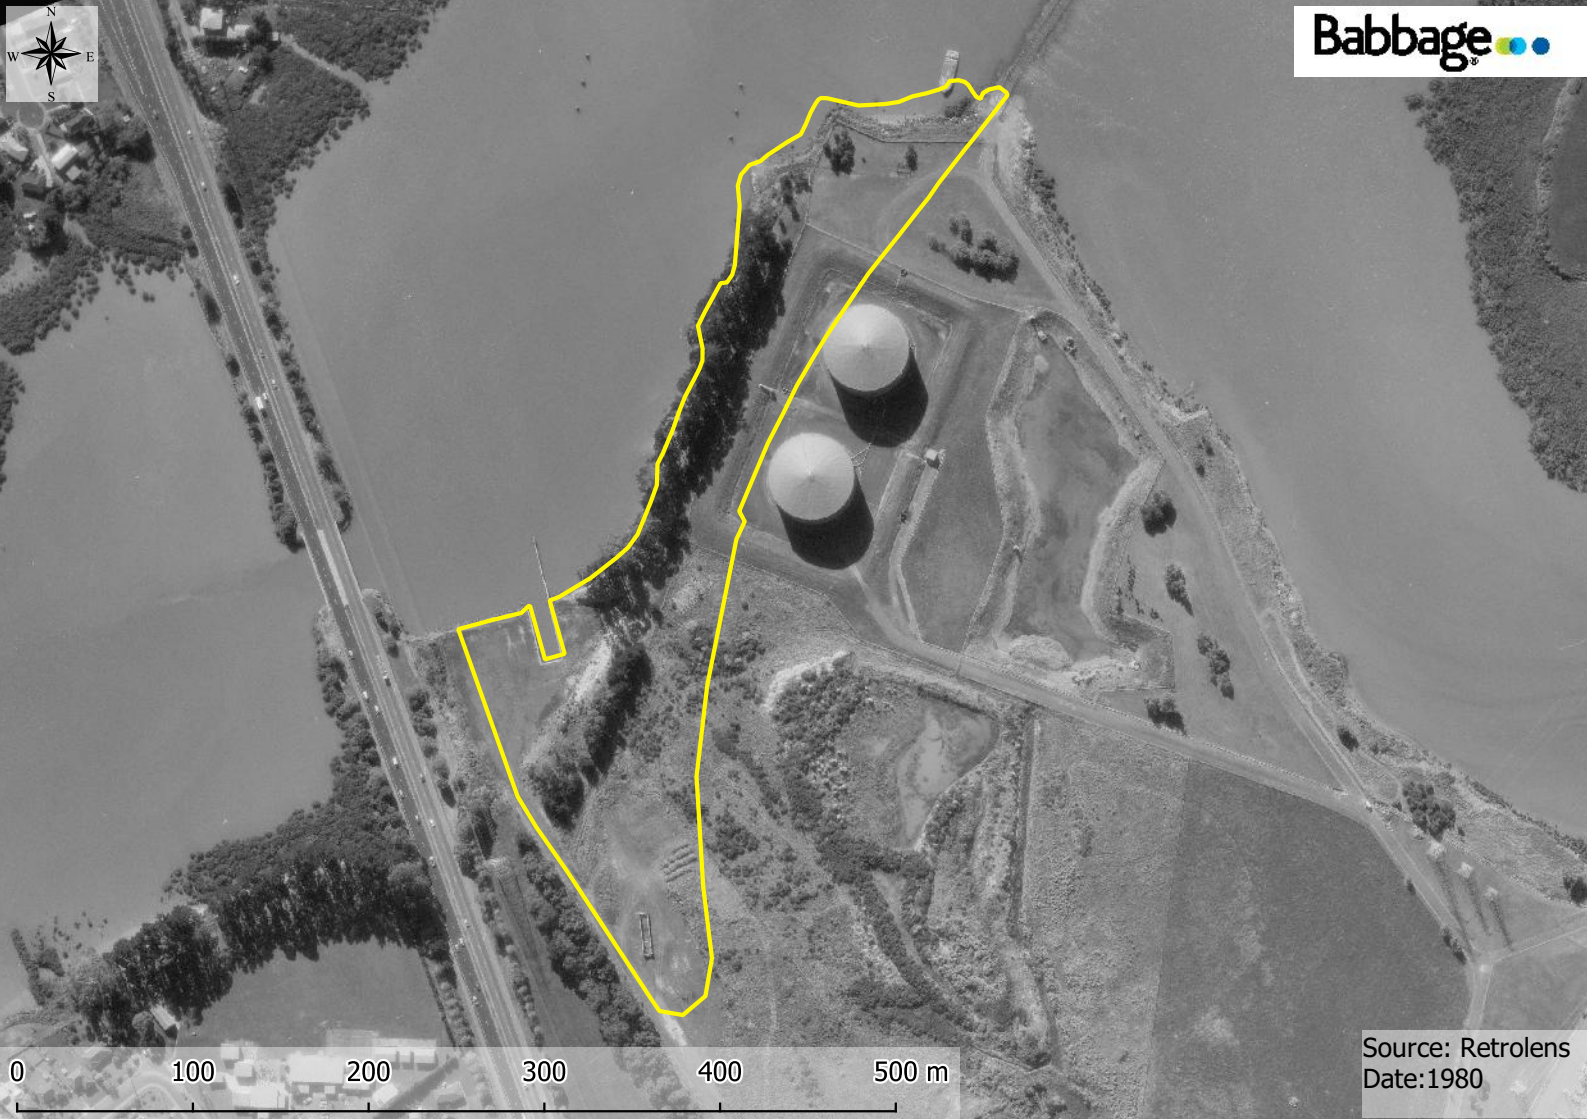
Source: Retrolens  
Date: 1980

1980	Some stockpiled material is visible to the north-east of the rectangular feature in the southern area of the site.	No significant changes observed.
1988	North-eastern portion of the site appears to be used as a construction yard. The rectangular feature in the south-western corner of the site has been removed.	No significant changes observed.
1996	The construction yard in the north-eastern portion of the site appears to have been removed.	The second pond to the south-east of the ASTs is no longer visible.
2001	No significant changes at the site.	The Ōtāhuhu B power station has been constructed south-east of the site.

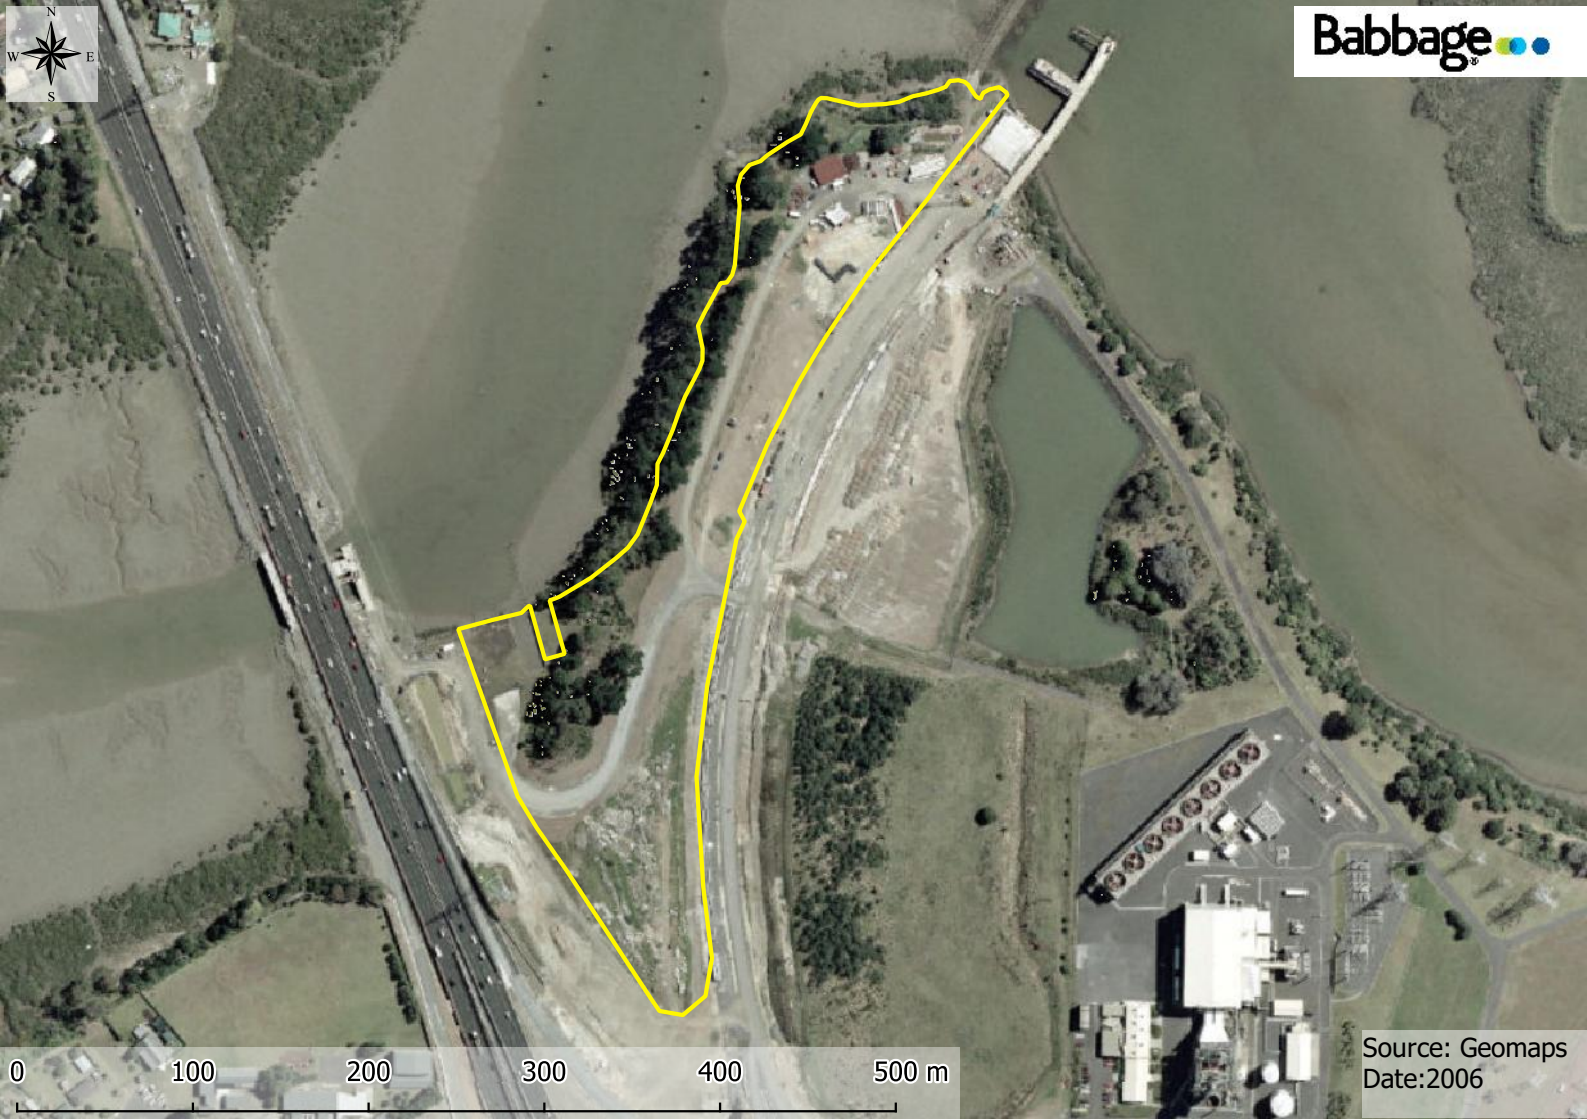
Source: Geomaps  
Date: 2006

Year	Site	Surrounds
2003/2004	The ASTs have been removed although their footprints and containment berm are still visible. A roadway is visible from the ASTs leading south-west.	No significant changes observed.
2006	The eastern part of the site has been subject to earthworks associated with the construction of Highbrook Drive along the eastern site boundary. The north-eastern portion of the site appears to be being used as construction yard for the road works. The roadway through the centre of the site appears to have been widened and extended to the yard in the north and to a site access from the Southern Motorway in the south-west portion of the site. Soil/fill material appears to have been stockpiled in the south-western part of the site.	A stormwater pond has been constructed between the motorway and the site. Placement of fill appears to be ongoing to the east of the northern part of the site where the former AST containment area was. Construction works for the bridge over the Otara Creek are visible to the east of the site.

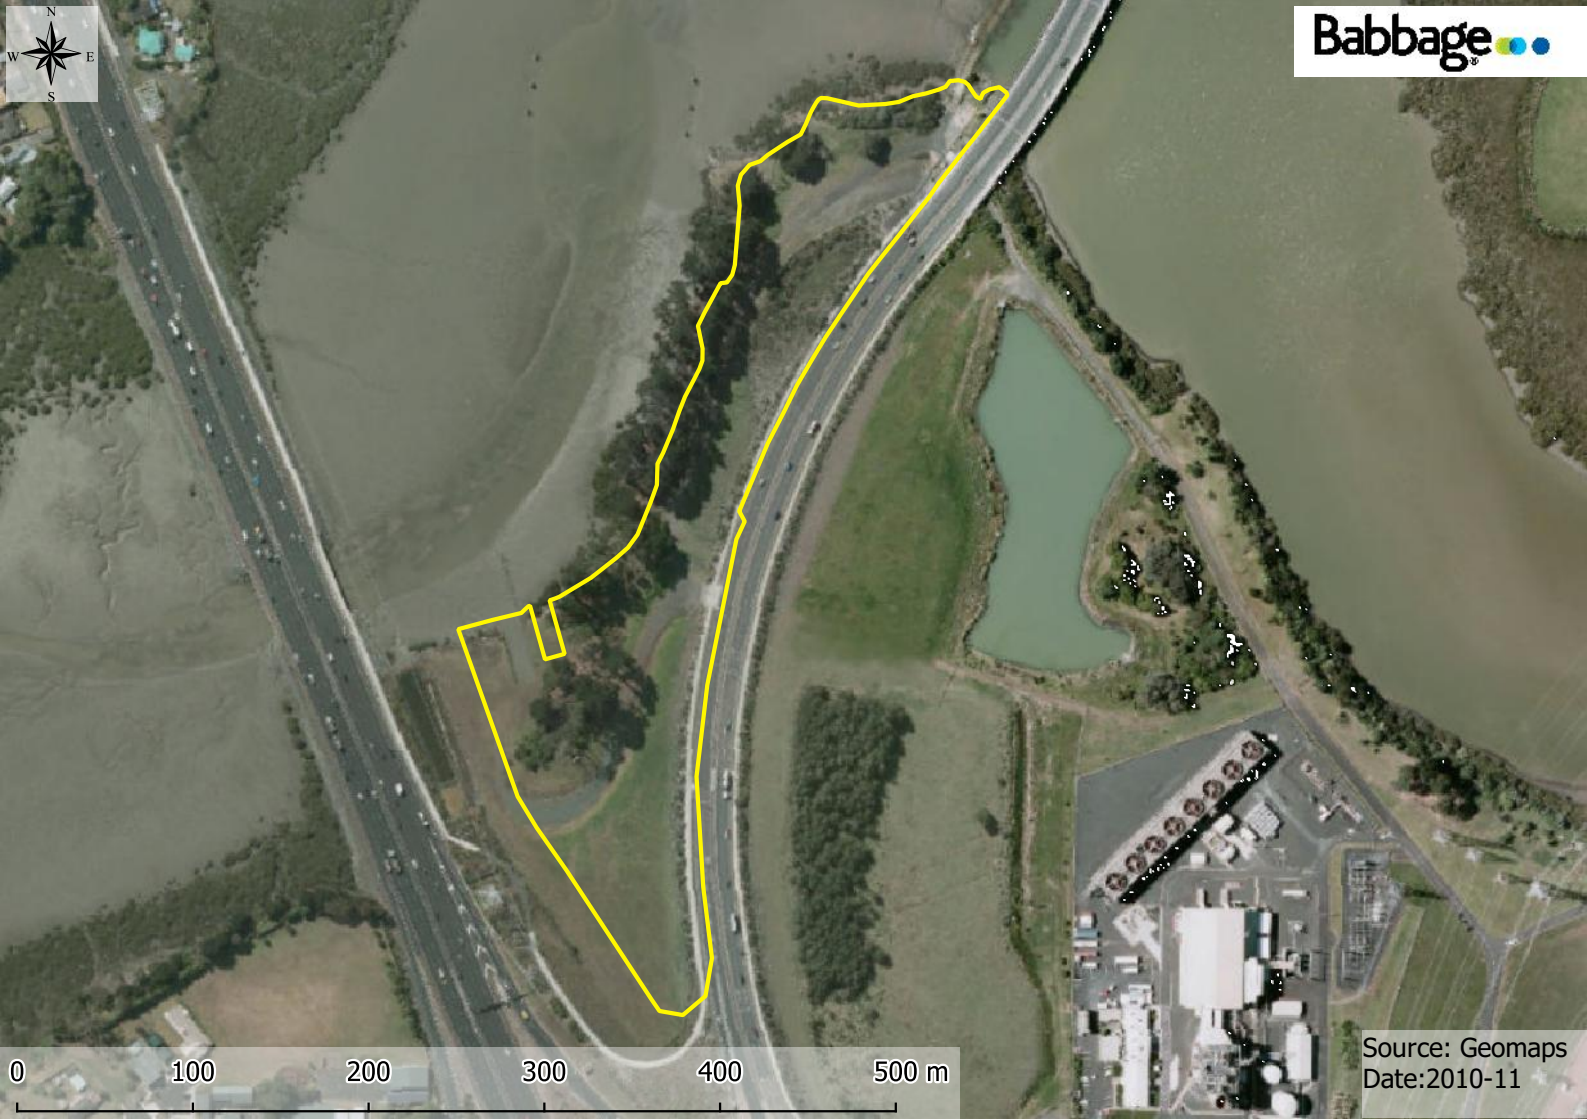
Source: Geomaps  
Date: 2010-11

2008	Highbrook Drive has been completed and areas adjacent to the road converted to grass or plantings.	Electric pylon visible between motorway and the north-western corner of the site.
2010-2011	The construction yard in the northern part of the site appears to be gone. The south-western corner of the site appears to have been levelled and is grassed.	No significant changes observed.
2017	No significant changes on site.	A large area between Highbrook Drive and the power station has been cleared of vegetation, and hardfill placed for use as a vehicle parking area. Stockpiled material is visible between the Highbrook Drive and the pond.
2021	No significant changes on site.	The large pond to the east of the site has been partially drained and earthworks are occurring in this area. Hardstand area to the west of Ōtāhuhu B power station has increased.

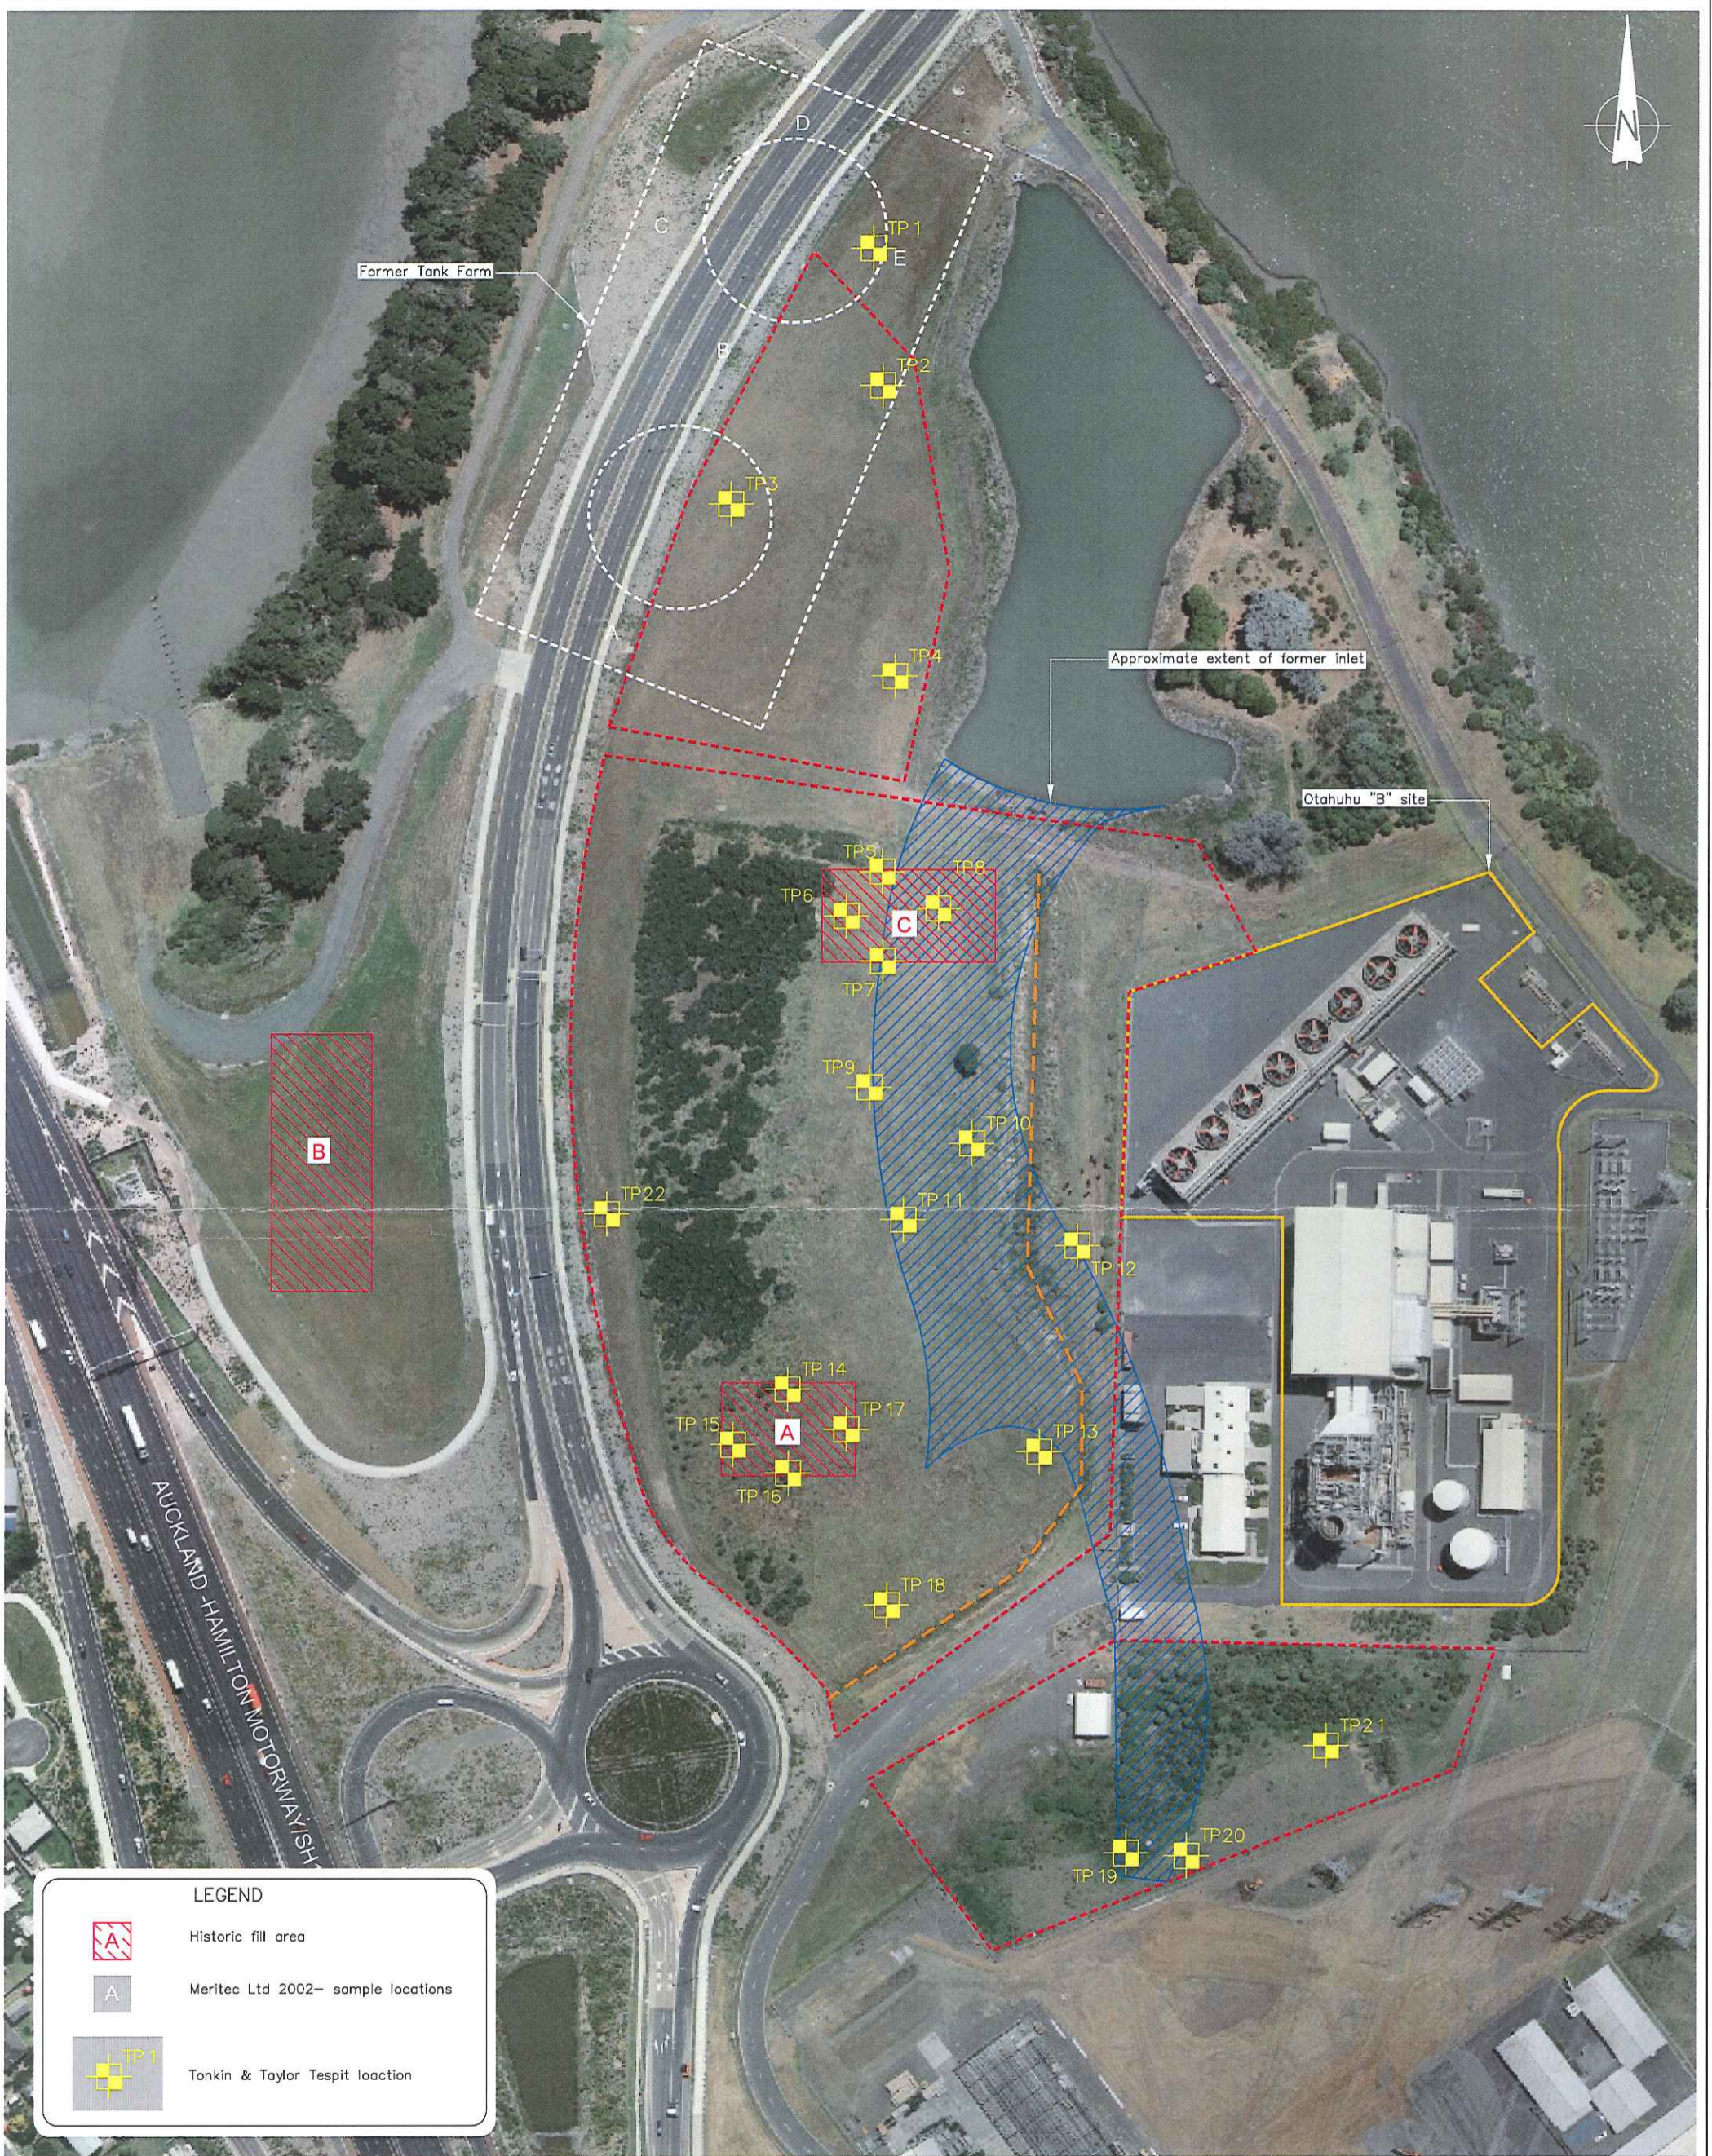
**CONTACT ENERGY LTD**  
 GROUND CONTAMINATION ASSESSMENT  
 PROPOSED TURBINE PLANT & TANK FARM  
 Site Investigation Plan

- Historic fill area
- Meritec Ltd 2002- sample locations
- Tonkin & Taylor Tespit location

T&T summarised soil investigation work carried out in August 2010 and reported in 2011 (T&T 2011). Refer to investigation area indicated on T&T Figures 3 and 4 in Appendix B. Selected soil samples were analysed for metals, TPH and PAH. Groundwater was collected from test pit TP2 and analysed for PAH and TPH. Excavations in the former tank farm area encountered fill comprising silt with minor sand and clay. A strong hydrocarbon odour was recorded in the fill material and groundwater at 2.5 m below ground level (m bgl) in the test pit TP2. Groundwater was encountered in the majority of the test pits approximately 0.5 to 1 mbgl. According to T&T, the majority of results are present below background values (non-volcanic) for metals, PAH and TPH. There are some concentrations of metals, pyrene and BAP equivalent that are present at levels above the published background, statistical analysis of these results indicates that following statistical analysis most elevated results fall below background for all contaminants except benzo(a)pyrene (BAP) equivalent. Laboratory results were below the NESCS SCS for residential land use 10% produce and for AUP PA criteria. Results of groundwater of TP2 show concentrations of PAH at or below both ANZECC 80% and 95% freshwater protection levels and total petroleum hydrocarbons were detected in all three ranges, but at relatively low levels (0.14 to 85 mg/l). According to T&T concentrations are low enough not to cause an ongoing

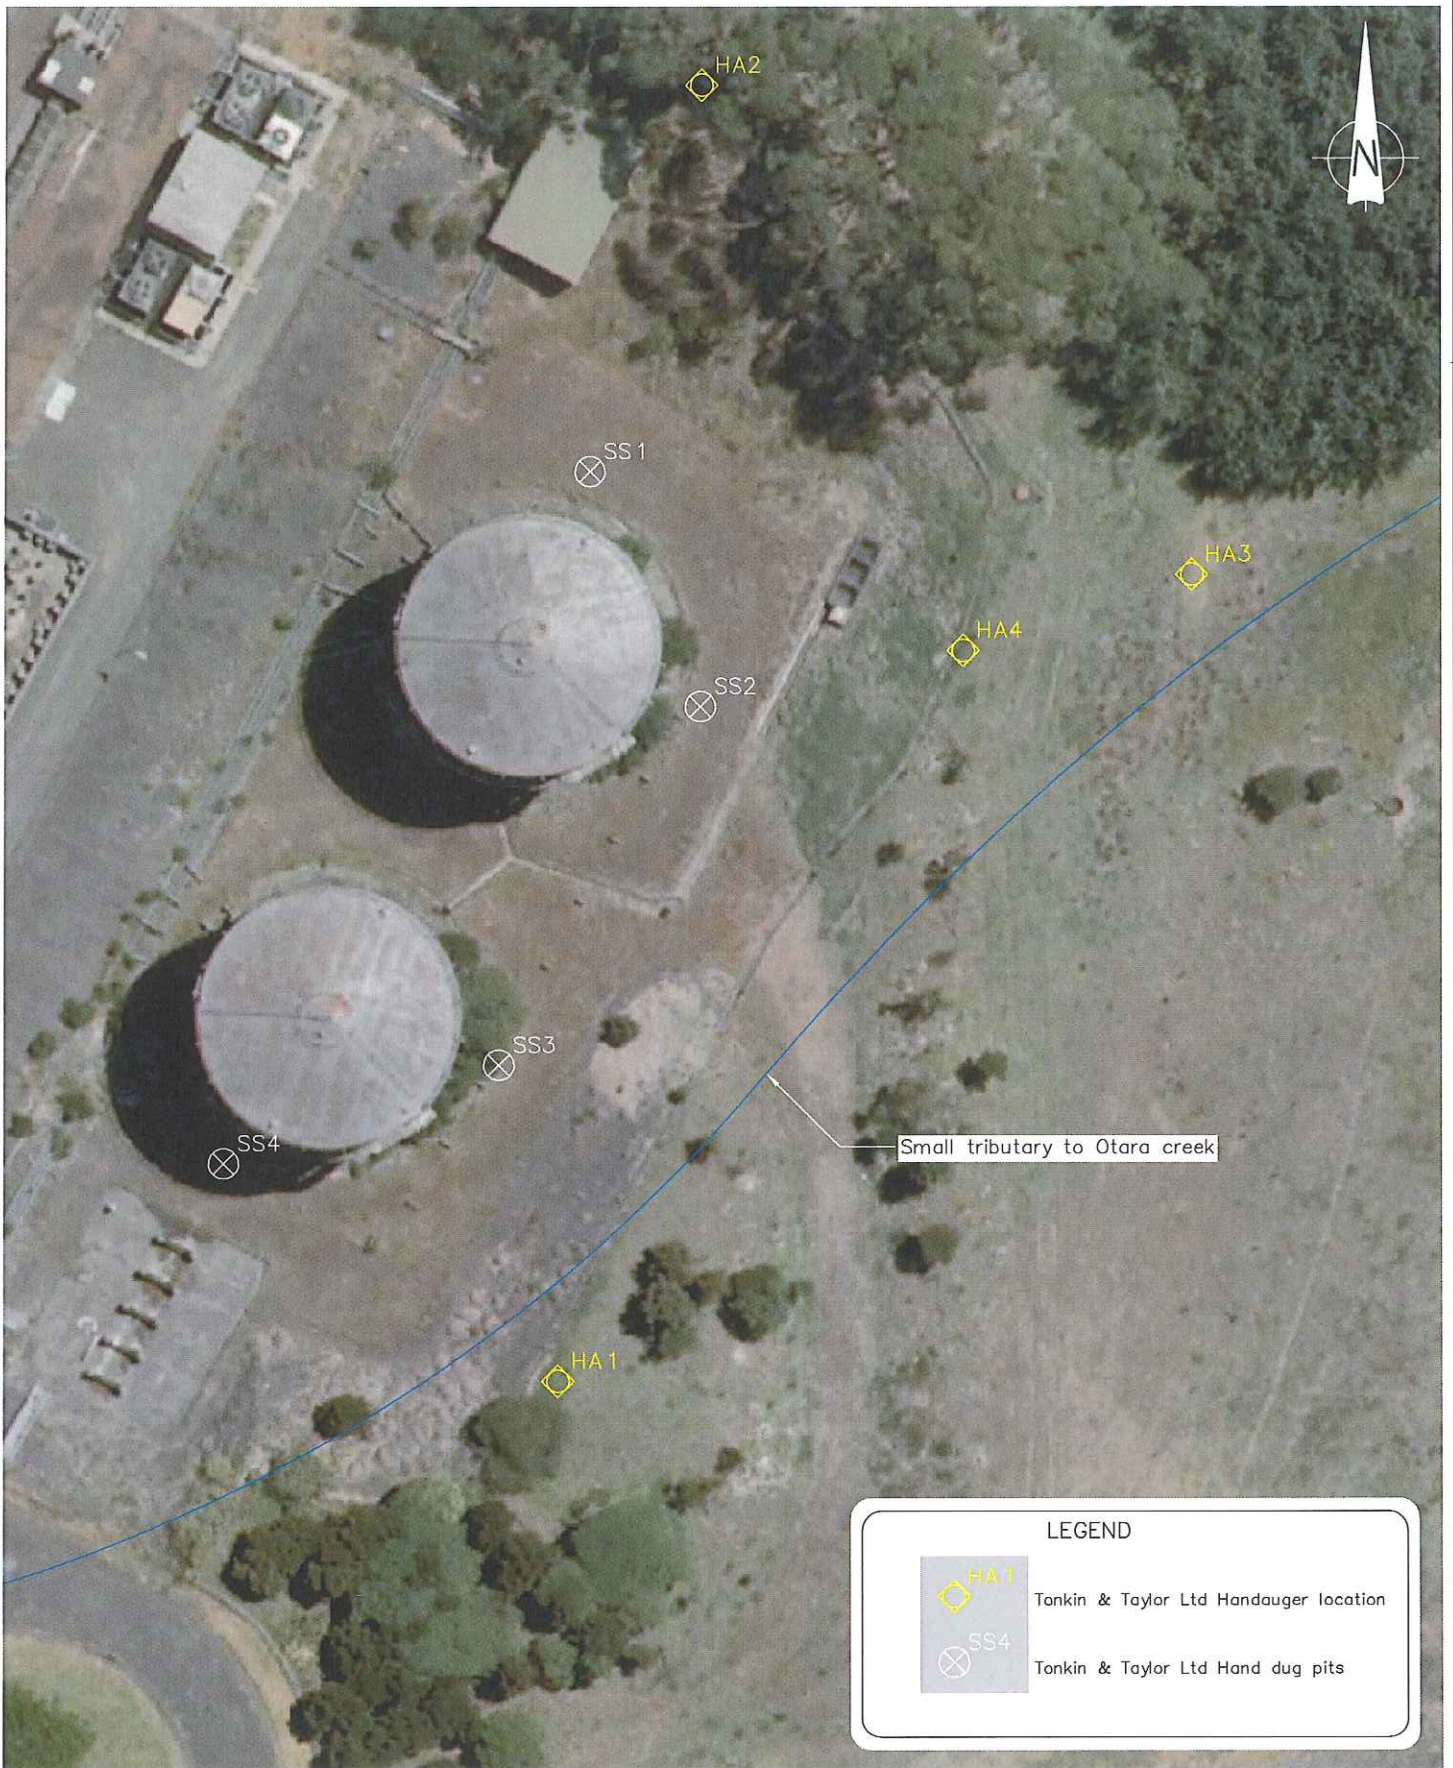
FIG. No. **Figure 4** REV. **0**

Tonkin & Taylor Ltd Handauger location
	Tonkin & Taylor Ltd Hand dug pits

**CONTACT ENERGY LIMITED**  
 GROUND CONTAMINATION ASSESSMENT  
 PROPOSED TURBINE PLANT & NEW TANK FARM  
 Site Investigation plan

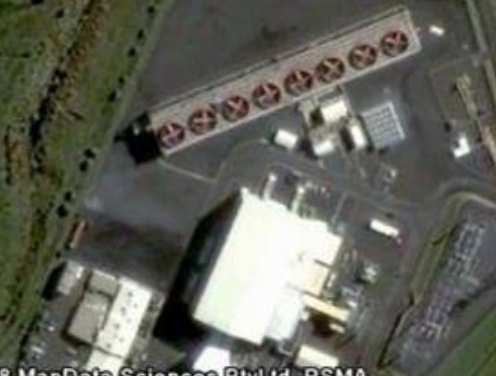
Otahuhu historic waste sites

Area A: Used as local rubbish dump for village and station general waste. Generally burnt off

Area B: Burn off area for Village and Otahuhu site general and industrial waste and hard fill. Bulldozed off to right hand side

Area C: Excavation waste from A station erection earthworks

NOTE: Otahuhu site used to include what is now Transpower and Transfield areas

- Potential asbestos material used in the reclamation area near the weir was observed during the site visit (north-eastern site corner, refer T&T Photograph A-61).
- Ōtāhuhu Power station staff provided information relating to three historic fill areas located on the western portion of the site (Fill Area A, Fill Area B and Fill Area C), however just Area B is located at the southwestern portion of the site. This area was used as the burn-off area for the nearby village and the Ōtāhuhu site for general and industrial waste and hard fill. Refer Appendix B (Google Earth image of T&T Appendix B).
