15 July 2022

Job No: 64872#BEE2

## HIGHBROOK PRIVATE PLAN CHANGE REQUEST – PRELIMINARY LAND CONTAMINATION REVIEW

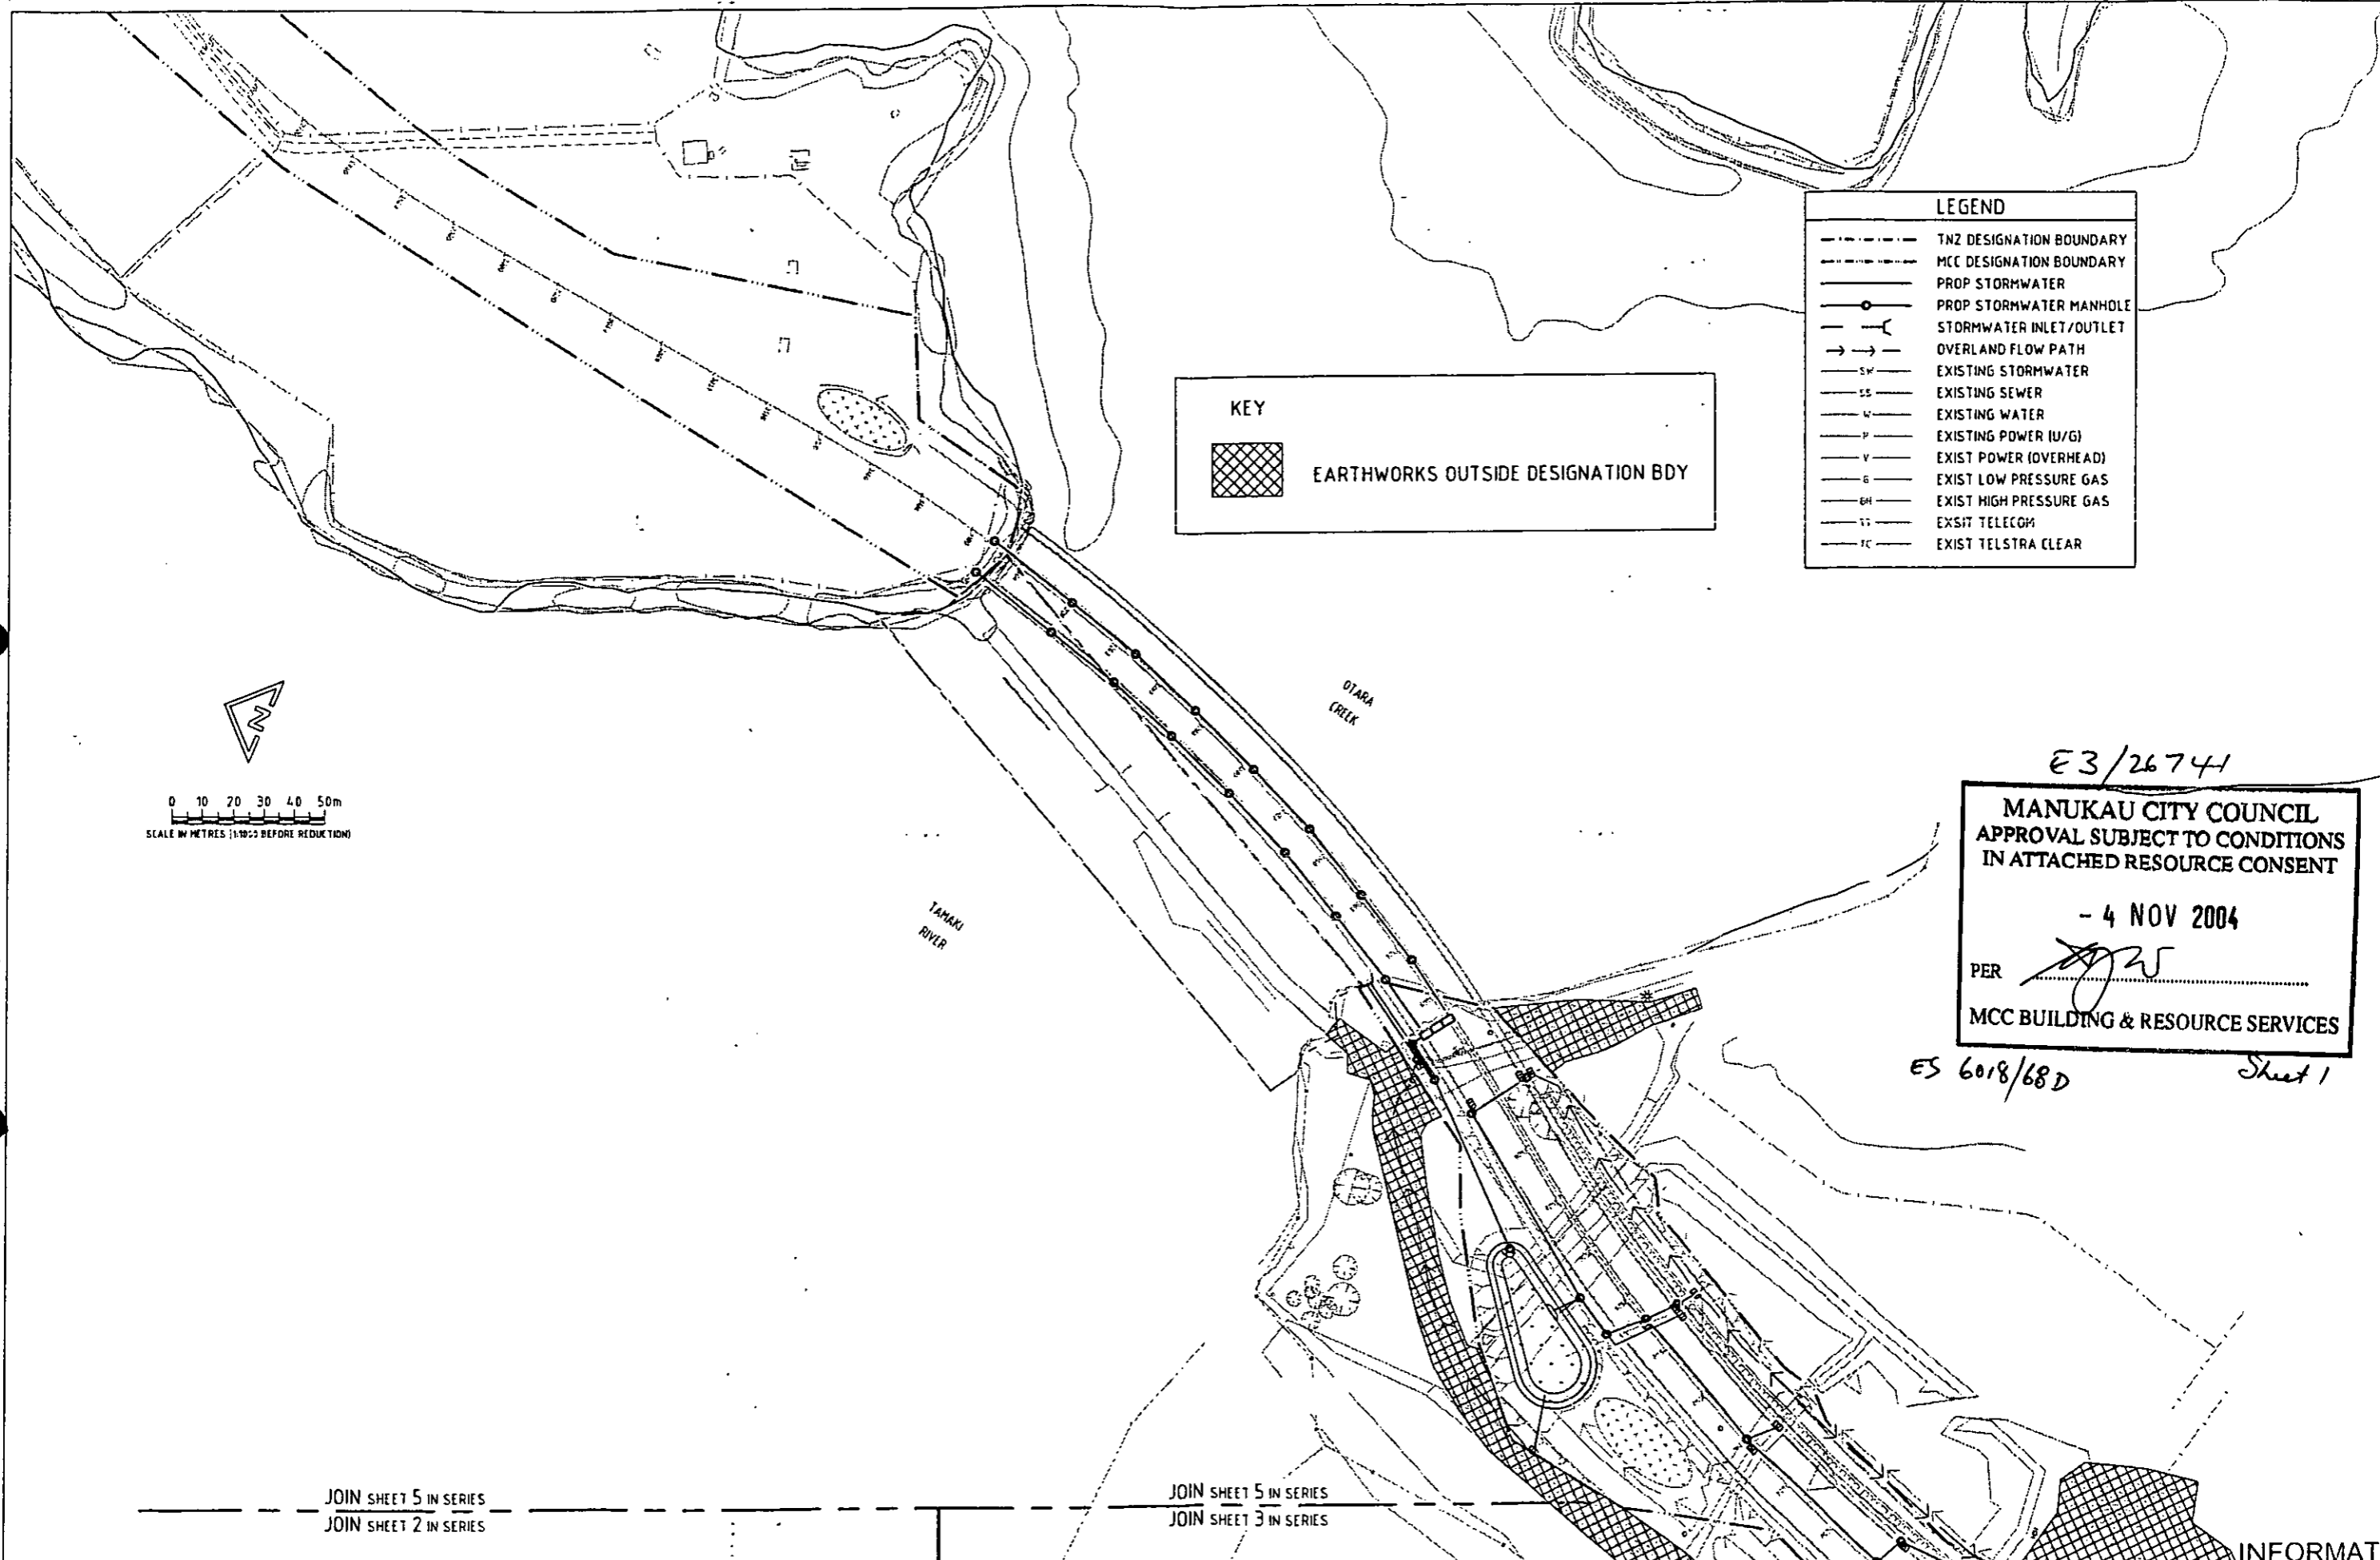
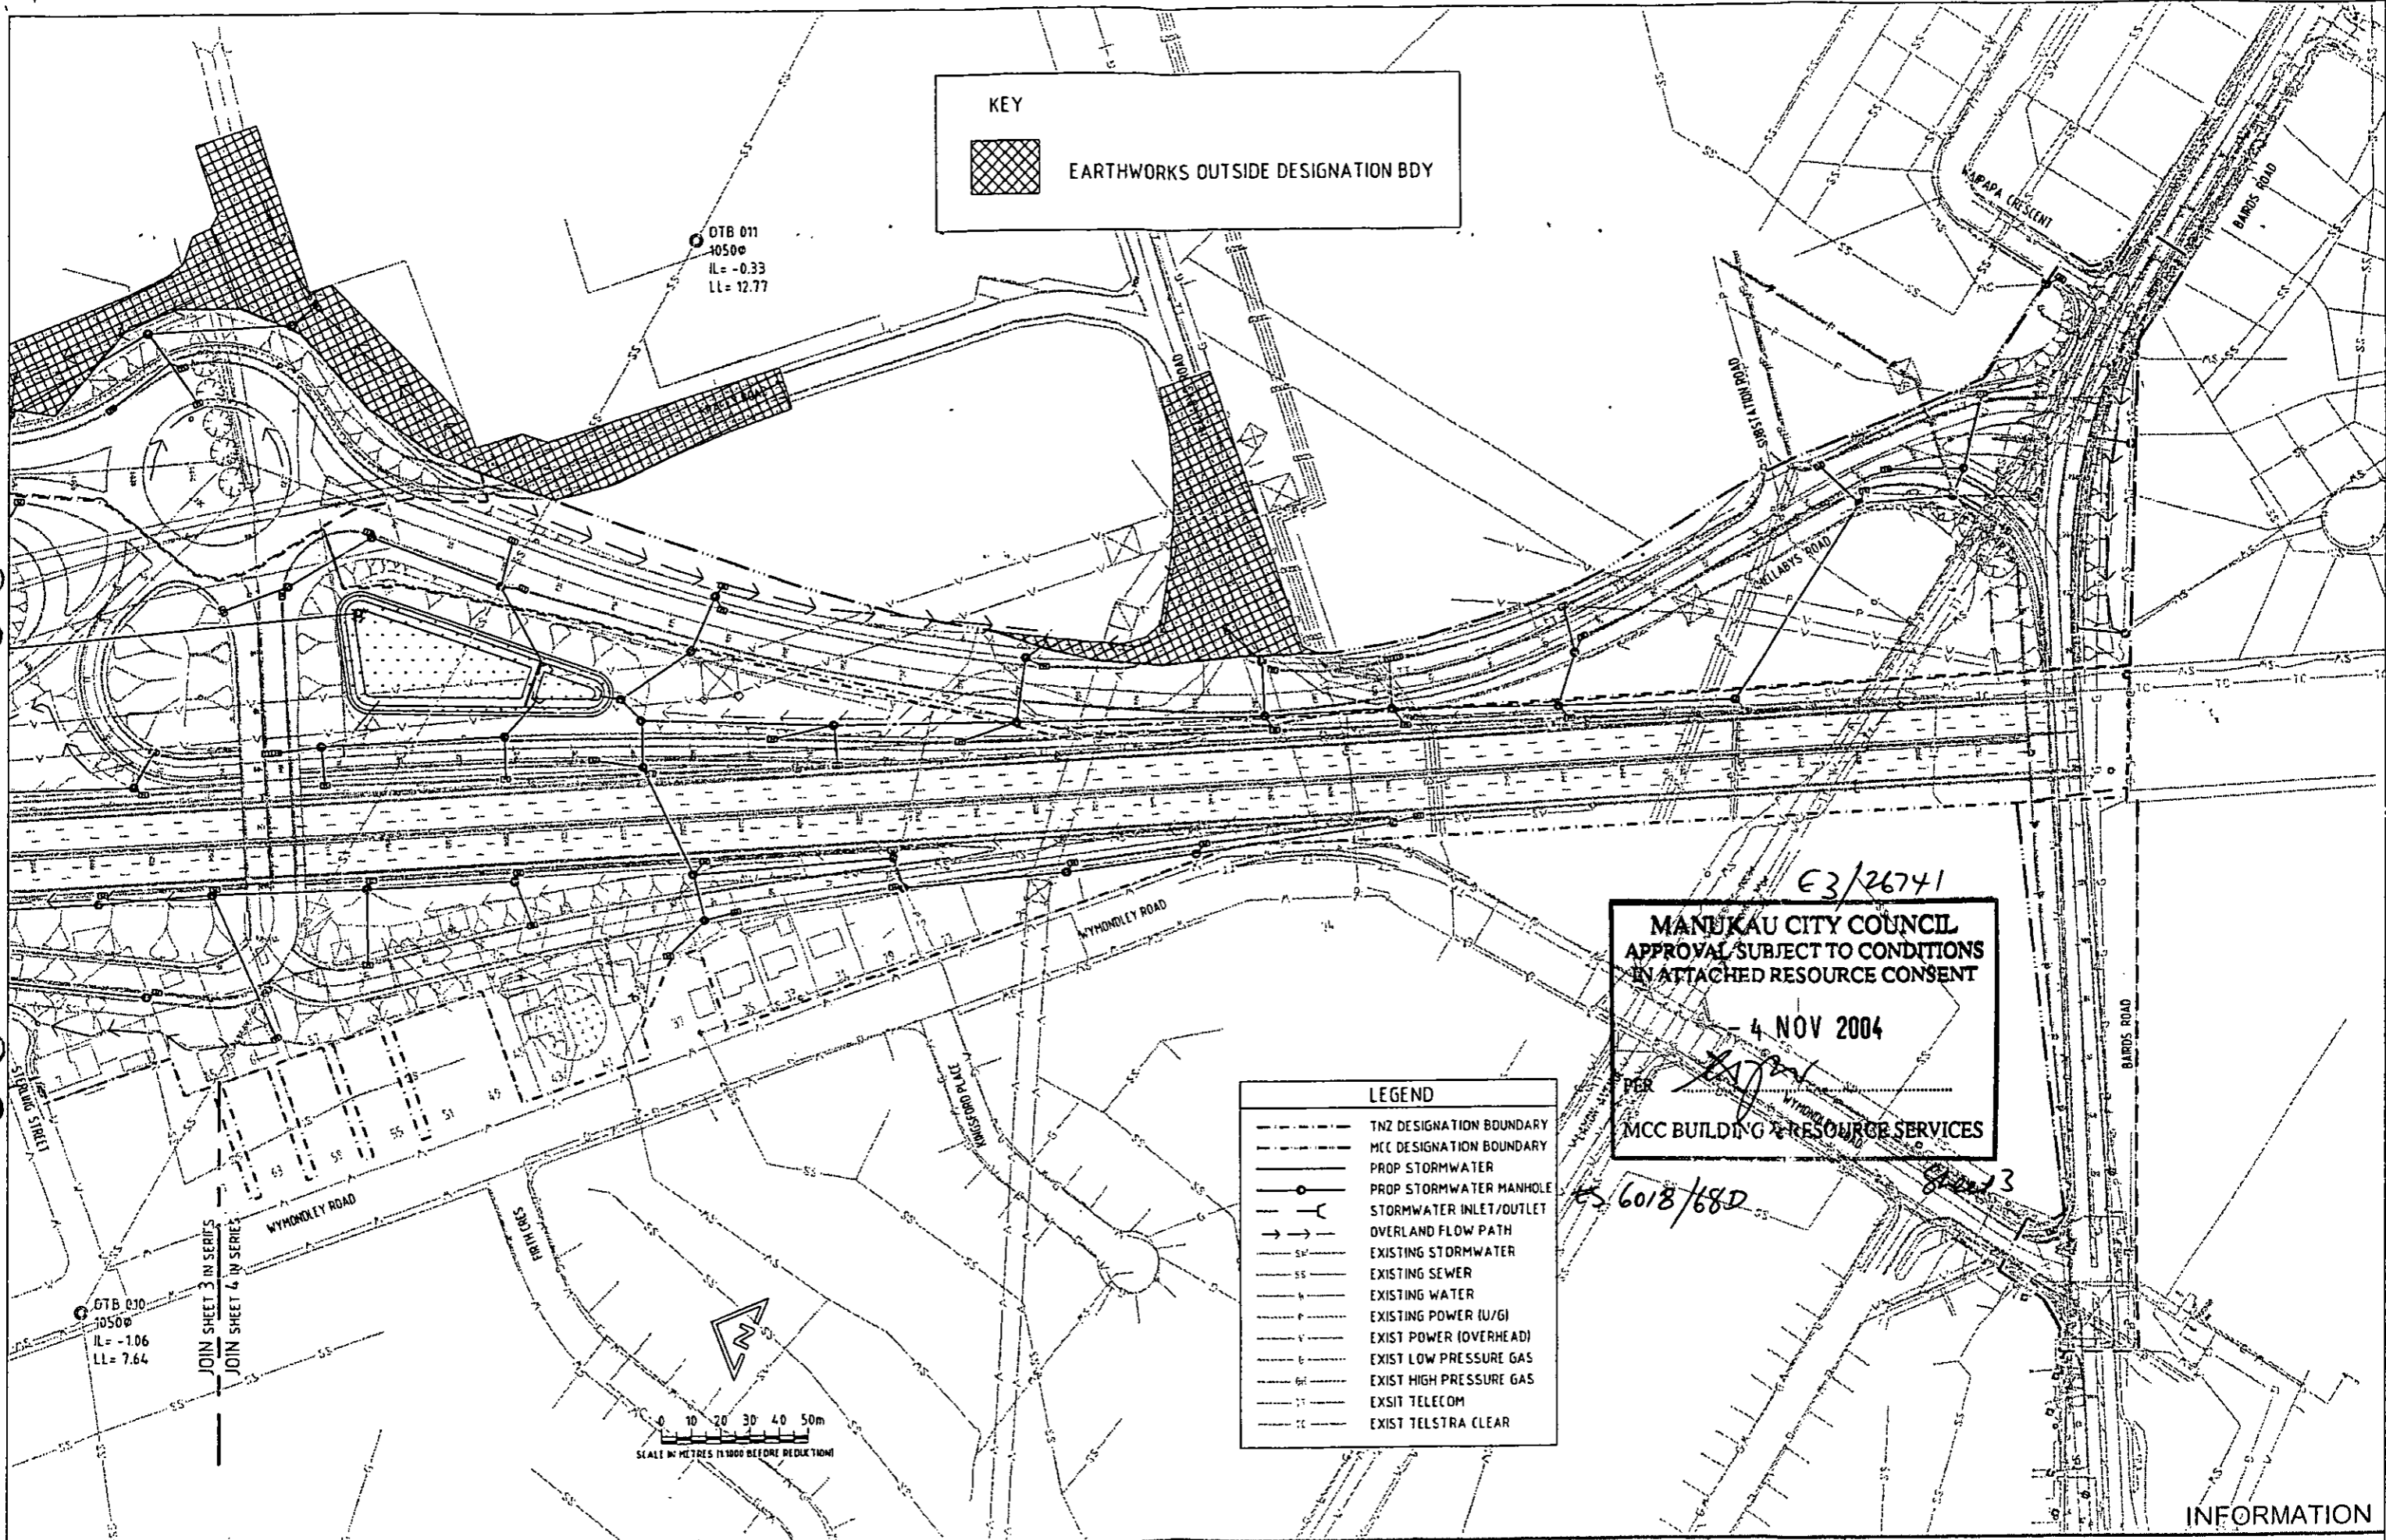
Client	MANUKAU CITY COUNCIL
Project	WAIOURU PENINSULA TO SH1 CONNECTION
Title	EARTHWORKS AREAS OUTSIDE DESIGNATION 1 OF 3
Original Size	A1
Drawing No:	51-19638-SK343
Rev:	A

**KEY**  
 EARTHWORKS OUTSIDE DESIGNATION BDY

APPROX. TOTAL CUT = 3100m<sup>3</sup>  
APPROX. TOTAL FILL = 19,000m<sup>3</sup>

APPROX. TOTAL ADDITIONAL FILL THAT  
CAN BE LOST ON SITE = 15,900m<sup>3</sup>

- No consents prior to 1997.
- Use of cleanfill material (19,000 m<sup>3</sup>) over the former tank farm for road construction purposes (Highbrook Drive). Refer GHD earthworks drawing No. 51-19638-SK779 Rev B – 2005 Approval (Appendix B).
- No recorded spill incidents for the site.
