# ECOLOGICAL ASSESSMENT

WARCKWORTH NORTH

**REFERENCE:** BIORESEARCHES (2019). ECOLOGICAL ASSESSMENT: WARKWORTH NORTH

<b>Document title:</b>	Ecological Assessment: Warkworth North
<b>Prepared for:</b>	Turnstone Capital LP
<b>Version:</b>	FINAL
<b>Date:</b>	03 May 2019
<b>Document name:</b>	<i>16141 Ecological Assessment - Warkworth North (Jan 2019)_FINAL.docx</i>

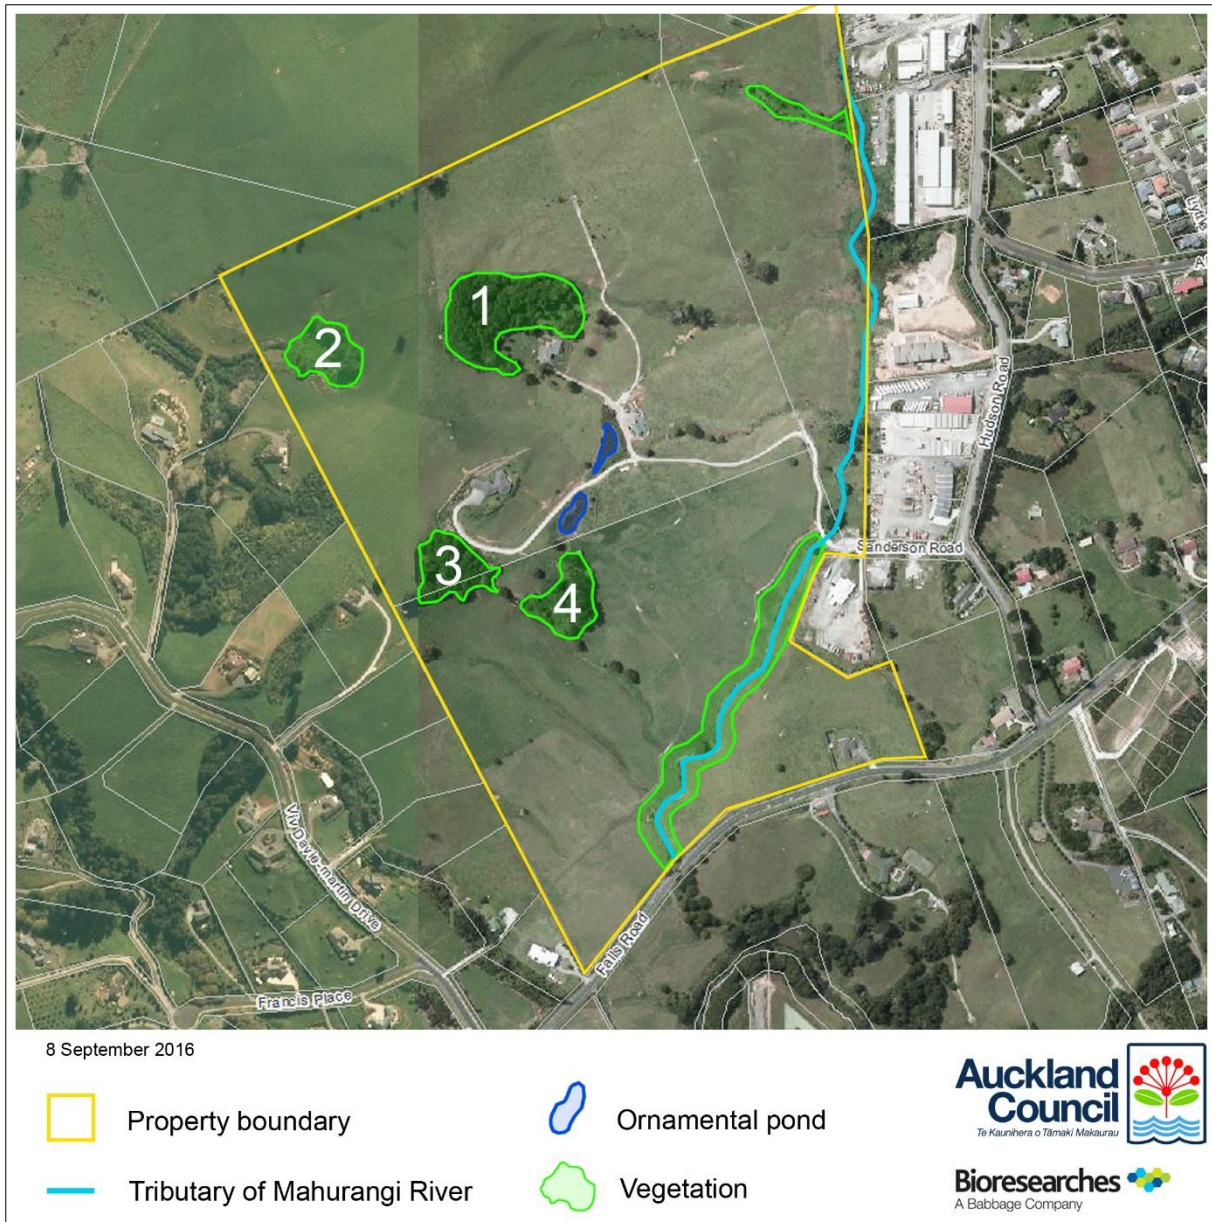
**Figure 2.3. Vegetation cover at the site, including vegetation areas (1 – 4) as described in the text and the location of the Mahurangi tributary.**

There were four areas of native trees or bush on the site (Figure 2.3) and numerous small wetlands associated with the watercourse and its tributaries. The Mahurangi tributary (main stream) was fenced off and the lower portion of it has been planted with native plants. Other areas are open and grazed except for a small stand of bush (Area 3) near the western house at 12 Sanderson Road. There were also several small farm dams and two ornamental ponds on the property at 12 Sanderson Road. These habitats are described in more detail below.

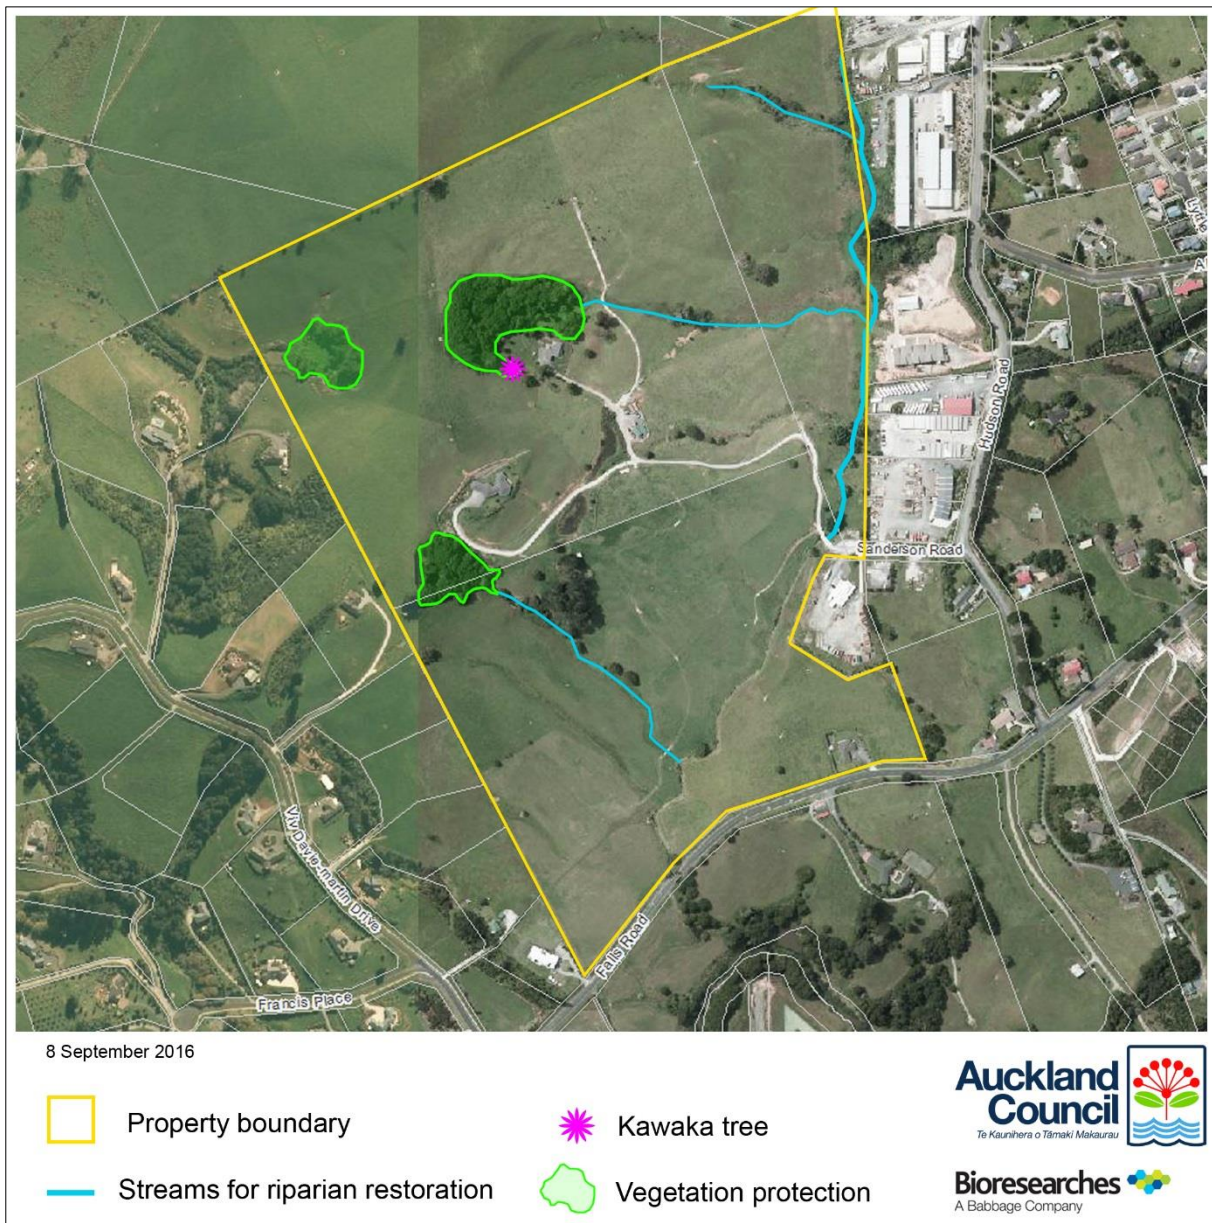
**Figure 2.4. Highest value sites recommended for vegetation and riparian restoration/ protection.**

Fencing and restoration planting of the smaller tributaries of this watercourse, particularly the two tributaries that flow through Area 1, Area 3 and the northern-most tributary, would provide valuable ecological connections and biodiversity benefits.

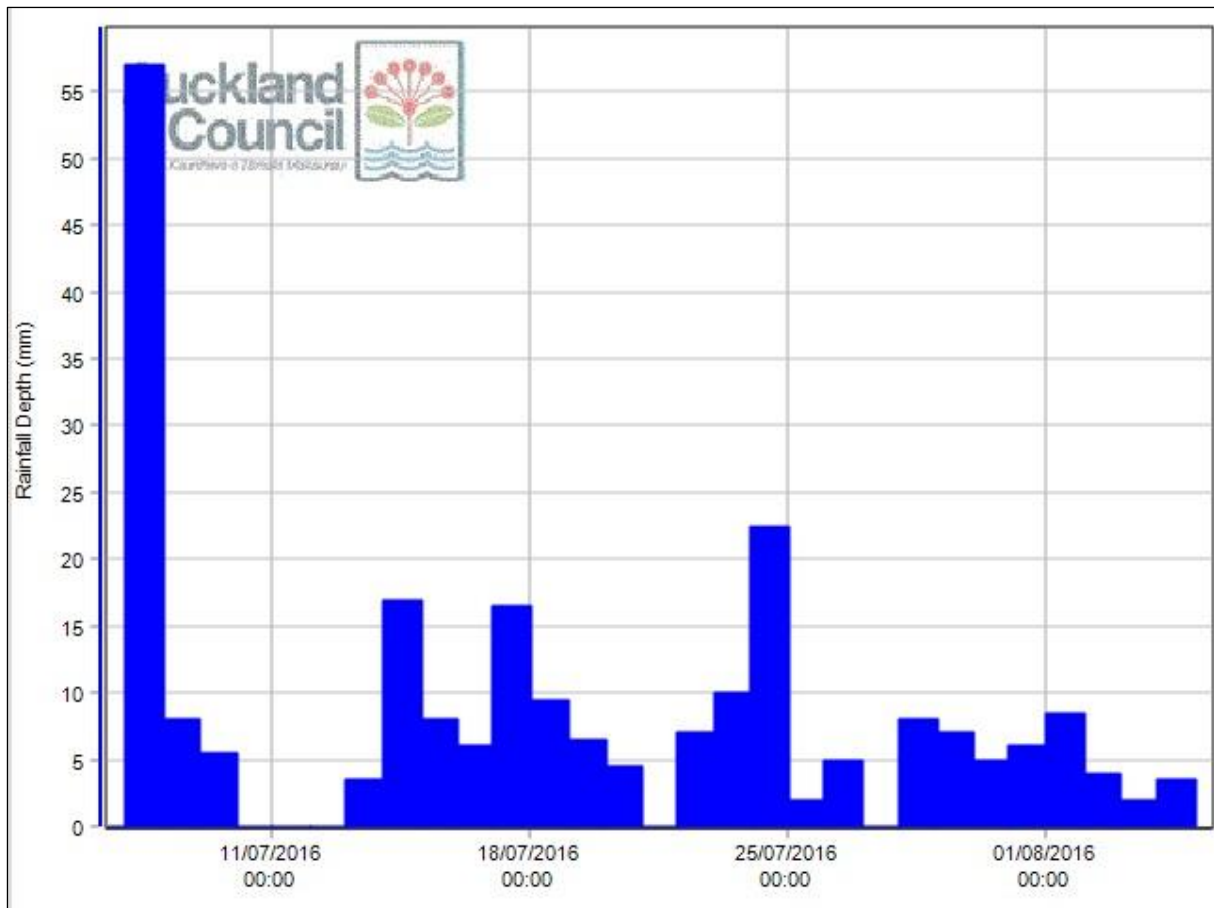
Figure 2.7. Totalled daily rainfall depth (mm) at the Mahurangi Satellite Dish between 06/07/16 – 05/08/16.

Rainfall within the area of the site in the preceding week before the survey was moderate and sustained, while the rainfall in the preceding four weeks was similar with one additional significant rainfall event (> 55 mm) (Auckland Council Environmental Monitoring Site: Mahurangi Satellite Dish) (Figure 2.7).

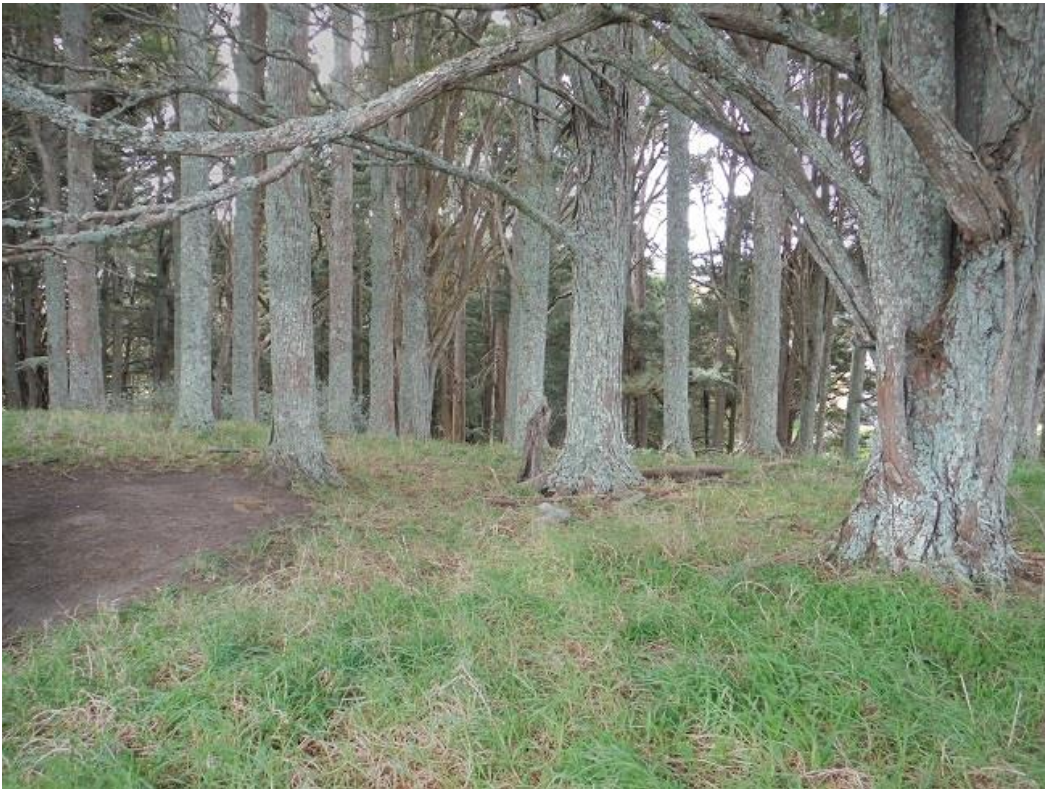
**Plate 2.1. Totara treeland on the western side of Area 1**

This area of bush (c. 1 ha) has a relatively good canopy predominantly of totara (*Podocarpus totara*). The trees are mainly tall, slim specimens to 10 m tall with larger open grown trees around the edges (Plate 2.1). Scattered tall, slim rimu (*Dacrydium cupressinum*), kanuka (*Kunzea robusta*), kauri (*Agathis australis*) and tanekaha (*Phyllocladus trichomanoides*) are found amongst the totara. A small stand of trees to the north east of the house has four medium-sized rimu, a large multi-trunked pohutukawa (*Metrosideros excelsa*) which is assumed to be planted and a double-trunked tanekaha. To the west of the house amongst several large Monterey pines (*Pinus radiata*) is a medium sized kawaka tree

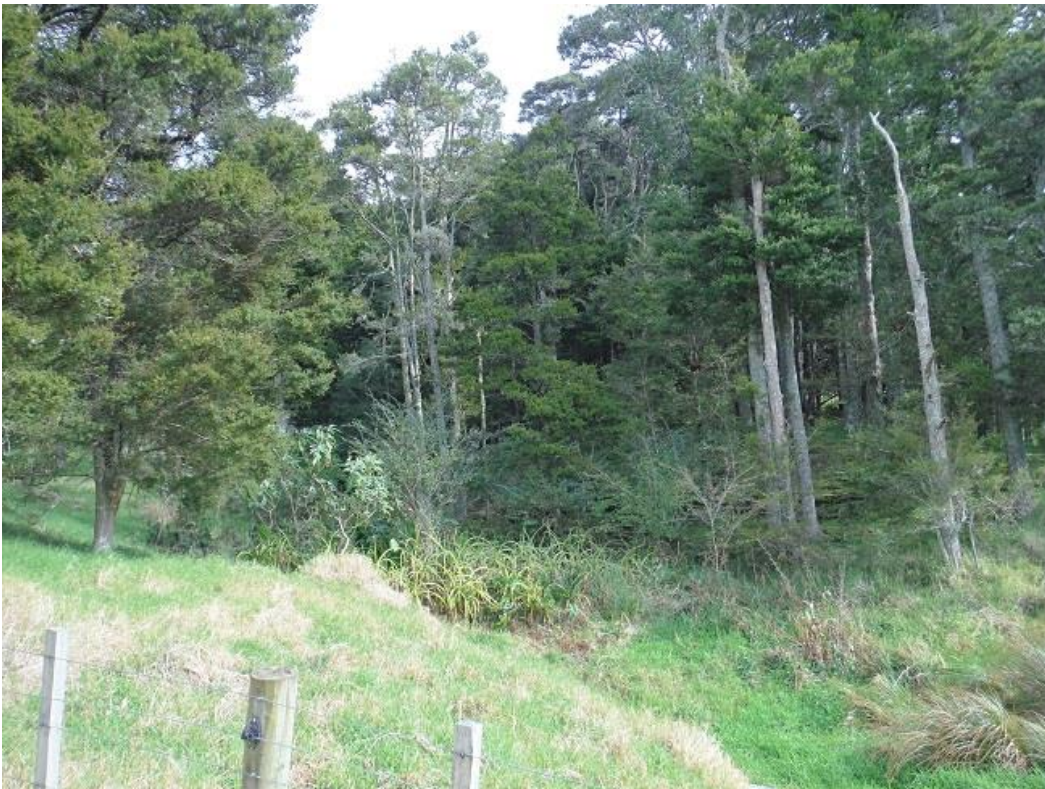
**Plate 2.2. Totara treeland above an open grassy wetland on the eastern side of Area 1 at the confluence of two small streams. Note taro in the upper wetland.**

At the confluence of the two watercourses on the eastern side of the bush stand the farm track forms a dam behind which is an open, grazed wetland (Plate 2.2) with mainly exotic rushes (*Juncus effusus*).

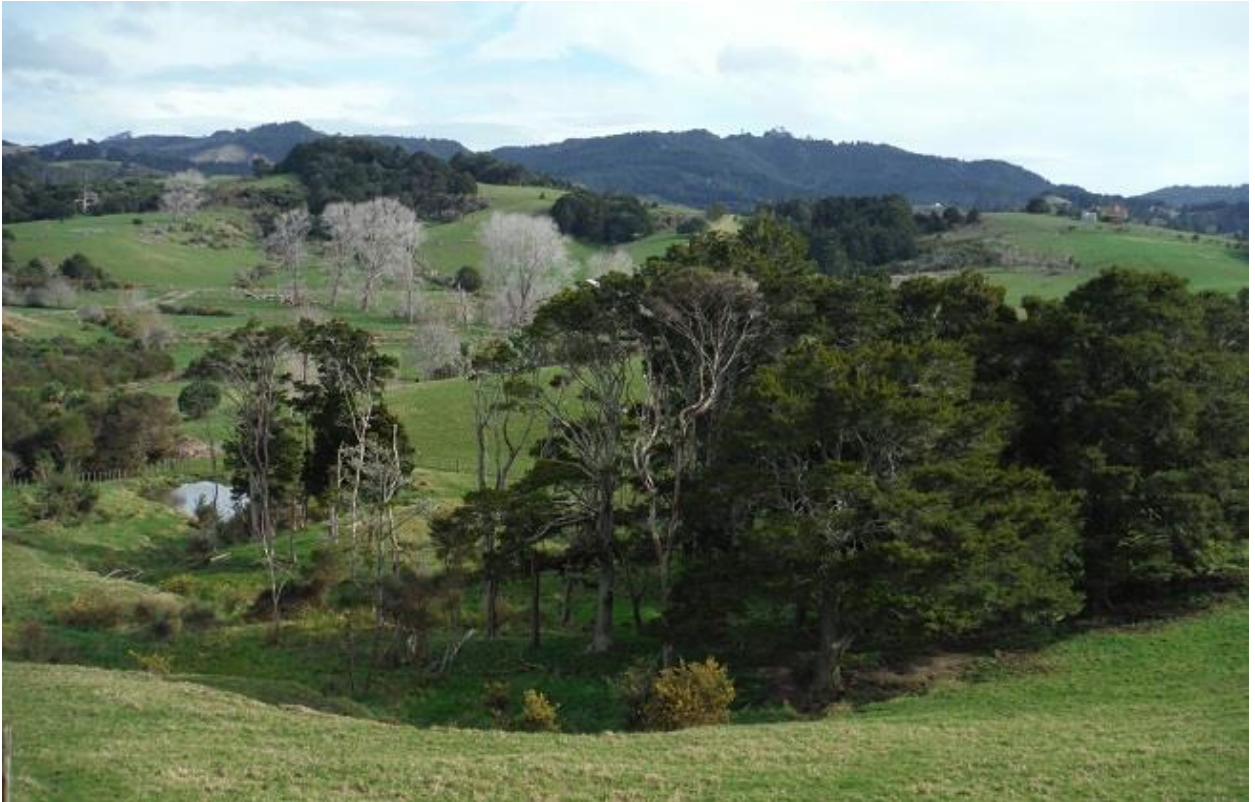
**Plate 2.3. Area 2 with totara and kanuka above a farm pond.**

A grouping of grazed totara trees stands above a small watercourse with a small farm pond below (c. 0.5 ha). The watercourse is an upper tributary of the Mahurangi River. The trees are of no great age or size and there are scattered tall kanuka (*Kunzea robusta*) amongst them (Plate 2.3). The area is all heavily grazed and pugged and there are few native riparian or wetland plants. In a small boggy area in the upper part of the watercourse are a few spindly manuka (*Leptospermum scoparium*) bushes associated with which are swamp kiokio (*Blechnum minus*) and native rushes including baumea (*Machaerina rubiginosa*) and fan flowered rush (*Juncus sarophorus*). Surrounding the pond are a few gorse bushes and reed sweet grass (*Glyceria maxima*). Across the boundary the watercourse has been fenced and planted with natives. Standing to the east of the totara some distance away is a lone tall kauri tree which appears healthy although the roots have been badly trampled by stock.

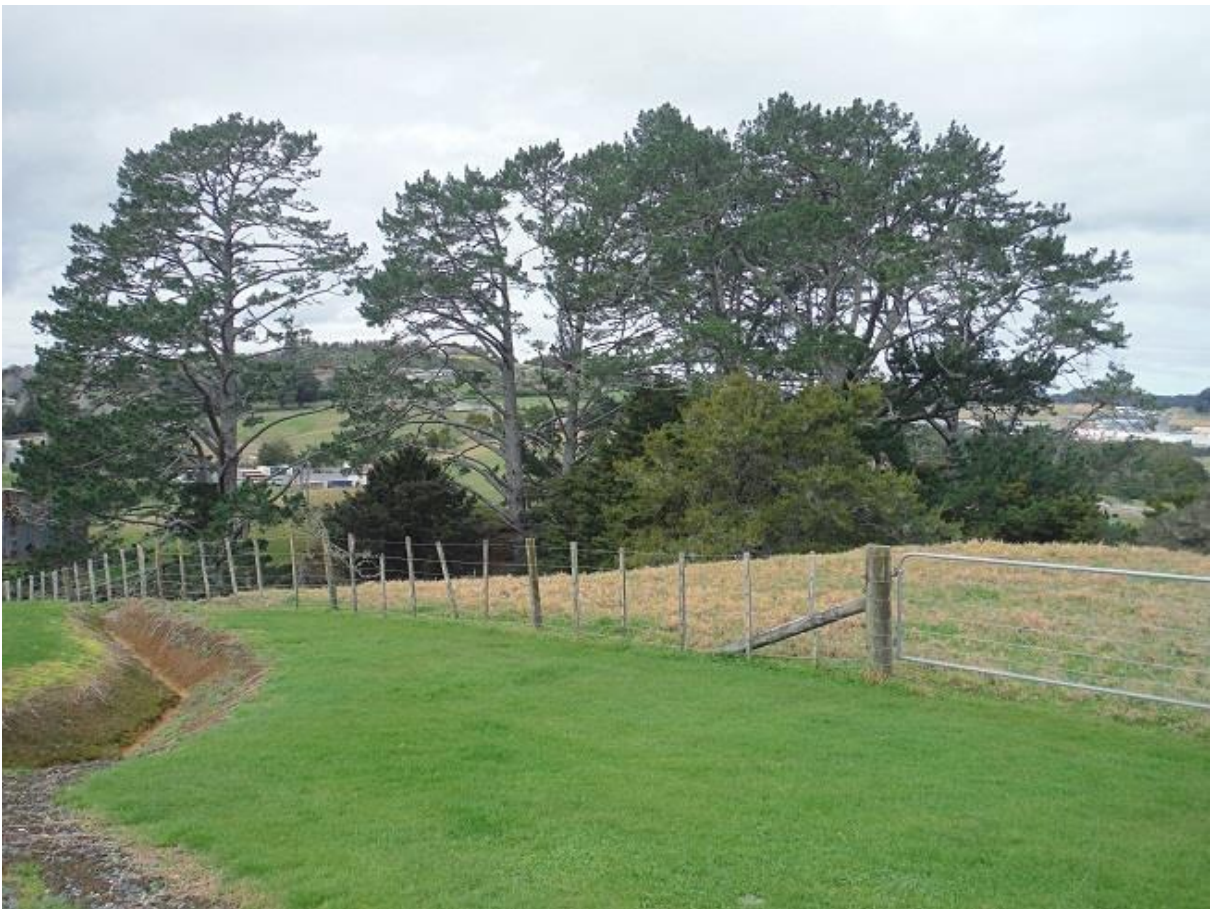
**Plate 2.4. Mature pines with totara below them in Area 4**

Downstream of the southernmost ornamental pond are at least 7 large mature pine trees (*Pinus radiata*) (Plate 2.4). The area is grazed and the only native vegetation are scattered totara and a few shrubs of mahoe (*Melicactus ramiflorus*) and hangehange with silver fern mainly clinging to the steeply incised watercourse banks where they are less easily reached by cattle (Plate 2.5). At the confluence of two small watercourses is a small wetland with some raupo (*Typha orientalis*), exotic reed sweet grass (*Glyceria maxima*), clumps of kiokio and a patch of rautahi (*Carex geminata*). The area is badly pugged, and the wetland may be partly artificial as a fence across the lower end of it appears to be impeding drainage (Plate 2.6).

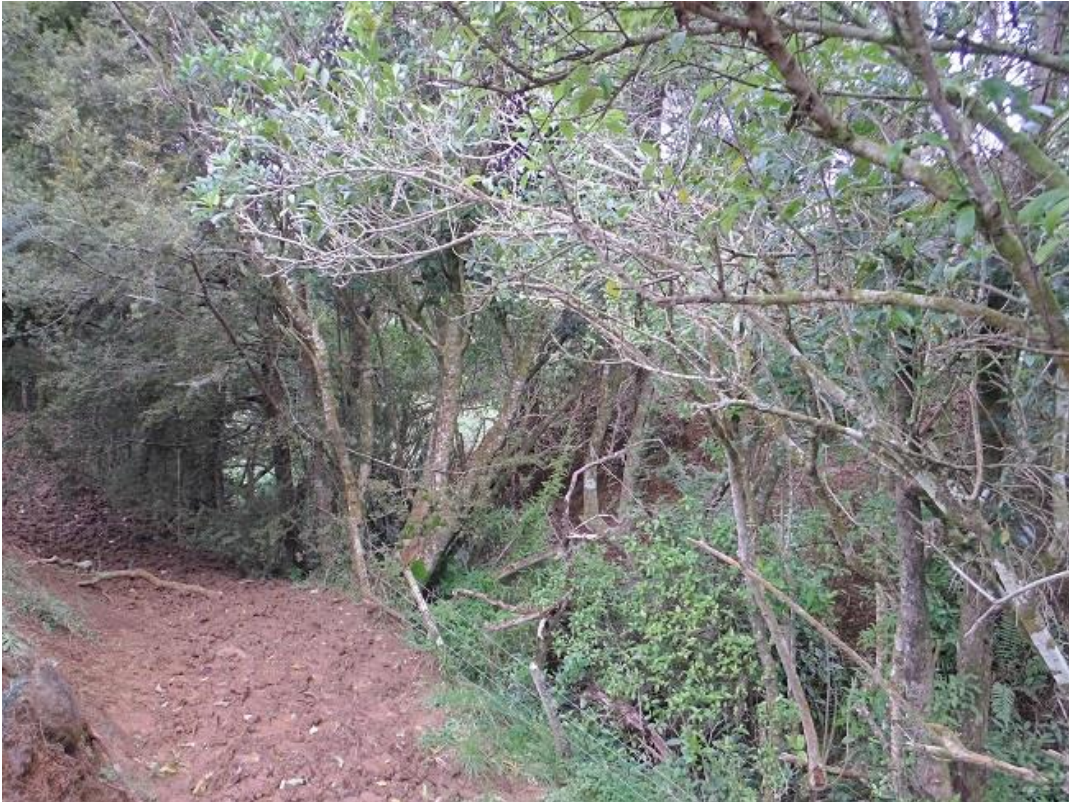
**Plate 2.5. Native shrubs and small trees cling to the steeply incised stream banks between Area 3 and Area 4. Note the severe pugging of the soils caused by cattle.**

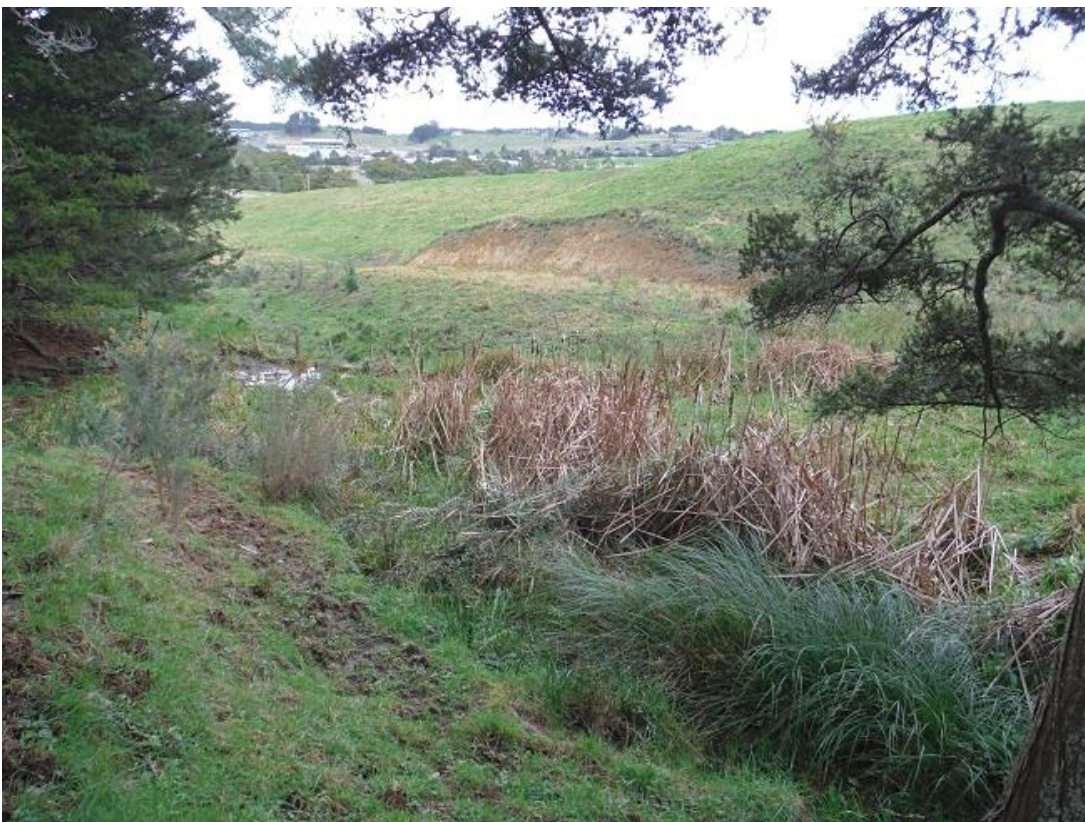
**Plate 2.6. Grazed wetland area at the confluence of two small watercourses to the west of Area 4**

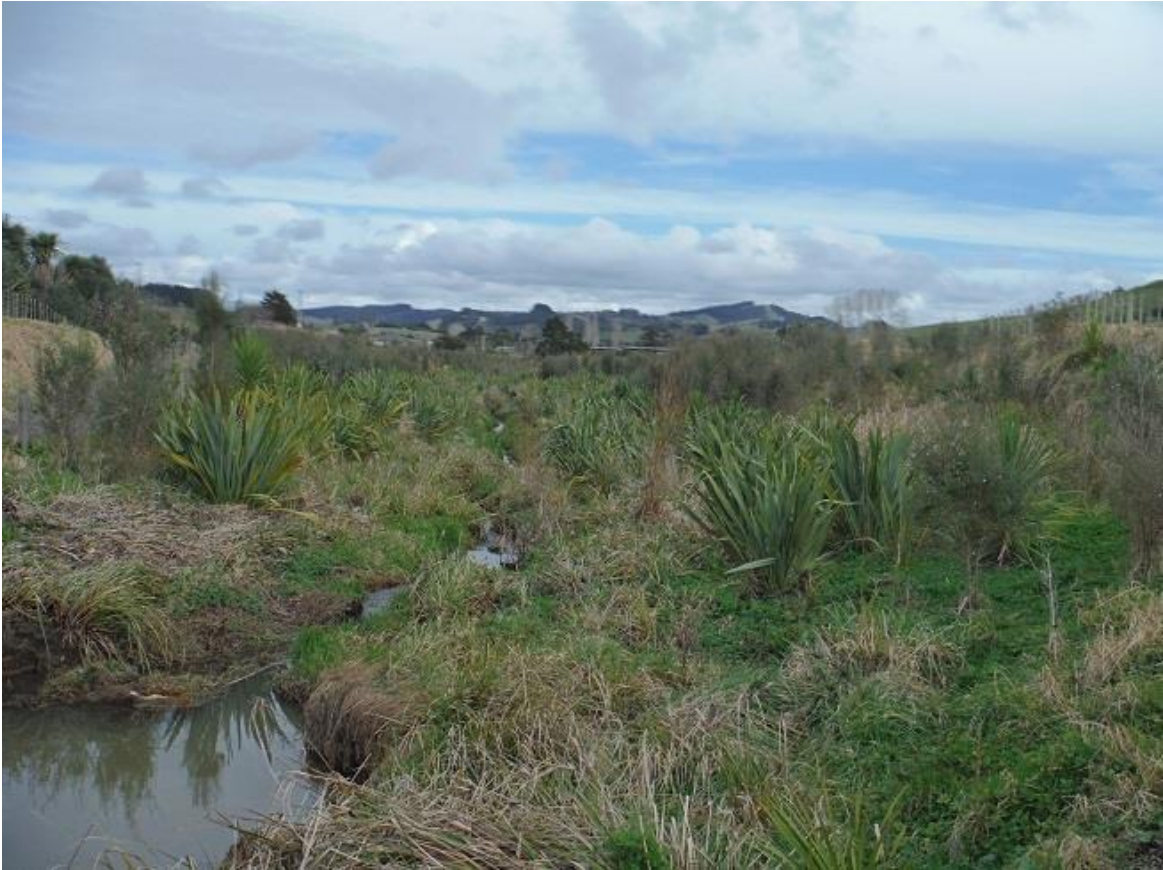
**Plate 2.7. Southern Mahurangi tributary with riparian restoration planting.**

A tributary runs along most of the eastern boundary of the property at 12 Sanderson Road and then diagonally crosses 220 Falls Road to the south-western boundary. Within 220 Falls Road the riparian margins are fenced and planted—in accordance with the conditions on the Watercare water take consent for the Warkworth Town Supply—with common pioneer natives, principally kanuka, flax (*Phormium tenax*) and cabbage trees (*Cordyline australis*). The planting is estimated to be between 3 and 5 years old (Plate 2.7).

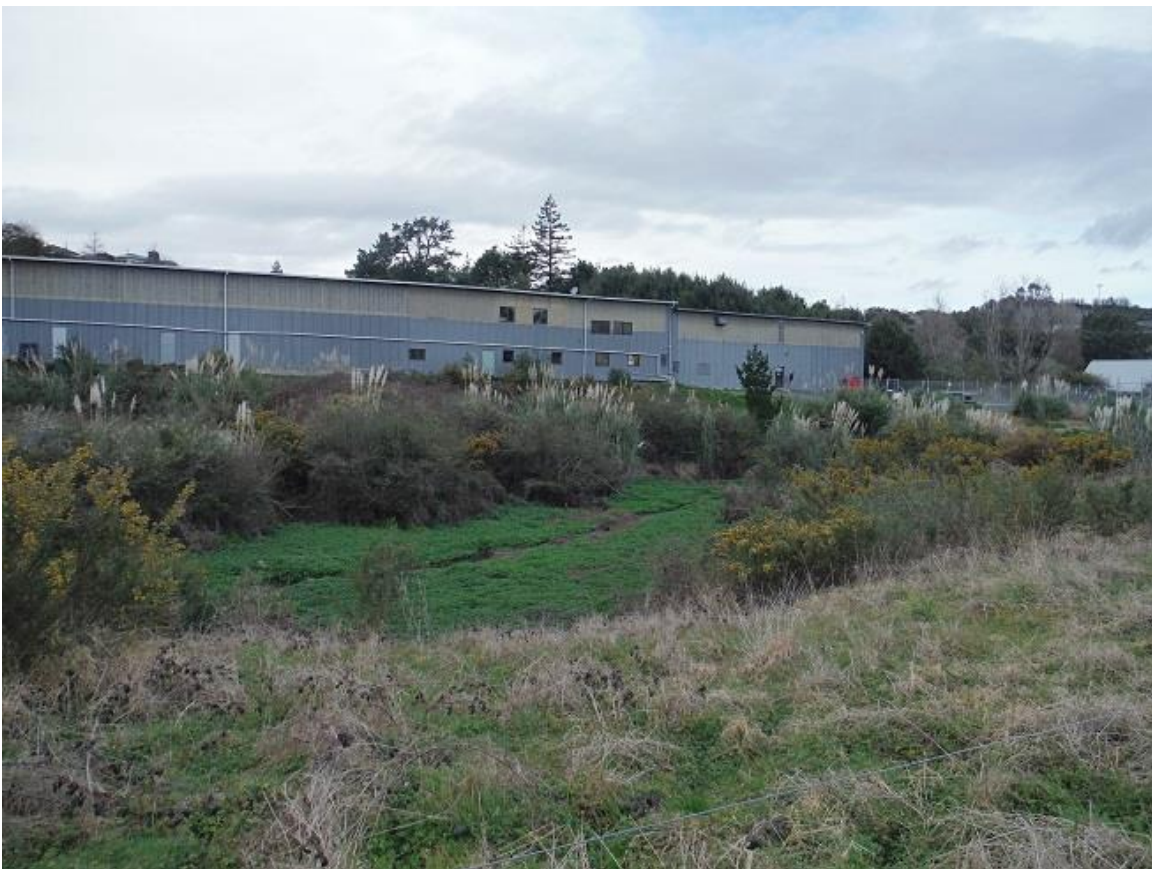
**Plate 2.8. Northern Mahurangi tributary with open grassy floodplain and weedy riparian zone**

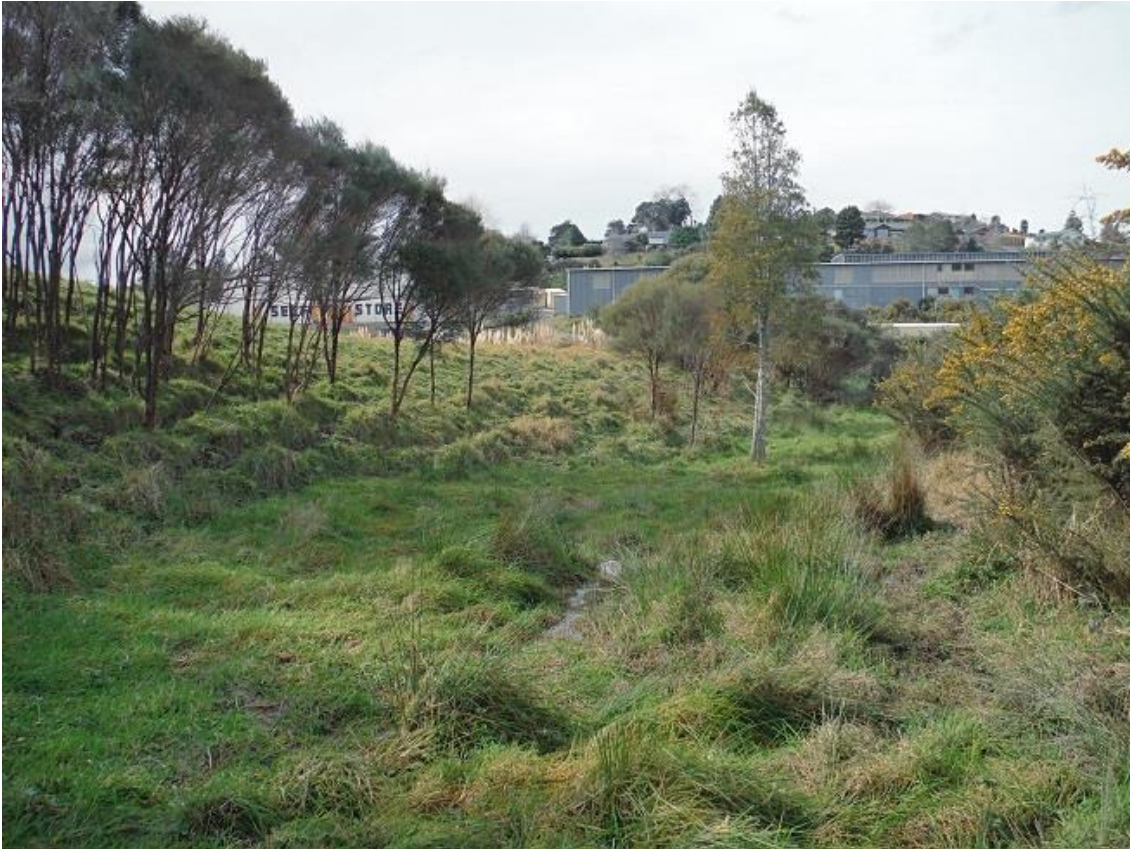
**Plate 2.9. Northern tributary showing scattered manuka, kanuka and a single kahikatea with gorse and exotic grasses and rushes.**

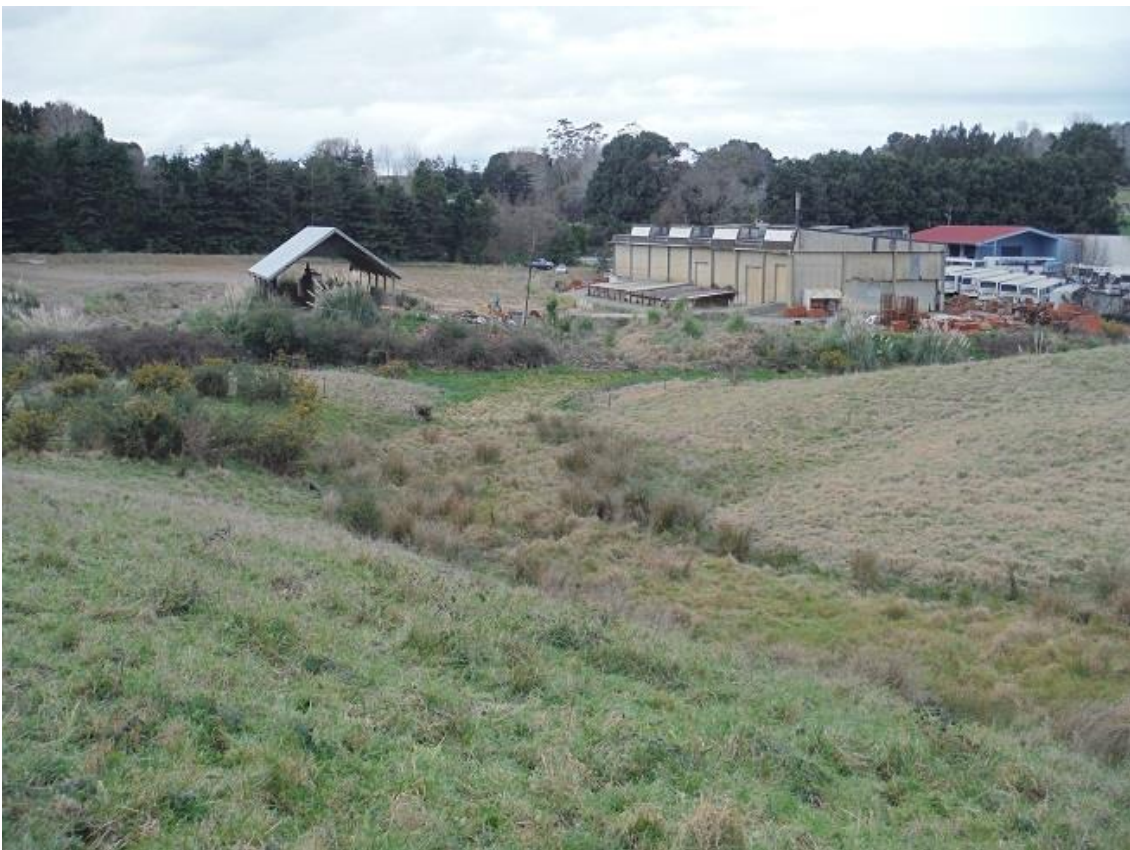
**Plate 2.10. Lower tributary below Area 1 showing its grazed and degraded state.**

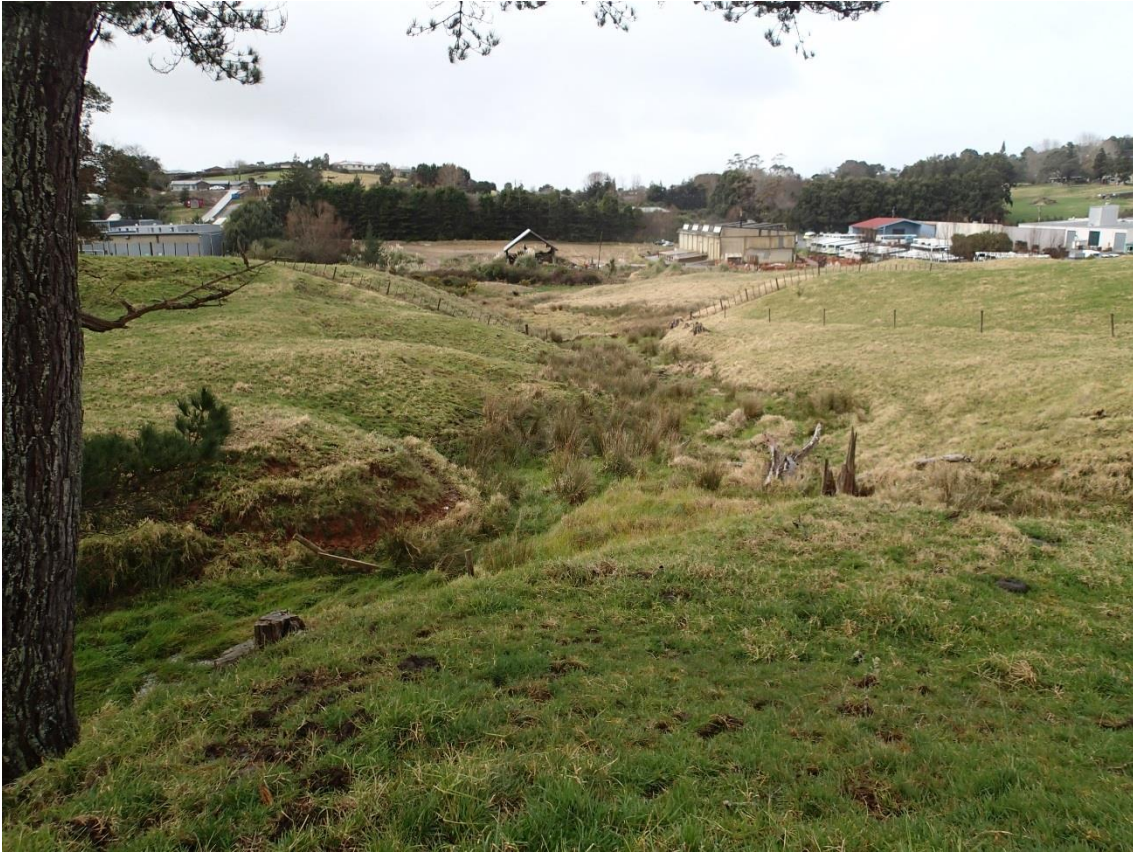
**Plate 2.17. Lower reach of Watercourse 2.**

Downstream of the pool the watercourse had a defined channel and a trickle flow was evident (Plate 2.17). The lower reach of the watercourse had an average width and depth of 0.55 m and 0.03 m, respectively. The substrate consisted of silt and terrestrial vegetation grew within the watercourse. Extensive pugging was evident throughout the watercourse and the riparian vegetation consisted of managed pasture with very low shading. No macrophytes were recorded. Water quality measurements within the reach reflected the winter conditions and showed a water temperature of 13.8°C, which is indicative of an 'excellent' temperature (Biggs *et al.*, 2002). Dissolved oxygen concentration and saturation were moderate, at 7.21 mg/L and 70% respectively, indicative of occasional minor stress for aquatic fauna (Davies-Colley *et al.*, 2013). The conductivity level was 'fair' (166 µS/cm), indicative of slightly enriched waters (Biggs *et al.*, 2002). Within the Mahurangi River tributary riparian margin the watercourse became diffuse and formed a boggy wetland before draining into the river.

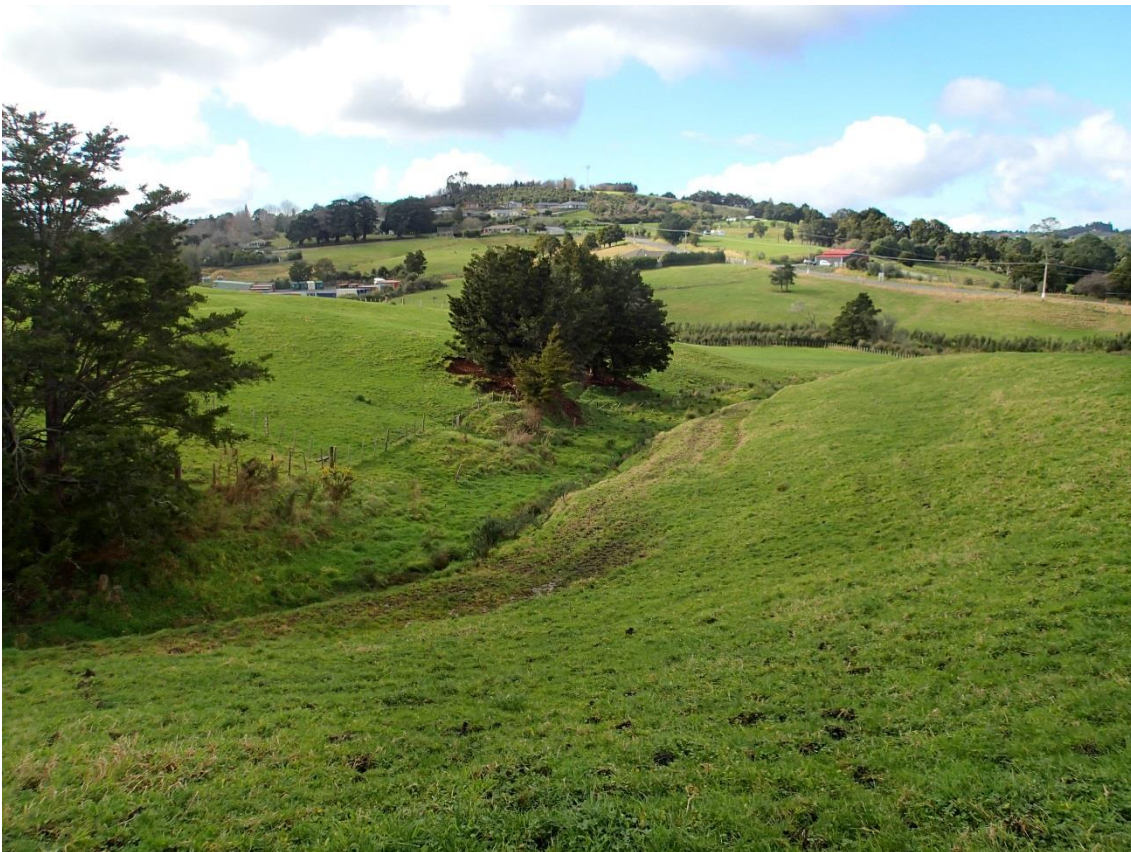
**Plate 2.24. Lower reach of Watercourse 6.**

At the confluence, water flow became diffuse and the land boggy. Downstream of the confluence the watercourse had an average width and depth of 0.35 m and 0.1 m, respectively (Plate 2.24). Small pools were present along the lower reach and had an average size of 0.7 m long by 0.3 m wide and 0.12 m deep. The substrate consisted of silt and much of the watercourse was choked with terrestrial vegetation. The riparian vegetation consisted of managed pasture which provided no shading along the lower reach. Water quality measurements within the reach reflected the winter conditions and showed a water temperature of 12.5°C, which is indicative of an 'excellent' temperature (Biggs *et al.*, 2002). Dissolved oxygen concentration and saturation were high, at 8.4 mg/L and 79%, respectively, indicative of no stress for aquatic fauna (Davies-Colley *et al.*, 2013). The conductivity level was 'good' (141 µS/cm), indicative of unlikely enriched waters (Biggs *et al.*, 2002).

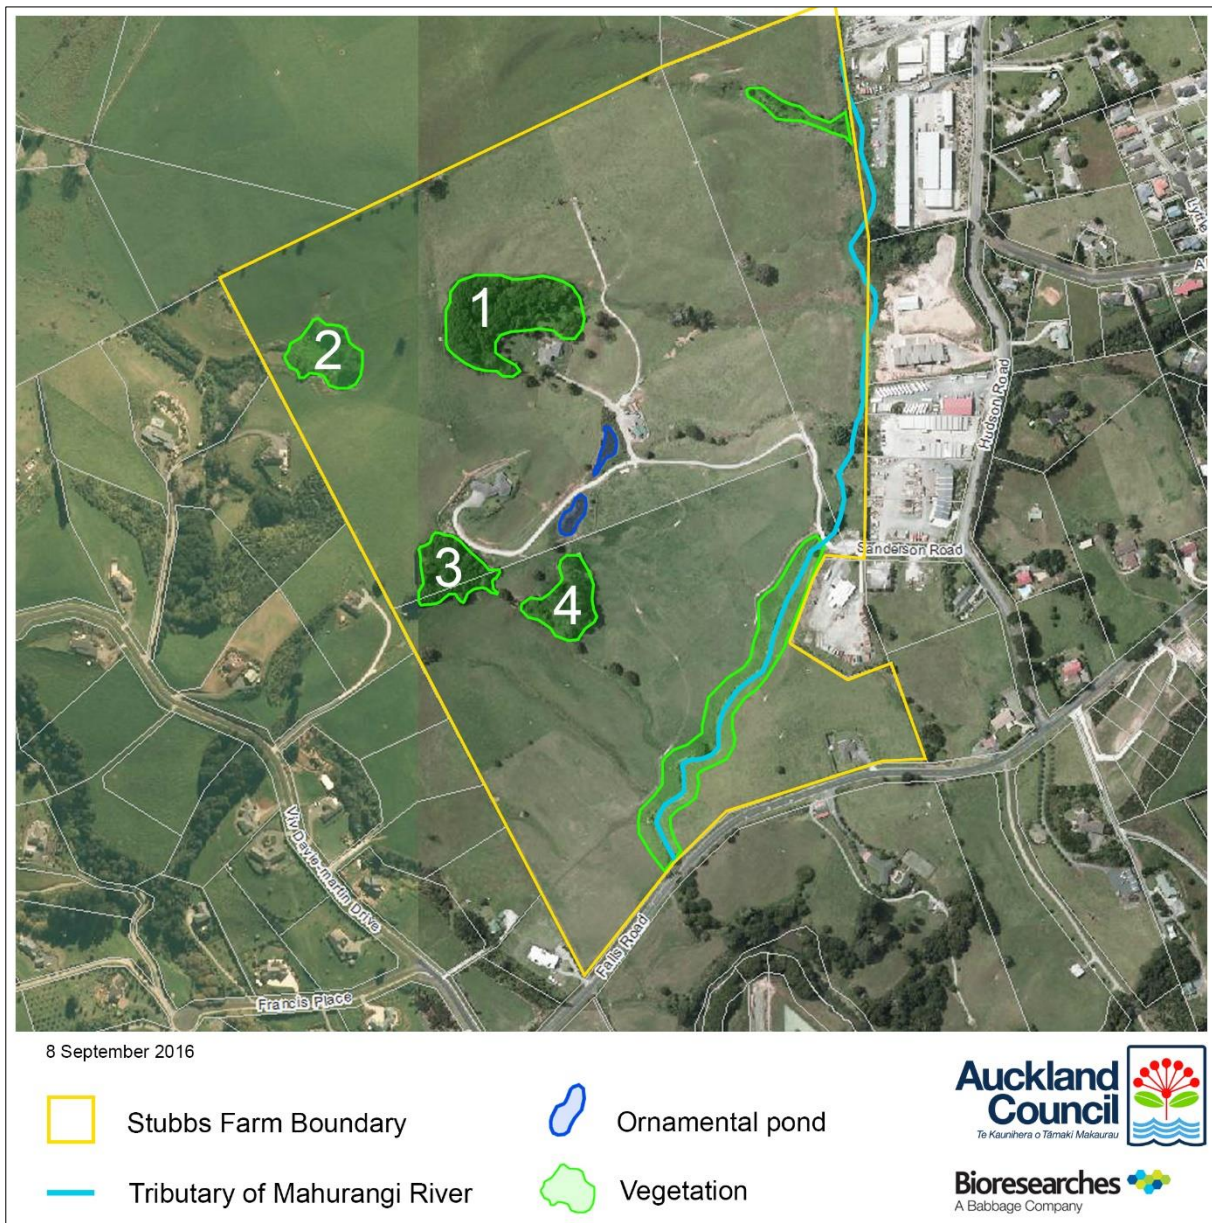
**Figure 3.1. Vegetation cover at the site, including vegetation areas (1 – 4) and the location of the Mahurangi tributary.**

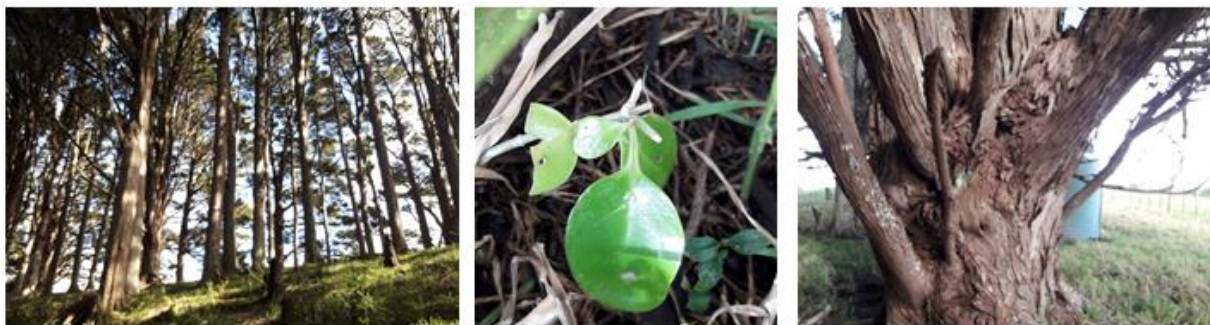
**Plate 3.1. From left to right: View of totara stand and clear understory; one of several seedlings found near trunk bases, and a photo of one of the largest totara on the western edge of remnant.**

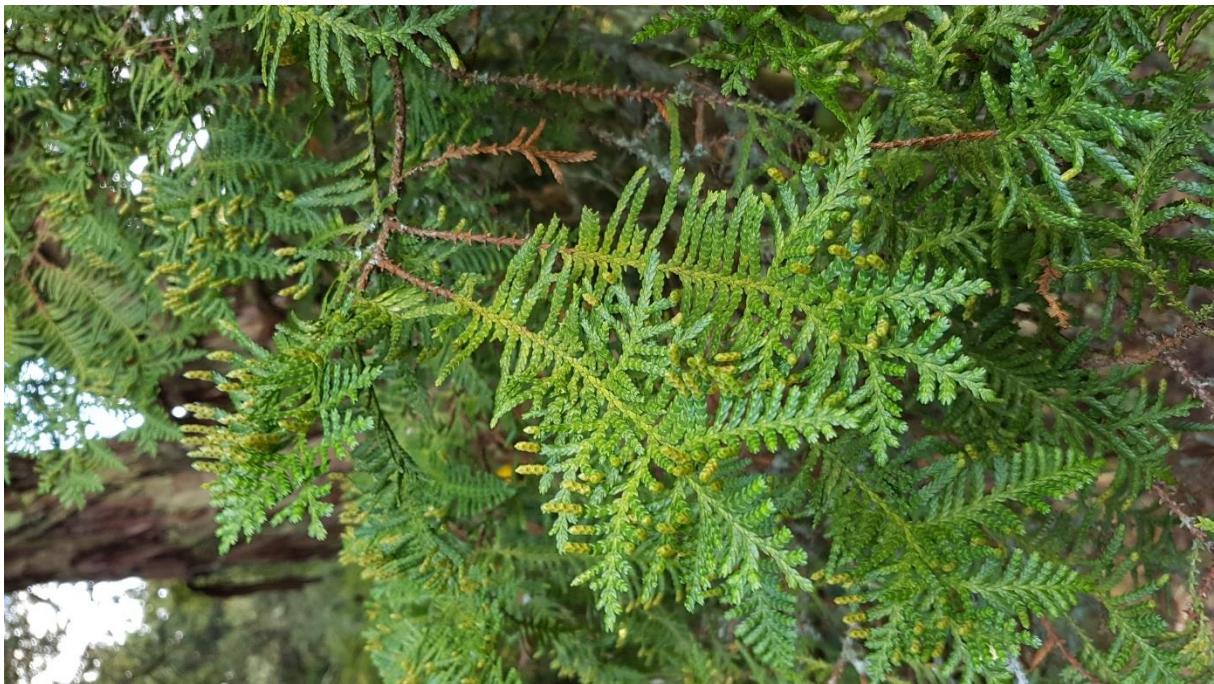
**Figure 3.3. Kawaka (*Libocedrus plumosa*), classified by the Department of Conservation as *Naturally Uncommon*, and by the IUCN as a vulnerable species.**

Stubbs Farm contains a forest remnant that supports two healthy kawaka (*Libocedrus plumosa*) of reproductive maturity, which appear not to be planted. *Libocedrus plumosa* has both male and female reproductive cones on the same plant (monecious), and so both individuals may reproduce (Allan, 1982; Tomlinson *et al.* 1993). *Libocedrus plumosa* has been classified by the Department of Conservation (de Lange *et al.*, 2013) as *Naturally Uncommon*; therefore, the supporting ecosystem qualifies for protection as a Significant Ecological Area under the criterion 2E(i).

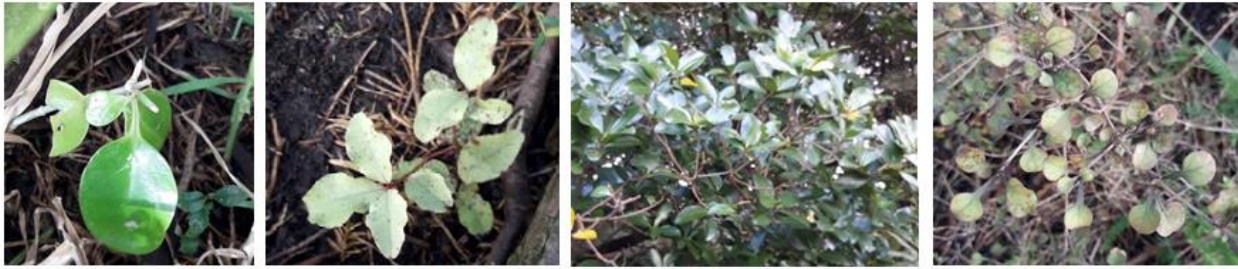
**Plate 3.2.** Some of the taxa that indicate the ecosystem type would shift to a WF11 forest if protected. From left to right: karamu seedling, mapou seedling, karaka sapling, *Coprosma* seedling

When determining the ecological value of an ecosystem, it is important to consider the probable future community composition and habitat type. Cattle grazing has had an obvious and significant impact on the diversity and abundance of seedlings and saplings; however, there remains a number of seedlings near the stream margins and immediately surrounding the tree basal regions. The seedling flora is moderately diverse and reflects a flora characteristic of a kauri podocarp broadleaved forest (WF11), including karaka, karamu, and puriri (Plate 3.2). This suggests that seed dispersers are successfully inputting native seed material into this fragment from the nearby kauri forests within this property and from the kauri podocarp broadleaved forests covenanted on the neighbouring sections. Therefore, the exclusion of cattle is expected to facilitate a transition from an anthropic tōtara forest system into a functioning kauri podocarp broadleaved forest with minimal additional intervention. Kauri podocarp broadleaved forests were historically common in this area; however, due to logging they are now classified as Endangered under the IUCN classification system (Singers *et al.*, 2017).

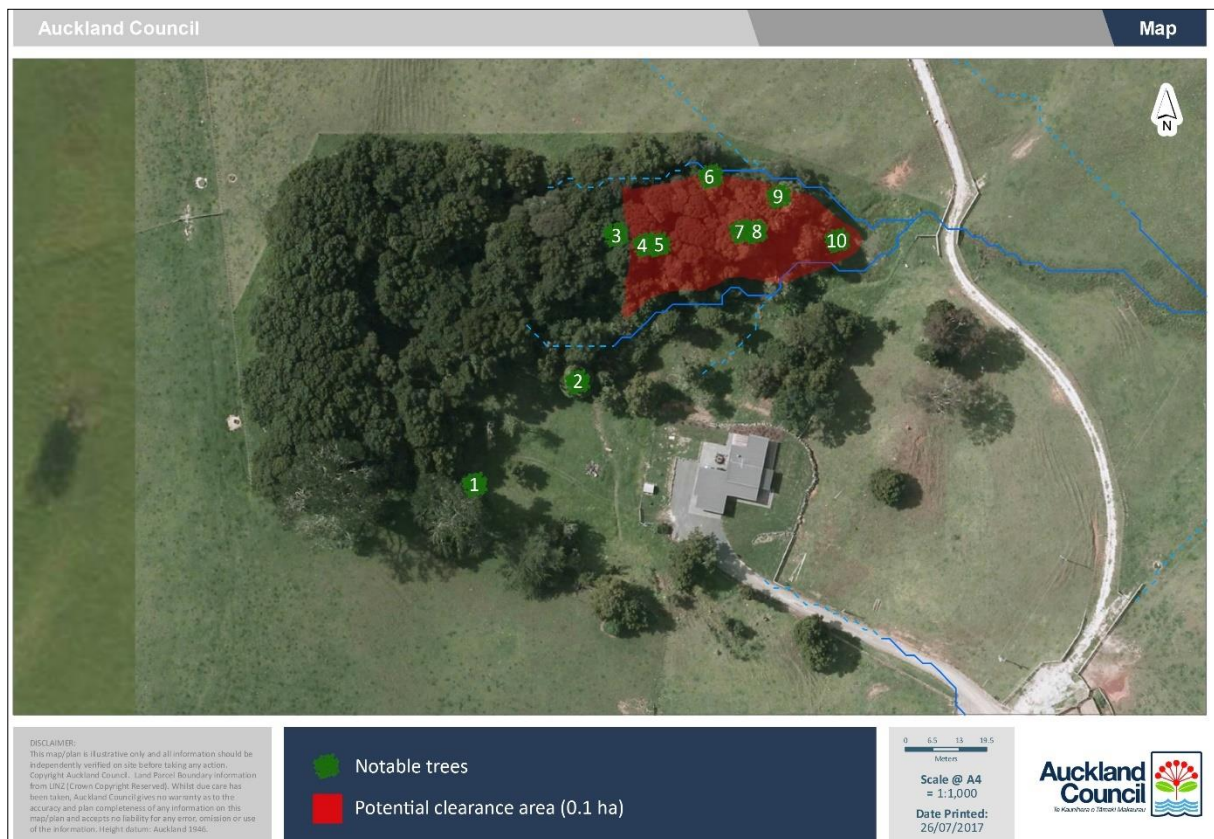
**Figure 3.4.** Aerial photograph of the remnant bush block, showing the location of notable trees and watercourses, and the area of younger vegetation that could be removed to create a recreational parkland.

Therefore, the native vegetation surrounding both streams should be retained and enriched with further riparian buffer planting to a distance of 5 – 10 m from the stream edges. All retained bush and replanted areas would require weed control and vertebrate pest management.
