# ECOLOGICAL ASSESSMENT

WARCKWORTH NORTH

**REFERENCE:** BIORESEARCHES (2019). ECOLOGICAL ASSESSMENT: WARKWORTH NORTH

<b>Document title:</b>	Ecological Assessment: Warkworth North
<b>Prepared for:</b>	Turnstone Capital LP
<b>Version:</b>	FINAL
<b>Date:</b>	03 May 2019
<b>Document name:</b>	<i>16141 Ecological Assessment - Warkworth North (Jan 2019)_FINAL.docx</i>

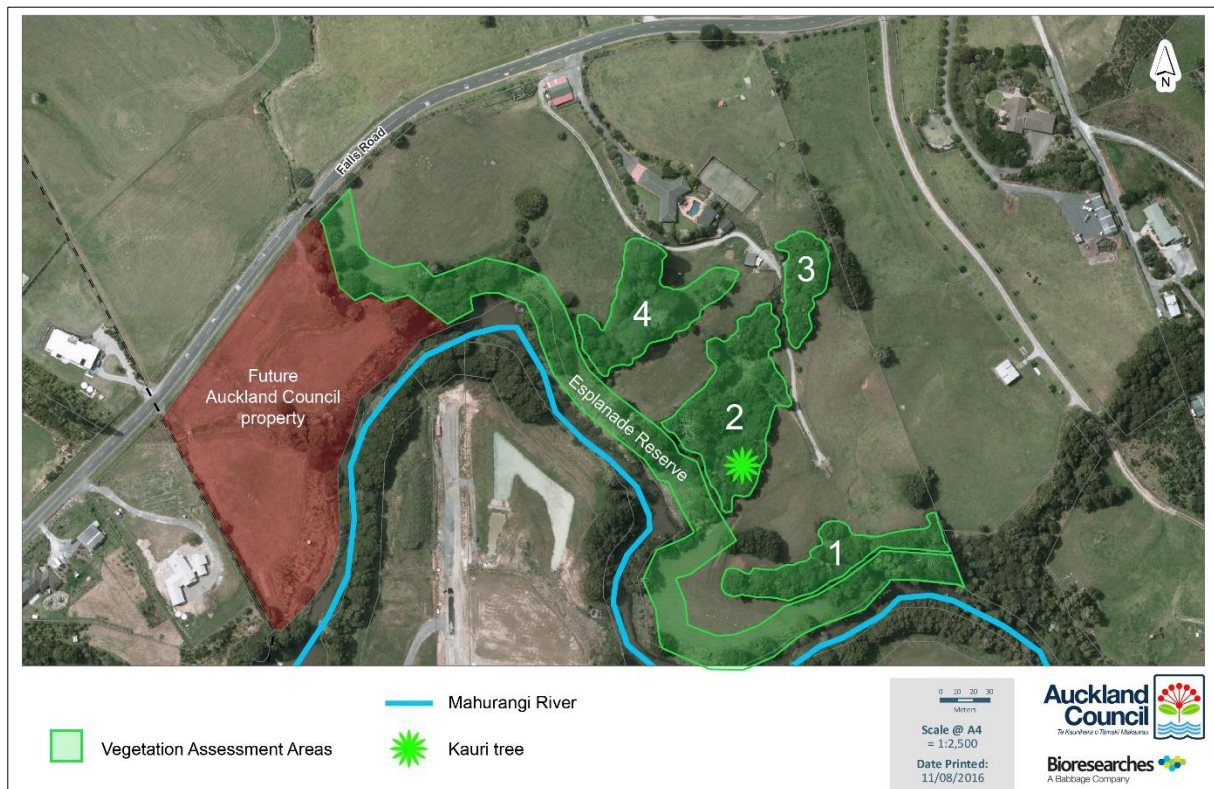
Figure 4.2. Areas 1 -4 of native vegetation at 223 Falls Road, Warkworth.

The main vegetation type at the site is totara (*Podocarpus totara*) dominant forest, much of which has been fenced off for between 10 and 20 years (Simon Ryburn *pers. comm.*). Outside the riparian vegetation along the Mahurangi River there are four main areas of native vegetation at the site (Figure 2). These areas are described in Sections 4.2.1 – 4.2.4 below. Section 4.9 Appendix I lists the native and exotic plant species recorded.

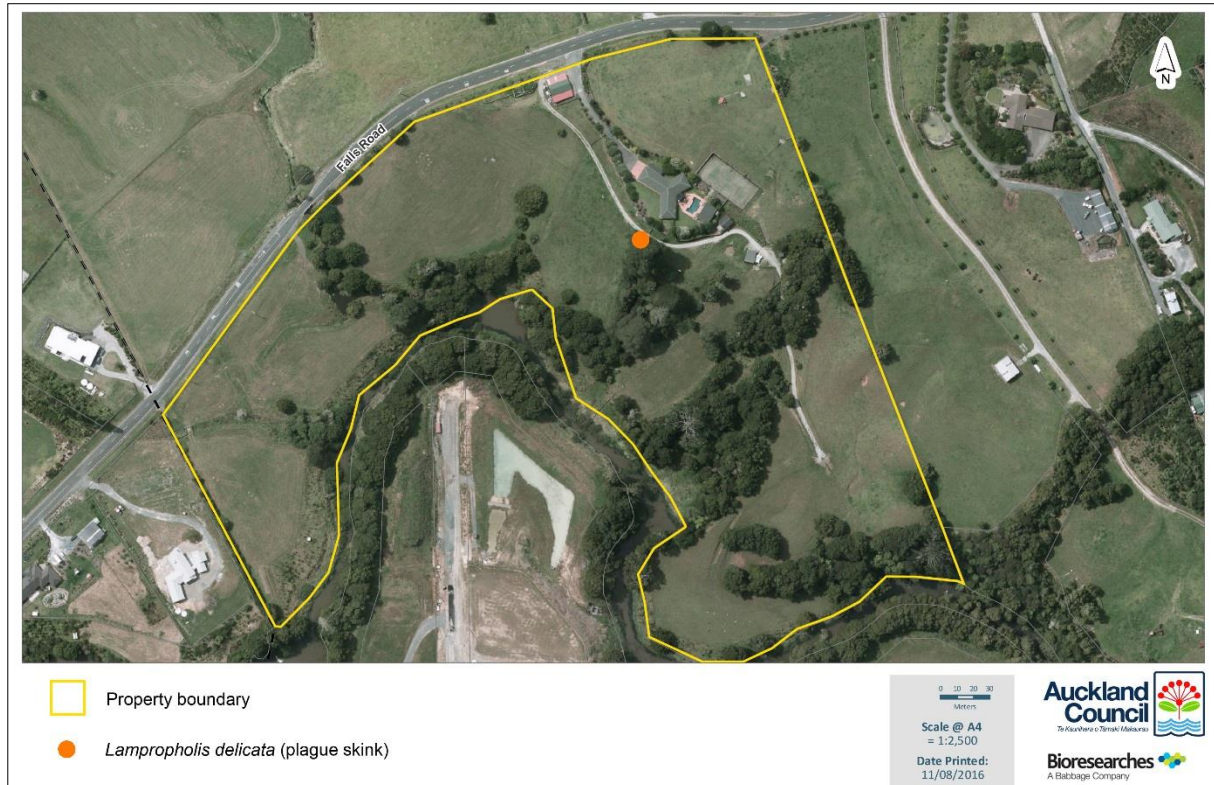
**Figure 4.5. Aerial image of the 223 Falls Road, Warkworth property showing the location of a plague skink (*Lampropholis delicata*) recorded on 5 August 2016.**

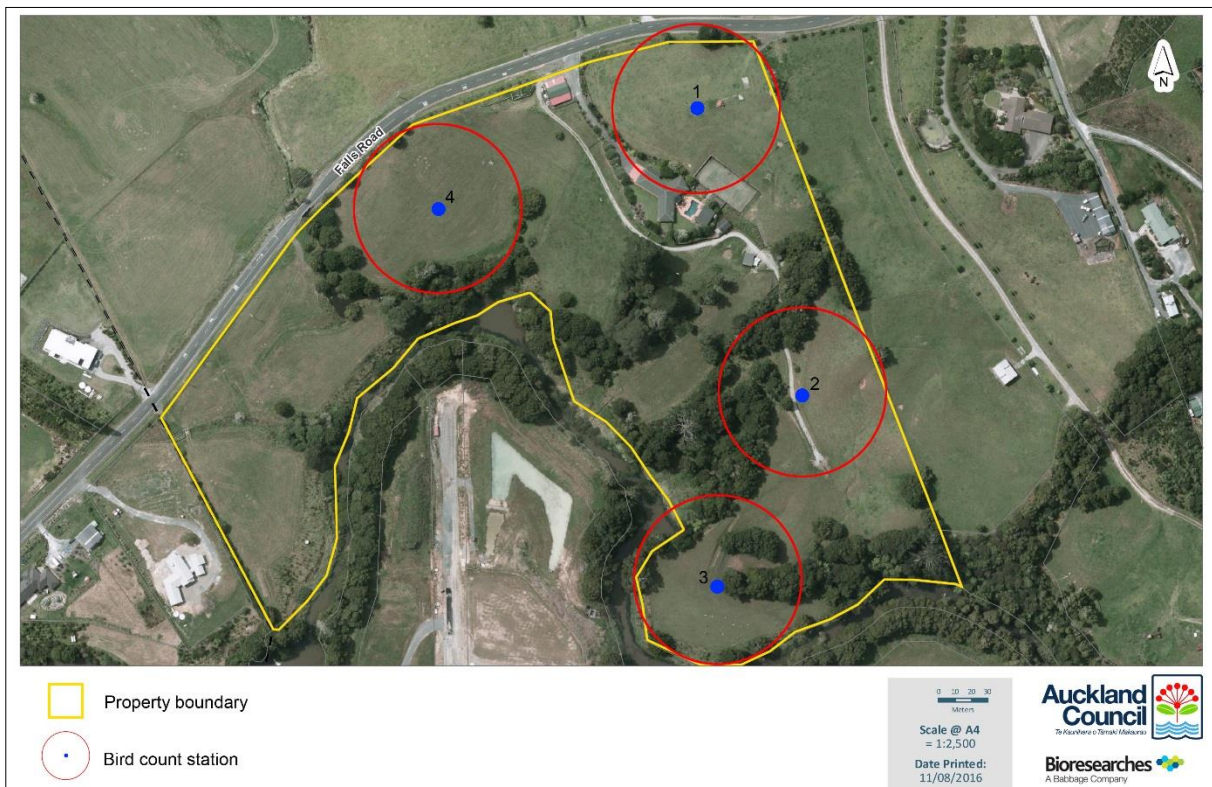
**Figure 4.6. Aerial image of the 223 Falls Road, Warkworth property showing the location of five-minute bird count locations.**

The avifauna (bird species) of the wider area were identified from a brief desktop assessment that involved a review of Robertson *et al.* (2007) and listing all bird species recorded within the 10 km<sup>2</sup> grid squares applying to the wider surrounding area from Orewa to Wellsford. In addition, field investigations (e.g. recording opportunistic sightings and undertaking dedicated five-minute bird counts) were carried out to document bird species utilising specific habitats at the site (Figure 4.6). Field surveys were undertaken on a single site visit on 5 August 2016.

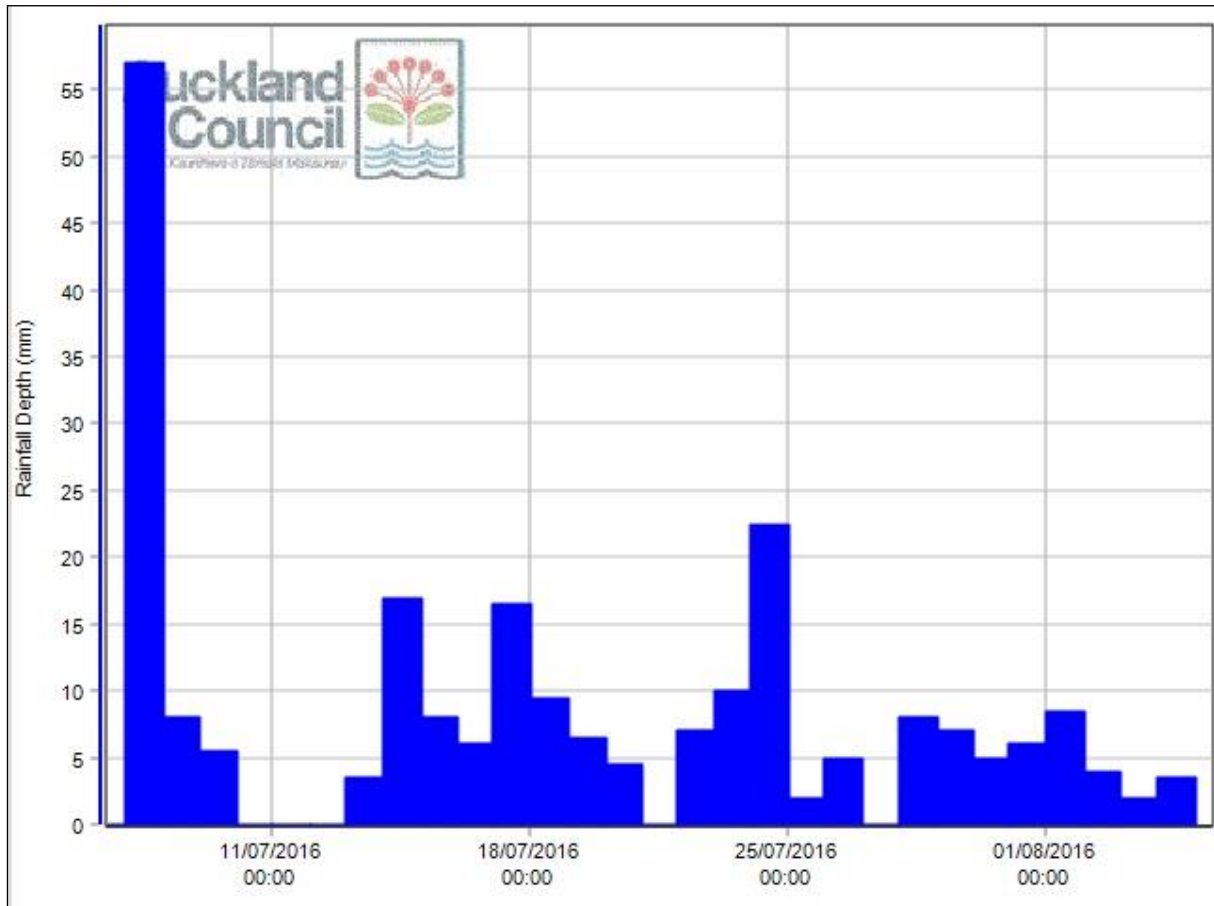
**Figure 4.8. Totalled daily rainfall depth (mm) at the Mahurangi Satellite Dish between 06/07/16 – 05/08/16.**

Rainfall within the area of the site in the preceding week before the survey was moderate and sustained, while the rainfall in the preceding four weeks was similar with one additional significant rainfall event (> 55 mm) (Auckland Council Environmental Monitoring Site: Mahurangi Satellite Dish) (Figure 4.8).

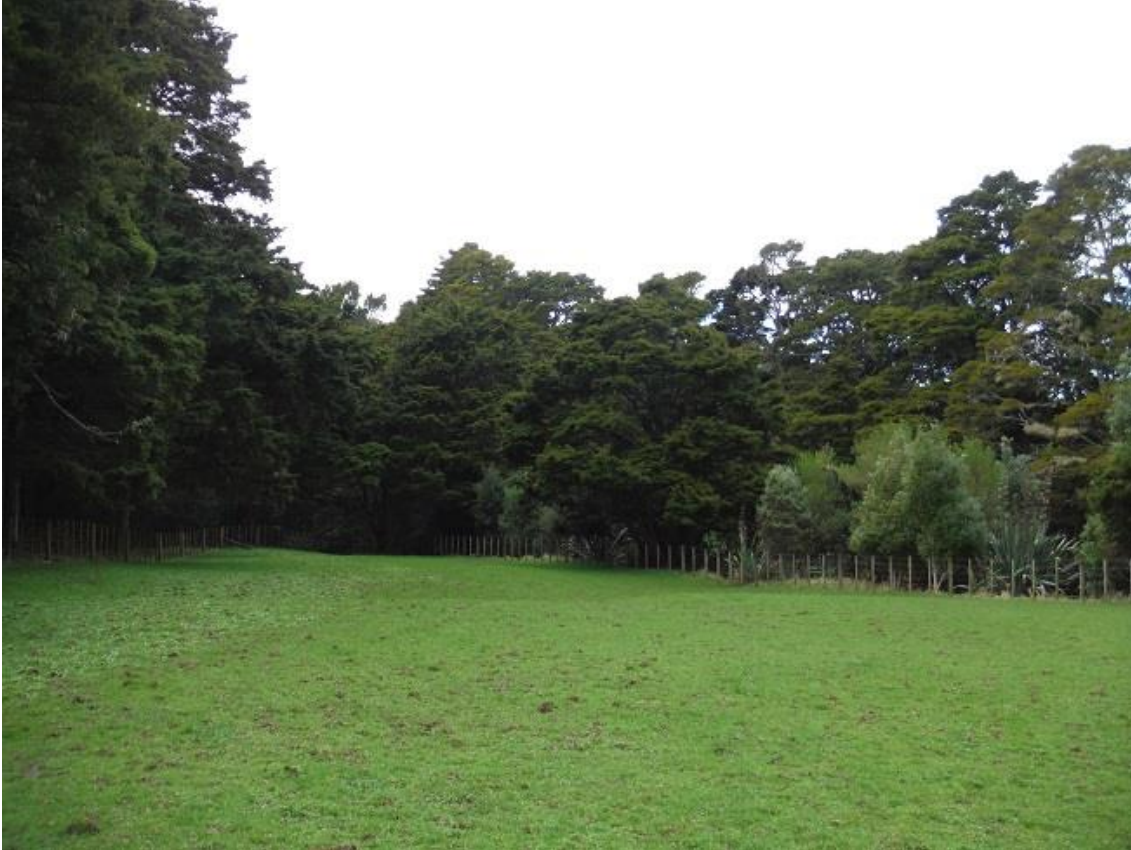
**Plate 4.7.** Riparian vegetation along the Mahurangi River in the south eastern part of the site showing mature totara with restoration planting between (right). On the left is the lower edge of Area 1.

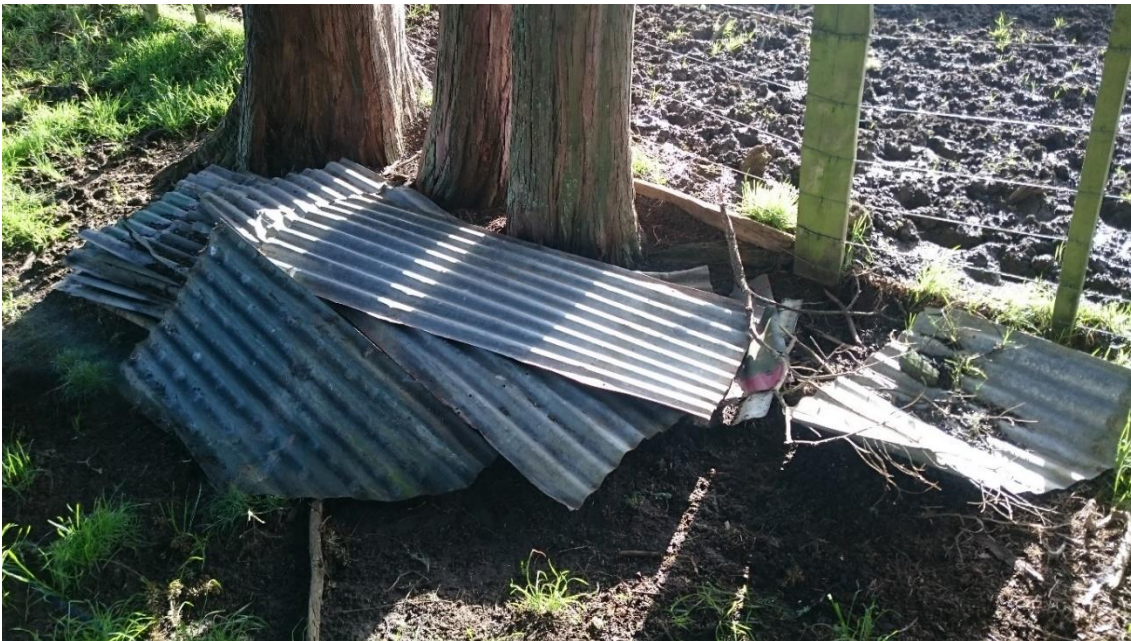
**Plate 4.8.** Corrugated iron debris, forming potential lizard refuge habitat.

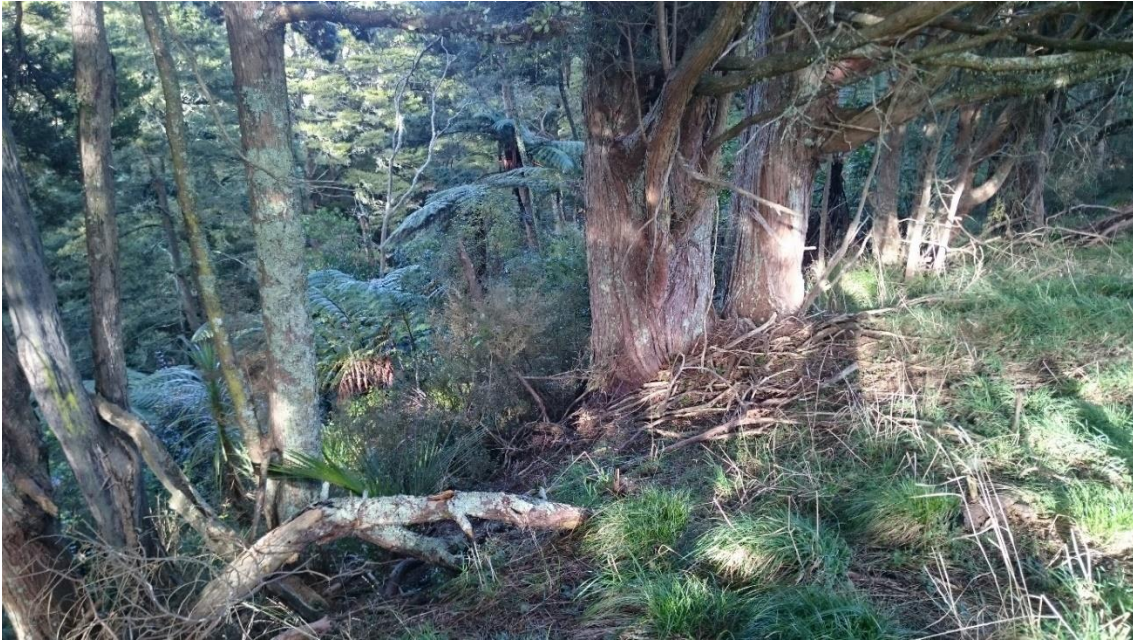
**Plate 4.9. Woody debris and flaky bark on trees that may provide refuge sites for native lizards (skinks and geckos).**

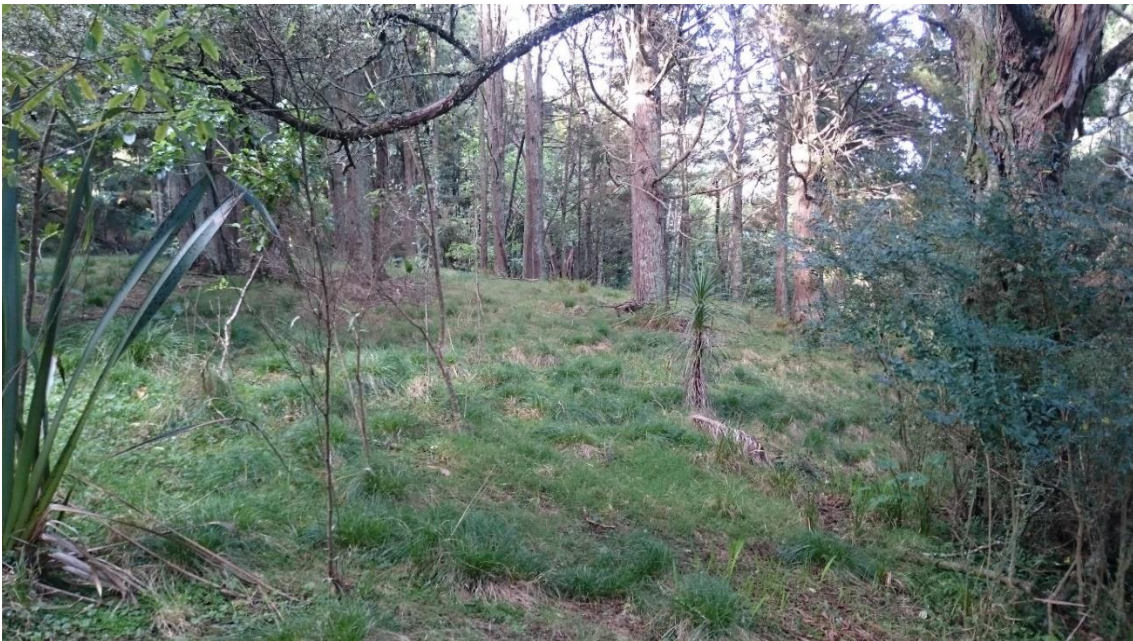
**Plate 4.10. Areas of rank grass—despite their apparent low ecological value—can provide suitable habitat for protected skinks.**

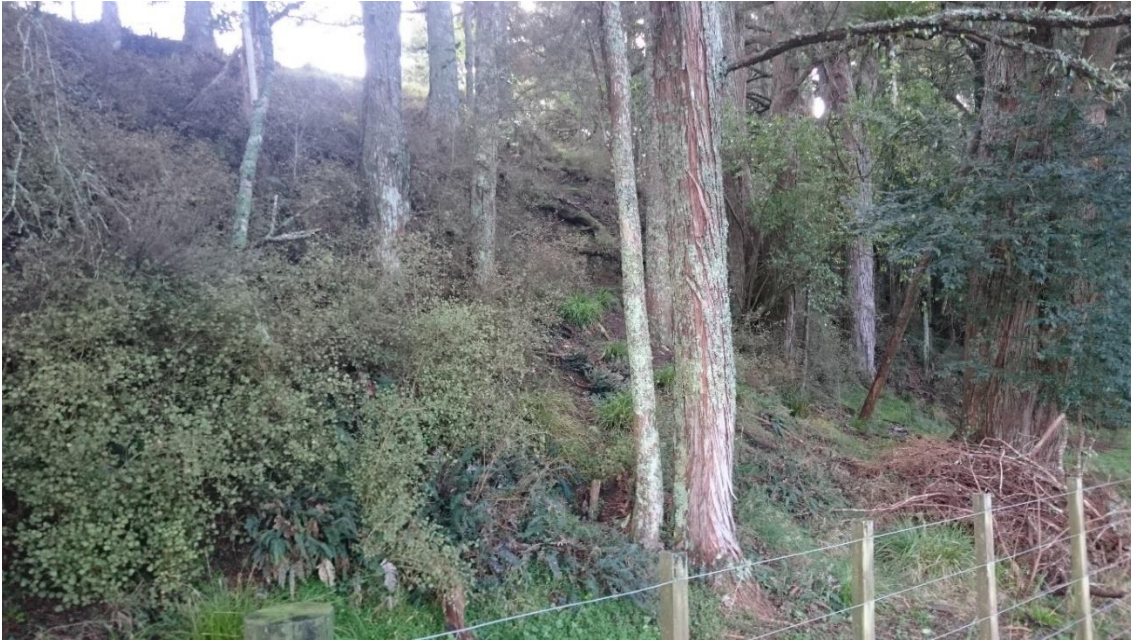
**Plate 4.11. Understorey scrub, rank grass and leaf litter that may offer suitable habitat for native lizards.**

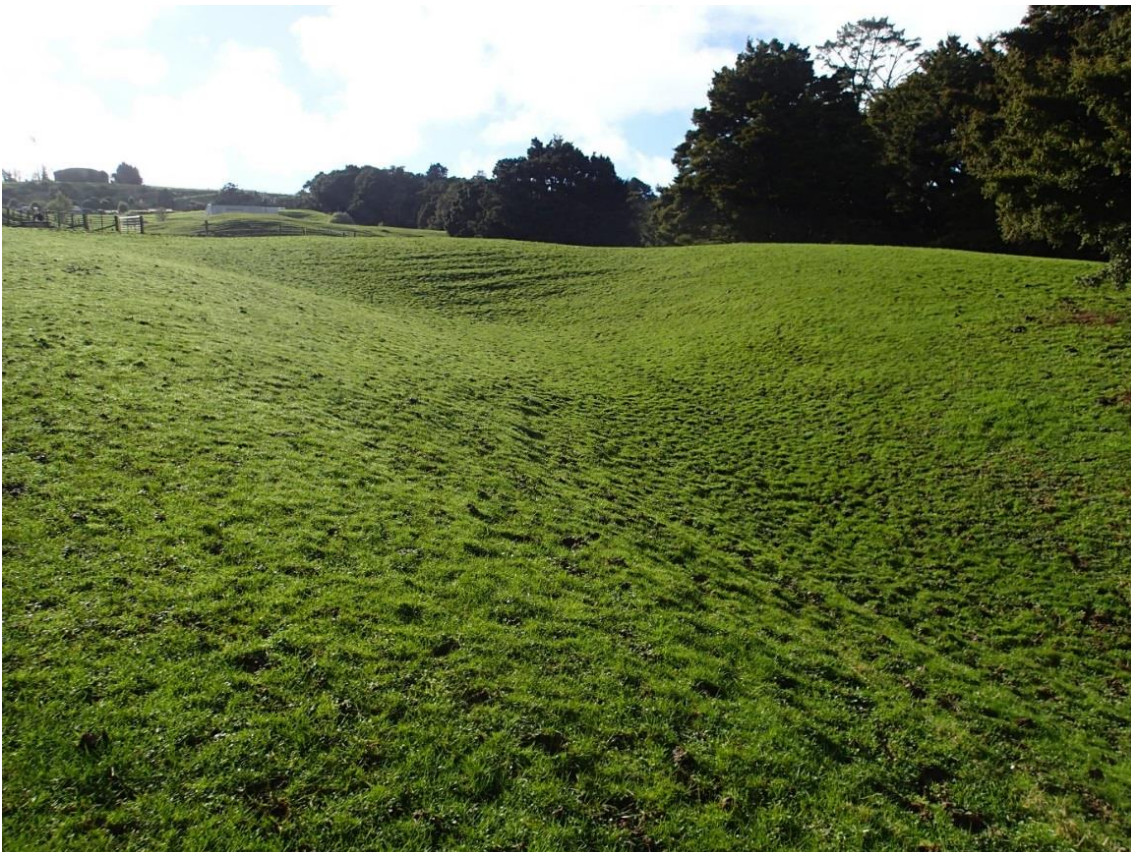
**Plate 4.12. Upper ephemeral reach of Watercourse 1.**

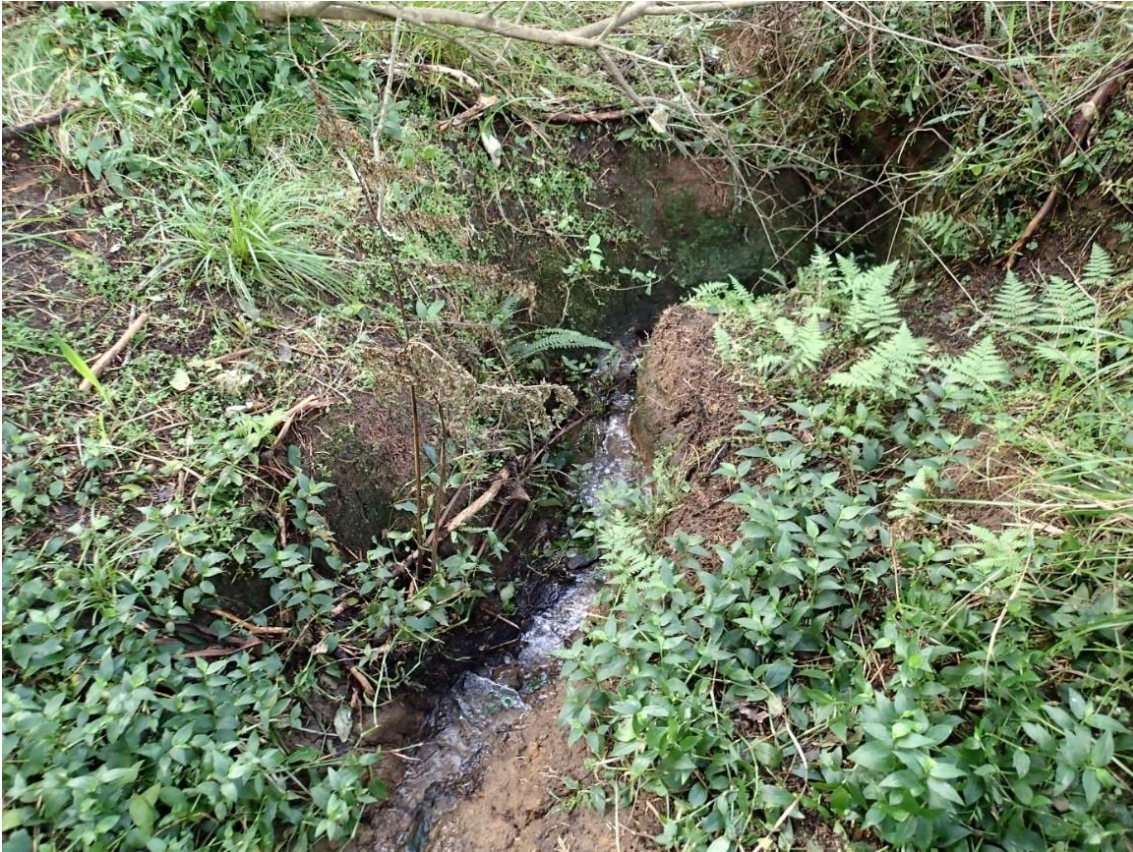
**Plate 4.13. Defined channel along the lower reach of Watercourse 1.**

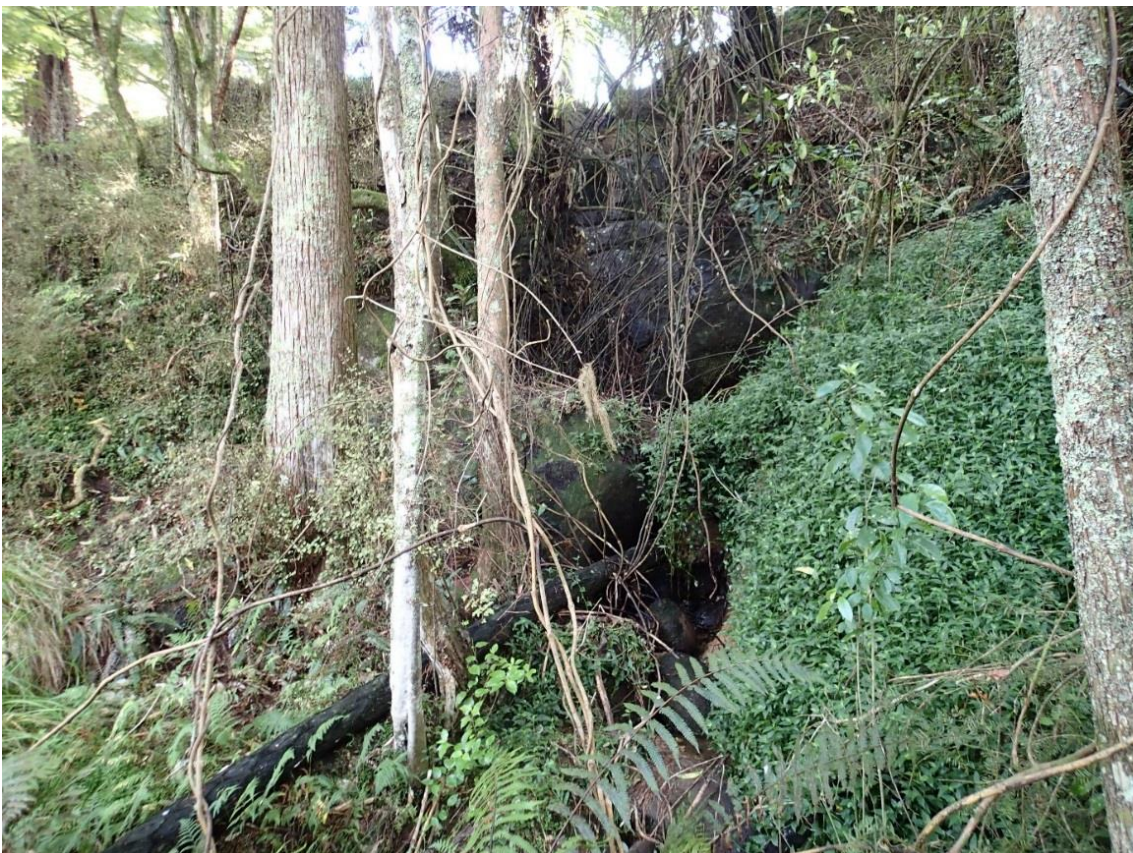
**Plate 4.14. Eight metre cascade along the lower reach of Watercourse 1.**

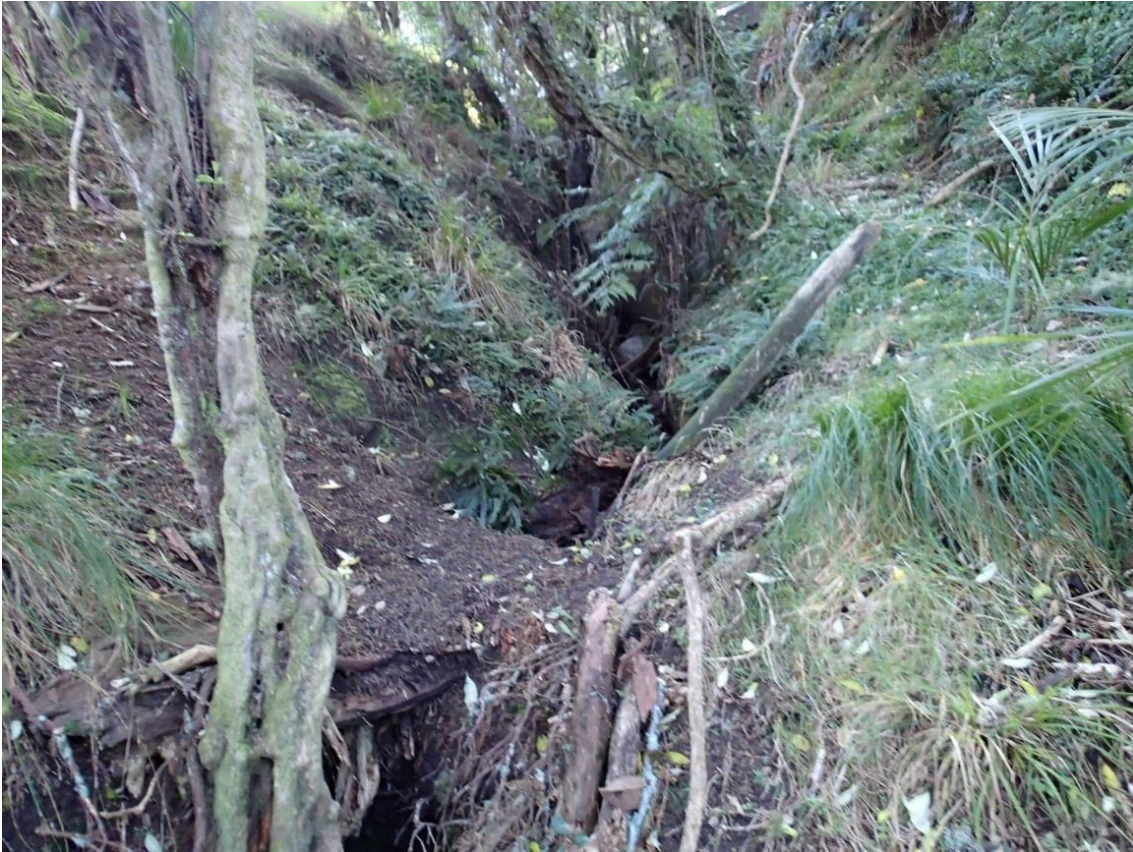
**Plate 4.15. Defined channel and incised banks of Watercourse 2.**

Watercourse 2 originated from within the site and ran for approximately 180 m before draining into the Mahurangi River. The watercourse had a defined channel with deeply incised banks in some places (Plate 4.15). The substrate consisted of silt, bedrock and large cobbles/ boulders (Plate 4.16). High shading was present along the whole watercourse and the majority of the riparian margin was fenced off. No macrophytes were recorded. Water quality measurements within the reach reflected the winter conditions and showed a water temperature of 13.8°C, which is indicative of an ‘excellent’ temperature (Biggs *et al.*, 2002). Dissolved oxygen concentration and saturation were high, at 9.2 mg/L and 90%, respectively indicative of no stress for aquatic fauna (Davies-Colley *et al.*, 2013). The conductivity level was ‘fair’ (163µS/cm), indicative of slightly enriched waters (Biggs *et al.*, 2002). Within the Mahurangi River riparian margin the watercourse became diffuse and formed a boggy wetland before draining into the river.

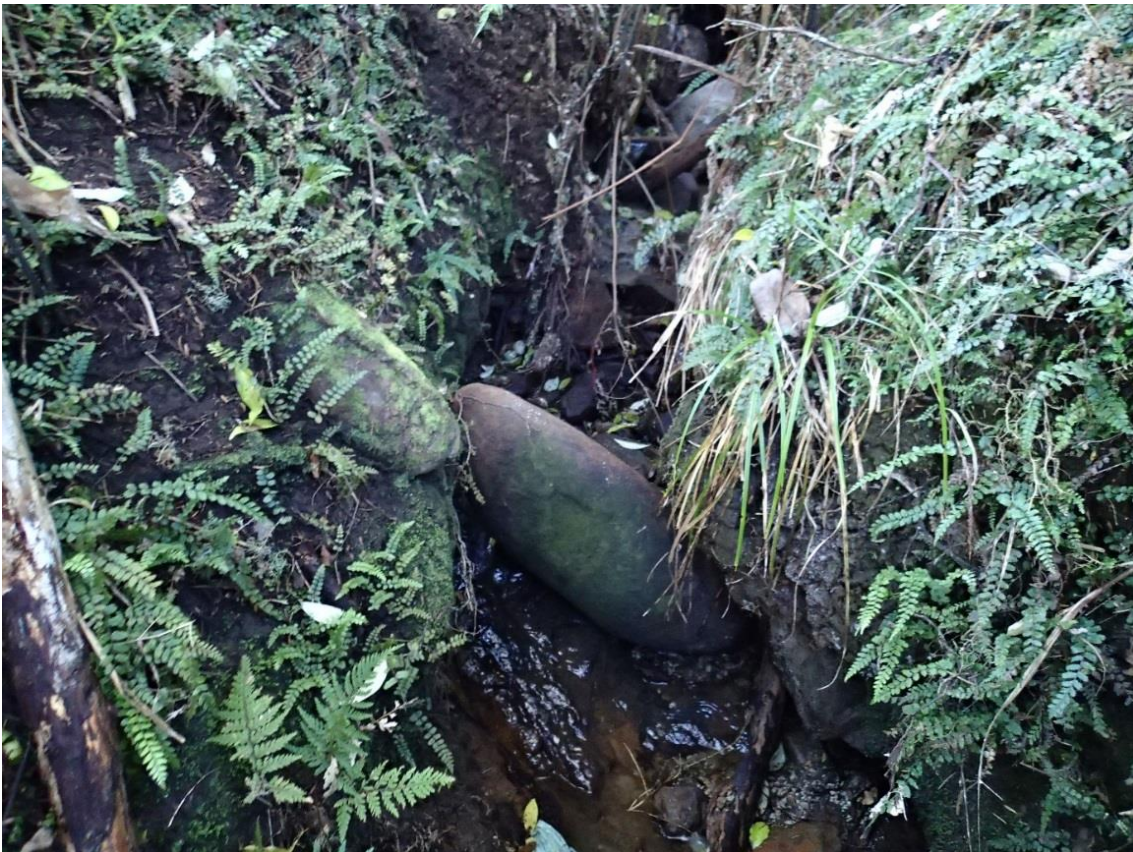
**Plate 4.16. Large cobbles/boulders within Watercourse 2.**

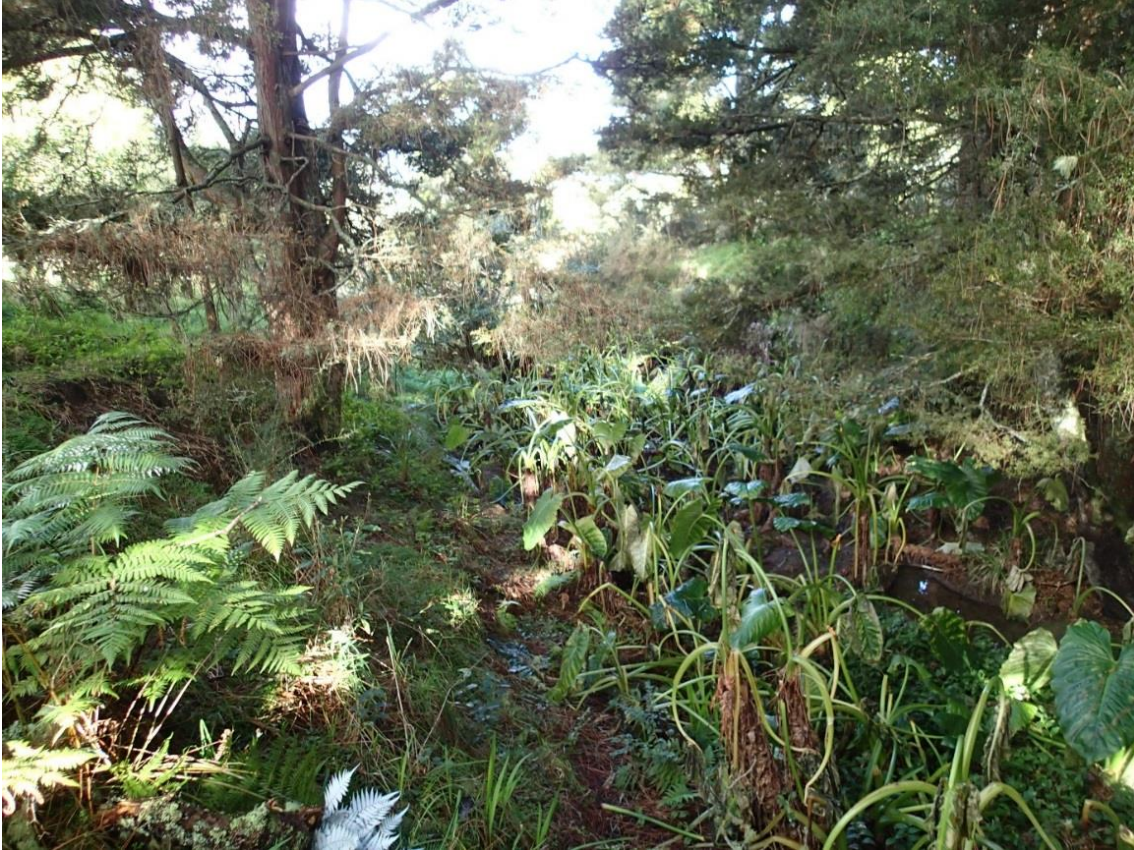
**Plate 4.17. Watercourse 3 showing high banks, diffuse watercourse and weeds.**

Watercourse 3 originated from within the site and ran for approximately 160 m draining into the Mahurangi River. Although the watercourse was situated within a steep-sided gully (2-4 m), the majority of the watercourse lacked a well-defined channel (Plate 4.17). The upper reach was choked with weeds and no running water was evident along the upper reach, but numerous small pools of water had formed. Further downstream the pools became larger and a trickle flow became evident which increased in strength further downstream. Along the watercourse, the substrate consisted of silt, a high level of shading was present and the riparian margin was fenced off. No macrophytes were recorded. Water quality measurements within the reach reflected the winter conditions and showed a water temperature of 12.6°C, which is indicative of an ‘excellent’ temperature (Biggs *et al.*, 2002). Dissolved oxygen concentration and saturation were high, at 9.3 mg/L and 88%, respectively indicative of no stress for aquatic fauna (Davies-Colley *et al.*, 2013). The conductivity level was ‘fair’ (150µS/cm),

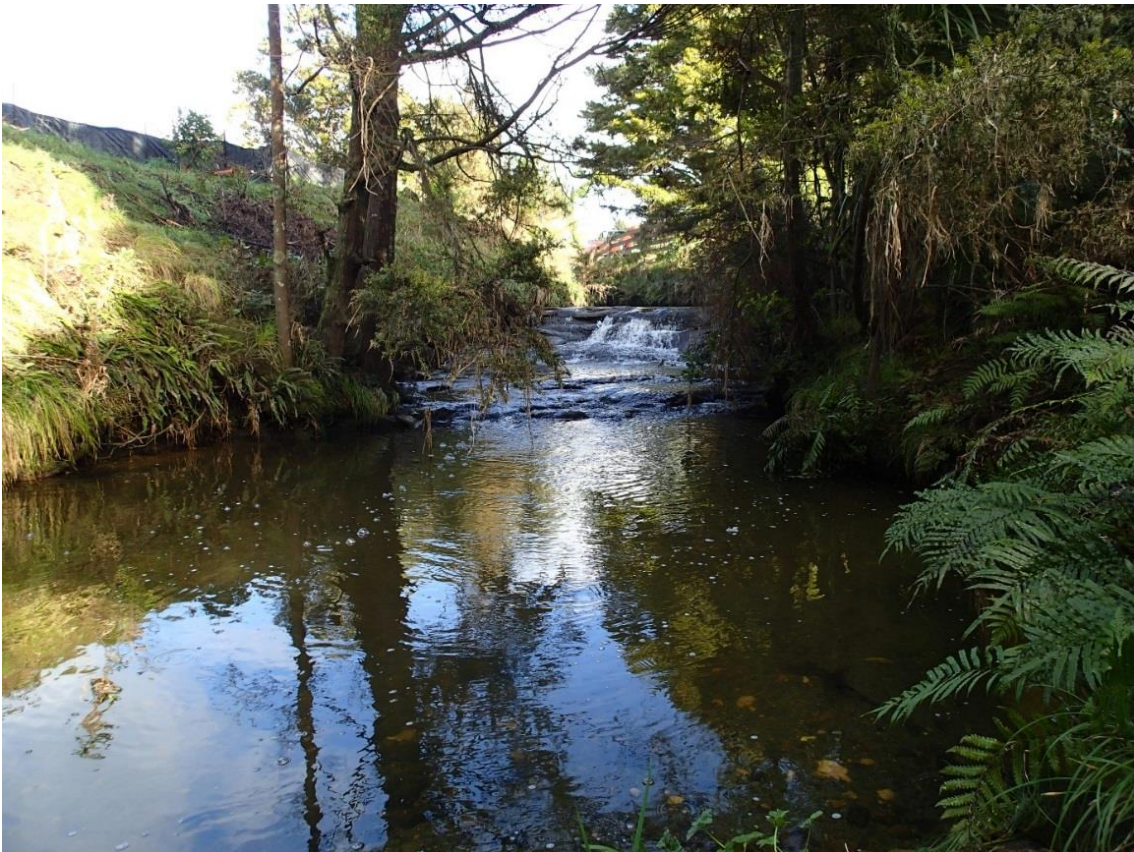
**Plate 4.18. Watercourse 4, showing a wide channel and hydrologic variation.**

Watercourse 4 originated north of the site and forms a significant tributary of the Mahurangi River. The watercourse runs for approximately 140 m within the site before draining into the Mahurangi River. The watercourse had a wide (3-4 m) defined channel with steep sided banks (Plate 4.18). The hydrologic heterogeneity was high with runs, pools and cascades. The substrate consisted of silt, cobble and bedrock. Moderate to high shading was present along the watercourse and the majority of the riparian margin was fenced off. No macrophytes were recorded. Water quality measurements within the reach reflected the winter conditions and showed a water temperature of 12.3°C, which is indicative of an 'excellent' temperature (Biggs *et al.*, 2002). Dissolved oxygen concentration and saturation were high, at 10.3 mg/L and 98%, respectively indicative of no stress for aquatic fauna (Davies-Colley *et al.*, 2013). The conductivity level was 'good' (143µS/cm), indicative of unlikely enriched waters (Biggs *et al.*, 2002).

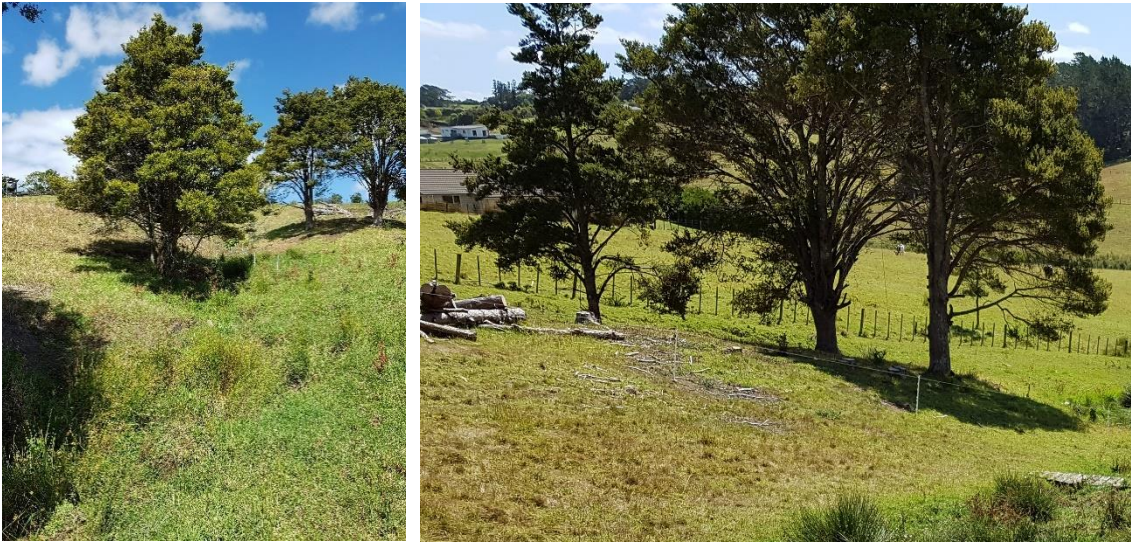
**Plate 5.1. Extent of the native vegetation on-site—totara trees growing alongside Watercourse 2.**

The site is almost completely in managed pasture apart from a small group of native totara (*Podocarpus totara*) trees along the western boundary (Plate 5.1), growing either side of a watercourse. A number of trees in the south-western corner have been felled, as evidenced by cut and stacked logs (Plate 5.2). Terrestrial vegetation (e.g. kikuyu grass, *Rumex* sp., *Rubus fruticosus*) was found growing within the channel of the most northern watercourse, while *Juncus edgariae*, Arum-lily (*Zantedeschia aethiopica*) and *Nasturtium officinale*—species associated with wetted areas—were present in the southern watercourse.

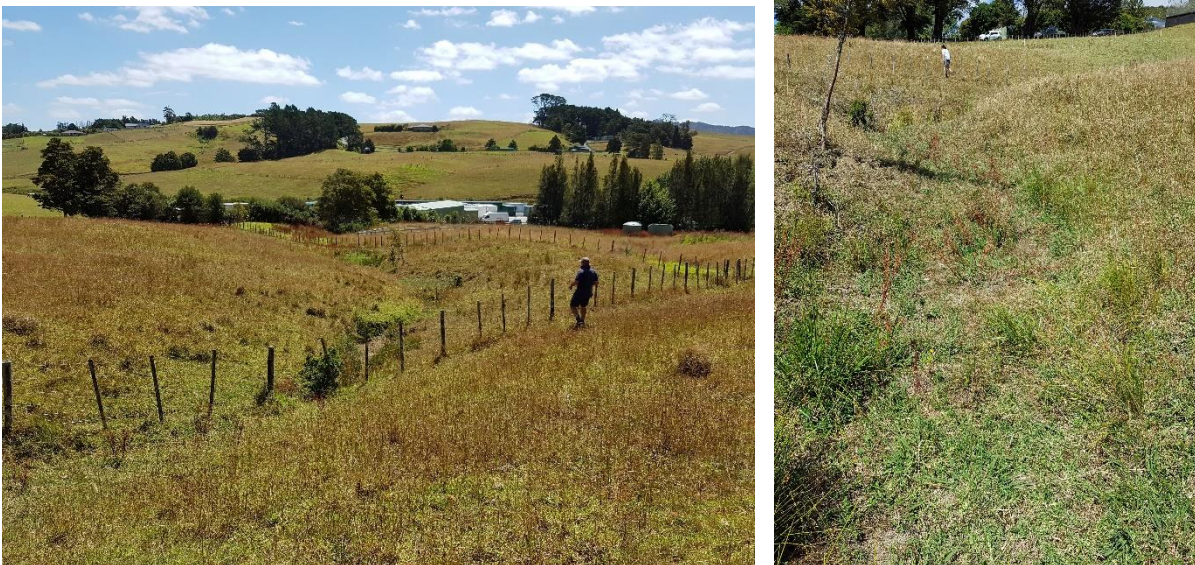
Plate 5.2. Watercourse 1 (northern watercourse/ overland flow path)

This watercourse was approximately 65 m in length with gently sloping banks covered in pasture grass. It contained no running or surface water, lacked a well-defined channel and terrestrial vegetation was present throughout the entire length of the watercourse (Plate 5.2; Figure 5.2).

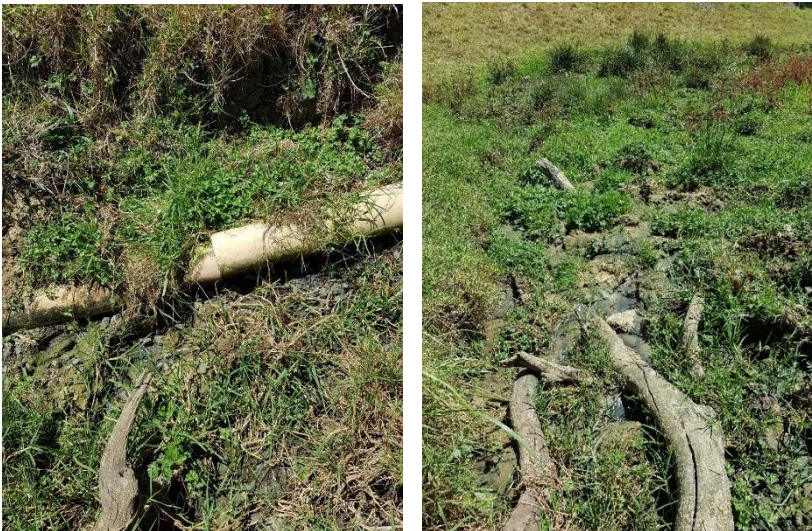
**Plate 5.3. Watercourse 2 (southern watercourse). Images showing the broken pipe in the upper reaches (left) and water pooling in pug marks downstream (right).**

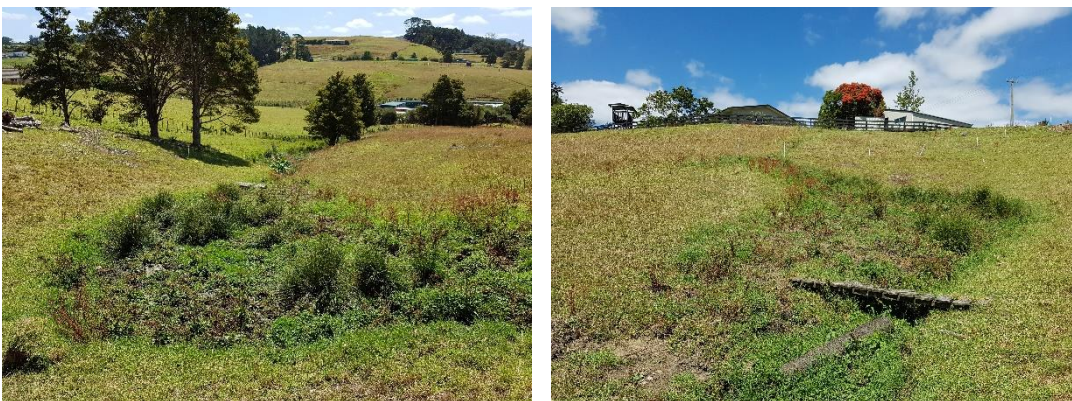
**Plate 5.4. Watercourse 2 (southern watercourse) showing the c. 4 m wide wetted area (left) and the small bridge (right).**

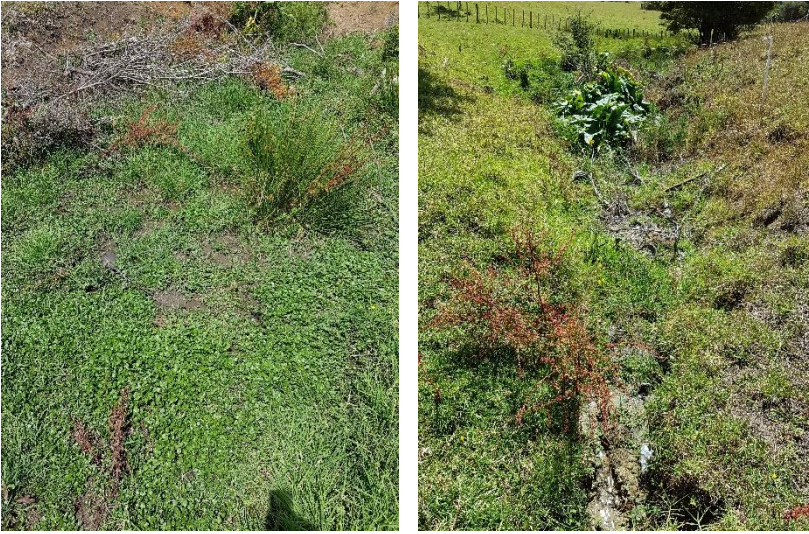
**Plate 5.5. Watercourse 2 (southern watercourse) showing the lower reaches (left) and *Nasturtium* (watercress) (right).**

widened again forming another wetted area (c. 3 m wide) (Plate 5.5). This area supported a slightly higher diversity of plants, including Arum-lily (*Zantedeschia aethiopica*) and aquatic or semi-aquatic watercress (*Nasturtium officinale*) (Plate 5.6). The presence of *Nasturtium* indicates the watercourse remains wet for much of the year. The watercourse then passed under the property boundary fence where it formed a distinct channel (c. 1.5 m wide; c. 0.5 m deep) that ran into the neighbouring paddock and eventually drained into the Mahurangi River.

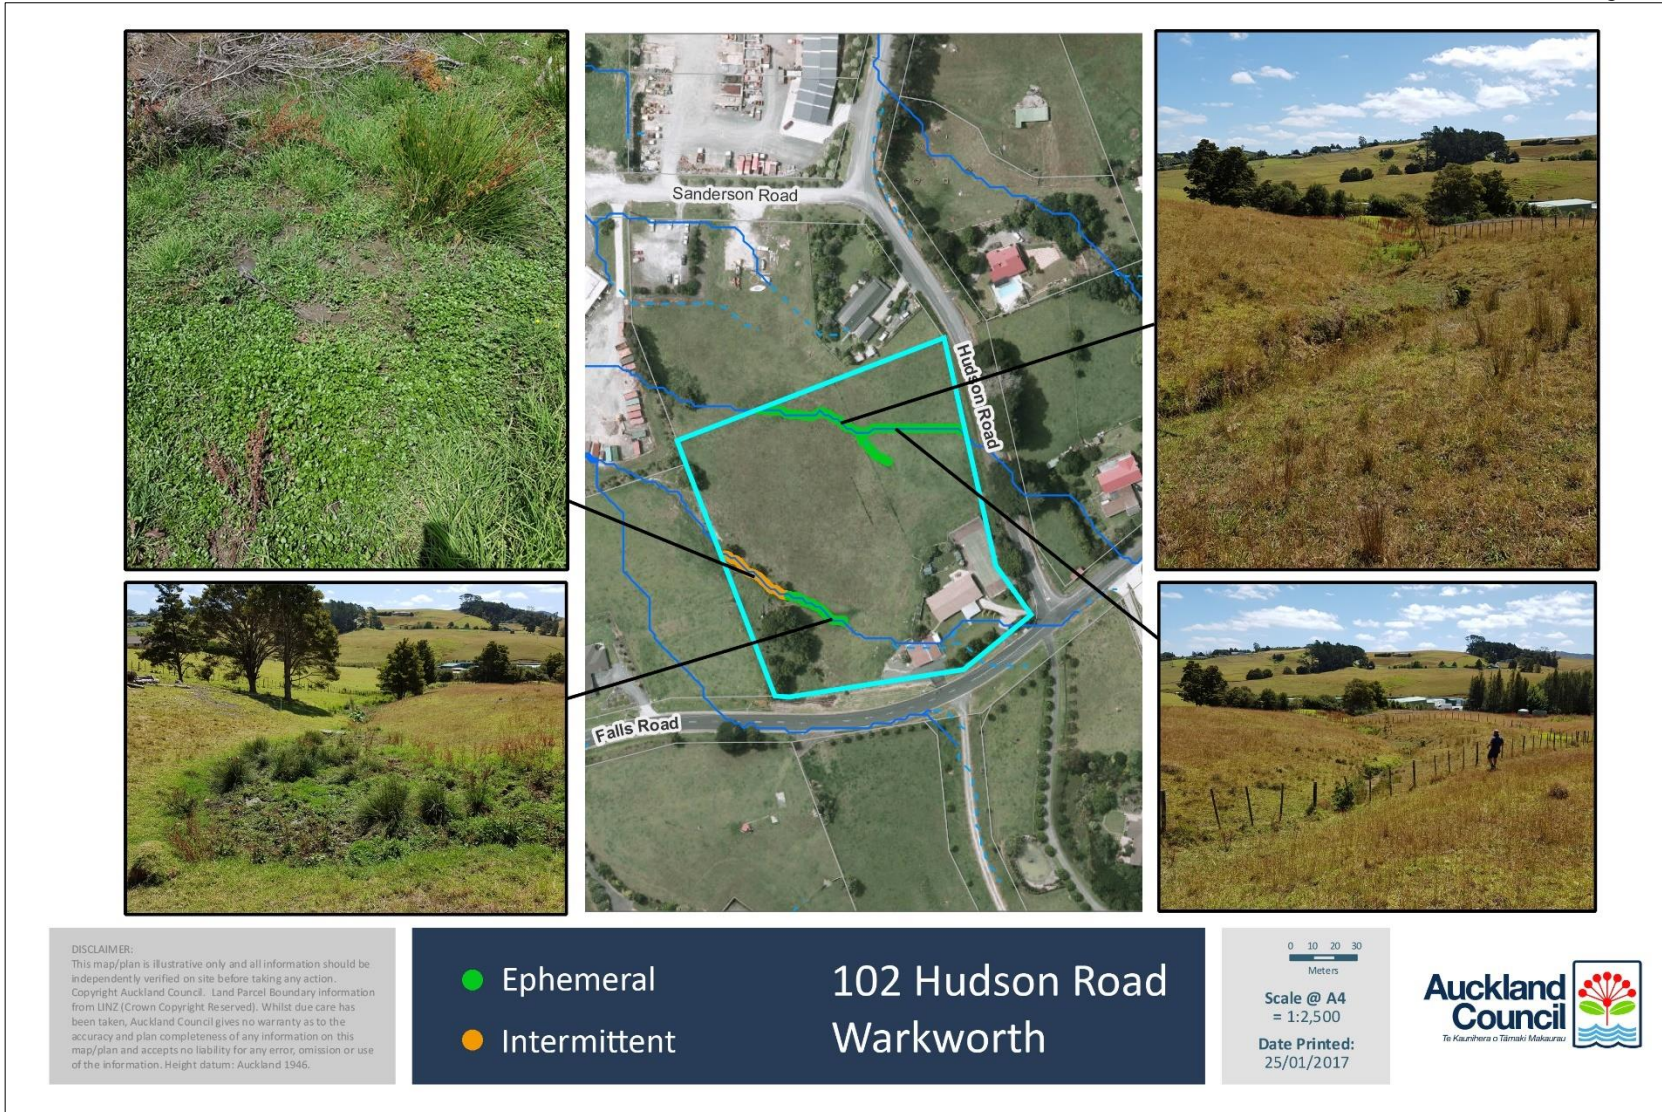
**Figure 5.2. Aerial photograph of the 102 Hudson Road, Warkworth property showing the location and classification of watercourses, and accompanying images**

Watercourse 1 was classified as ephemeral (Figure 5.2) and considered to have a low ecological value predominantly due to the lack of water and lack of riparian vegetation, resulting in negligible habitat for native fauna. Works in or alteration to this ephemeral watercourse is a permitted activity (AUP Op, E3: (A53)). Watercourse 2, although classified as intermittent (Figure 5.2), was also considered to have low ecological value. This watercourse supports some species of plants generally associated with aquatic environments (e.g. watercress); however, its degraded condition—predominantly due to riparian vegetation grazing and erosion caused by stock—has reduced both water quality and habitat available for native fauna. Where degradation, reclamation or culverting of an intermittent watercourse cannot be avoided, due to engineering or planning constraints, the adverse ecological effects would be appropriately mitigated or compensated for through offsetting in accordance with Policy E3.3 (4) of the AUP Op.

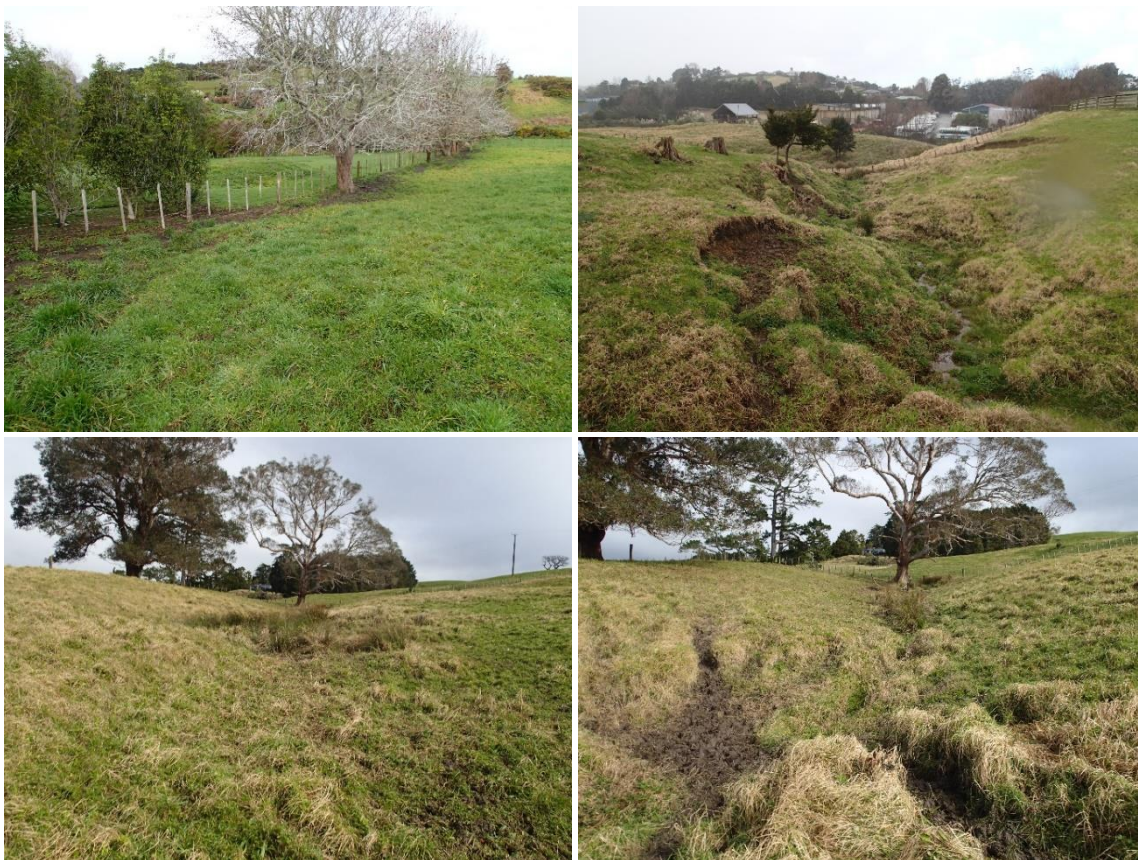
**Plate 6.1. Selection of individual trees or small stands of trees present within the Structure Plan area.**

managed pasture or present along intermittent or ephemeral watercourses (Plate 6.1). Most of these trees are exotic (e.g. *Eucalyptus* sp., *Salix* sp. or *Pinus radiata*) and are either amenity trees or serve the purpose of providing shade to livestock. Thus, these trees have negligible ecological value. Individual mature rimu, kauri, totara and kahikatea trees are also present and where these are to be removed, mitigation via compensatory native planting (i.e. replacement equivalent to basal wood area) would occur. Replanting with native fruit and nectar producing species would provide higher value to wildlife by offering natural food resources.
