# ECOLOGICAL ASSESSMENT

WARCKWORTH NORTH

**REFERENCE:** BIORESEARCHES (2019). ECOLOGICAL ASSESSMENT: WARKWORTH NORTH

<b>Document title:</b>	Ecological Assessment: Warkworth North
<b>Prepared for:</b>	Turnstone Capital LP
<b>Version:</b>	FINAL
<b>Date:</b>	03 May 2019
<b>Document name:</b>	<i>16141 Ecological Assessment - Warkworth North (Jan 2019)_FINAL.docx</i>

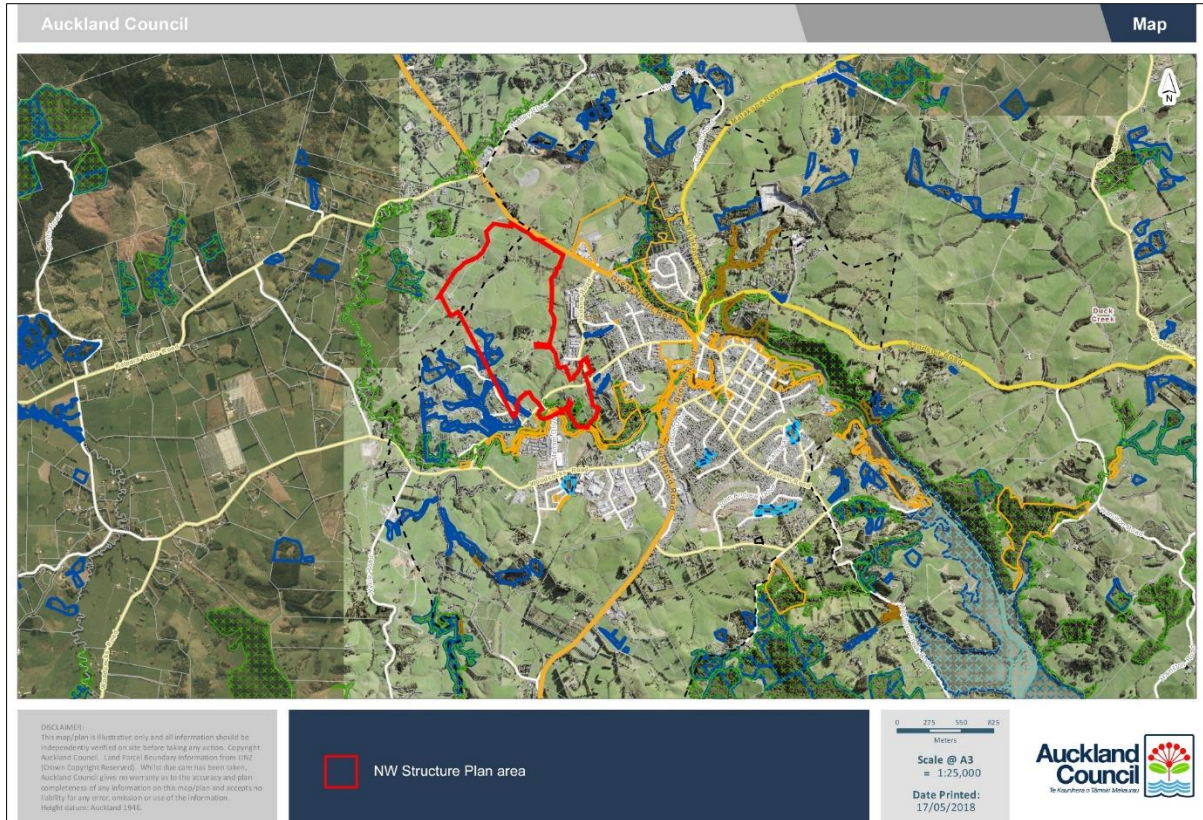
**Figure 6.12. Habitat Protection Areas (covenants) of North Warkworth (map provided by AC)**

Figures 6.12 shows the current state of the protected areas (Significant Ecological Areas, habitat protection areas [covenants]) present in the North Warkworth landscape and the location of the proposed NWSP area, and Figure 6.13 provides a visual concept of the green network within the proposed NWSP area and its position relative to other local SEAs.
