Environmental Site Investigation

## **Warkworth Private Plan Change**

for: Turnstone Capital

Job No: 52864  
Version: Final  
eTrack No: 200024304  
Date of Issue: 23/01/2019

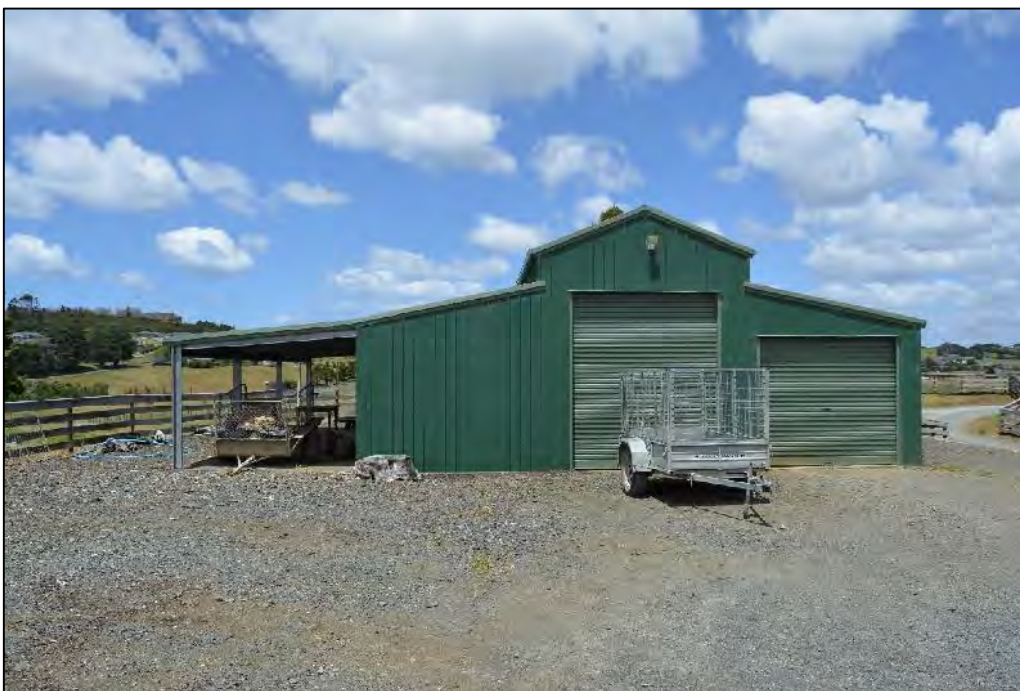
Structures observed during the site visit included the four residential houses, a farm shed and a hay storage barn.

**Figure 2: Farm Shed**

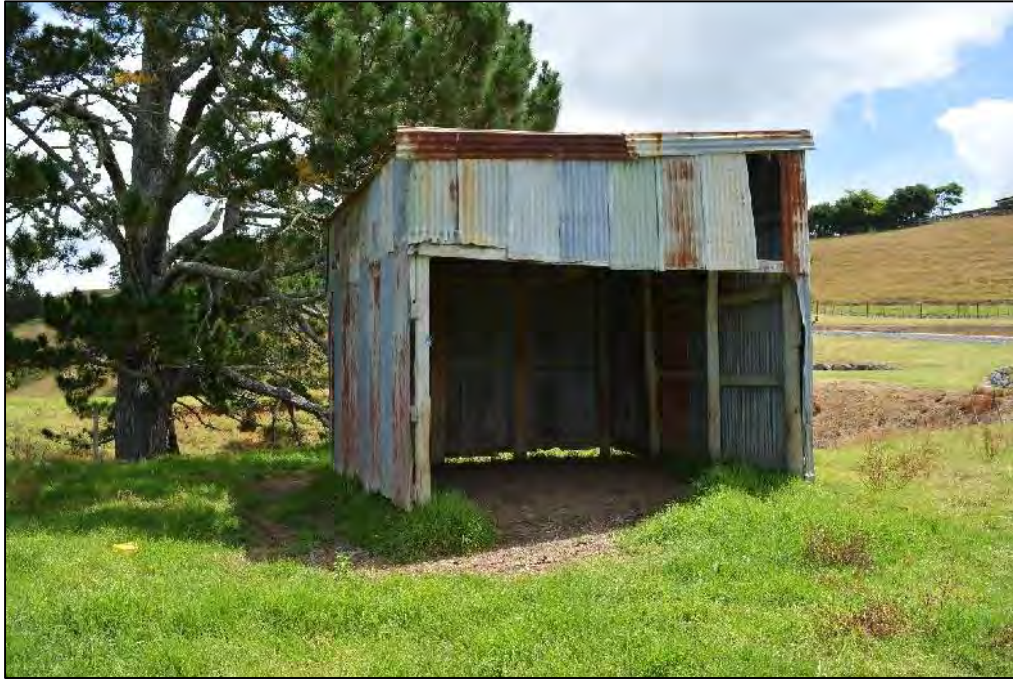
**Figure 3: Hay Barn**

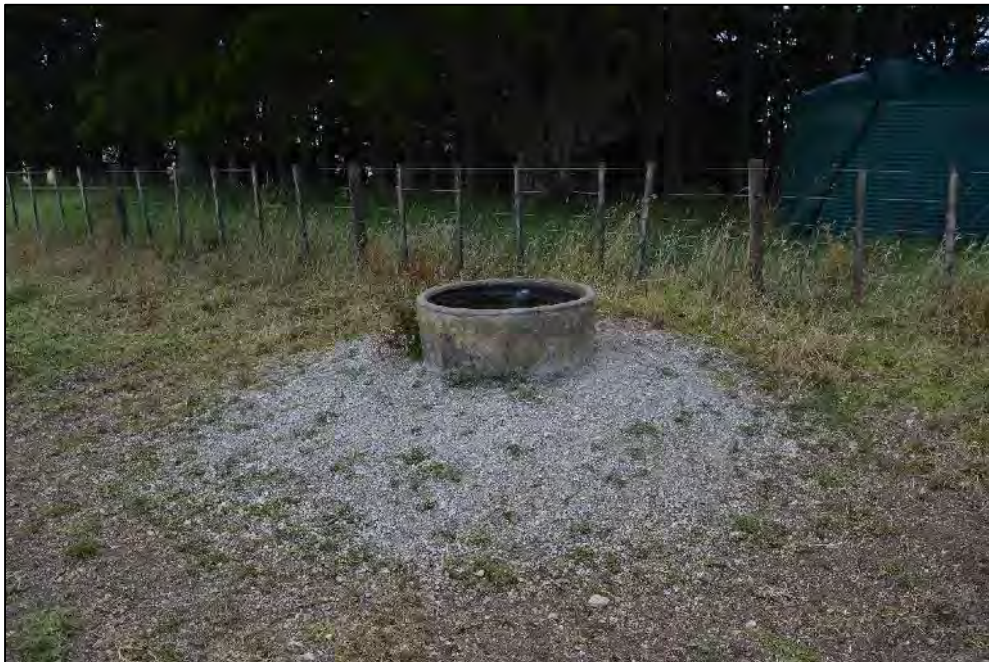
A number of watering troughs were also observed on the site. These were surrounded by crushed lime rock and no evidence of asbestos containing material was observed.

**Figure 4: Water Trough**

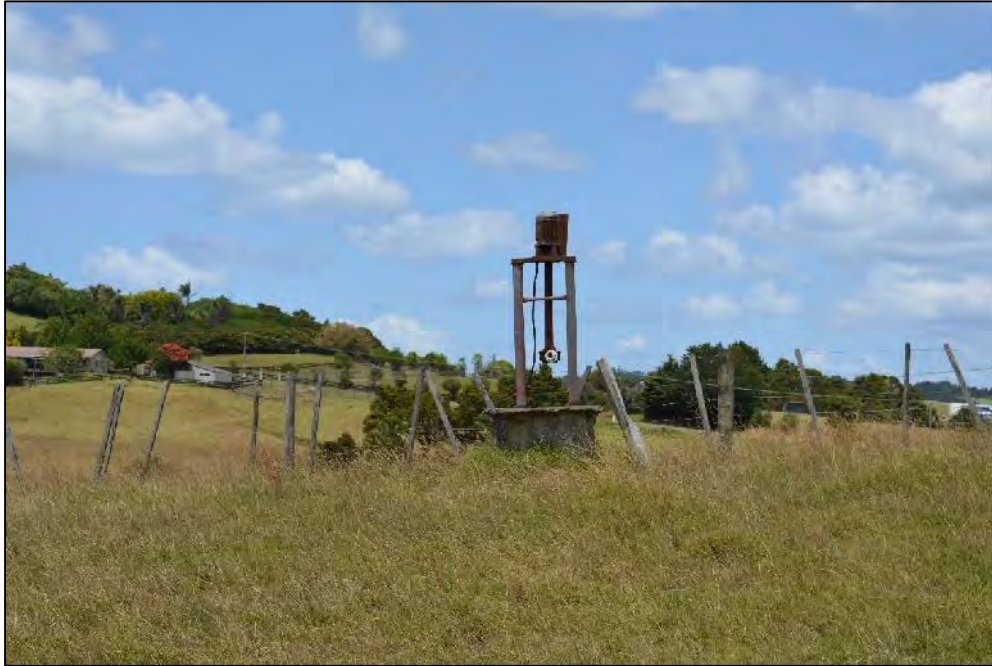
- Effluent from the slaughter house was irrigated on 12 Sanderson Road through a series of pipes and pumps. This included biodegradable wastes only.
- The buildings beside the driveway were a barn and turkey coop. He removed them both to construct the current barn and stock yards.
- Was unaware of any sheep dips or chemical storage sheds on the site.

**Figure 5: Effluent Pump**

Bacteria, viruses, and other microorganisms are biodegradable so any risk will be short term (<6 months), and since tanks and irrigation channels are buried they are unlikely to be disturbed unless there are earth works in this area. As the properties are likely to be vacant for at least 6 months prior to any significant earthworks, the risks associated with the septic tanks and the abattoir are considered to be low, and further investigation is not necessary.

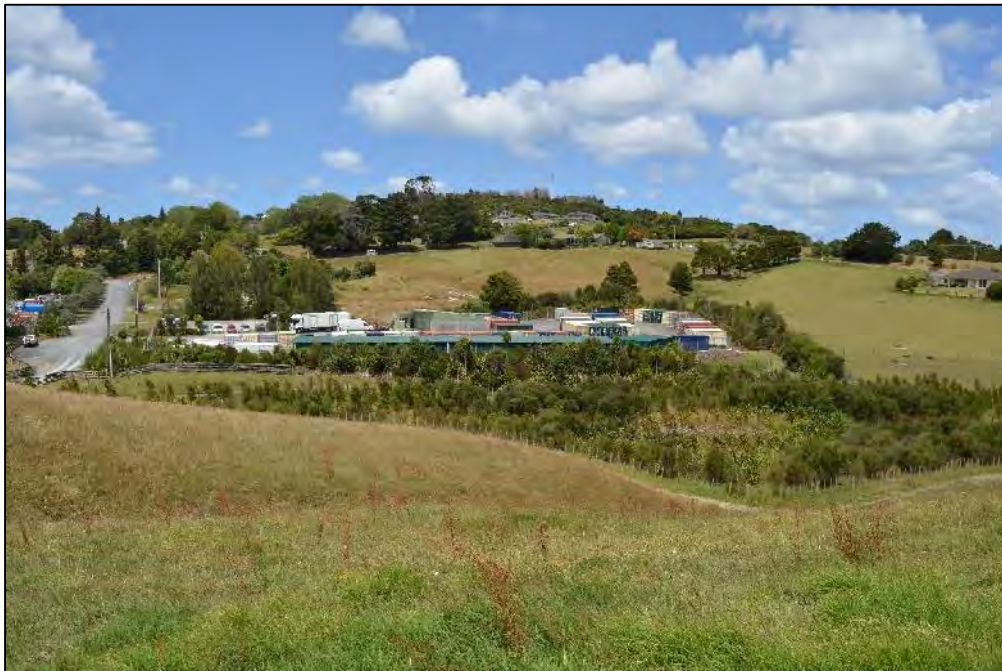
The slaughter house has been removed from 11 Sanderson Road. The site is now a container storage yard.

**Figure 6: Container Storage**

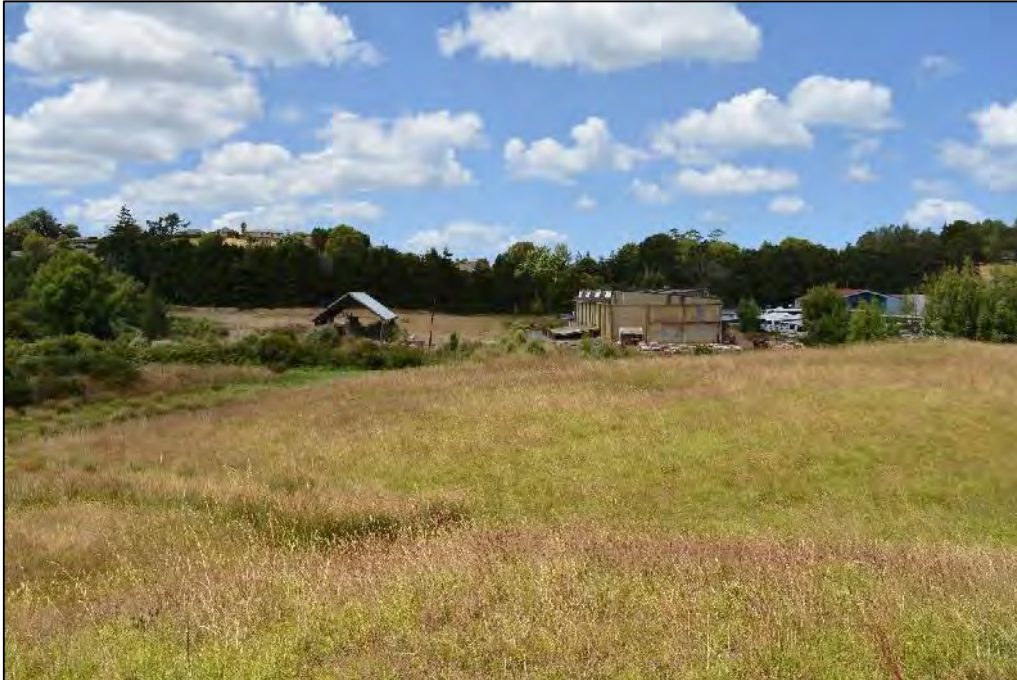
**Figure 7: Tile Factory and Storage**

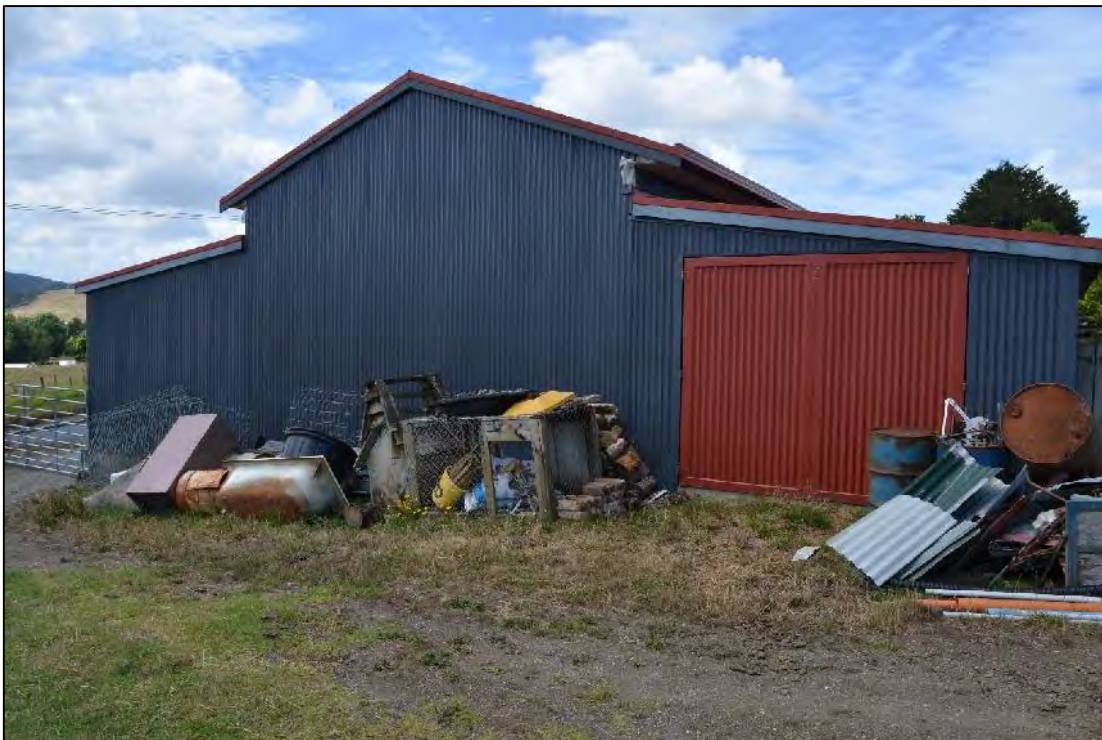
Structures observed during the site visit included the residential house, a hay barn and a woolshed.

**Figure 2: Woolshed**

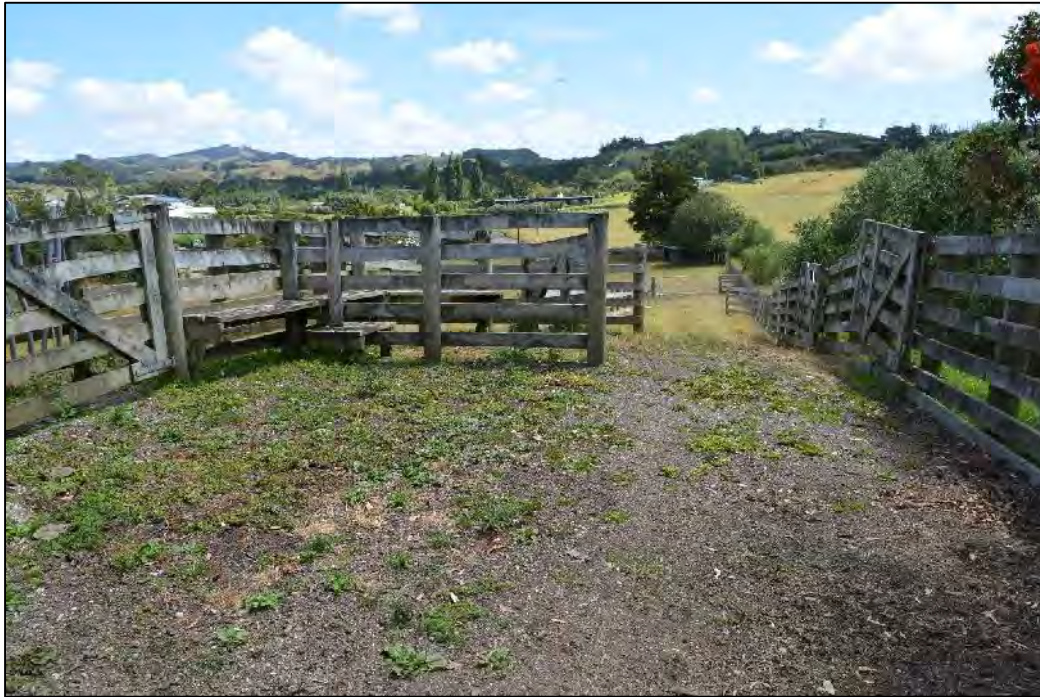
**Figure 3: Stockyards behind woolshed**

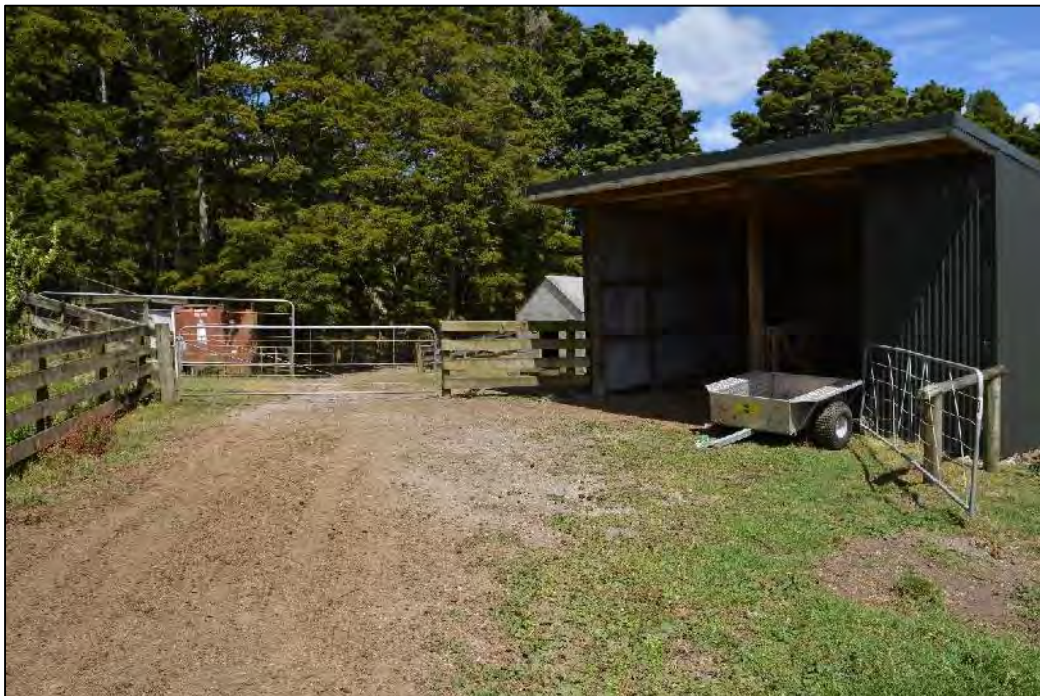
**Figure 4: Hay barn**

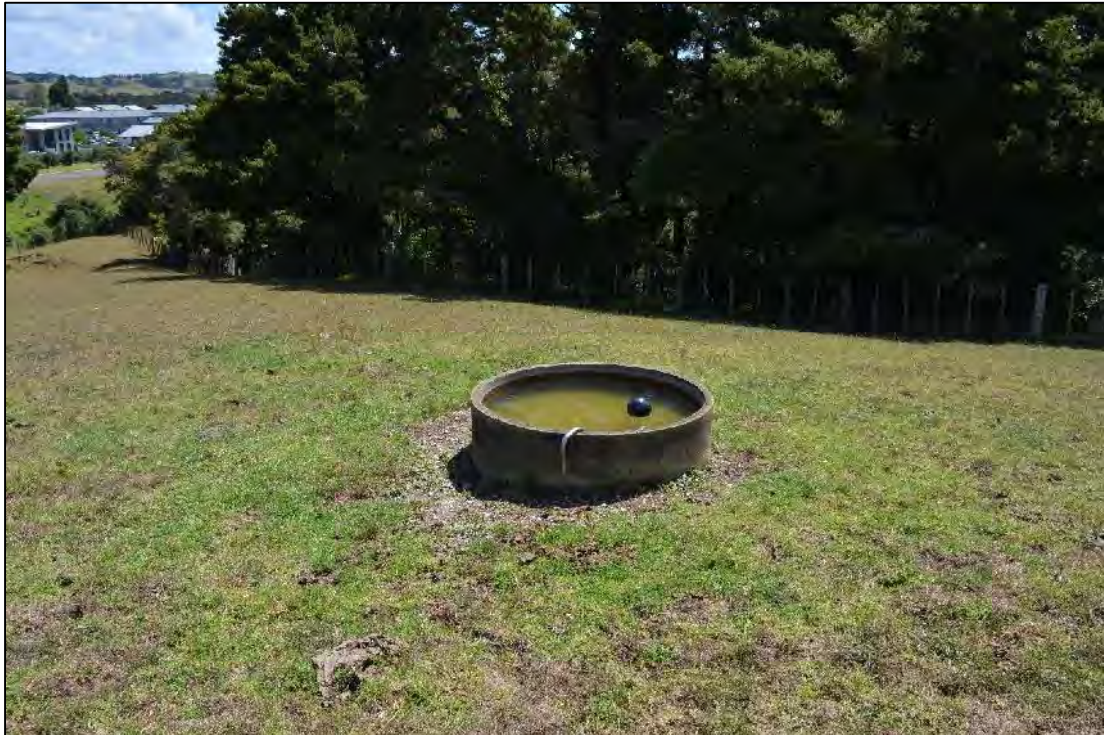
**Figure 5: Water trough**

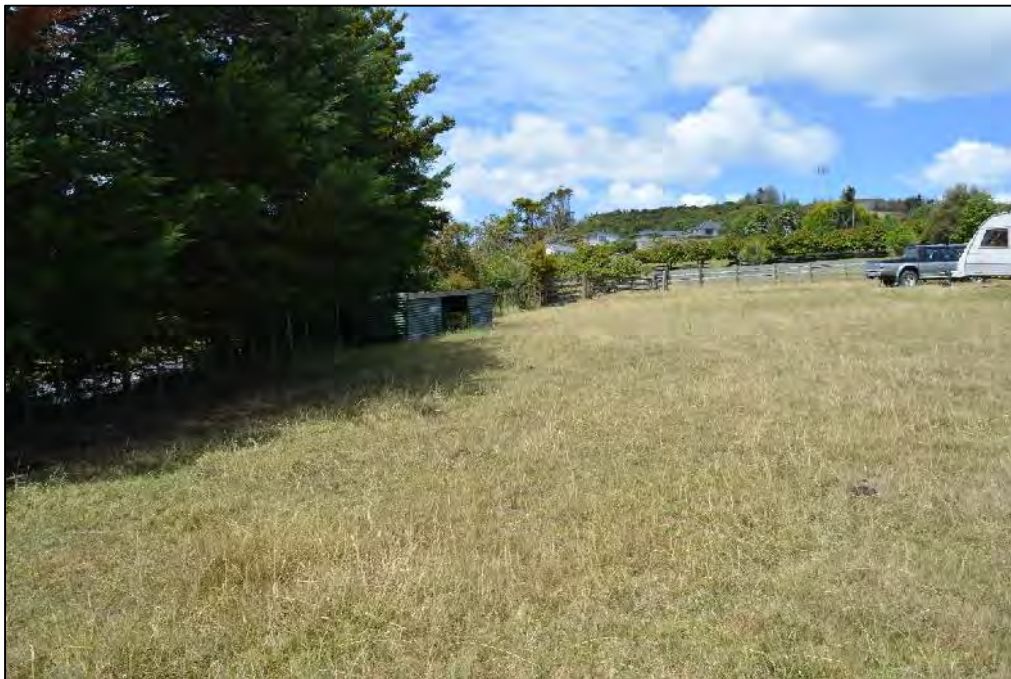
**Figure 6: Site of former dwelling in north-eastern corner of site**

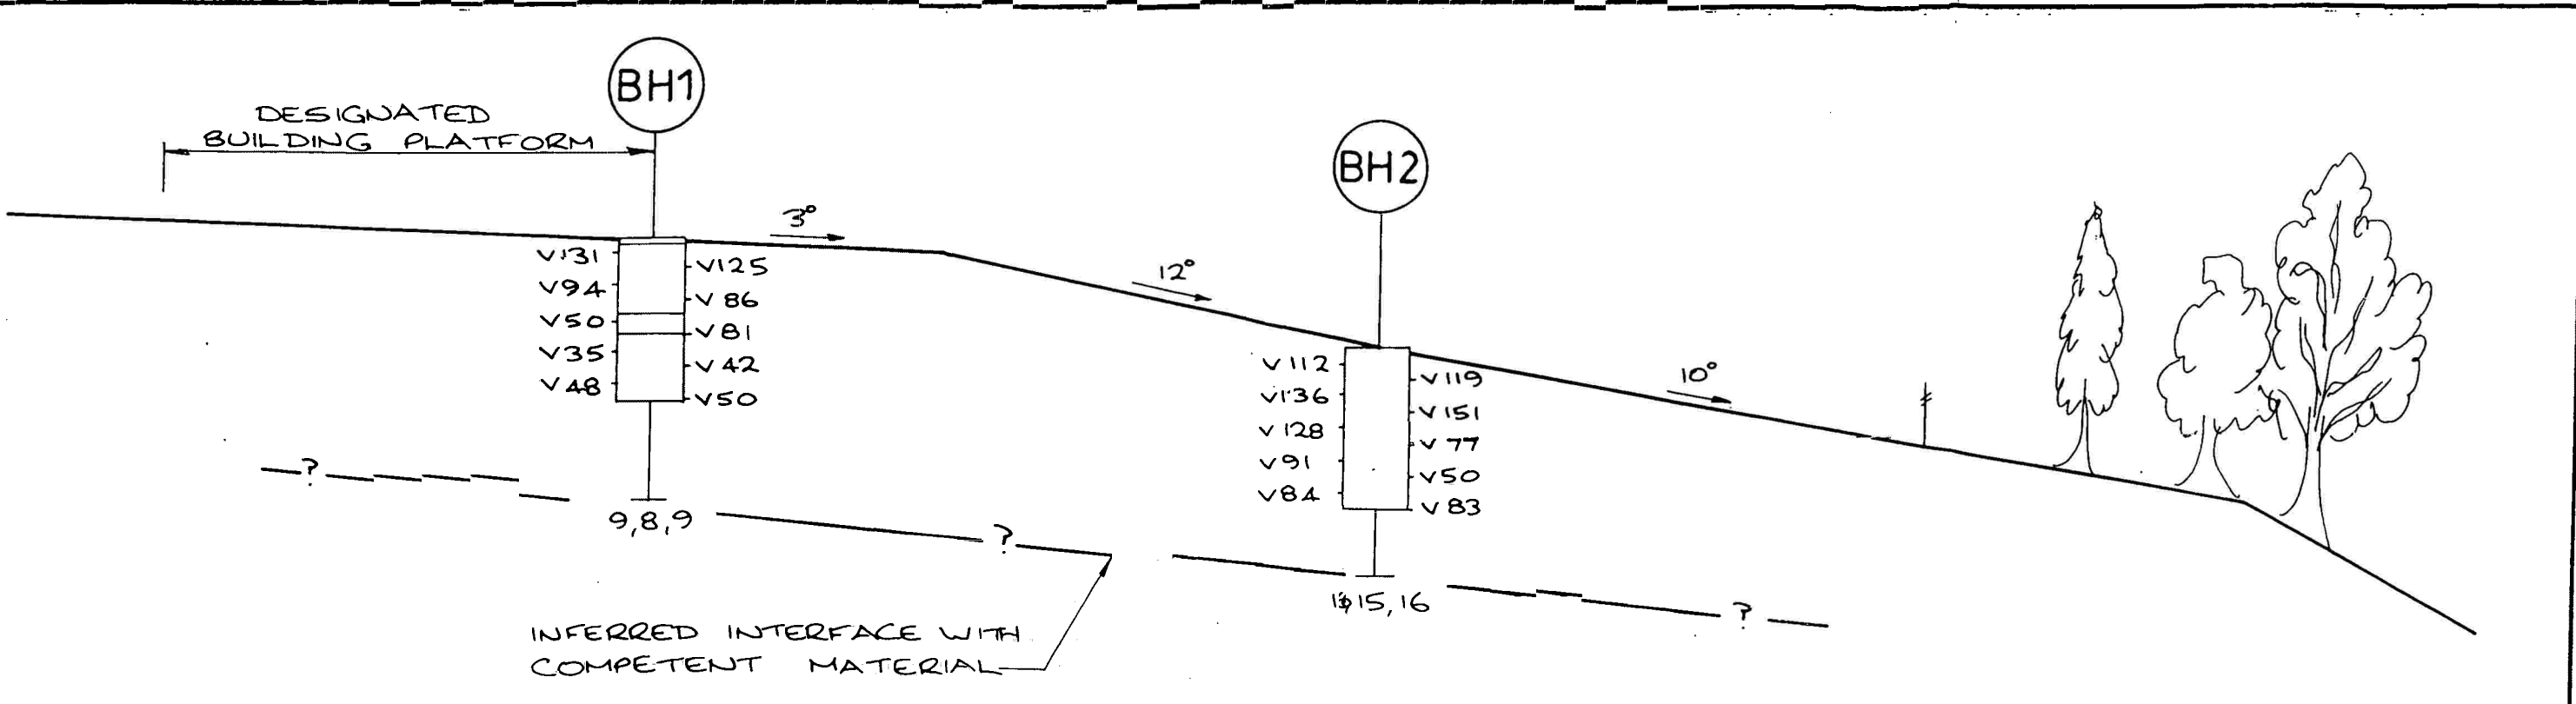
CROSS SECTION A-A'

A previous geotechnical report prepared for the subdivision of 93 Falls Road (Riley Consultants Ltd 1998) included five hand auger holes 5 – 7 metres below ground level (mbgl). The report noted that topsoil depths varied from 100-200 mm across the site. Beneath the topsoil the natural ground consisted of alternating bands of orange brown silts and light grey clays. Materials tended to be firm to very stiff. These observations are in general accordance with the published geology.
